Cause and Control of Transverse Cracking in Concrete Bridge Decks

Final Report
December 2002

1. Report No. FHWA-NJ-2002-019		2. Government Accession No.		3. Recipient's Catalog No.	
4. Title and Subtitle Cause and Control of Transverse Cracking in Concrete Bridge Decks				5. Report Date December 2002

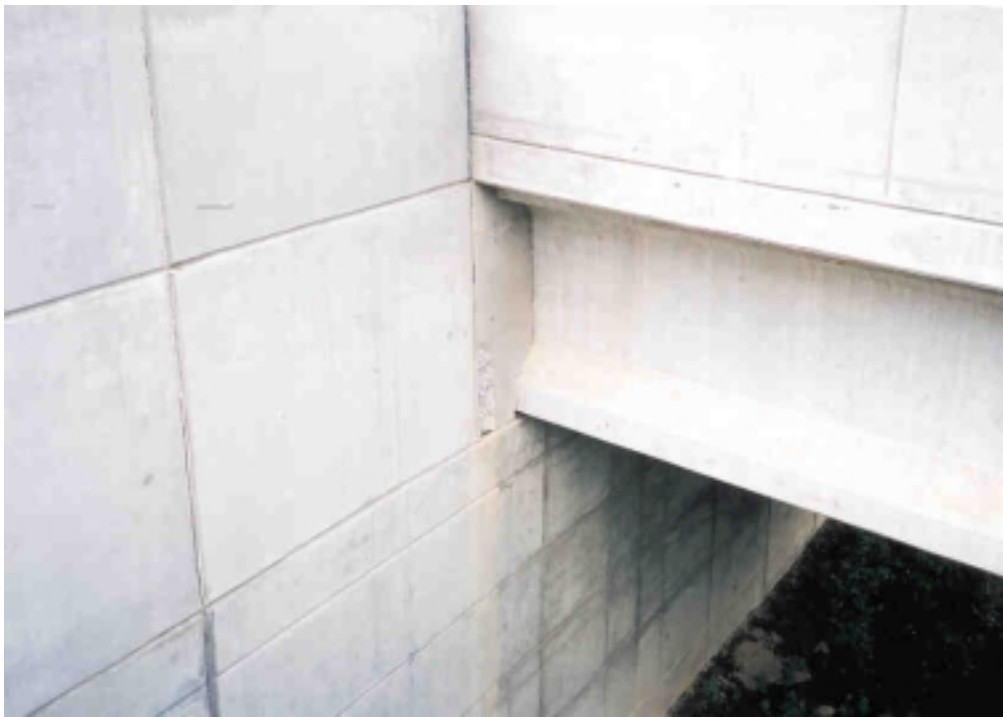
Figure 10. Boundary condition: girders are bounded.

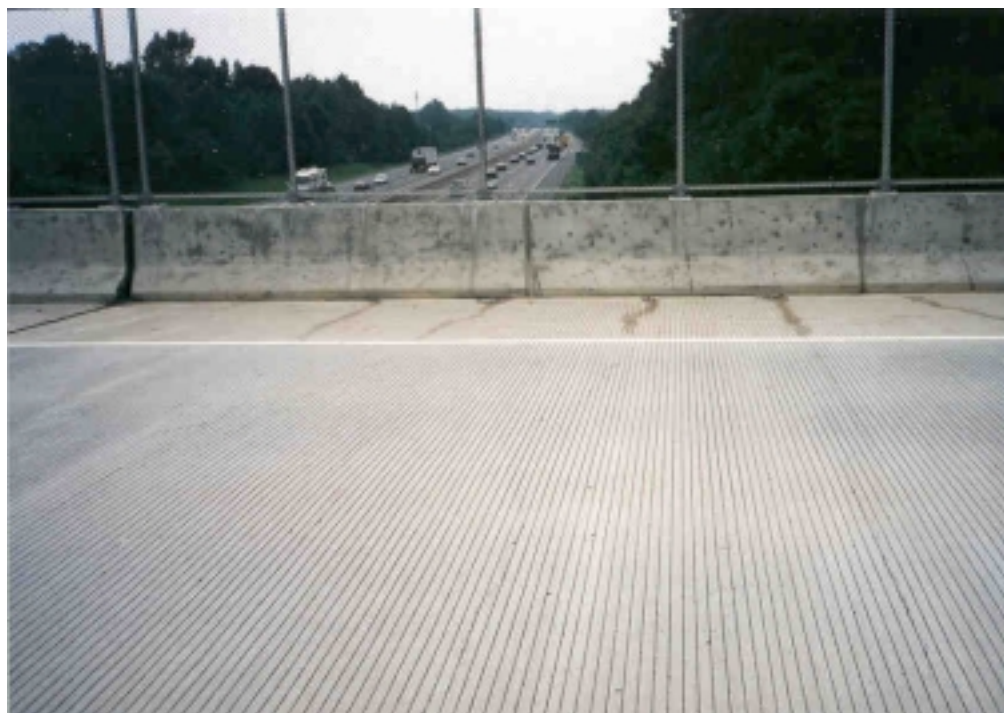
Figure 16. Rt. 133 bridge deck crack.

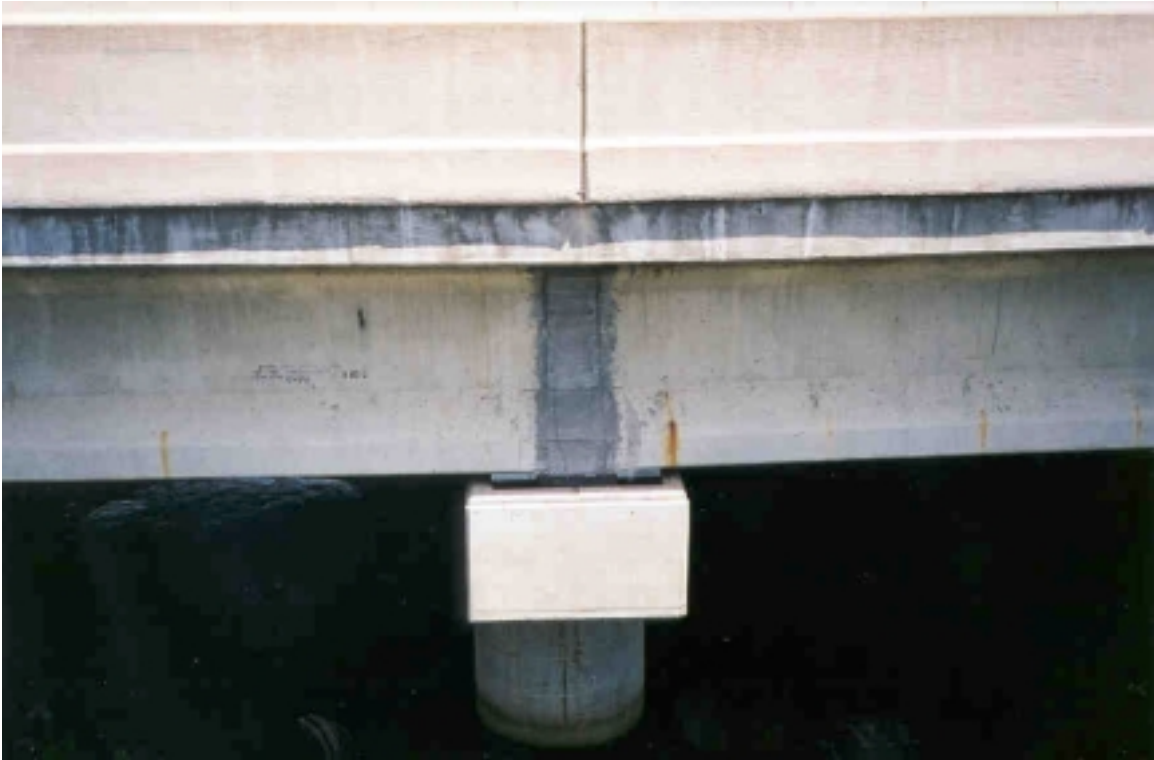
Figure 17. Watson Creek Bridge (West Bound): Cracked continuity joints (bridge No.1130-152).

deck cracking. Examination of the joint continuity for these two bridges showed that the joints on the westbound side were cracked, while the continuity joints on eastbound side were intact (see Figure 17 and 18). That is, the bridge with cracked joint (less rigidity/constraint) did not develop any cracking in the deck, while the one with uncracked joint (more rigid/restraint) did develop transverse deck cracking. These observations point to the role of structural design factors in deck cracking and the need for further research to enhance or knowledge on these factors.

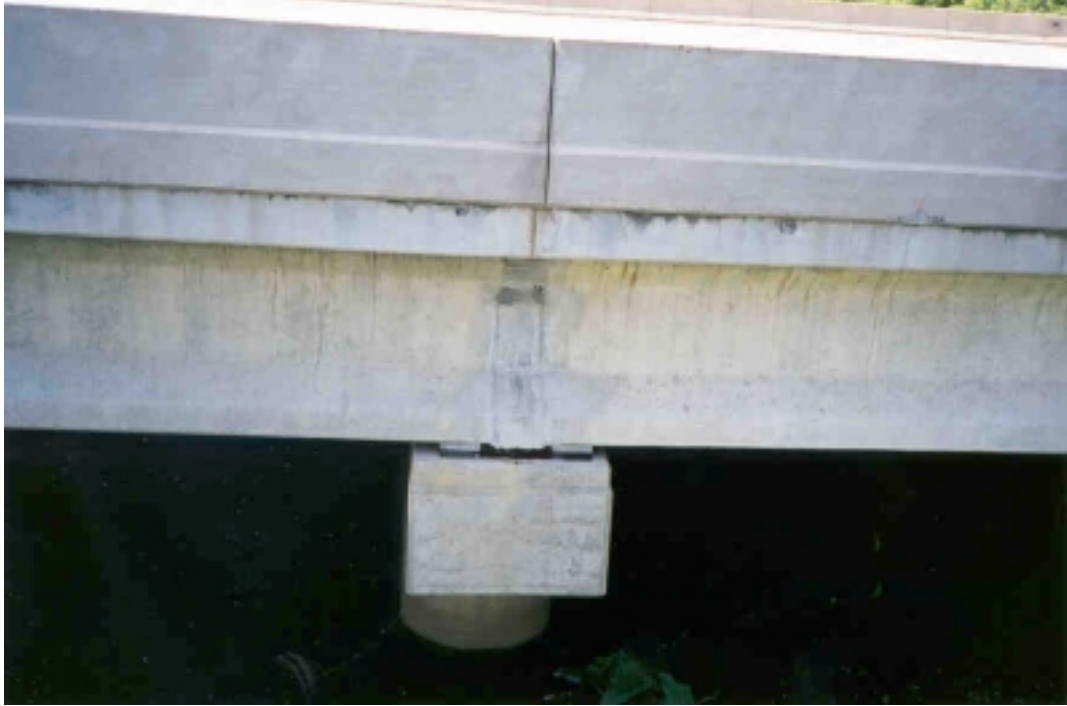
Figure 18. Watson Creek Bridge (East Bound): Un-cracked continuity joints (bridge No.1130-153).

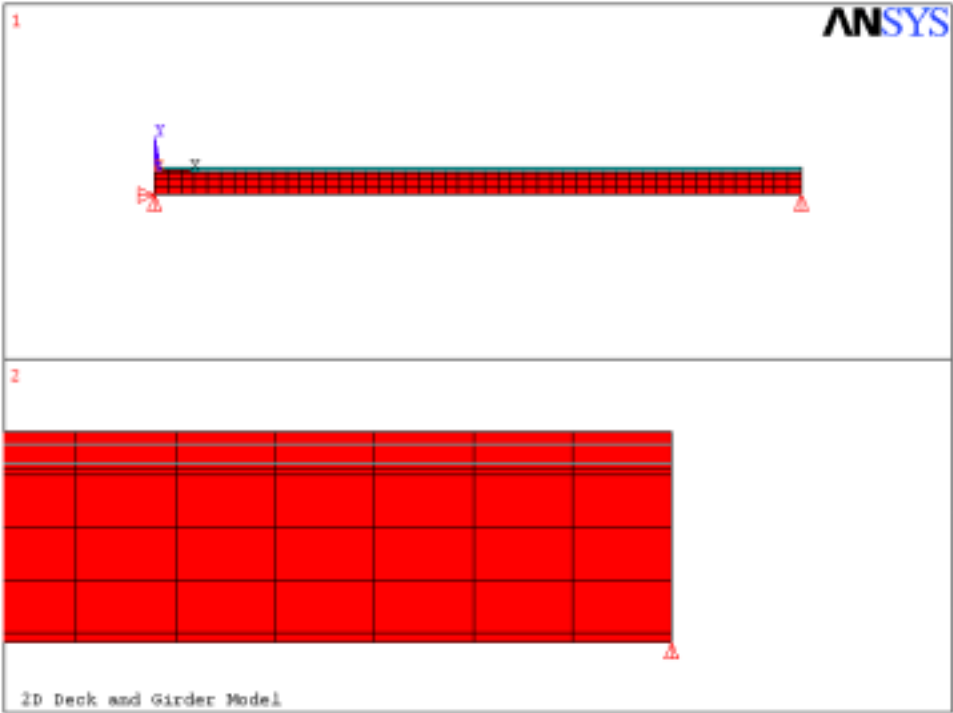
Figure 33. Two-dimensional (2D) finite element model.

Reinforcement Elements: The two layers of longitudinal reinforcement are modeled with truss elements. These elements are placed along the boundary of the deck plane stress elements at two different depths within the deck and are connected to the same nodes as plane stress deck elements. Based on the design detail for the bridge being modeled, total area of truss elements is chosen equal to total area of longitudinal reinforcements at the corresponding depth.

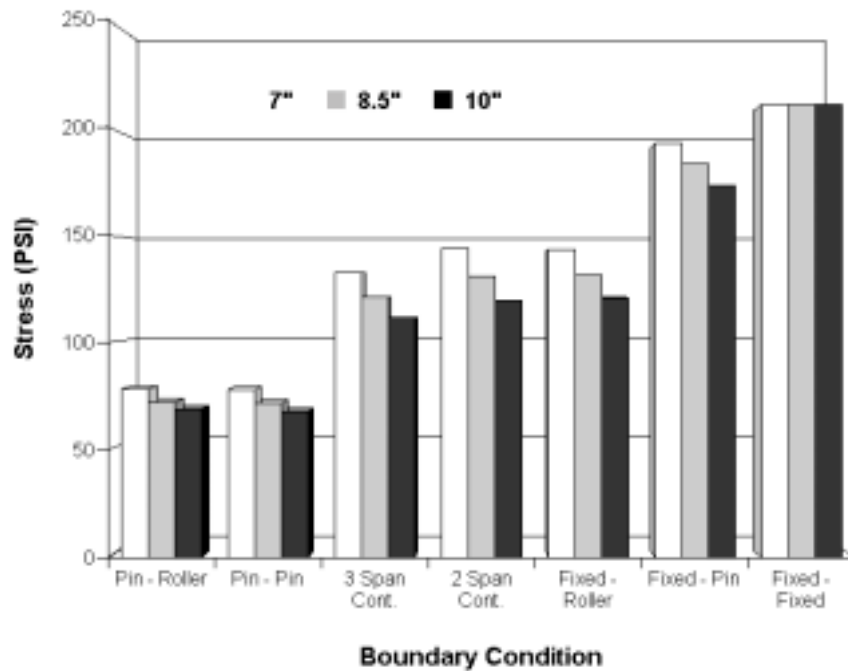
Figure 37. Deck bottom stresses caused by 55-microstrain uniform deck shrinkage for different deck thickness and boundary conditions.

Table 7 shows effect of thickness on deck stresses due to shrinkage. Concrete cover is held constant while deck thickness is changed. Figures 37 and 38 show graphically the effect of deck thickness on bottom and top stresses for different boundary conditions. These stresses are produced by 55-microstrain uniform concrete deck shrinkage.

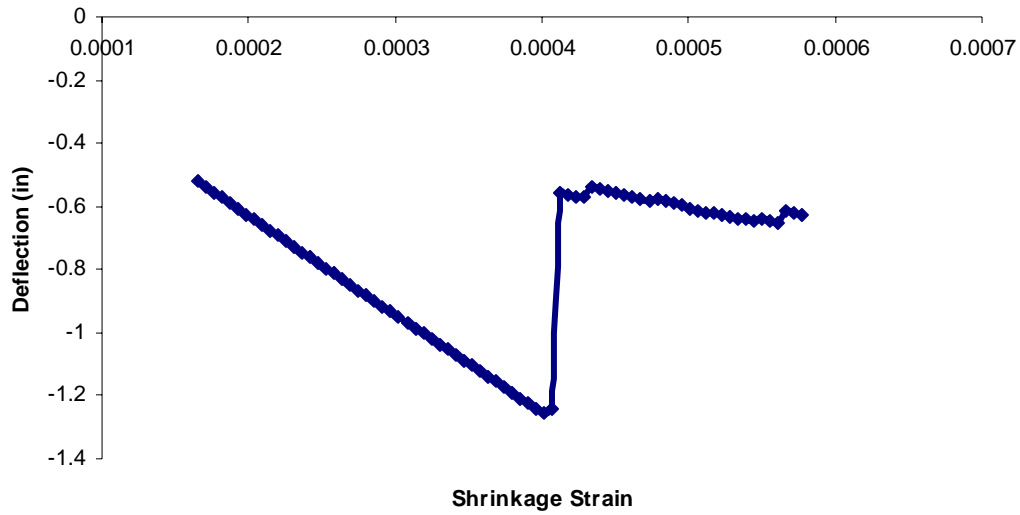
Figure 60. Mid span girder deflection vs. shrinkage strain (pin-roller case).

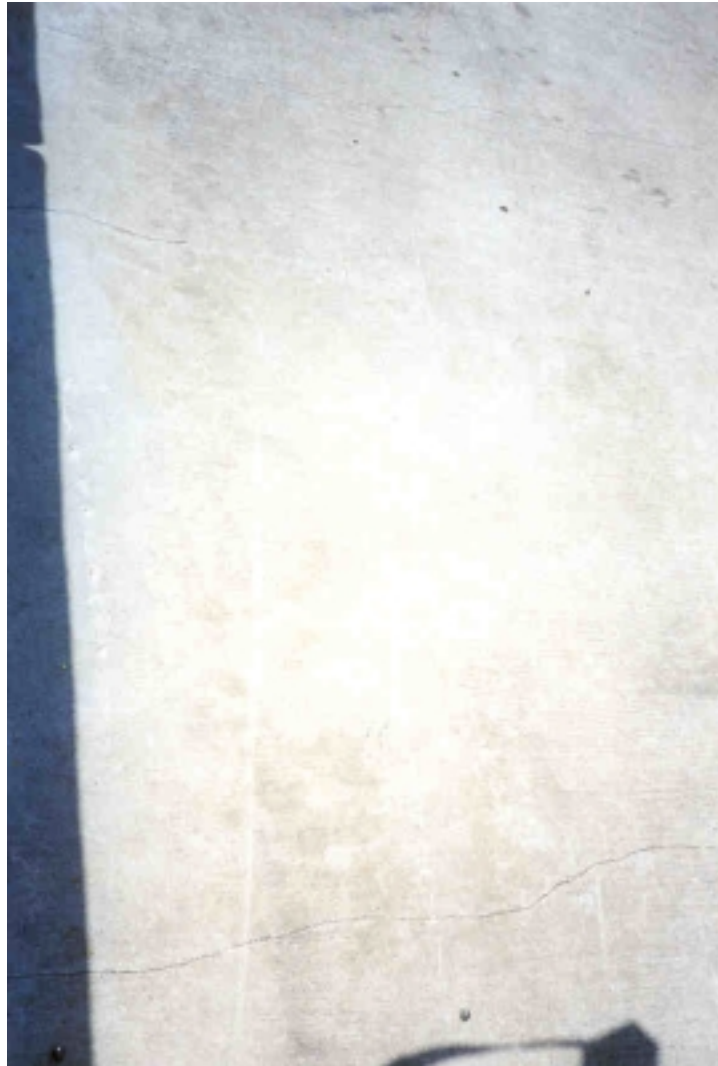
Figure 90. Crack on the deck (Bridge No 0713-151).

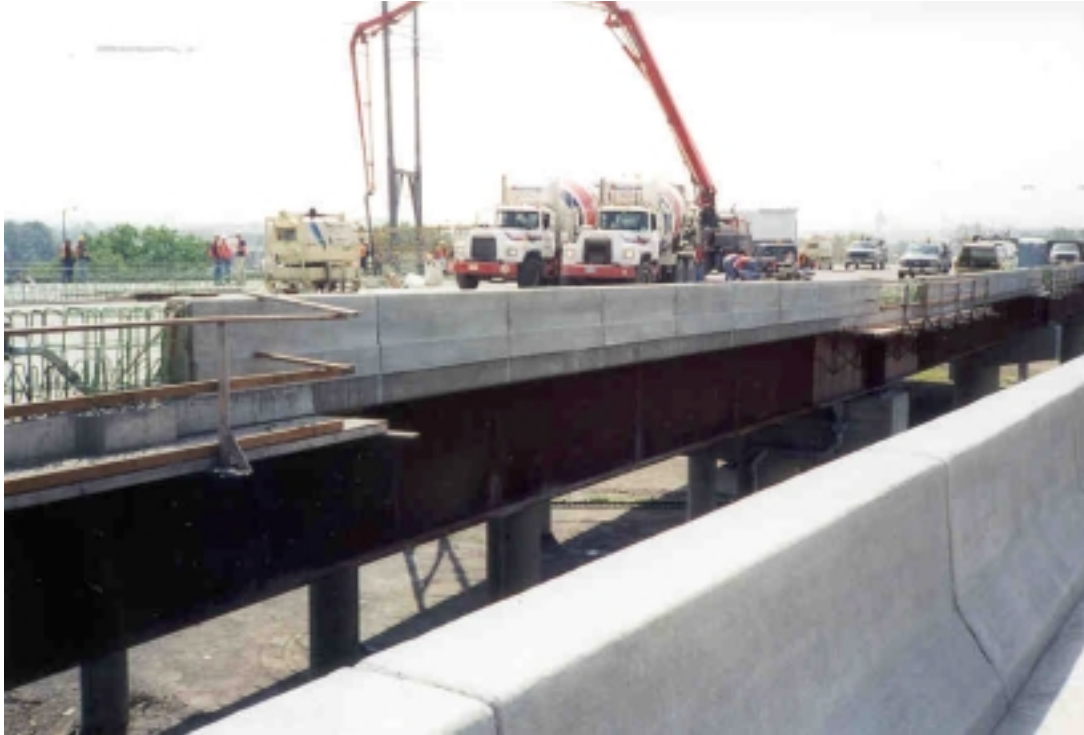
Figure 91. Construction vehicle traffic on the bridge (Bridge No. 0713-151).

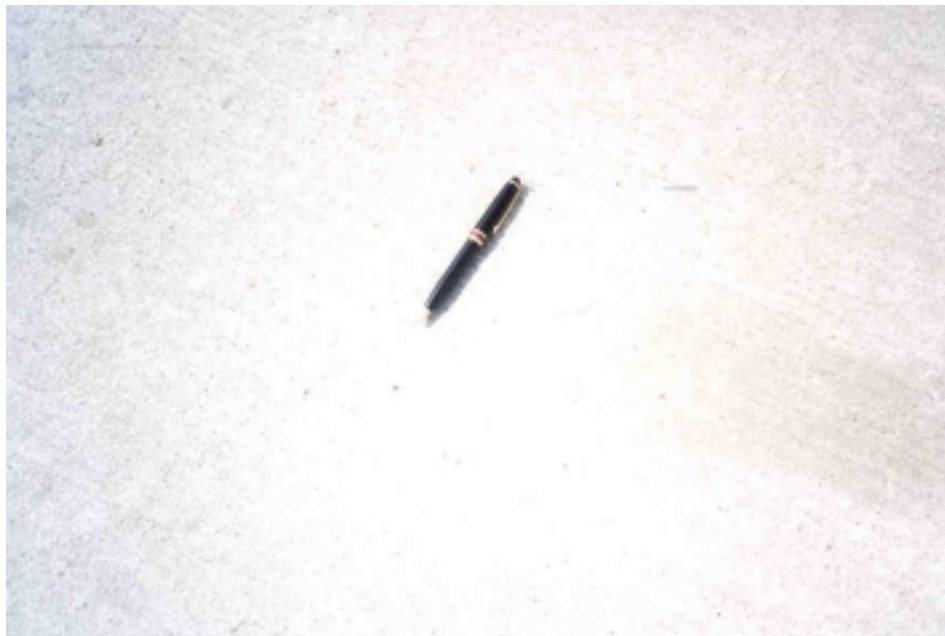
Figure 92. Crack on the deck (Bridge No. 0713-151).

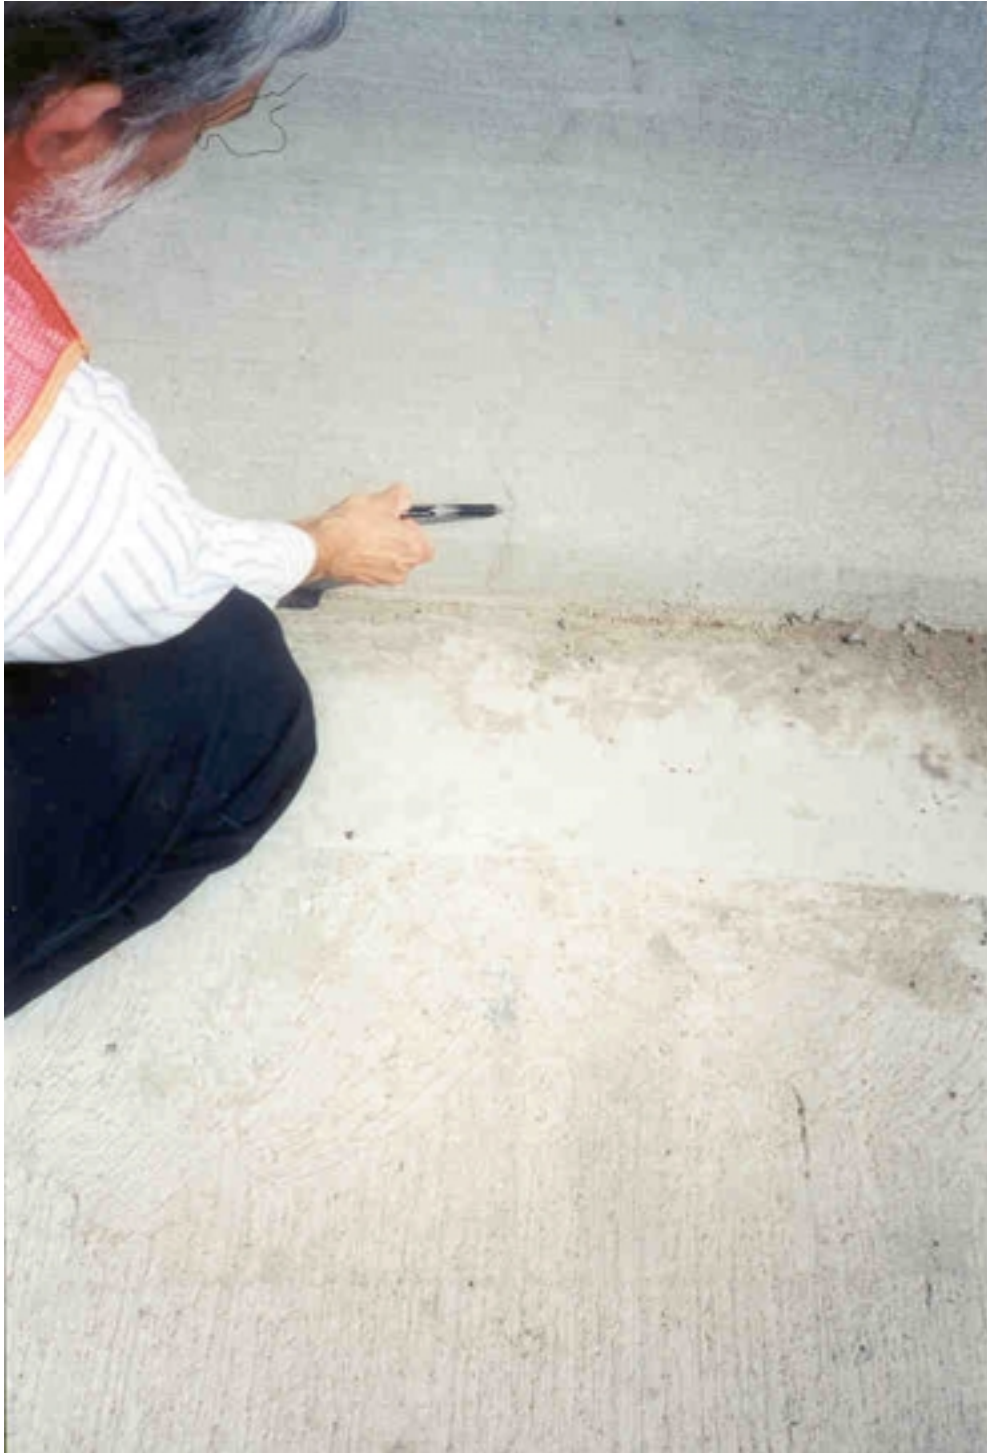
Figure 93. Crack extending into the parapet (Bridge No. 0713-151).

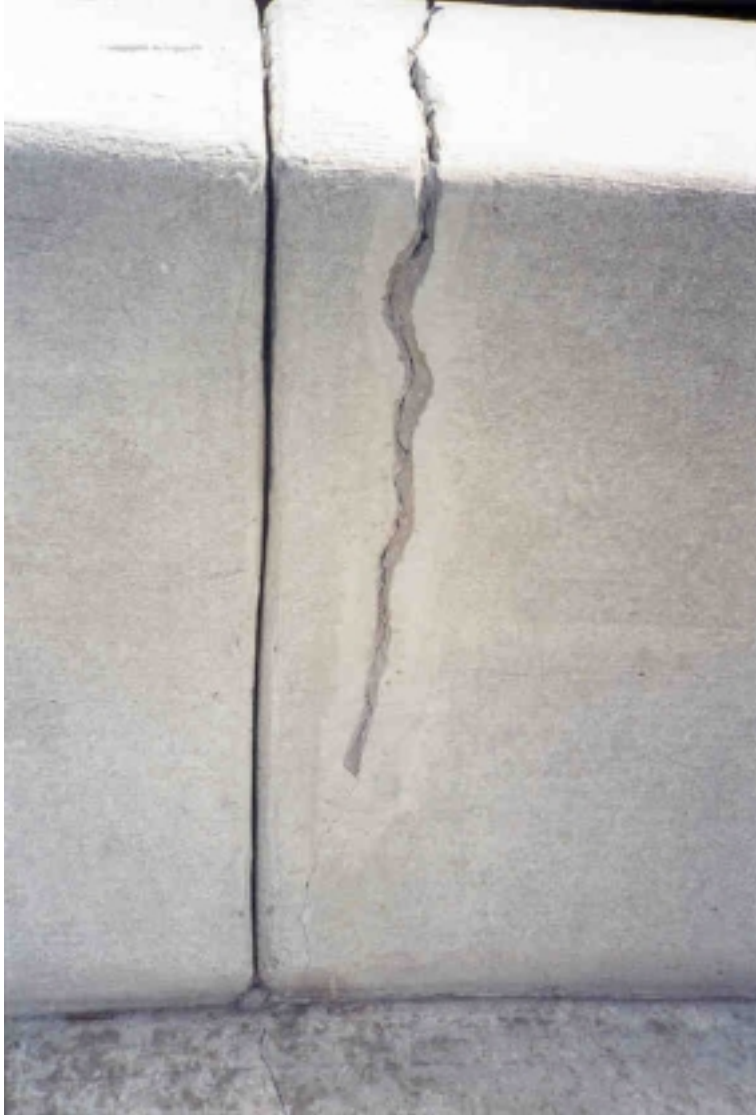
Figure 94. Crack on deck and parapet (Bridge No. 0173-151).

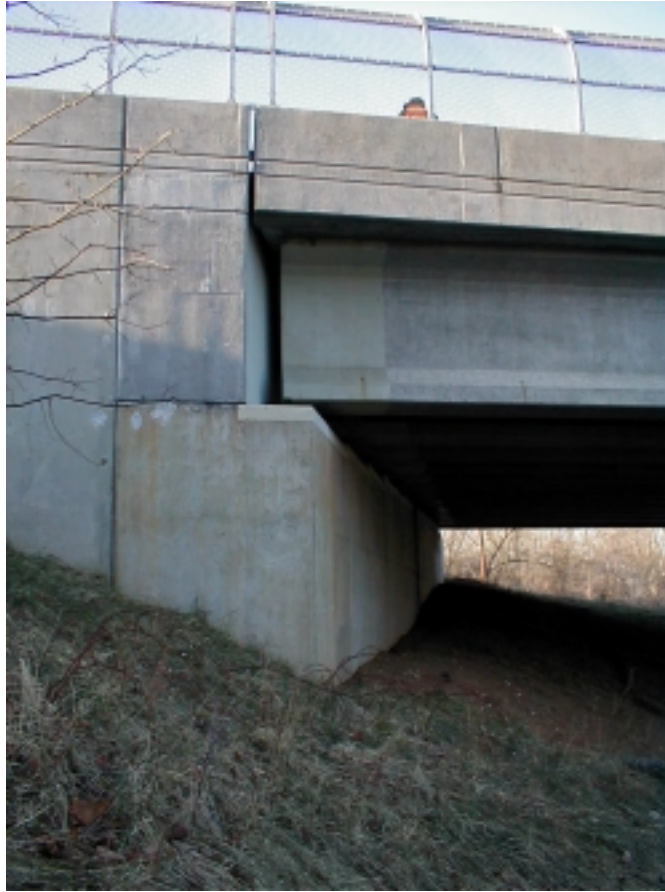
Figure 96. Girder end condition at the abutment (Bridge No. 1013-151).

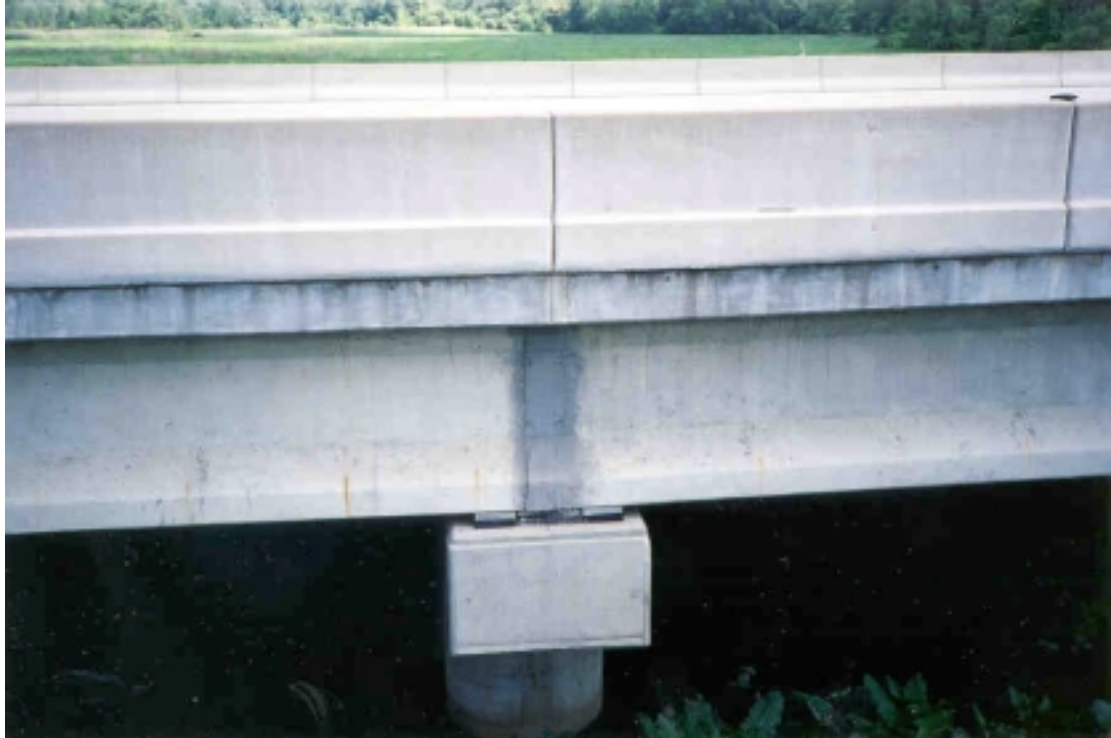
Figure 97. Cracked continuity joint (Bridge No. 1130-152).

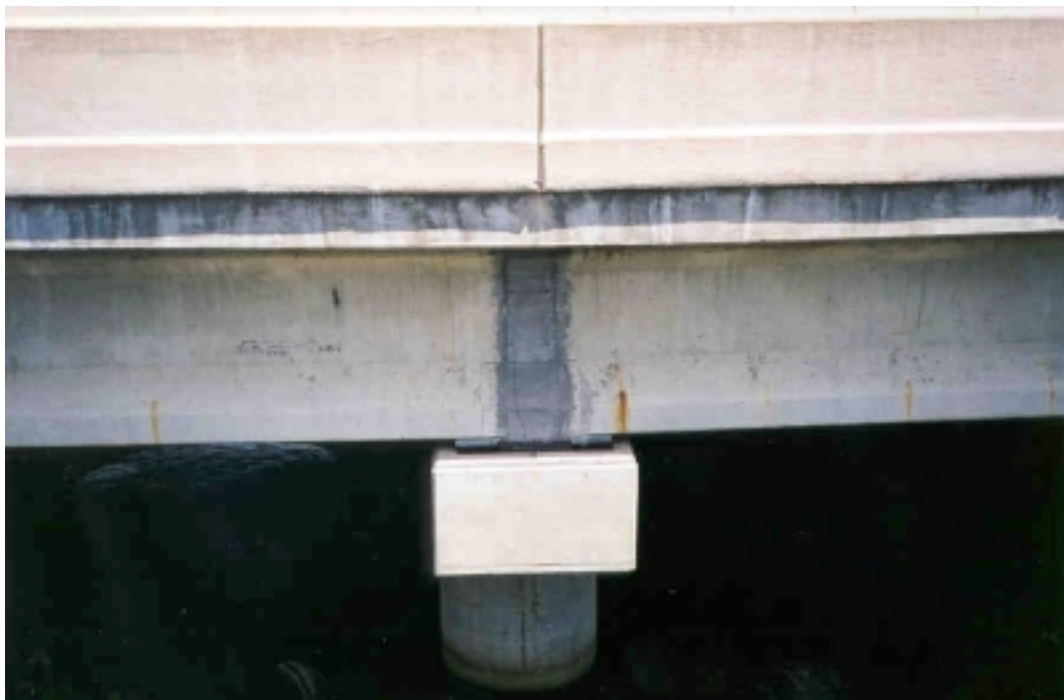
Figure 98. Another cracked continuity joint (Bridge No.1130-152).

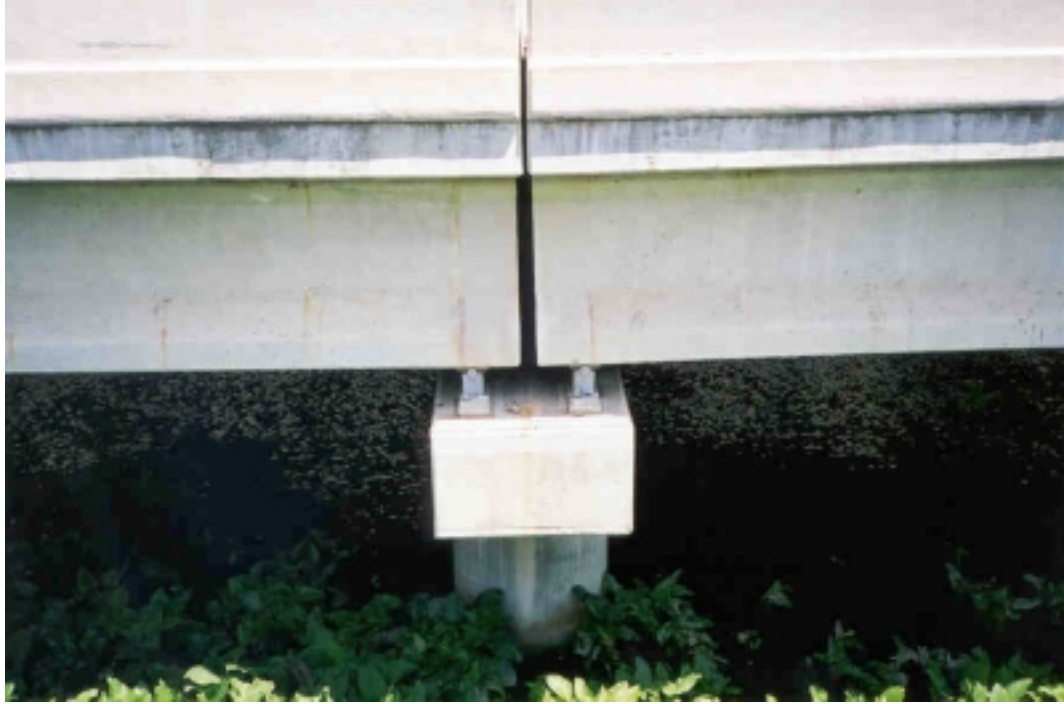
Figure 99. End condition in simply supported spans (Bridge No 1130-152).

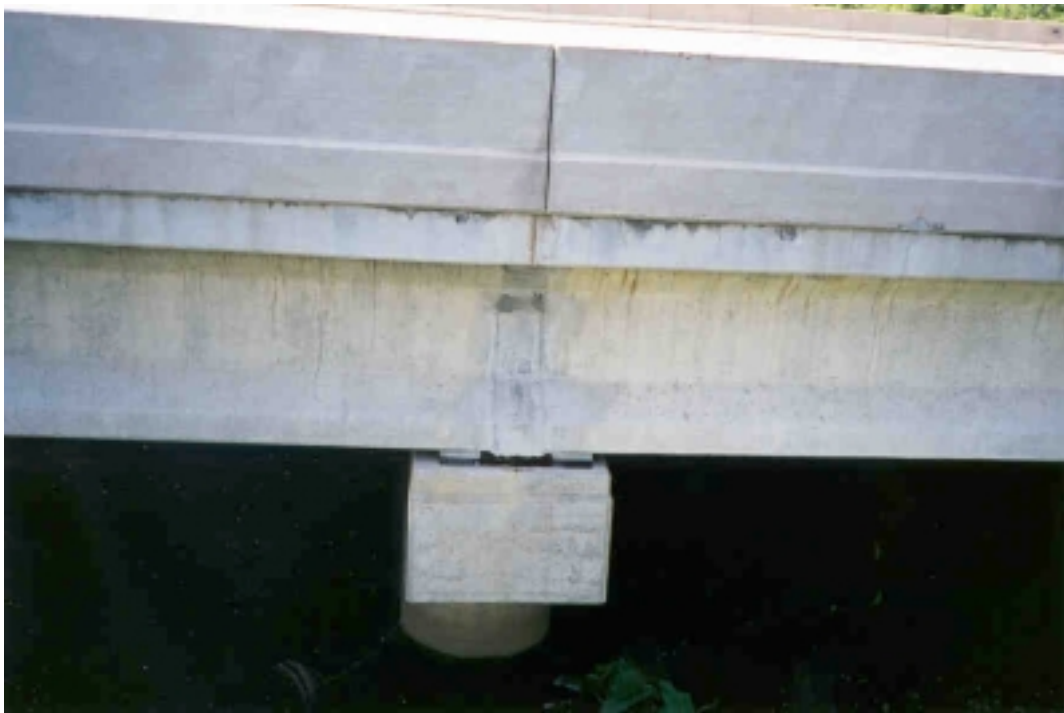
Figure 101. Un-cracked continuity joint (Bridge No.1130-153).

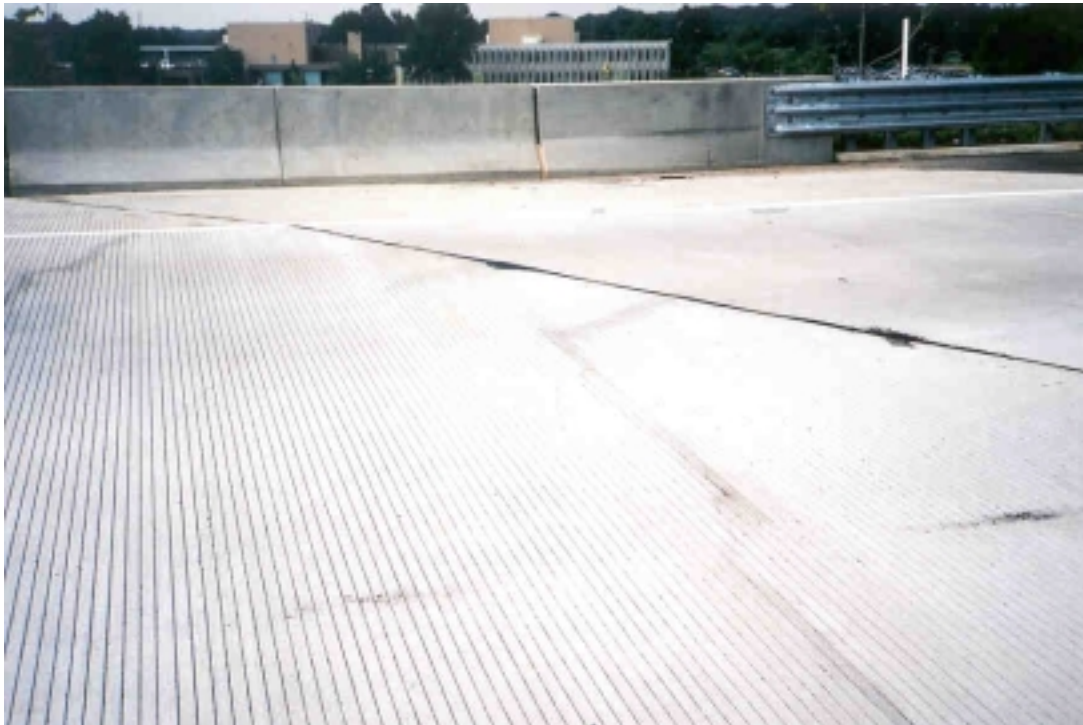
Figure 102. Deck cracks at the bridge end (Bridge No. 1143-466).

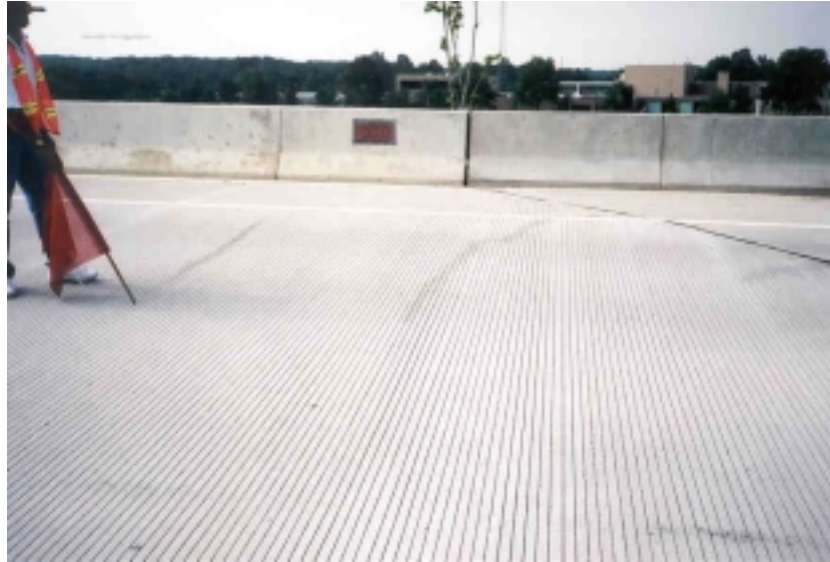
Figure 103. Wide view of deck cracks at the bridge end (Bridge No. 1143-466).

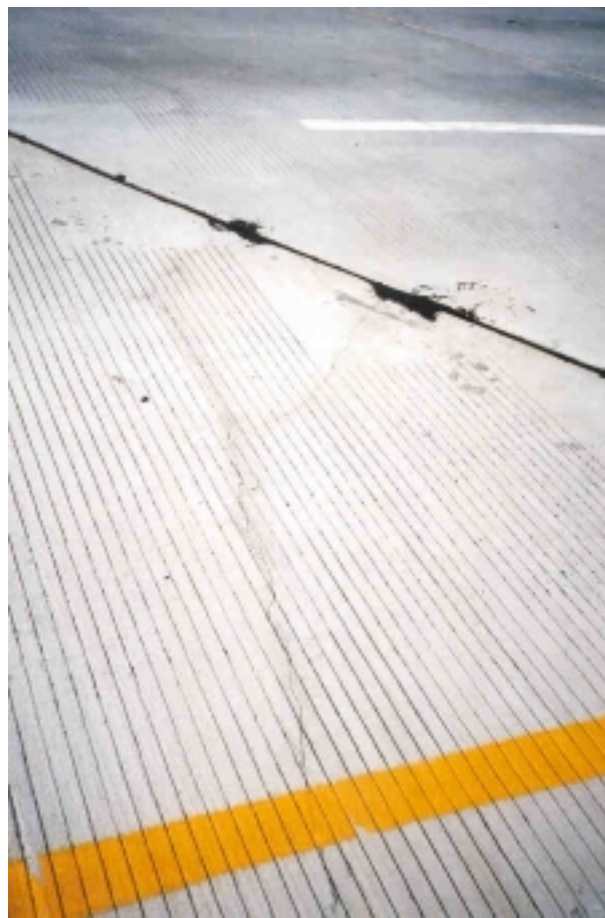
Figure 104. Close view of a crack (Bridge No. 1143-166).

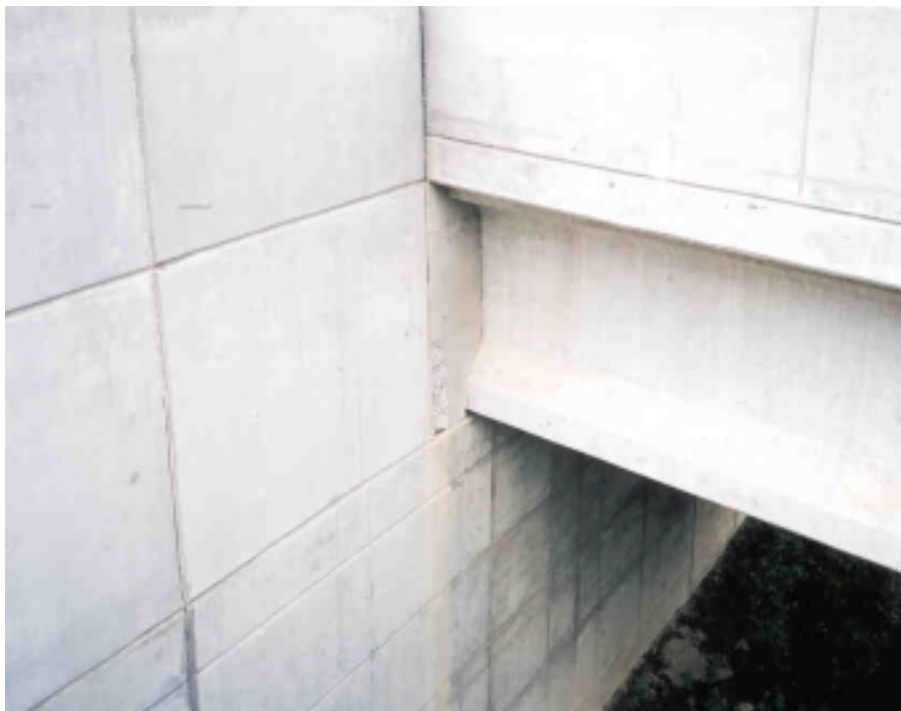
Figure 105. Girders embedded in end diaphragm (Bridge No.1143-168).

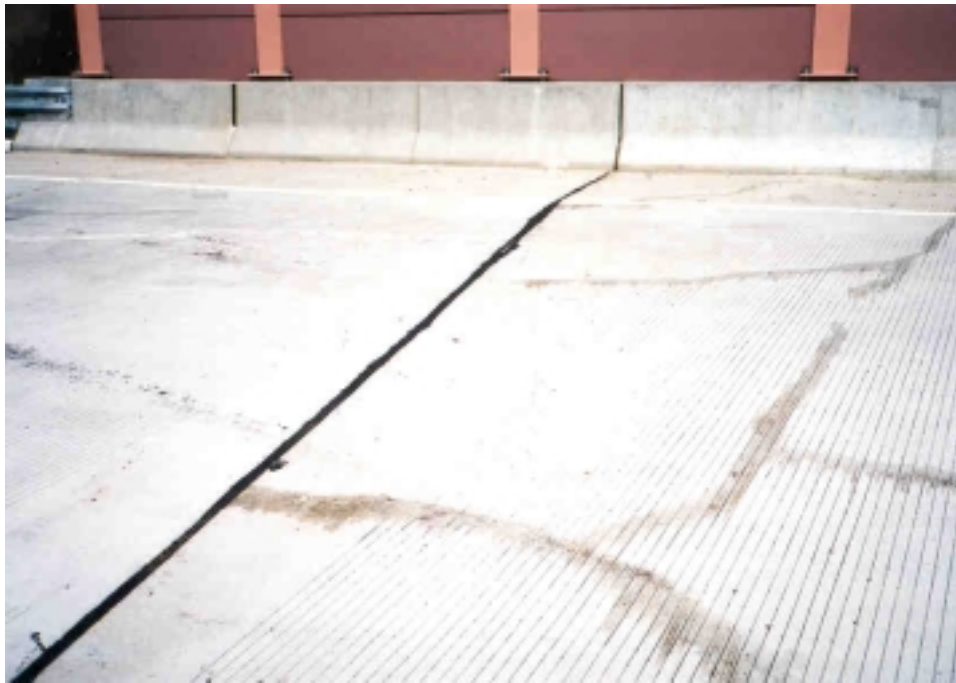
Figure 107. Transverse cracks on bridge deck (Bridge No. 1143-169).

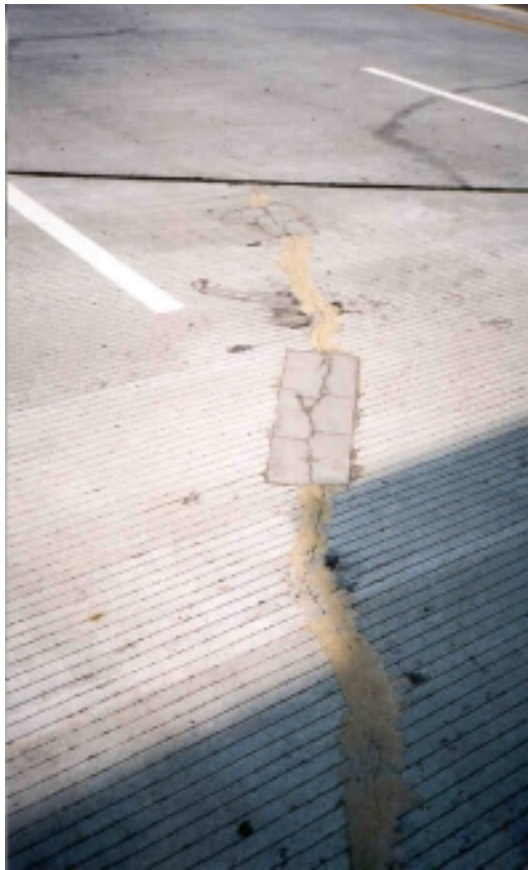
Figure 108. Repaired transverse crack (Bridge No. 1143-170).

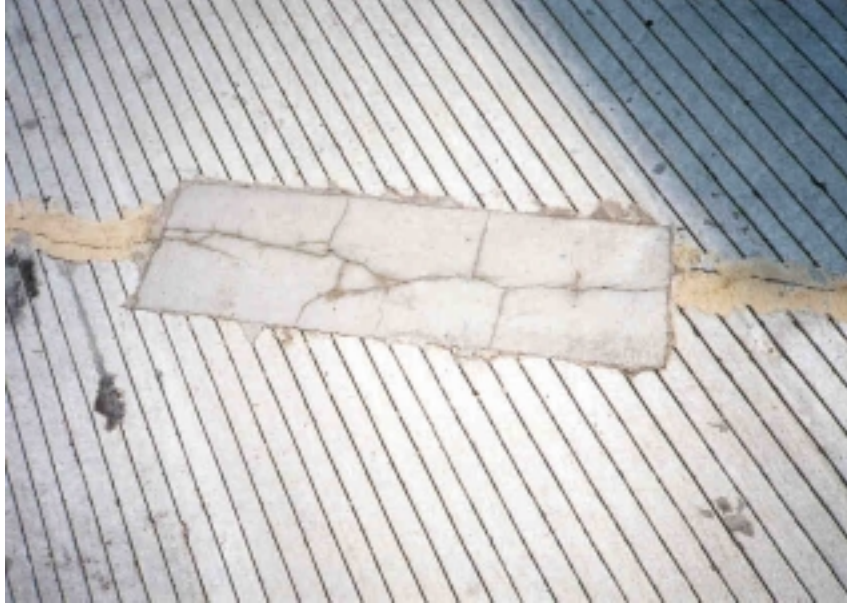
Figure 109. Close up view of repair patch (Bridge No. 1143-170).

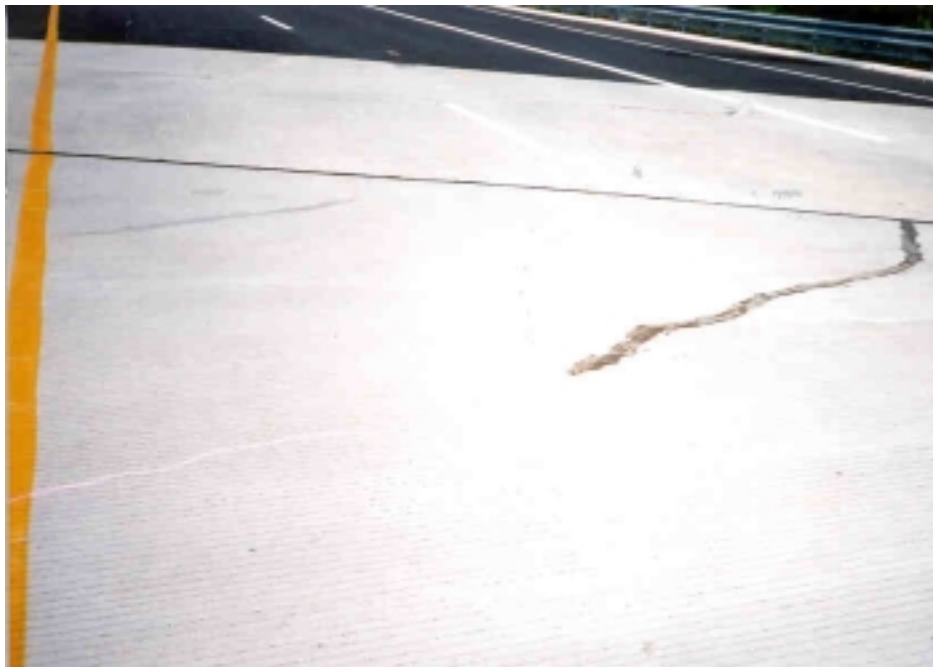
Figure 110. Cracks on the deck (Bridge No.1143-171).

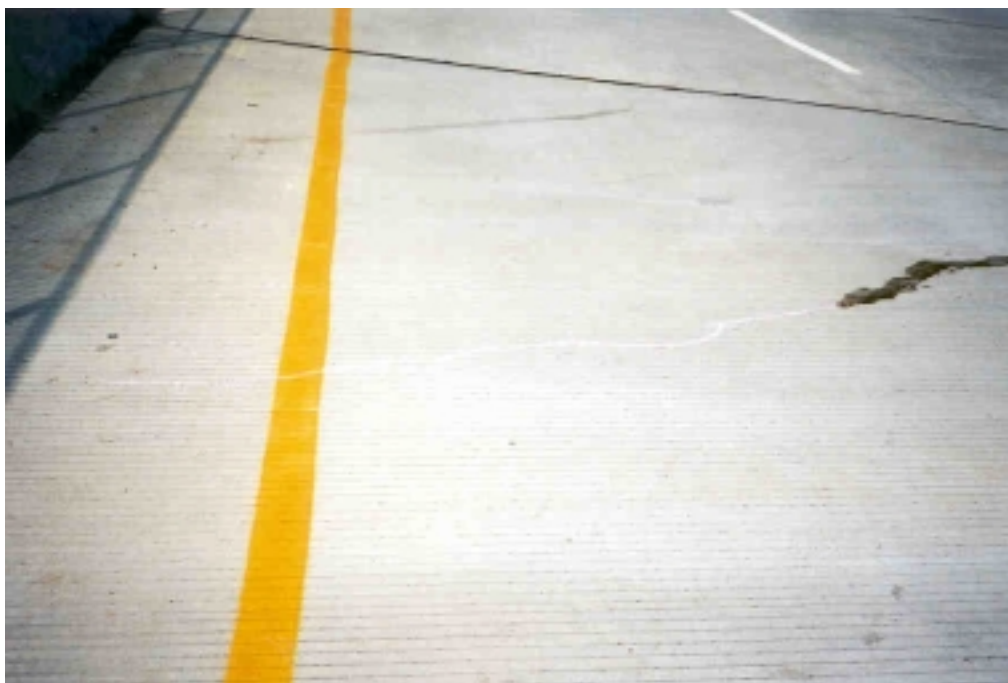
Figure 111. Another marked crack on the deck (Bridge No.1143-171).

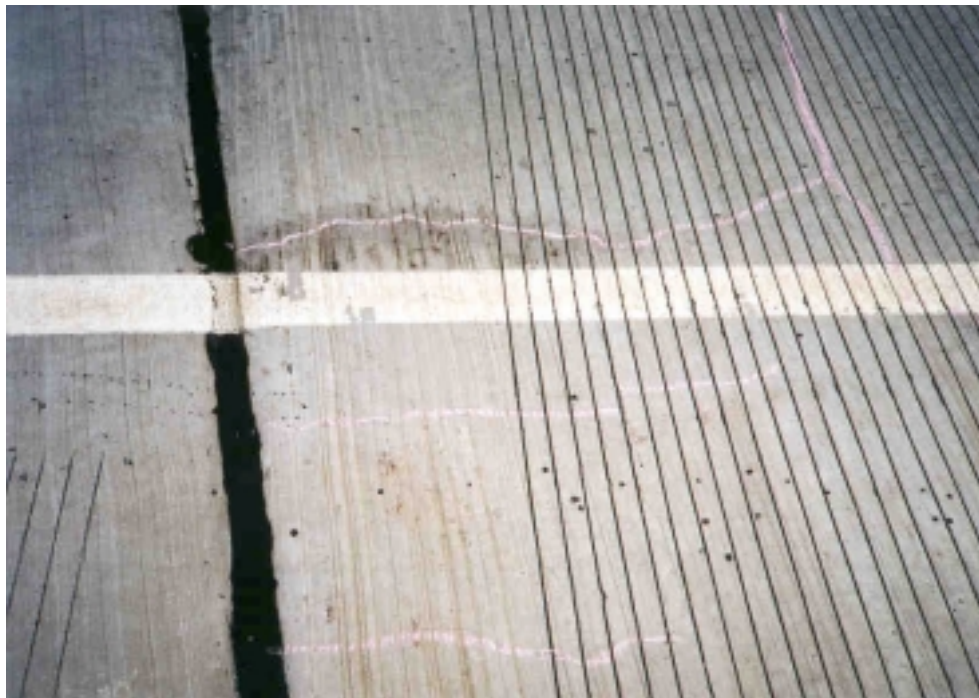
Figure 112. Close up view of deck cracks at the ends (Bridge No.1143-172).

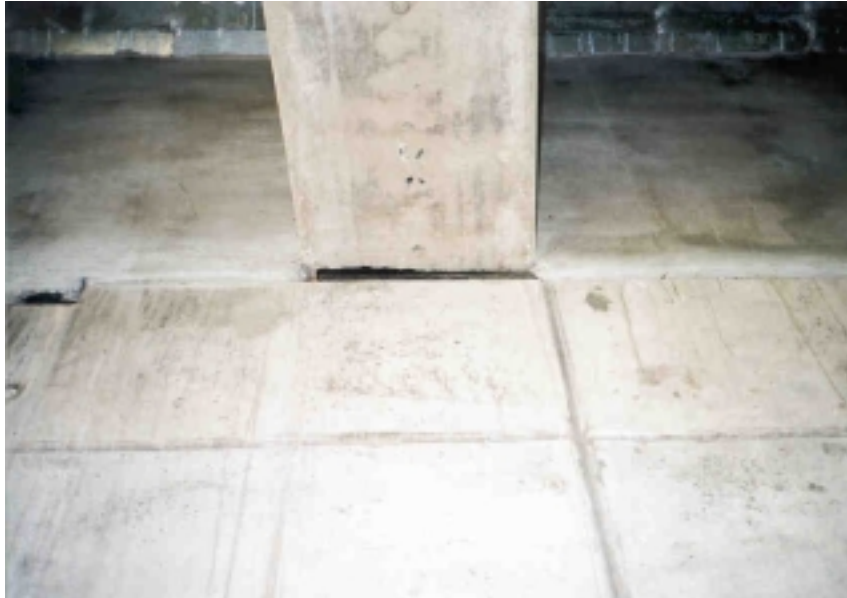
Figure 113. End diaphragm (Bridge No.1143-176).

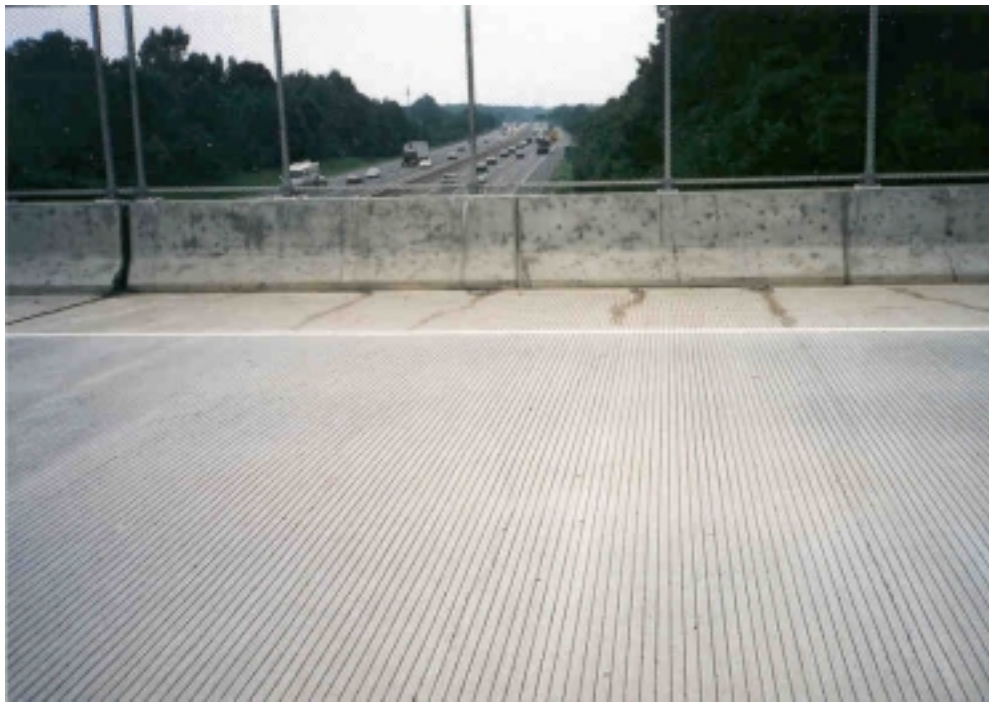
Figure 115. Transverse deck cracks on Bridge No.1143-176 (NJ Turnpike in the background).

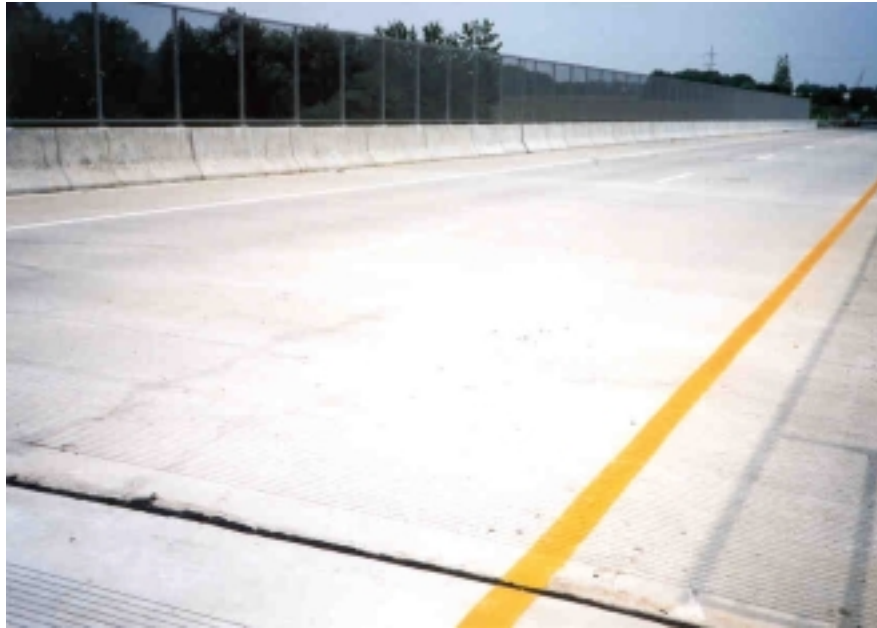
Figure 116. Transverse (and longitudinal) cracks on deck (Bridge No.1143-177).
