DOT/FAA/TC-13/26

Durability and Damage Tolerance Testing of a Beechcraft Starship Forward-Wing With Large Damages

April 2017

Final Report

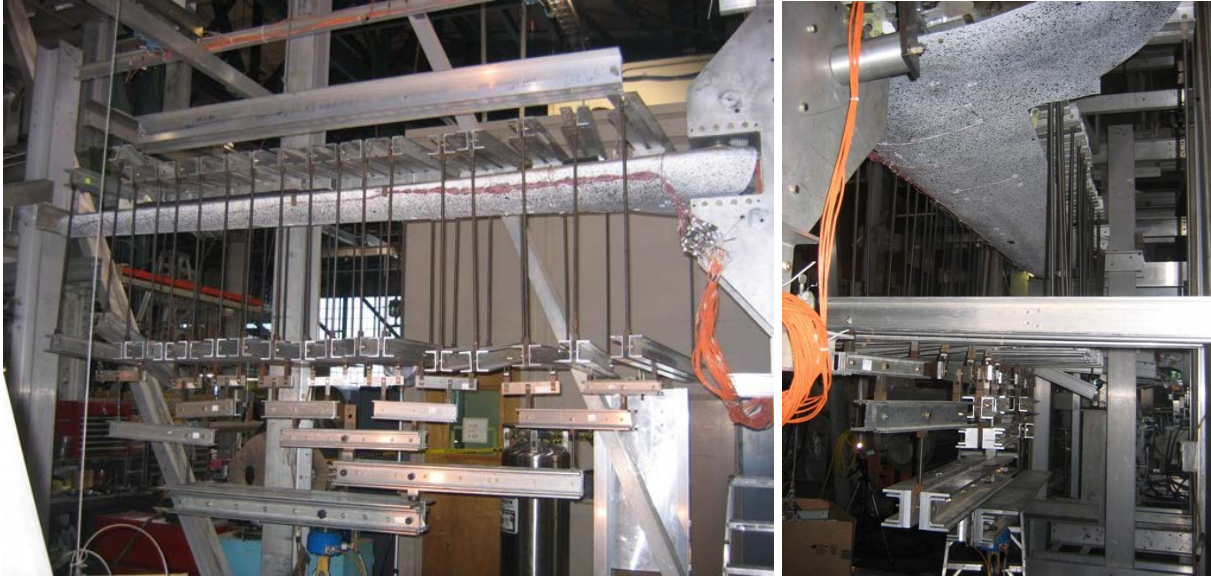
Figure 5. Full-scale static test setup—load formers

Load-formers and bonded patches attached to whiffletree assemblies were used to load static (figure 5) and fatigue (figure 6) test articles, respectively. Each actuator was connected to the test rig and to the loading fixture through swivel (universal) joints releasing rotational degrees of freedom to minimize localized bending and unintentional side loads. A static test whiffletree was attached to the actuator through a steel cable-pulley assembly and the control load cell was mounted directly to the whiffletree end through a hinge connector. This arrangement reads the applied load at the whiffletree and eliminates errors induced by the friction of the pulley assembly.

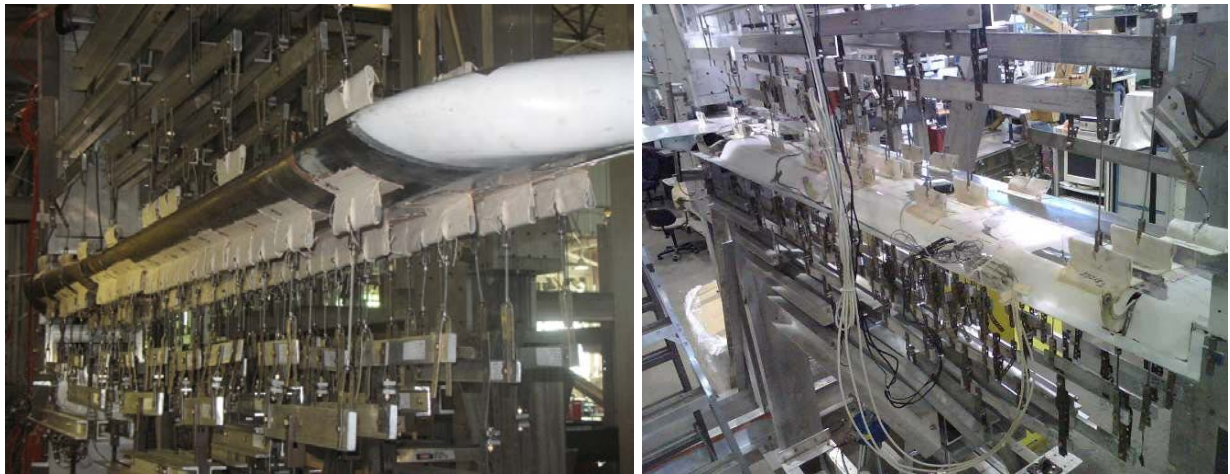
Figure 6. Full-scale fatigue test setup—load patches

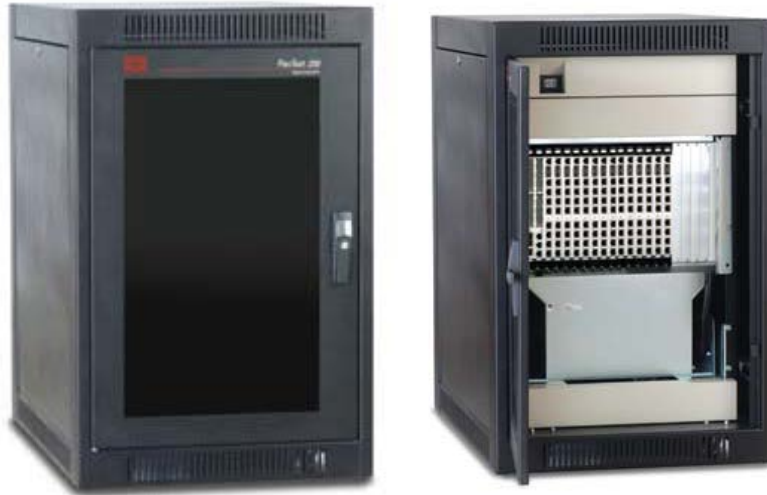
Figure 7. AeroST Structural Test Controller

A closed-loop force feedback MTS[®] AeroST structural test controller (figure 7) with full-range 493.79 digital universal conditioners (DUC) with MTS AeroPro[™] control and data acquisition (DAC) software was used for the full-scale tests. AeroPro software features a powerful arsenal of test accelerating and optimization tools facilitating a streamlined test setup and execution. AeroPro helped speed up pre-test diagnostics and post-test analysis by quickly running targeted queries across large amounts of data to isolate essential information.

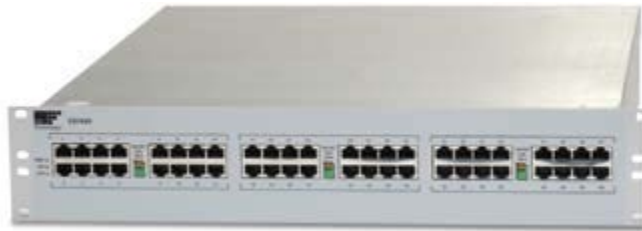
Figure 8. The EX1629 DAC System

The EX1629, a 48-channel high-performance strain gauge instrument from VXI Technology, Inc., was used to acquire data during full-scale testing. This high-performance DAC system, which is tightly integrated into MTS AeroPro software, is a standalone DAC platform and has a modular 48-channel design (figure 8).

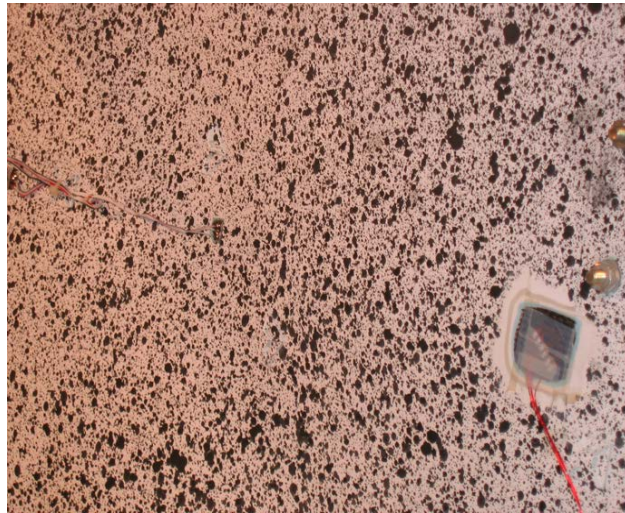
Figure 10. The ARAMIS photogrammetry system and speckle pattern

The ARAMIS photogrammetry full-field strain measurement system, as shown in figure 10, was used to measure localized buckling in the region of debonds/defects. The ARAMIS [41] is a noncontact, optical, three-dimensional deformation measuring system. It uses two high-definition cameras to track translation and rotation of the surface details (object characteristics) with subpixel accuracy. Surface details are obtained by applying a stochastic speckle pattern that follows surface displacement during loading (figure 10). The ARAMIS uses this pattern to recognize the surface structure and uses digitized images from both cameras for the triangulation of surface details (micropattern) to determine the precise location of each point. Therefore, this system has the capability of digitizing the precise shape (surface) of the structure during loading. The first set of coordinates for object characteristics is obtained in the undeformed stage. After load application, a new set of coordinates (digital images) is recorded. ARAMIS then compares the digital images and calculates the displacement and deformation of the object characteristics. The ARAMIS photogrammetry system with a typical stochastic speckle pattern is shown in figure 10.

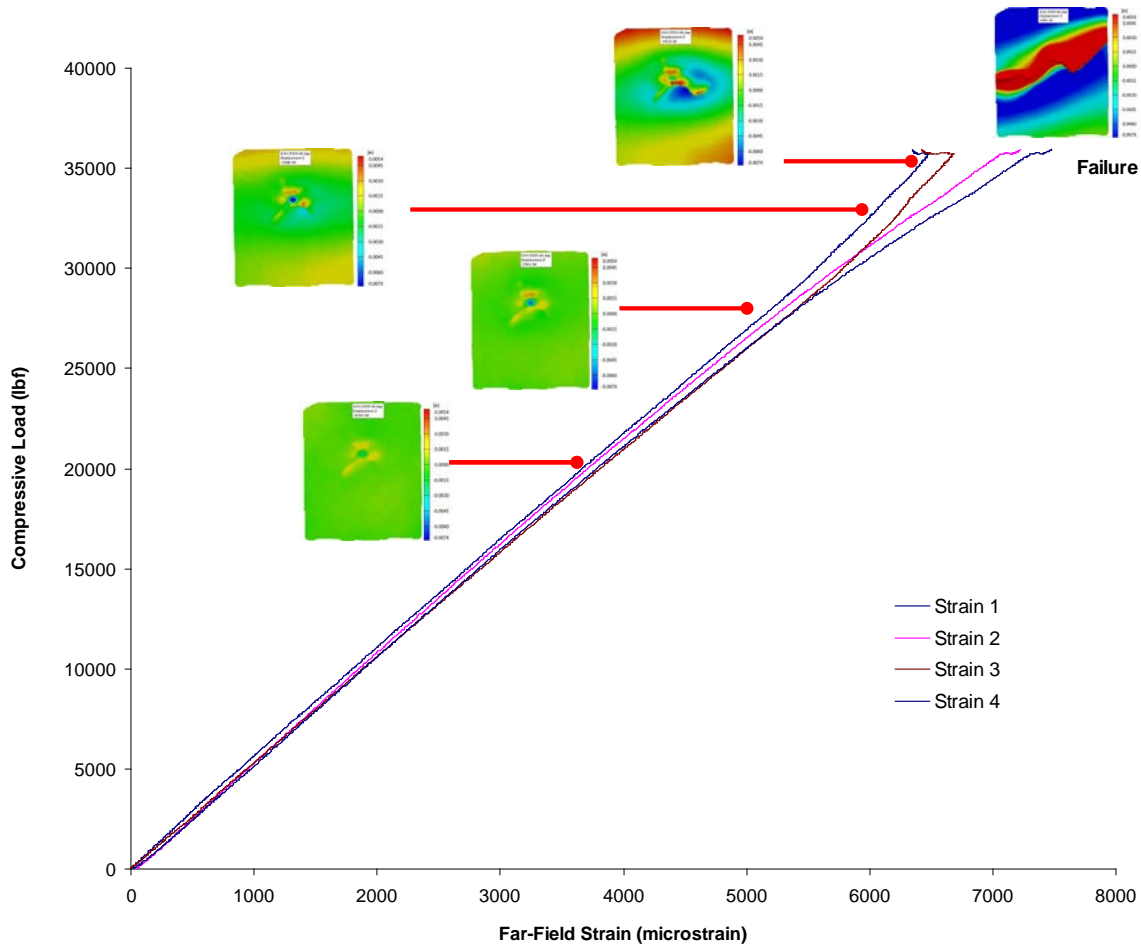
Figure 11. Damage evolution of a CAI specimen under static loading

The ARAMIS is capable of three-dimensional deformation measurements under static and dynamic load conditions to analyze deformations and the strain of real components. In addition, this system is able to eliminate the rigid-body motion component from the displacement results. Therefore, it can be used for specimens that exhibit large displacements. Strain sensitivity of the system is approximately 100-200 microstrains, and the scan area can be as large as 47 by 47 in. Full-field displacement and strain data are then used to examine any propagation of the defects according to the procedures outlined by Tomblin et al. [42], which assess the localized skin buckling (out-of-plane displacement) around the debonded or delaminated region. The full-field strain evaluation of compression after impact (CAI) specimens during static (figure 11) and fatigue loading was measured using the ARAMIS photogrammetry system.

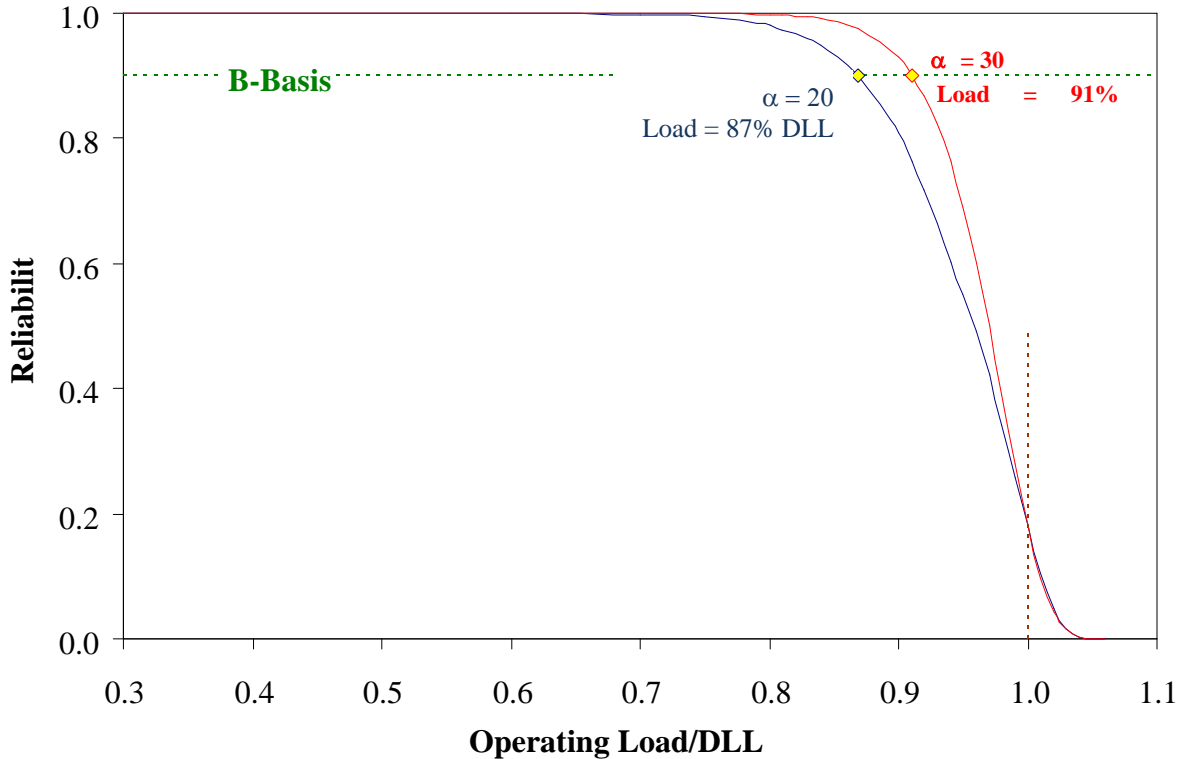
Figure 22. Static-strength reliability at operating loads for a structure with CAT3 damage

diminished at DLL, the post-impact reliability of the structure for some operational loads (simulated by spectrum during the DaDT test) still remains above the B-basis reliability level (i.e., the B-basis reliability of a CAT3-damaged article [based on $\alpha = 30$] is still maintained for operational loads below 91% of DLL, assuming no residual strength degradation).

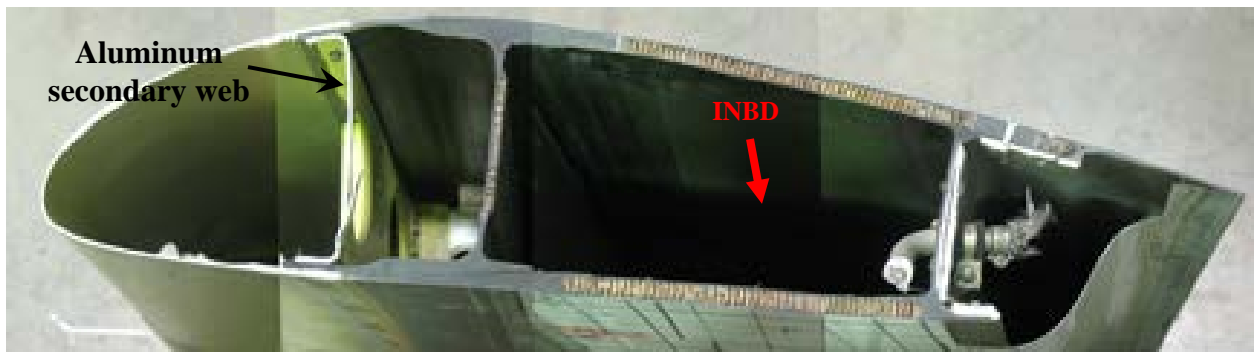
Figure 59. Cross-sectional view near FWS 65

An aluminum closeout rib at FWS 64.5 was mechanically fastened to the secondary web, and bonded to the upper and lower spar caps and front spar web (figure 59). This provided additional strength in the direction of impact at the contact location (FWS 65), thereby minimizing front spar web crush, as shown in figure 31. This resulted in penetration rather than springback of the spar caps (and web crush) that was observed in trial tests conducted on ST002 (table 9).

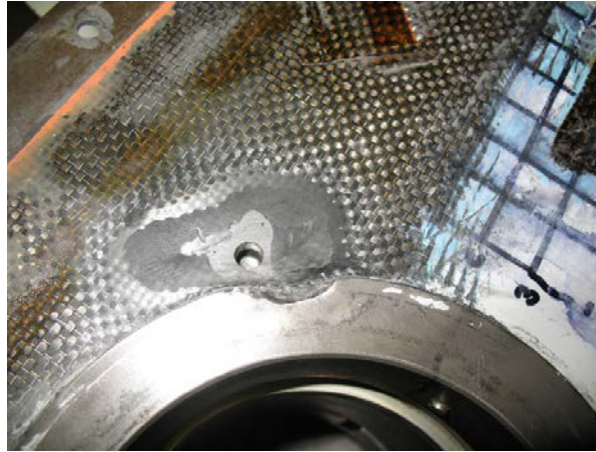
Figure 87. Hole repair after 1.5-DLT inspections

the fastener holes located at the web to attach the main lug, skin, and surface fractures were noted, but they were not repaired. Furthermore, the leading-edge fastener-pullout failed sections were left unrepaired. A fastener hole adjacent to the sleeve was damaged during lug removal and repaired using Hysol® EA 9394™ paste adhesive and chopped fibers (figure 87).

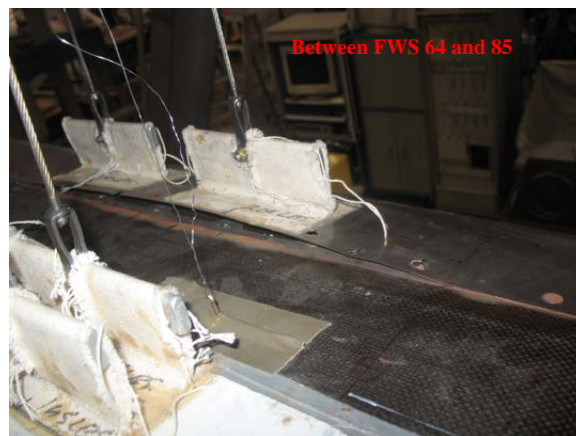
Figure 88. Leading-edge fastener-pullout failure (bottom surface) after 2 DLTs

An inspection of ST004 following 2 DLTs of cyclic loading noted a leading-edge fastener-pullout failure on the bottom skin that spread from FWS 64 to FWS 85 (figure 88). In this area, no damage to the composite structure was found. Furthermore, the bottom skin fracture near the sleeve grew approximately 5 more inches between 1.5 and 2 DLTs of cyclic loading.

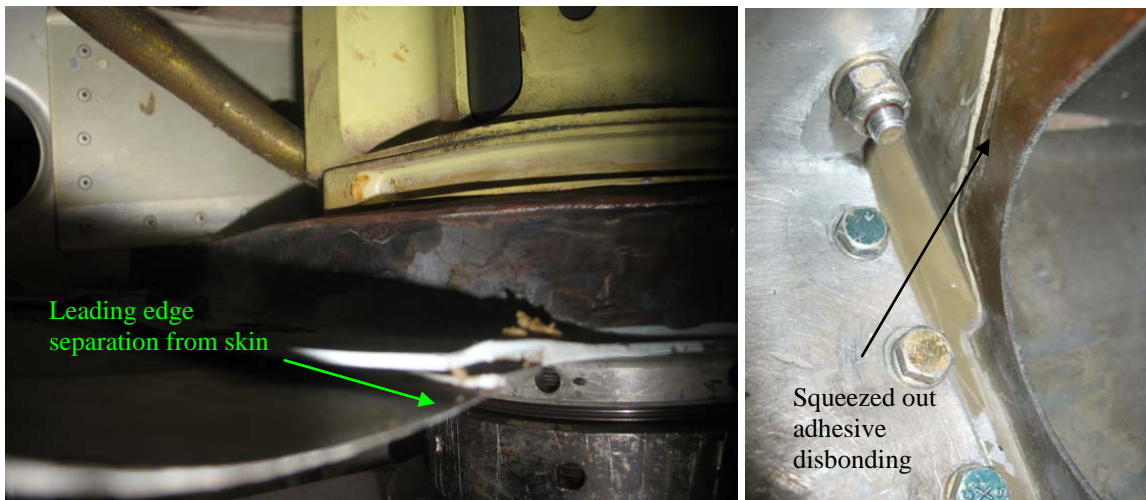
Figure 92. Visual inspection findings after load block D (80,033 cycles)

No significant damage was detected until after load block D when the damage noted in figure 90 increased (as shown in figure 92). Furthermore, the leading edge indicated that local buckling between rivets on both the top and bottom sides ruptured the filler material that was applied closer to the root end between the periphery of the leading edge and skin.

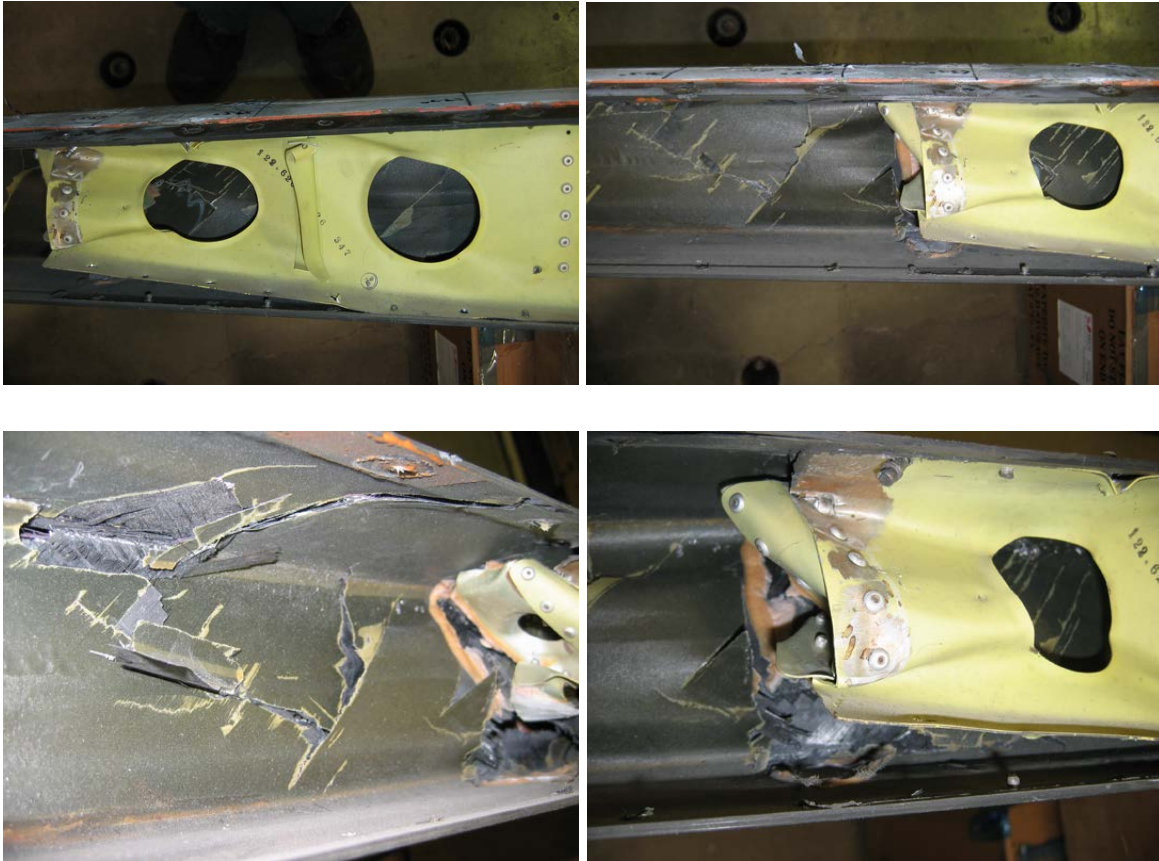
Figure 94. Post-test inspections of ST003 on removal of leading edge

Once the leading edge was removed, severe damages to the web and front-spar flanges were noted, especially around the outboard closeout rib of the aluminum secondary spar (figure 94). This close-out rib and aluminum spar were also severely deformed because of high brazier loads due to wing-box bending [54]. Flexural stress on the front web because of bending resulted in 45° fractures (see figure 94). After sectioning the test article around these stations, it was determined that the top and bottom spar caps were intact with no fractures.

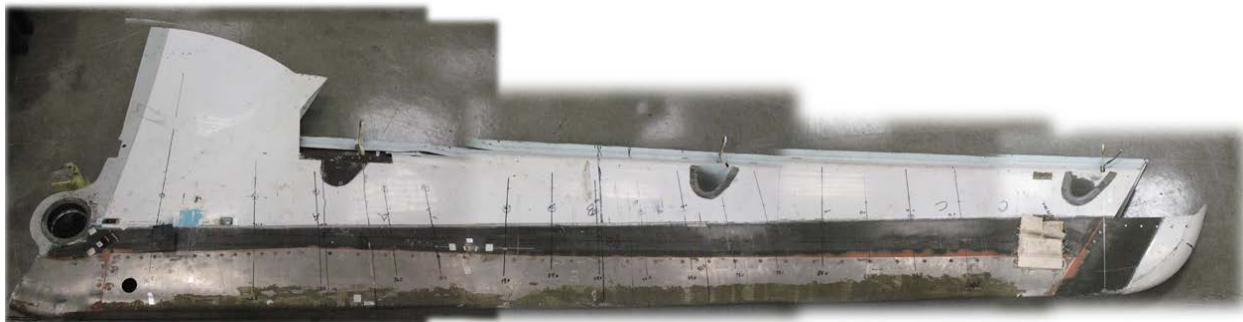
(d) Bottom view

Figure 98. Ultrasonic and visual post-test inspections of ST005

Both ST005 and ST006 test articles with CAT3 damages on the front spar failed (figures 98 and 99, respectively), which followed skin delamination at the trailing edge just outboard of the elevator attachment hinge. The video showed that, prior to failure, the skin underwent compression buckling rather than shear buckling mode, which had been observed during previous tests (sections 5.6.1 and 5.6.2). It also indicated that the primary failure was initiated at CAT3 damage. This was expected, because the CAT3 damage creates a significant stress concentration around the damage. Furthermore, damage to the front web below the CAT3 damage resulted in a significant reduction in flexural strength of the front spar. Once the top spar cap fractured across the damage instantaneously, the aft spar failed and a major crack formed across FWS 66.5. As shown in figure 98, damage was primarily across the region delineated by ultrasonic inspections, trailing-edge delamination, and leading-edge buckling around FWS 66.5.

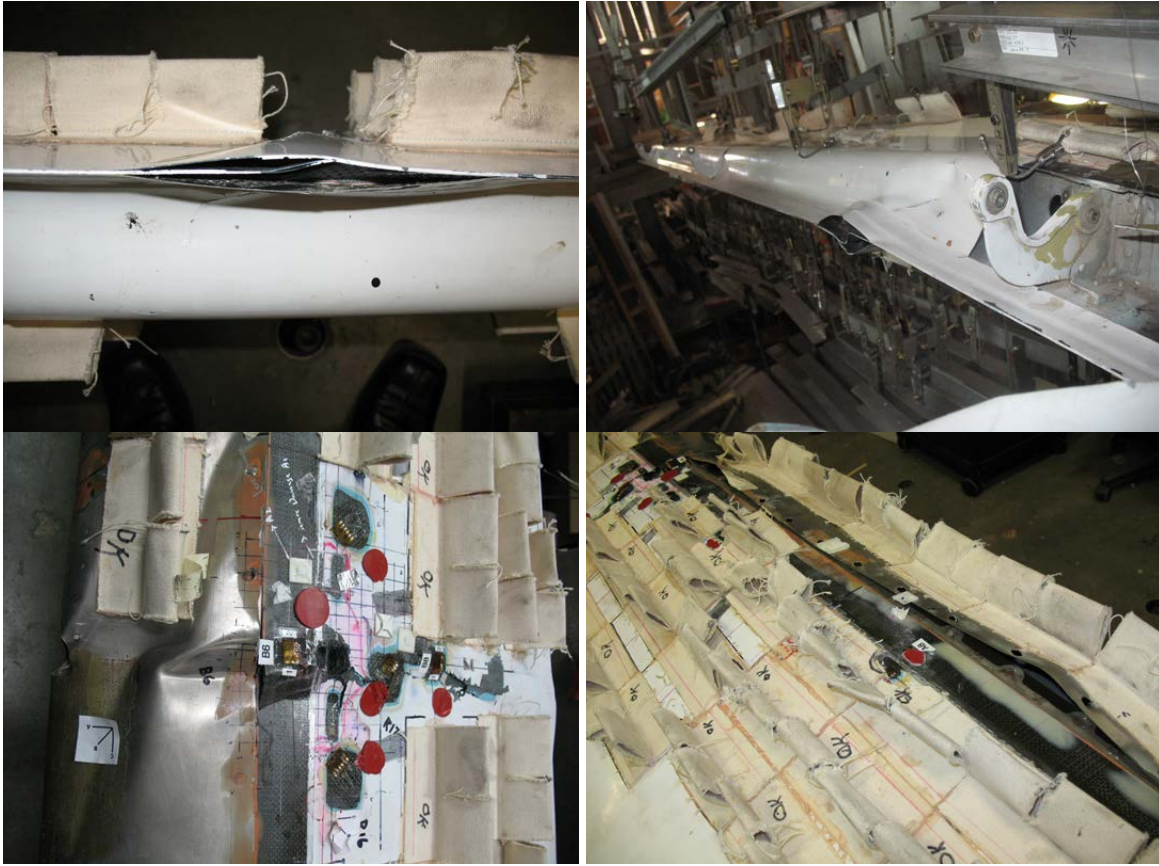
Figure 99. Post-test visual inspections of ST006 DaDT test article after residual strength test

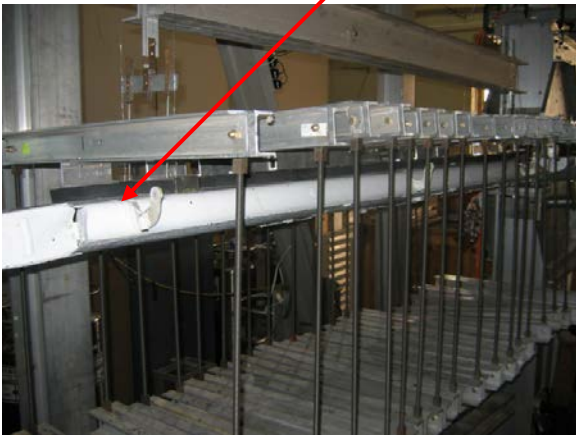
Figure C-2. Forward wing static test whiffletree setup with bonded load formers

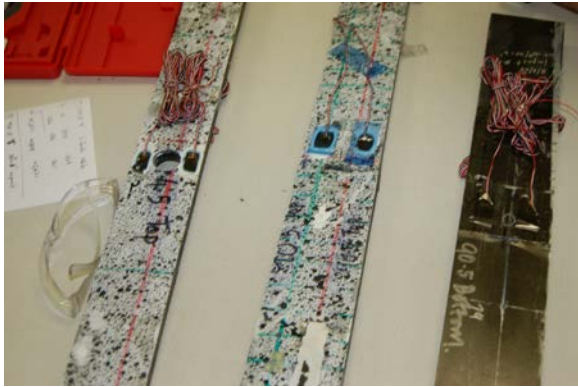
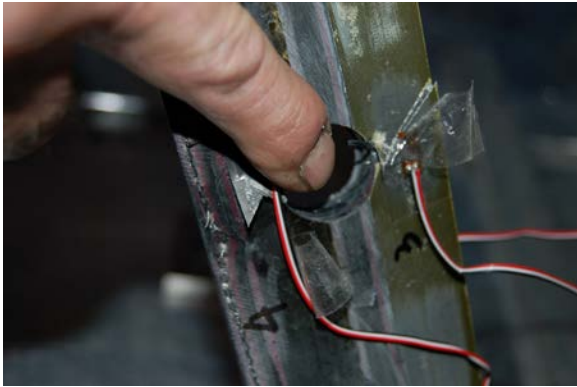
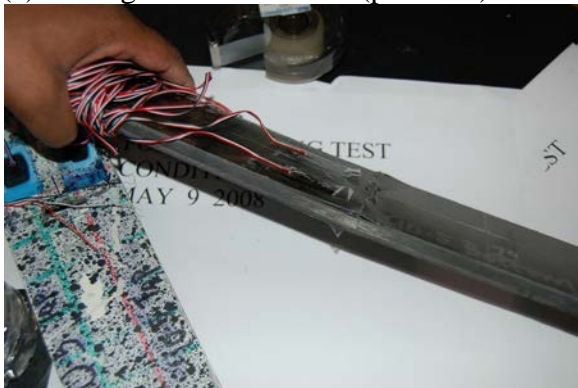
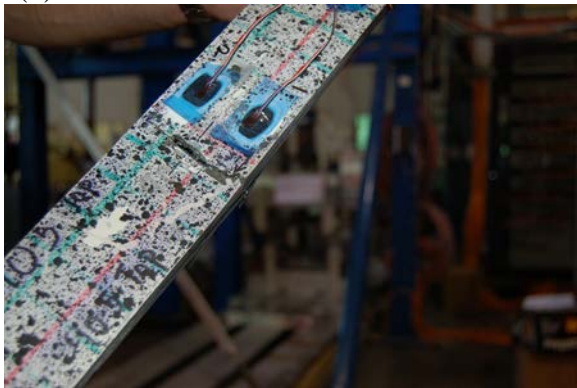
(a) Damaged 4PB elements (post-test)

(b) 114.5T failure mode

(c) 90.5B failure mode

(d) 90.5T failure mode

Figure E-2. 4PB test specimens (before and after test)

Several 24-in.-long specimens were cut from both top and bottom spar caps (front spar) to be tested in 4PB test configuration. The web was cut and cleaned to form relatively flat specimens. Several damage configurations, along with the undamaged 4PB specimens, were tested (figure E-2). Test specimens were named using the forward wing station (FWS) corresponding to the center of the specimen followed by “T” or “B” to indicate whether the specimen was extracted from the top or bottom spar cap, respectively (i.e., specimen name 90.5B corresponds to a specimen extracted from the bottom spar cap and the center of the specimen corresponds to FWS 90.5). Two holes, a 1/2- and a 1-in., were drilled at the center of test specimens 66.5B and 114.5T, respectively, while test specimens 90.5T and 90.5B were impacted with a 180 ft-lb energy level using a 1-in.-wide knife edge (as shown in figure E-3). Specimen 90.5T was impacted while resting on two wood bases placed 5 in. apart and lightly clamped. Because the backside of this specimen indicated significant delaminations, specimen 90.5B was sandwiched between the wood bases and an aluminum picture frame with an 8-by-8-inch opening (figure E-3).

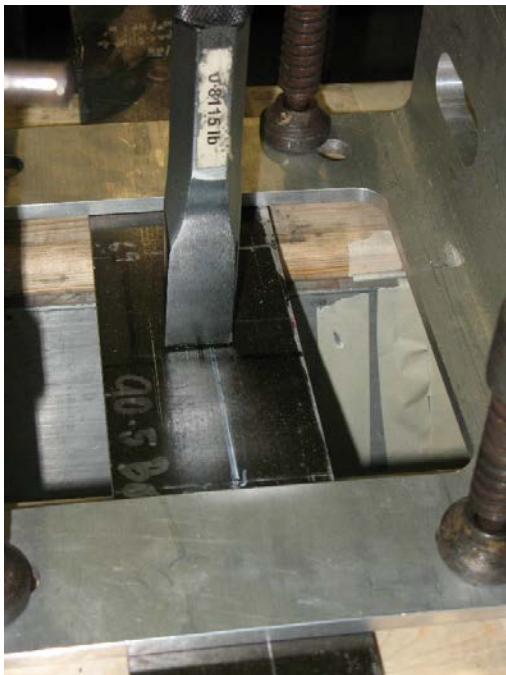
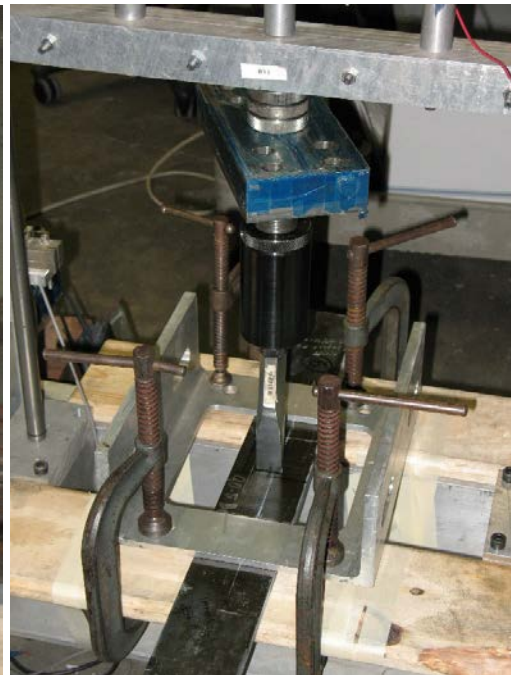
Figure E-3. Impact setup for 90.5B 4PB test specimen

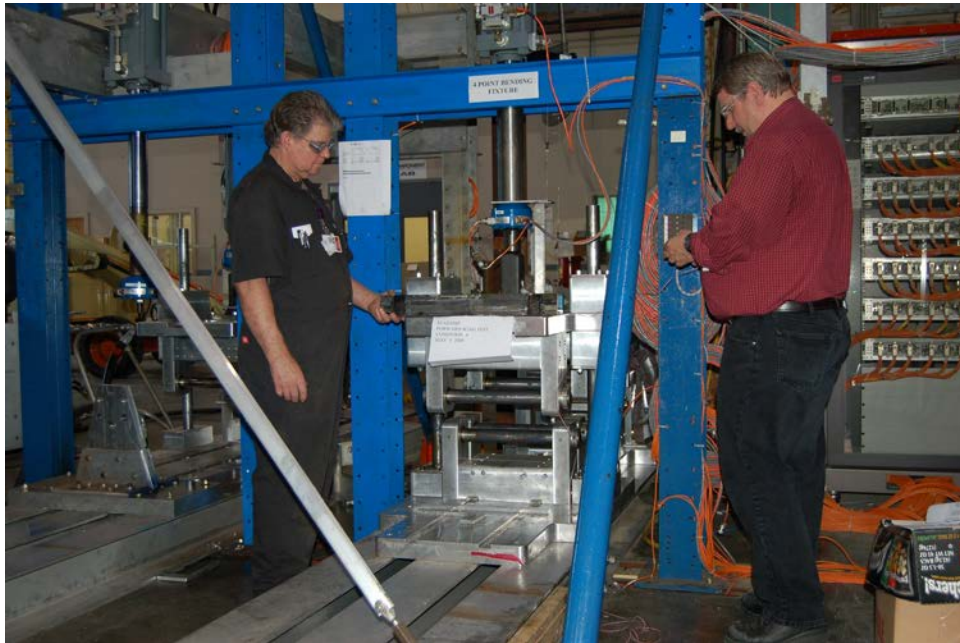
Figure E-4. 4PB element test setup

Damaged specimens were then strain-gaged and tested in 4PB test configurations, as shown in figure E-4. Strain data from damaged specimens were compared with those of undamaged 4PB specimens in figure E-5. Next, the stress and strain data corresponding to the onset of damage growth of open hole and impacted specimens were normalized by the corresponding data from the undamaged specimens and compared in figure E-6. The 1/2- and 1-in. open-hole specimens indicated approximately 20% and 40% decrease, respectively, in load-carrying capability, whereas the strain values corresponding to the onset of damage growth were approximately 10% and 20% lower than those for undamaged specimens. Both impacted specimens indicated significant load-carrying capabilities because the damage spread mostly across the width of the specimen, especially on outer plies.
