DOT/FAA/TC-14/52

Nondestructive Inspection Research of Composite Materials Used on the Commercial Fleet: Infrared Imaging for Defect Detection in Aircraft Structures Using Chaotic and Broadband Sound Excitation

Final Report

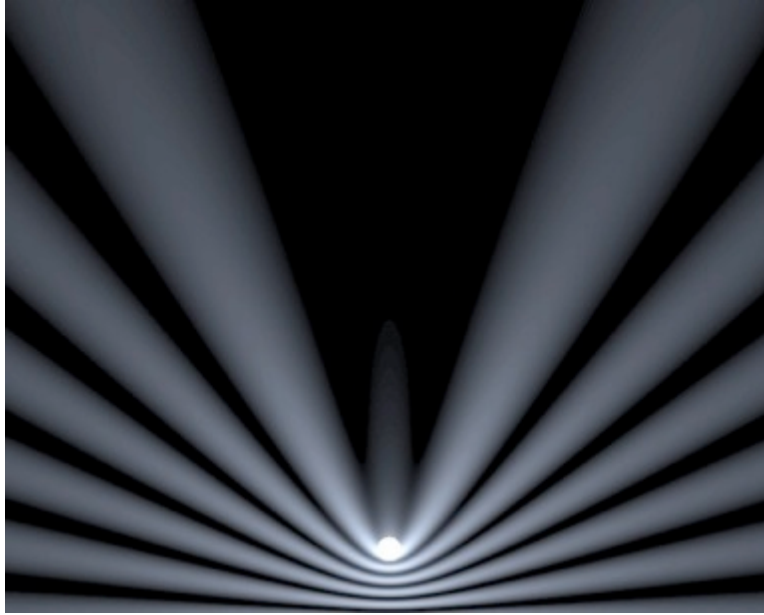
Figure 13. The result of an analytical calculation of the effect of the reflection of sound from the edge of a sample (this effect was seen experimentally in figure 12)

The results of an analytical calculation that shows the same “beam” effect as in figure 12 are shown in figure 13. The calculation shown in figure 13 contains only the essential cause of the beams in the experimental image. In the calculation, the sound is allowed to reflect from the bottom edge of the sample, but not from any other edges. In the experimental image, the sound has diminished before it reaches the other edges, so what would happen there is irrelevant. For simplicity, this damping of the sound intensity was not included in the calculation. The effect of the edge reflection is that the reflected sound interferes with the directly emitted sound to produce a series of bands of high and low intensity. The number and intensity of the bands depends on the distance of the transducer from the edge. This distance and the other parameters of the panel were chosen to reproduce as accurately as possible the same number of beams as in the experimental image. This effect is the explanation for the patterns near the transducer in figure 11. However, in that image, the beams are also reflected from the stringers, so the pattern is more complicated.

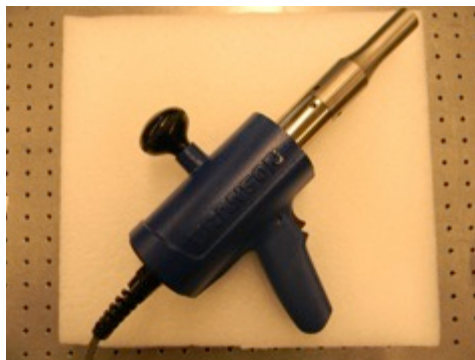
Figure 17. Photograph of the handheld 20 kHz Branson unit with the 1" diameter horn attached

A photograph of the Branson handheld unit is shown in figure 17. A photograph of the prototype in use taken during evaluation of various operators is shown in figure 18. In this photograph, the two-wheeled dolly carrying the laptop computer and two power supplies (one in use and one spare) is shown in the foreground. The operator holding the Branson handheld transducer unit is seen about to inject the sound into one of the Bell Helicopter panels behind, and slightly to the right, of the dolly. A student is seen ready to click the mouse to fire the transducer and start the image acquisition. Below the computer is a video display showing a real-time image from the camera. The final Sonic IR images appear on the computer screen and are stored. The camera is visible on a tripod in the background. It can also be mounted on an upright post on the side of the dolly for direct operation, therefore reducing the number of units that must be moved to the next inspection station. The Branson transducer unit can also be hung on a hook on the dolly to facilitate ease in moving the system.

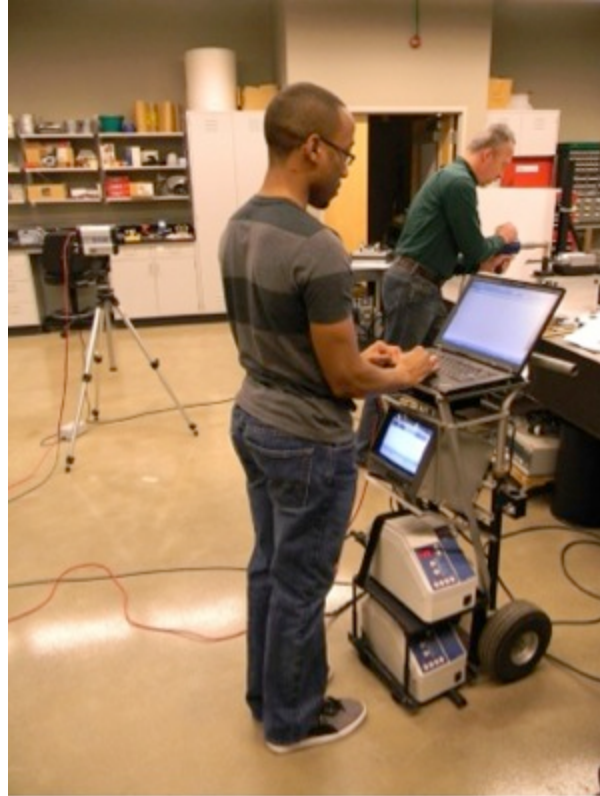
Figure 18. The prototype system being tested in the lab (a two-wheeled dolly carries the power supply for the transducer, a video monitor, and the computer that controls the system. A second, newer power supply was being stored on the dolly for later testing. The operator in the background is holding the handheld transducer against a large aircraft composite panel, and the IR camera is mounted on a tripod in the background. For more compactness, the camera can also be mounted on the dolly.)

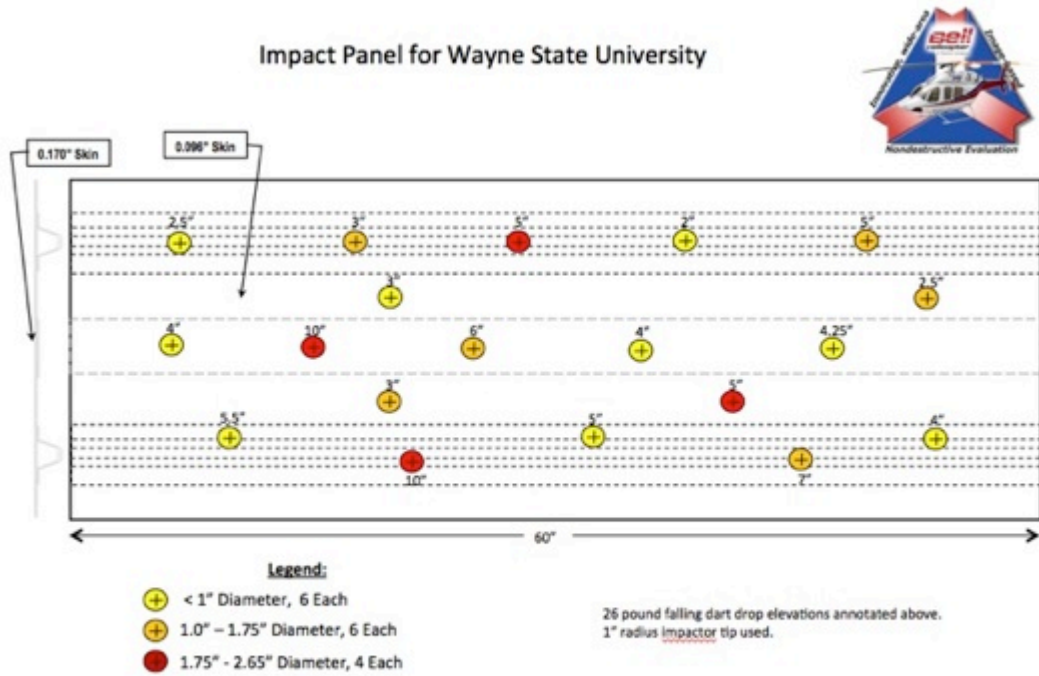
Final Impact Plan - RJB

Figure A-9. Impact plan on the 22" x 60" hat panel (the intended defect locations are indicated in the drawing. In addition, the elevation values at which a 26-pound falling dart with a 1" radius impactor tip was dropped are shown)

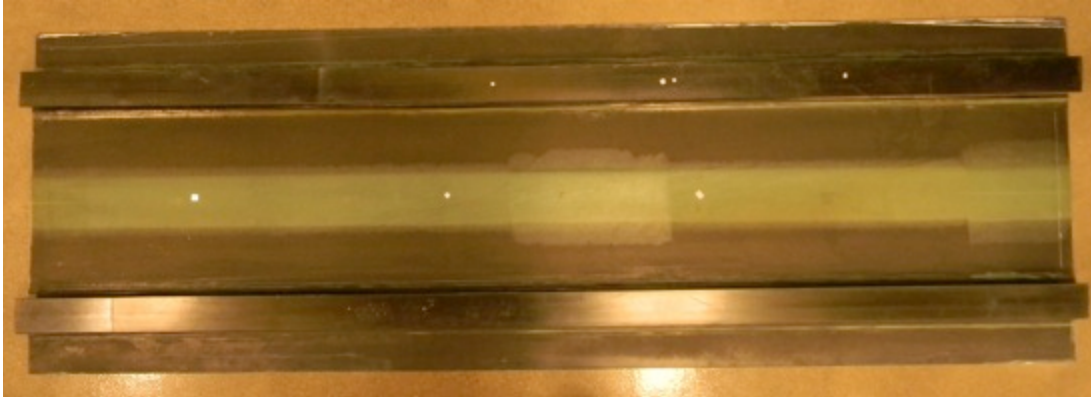
Figure A-11. Photograph of the larger I-beam channel panel from Bell Helicopter
