**DOT/FAA/TC-15/49**

# **Wireless Sensors Activated by Structural Damage**

Final Report

6. Performing Organization Code	
7. Author(s) Robert Kauffman				8. Performing Organization Report No.	
9. Performing Organization Name and Address University of Dayton Research Institute 300 College Park Dr. Dayton, OH 45469-0161				10. Work Unit No. (TRAIS)

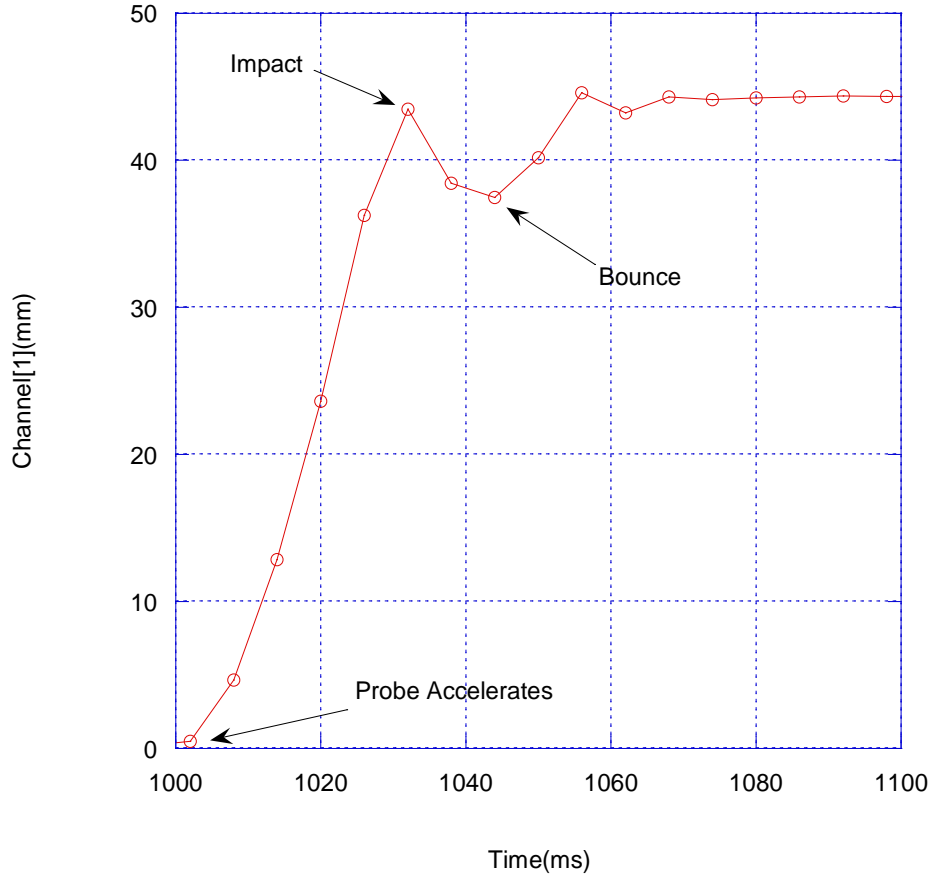
To determine the g experienced by the composite surface during the impact event, the position of the projectile (millimeter [mm] from starting position) was plotted vs. time (milliseconds [msec]), as shown in figure 19.

**Figure 19. Plot of projectile position (mm) vs. time (msec) for projectile during linear motor impact test**

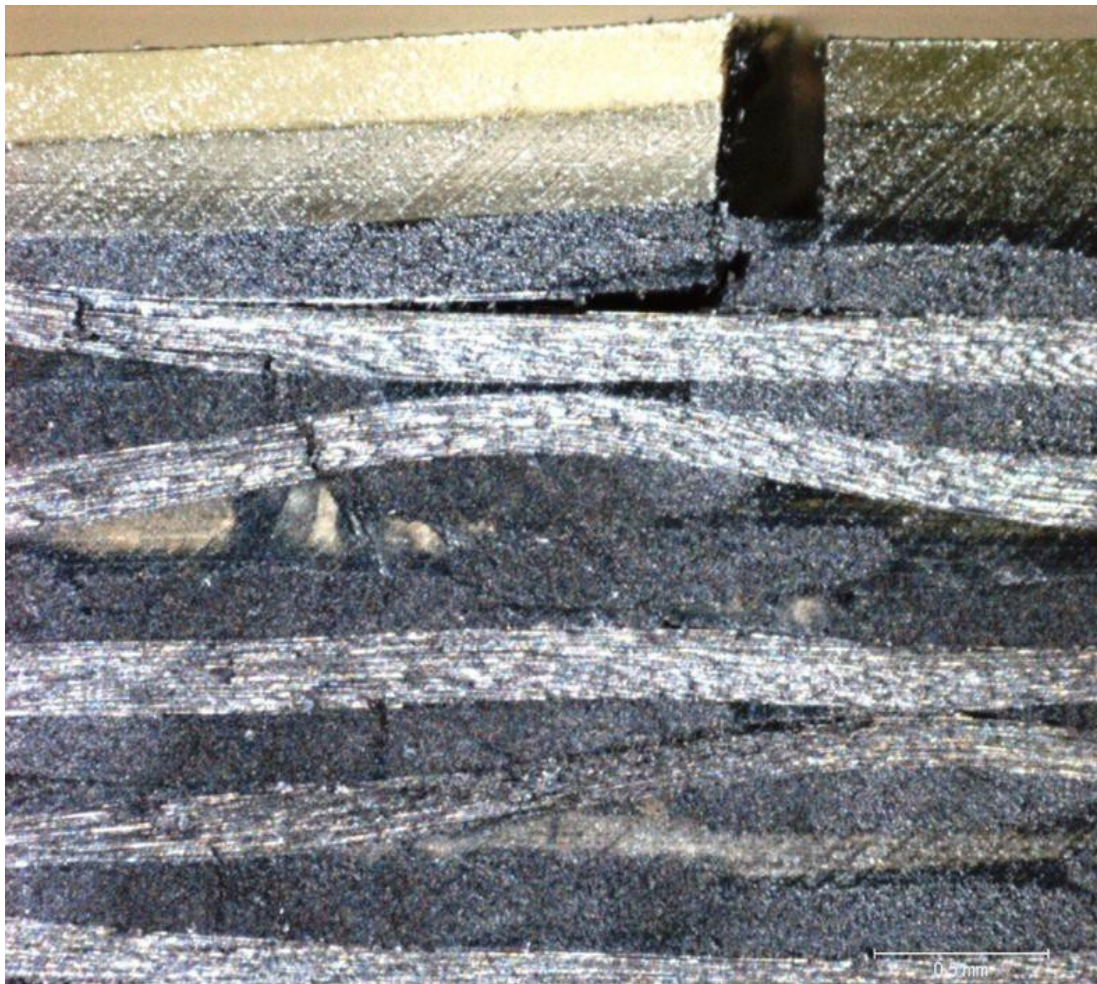
**Figure 40. Cross-sectioned composite with crack in the epoxy-coated underside surface (top) from ASTM D7136 impact test**

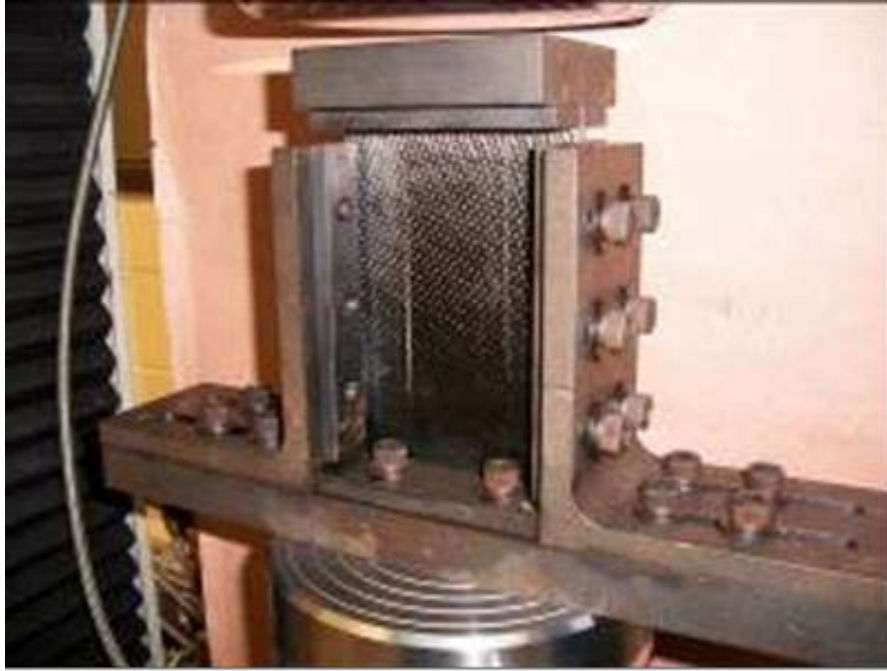
**Figure 43. Specimen loaded into compression fixture prior to test**

After the C-scans were completed, the ultimate compressive strengths of the two sets of impacted composite specimens were determined using the ASTM 7137 test method. The compression test fixture used to perform ASTM D7137 is shown in figure 43.

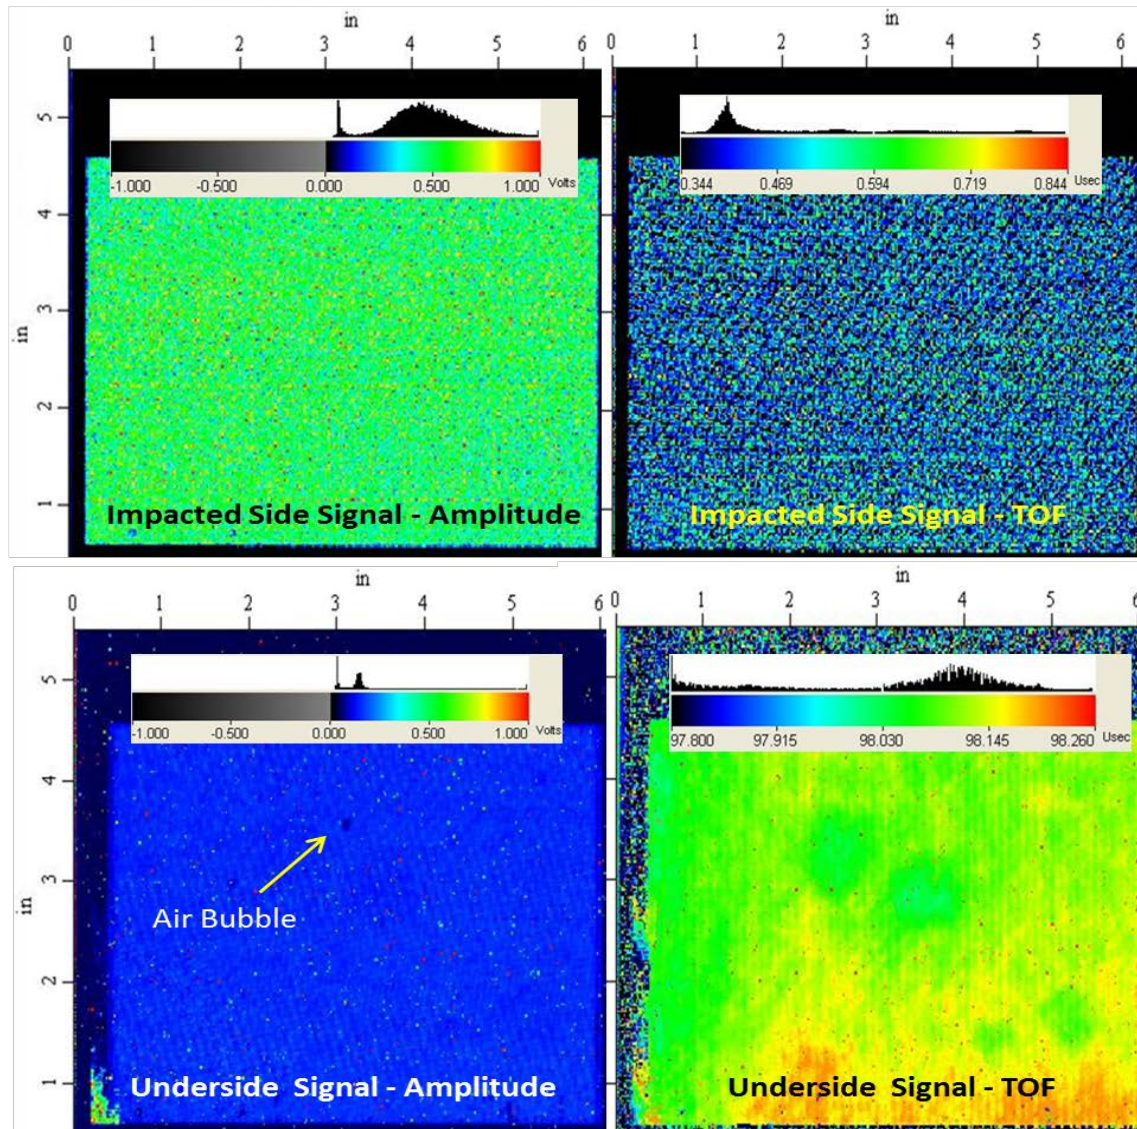
**ASTM 7137**  
Ultimate Compressive Strength = > 38.2 ksi  
(Average of Three panels, All Broke at Top)

**Figure 49. C-scans (amplitude and TOF) and ASTMD7137 test data for a baseline test specimen with epoxy-coated underside before impact**

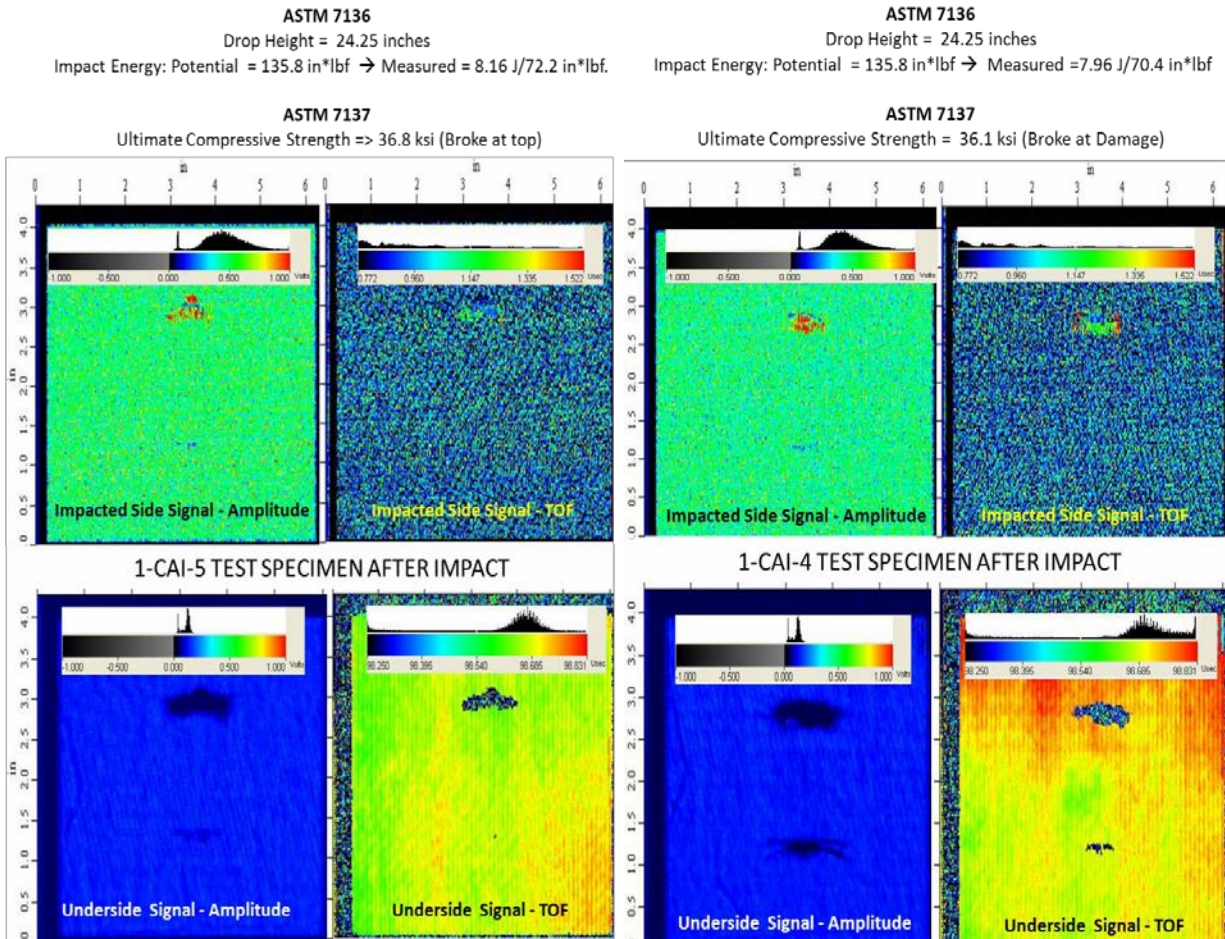
**Figure 50. C-scans (amplitude and TOF) and CAI test data for impacted test specimens 1-CAI-5 and 1-CAI-4 with epoxy-coated underside surfaces**

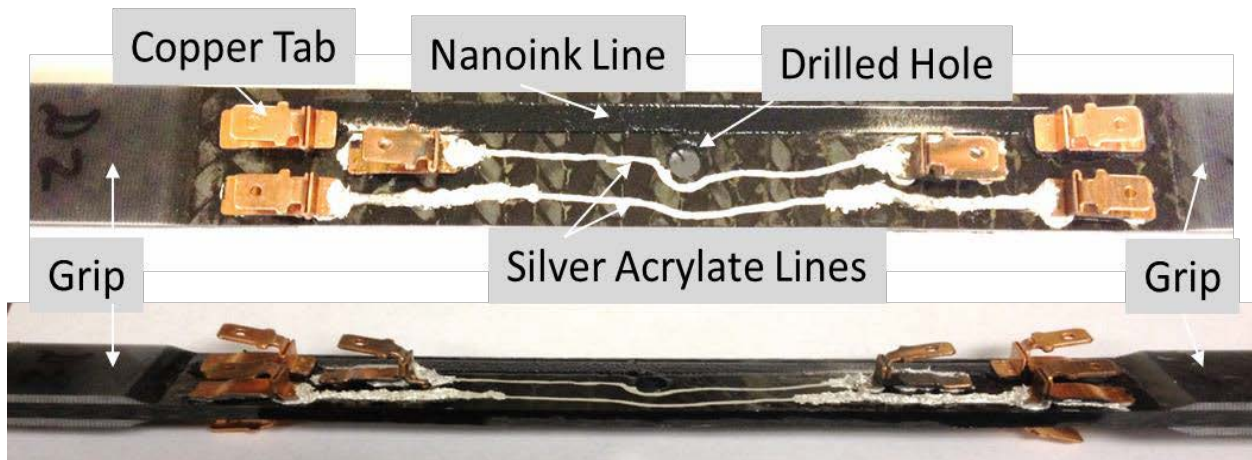
**Figure 58. Fatigue test specimens with drilled hole (0.25") and conductive lines (nanoink and silver acrylate)**

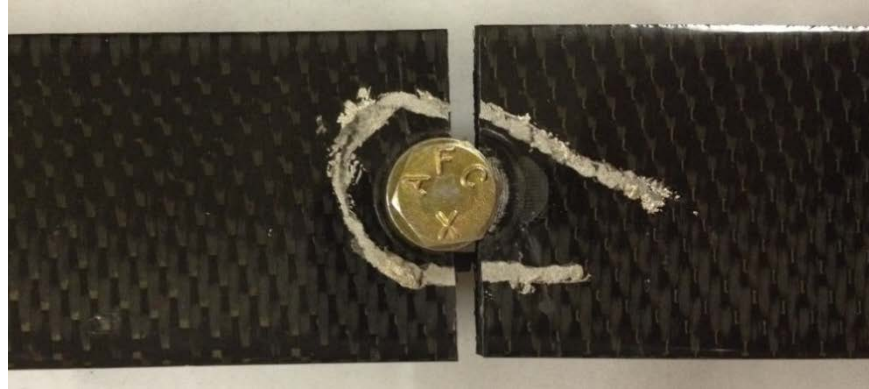
**Figure 66. Filled-hole test specimen FHF-5 with silver epoxy bead conductive line after fatigue failure**

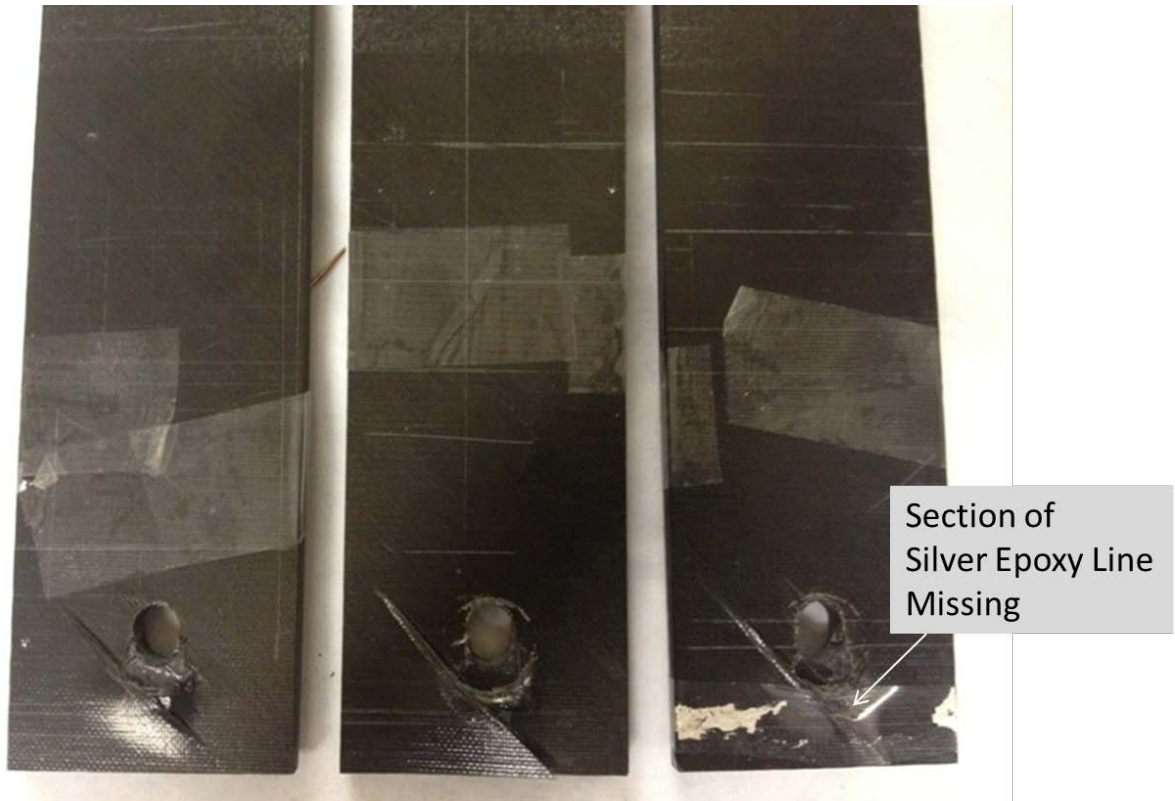
**Figure 78. The back surfaces of ASTM D5961 failed test specimens**

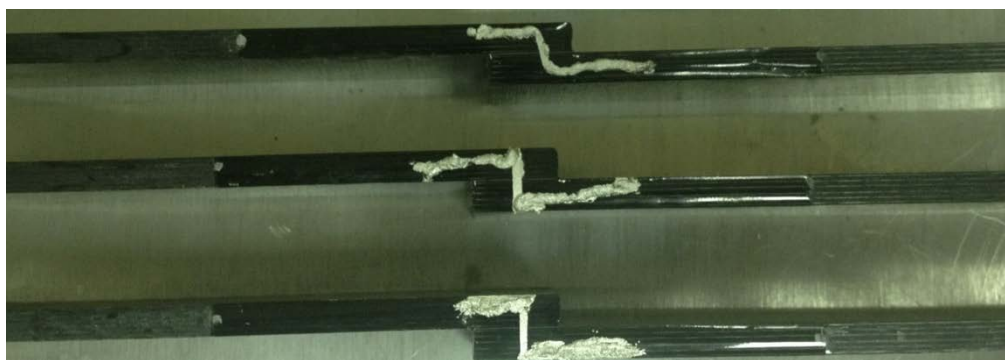
**Figure 79. Lap shear test specimens with different types of silver epoxy adhesive conductive lines on epoxy-coated edges**

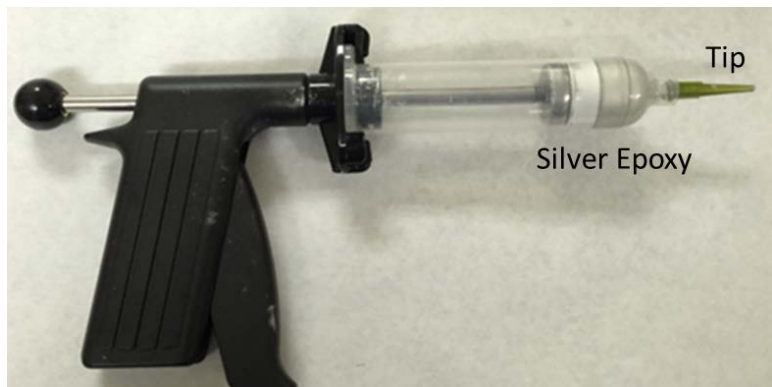
**Figure 88. Handheld caulking gun containing silver epoxy**

In contrast to the complete sensor in figure 94, the SMART sensor for curved/connecting surfaces was designed as an RFID tag adhered to double-stick tape (without the silver epoxy lines). The RFID/tape combination is applied to the composite surface so that the RFID tag is adhered to a fairly even surface and the accompanying tape surface is then smoothed/adhered over the curved/connecting surfaces of interest. Once the tape makes continuous contact with the composite surface(s), the silver epoxy lines are applied using a hand-held caulking gun with a tip attached, similar to that shown in figure 88.

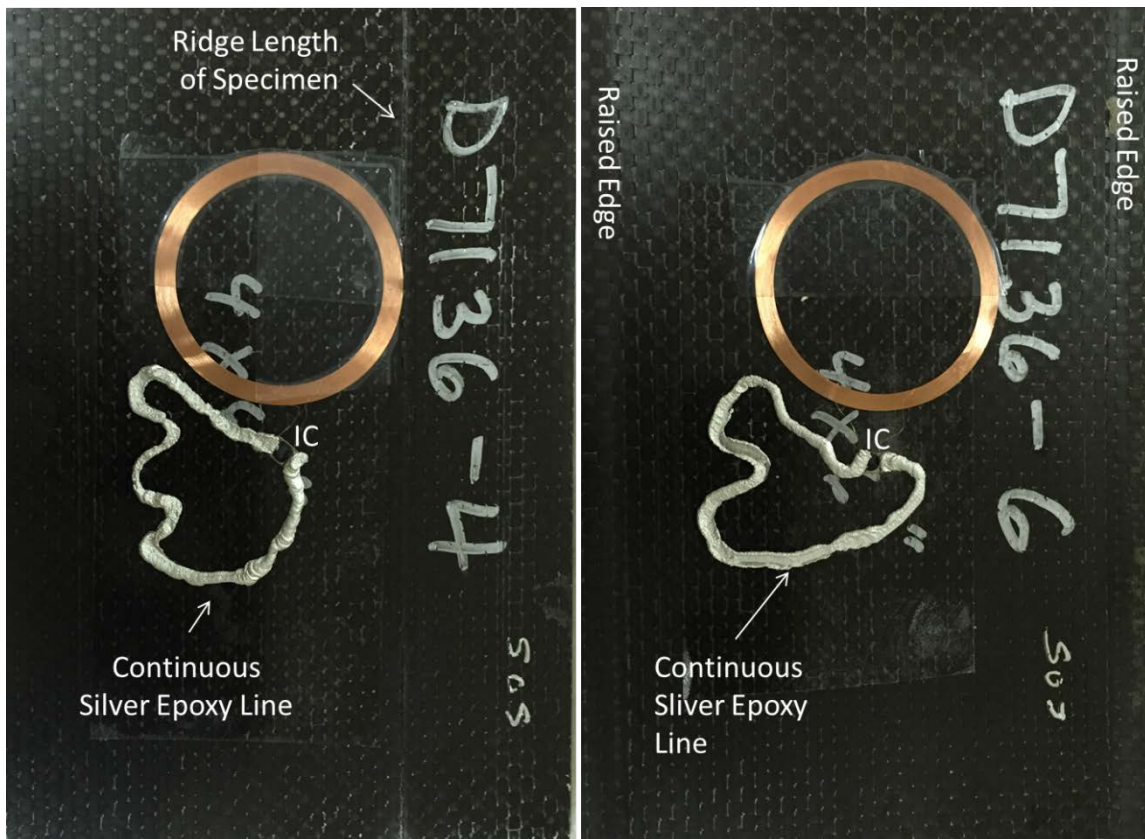
**Figure 95. Representative ASTM D7136 test specimens with metallic mesh and Peel-N-Stick smart sensors**
