DOT/FAA/TC-15/63

A Quantitative Assessment of Conventional and Advanced Nondestructive Inspection Techniques for Detecting Flaws in Composite Honeycomb Aircraft Structures

Final Report

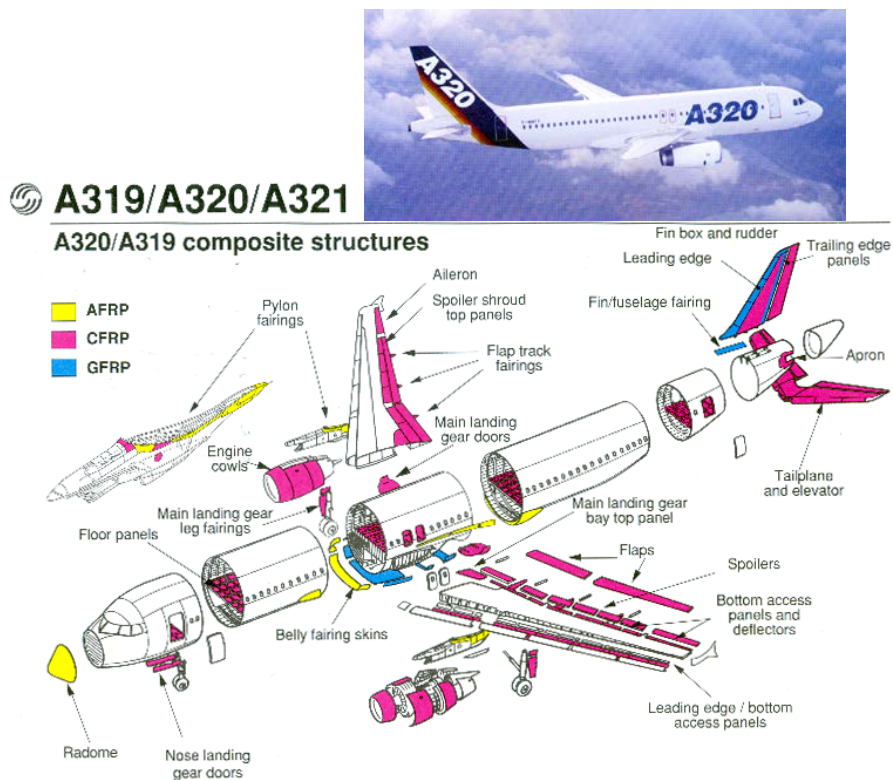
Figure 2. Use of composite structures on Airbus 320 series aircraft

Figures 2–5 depict the increasing use of composite materials in aircraft manufacture and highlight the wide range of composite structures on commercial aircraft. The photos in figures 6 and 7 show several finished composite aircraft components. They underscore the degree of complexity associated with these structures and the size of components that are being fabricated from composites.

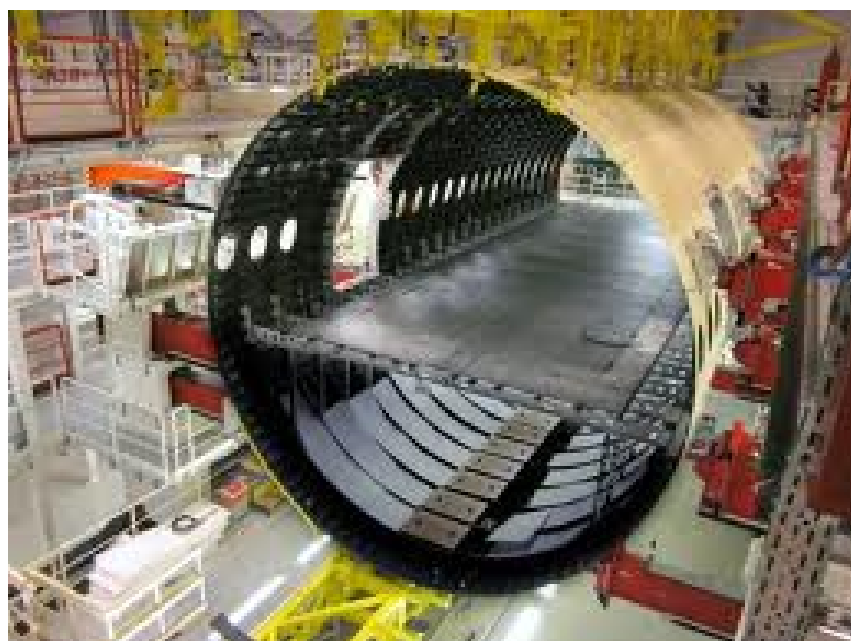
Figure 6. Production of an all-composite fuselage section

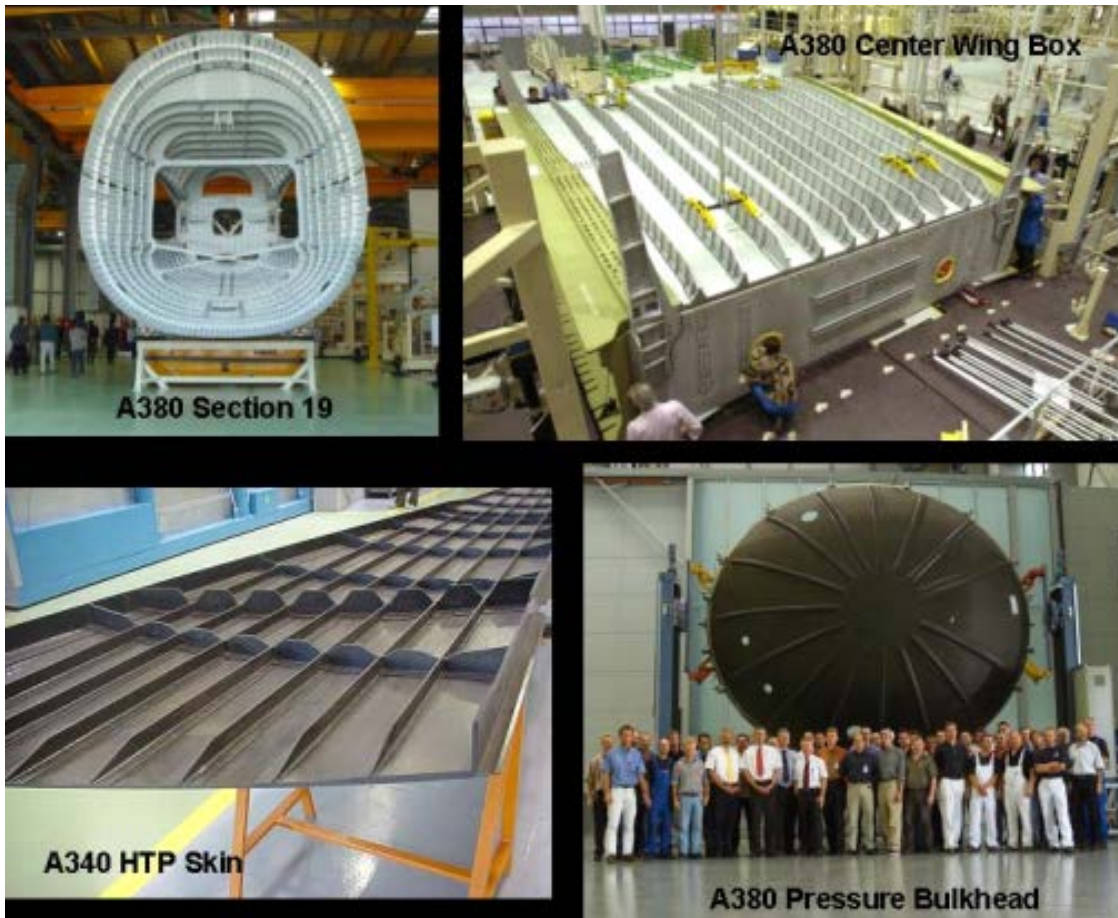
Figure 7. Summary of advanced composite applications on A380 primary structures

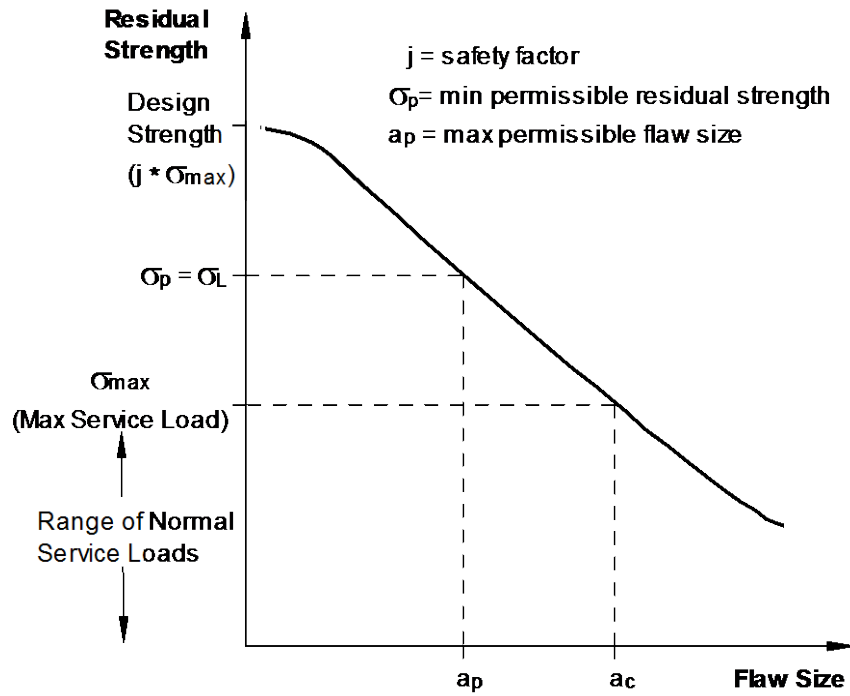
Figure 8. Residual strength curve

Damage tolerance is the ability of an aircraft structure to sustain damage, without catastrophic failure, until such time that the component can be repaired or replaced. The U.S. Federal Aviation Requirements (i.e., Title 14 Code of Federal Regulations Part 25) specify that the residual strength shall not fall below limit load, P_L , which is the load anticipated to occur once in the life of an aircraft. This establishes the minimum permissible residual strength, $\sigma_p = \sigma_L$. To varying degrees, the strength of composite doubler repairs is affected by crack, disbond, and delamination flaws. The residual strength as a function of flaw size can be calculated using fracture mechanics concepts. Figure 8 shows a sample residual strength diagram. The residual strength curve is used to relate this minimum permissible residual strength, σ_p , to a maximum permissible flaw size, a_p .

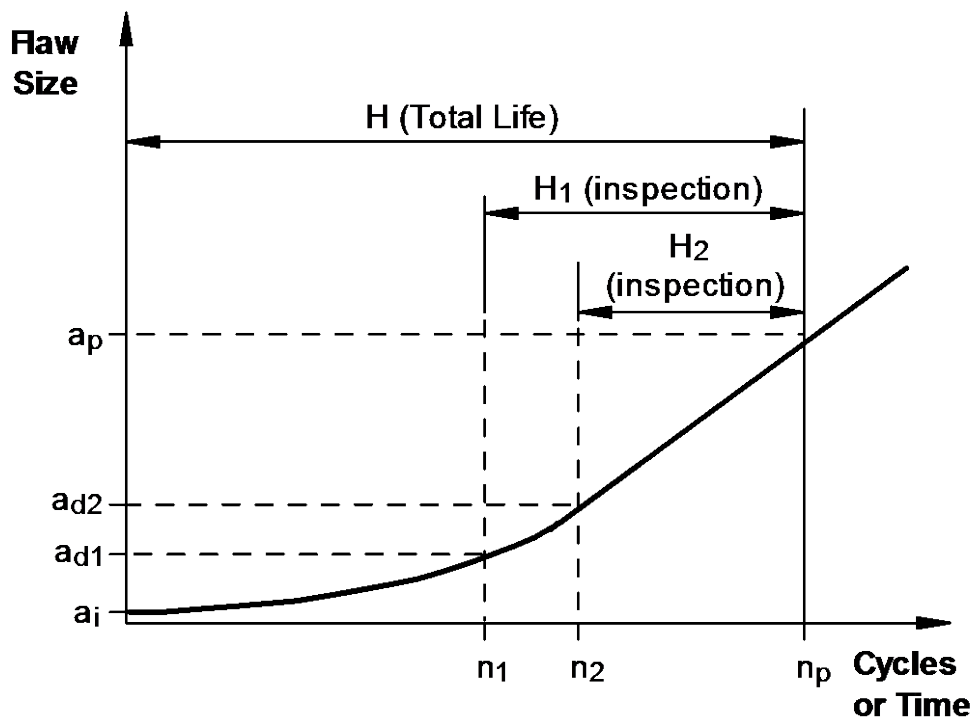
Figure 9. Crack growth curve showing time available for fracture control

A damage control plan is needed to safely address any possible flaws that may develop in a structure. NDI is the tool used to implement the damage control plan. Once the maximum permissible flaw size is determined, the additional information needed to properly apply NDI is the flaw growth versus time or number of cycles. Figure 9 contains a flaw growth curve. The first item of note is the total time, or cycles, required to reach a_p . A second parameter of note is a_d , which is the minimum detectable flaw size. A flaw smaller than a_d would likely be undetected and, thus, inspections performed in the time frame prior to n_d would be of little value. The time, or number of cycles, associated with the bounding parameters a_d and a_p is set forth by the flaw growth curve and establishes $H(\text{inspection})$. Safety is maintained by providing at least two inspections during $H(\text{inspection})$ to ensure flaw detection between a_d and a_p .

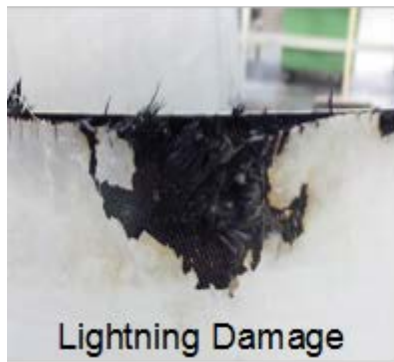
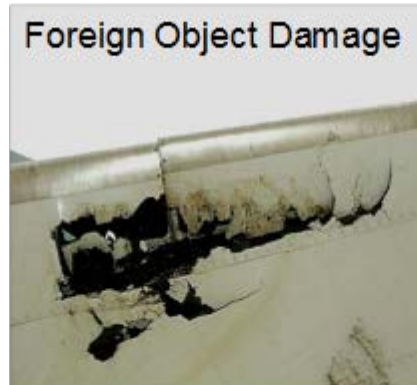
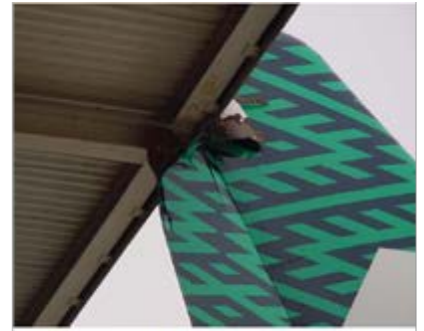
Figure 13. Sample sources of damage to composite structures

Sample damage found in composite structures is shown in figures 13–18. Information from one airline report indicates an average of eight composite damage events per aircraft, with 87% of those stemming from impact. Figure 19 shows data relating the probability of an aircraft being impacted by runway debris alone. The data indicate probability of impact that reaches the 25–30% range. The costs associated with the repair of such impact damage averages \$200,000 per aircraft. Another report indicates that fuselage damage is incurred every 1,000 flights in wide body aircraft and every 4,600 flights in narrow body aircraft.

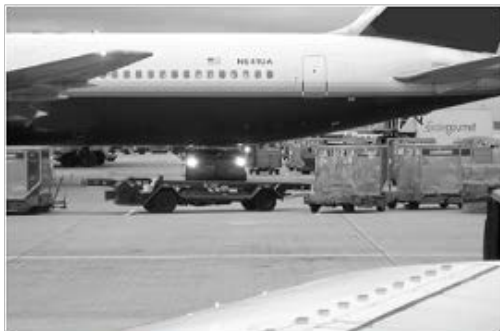
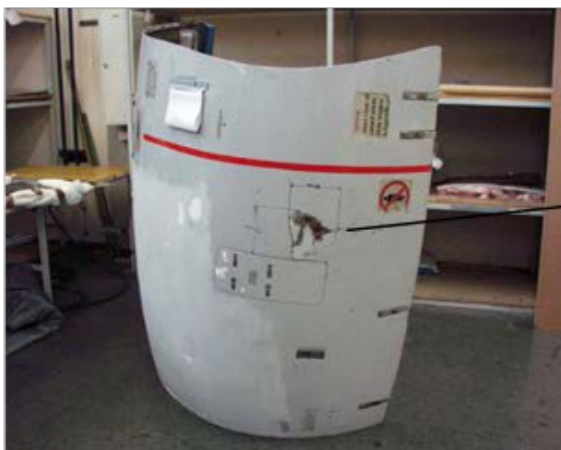
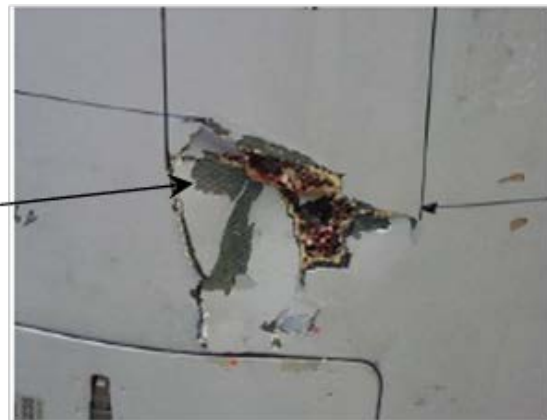
**Ground Service
Vehicles**

Figure 14. Sample damage from ground service vehicle impact

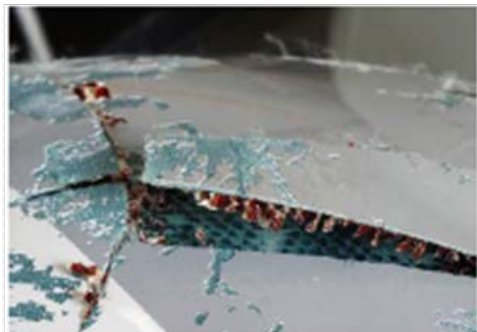
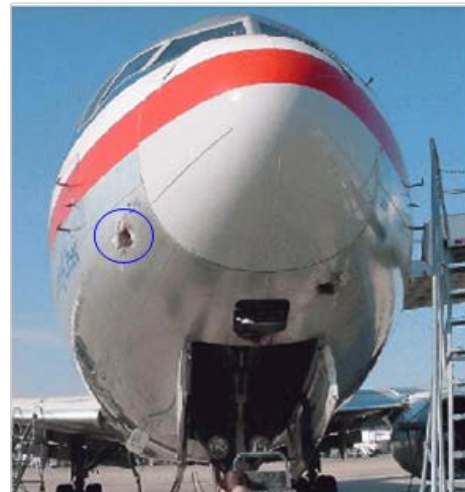
Bird Strike

Figure 16. Sample damage from impacts during flight

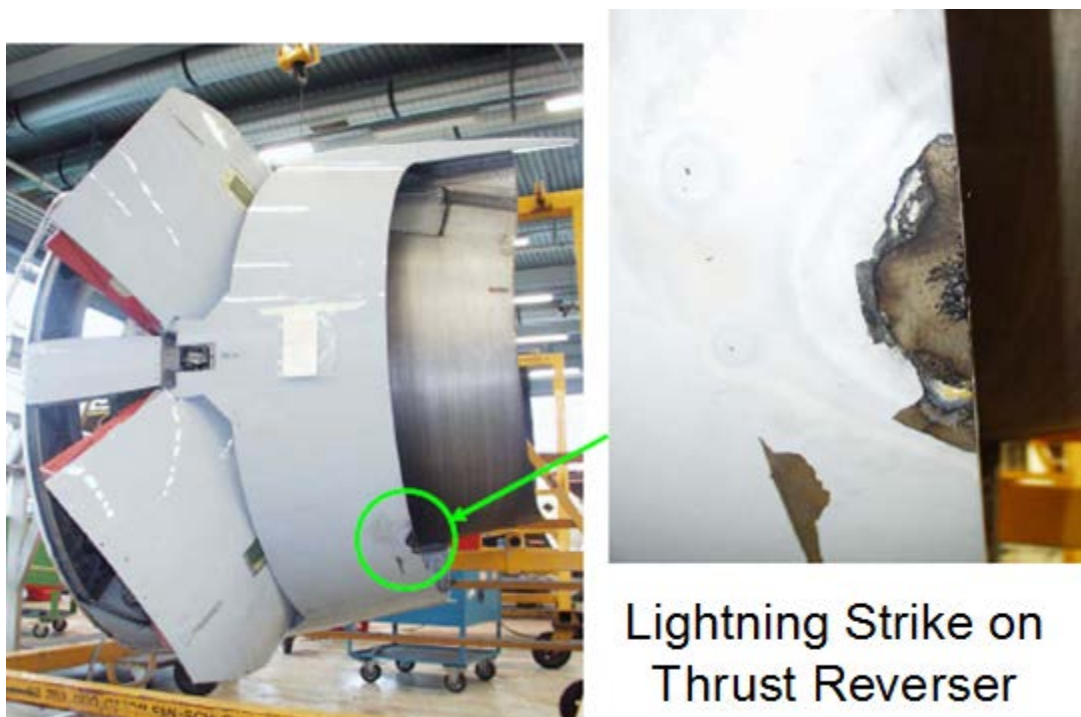
Figure 17. Sample damage from lightning strike

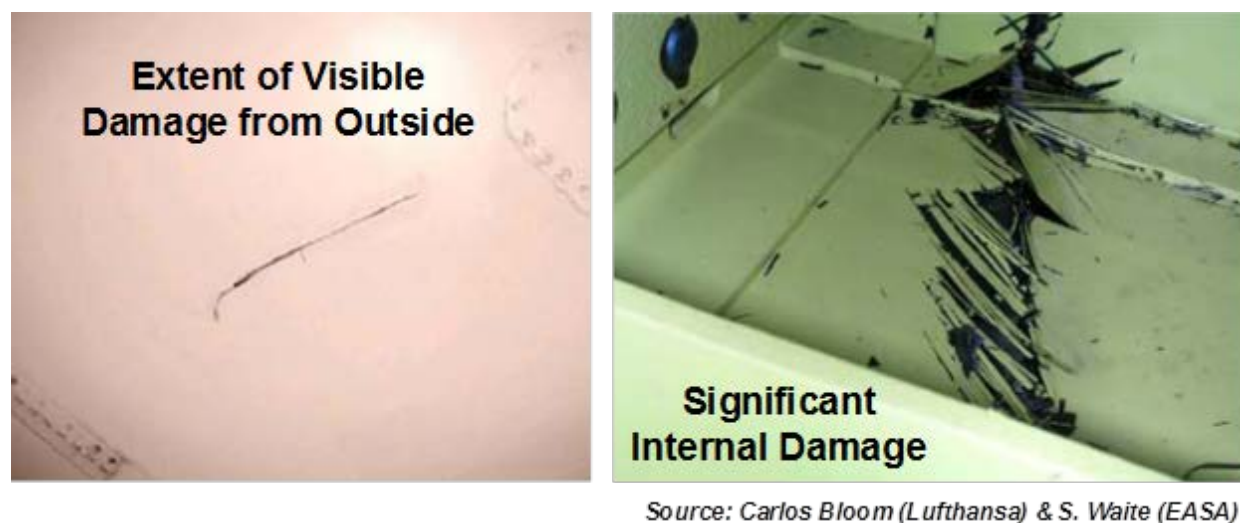
Figure 21. Example of external impact creating minor surface demarcation but significant internal damage

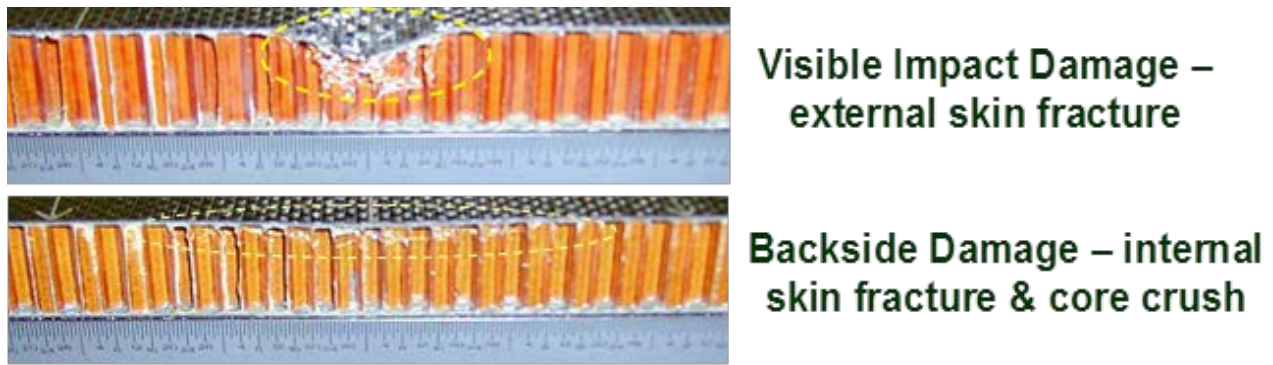
Figure 22. Comparison between visible and backside damage (crushed core and backside fiber fracture) in honeycomb structures

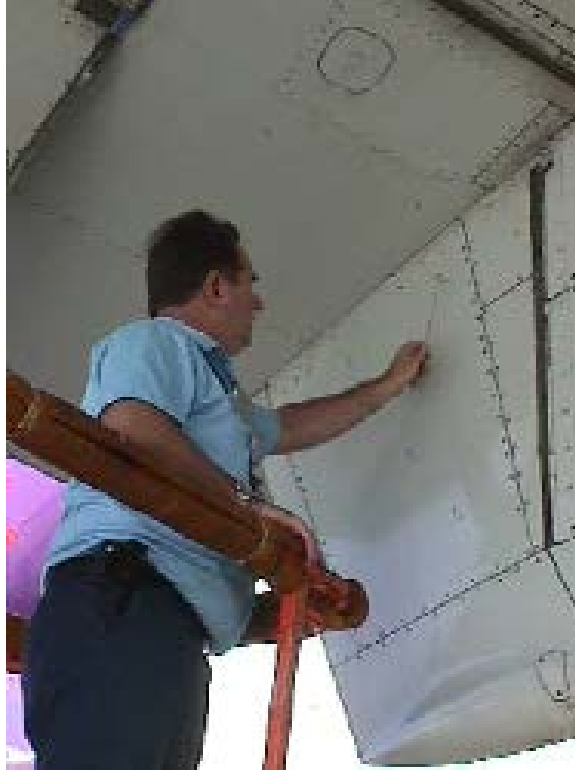
Figure 23 shows a tap test inspection of a composite engine shroud. Tap testing has been used for many years and is still one of the primary methods used to assess the health of composite honeycomb structure. During tap test inspections, low-energy impacts are applied to the surface of the honeycomb sandwich structure. Subtle variations in the audible response from the structure are detected by the inspector and used to infer the presence of flaws. The subjective nature of this approach, coupled with the high probability of human factors issues adversely affecting its performance, were the main reasons that prompted this study. The desire to validate advanced NDI techniques for more demanding composite inspections was another major reason for undertaking this research effort.

Figure 23. Tap test inspections of composite aircraft structure

The mechanical tap test is a manual method wherein a small diameter rod or hammer with a spherical tip is used to tap the surface of a structure while the human ear is used to monitor the audible results (see figure 23). Tap testing has been used for many years and is still one of the primary methods used to assess the health of composite structures. During tap test inspections, low-energy impacts are applied to the surface of the structure being inspected. Subtle variations in the audible response from the structure are detected by the inspector and used to infer the presence of flaws. The audible sound resonating from the part will be characteristic of the mass, cohesive stiffness, and the cross-sectional thickness of the part or assembly being inspected. The

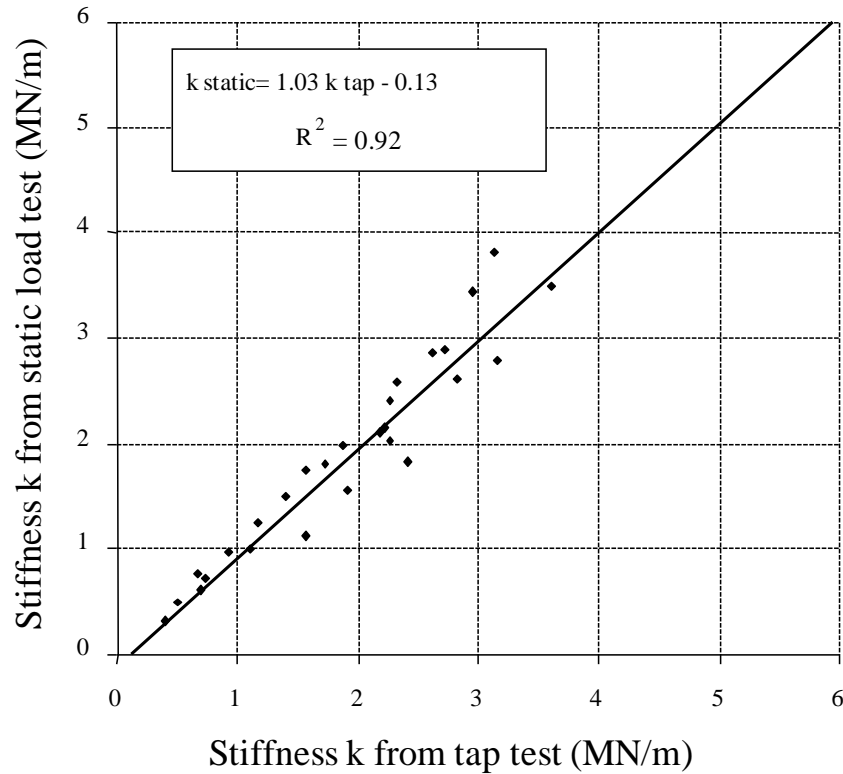
Figure 31. Comparison of the surface stiffness deduced from the tap test with the stiffness measured in a static load test

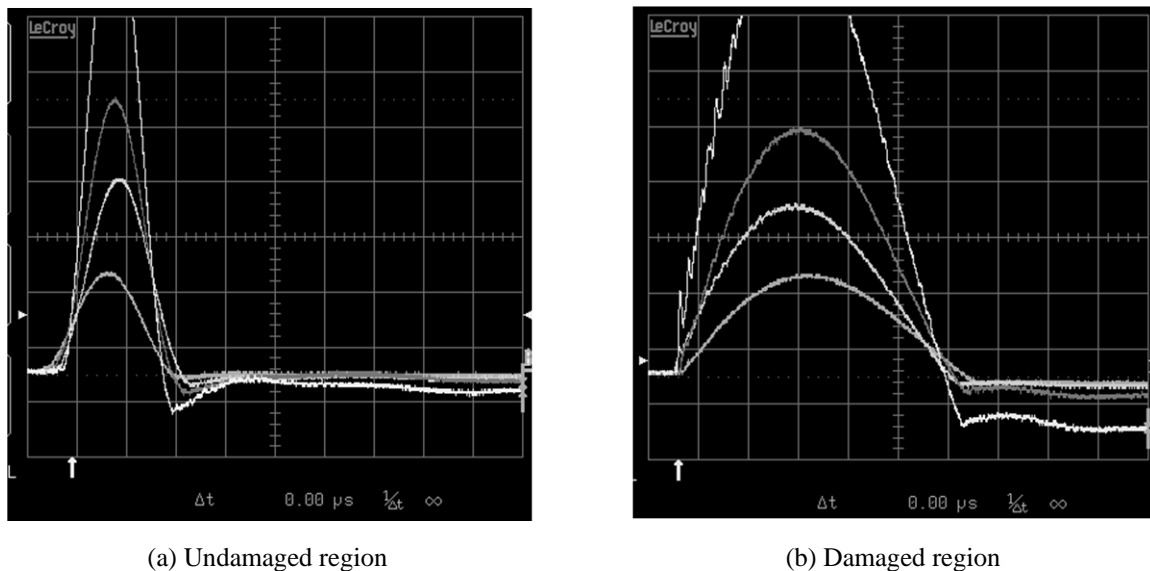
Figure 32. Force vs. time history for various tapping forces in a good region and a damaged region on a composite honeycomb panel

Figure 32(a) shows the time of contact response on an undamaged part of a composite honeycomb panel tapped by an accelerometer. The larger amplitudes correspond to taps of greater force. The Y-axis shows the force or acceleration while the width of the curve on the X-axis represents the contact time for the impactor. Figure 32(b) shows the time of contact response of an impact-damaged portion of the panel, as tapped by the same accelerometer. The damage in the honeycomb core caused a reduction of the contact stiffness (k) and, therefore, led to a longer time of contact (τ).

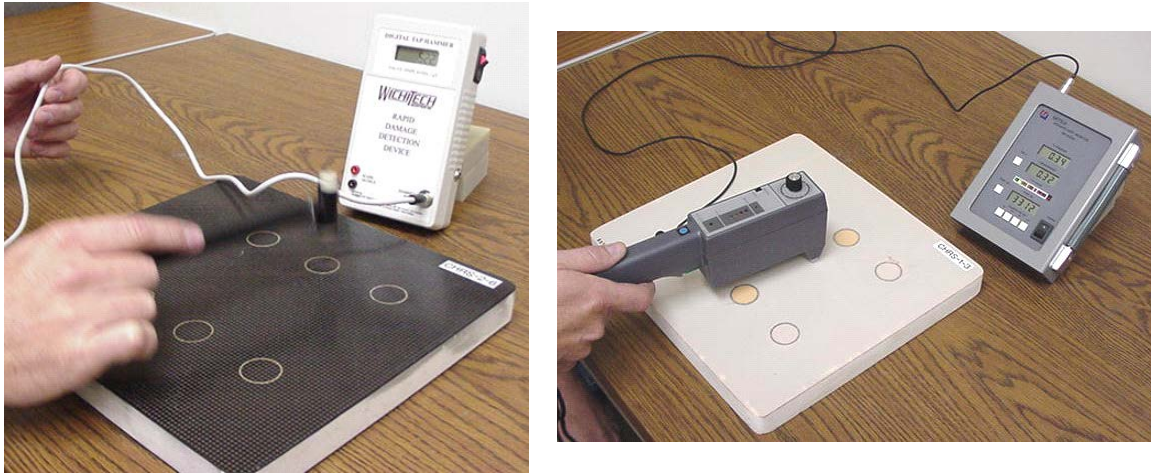
Figure 33. Instrumented tap test devices: DTH (left) and Woodpecker (right)

Electronic tap test instruments, such as those shown in figure 33, have been developed to automate the inspection process. These devices use the physics discussed above and a force/acceleration transducer to quantify the stiffness of the local impact region. Changes in stiffness can be observed by the user to infer the presence of damage. Some of these instruments measure the duration of the impact while others measure the frequency content of the tap signal. These will be discussed further in section 4.

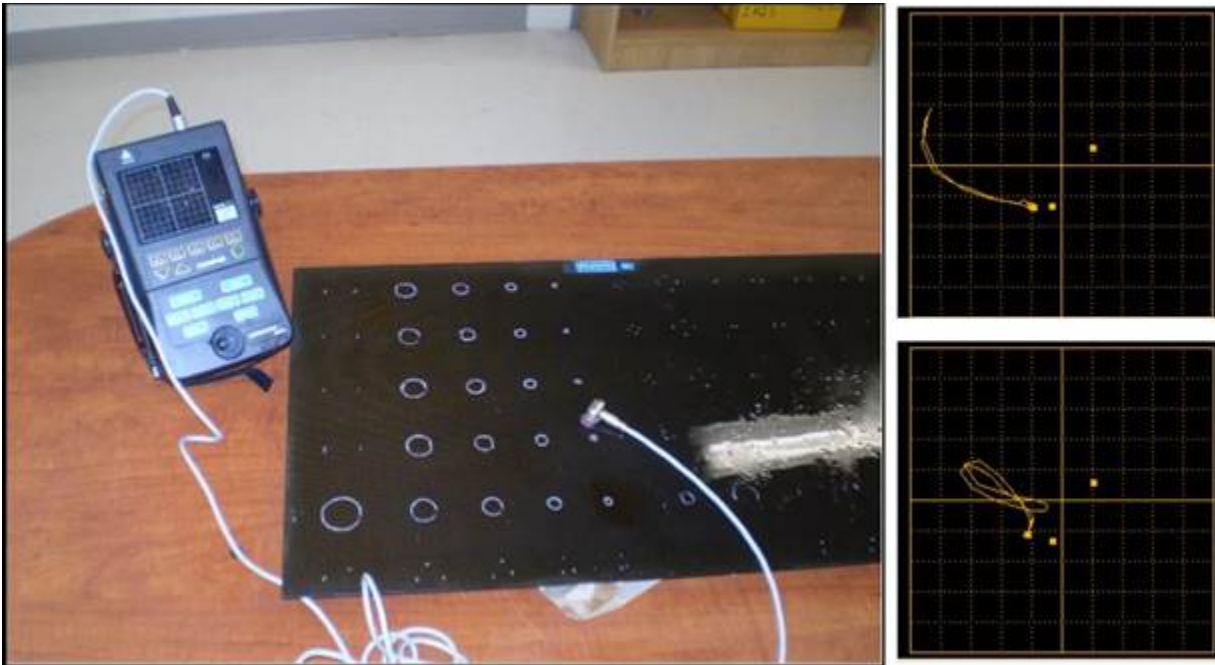
Figure 35. Olympus BondMaster device operating in HFBT/resonance test mode

composite structure for the detection of inter-ply delaminations. Figure 35 shows the use of a BondMaster device in resonance test mode to inspect a composite panel. The data on the right show the typical display, known as the “flying dot” response, used to determine the presence of damage. The constantly changing path of the flying dot can make the signal interpretation difficult. This is especially true in the areas where signal changes corresponding to changes in part geometry can be misinterpreted. The challenge associated with flaw detection from this type of signal is, in some part, the cause for a reduction in the performance of this NDI method for handheld resonance testing. When these data are transformed into a resonance C-scan image, the test results, as shown in this report, are quite good.

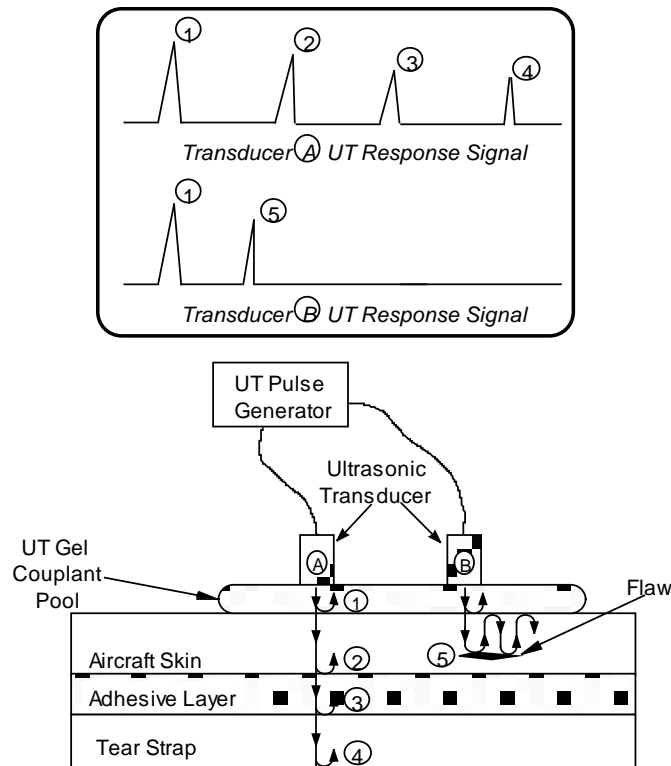
Figure 37. Schematic of pulse-echo ultrasonic inspection and A-scan signal showing reflection of UT waves at assorted interfaces

In most pulse-echo systems, a single transducer acts alternately as the sending and receiving transducer. If the pulses encounter a reflecting surface, some or all of the energy is reflected and monitored by the transducer. The reflected beam, or echo, can be created by any normal (e.g., layer in a multilayered structure) or abnormal (flaw) interface. Figure 37 is a schematic of the pulse-echo technique. It shows the interaction of UT waves with various interfaces within a structure and the corresponding A-scan waveforms that are displayed on a UT inspection instrument. Complete reflection, partial reflection, scattering, or other detectable effect on the UT waves can be used as the basis of flaw detection. In addition to wave reflection, other variations in the wave that can be monitored include time of transit through the test piece, attenuation, and features of the spectral response [28, 29]. Sometimes it is advantageous to use separate sending and receiving transducers for pulse-echo inspection. The term pitch-catch is often used in connection with separate sending and receiving transducers. The degree of reflection depends largely on the physical state of the materials forming the interface. Cracks, delaminations, shrinkage cavities, pores, disbonds, and other discontinuities that produce reflective interfaces can be detected.

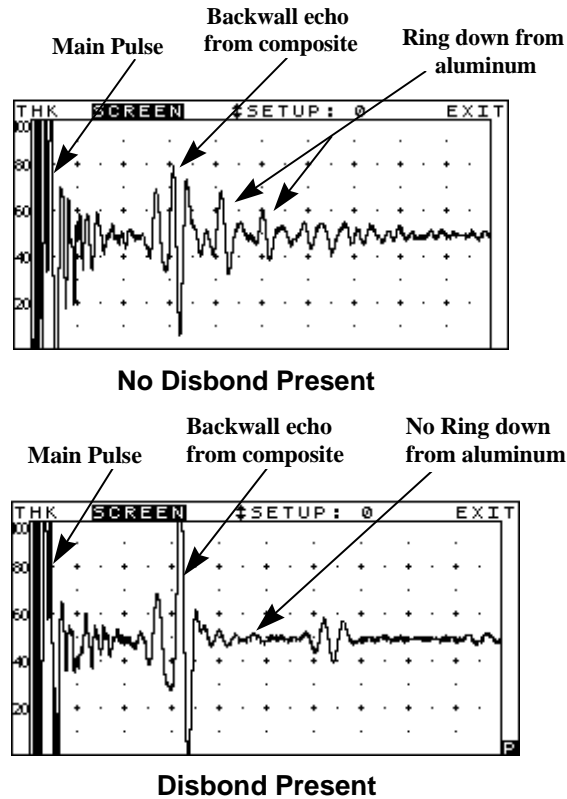
Figure 38. A-scan waveform from bonded and disbonded portions of a composite structure

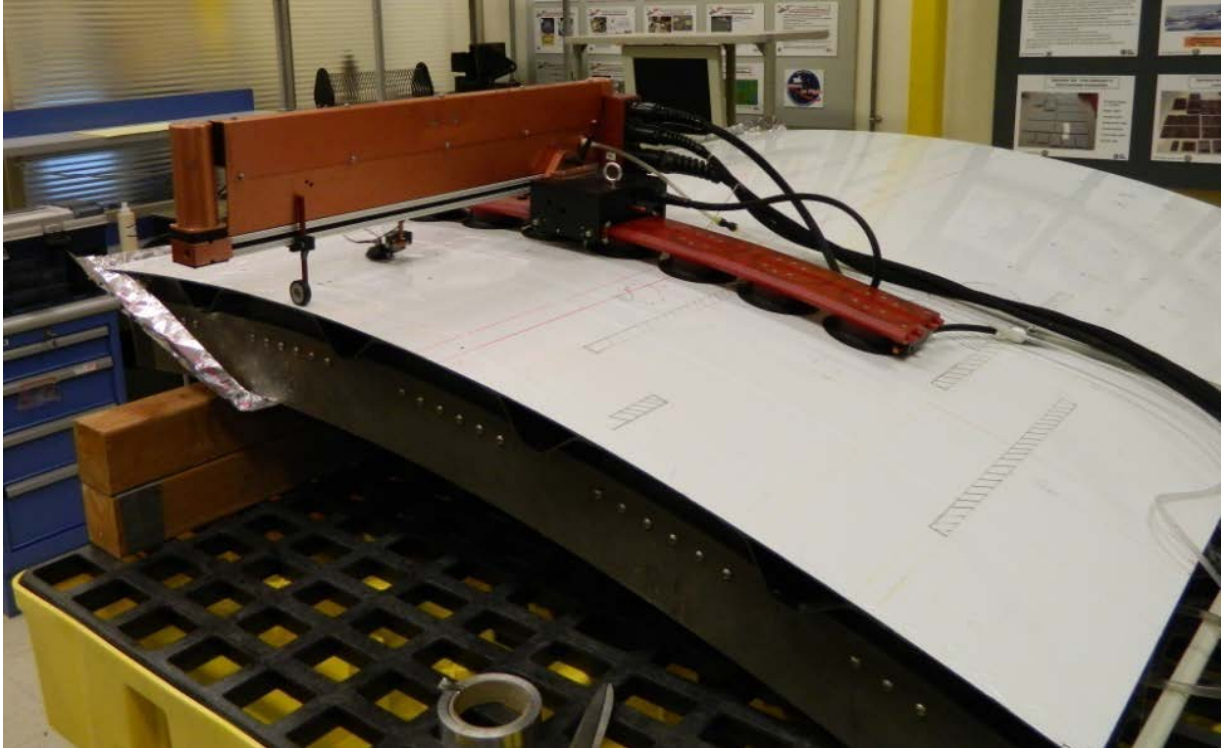
A photograph of an automated (motorized) scanner, the Boeing MAUS system, inspecting an aircraft fuselage section is shown in figure 40. The entire UT C-scan device is attached to the structure using suction cups connected to a vacuum pump. The unit is tethered to a remotely located computer for control and data acquisition. Figure 41 shows a comparison of A-scan signals from damaged and undamaged portions of a composite structure that were produced by the PE-UT method. Note the clear reflection peak produced by uninterrupted signal travel to the back wall in the “undamaged” A-scan signal. Compare this to the A-scan signal from the “damaged” region where the amplitude of the back wall signal is decreased, and a new intermediate peak (reflection) is observed. Both of these A-scan changes indicate the presence of damage or other anomaly. Figure 42 shows a sample C-scan image (based on amplitude) from a PE-UT inspection of a composite fuselage structure containing stringers and frame shear ties (see figure 40). Dark spots and irregularly shaped regions of non-uniform color indicate the presence of impact damage in this panel. The value of using two-dimensional color coding, stemming from the sum total of the A-scan signals, to identify and size composite flaws is evident in this C-scan image.

Figure 40. MAUS automated ultrasonic scanning system

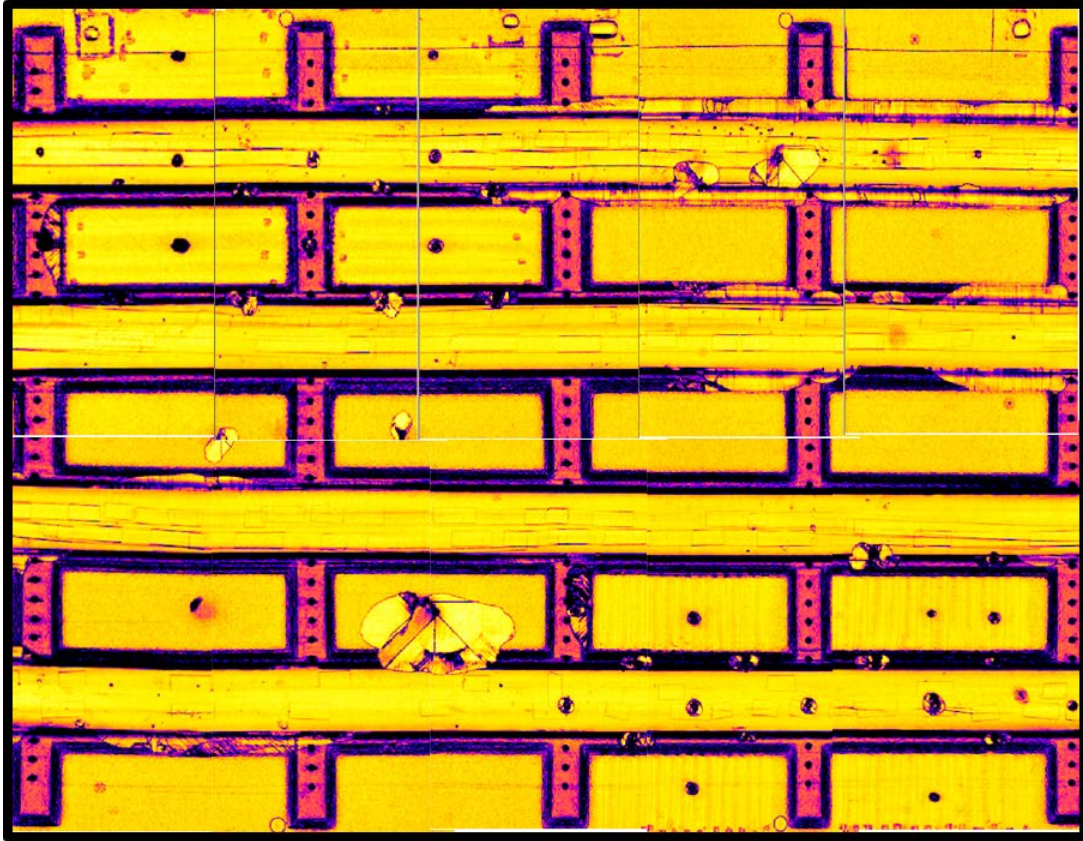
Figure 42. Sample C-scan produced by an automated ultrasonic scanning device

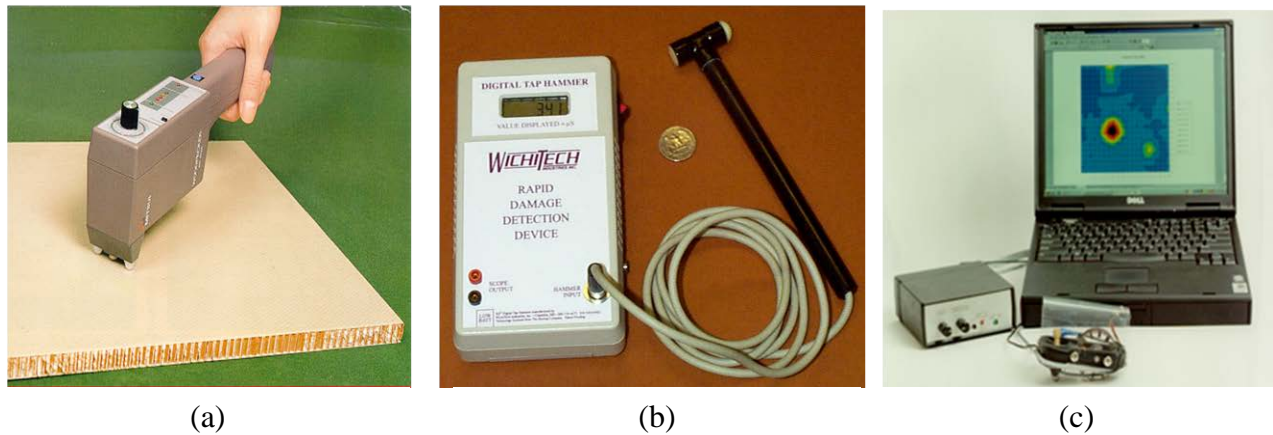
Figure 47. Three examples of instrumented tap test devices: a) Woodpecker, b) RD³, and c) CATT

operated digital hammer, called the WichiTech DTH or Rapid Damage Detection Device (RD³), is also commercially available [33, 34]. The DTH uses a digital LCD readout to display the value of the contact time. For this device, the impactor is a hand-deployed plastic hammer that contains an acceleration sensor. Finally, the CATT, developed at Iowa State University, uses a piezoelectric accelerometer fitted with a hemispherical tip as a handheld impactor and also in a semi-automated, cart-deployed magnetic tapper. The CATT uses the contact time data and converts it into the local stiffness based on the mass of the impactor [35]. Figure 47 shows three of the four systems described above.

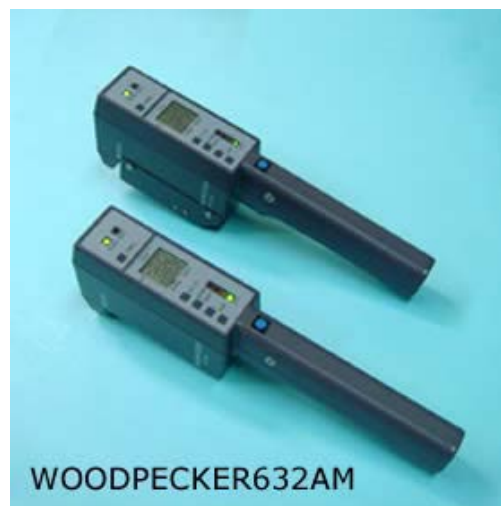
The Woodpecker device, developed by Mitsui, is shown in figure 48. It uses automatic tapping, produced by an electric solenoid, to drive the hammer tip. The device uses a calibration feature to store a response corresponding to an undamaged region, which it then compares with the response from subsequent inspection regions. The device then displays green (good), yellow (possible damage), and red (probable damage) lights, along with audible alarms, to relay the results from this relative comparison in real time. Thus, it does not depend on the audible responses, which may be difficult to distinguish from each other, especially in noisy environments. The quantitative values associated with the impacts are transmitted to the Woodpecker's monitoring unit. A user-selected number of taps can be averaged into a single impact duration number to better normalize the results and minimize the detrimental effects of noise sources (e.g., a non-perpendicular deployment angle). An attachment to the Woodpecker displays the numerical value of the contact time in microseconds. This separate monitoring unit can be used for displaying and storing measured values. This unit can also be connected to a computer so that a grid of measurements can be logged corresponding to various locations on a structure. In this manner, the duration of impact values can be color-coded according to specific bins, and two-dimensional images (C-scans) can be produced of the structure's surface. The Woodpecker is small and lightweight to permit operation with one hand.

Figure 48. Woodpecker automated tap test device

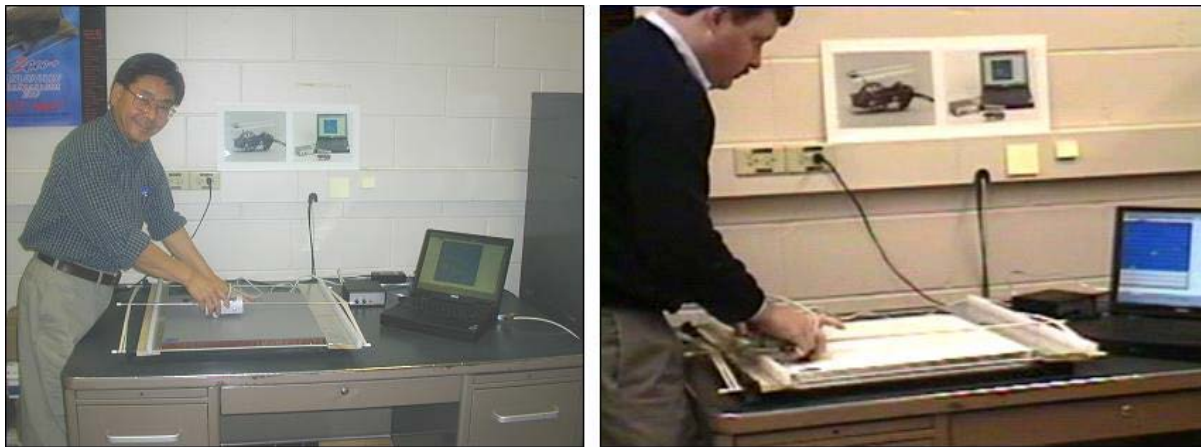
Figure 52. CATT system being deployed by Iowa State University developers on honeycomb flaw detection experiment test panels

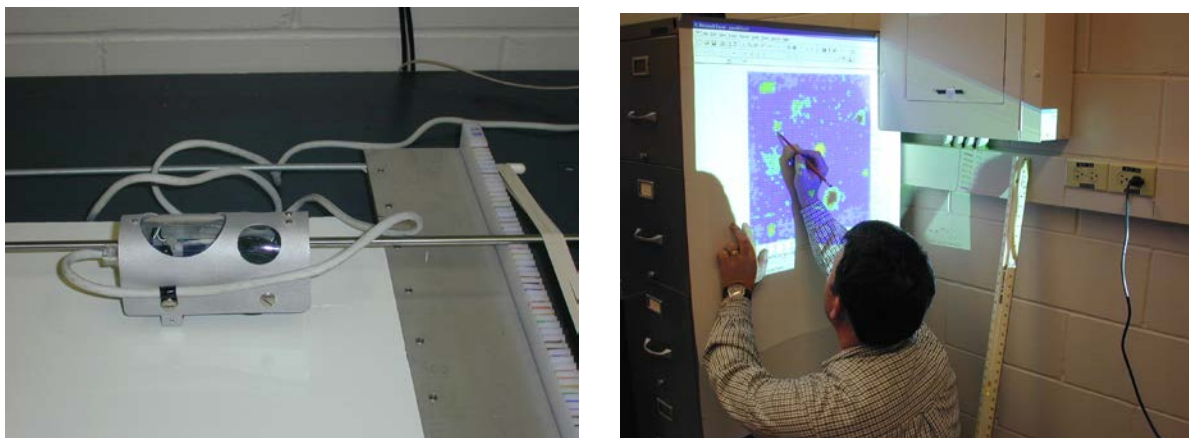
Figure 53. Close-up of CATT tapper and transfer of data from computer to grading sheets

To take advantage of the visual interpretive power of the inspector, the impact duration of an instrumented tapper is measured and fed into a Microsoft Excel spreadsheet to produce C-scan images. A graphical user interface is used to produce a C-scan image by displaying the relative stiffness values acquired across the scan as color-coded values of impact durations. The system significantly improves the quality of the inspection by producing a visual image of the condition of the structure. To initiate a scan, a transparent plastic sheet with a printed grid is taped over the region to be tapped. The number of taps in the length and width directions is entered into the computer. The operator then taps each square of the grid with the handheld accelerometer tapper in a systematic manner (for example, from left to right and top to bottom) until all the squares are tapped. The manual tap probe is used to inspect small or confined areas and surfaces with a significant curvature. The semi-automated version of the CATT system uses a magnet-operated cart that impacts the surface with the accelerometer at a pre-set spacing interval as the cart is pushed over the surface (see figures 51 and 52). Using the cart, a large area can be inspected very rapidly. Each tap triggers the A/D board and prompts the program to record one impact duration value for the corresponding location. A C-scan type image is generated as the tap scan progresses. The measured values of the impact duration are displayed in 16 different colors. The resulting image shows a damaged area as a region of higher impact duration values. Such an image also reveals internal substructures of the composite part, including core splices, ply drop-off or build-up, reinforcing doublers, and septum changes. Based on a mechanical model of the impact response, the impact duration image can be converted into an image of an effective spring constant that indicates the local stiffness of the structure. Tap scan images of different parts of a component or of different components may be stored in the computer for future reference and assessment of damage progression.

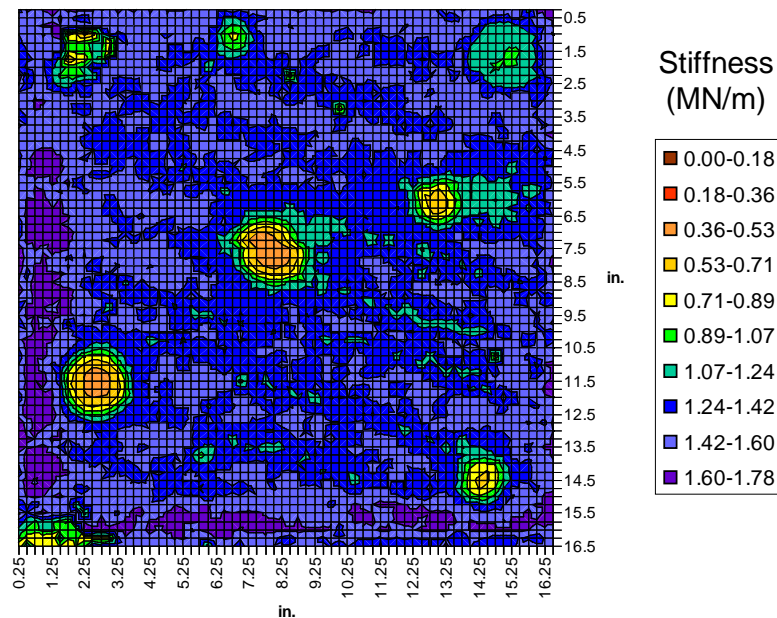
Figure 54. CATT C-scan tap test image of surface contact stiffness of a composite honeycomb sandwich panel containing engineered defects

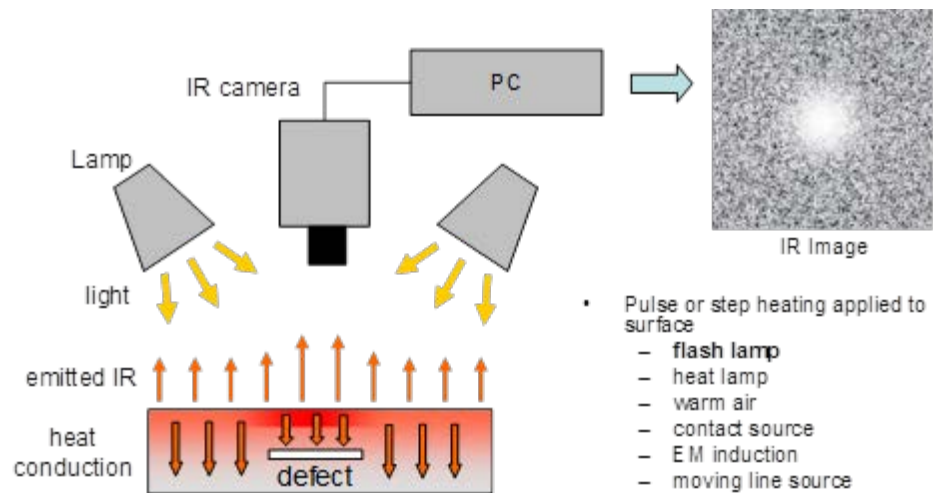
Figure 58. Principle of active pulsed thermography

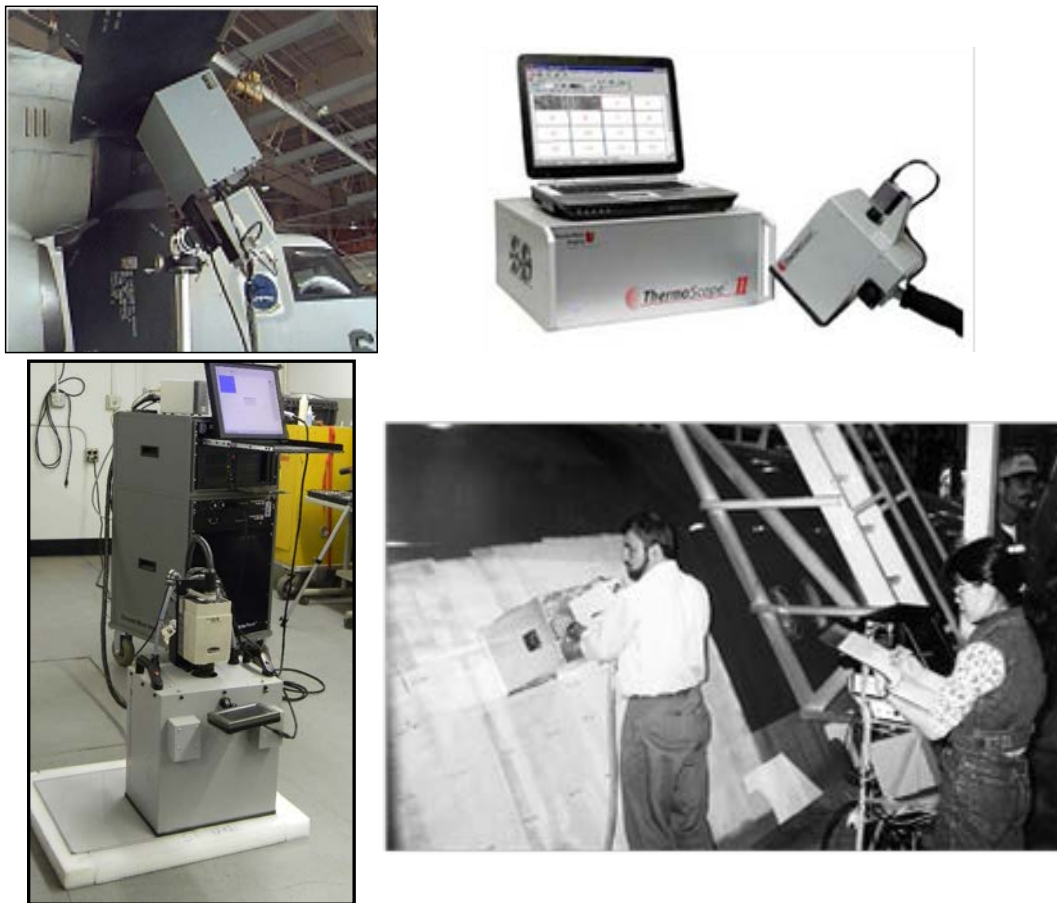
In the solid laminate flaw detection experiment, a turnkey thermography inspection system—the Thermal Wave Imaging (TWI)—was used to assess the merits of thermography to detect flaws in composite honeycomb construction. Figure 61 shows a photo of this inspection device and example applications on aircraft. The TWI ThermoScope[®] and EchoTherm[®] NDI systems are designed for in-service applications and are integrated hardware and software systems for analyzing and measuring physical properties of materials using pulsed thermography. The system includes TWI's Thermographic Signal Reconstruction[®] (TSR) processing technique, which increases spatial and temporal resolution of a thermogram sequence.

Figure 61. TWI system equipment and inspection of aircraft

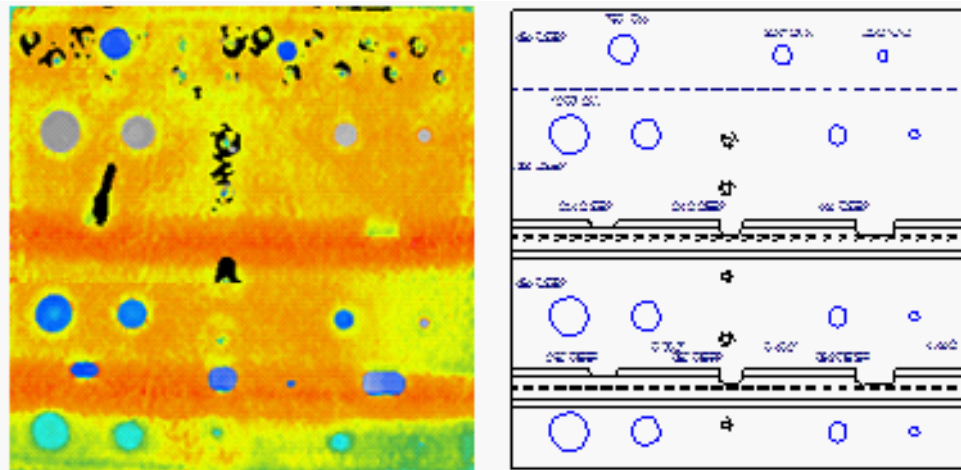
Figure 64. Thermography image produced from inspection of composite laminate panel with flaw profile as shown in drawing on the right
