DOT/FAA/TC-15/63

A Quantitative Assessment of Conventional and Advanced Nondestructive Inspection Techniques for Detecting Flaws in Composite Honeycomb Aircraft Structures

Final Report

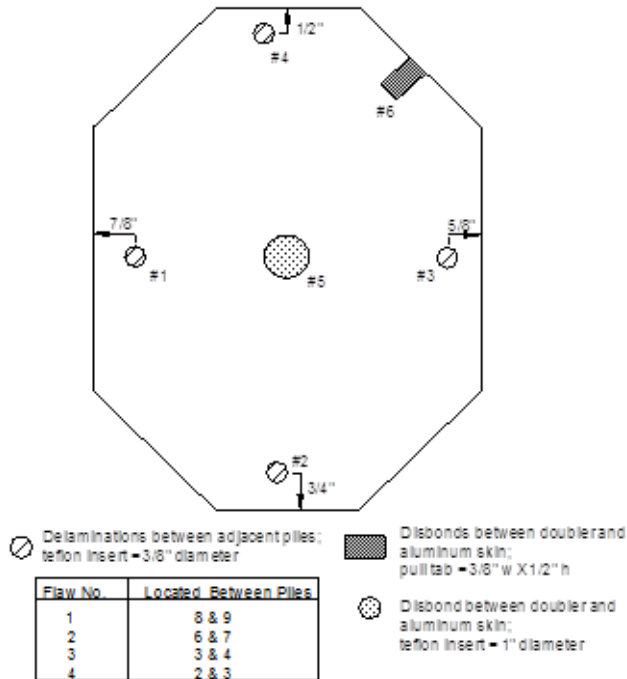
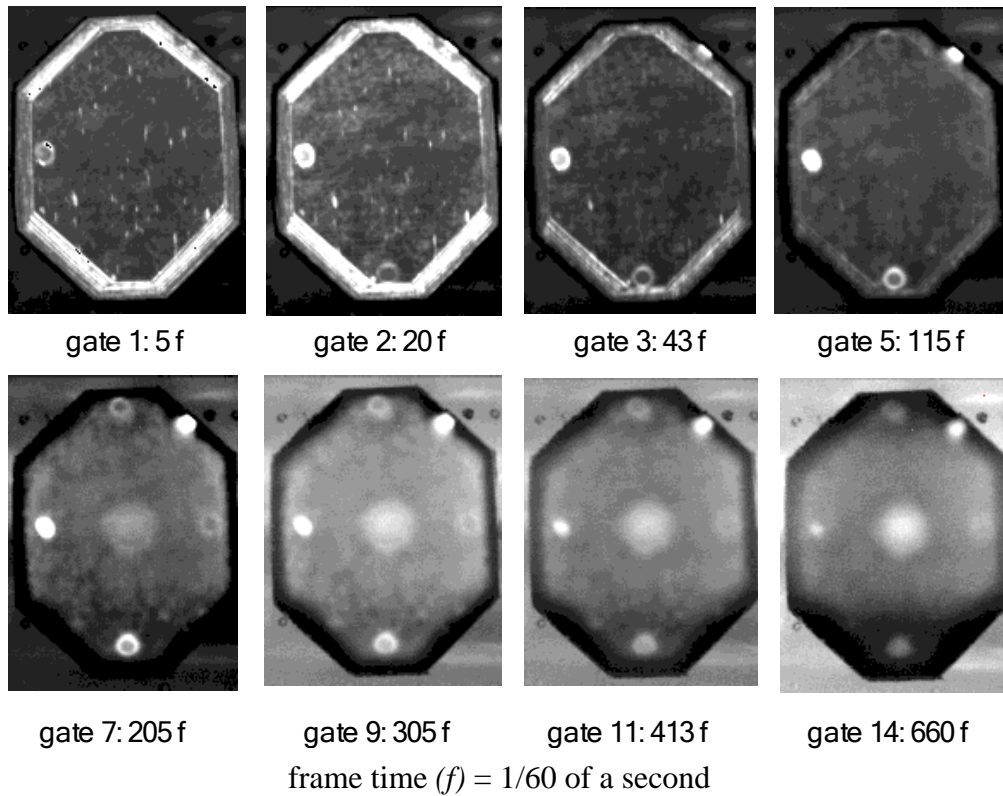
Figure 66. Sequence of thermal wave images from DC-9 composite doubler inspection

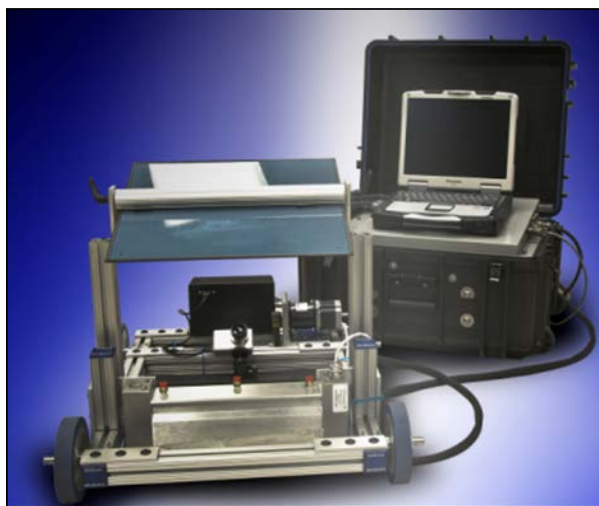
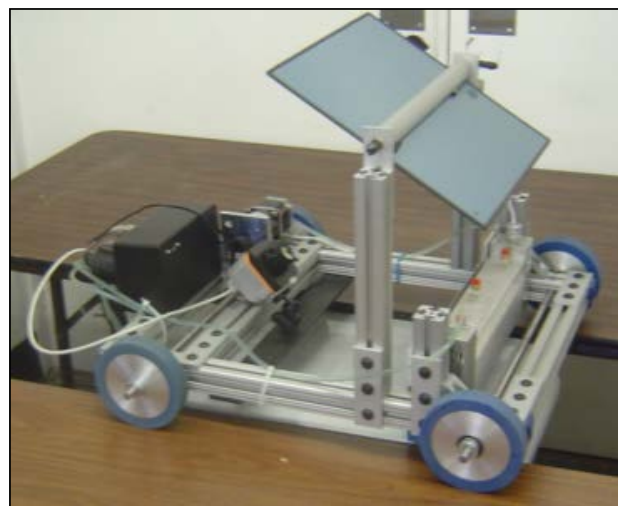
Figures 70 and 71 show the MISTRAS Line Scan Thermography™ (LST) scanner used for scanning composites. The LST technique requires that the camera moves in sync with the lamp used for depositing the heat over the surface of interest. The movement is controlled using a motor. These components have been organized in different ways depending on the structure to be scanned and the size of the area of interest. MISTRAS has fabricated mainly three different systems for inspecting different structures. The first one is a gantry-type system capable of performing vertical scans of up to 1.5 m long and 40.64 cm in width. The system employs a cooled IR camera working in the mid-wave IR range (3–5 micrometers). The lamp employed in the system corresponds with a quartz lamp 40.6 cm long. The second LST system is a small area scanner that offers a 30.5 cm x 81.2 cm area scan and uses suction cups for attaching to the surface of interest. This scanner uses a microbolometer working in the 8–12 micrometers range. Finally, the third MISTRAS LST system is a motorized crawler designed to scan flat areas. This scanner offers a 4–6 cm wide field of view and can cover scan lengths of up to 12 m in a single scan. This scanner can hold a cooled camera or a microbolometer. This crawler can be easily modified to scan composite structures of different thicknesses, like fiber glass wind turbine blades, for which it is necessary to wait significant time for observation after the heat deposition. This is achieved by adding a train that increases the separation between the observation area and the heat deposition location.

Figure 70. MISTRAS LST system—crawler used on composites

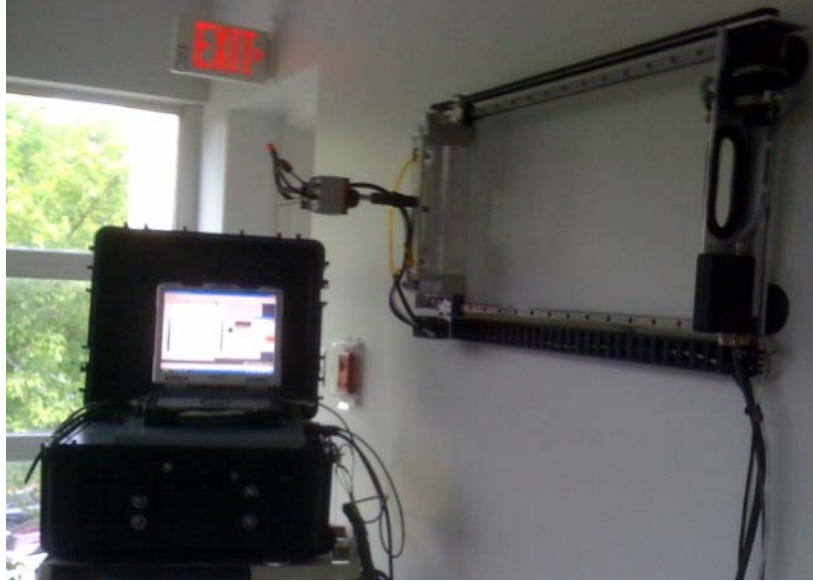
Figure 71. MISTRAS LST system—small area scanner

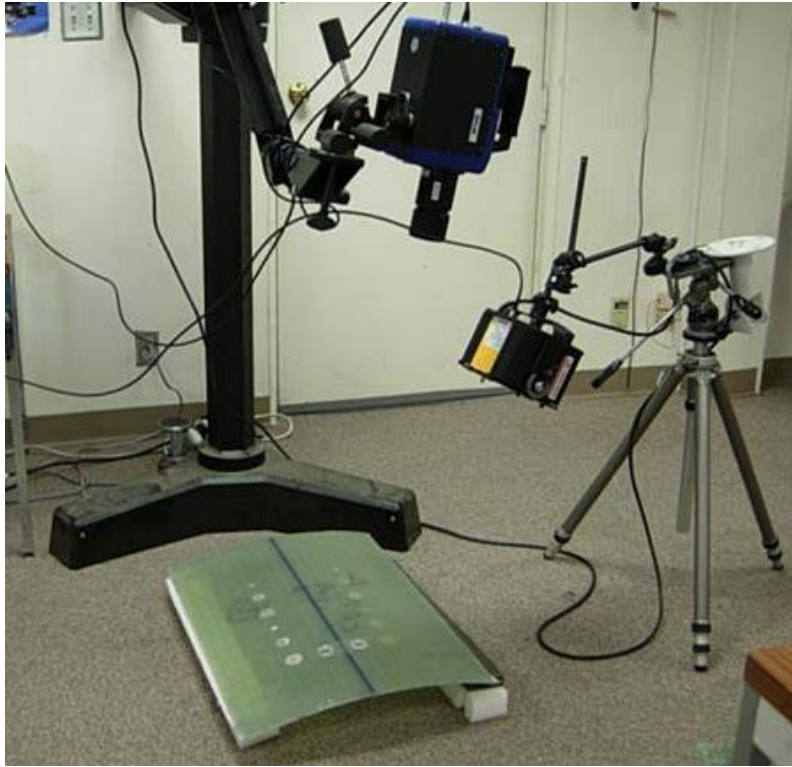
The most common excitation source for lock-in thermography is the halogen lamp. Figure 74 shows the MoviTHERM lock-in thermography equipment featuring a FLIR camera SR2 SC7650 with a Hedler 2500 watt lamp. Lock-in thermography can be used to detect damages such as delamination, inclusions, and impact in composite structures. Figure 75 shows inspection results from a 32-ply (0.23" thick skin) solid laminate composite panel with a 58-ply (0.192" thick) upper stringer and 50 ply (0.125" thick) lower stringer. The engineered flaw profile is also shown on the left for comparison purposes.

Figure 74. MoviTHERM lock-in thermography with halogen heat lamp being used as the excitation source

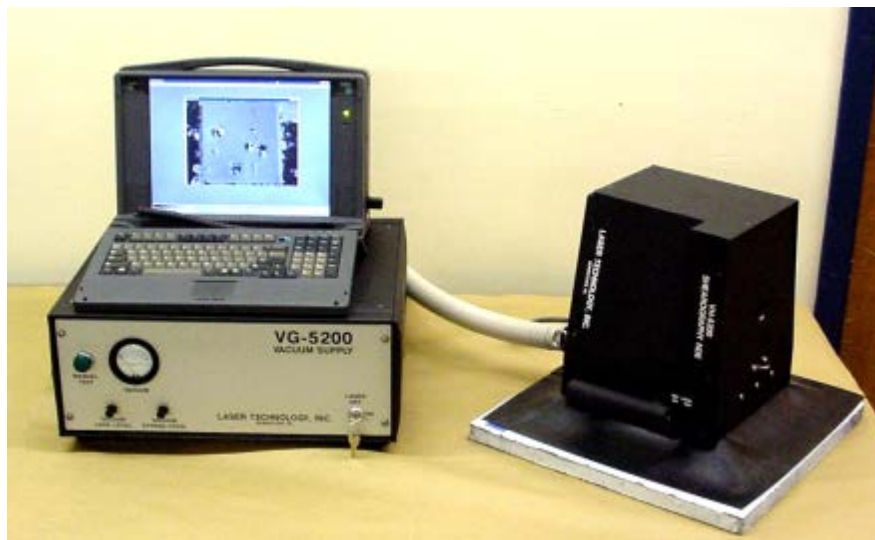
Shearography is a wide-area interferometric imaging technique that is capable of detecting micron-sized displacements in the surface of a structure. Shearography equipment, shown in figure 76, monitors the surface of a structure for any changes in the surface strain field. Stressing the material in the appropriate way ensures that the subsurface anomalies are manifested on the

Figure 76. LTI-5200 portable shearography system with camera on test specimen

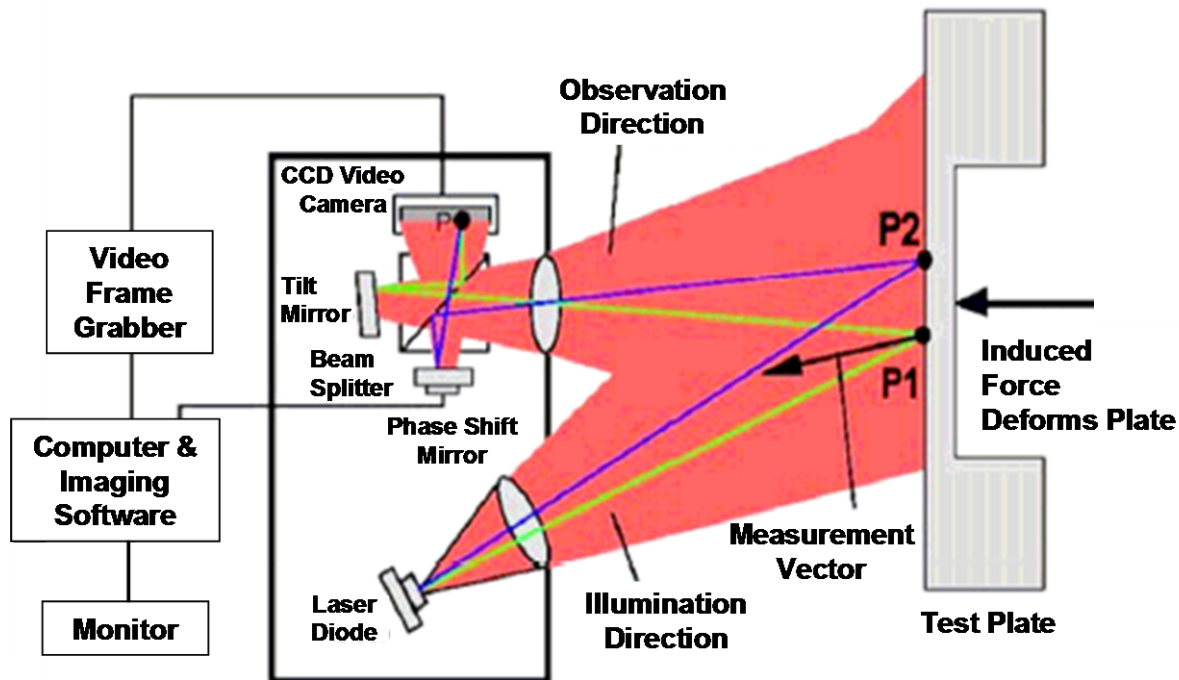
Figure 77. Basic principles of shearography

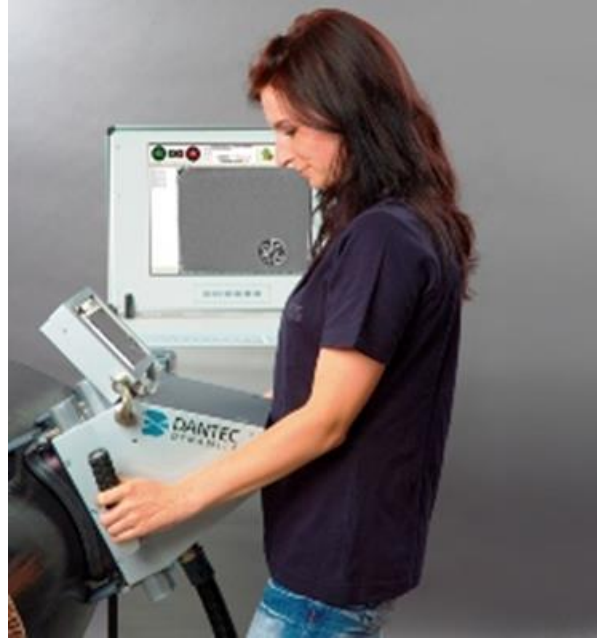
The Q-810 laser shearography system, shown in figure 84, is oriented toward use on composite materials over large surface areas. It can detect defects such as delaminations, disbonds, kissing bonds, wrinkling, impact damage, and crushed core with no surface preparation. The turnkey optical systems are non-contact and full-field, and will work on such materials as carbon-fiber, glass-fiber, laminates, honeycomb, foam, metal, and GLARE (glass laminate aluminum reinforced epoxy). The integrated systems are optimized for large surface area inspections—for example on aircraft fuselages, wings, control surfaces, ship hulls, wind turbine blades, and rocket components.

Figure 84. Q-810 laser shearography system

The full-field inspection rate of the Q-810 laser shearography system is approximately 300 mm x 200 mm every 10 seconds. With adaptive seals, the Q-810 can be used on flat as well as highly curved surfaces. The system operates independently of the local environmental conditions and can be used for production or in-field inspections. The interferometric technique measures microscopic surface deformations caused by internal flaws when a small loading is applied to the object. This can be done using thermal, pressure, vibration, or mechanical excitation. The results are displayed live as the material responds to the excitation. Further image processing is also available for export and reporting. Figure 85 shows a sample shearography image produced by the Q-810 system while inspecting a composite laminate that contains wrinkles.

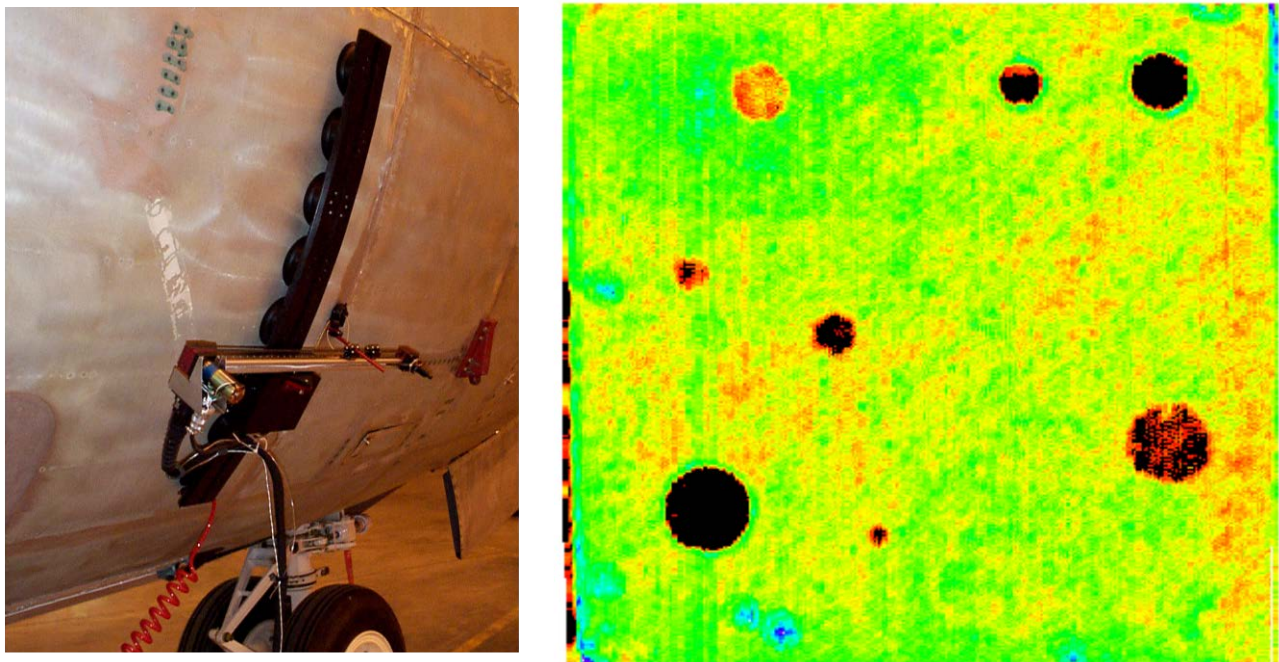
Figure 87. MAUS system operating on an aircraft fuselage with sample C-scan image produced from resonance inspection on a 6-ply carbon skin honeycomb panel

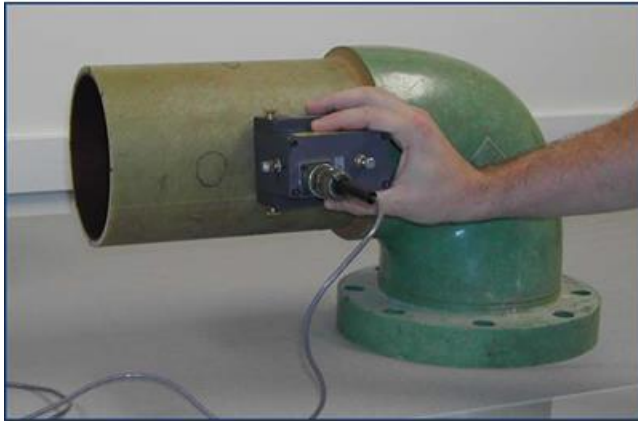
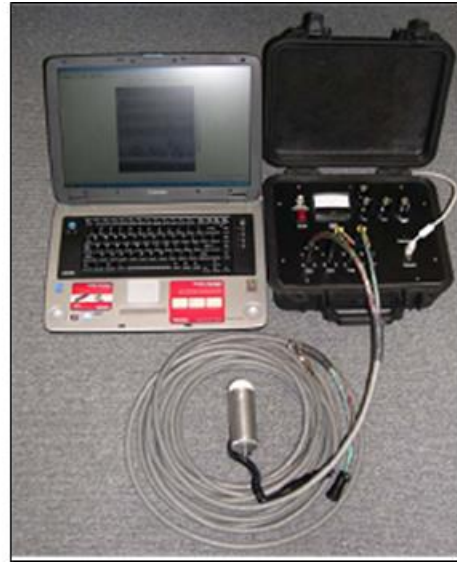
Figure 91. Basic equipment setup for microwave inspection

Microwave techniques are able to detect voids, delaminations, porosity variation in a variety of materials, impact damage, and water infiltration—all problems that affect composite materials. It can also provide the possibility of process control during the manufacturing of composites so that the final product may not need any scrutiny and may only require occasional testing once under some loading. Finally, microwave NDT techniques do not require a high level of expertise from an operator and can be conducted in real time with simple, portable hardware. The main limitation of the microwave method is that it is limited to non-conductive materials. Thus, it has been successfully applied to fiberglass composite structures but cannot be used to inspect carbon-graphite composites. Figure 92 shows microwave results highlighting delamination in a fiberglass laminate boom structure. Figure 93 and 94 show results from the microwave tests on Sandia National Laboratories' composite honeycomb panels ranging in thickness from 3–12 plies. Note that the microwave method performs better on fiberglass skin panels than on the carbon skin panels; this is because the carbon material does not possess dielectric properties appropriate for the propagation of the microwave scan waves.

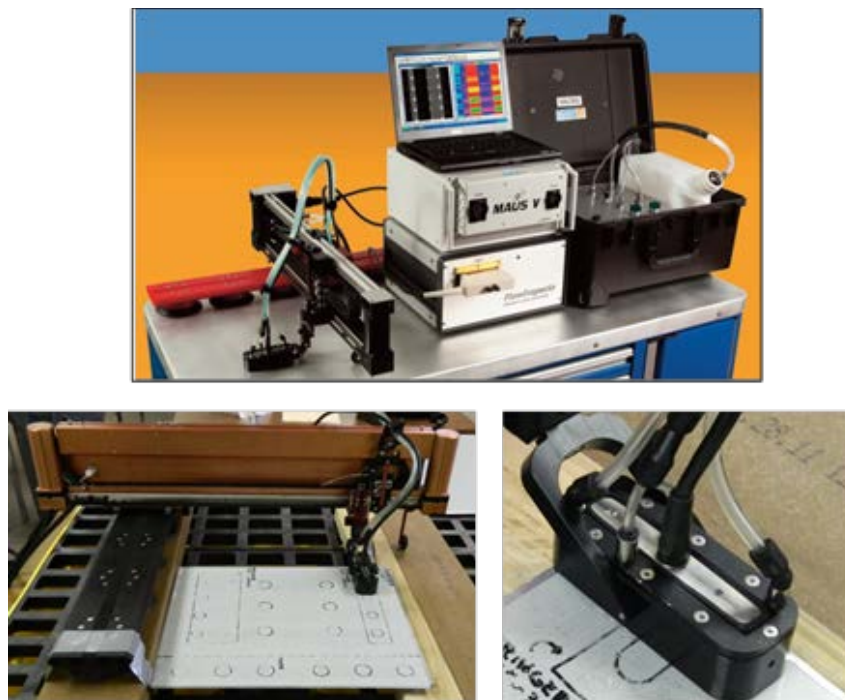
The FlawInspecta system, shown in figures 106 and 107, was designed to address the requirement for a rapid, low-cost UT phased/linear array inspection system. The imager is a laptop-based device that allows for easy transfer of images to other applications or via the Internet to remote locations. It works with a wide range of integrated arrays and is suited for applications ranging from rapid large-area flaw detection to high-speed, low-cost corrosion mapping with 100% coverage. The data acquisition is fast enough to allow for interactive B-scan imaging or rapid C-scanning—typically 40,000 mm²/s (64 in.²/s) for 1 mm pixels—for manual coverage of large areas. The system is also able to perform full waveform capture (FWC), in which the full A-scan (RF or rectified) is acquired and stored for every point on the inspection surface. This volumetric representation offers the ultimate in data acquisition for archiving and offline review yet is achieved at similar data rates. The FlawInspecta system is capable of a pulse rate of 30 kHz, corresponding to a scan rate of 10 in./second or 19.3 ft²/minute, with a 128-element array. Smart arrays can be used with a wide range of conventional equipment such as

Figure 107. FlawInspecta linear array UT system deployed on MAUS V scanner platform—linear array UT probe includes a delay line shoe

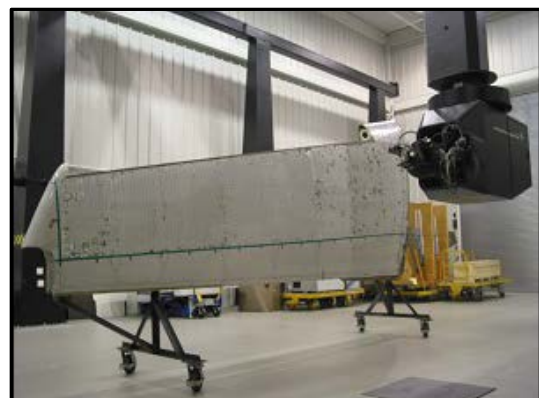
Articulated robot system on a linear rail
Freq. Range = 0.5 MHz – 20 MHz

Figure 120. Schematic of laser UT method and deployment in gantry system and rail system

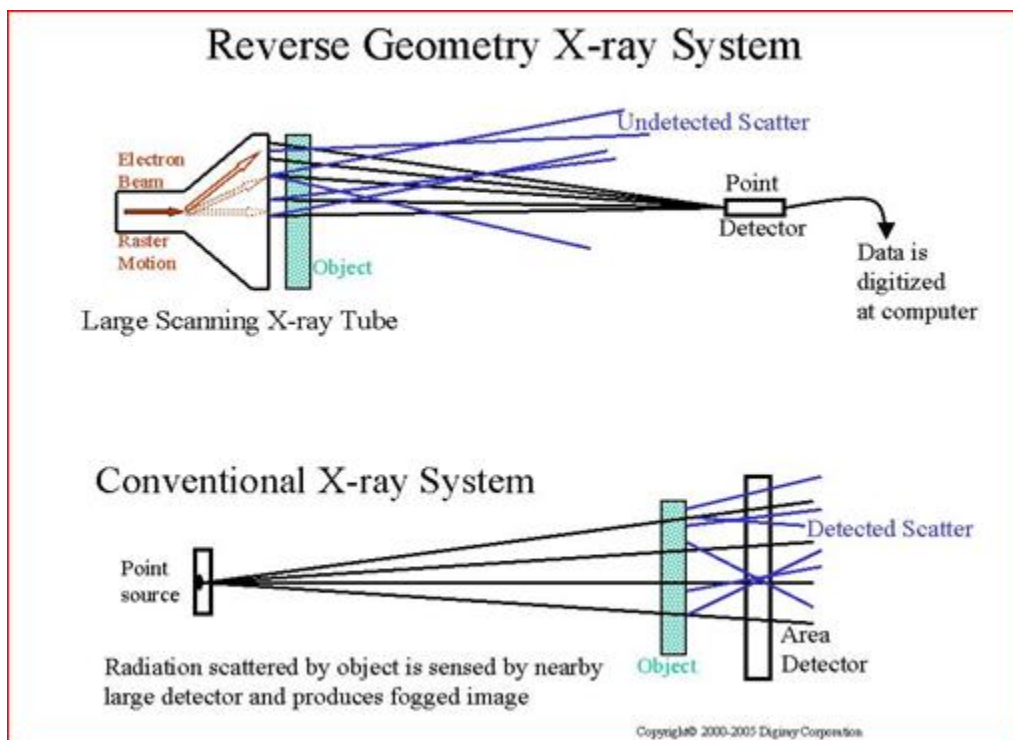
Figure 126. Schematic of the reverse geometry laminography concept

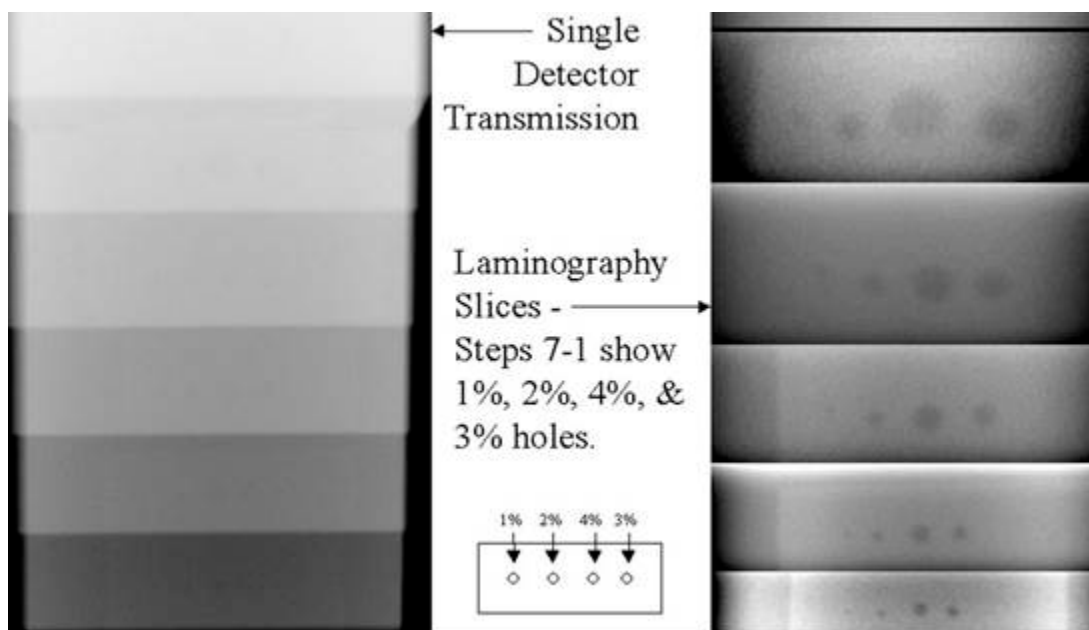
Figure 129. Comparison of normal X-ray with laminography images showing ability of laminography to detect damage in a 4" thick Lucite part

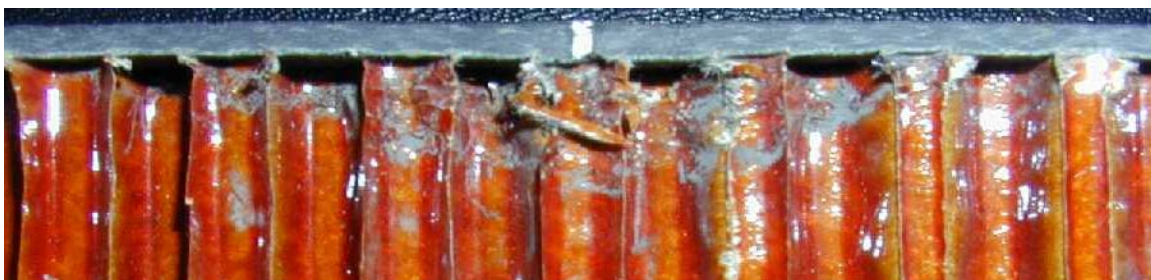
11. Impact specimens – Two impact panels were added for each of the six- and nine-ply families. Nominal impactor sizes of 0.75", 1", 1.5", and 2" diameter were used to create representative flaws of different sizes. As the impact panels represent normal manufactured structure, the laminate and honeycomb core were co-cured in an autoclave at elevated pressures (45 psi versus the 11 psi panels with engineered flaws that represent worst-case repair cures). Figure 136 shows the different impactors along with the drop-table apparatus that was used to produce repeatable, controlled impact energy for the impact panels. Figure 137 shows one of the impact calibration tables that was produced using trial impacts on duplicate composite honeycomb panels. Similar curves were made for fiberglass and carbon skin panels of three-, six-, and nine-ply thickness. Then, these predetermined energy levels were used to produce the actual impact damage on the experiment honeycomb panels. Sample damage produced by the impacts are shown in figures 138 (fiber and matrix cracking) and 139 (crushed core and disbonds).

Figure 139. Cross-section of sample impact damage in composite honeycomb experiment panels showing crushed core but no skin deformation

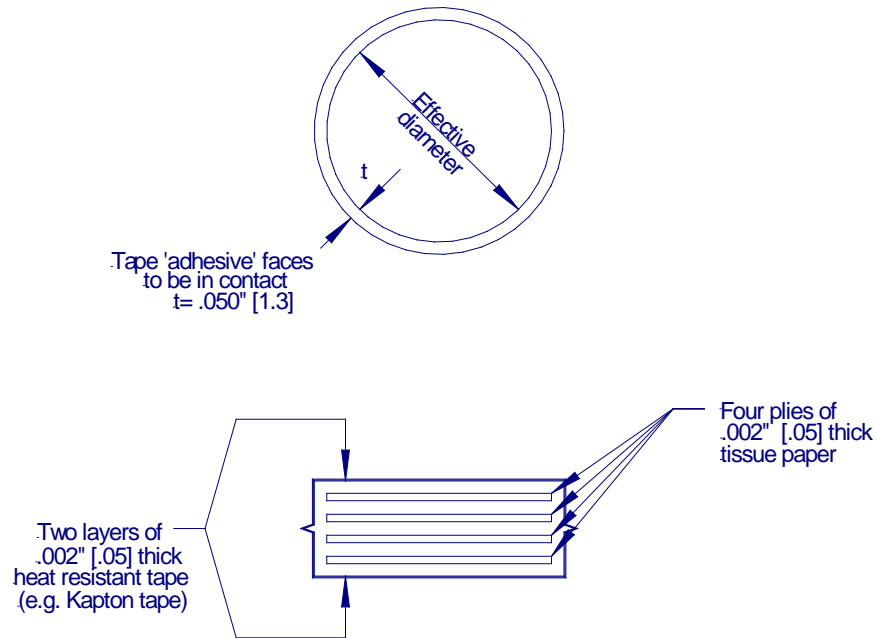
Figure 141. Construction of pillow insert for delamination flaws

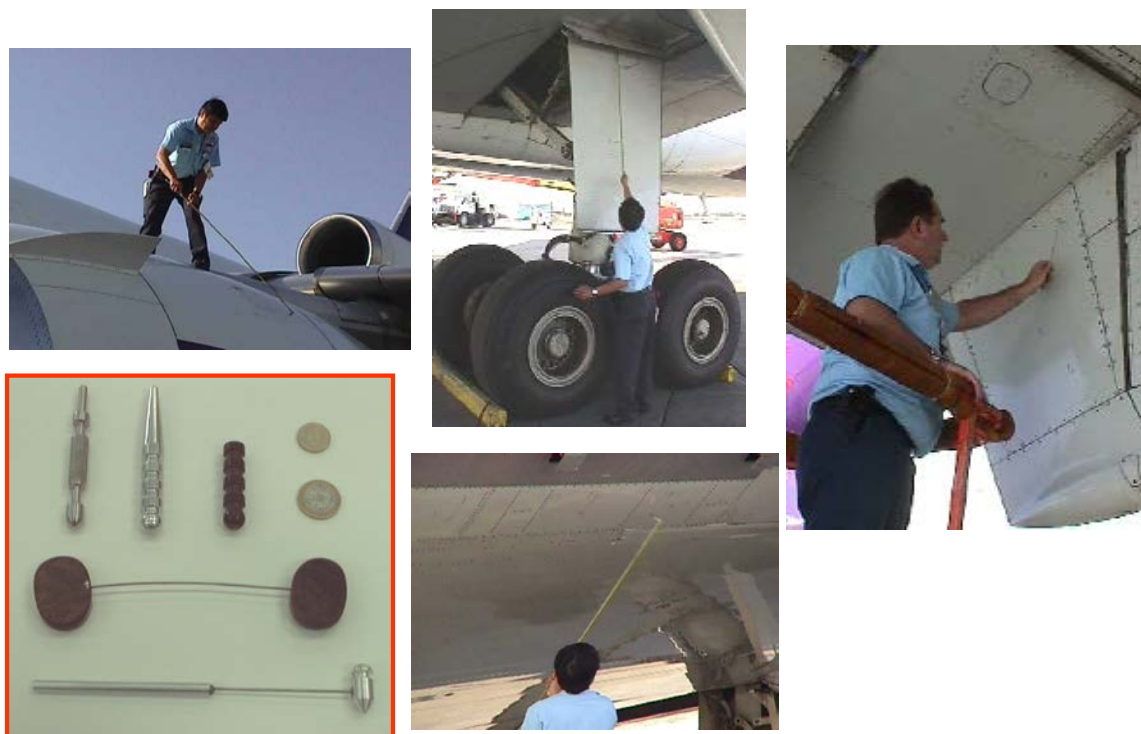
The inspections were conducted on the series of 18" x 18" panels described in section 5. The panels were placed on a foam pad, as shown in figure 148, to produce uniform boundary conditions across all experimenters. Experimenters were asked to work at a pace that is comfortable for them. Although experiment monitors did note start and stop times for each panel inspection, time-to-inspect was a secondary variable of the experiment. Inspectors were instructed to take whatever time was necessary to ensure that any and all flaws in the test specimens were found. Experiment monitors logged observations using the data sheets shown in appendix B. For example, monitors noted: 1) the tap spacing used by the inspector; 2) whether visual clues were used by the experimenters to aid in flaw detection; and 3) whether use of and adherence to OEM recommended procedures were used. An array of acceptable tap test devices (see official Boeing and Airbus tap hammers in section 3) were provided, and the inspectors chose one. This eliminated the use of flashlights, washers, and other devices that do not meet the size and weight criteria (see figures 149 and 150).

Figure 150. Sample tap testing at maintenance depots and alternative tappers identified in study

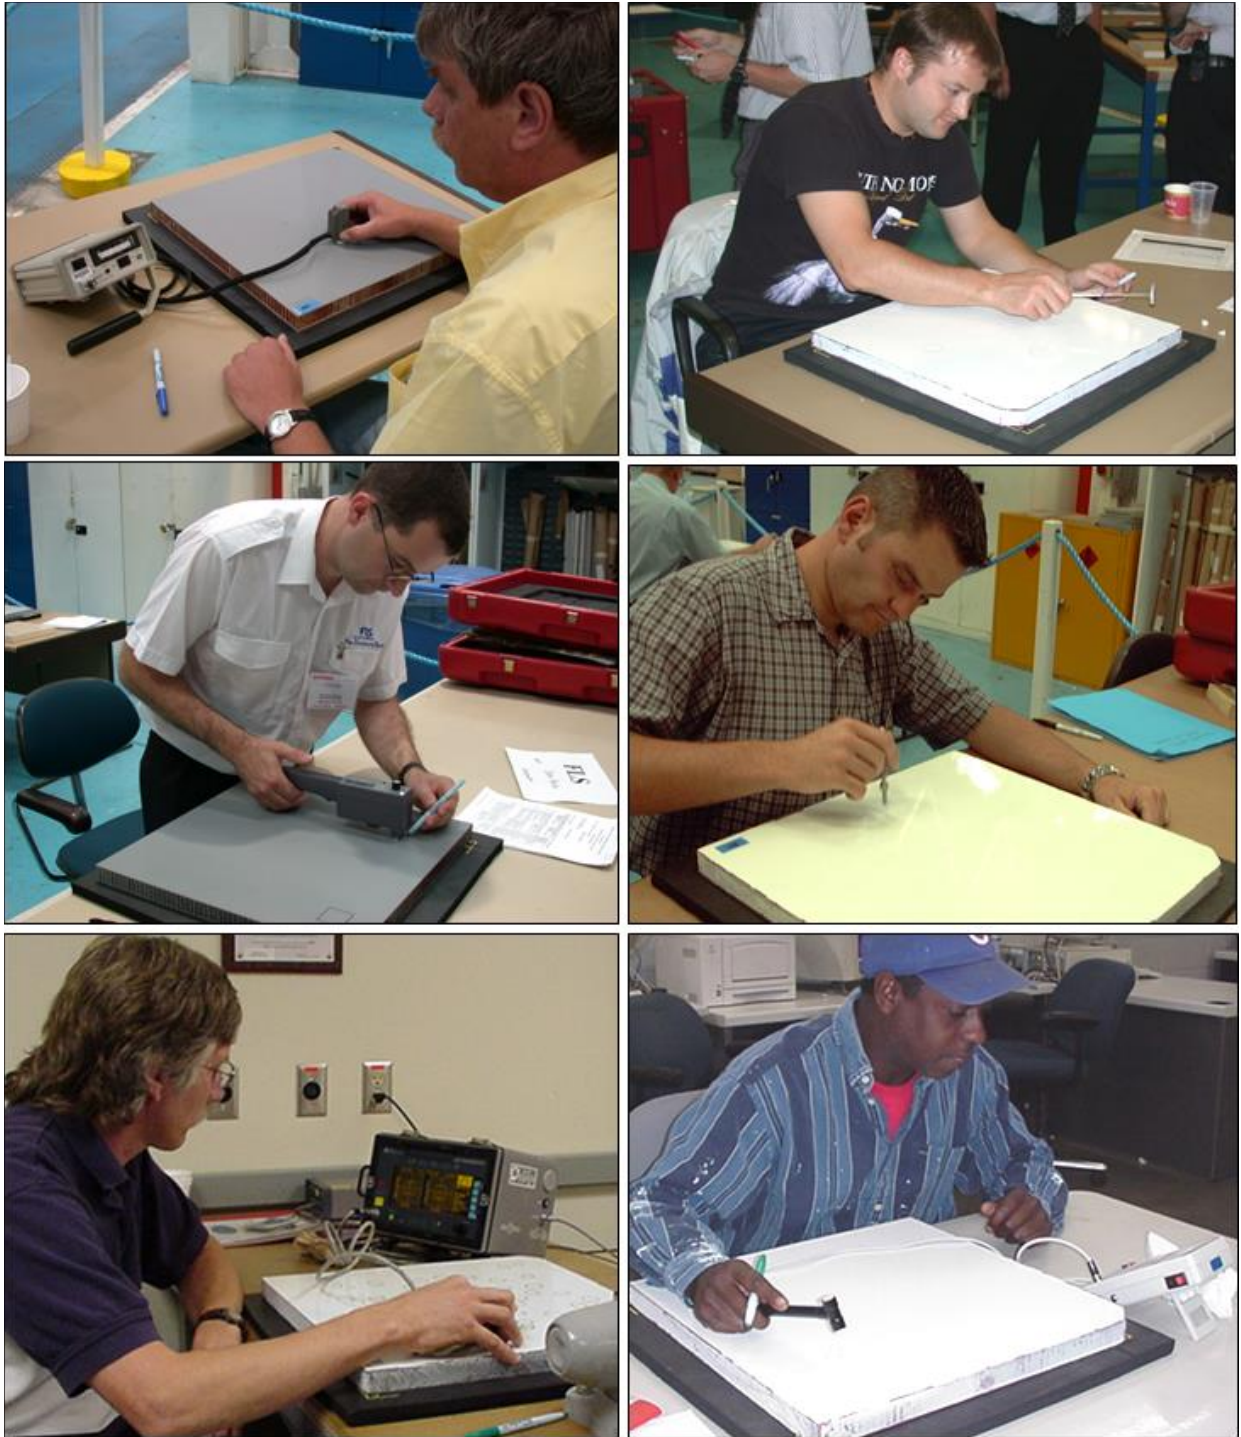
Figure 156. Inspectors completing inspections and marking flaw detections on the test specimens—clockwise from upper right: Airbus tap hammer, Boeing tap hammer, DTH, LFBT, Woodpecker, and MIA

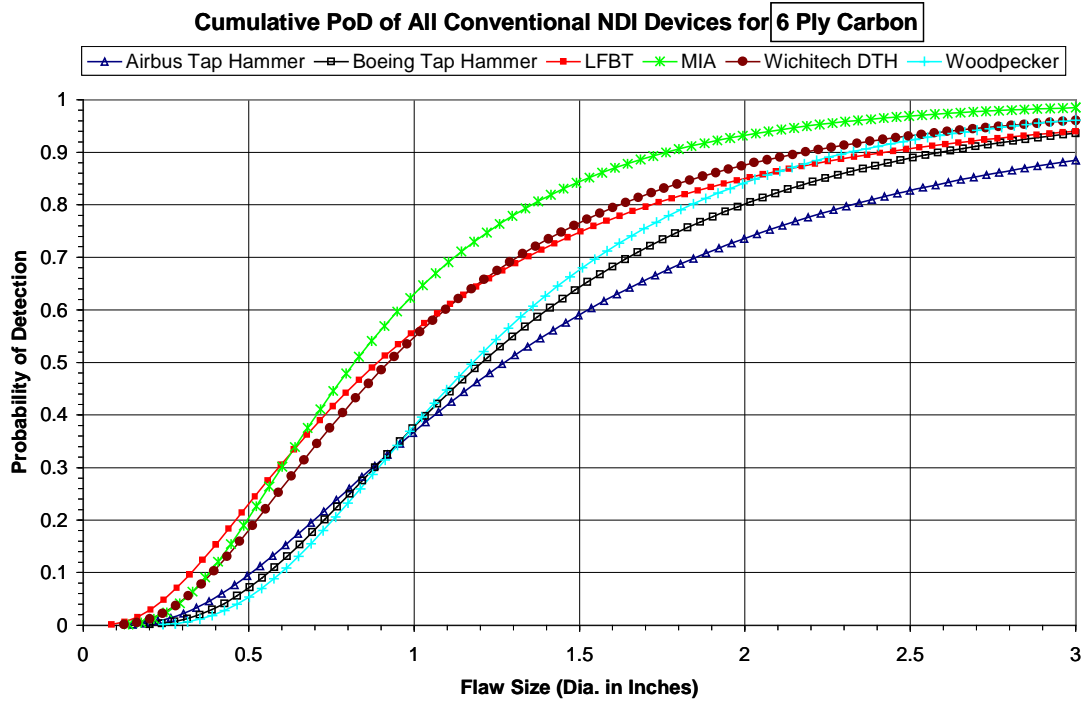
Figure 159. Probability of detection curves showing the performance of multiple NDI devices for a single type of test specimen: 6-ply carbon

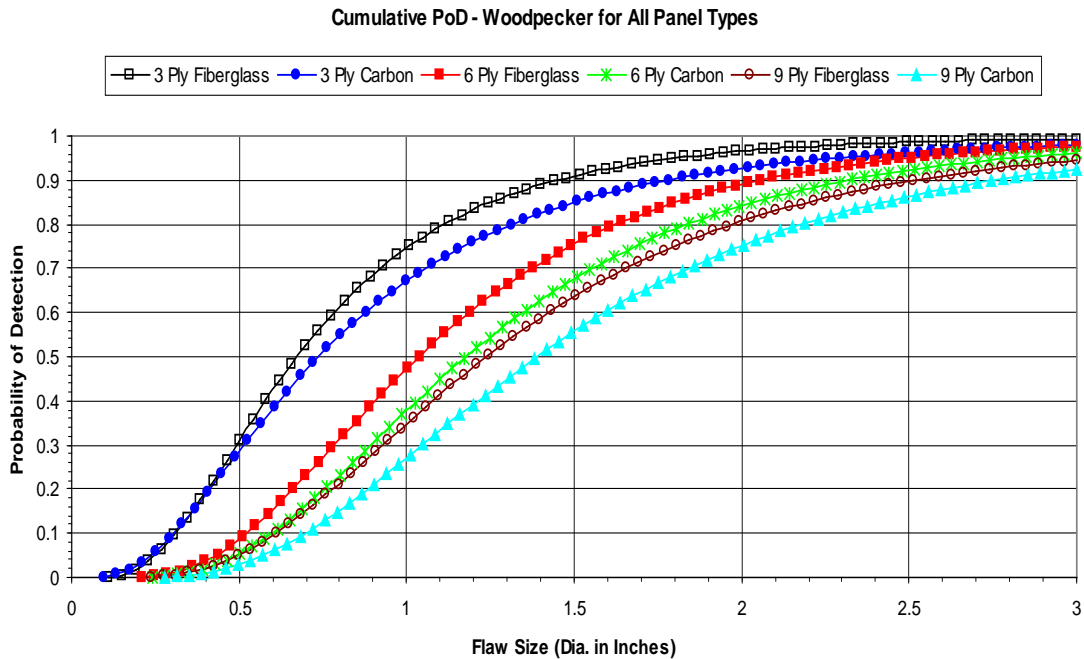
Figure 160. Probability of detection curves for flaw detection performance of a single device (Woodpecker) over the range of test specimen types

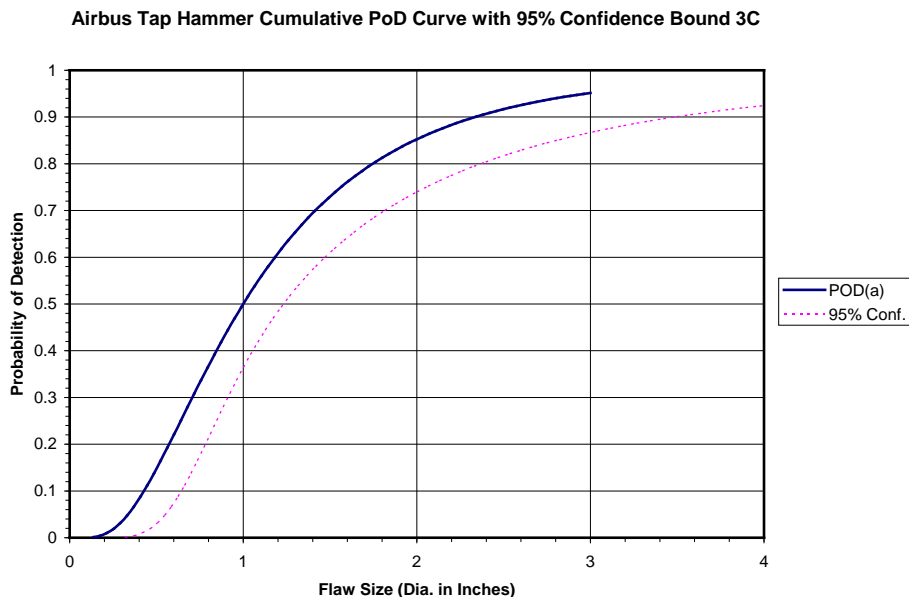
Figure 203. Cumulative PoD curve with 95% confidence bound—Airbus tap hammer, 3-ply carbon

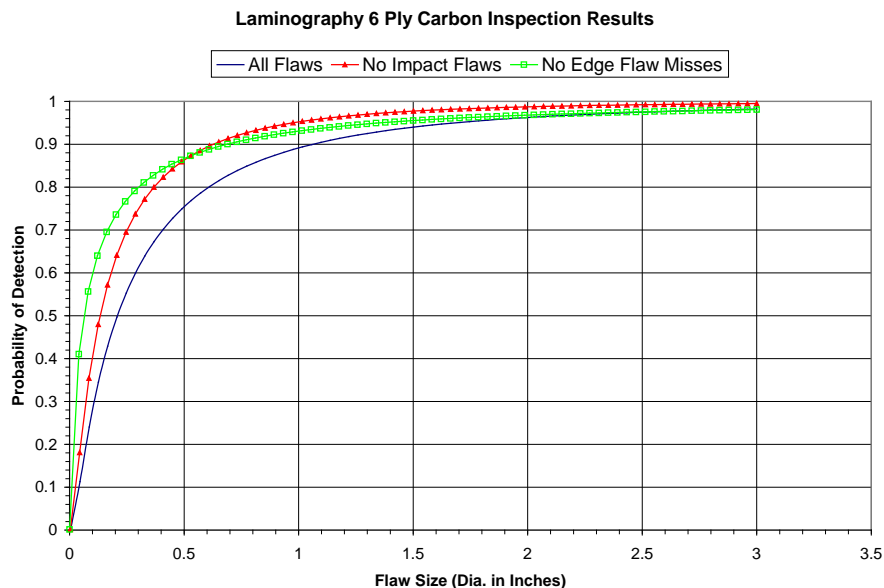
Figure 279. PoD curve comparisons for laminography showing the improvement when impact and edge (inspection image overlap) flaws are removed from PoD calculation on 6-ply carbon
