**DOT/FAA/TC-16/20**

# **Investigating the Discrepancies in Aircraft Anti-Icing Fluid Endurance Times Derived by the Indoor Snow Machine Versus Natural Outdoor Snow Conditions**

August 2016

Final Report

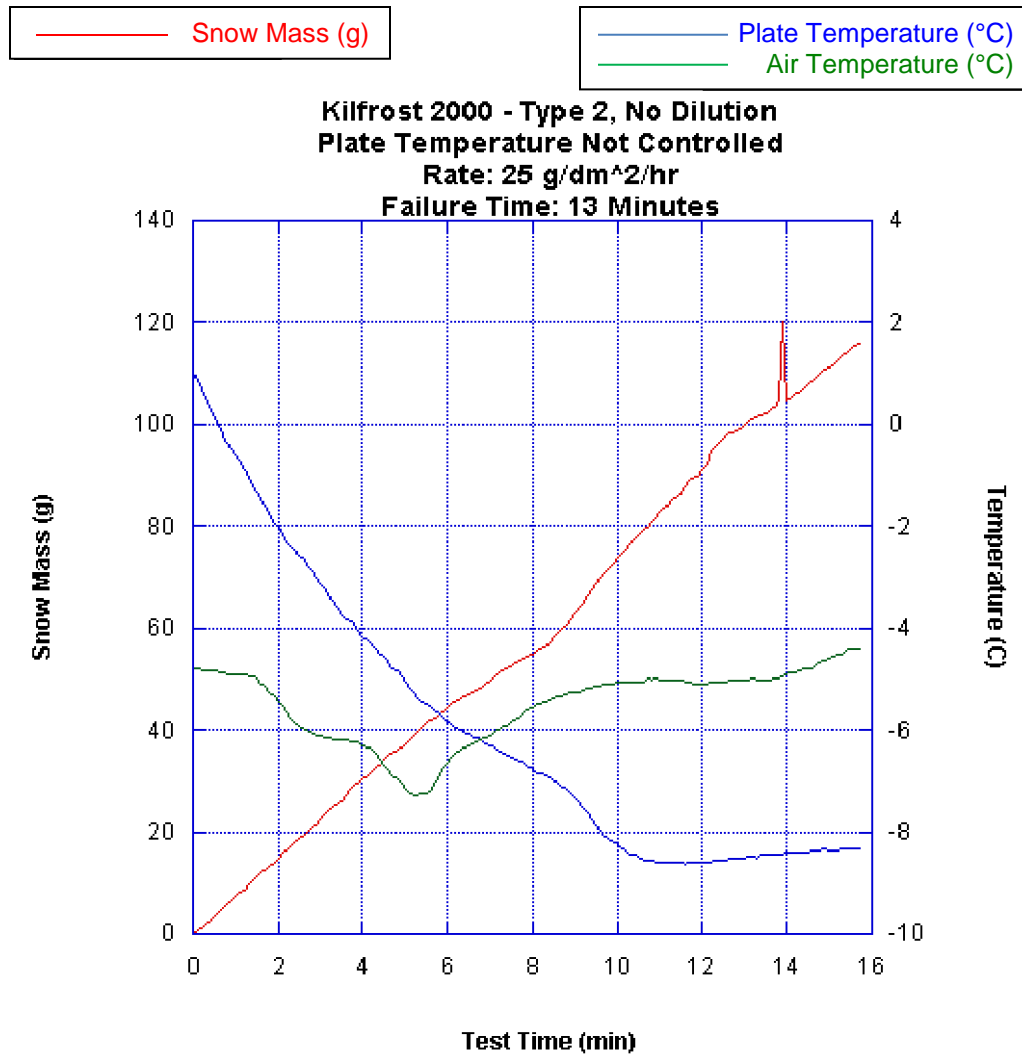
**Figure 1. Example of prior snow machine test showing the plate temperature relative to ambient temperature**

The variability of outdoor to indoor tests was attributed to the strong variability of the plate temperature for the indoor tests as compared to the outdoor tests [3]. The plate temperature variation of the indoor snow machine tests was mainly because of the plate cooling that resulted from the latent heat removal from the fluid and the plate used to melt the snowflakes as they were absorbed into the fluid [3]. Higher snowfall rates result in greater cooling and latent heat removal from the fluid/plate because of the higher mass rates. Because of the removal of heat from the fluid/plate to melt the snowflakes, the fluid/plate temperature would drop below ambient temperature in low wind speeds. This is especially true for the indoor tests that were conducted in an environment with little or no horizontal wind velocities. Figure 1 shows an example of a prior indoor test using the snow machine. The initial fluid temperature was warmer than ambient, causing the plate temperature to also be above ambient; however, the plate temperature can be seen dropping after the start of the experiment and continuing to drop below ambient temperature approximately 7 minutes after the beginning of the test. By the time the fluid fails, the plate temperature is almost 2° colder than ambient.

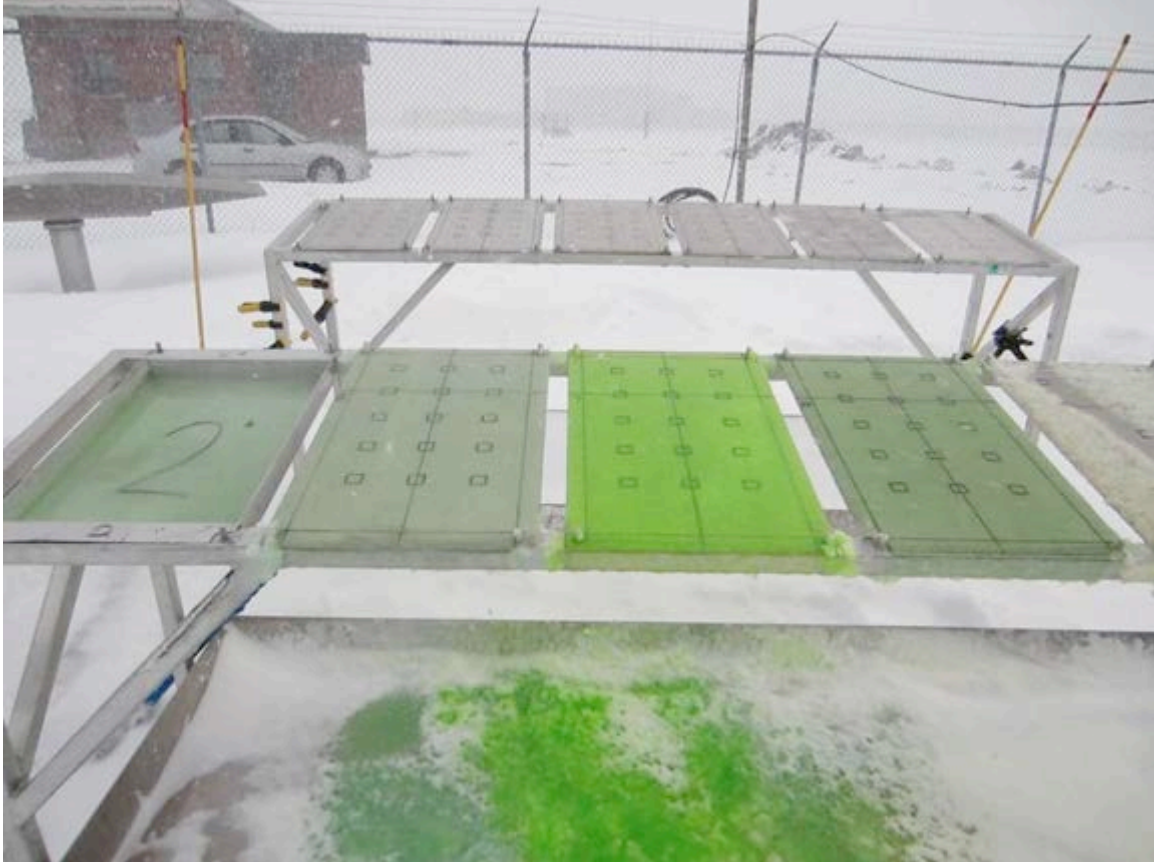
**Figure 2. Outdoor frosticator plates used for anti-icing fluid testing and the corresponding rate pan, shown at far left with a drawn-in “2”**

The standard procedure for outdoor testing involves the use of freestanding polished aluminum “frosticator” plates measuring 30 x 50 cm. Each plate is 0.3-cm thick and is sloped at a 10-degree angle to simulate an aircraft wing (see figure 2). The fluid testing procedures summarized here are based on the SAE document ARP5485 [6]. The plates are turned so that they face into the wind at the beginning of each test, and a liter of anti-icing fluid is poured over them. The plates are then left exposed to the natural snowfall conditions. As the fluid begins to lose its ability to absorb the precipitation, snow will begin to build up on top of the fluid until approximately 1/3 of the plate has snow on top of the fluid. This indicates the fluid’s failure to continue providing protection against snow and ice buildup. To determine the snowfall rates, special rate pans are used that are coated in glycol and exposed to the same snowfall conditions as the frosticator plates. These rate pans have the same dimensions as the frosticator plates and contain a small 1-cm-high lip around the outer edge of the pan, which prevents the precipitation and glycol from running out of the pan. These pans are weighed before exposing them to snowfall conditions and then placed outside. The pans are swapped every 10 minutes with a new set and weighed to get their final weights. The difference in weight is then used to determine the 10-minute snowfall rate. An example of the rate pan is shown on the left side in figure 2 with a giant “2” written in the pan.

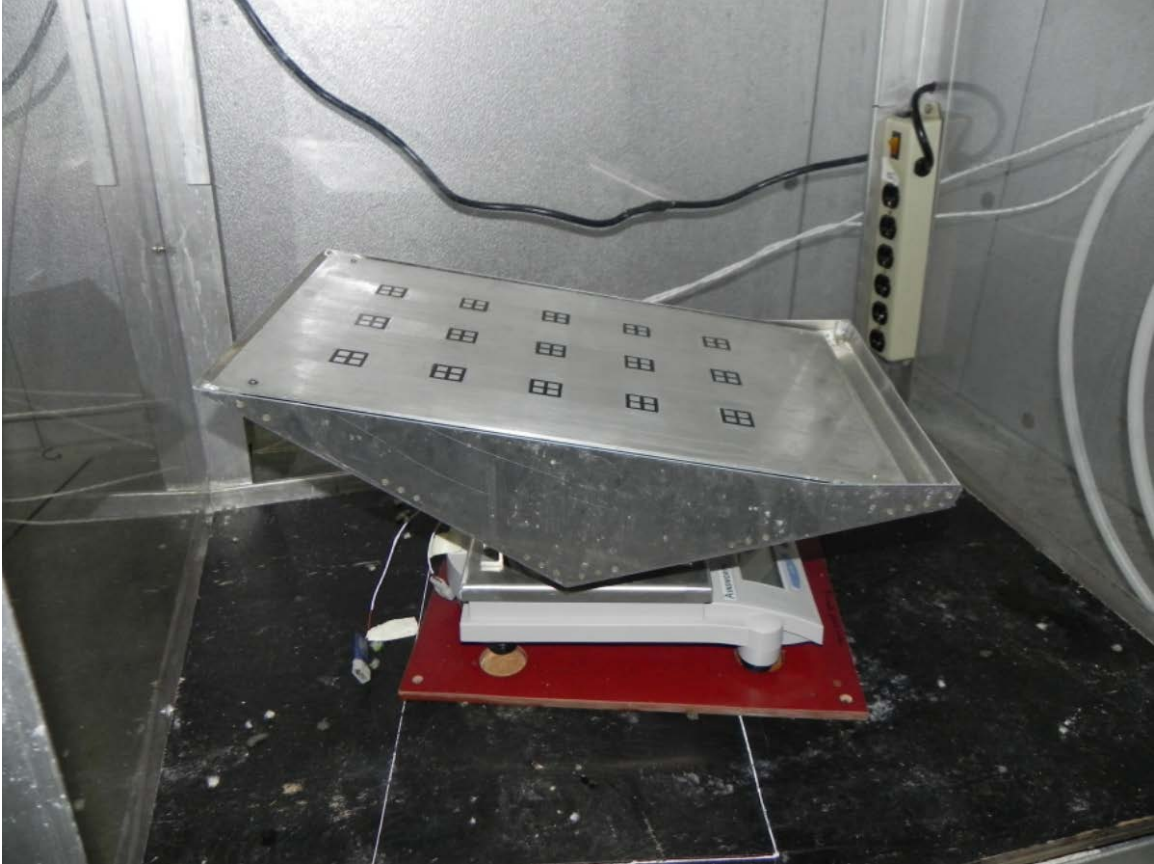
**Figure 3. Indoor frosticator plate and tray assembly on a mass balance in the snow machine**

Indoor testing of fluids using the snow machine cannot be performed in the same manner as the outdoor tests. Controlling the snowfall rate using the snow machine requires real-time measurements of the added snowfall mass using a mass balance placed under the frosticator plate. Using the outdoor technique would allow fluid to drip off the plate and would result in a loss of mass. The snow machine design uses a tray assembly that the frosticator plate rests on, which collects the fluid dripping off the plate (see figure 3). The tray assembly is slightly wider and longer than the frosticator plate, which minimizes the chances of snow collecting on the tray assembly and not on the plate. The tray assembly and frosticator plate are placed on a mass balance from which the computer takes measurements every 6 seconds and uses those measurements to adjust to the snowfall rate. With the fluid contained on either the frosticator plate or in the tray assembly, any change in mass is attributed to the addition of the snow falling on the fluid.

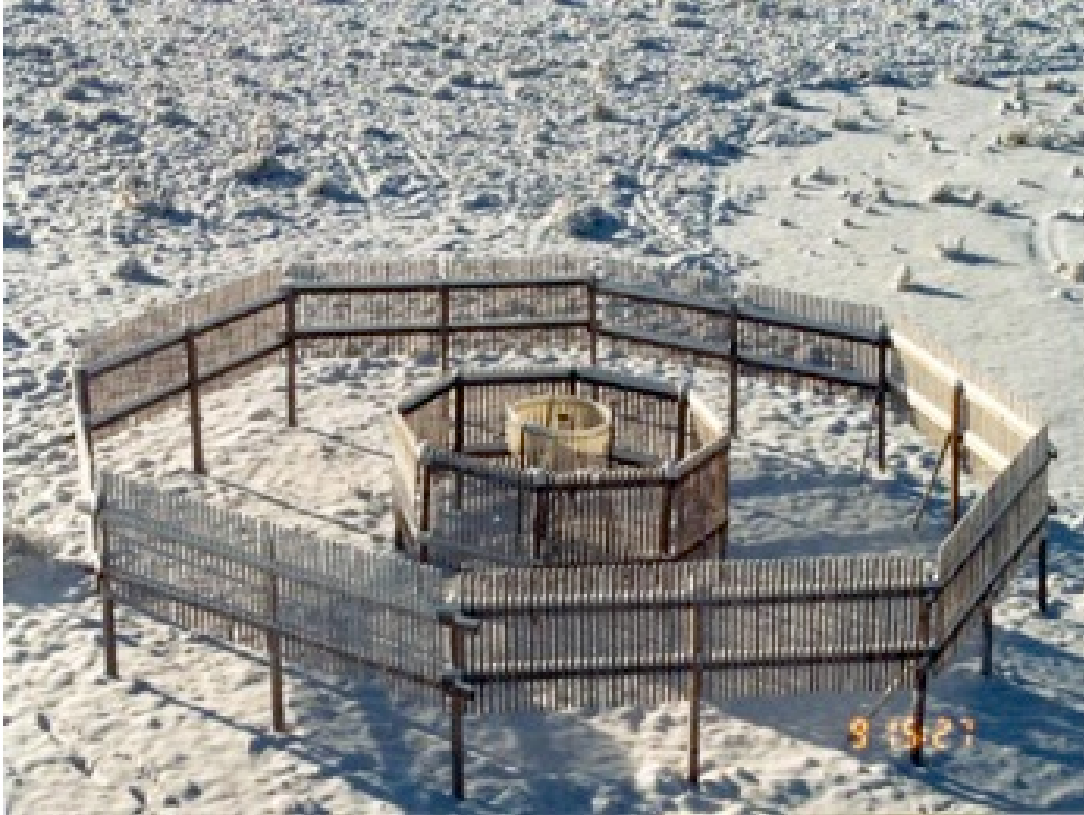
**Figure 4. The DFIR shield**

To determine the effects of wind on the combined tray/frosticator combination (henceforth referred to as the frosticator assembly), an outdoor experiment was designed that incorporated the use of a DFIR shield (see figure 4). The DFIR is considered to be the most effective shield at slowing the horizontal winds and helping remove the effect the wind has on precipitation (snow in particular) [7]. Using this shield allows for outdoor testing in low-to-no-wind conditions, similar to what would be experienced with the indoor snow machine. The Marshall Field Instrument Test Site, just south of Boulder, Colorado, has several DFIR shields and was chosen as the site to conduct the experiments.

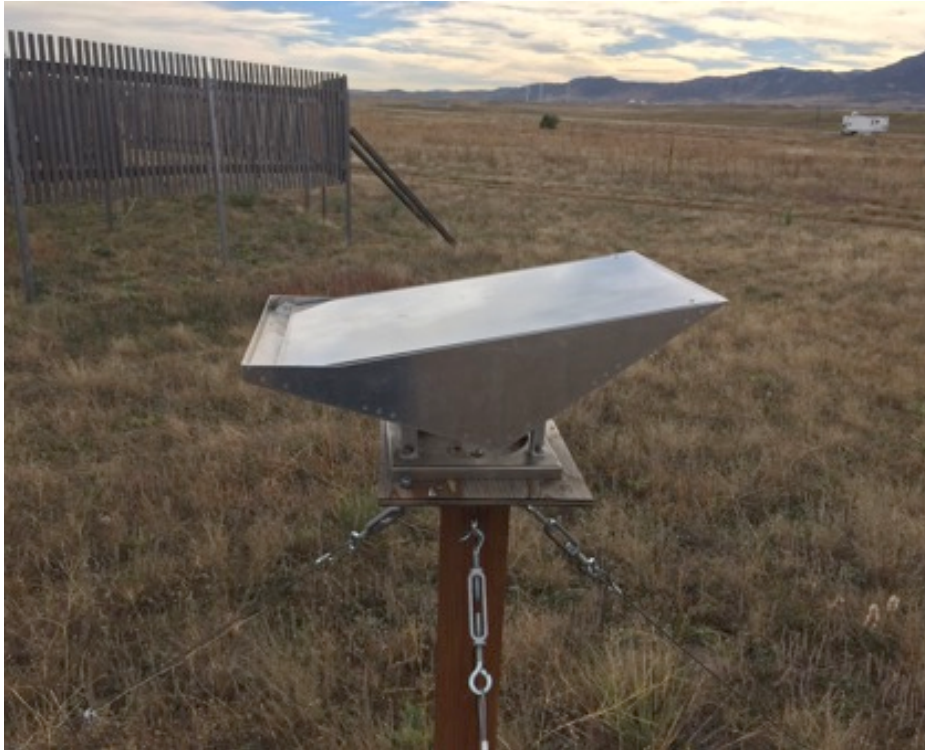
**Figure 5. The outdoor standard frosticator assembly used in the free-stream environment**

Three frosticator assemblies were used in this experiment. One standard frosticator assembly, such as the one typically used in the snow machine, was installed outside of the DFIR shield on the predominant upwind side during precipitation events to minimize the effects the shield would have on snow in the free-stream air (see figure 5). A second frosticator assembly was also installed in the free-stream environment, but the frosticator plate was modified and raised 15 cm above the tray, allowing the wind to move freely beneath the plate (see figure 6). This second assembly is also referred to as the “tall assembly.” A third standard frosticator assembly was located inside the DFIR shield (see figure 7). All of the frosticator plates had temperature probes connected to the back of the plates that took measurements of the plate temperature every minute. These measurements can be correlated to wind speed to see if the temperature of the plate remains higher for the assemblies outside the DFIR during higher wind events versus the temperature of the plate inside the DFIR. Each frosticator assembly resided on a mass balance to record the increase in snow mass throughout an event. Two R.M. Young Company wind sensors were also used in the experiment to record wind speed and direction during events; one was installed inside the DFIR shield and the other near the free-stream frosticator assemblies. Two webcams were also used (one inside the DFIR and one outside) to view and record photographs of the frosticator assemblies during events.

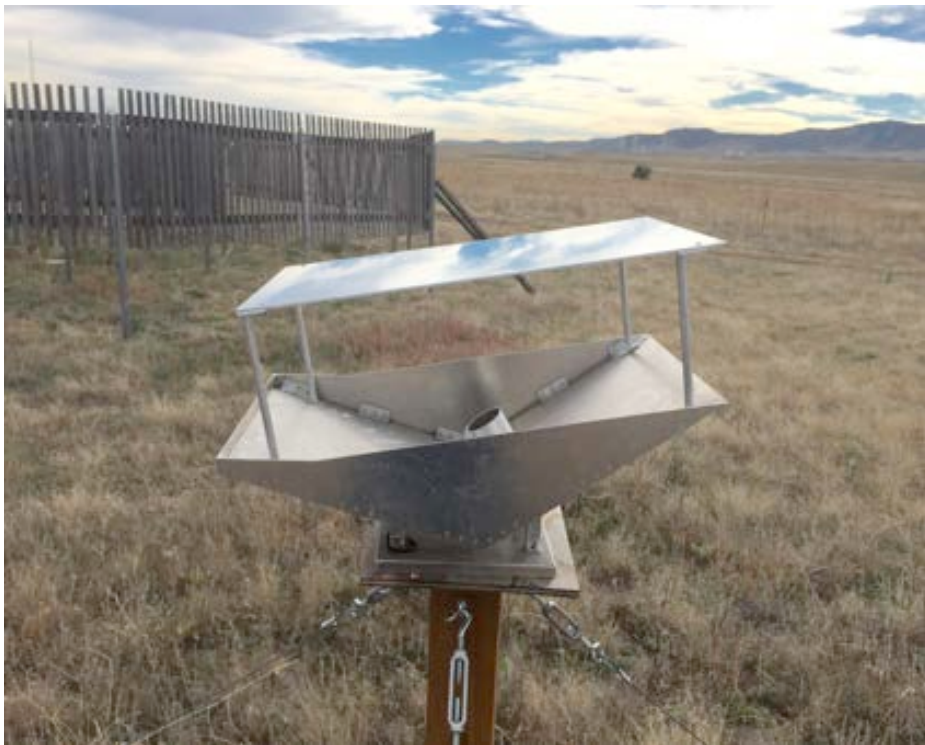
**Figure 6. The outdoor tall frosticator assembly used in the free-stream environment**

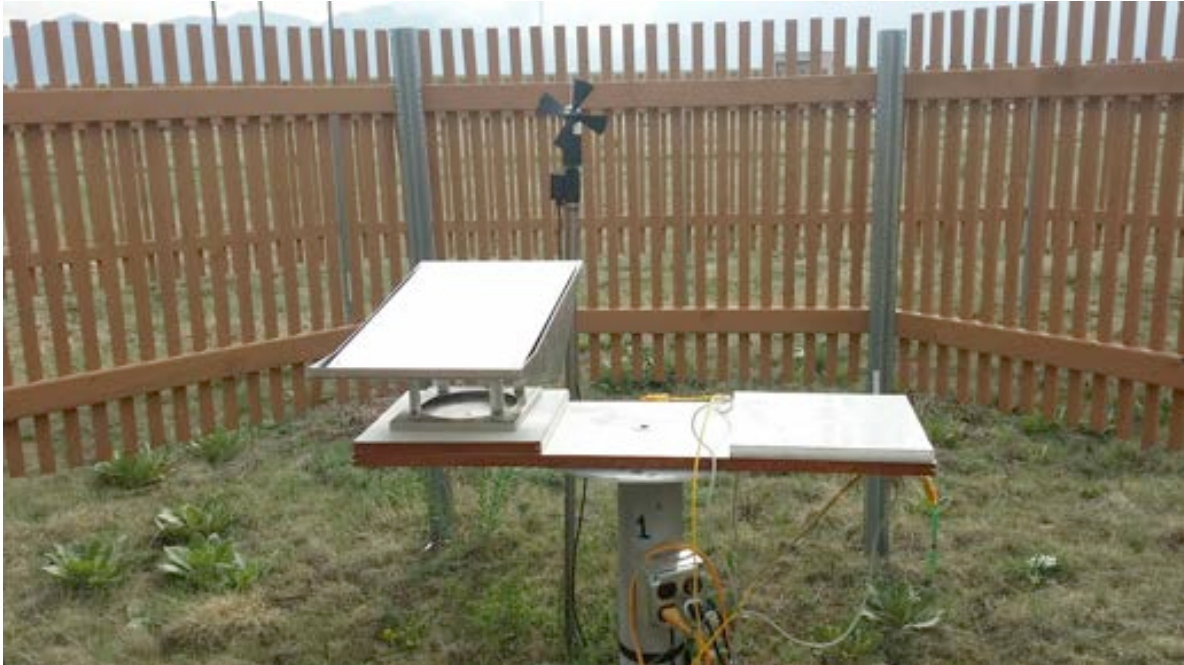
**Figure 7. The standard frosticator assembly used in the DFIR shield**

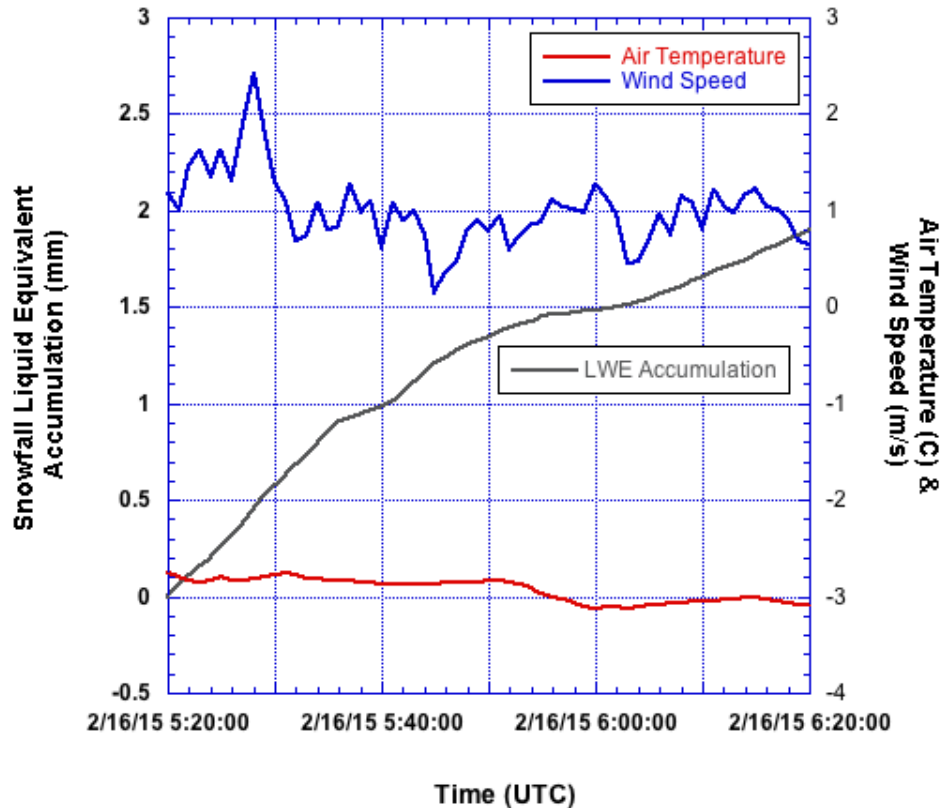
**Figure 8. Ambient wind speed during the first outdoor test on February 16, 2015**

The February 16, 2015 event proved to be extremely useful in understanding the discrepancies between the tall and the standard frosticator assemblies located outside the DFIR. Wind speeds throughout the test were lower (<3 m/s) than the average 3–5 m/s typically experienced during snow events at Marshall. The test began at approximately 0520 UTC (2220 MST) on February 16 (February 15, MST). Figure 8 shows the wind speed, ambient air temperature, and liquid water equivalent (LWE) snowfall amounts during the test. There was a brief spike in wind speed up to 2.5 m/s after the start of the test, but the wind speeds fell after that and remained mostly near or below 1 m/s throughout the rest of the test. Ambient temperature remained steady near -3° C. Snowfall liquid equivalent amounts from a co-located GEONOR all-weather precipitation gauge in a DFIR shield are also shown. During the course of the test, the GEONOR accumulated nearly 2 mm of precipitation, indicating an average rate of 2 mm/h (20 g/dm<sup>2</sup>/h), which indicates snowfall intensities in the moderate category (see table 2).

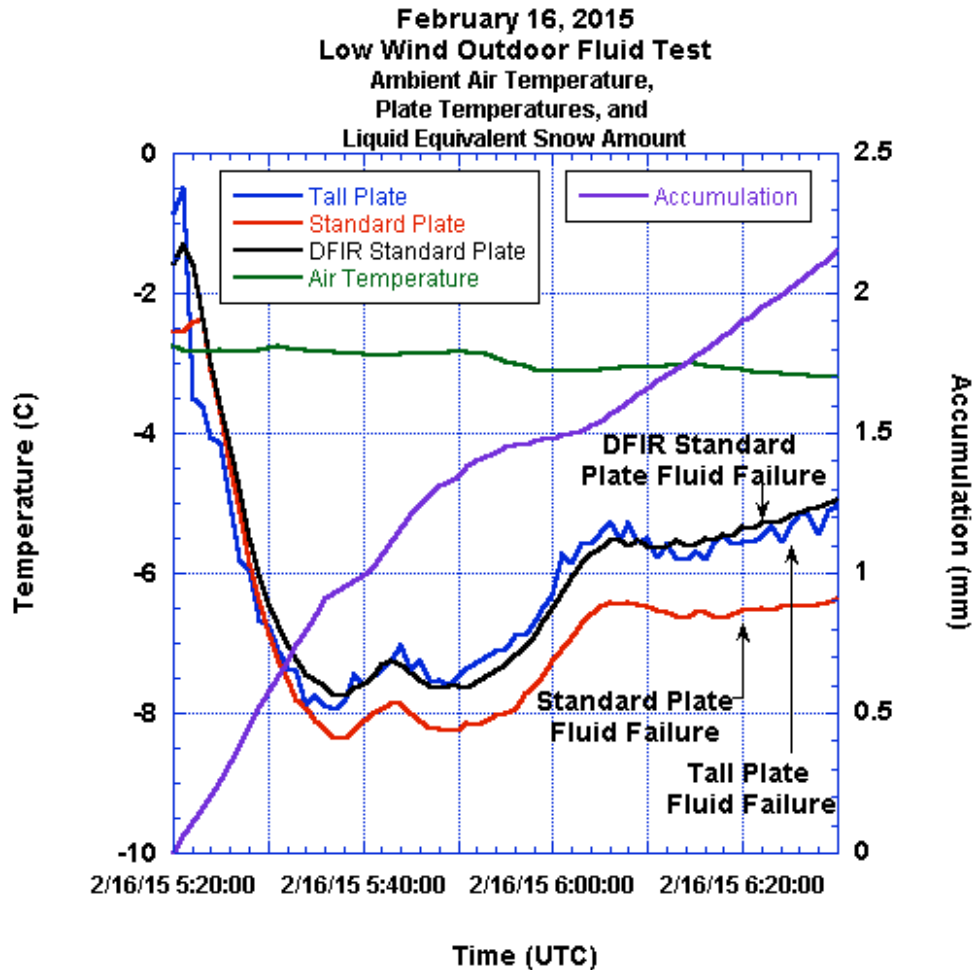
**Figure 9. Frosticator plate temperatures, ambient air temperature, and snowfall mass from the February 16, 2015 (20150216a) event**

Figure 9 shows the temperature of each of the frosticator plates as compared to the ambient air temperature and the snowfall accumulation. All three plates cool below ambient temperature relatively quickly after the fluid has been applied and remain below ambient throughout the remainder of the experiment. Figure 9 shows that the plate temperatures appear well-correlated to the change in snowfall rate. As the accumulation rates increase (indicated by the accumulation trace getting steeper), the temperature of the fluid decreases more quickly. At 0535 UTC and 0550 UTC, the snowfall accumulation trace becomes less steep, indicating a decrease in snowfall

rates. The plate temperatures respond accordingly and begin to warm until the rates increase again. Eventually, towards the end of the experiment, the fluid begins to lose its capacity to absorb the snow and begins to warm toward ambient, though the snowfall rate increases again. This provides further evidence that the fluid has failed and is no longer able to pull latent heat from the plate to continue melting the snow.

When examining the plate temperature traces in figure 9, the tall frosticator plate temperature appeared noisier than the other two. Figure 10 shows the tall frosticator plate temperature and the ambient wind speed. Though there does not appear to be a strong correlation between the two (i.e., wind spikes increase the plate temperature and vice versa), the variability in the wind does appear to match the increased variability in the temperature of the plate. This may indicate that wind does have an effect on the plate, but not as strong as the snowfall rate.

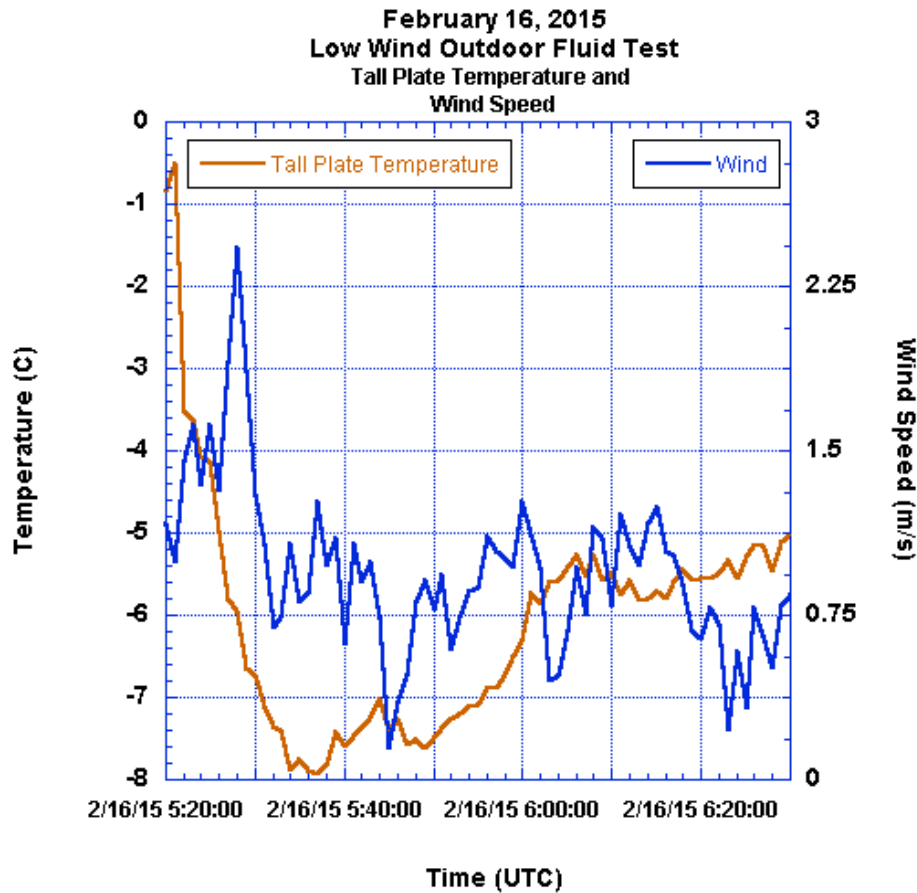
**Figure 10. Tall frosticator plate temperature and ambient wind speed from the February 16, 2015 (20150216a) event**

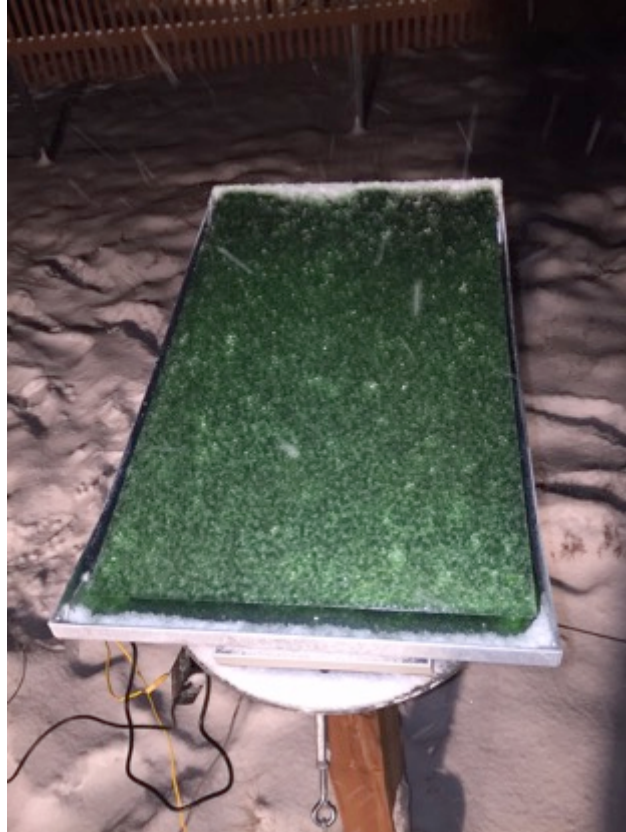
**Figure 11. Snow buildup/fluid failure beginning near the top of the standard frosticator assembly at 0550 UTC**

Throughout the course of the event, the fluids were checked regularly to monitor their behavior. At 0550, 30 minutes after the start of the event, it was observed that the standard frosticator assemblies (both inside and outside the DFIR) were already showing a buildup of snow at the top of the plate (see figure 11). At the same time, the tall plate still showed almost no indication of any snow contamination buildup (see figure 12). Because both frosticator assemblies outside the DFIR were being subjected to the same snowfall rates, low ambient wind speeds, and temperatures, there should not be any meteorological reason why one plate would exhibit snowfall buildup and not the other. By 0622 UTC, the fluid on the standard frosticator assemblies had both failed; however, the fluid on the tall frosticator assembly continued for nearly an additional 5 minutes before failing.

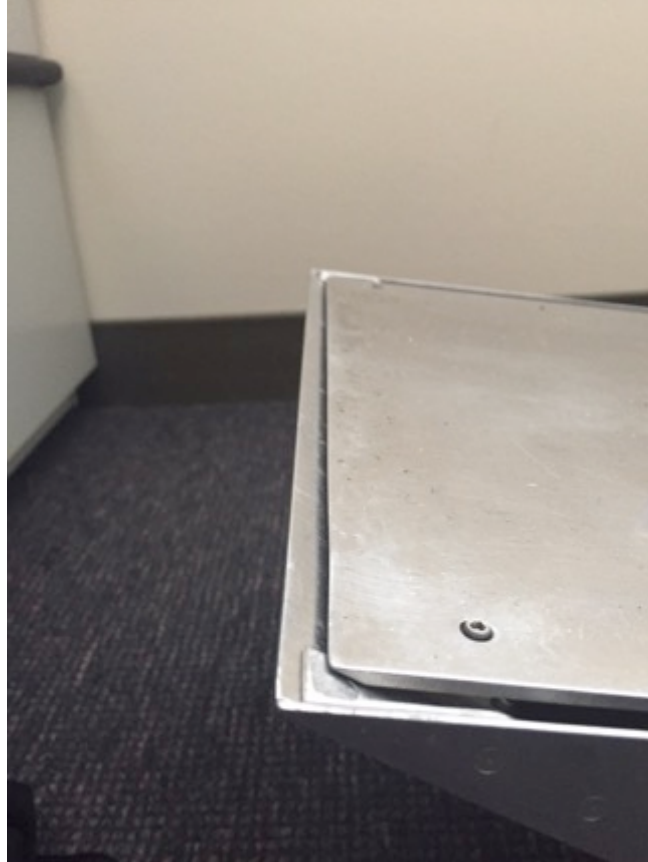
**Figure 13. Close-up view of the top of the standard frosticator assembly showing the shallow gap between the tray and the frosticator plate**

On closer inspection of the standard frosticator assemblies, it appeared that the earlier fluid failures might be caused by snow building up in the gap between the tray and the frosticator plate at the top of the frosticator assembly. Figure 13 shows a close-up view of the top of the standard frosticator assembly. Because of the relatively shallow depth of the tray assembly behind the frosticator plate, it was theorized that snow falling on this portion of the tray would begin to build up on the edge of the tray and bridge the gap between the tray and the frosticator plate. The snow that built up in this gap would begin to absorb the fluid near the top of the plate, causing a thinning of the fluid near the top of the plate, which would lead to an early failure of the fluid.

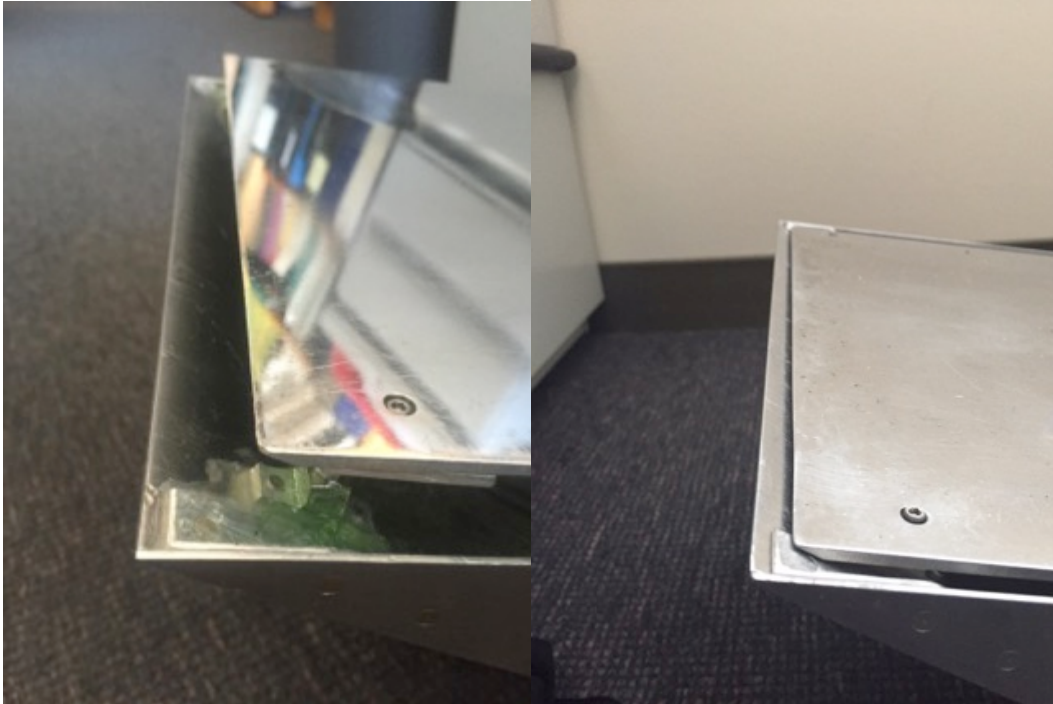
**Figure 16. The modified height frosticator assembly used for testing in the snow machine (the standard assembly is shown to the right to emphasize the differences)**

After reviewing the outdoor test data, a series of experiments using the snow machine were developed to test the tall frosticator assembly against the standard frosticator assembly. These tests required using constant snowfall rates at fixed ambient air temperatures and duplicating the tests for both the tall and the standard frosticator assemblies. To prevent snow from falling into the tray beneath the plate on the tall frosticator assembly (thereby creating abnormally higher rates, as measured by the mass balance), the plate height was adjusted downward so that it was only a few centimeters above the tray assembly (see figure 16).

The first (and likely the most important) reason is the design of the existing frosticator assembly used in the snow machine. The preliminary snow machine tests showed encouraging results when using the modified-height frosticator plate. More testing needs to be completed, but the fluid failure times did increase in length, bringing the fluid failure times closer to what was expected based on the currently published holdover time tables. Higher and lower rates and temperatures and additional fluids need to be tested to determine the true effects of raising the frosticator plate.

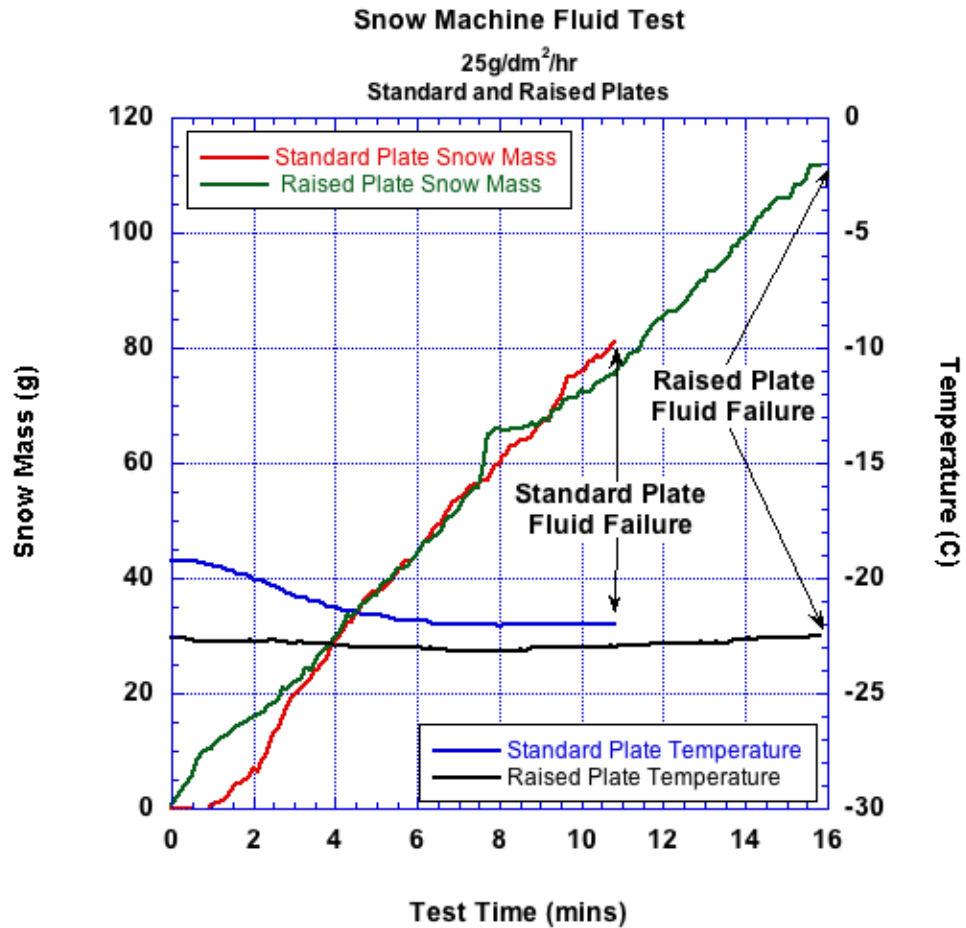
**Figure 17. Indoor fluid tests at a constant rate of 2.5 mm/h (25 g/dm<sup>2</sup>/h) at -20° C**

Though only four tests were completed, the results were encouraging regarding the discrepancies in fluid failure times. Figure 17 shows the results of tests 1 and 2 for a snowfall rate of 2.5 mm/h (25 g/d<sup>2</sup>/h). The snow mass accumulation was relatively constant between the two tests, but the standard frosticator assembly had a shorter failure time by approximately 5 minutes. Though the fluid applied to the standard plate was slightly warmer at the beginning of the experiment, it still failed more quickly than the fluid on the tall frosticator assembly. Fluid temperature can have an effect on the failure time, particularly if it is significantly warmer or colder than air temperature; therefore, the fluids are usually kept near ambient temperature to remove this variable during testing.

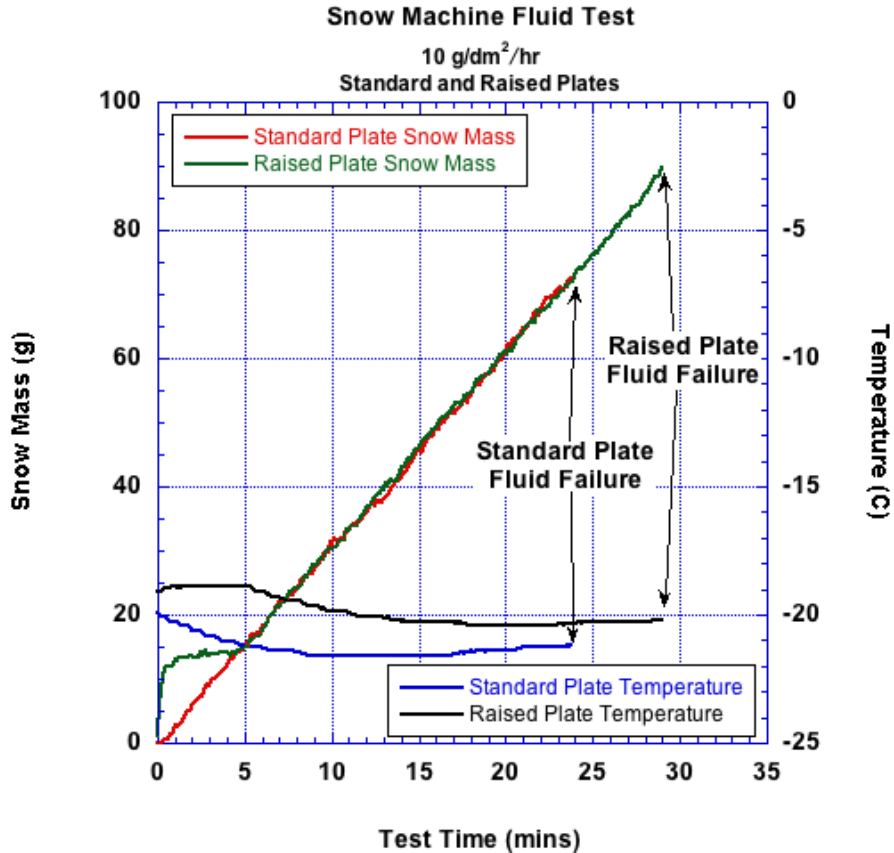
**Figure 18. Indoor fluid tests at a constant rate of 1.0 mm/h (10 g/dm<sup>2</sup>/h) at -20 °C**

Figure 18 shows the results of tests 3 and 4 using a snowfall rate of 1 mm/h (10 g/d<sup>2</sup>/h). As with the prior tests, the standard frosticator assembly fluid failed approximately 5 minutes before the fluid on the tall frosticator assembly.

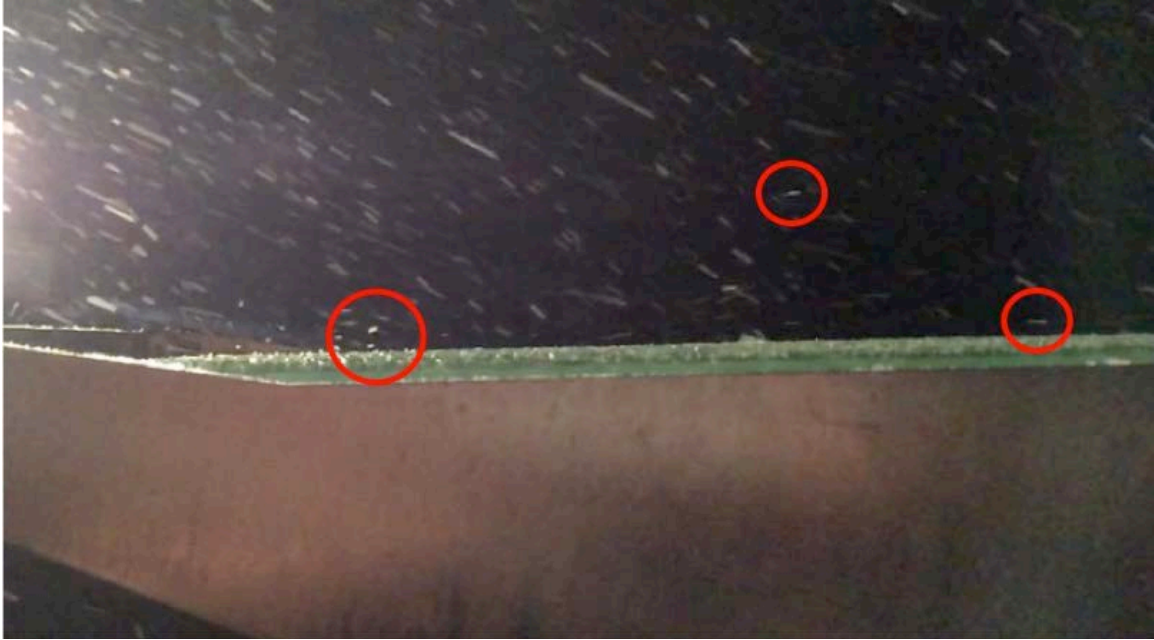
**Figure 20. Photograph of snow particles bouncing (noted by streaks moving anti-parallel to the free-stream particles) when they hit the fluid surface**

In the course of testing outdoors, another observation was made regarding the interaction of the snow particles with the fluid. In higher wind conditions (wind speeds > 3 m/s), it was observed that some of the snow particles hitting the fluid would bounce. They would sometimes bounce higher on the plate and stick to the fluid, whereas other times they would bounce off the plate altogether. This behavior occurred regardless of whether the fluid had just been poured or was nearing failure. The photographs in figures 20 and 21 attempted to capture the bouncing particles. These can be seen as white streaks oriented from the lower left to the upper right of the image, whereas the normal snowfall (and streaking pattern) was from the upper left to the lower right. This is particularly noticeable in figure 21. This behavior implies that the collection efficiency of the fluid is not 100% in higher wind speeds and may also be another indication of why the outdoor tests last longer (because of snow bouncing off) than the indoor tests.

Lastly, the effect of snow particles bouncing off the fluid in higher winds may also contribute to longer failure times in natural snow conditions. Beyond observing this phenomenon, no actual measurements were taken to determine how much snow might be lost because of bouncing. This does, however, indicate that failure times may also be a function of higher winds creating a lower collection efficiency of the fluid and needs to be investigated further.

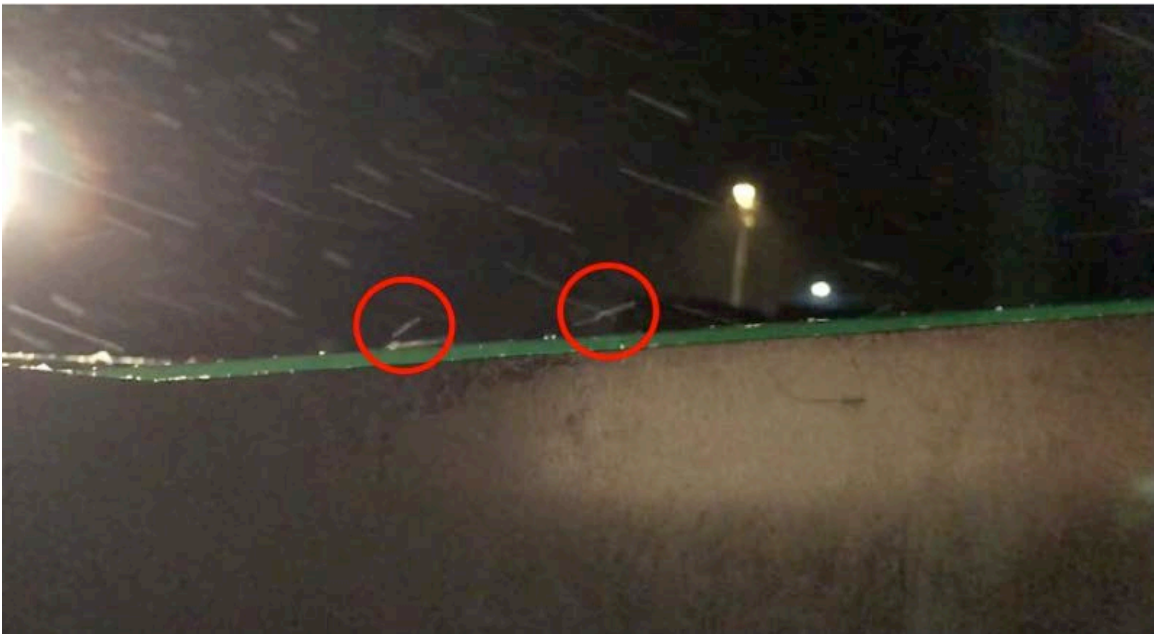
**Figure 21. Another photograph of snow particles bouncing (noted by streaks moving anti-parallel to the free-stream particles) when they hit the fluid surface (this was taken immediately following fluid application)**
