DOT/FAA/TC-17/27

Thermal Imaging for Aircraft Rescue and Fire Fighting Applications

May 2017

Final Report

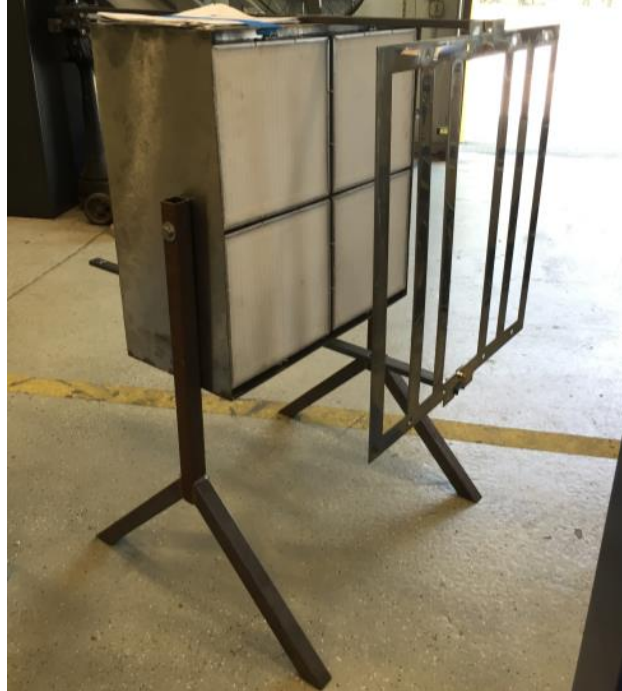
The quartz heater assembly was comprised of four Omega[®] Engineering, Inc. model QH-121260-T electric radiant heaters, which were 12 by 12 inch (in.), 8640 W, and 60 W/in.². The heater operating temperatures were between ambient temperature and 1800°F. A stainless steel and aluminum housing was fabricated to contain the four heaters for ease of movement and adjustability in heater angle. The quartz heater assembly was designed to have an adjustable panel holder, which was used to simulate the skin of a unit load device (ULD) during L-1011 testing and to hold test panels during panel testing. This panel holder placed the panel at distances that were 1, 2, and 3 feet (ft) from the heater array; however, it could be completely removed. A photo of the quartz heater assembly is shown in figure 6.

Figure 6. Quartz Heater Assembly

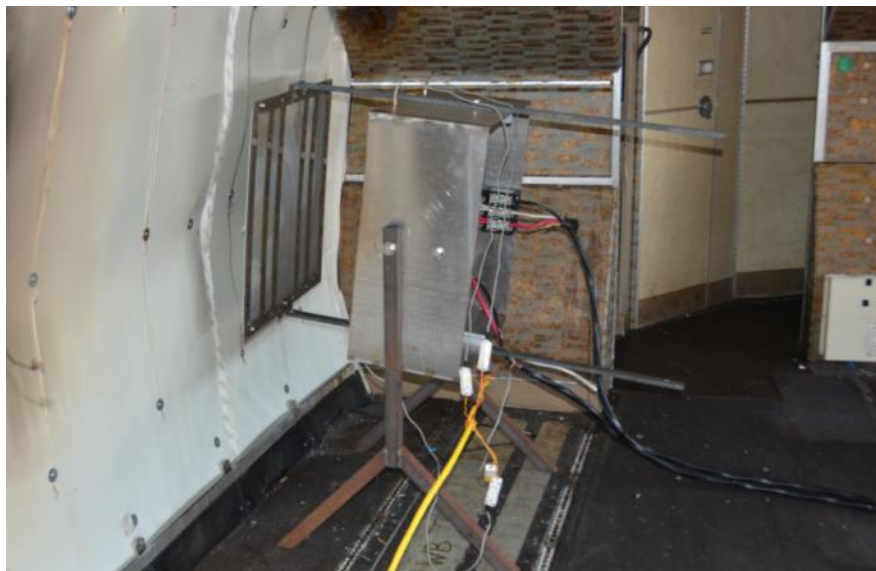
Heater parameters were changed between tests 1 and 2 to more accurately simulate a fire on board the aircraft and to shorten test duration. Instead of incrementally changing the heaters' temperature, they were turned on to their maximum output. Test 7 was the exception wherein the heaters surpassed the thermocouple maximum operating temperature of 1800°F. The aluminum panel reflected the heat back into the quartz heaters. The temperature control was turned down to 1800°F to reduce the likelihood of heater assembly failure. A photo of the quartz heater assembly configuration to simulate a ULD is shown in figure 13.

Figure 13. Quartz Heater Assembly With Simulated ULD Panel

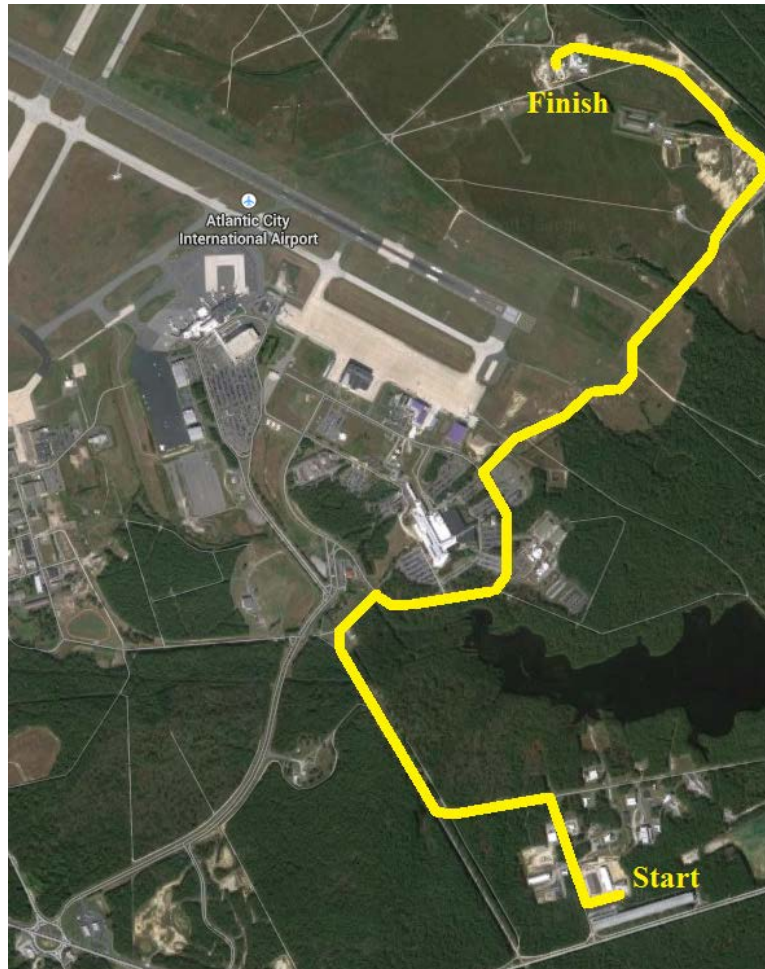
The DEVS thermal camera is advantageous to identify roads under low-visibility conditions. It is important to mention that depending where an incident takes place, not all roads on which an ARFF vehicle driver has to drive are paved. Many of these paths are surfaced with gravel or dirt. To analyze how various road types are shown through different thermal cameras, the FAA Striker was driven through the path shown in figure 18 at the FAA William J. Hughes Technical Center (WJHTC). This path included roads surfaced with asphalt, dirt, and gravel.

Figure 18. Road Comparison Test Path

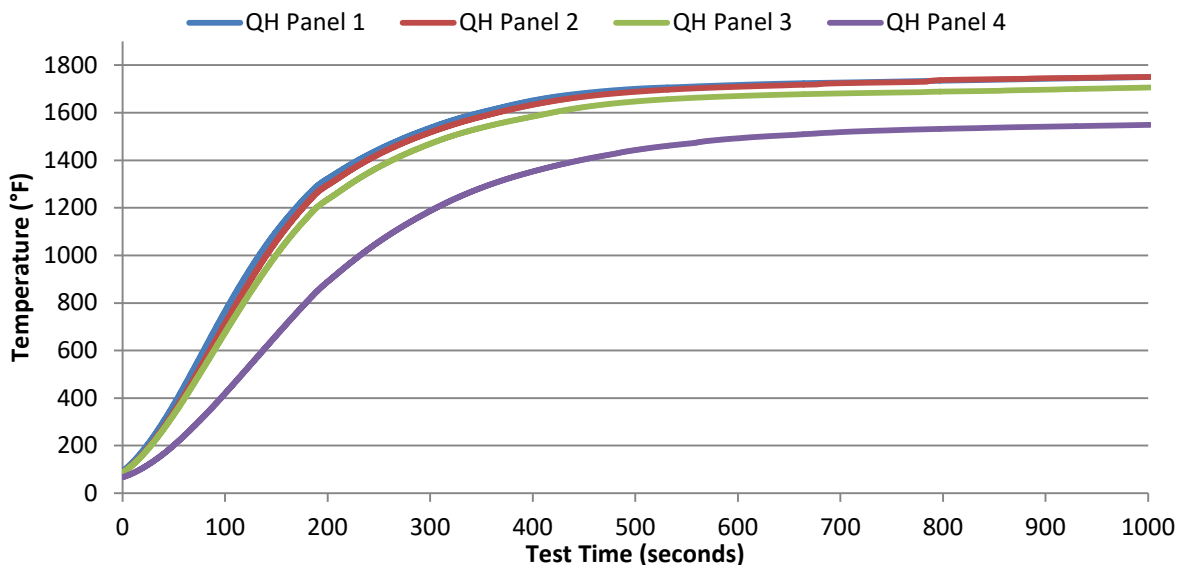
The heater assembly reached within 5% of its maximum temperature of 1750°F within 10 minutes of the test start. The characteristic warming curve for the heater assembly is displayed in figure 19. It should be noted that panel 4 was powered by the lower 208-VAC site power, and therefore, operated at a lower maximum temperature of 1550°F.

Figure 19. Quartz Heater Thermocouples: Test 6

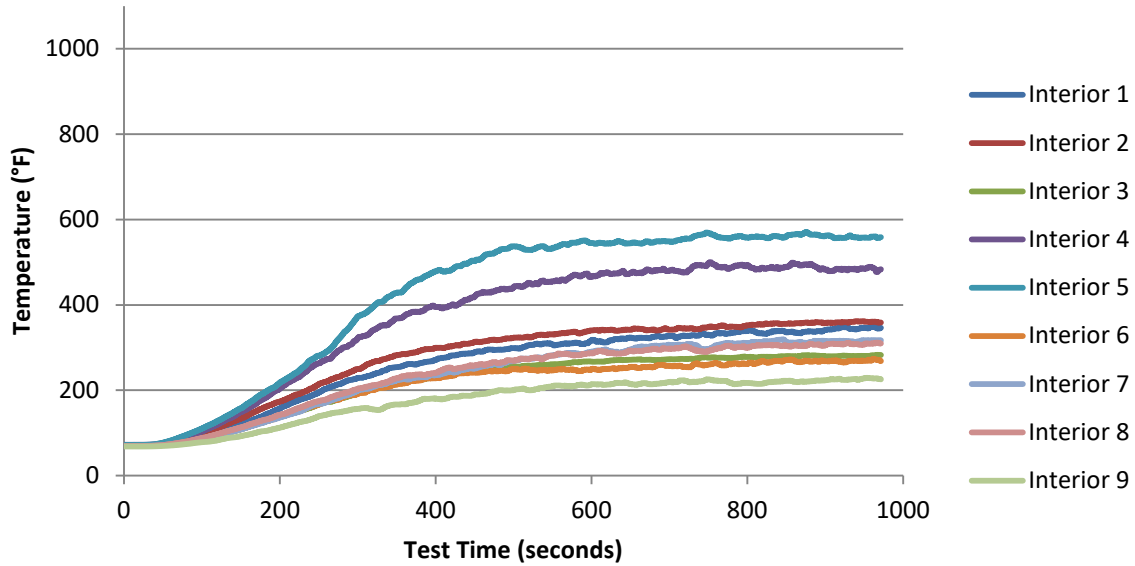
Interior temperatures for all tests were shown to directly correlate to the quartz heater assembly's distance from the aircraft wall. Figure 20 shows the interior temperature for test 5, which is a cargo configuration test.

Figure 20. Interior Thermocouples: Test 5

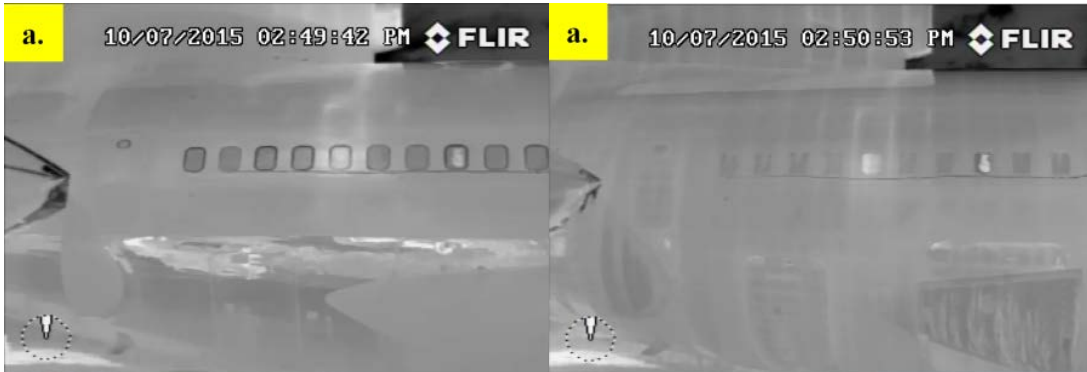
be visible after a wet down since it depends on the heat source size and the materials the heat has to penetrate.

Figure 26. Before and After Wet-Down Strategy: Test 2 Using Patrol IR

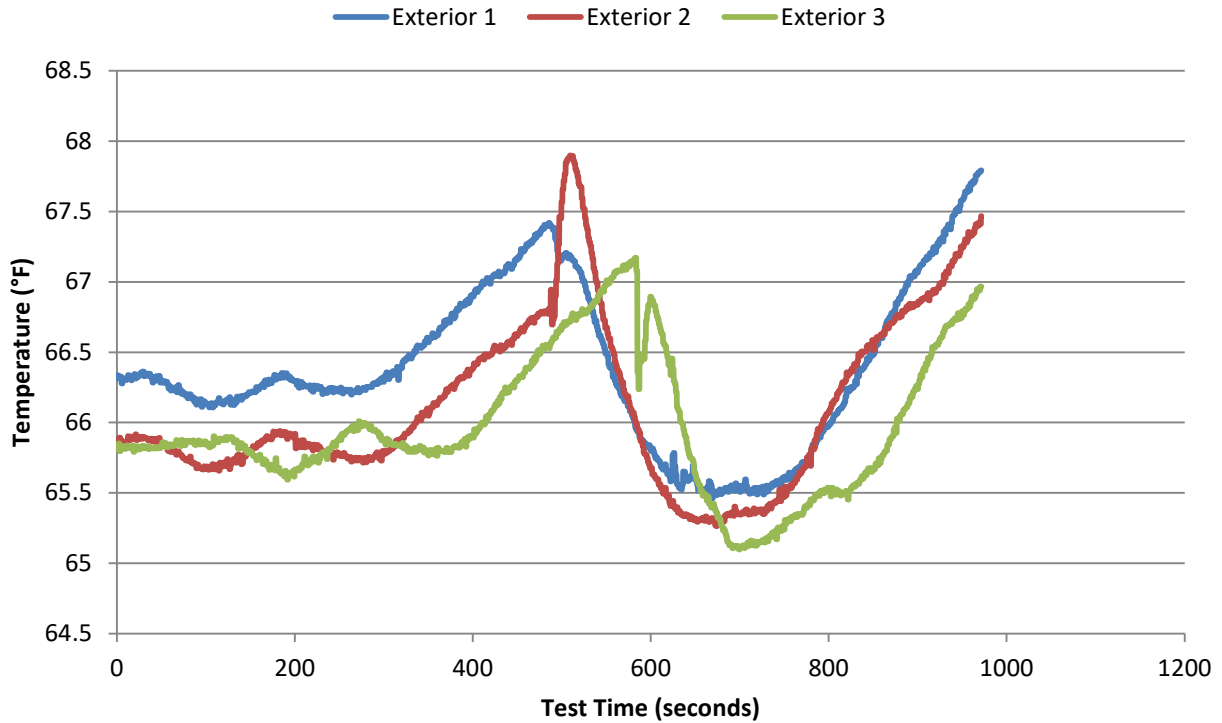
Wetting the aircraft temporarily decreased the temperature of the aircraft exterior. The exterior thermocouples are shown in figure 34. The decrease in exterior temperature lasts nearly 3 minutes until the exterior temperatures begin to climb again. The wet-down strategy may offer IR camera operators up to 6 minutes of reduced ancillary hot spots on the aircraft exterior.

Figure 34. Exterior Temperature: Test 5

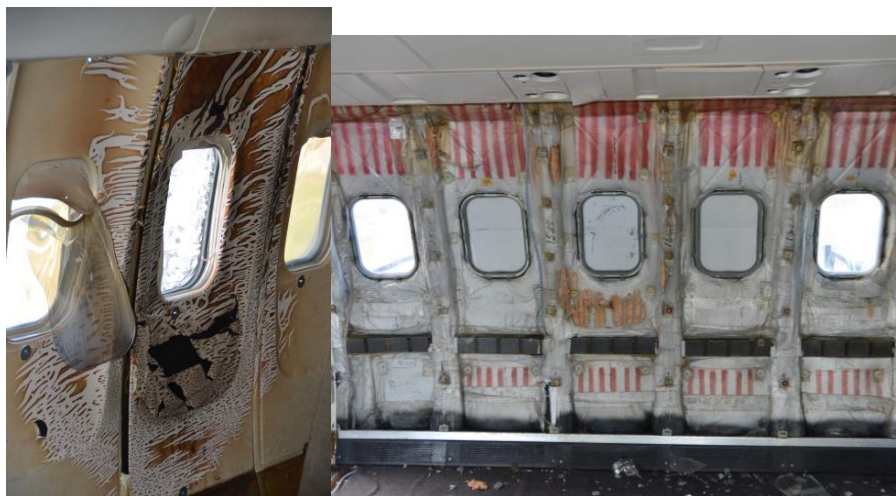
Damage caused by the quartz heater assembly was a function of heater temperature and distance from the wall. Test 1 damage included discoloration of the interior panel, bubbling of the upper compartments, and failure of the interior and exterior windows. Damage to the insulation was also minimal. The insulation did not show evidence of charring and only minor heat-related damage. The damage to test section 1 is depicted in figure 35.

Figure 35. Damage to Aircraft Interior: Test 1

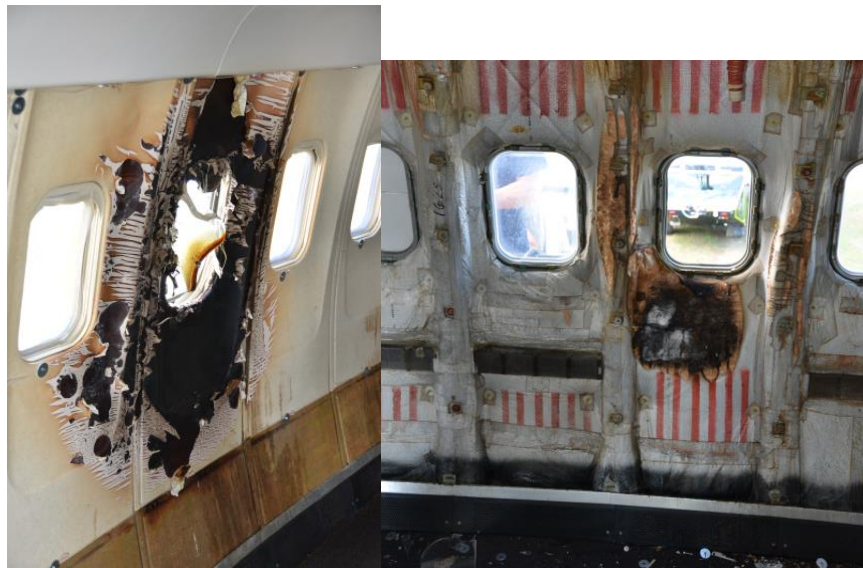
Test 2 damage was more rapid and severe than test 1 damage. Damage extended past the center window of the test area. Both interior and exterior windows failed as in test 1, and charring was noticeable on the insulation behind the interior panels, as shown in figure 36.

Figure 36. Damage to Aircraft Interior: Test 2

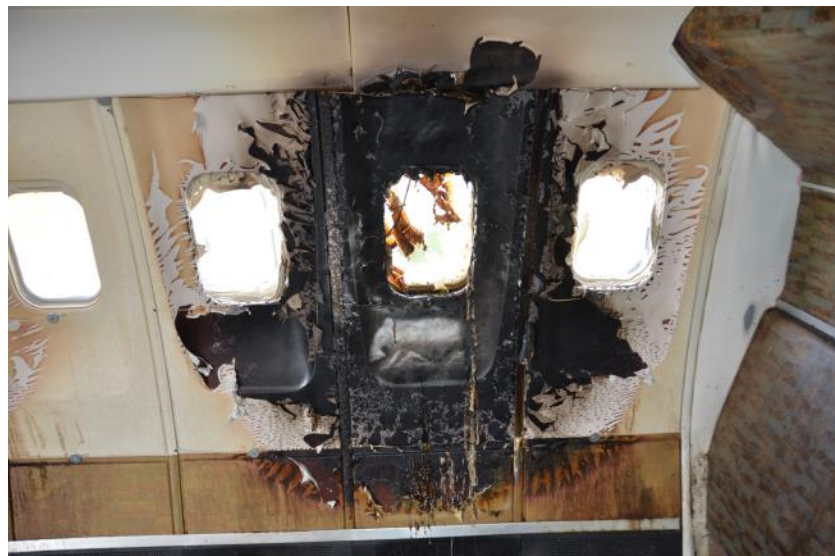
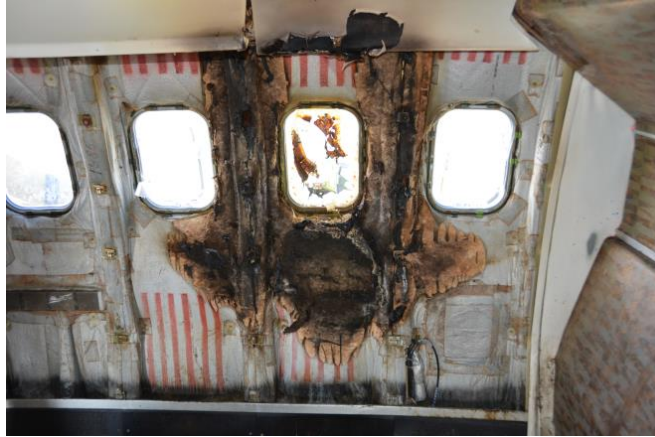
Test 3 presented the most severe damage to the aircraft interior. The entire center panel and the two flanking panels were charred. The left, right, and center windows failed during testing. The insulation behind test section 3 was severely charred and was replaced following the test. Figures 37 and 38 show the damage to test section 3.

Figure 37. Damage to Aircraft Interior: Test 3

Figure 38. Damage to Aircraft Insulation: Test 3

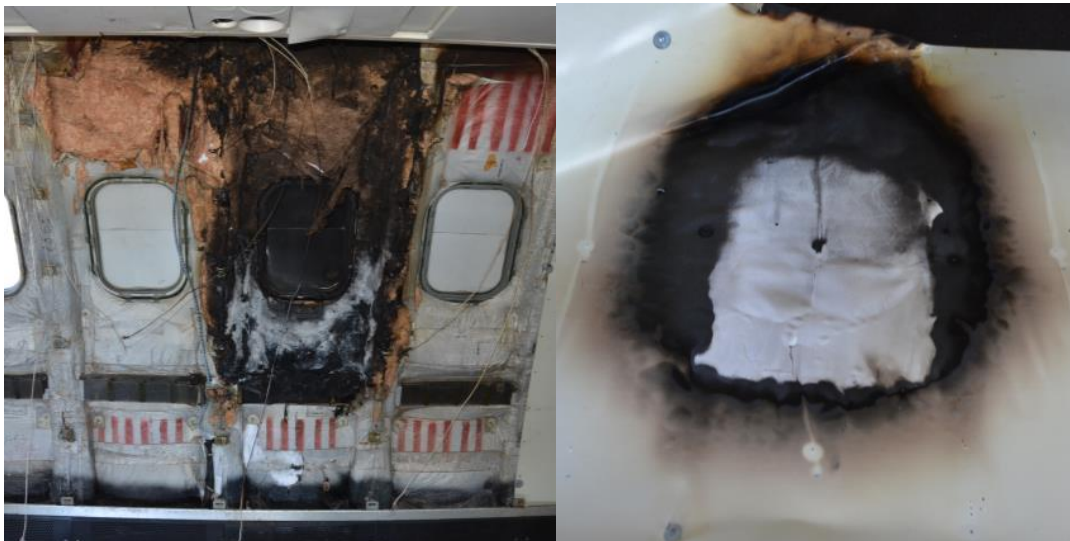
Damage to the cargo liner and insulation was severe, partly due to the fire that propagated between them. Figure 41 depicts the damages to the aircraft wall. It should be noted that the cargo liner was removed from the wall during the interior team’s fire response efforts.

Figure 41. Damage to Aircraft Interior: Test 4

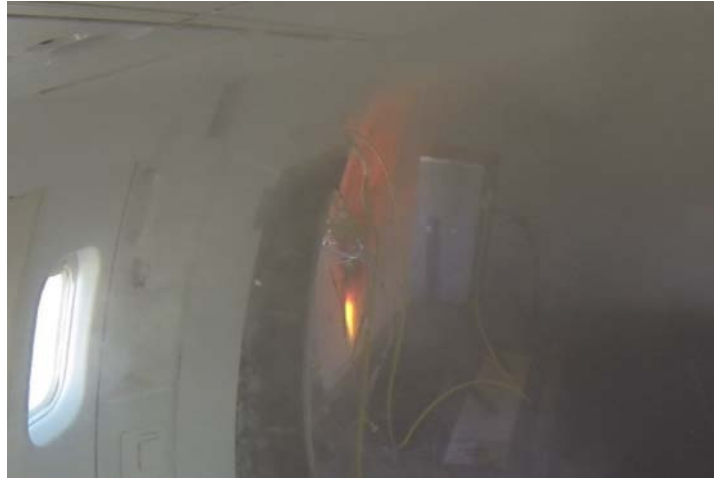
occurred through a tear in the wall, approximately 1/2 in. long, positioned in the center of the cargo-liner test section. An image of the ignition is shown in figure 42.

Figure 42. Autoignition: Test 4

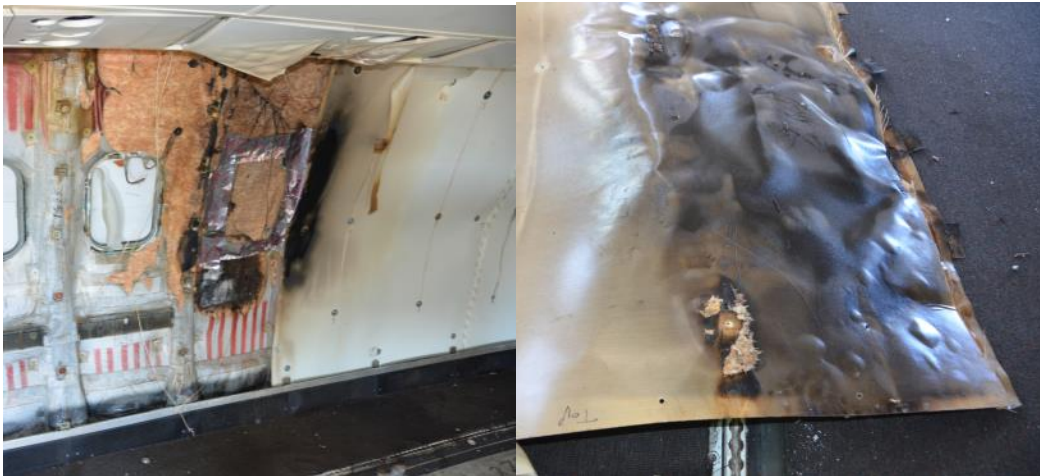
Prior to test 5, the distance of the heater assembly to the aircraft wall was increased from 1 ft, 4in. to 2 ft, 1.5 in. This increase was to prevent autoignition and increase the likelihood of a full-length test. Damage to the aircraft interior during test 5 was similar but not quite as severe as test 4. There was significantly less off-gassing, and ignition did not occur. The damage caused by test 5 is shown in figure 43. It should be noted that the cargo liner was removed by the interior team to ensure that fire was not present after testing.

Figure 43. Damage to Interior: Test 5

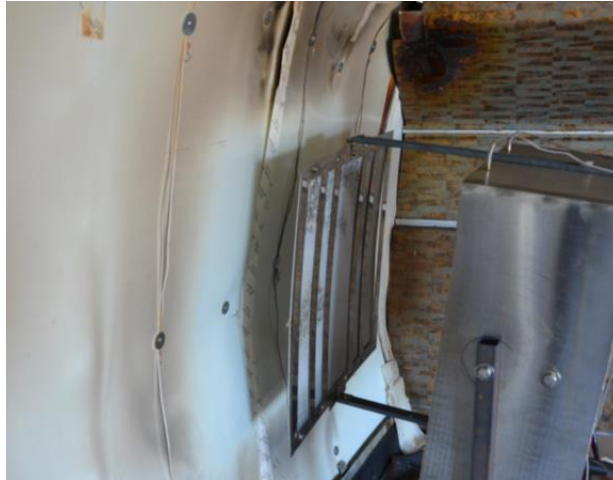
Test 6 exhibited much lower temperatures on the cargo liner wall as the heat was reflected by the aluminum panel. Damage to the cargo liner, insulation, and aluminum panel was negligible. A slight discoloration of the cargo liner around the aluminum panel was observed. Figure 44 shows damage to the interior during test 6.

Figure 44. Damage to Interior: Test 6

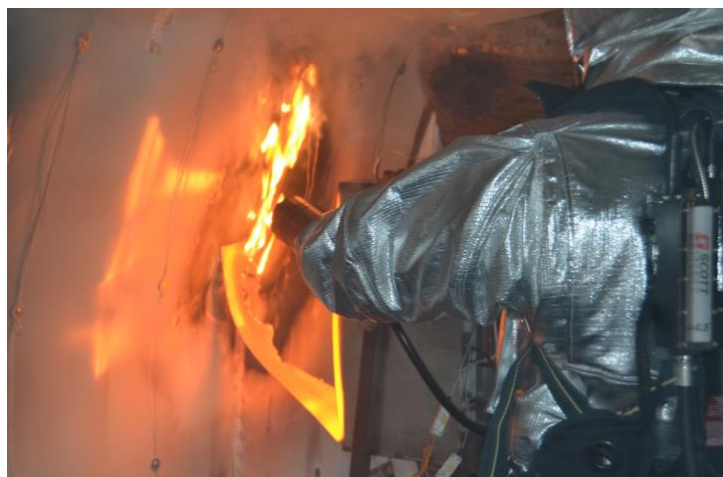
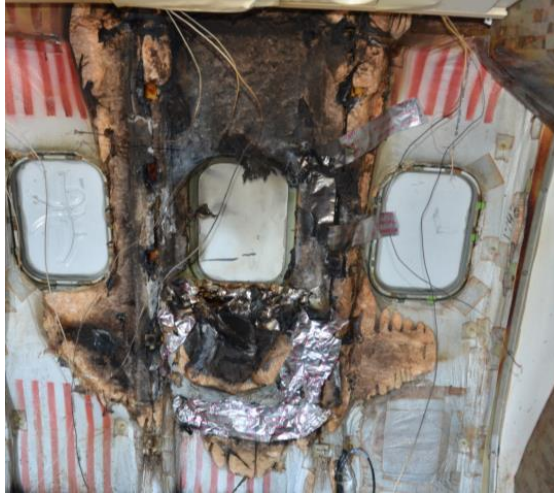
The third cargo configuration test section that was used for test 6 was reused during test 7 since there was minimal damage to the test section present after test 6. The aluminum panel simulating the ULD was moved flush with the heater to increase the aluminum panel's temperature. During test 7, the aluminum panel failed, causing a spike in interior temperature. A small fire occurred during test 7 when the failed aluminum panel came into contact with the cargo liner. The fire ignited the insulation behind the cargo liner and the test was aborted. Damage to the aircraft interior was similar to test 4 with damage to the insulation and cargo liner present. Off-gassing during tests 6 and 7 was not as severe as in test 5. Figures 45 and 46 show the fire caused by the failed aluminum panel, and the interior damage caused during test 7.

Figure 45. Fire Caused by Failed Aluminum Panel: Test 7

Figure 46. Damage to Interior: Test 7

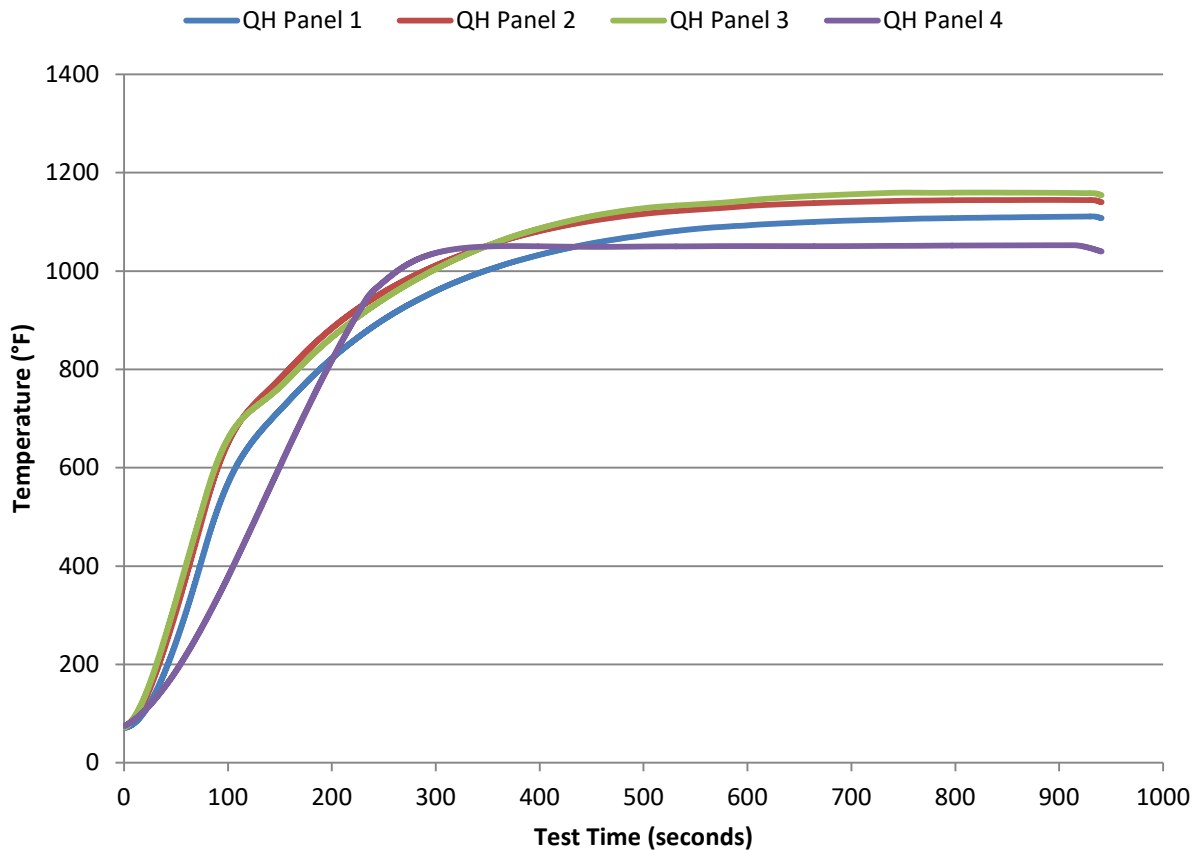
All heating curves are identical because the quartz heater assembly was given the same input of 1112°F. A single example of this curve is provided in figure 48.

Figure 48. Quartz Heater Assembly Heating Curve

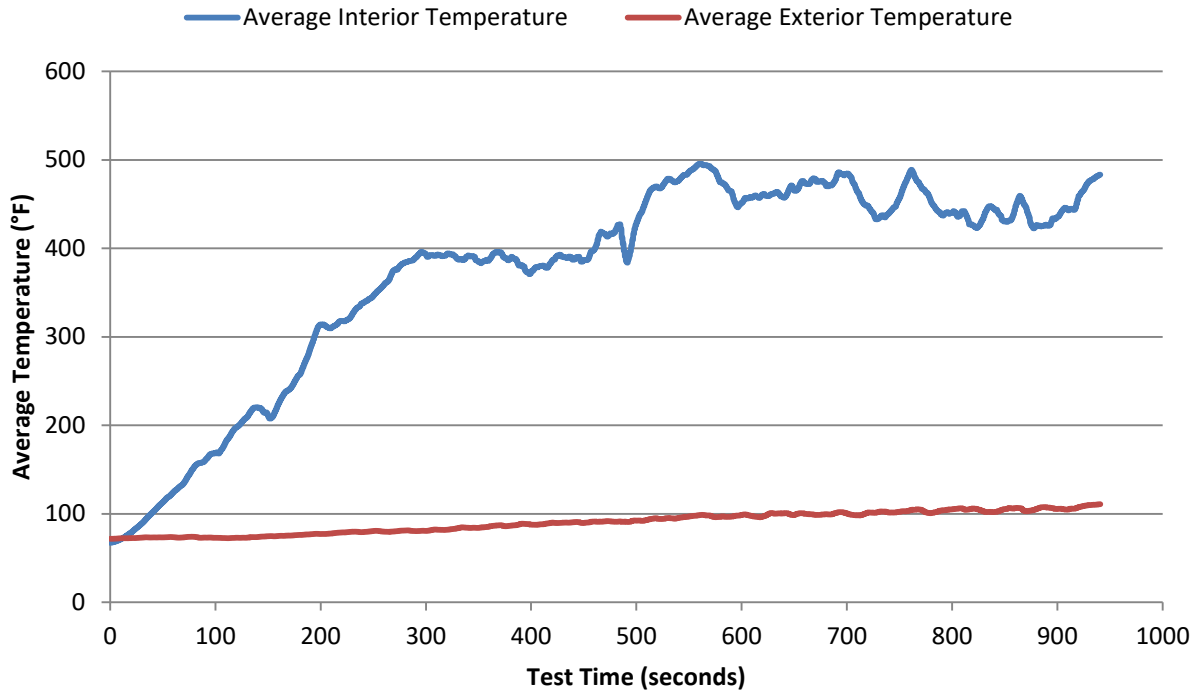
panel testing, a single layer of aircraft insulation provided a difference in temperature of up to 400°F.

Figure 50. Average Interior vs Exterior Temperature: Test 1

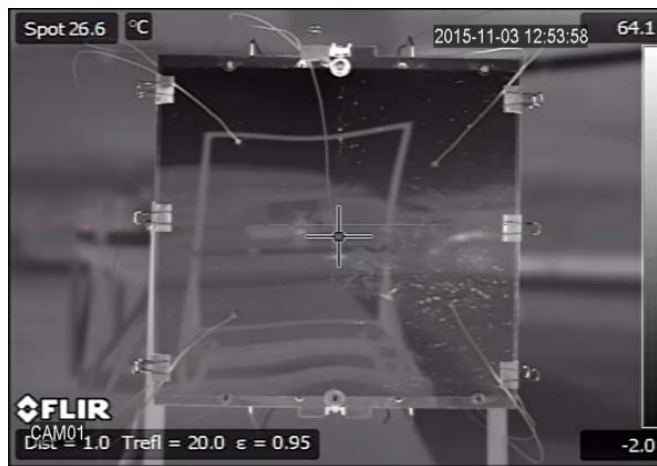
Unpainted aluminum had the smallest error compared to all other panels. This error was most likely due to its' low emissivity and high reflectiveness. Since the exterior panel was insulated from the heater, the indicated thermocouple temperature was not much higher than the ambient temperature. Instead of measuring the unpainted aluminum panel, the IR cameras instead read the scene behind the cameras, which decreased camera-indicated temperature. An example of this phenomenon is shown in figure 52, in which the reflection of the camera, camera stand, and background behind the camera were clear in the unpainted panel reflective surface. The camera did not correctly read the test panel temperature, but instead read the temperature of the scene behind the camera.

Figure 52. Sample of Panel Reflection Error

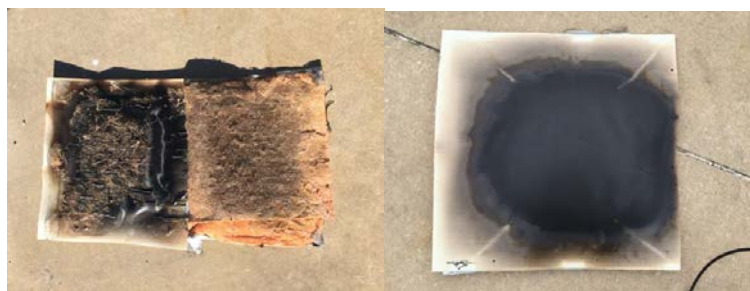
Figure 54. Sample of Insulation and Interior Cargo Liner Panel Damage

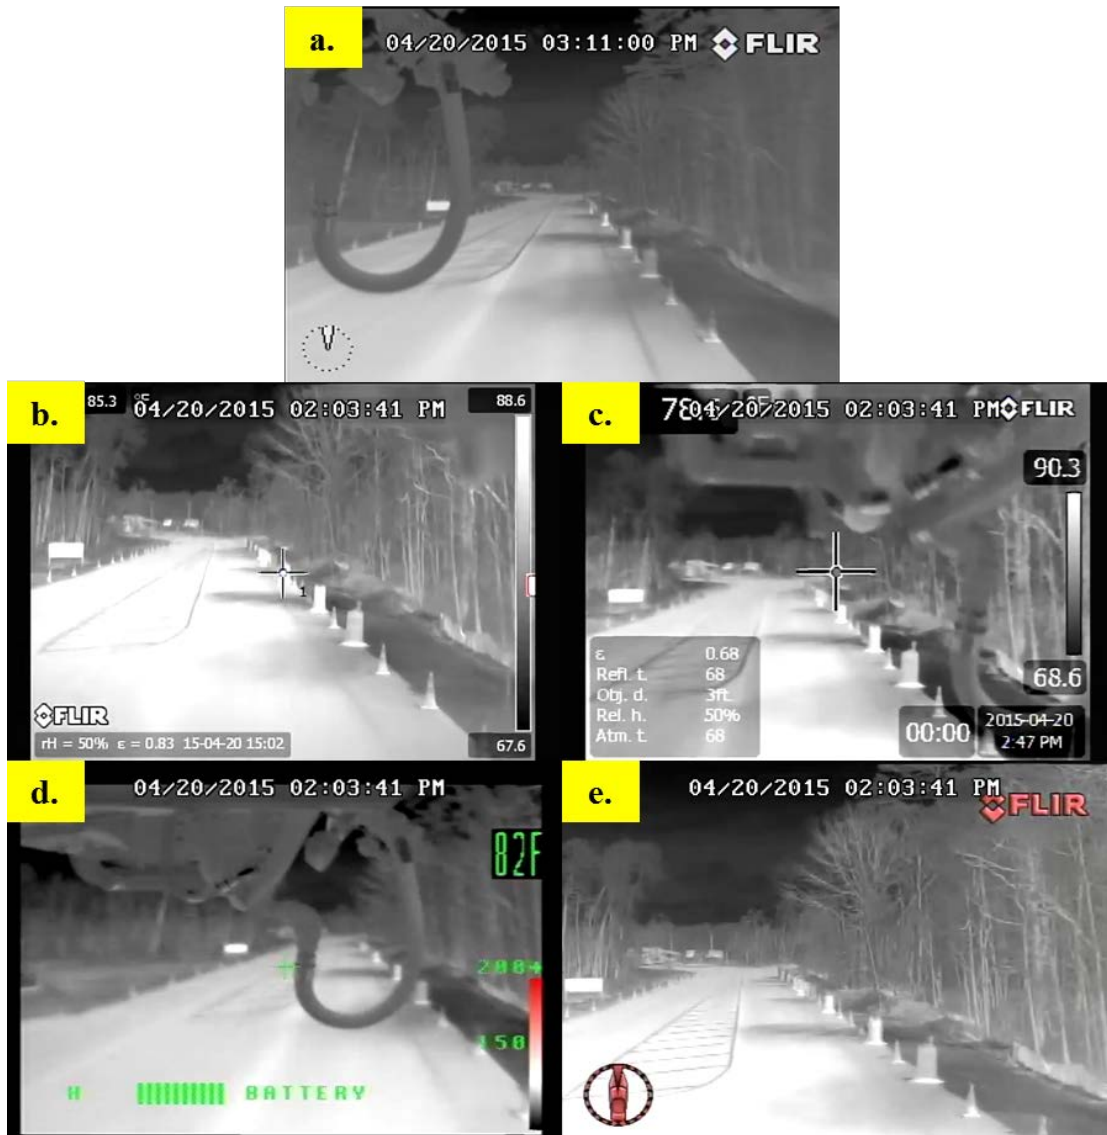
Figure 58. Asphalt Road Comparison II Using (a) Patrol IR, (b) P660, (c) T420, (d) XR, and (e) M625L

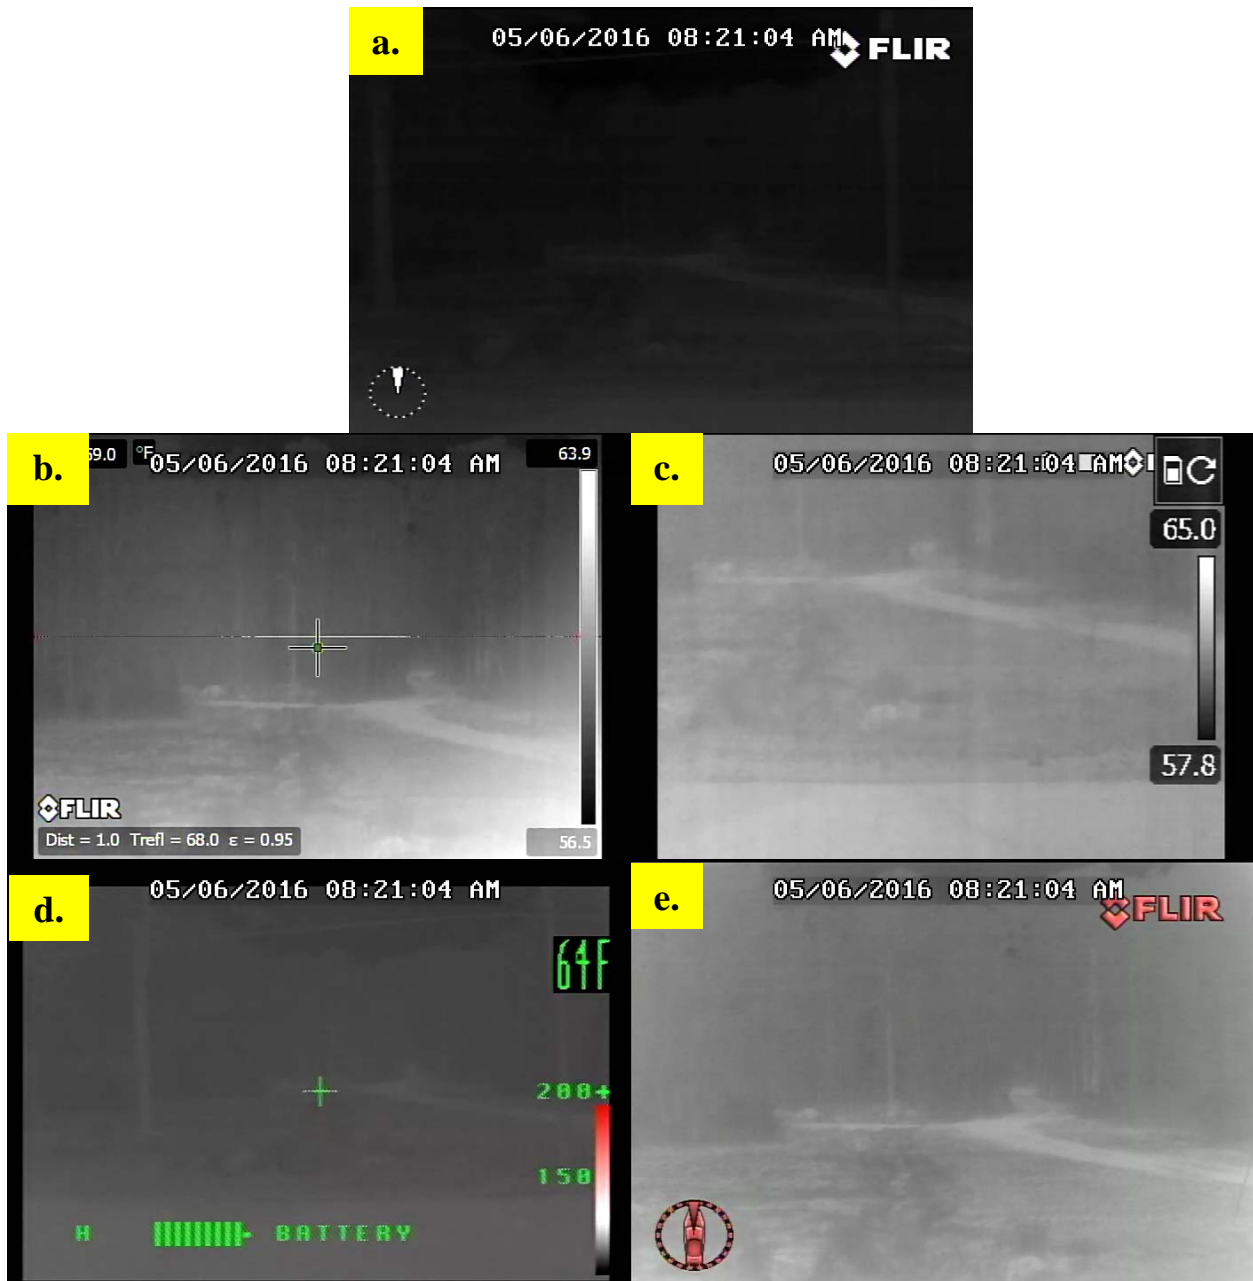
Figure 63. Moderate Rain, Woods/Dirt Road View Using (a) Patrol IR, (b) P660,(c) T420, (d) XR, and (e) M625L

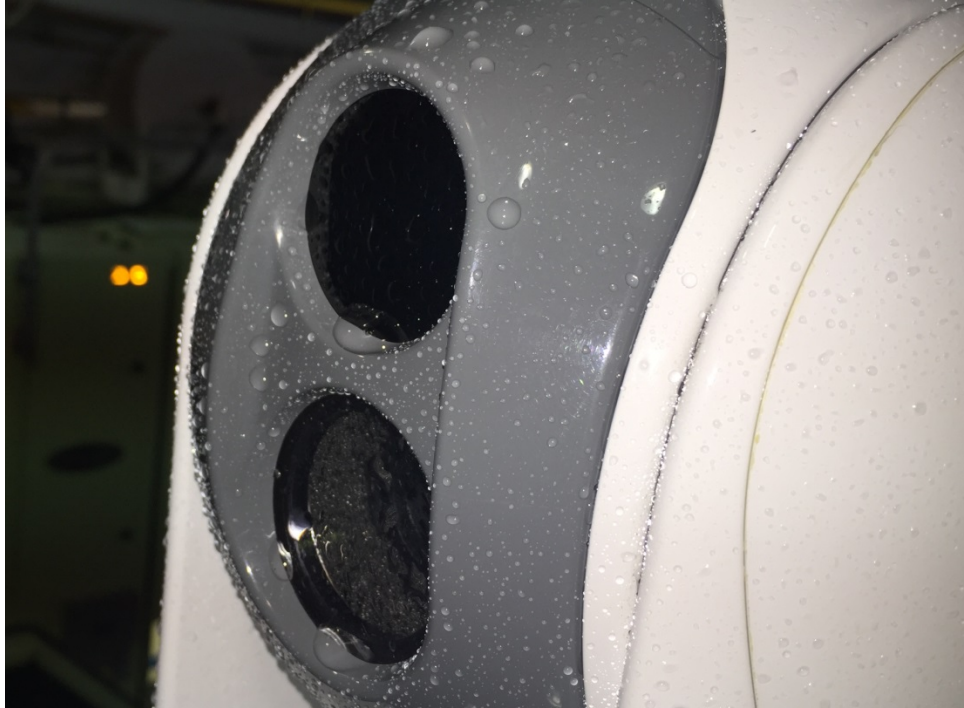
Figure 64. Rain Accumulation for Moderate Rain

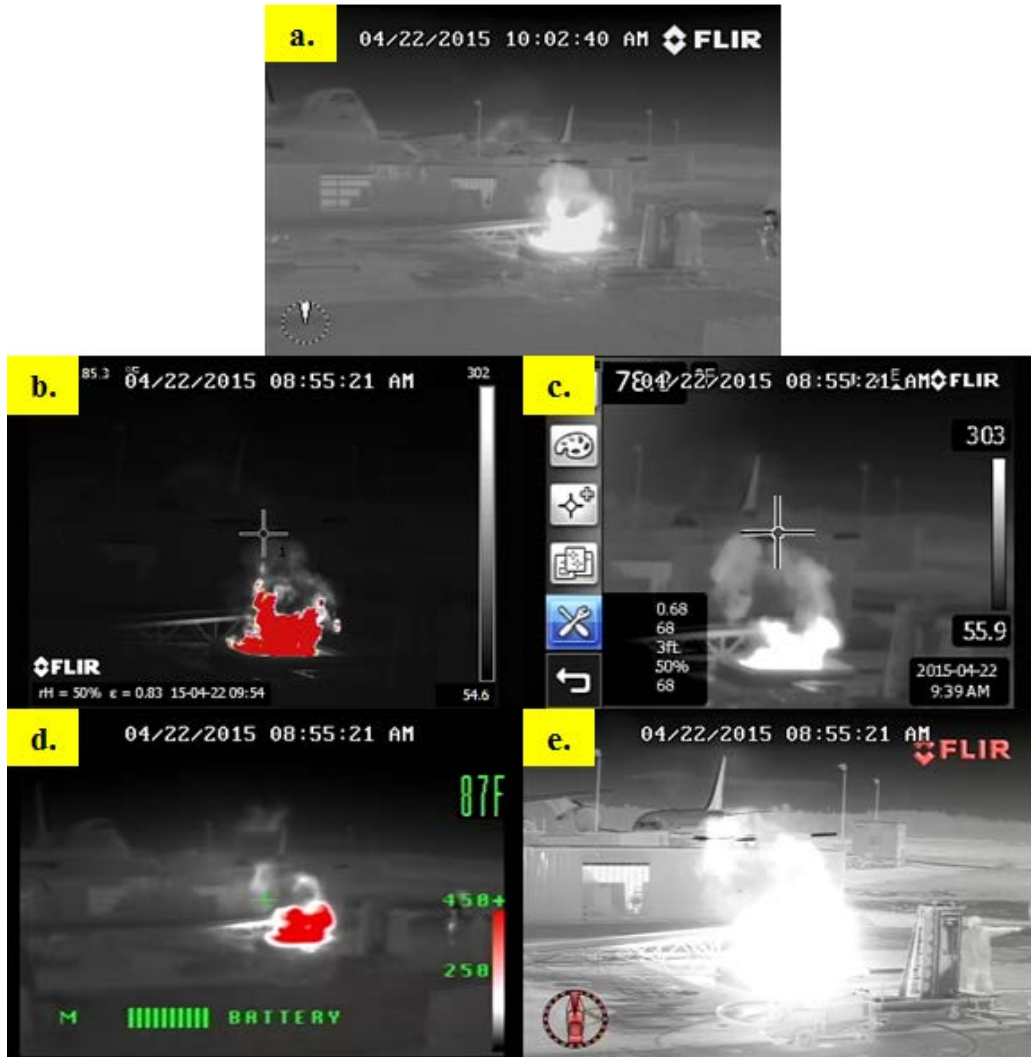
Figure 68. The 6-ft-Square Pan Fire Captured by (a) Patrol IR, (b) P660, (c) T420, (d) XR, and (e) M625L

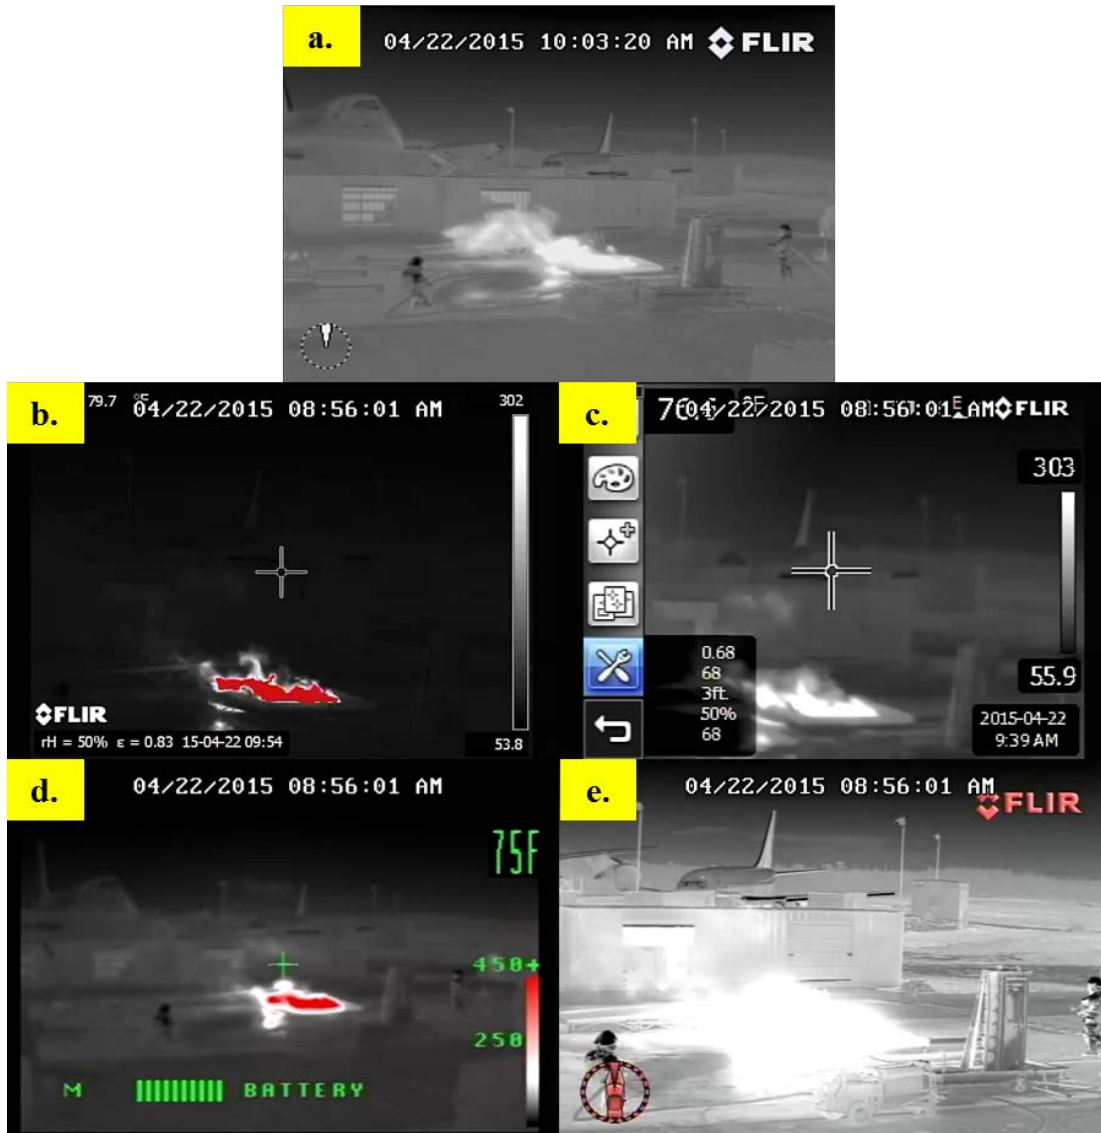
Figure 69. The 6-ft-Square Pan Fire Being Extinguished Captured by (a) Patrol IR, (b) P660, (c) T420, (d) XR, and (e) M625L

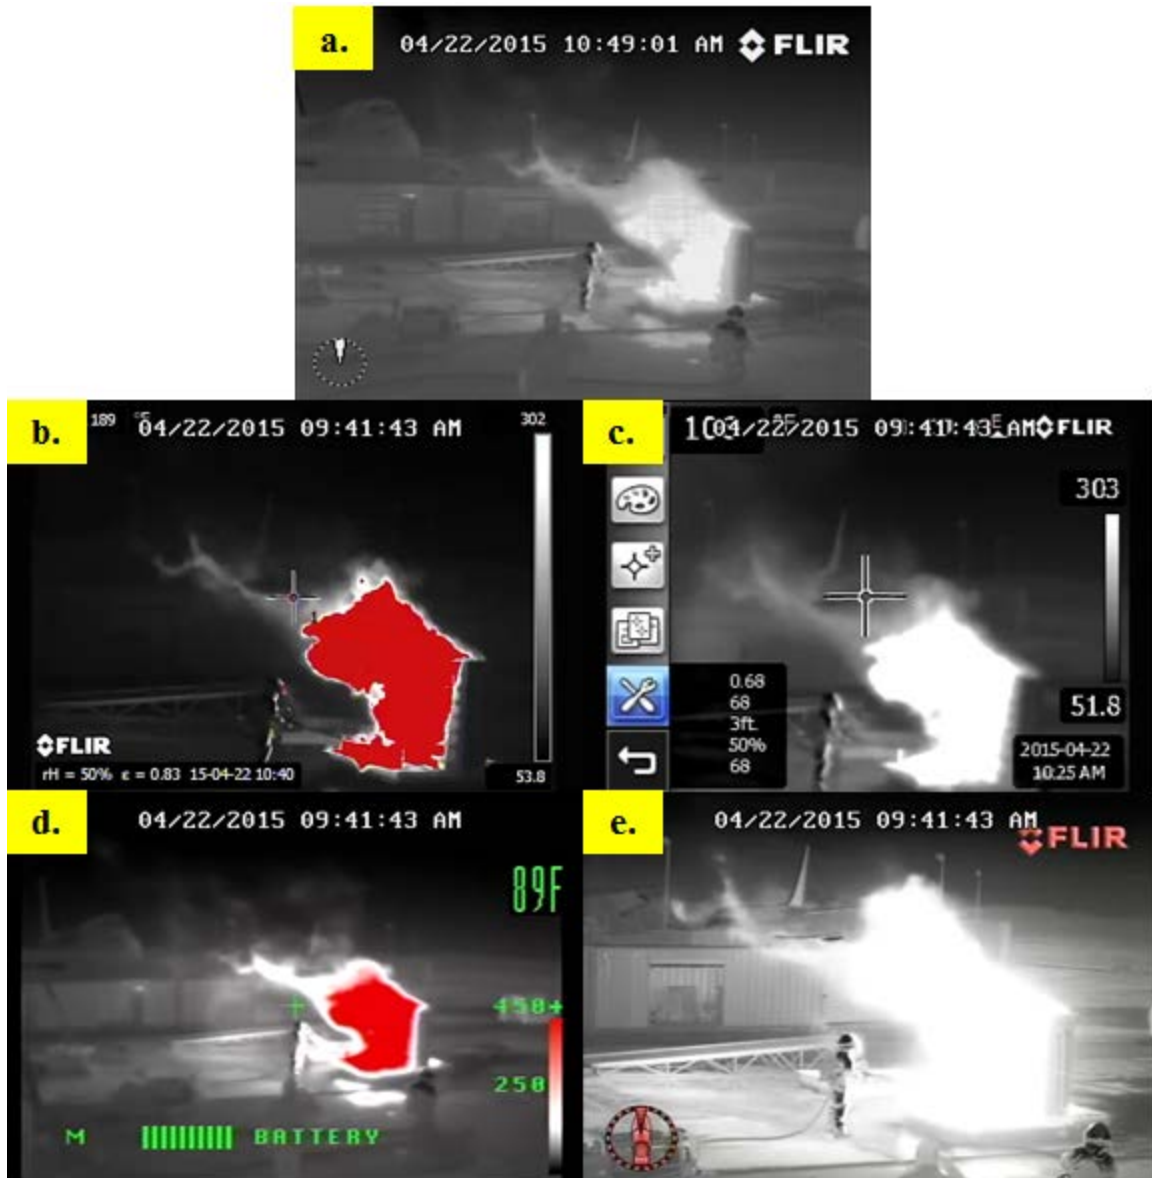
Figure 71. The 3-D Fire Being Extinguished Captured by (a) Patrol IR, (b) P660, (c) T420, (d) XR, and (e) M625L

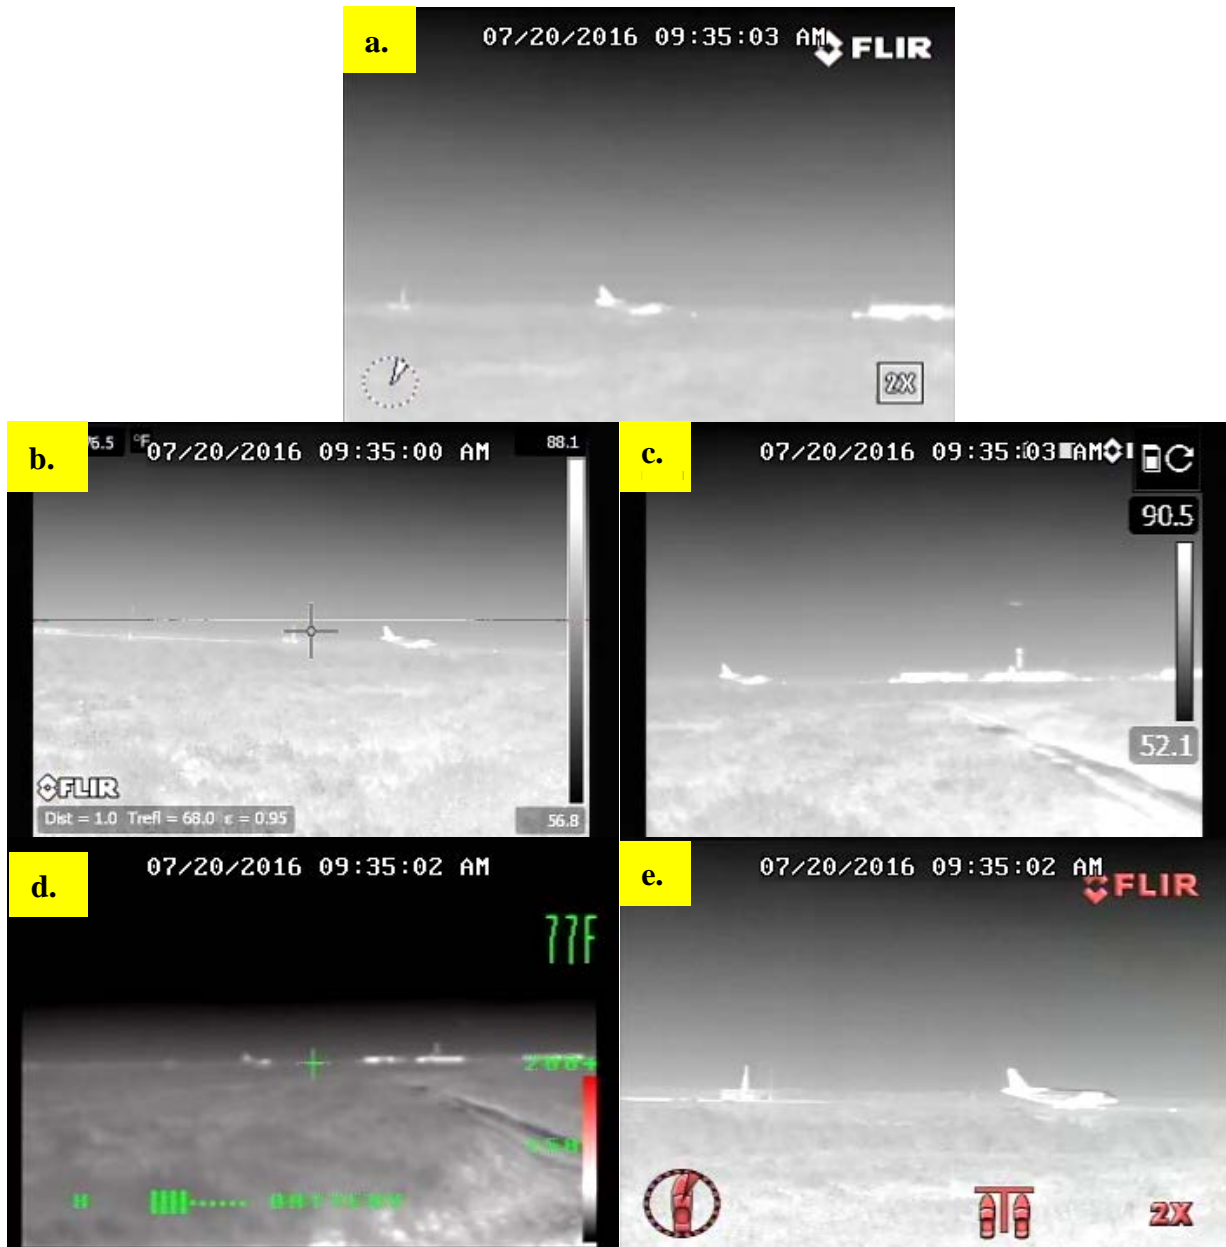
Figure 77. The 3000-ft DEVS Daytime Test 2 Using (a) Patrol IR, (b) P660, (c) T420, (d) XR, and (e) M625L
