DOT/FAA/TC-17/27

Thermal Imaging for Aircraft Rescue and Fire Fighting Applications

May 2017

Final Report

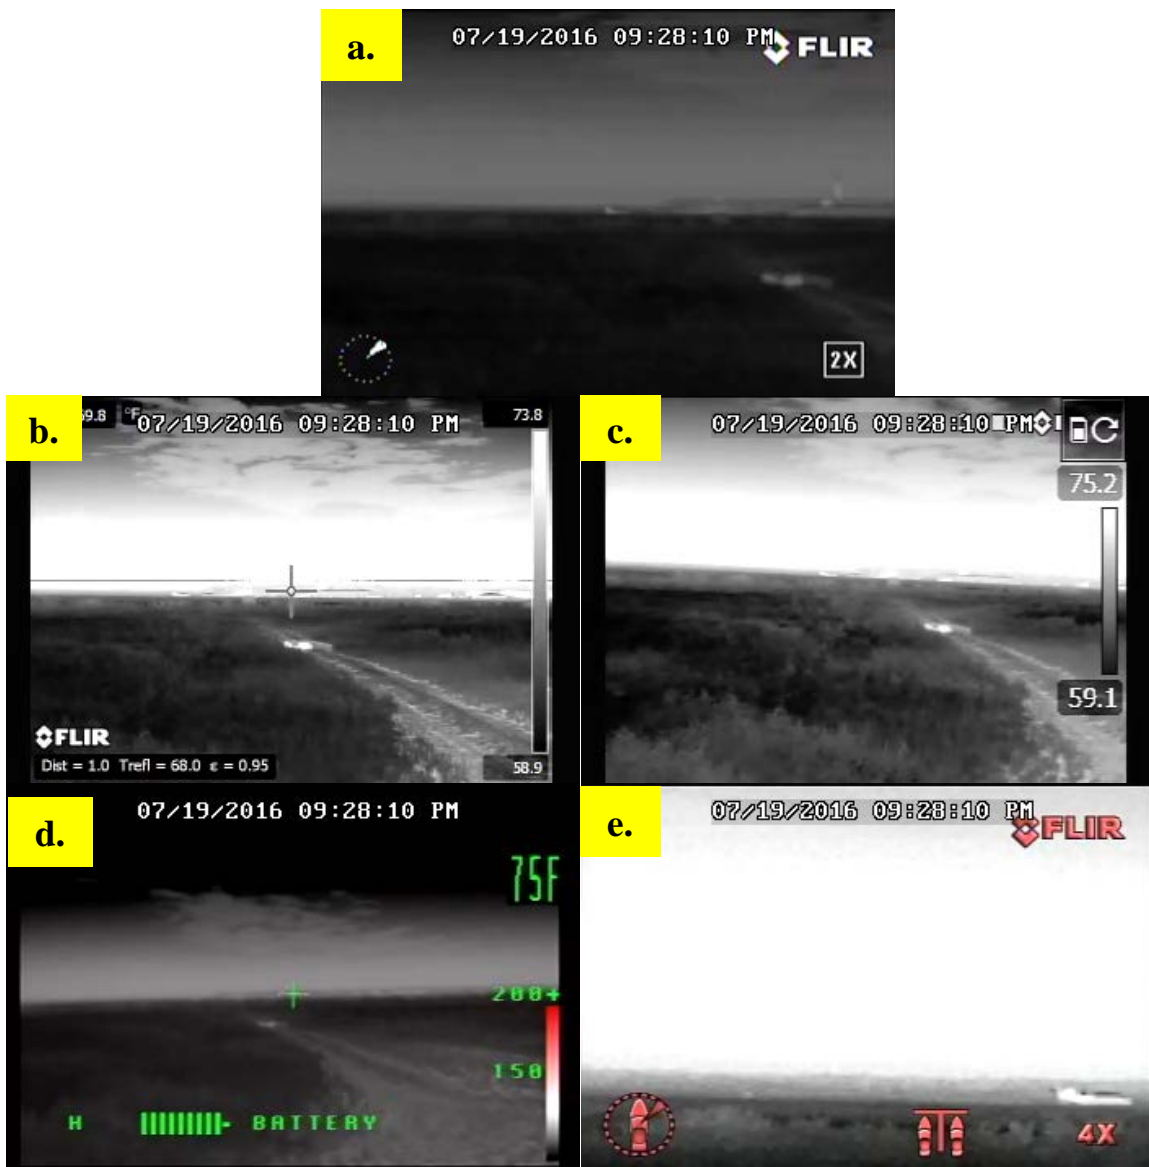
Figure 78. The 3000-ft DEVS Nighttime Test Using (a) Patrol IR, (b) P660, (c) T420, (d) XR, and (e) M625L

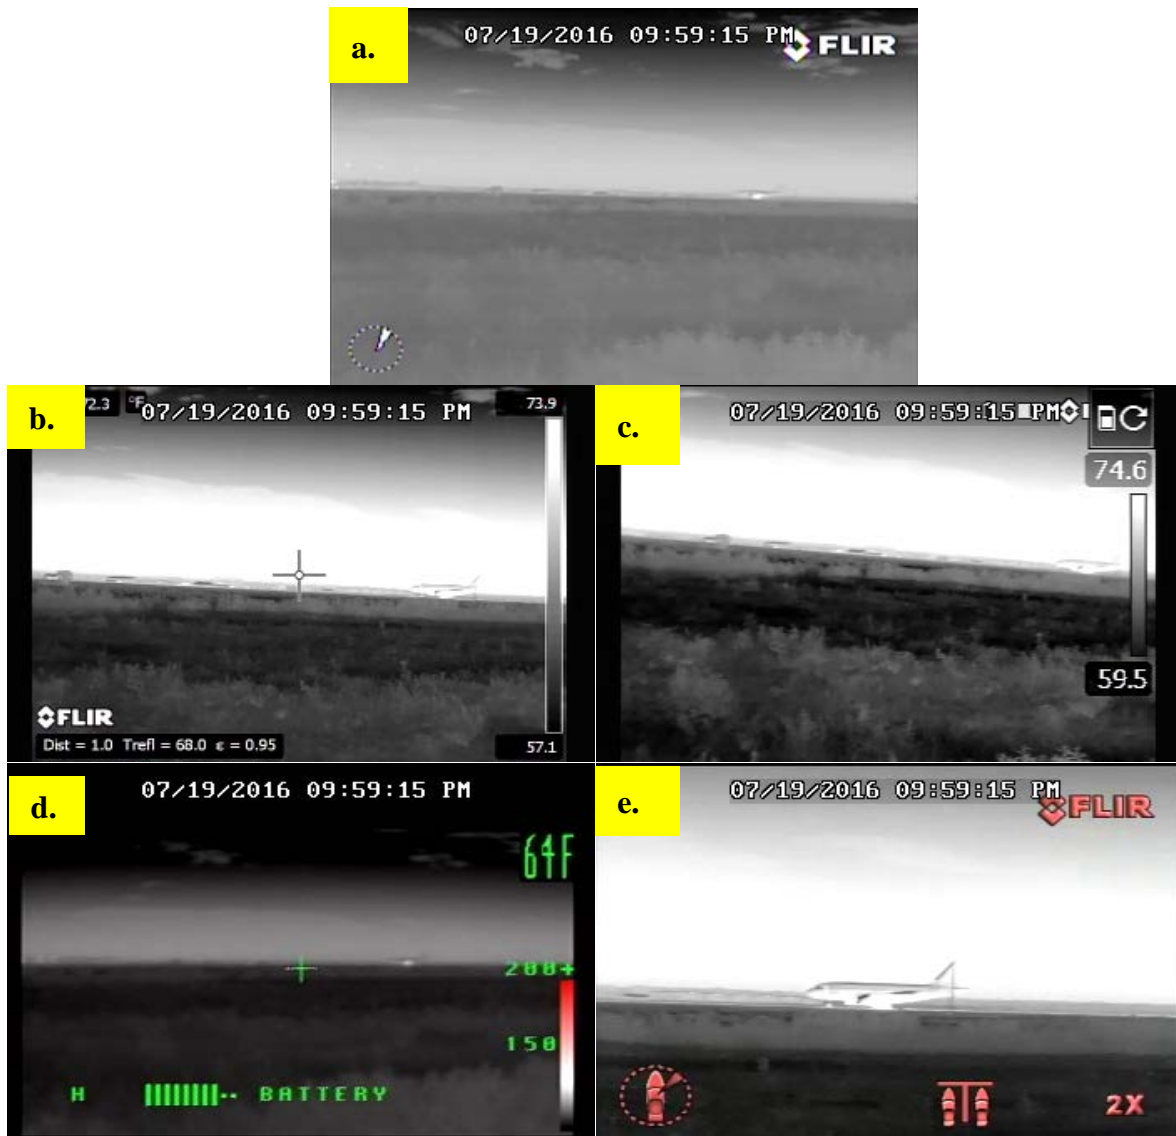
Figure 79. The 2500-ft DEVS Nighttime Test Using (a) Patrol IR, (b) P660, (c) T420, (d) XR, and (e) M625L

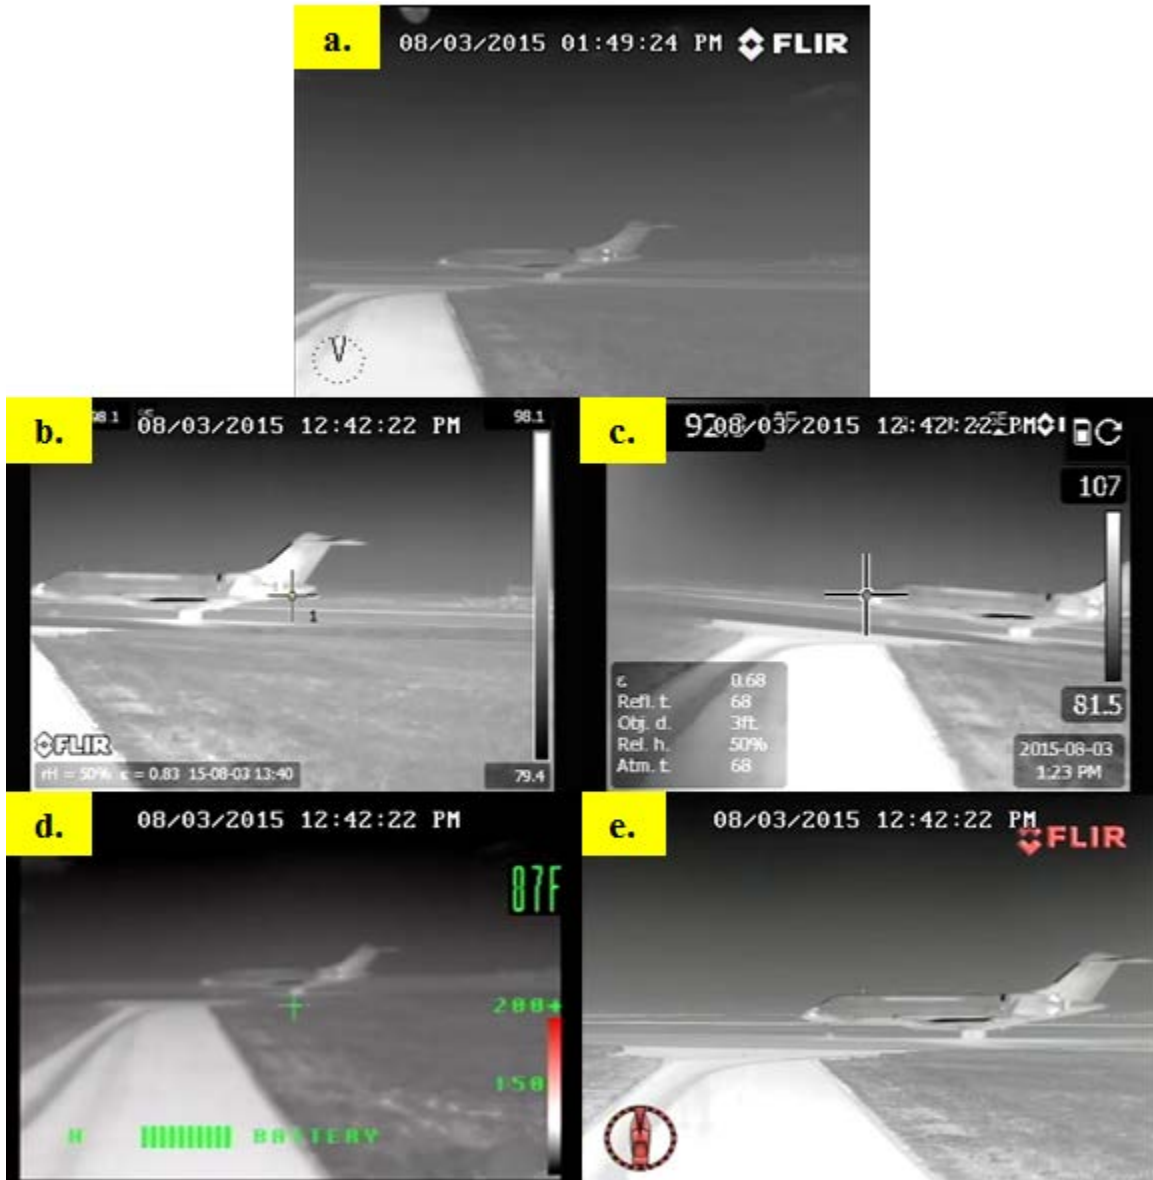
Figure 80. Hot Brakes Test Using (a) Patrol IR, (b) P660, (c) T420, (d) XR, and (e) M625L
