DOT/FAA/TC-17/30

Performance Assessment of the Vestas IntelliLight™ System as an Aircraft Detection Lighting System

Interim Report

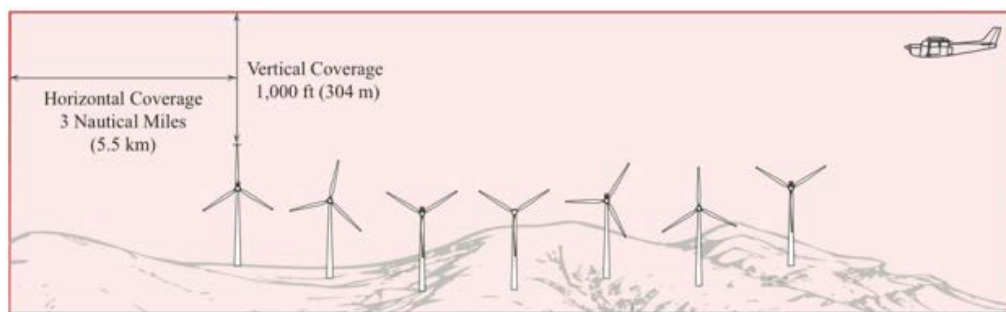
* System above shown in active mode with aircraft in coverage area

Figure 1. Required ADLS Detection Coverage [1]

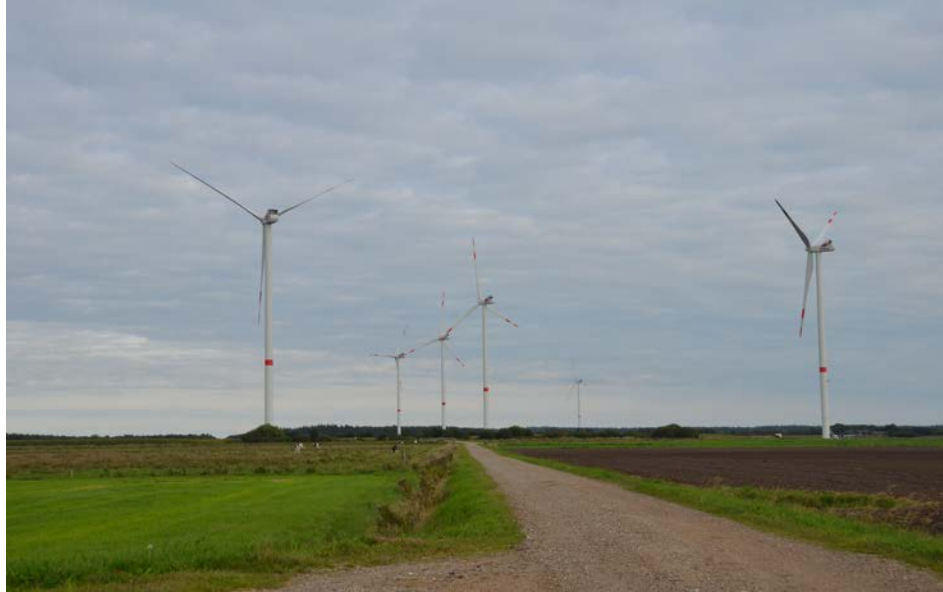
Figure 6. Wind Turbines at the Braderup Wind Park

Vestas installed its Vestas IntelliLight system on a wind turbine at the Braderup Wind Park, a wind turbine farm located near the town of Braderup, in northern Germany. As shown in figure 5, this site was located a short distance south of the border between Denmark and Germany. The Braderup Wind Park contains six Vestas V112-3.3MW™ wind turbines, which are shown in figure 6. These turbines reach up to 574 ft (175 m) AGL at their highest point.

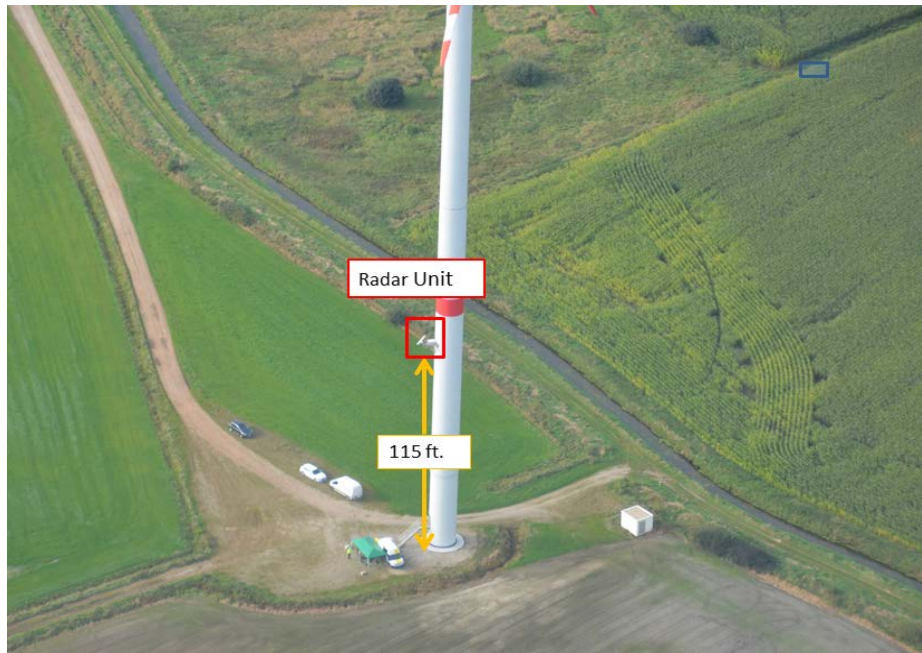
Figure 9. Vestas IntelliLight Radar Position

The radar was mounted at a height of 115 ft (35 m) AGL, as shown in figure 9.

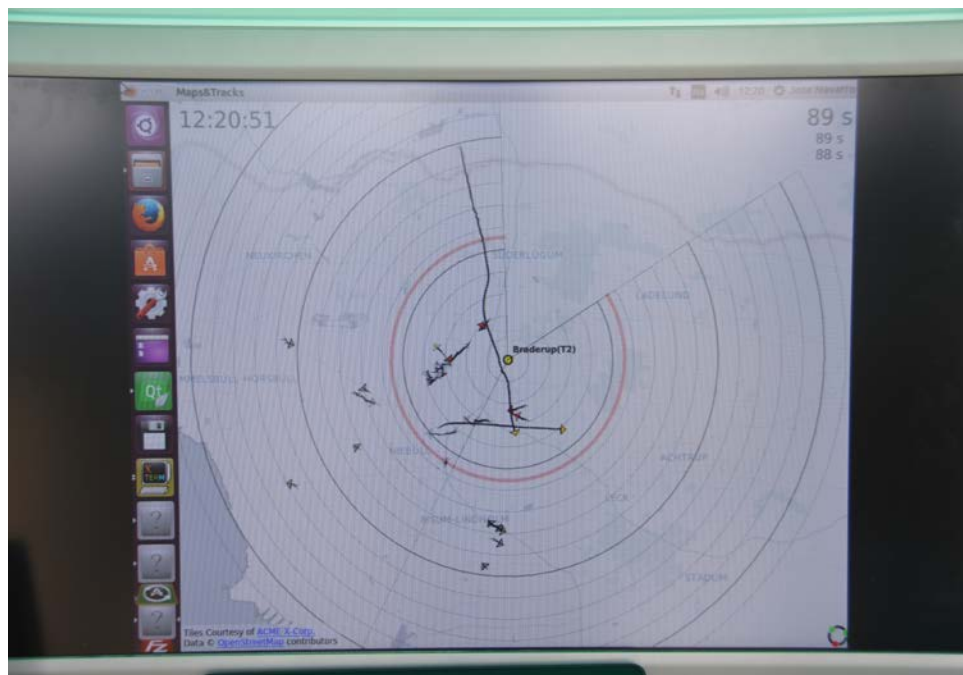
Figure 10. Radar Interface Monitored During Assessment

Beneath the turbine, a pop-up tent was set up by Vestas for ATR personnel to monitor the Vestas IntelliLight system's performance. This pop-up tent included a computer monitor showing live radar tracks and system status, as shown in figure 10. It should be noted, this computer monitor (graphical user interface) was only available for the assessment.

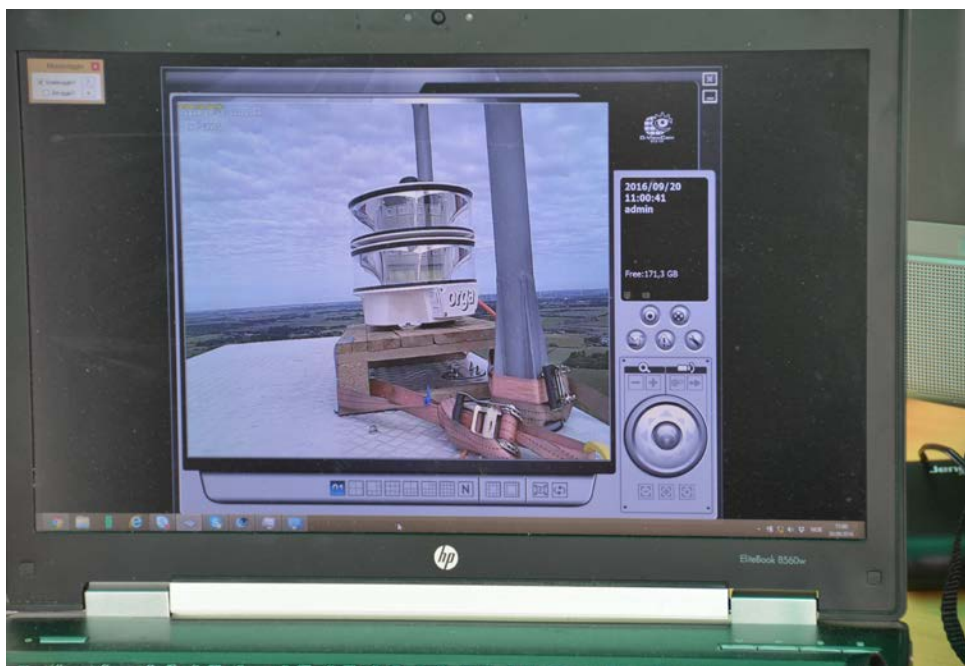
Figure 11. Camera Feed Used to Monitor Obstruction Light Status During Assessment

The Vestas IntelliLight system was connected to a low-intensity, red obstruction light and a high-intensity, flashing obstruction light installed on the wind turbine nacelle. Both types of obstruction lights were visible from the aircraft during the assessment. To allow FAA ATR personnel on the ground to monitor these lights, Vestas personnel installed a webcam to transmit video on a computer monitor at ground level, as shown in figure 11. It should be noted, the video feed was only available for the assessment. An additional steady burning obstruction light controlled by the Vestas IntelliLight system was also installed at ground level by Vestas to provide ATR personnel additional evidence the system was functioning as required.

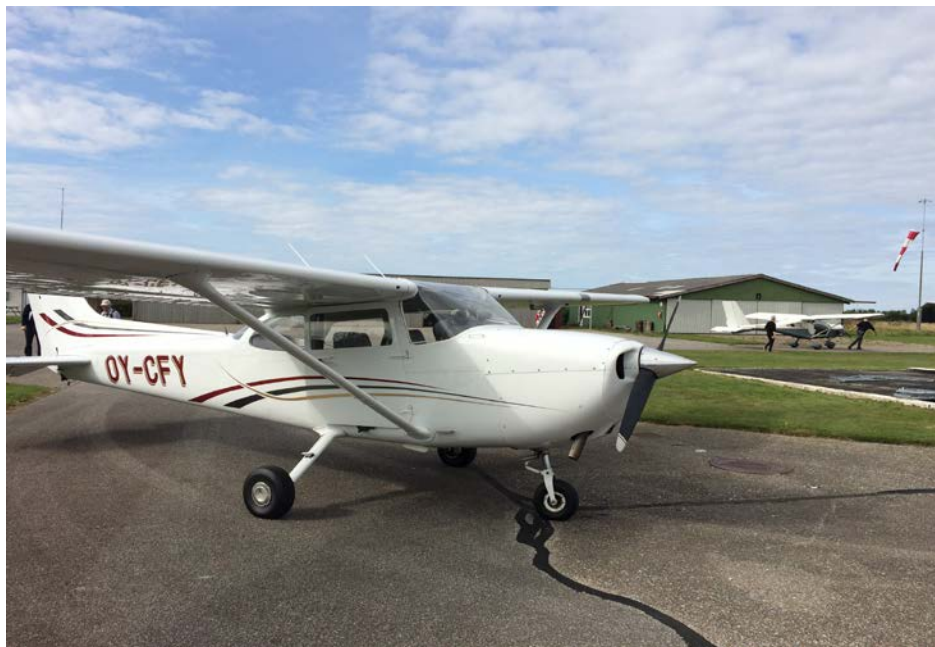
Figure 12. Cessna 172 Used for Assessment

ATR personnel used a Cessna 172 aircraft to conduct the flight pattern tests, shown in figure 12. These flights were operated out of the Tønder Airport, located outside the city of Tønder, Denmark. Figure 13 shows a Google Earth™ map image overlaid with the flight tracks (shown in light blue) recorded by a global positioning system (GPS) unit on board the aircraft over the course of the two flights.
