DOT/FAA/TC-17/7

Mode I (G1c) Fracture Toughness of Composite Sandwich Structures for Use in Damage Tolerance Design and Analysis: Vol. III Supplemental Static Testing

March 2018

Final Report

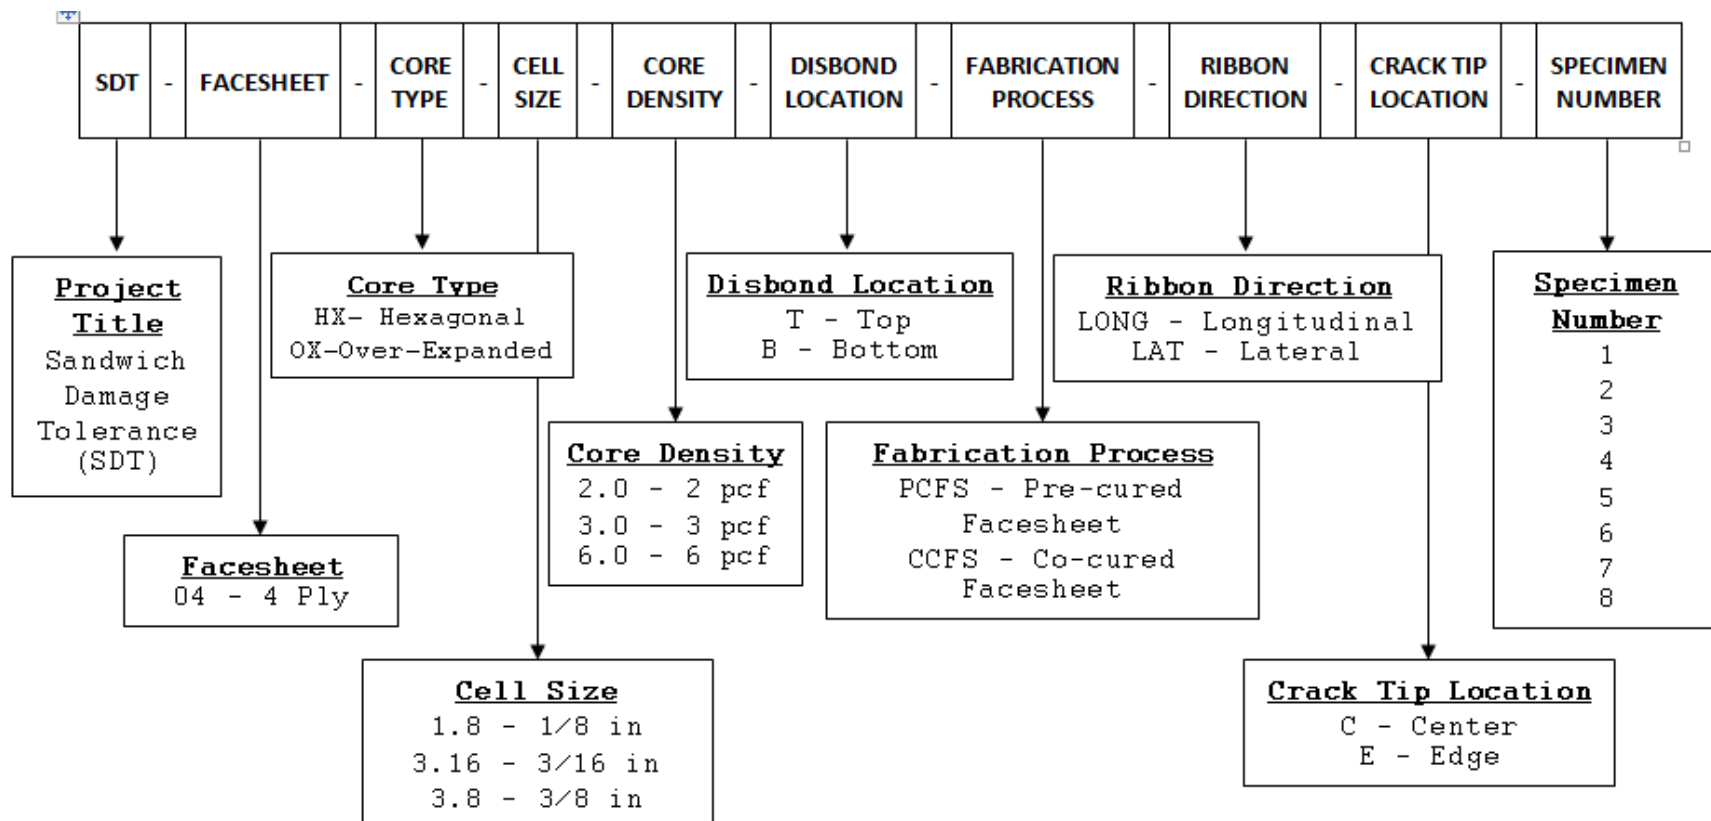
Figure 7. Specimen nomenclature

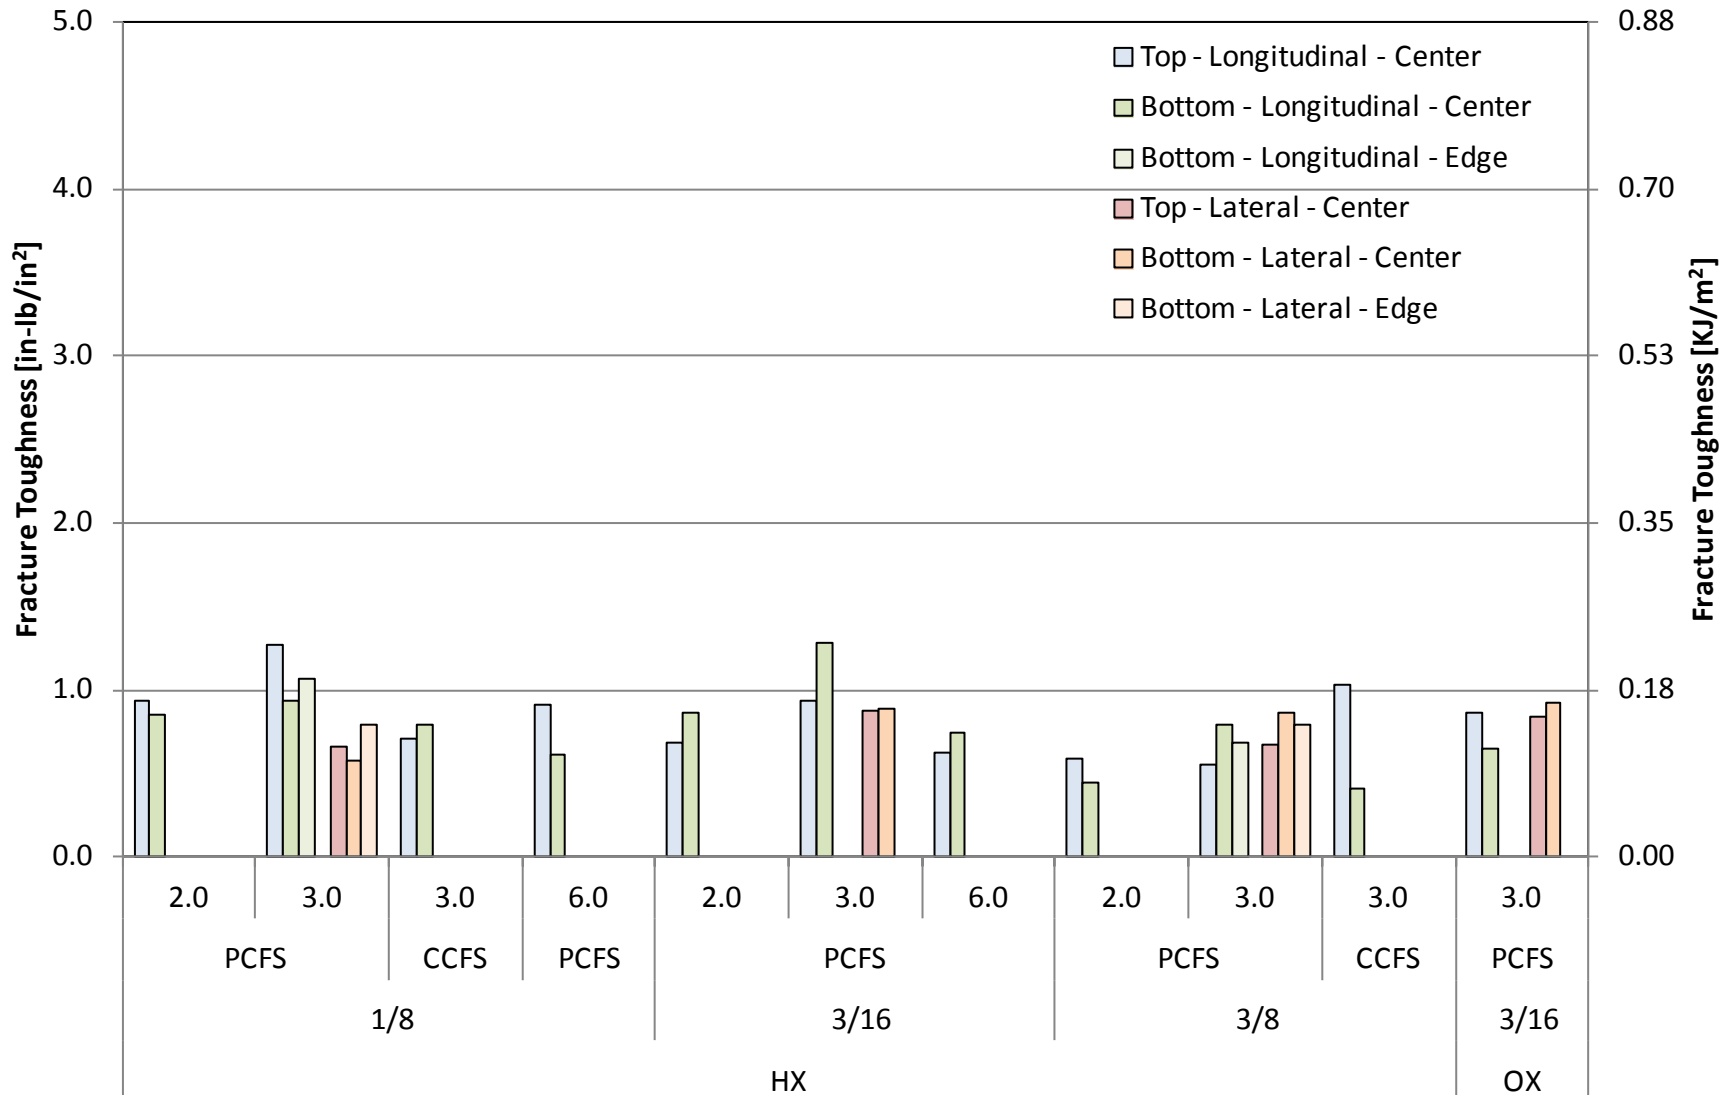
Figure 27. Fracture toughness (NL) master summary

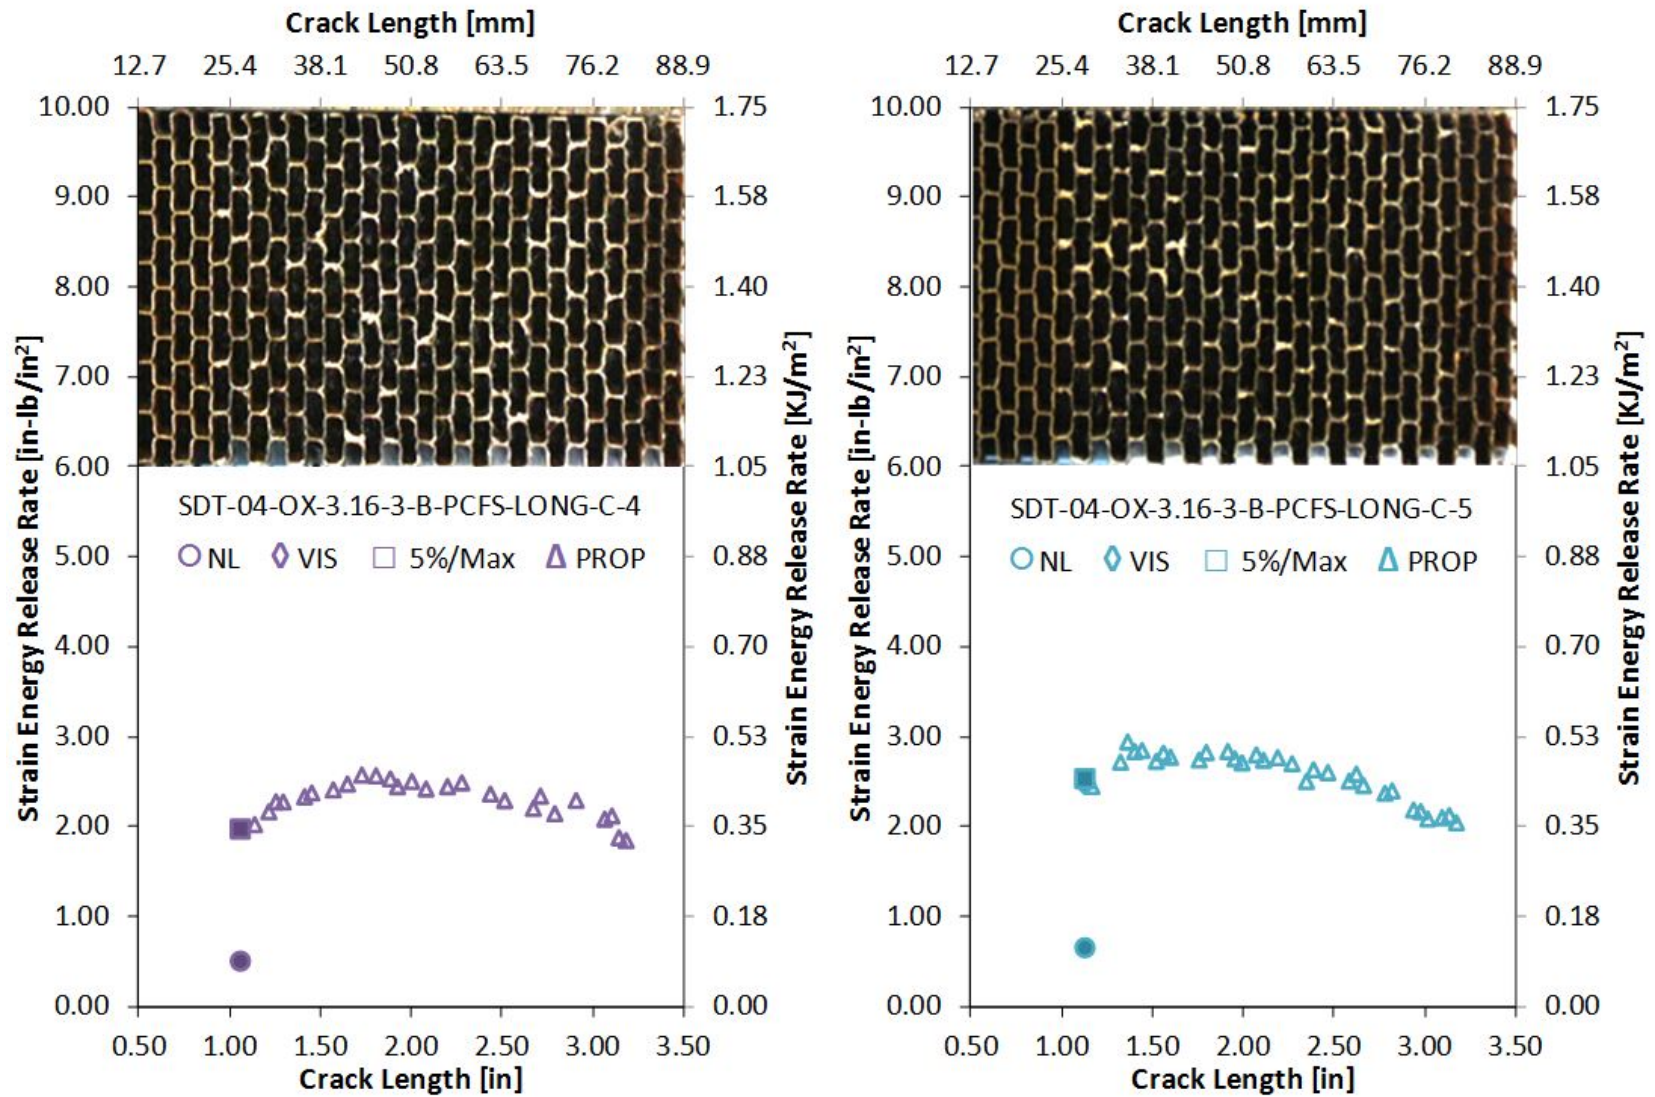
Figure C-10. Failure mode image and resistance curve of SDT-04-OX-3.16-3-B-PCFS-LONG-C-X #4 and #5
