**DOT/FAA/TC-18/18**

# **Development of Engineered Materials Arresting Systems From 1994 Through 2003**

May 2018

Final Report

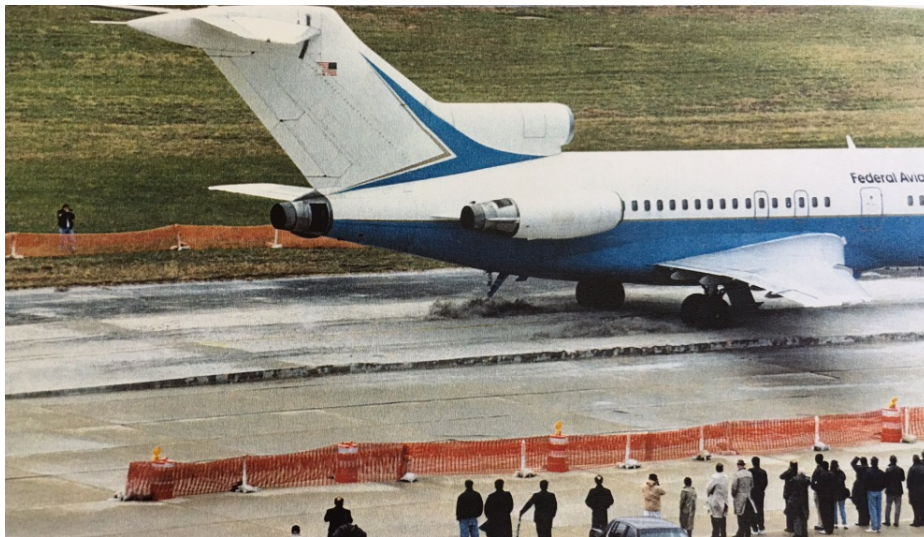
Figure 3. The FAA B-727 Aircraft Entering Foamed Concrete Test Bed at the WJHTC

In the fall of 1994, ESCO designed and hired a cement producer to construct a foamed concrete bed at the WJHTC. The cast-in-place test bed measured 192 ft long by 40 ft wide and tapered to a maximum height of 12 inches (in.). The lead-in ramp was 80 ft long, the 12-in.-high plateau was 40 ft long, and the exit ramp was 72 ft long. The test plan called for the FAA's instrumented B-727 (formerly N-46 and then called Ground Test Vehicle 1 or GTV-1)<sup>2</sup> to taxi through the bed with an entry speed of 35 kt (40 mph) with engines set to idle thrust and flaps at 15 degrees. The thrust and flap settings offset each other to simulate a coasting scenario. Figure 3 shows the B-727 in the foamed concrete test bed at the WJHTC.

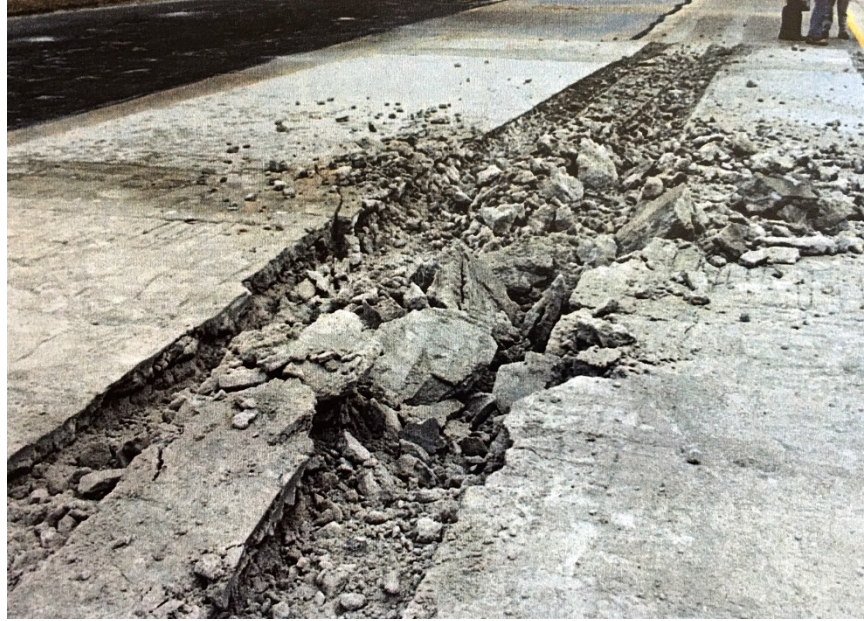
Figure 4. Foamed Concrete Test Bed Mode of Failure

General consensus between the FAA, ESCO, and PANY&NJ personnel was that the foamed concrete displayed improved stopping ability compared to phenolic foam. However, lack of uniformity with regards to cured compressive strength and density was unacceptable. Figure 4 shows the nonuniform mode of failure, which indicates a nonhomogeneous material.

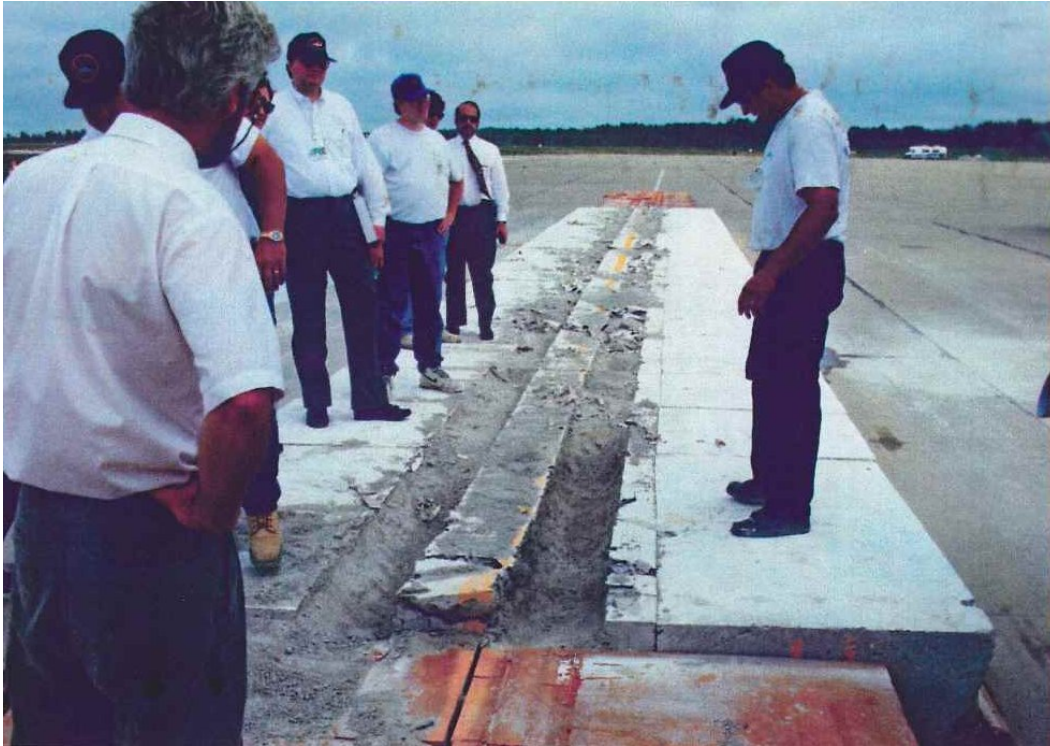
Figure 6. The B-727 Nose Gear Ruts

Figure 6 shows the path of the B-727's nose gear through the cellular cement blocks, including the phenolic foam lead-in ramp.

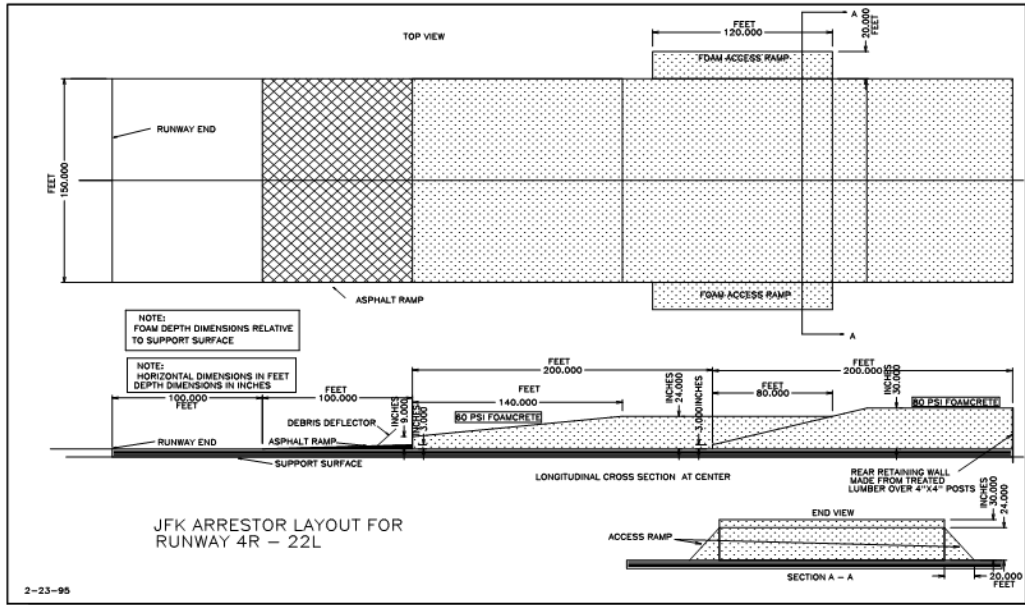
Figure 7. Preliminary Design for Prototype Arrestor System for JFK Runway 4R

The preliminary design was prepared by Robert F. Cook.<sup>4</sup> The design, shown in figure 7, depicts an arrestor system 400 ft long by 150 ft wide and tapered up to a plateau 30 in. high. Figure 7 shows the initial prototype arrestor system layout. The design resulted from multiple overrun simulations for a PANY&NJ-specified fleet mix: DC-9, B-707, B-727-100, B-727-200, DC-10, and B-747. The simulations indicated the arrestor system as an effective means of safely stopping overrunning aircraft, especially in wet and icy runway surface conditions. The design used information from three previous reports, one published by the FAA [4] and two authored by Robert F. Cook [6 and 7].

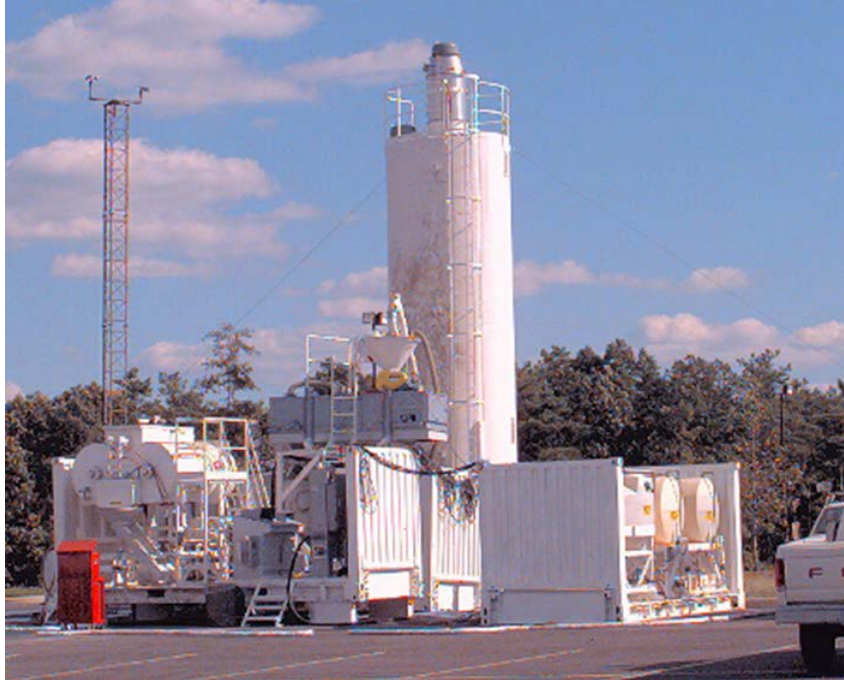
Figure 8. The ESCO Cellular Cement Block Manufacturing Plant at WJHTC

By October 1995, ESCO and the FAA acquired necessary permits and approvals to assemble and operate a cellular cement production facility at the WJHTC, as shown in figure 8. ESCO provided all the material, equipment, and manpower necessary to cast, cure, and install the cellular cement blocks required to conduct a full-scale arrest of the B-727.

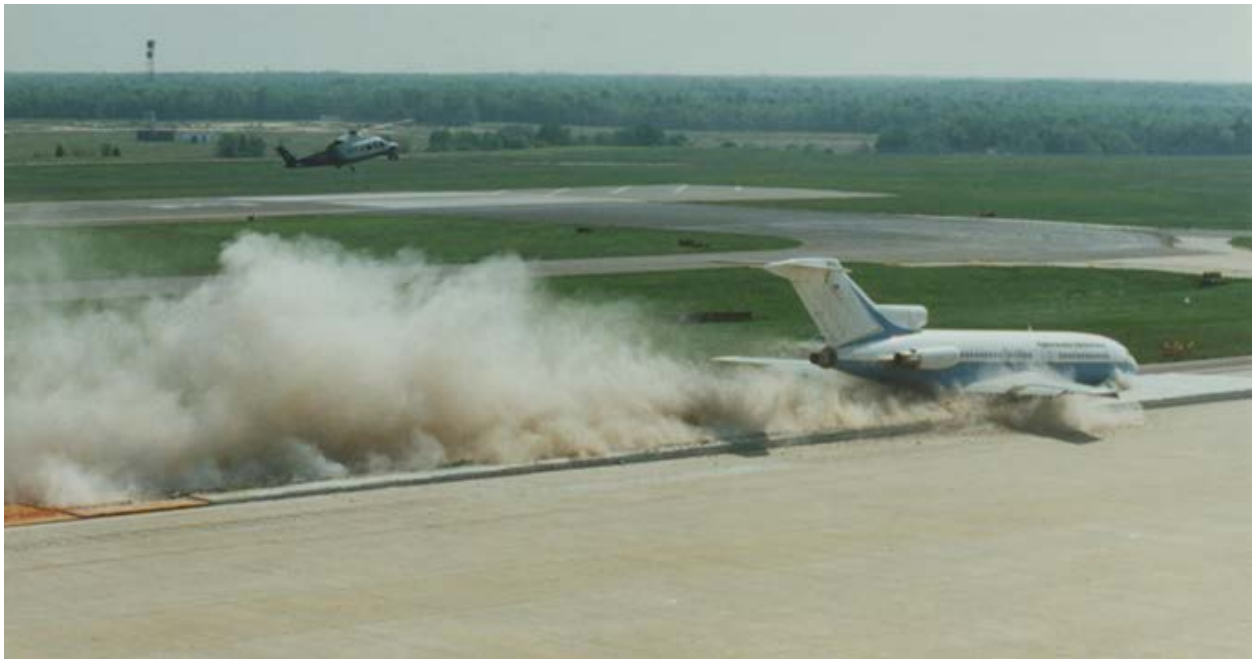
Figure 10. The B-727 Entering Cellular Cement Test Bed at 55 kt

Figure 10 shows the B-727 entering the test bed at 55 kt.

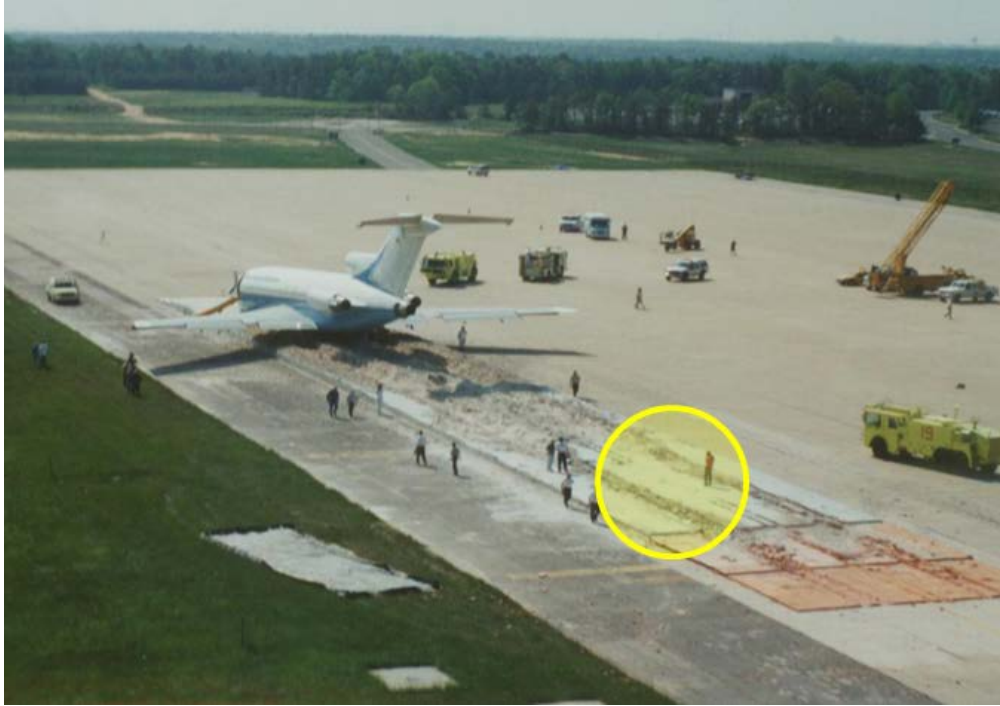
Figure 11. Area Highlighted Shows Where Nose Gear Lifted From Test Bed

As the aircraft entered the test bed, the nose gear lifted briefly and only skimmed the top of the bed. The highlighted area in figure 11 shows where this event occurred. As the nose gear reentered the bed, the nose gear structure rotated aft, and the nose wheel and strut separated from the aircraft. Despite the loss of the nose gear, the aircraft maintained a straight trajectory.

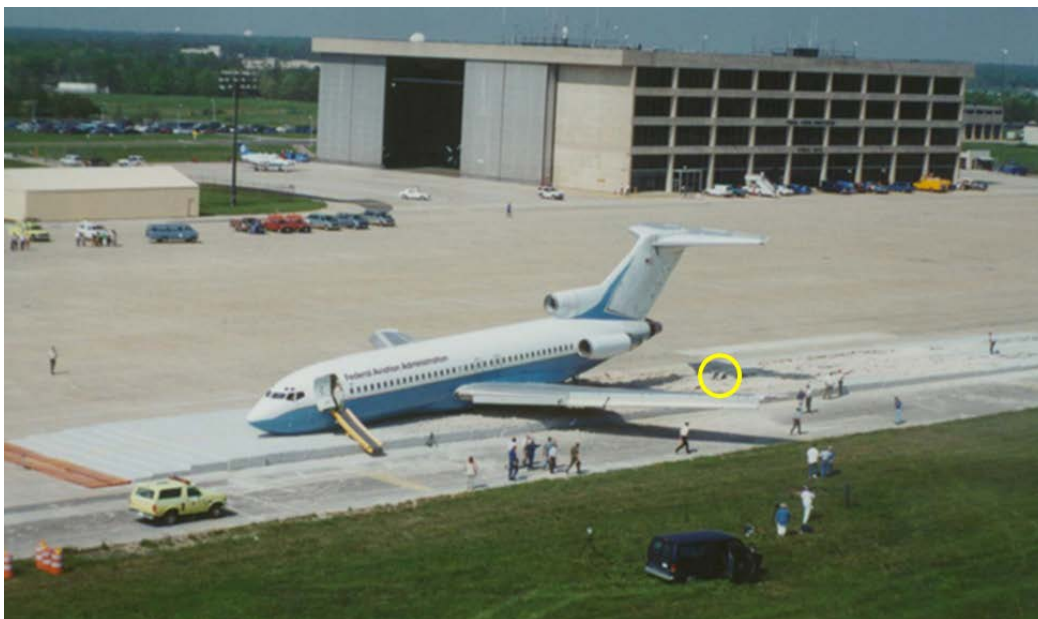
Figure 12. The B-727 Stopped 278 ft Into the Cellular Cement Test Bed

The aircraft came to a stop 278 ft into the test bed. Figure 12 shows the aircraft after it was arrested. The detached nose gear is circled in yellow.

30 ft short of the predicted location. The unexpected nose gear failure was attributed to corrosion cracks in one of the landing gear support fittings; which was not evident prior to the test.

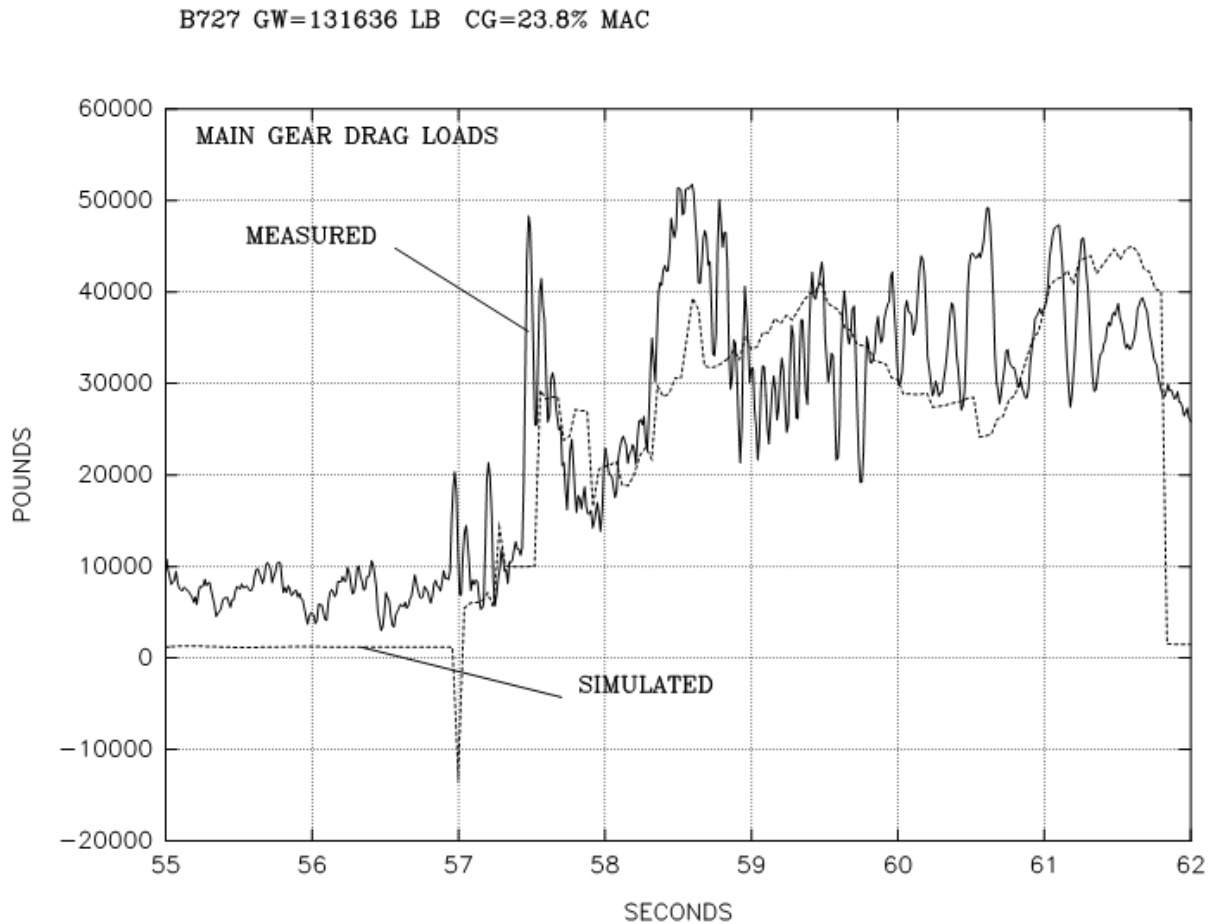
Figure 13. Comparison of Measured and Simulated Main Gear Drag Loads

Comparison of mathematical model simulations and measured results for the main gear only are shown in figures 13 and 14. These graphs compare mathematical model predictions against loads and accelerations measured during the test. Comparisons between the main gear drag loads and main gear vertical loads are shown in figures 13 and 14, respectively.

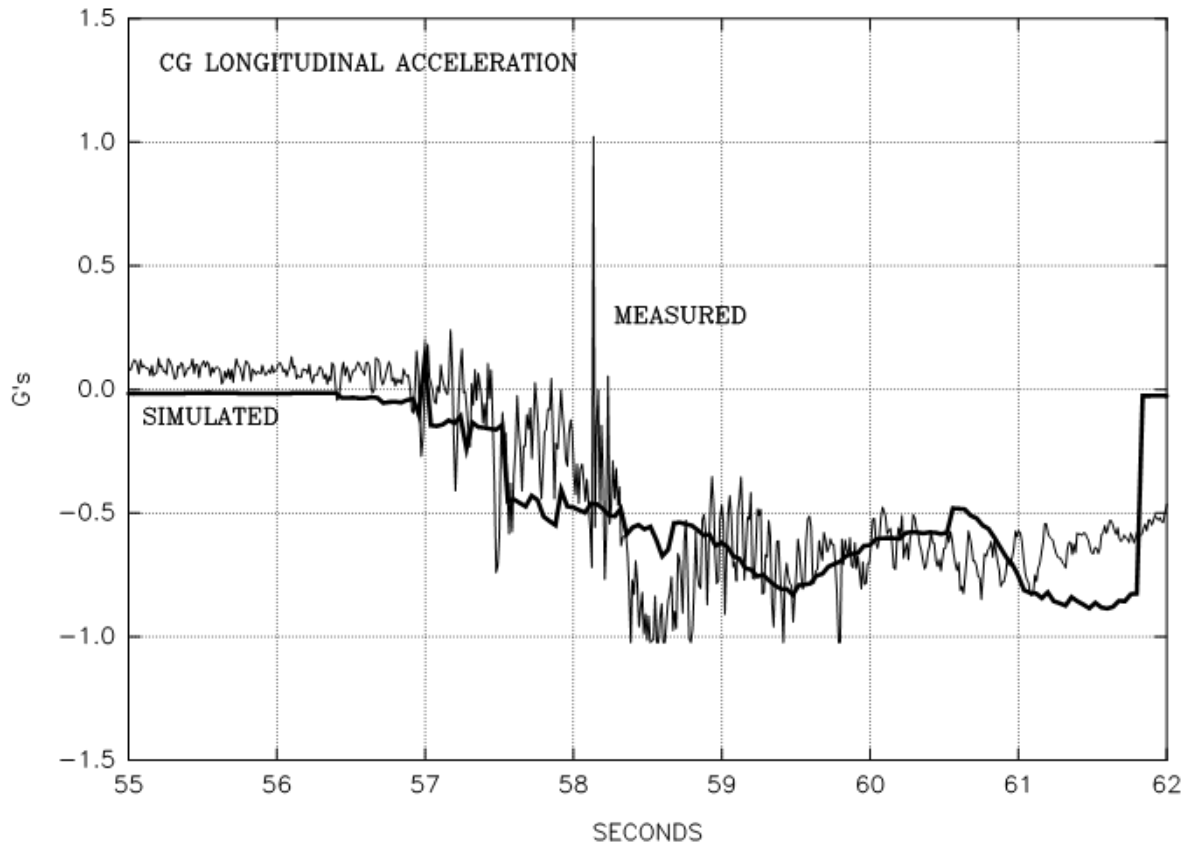
Figure 15. Comparison of Measured and Simulated Longitudinal Accelerations

The measured and simulated CG longitudinal acceleration data in figure 15 compared very well until the nose gear failure. The measured acceleration shows a very high acceleration at 58.2 seconds, indicating a very large forward force. The source of the force was not determined but coincided with the time that the nose gear failed.

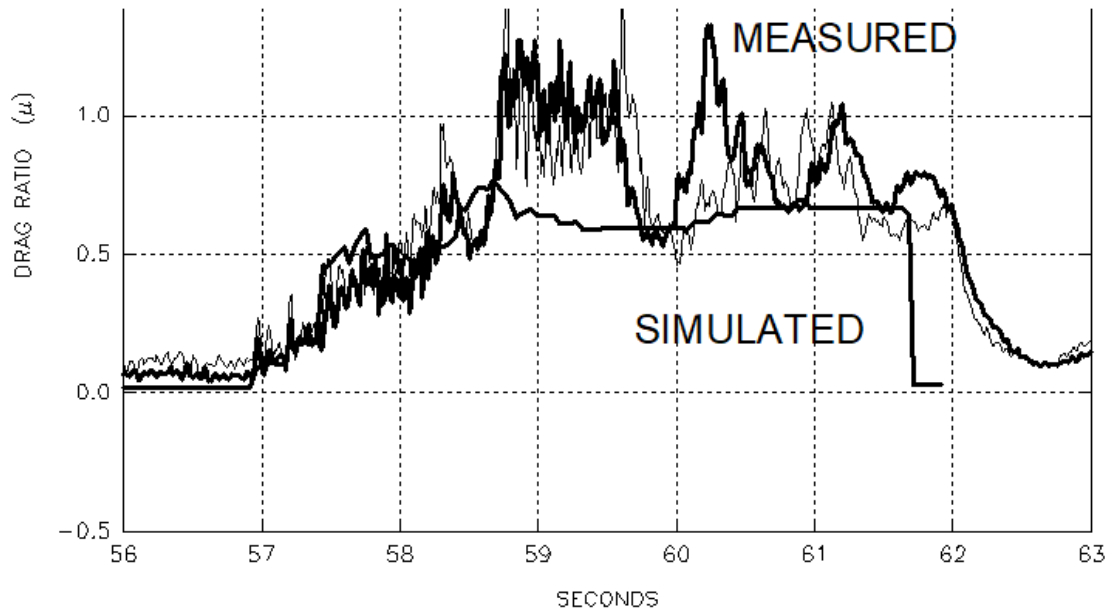
Figure 16. Equivalent Braking Ability in Terms of Mu as a Function of Time

The curves in figure 16 were obtained by dividing the measured main gear drag loads by the vertical main gear loads, the definition of the coefficient of friction or braking ability. The statistical average of the drag ratios was 0.6, as measured and predicted by the simulation.

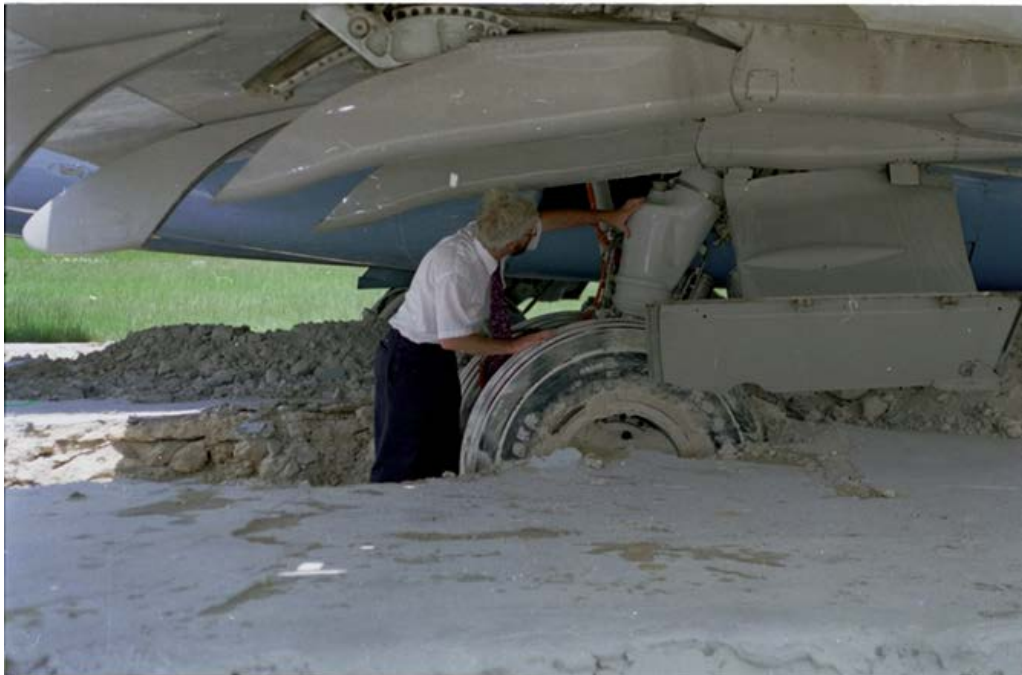
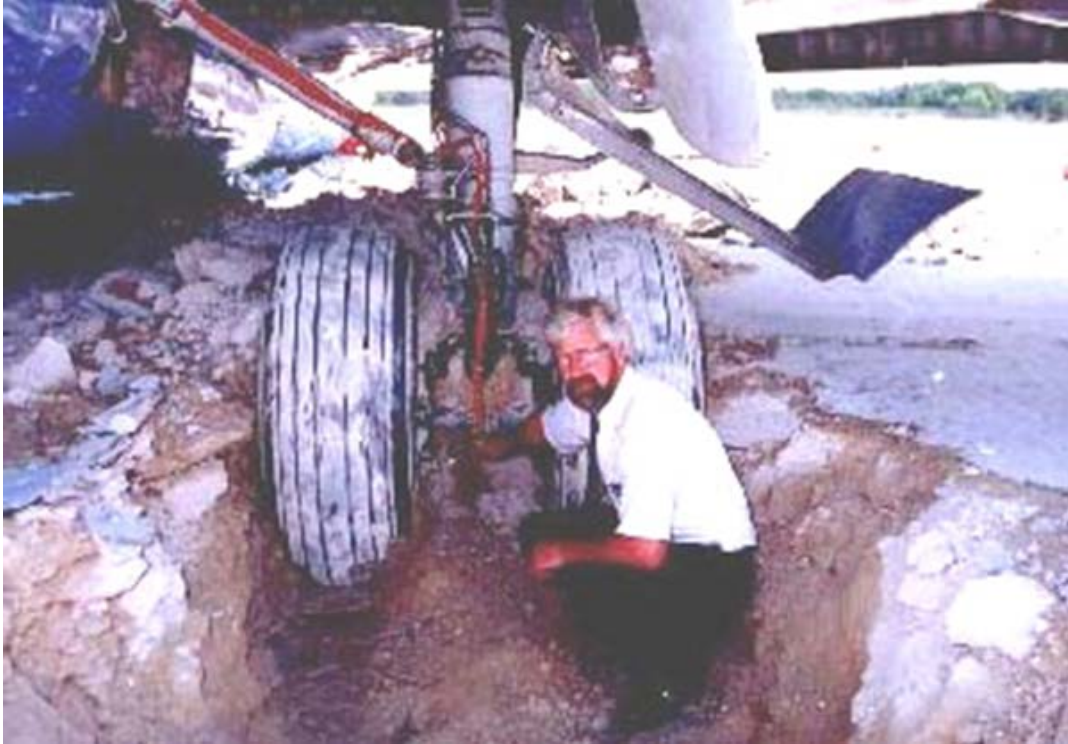
Figures 17 and 18 show an FAA research engineer examining the condition of the right main gear after the ruts were cleared of debris. These figures indicate a full depth compression of the cellular cement material.

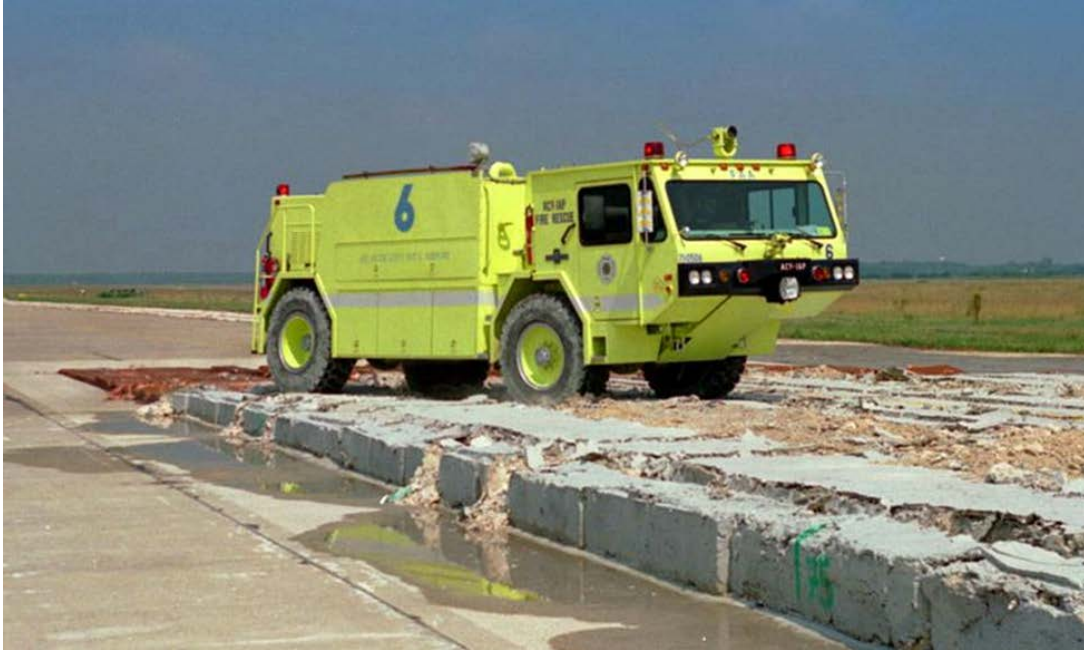
Figure 19. The P-19 ARFF Vehicle Maneuvering in Arrestor Bed

Videotape analysis and interviews with the test vehicle operator indicated that the P-19 ARFF vehicle could enter the arrestor bed and maneuver across the bed without difficulty. Figure 19 shows the P-19 ARFF vehicle traversing the arrestor bed on a diagonal.

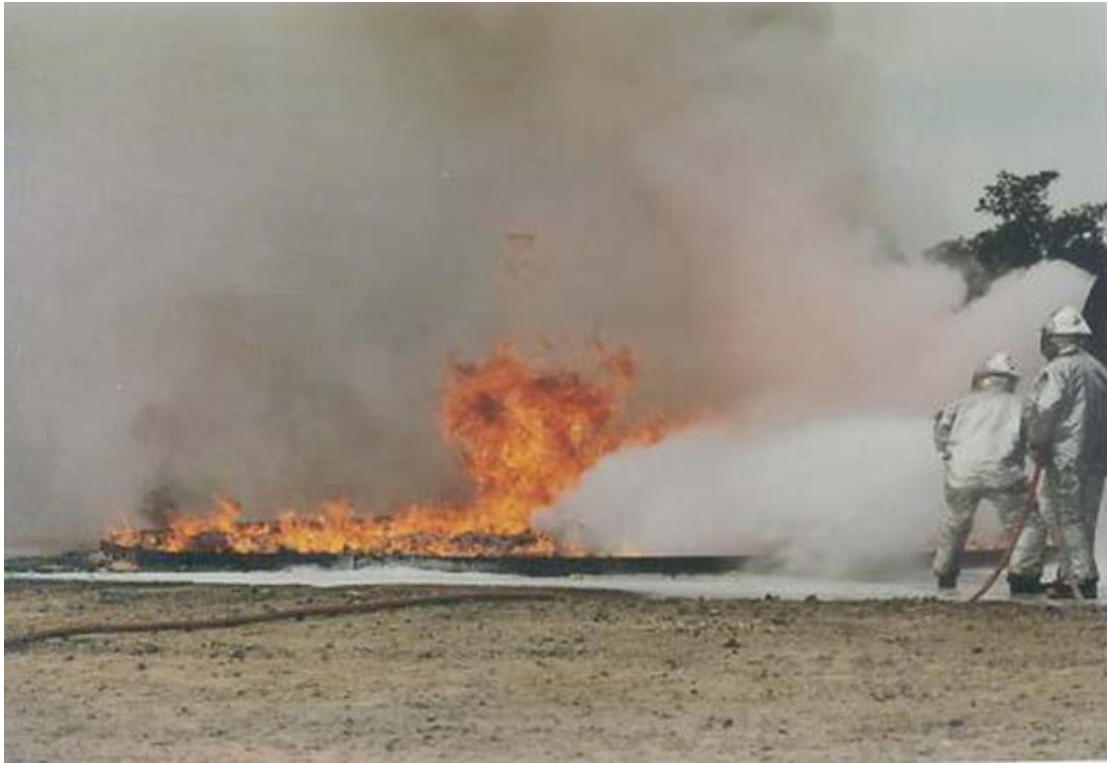
Figure 20. Firefighters Discharging Extinguishing Agent

In April 1997, four medium-scale fire tests were performed by Air Force Research Laboratory's Fire Research Group at the fire test facility located at Tyndall Air Force Base, Florida. The tests conducted within a 30-ft-diameter containment steel ring with 6-in. sides. Two cellular cement blocks, each measuring 8 ft long by 4 ft wide by 2 ft high, were placed in the center steel ring and manually crushed to simulate broken cellular cement from an aircraft arrestment. Each test consisted of dousing the cellular cement in 100 gallons of fuel and igniting a fire. The test objectives were to measure the time and amounts of firefighting agent necessary to extinguish a fire in cellular cement. Figure 20 shows firefighters discharging agent during a fire test. After each test, the containment ring was cleared and another test was conducted using new cellular cement material.

Video cameras recorded the fire tests from two perspectives, northerly and westerly views. The footage was timecoded and analyzed to provide extinguishment times and determine amounts of agents used. The westerly view faced the backs of the firefighters, and the northerly view faced right angles to the firefighters. The northerly view provided better visual information regarding flame extinguishment.

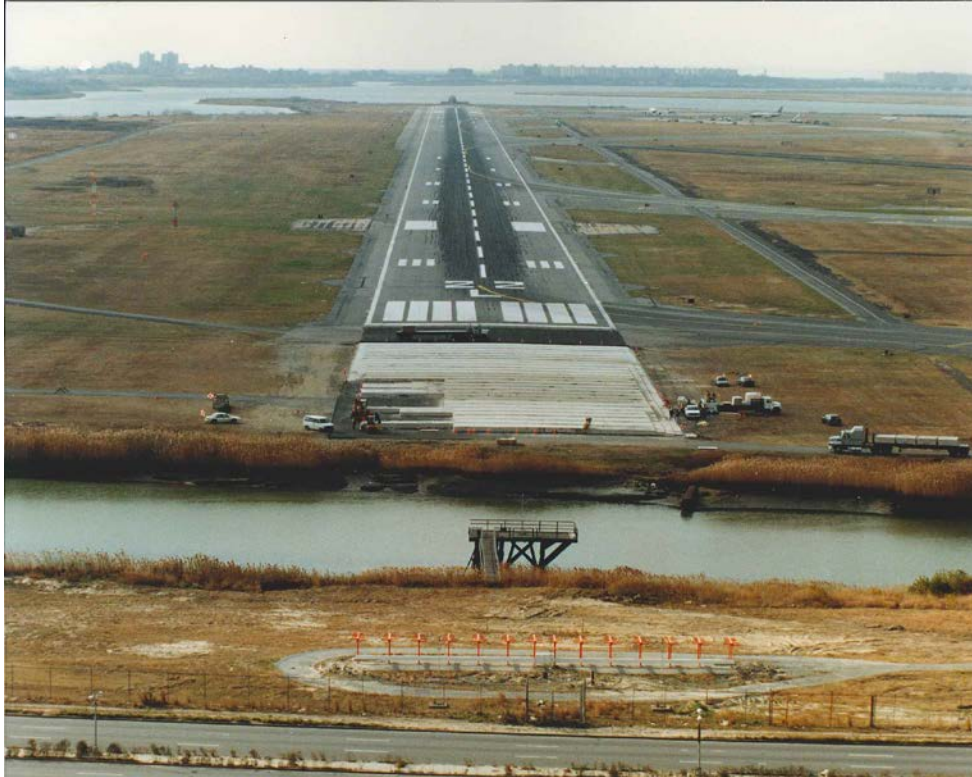
Figure 21. The EMAS Prototype Serving JFK Runway 4R

The PANY&NJ funded the final design and installation of the EMAS prototype for JFK Runway 4R. They selected ESCO as the designer and supplier for all materials. The PANY&NJ selected a separate firm to provide construction management and a general contractor for installation. Figure 21 shows the construction at JFK with Thurston Basin and the localizer in the foreground. EMAS construction was completed in November 1996. The onset of cold weather precluded the application of an elastomeric coating to the top of the system until the spring of 1997. As a result, the cellular cement material was exposed to the elements and absorbed significant amounts of water. Planned moisture-monitoring efforts were judged to be of limited value and cancelled. The PANY&NJ and ESCO expended substantial effort to maintain the top surface of the arrestor system. It proved very difficult to adhere protective sealants to the surface.

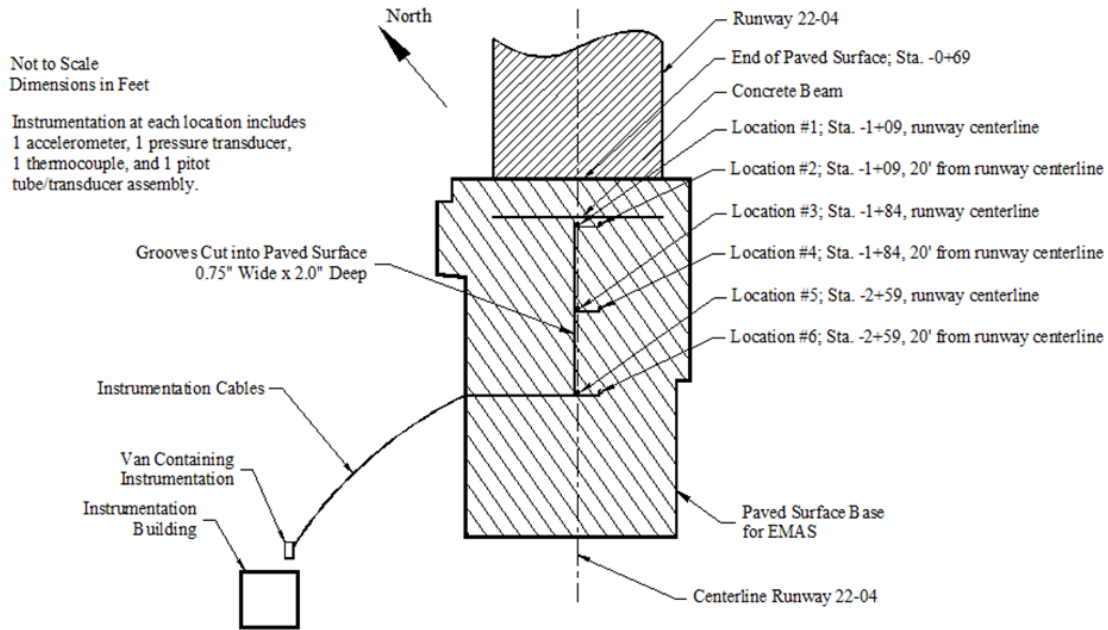
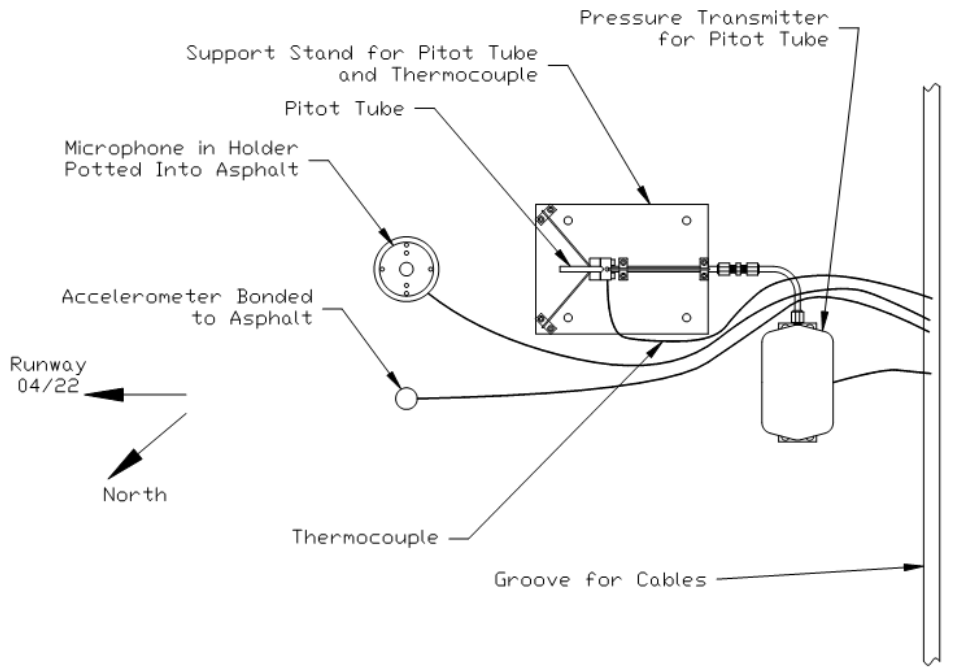
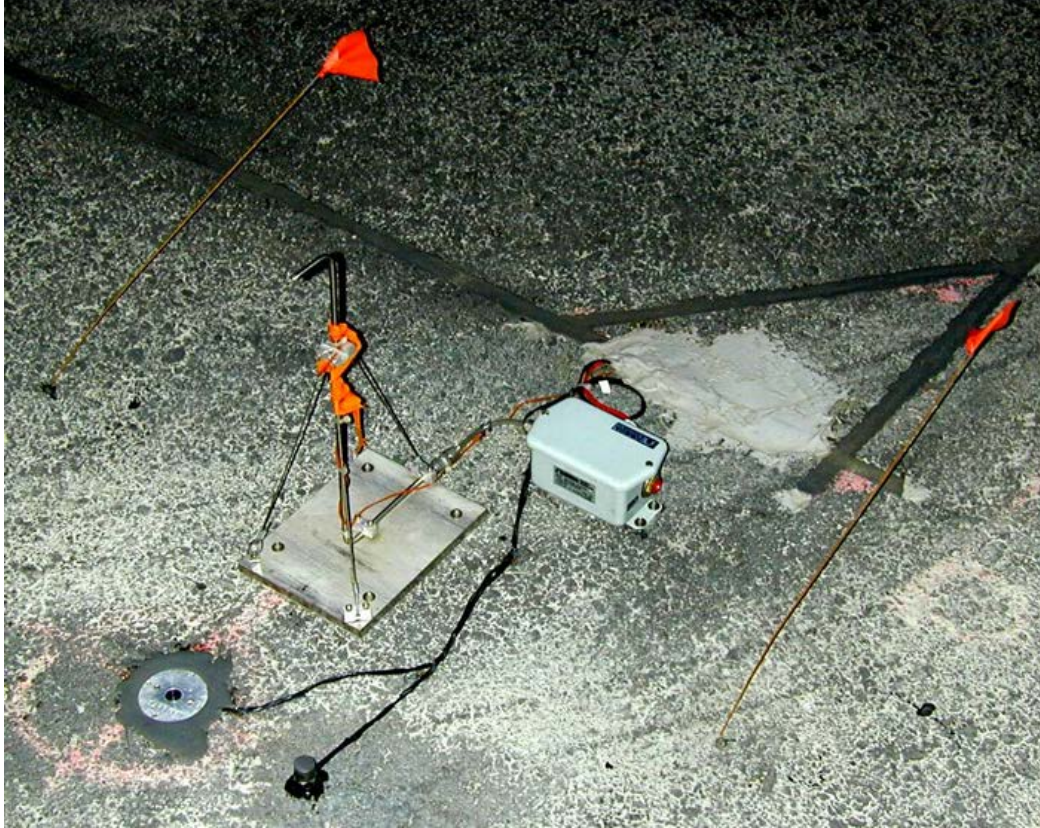
UDRI installed instrumentation packages in six locations end of LGA Runway 22. Figure 23 shows the general layout of the instrumentation, figure 24 shows a schematic of each measurement station, and figure 25 is a photograph of a typical measurement station.

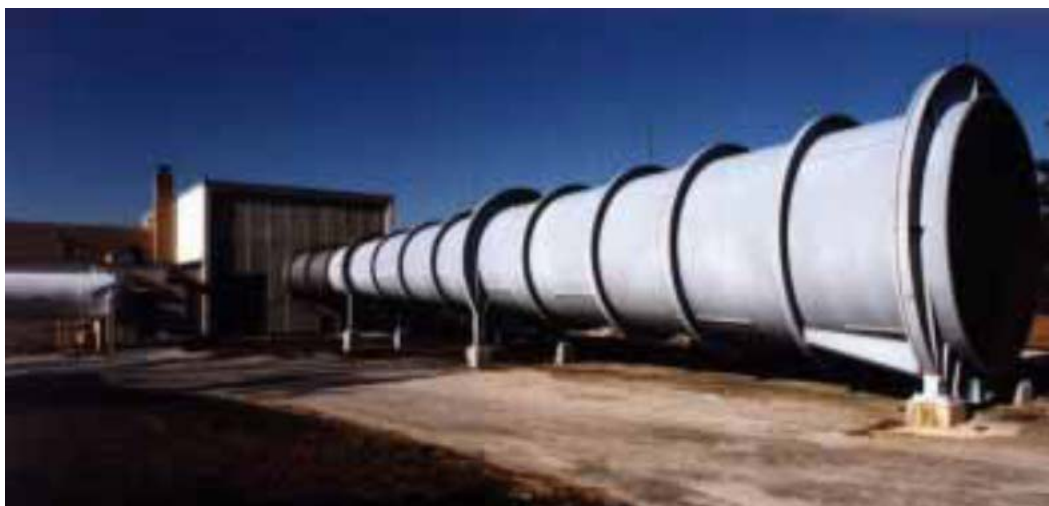
Figure 26. The Wind Tunnel at the WJHTC Airflow Induction Test Facility

The main component of the WJHTC Airflow Induction Test Facility is a wind tunnel powered by two Pratt & Whitney® J-57 turbine engines exhausting into the diffuser cone of the facility. The high-speed exhaust provides the primary flow that induces a secondary flow through the test sections that can approach 0.9 Mach. At the exhaust end of the tunnel, winds speeds are much lower, but they include sound pressure waves, particulate matter, and heat not found on the induction side of the facility. As a result, the exhaust end of the tunnel replicates jet blast conditions near the departure end of a runway. Figure 26 shows the exhaust end of the WJHTC Airflow Induction Test Facility wind tunnel.

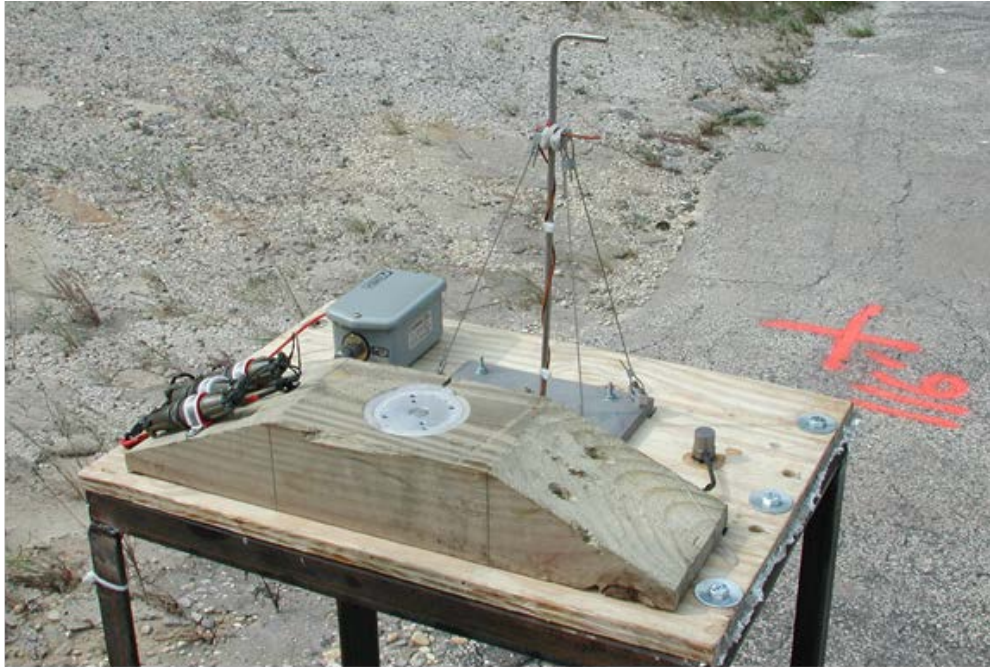
Figure 28. Instrumentation Package Mounted on a 36-in.-High Metal Stand Behind the Wind Tunnel

The instrumentation mounting system resulted in wind speed measurements 16 in. above ground, temperature measurements 12 in. above ground, and sound pressure measurements 4 in. above ground. Vibration measurements were also made with an accelerometer mounted directly to plywood. These accelerations are indicative of the plywood motion rather than the ground vibration. Higher elevation measurements were taken with the plywood base mounted to a 36-in.-high metal stand (figure 28), thus increasing the elevation of all measurements by 36 in.

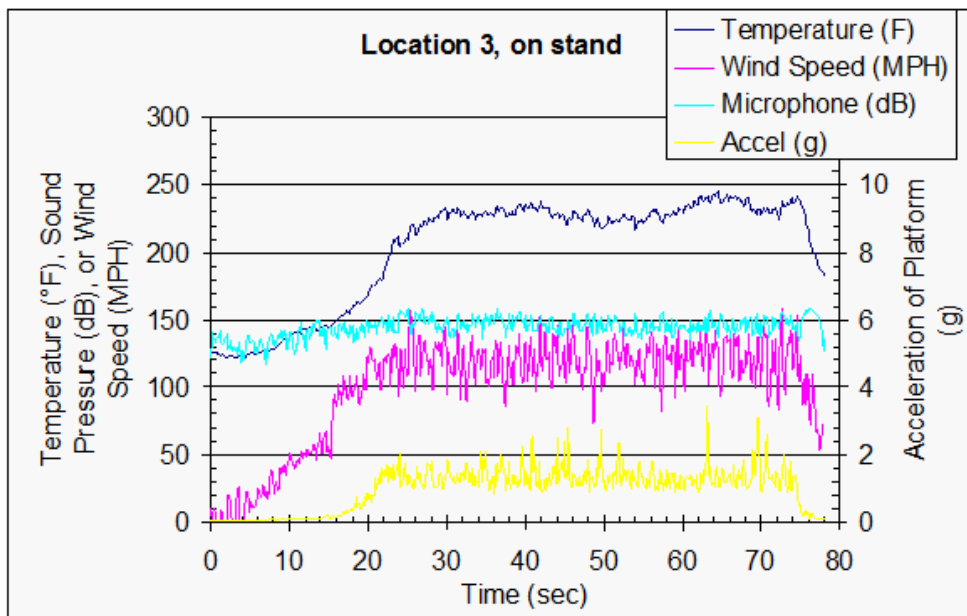
Figure 29. Data Showing Run-up From Idle to Full Power and 45-Second Hold at Full Power

The data showed that wind speed and sound pressures behind the wind tunnel, particularly at locations 1 and 3 on the elevated stand, were reasonably comparable for testing purposes with conditions measured at LGA. Figure 29 shows the data set collected at location 3 on the elevated stand.

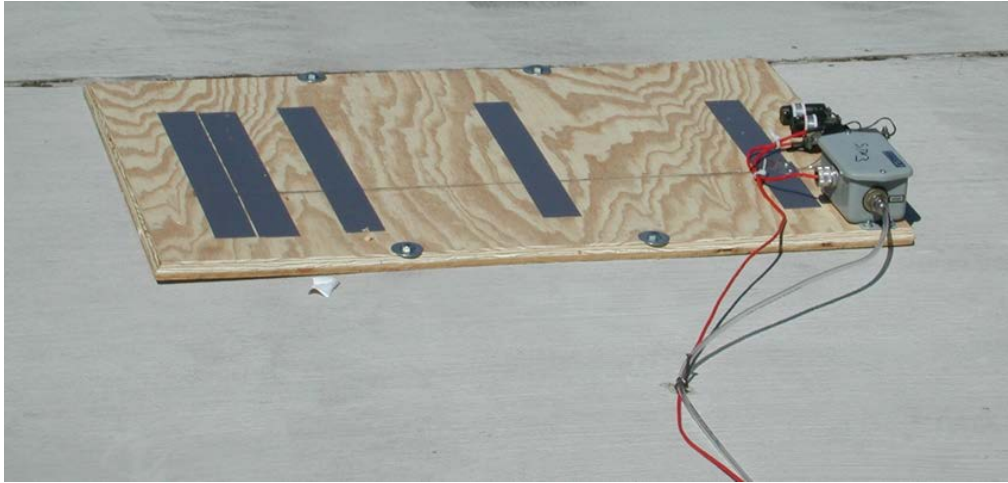
Figure 30. Uplift Pressure Sensor on Elevated Platform

Test results from the initial wind tunnel test led ESCO personnel to construct an elevated concrete platform behind the wind tunnel at a location and elevation where jet blast conditions most closely resembled those measured at LGA. UDRI personnel installed data acquisition packages similar to previous testing at three locations on the elevated platform. Figure 30 shows the uplift pressure sensor.

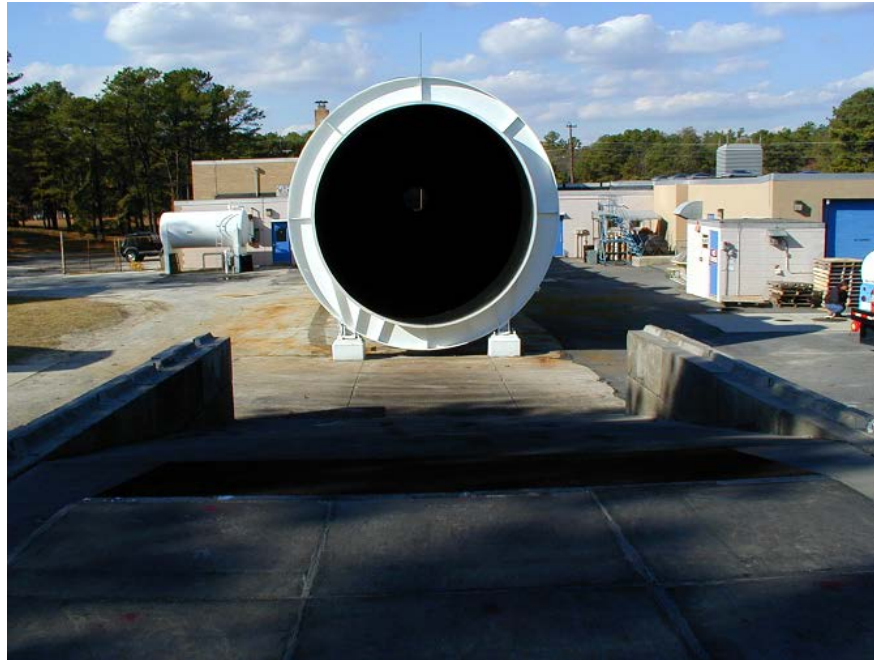
Figure 31. View From Top of Platform Facing Into Exhaust End of the Wind Tunnel

In November 2000, ESCO personnel installed a 12 ft by 12 ft JBR system behind the wind tunnel. Figure 31 shows the location of the first two of three rows of blocks on the elevated platform.

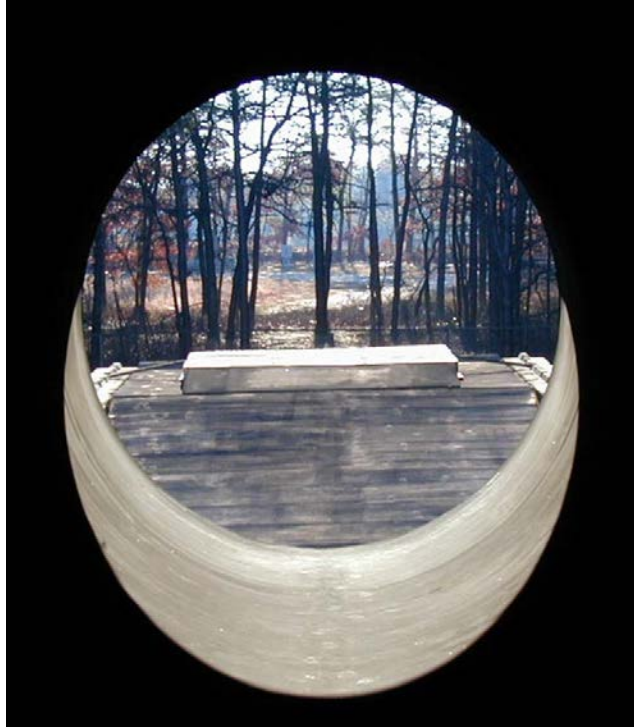
Figure 32. View From Inside the Wind Tunnel Facing the Platform With JBR Test Bed

Figure 32 shows a view from inside the wind tunnel facing the raised platform and the JBR EMAS test bed.

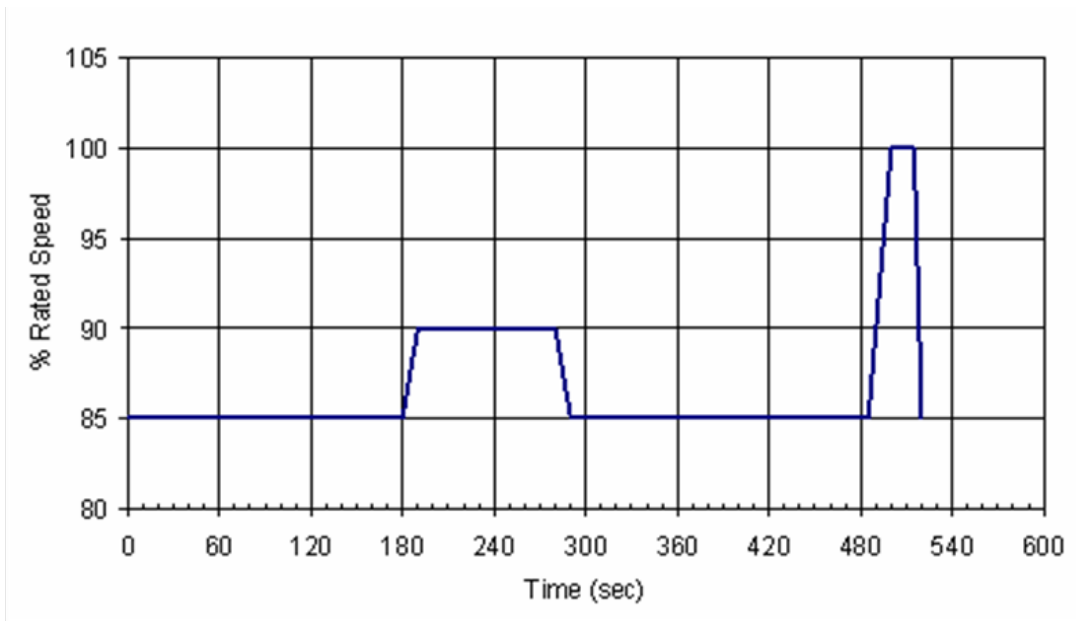
Figure 33. Wind Tunnel Testing Profile for a 75-ft Setback

FAA and ESCO personnel selected a wind tunnel power-setting plan to simulate LGA jet blast conditions with a 75-ft setback. Figure 33 shows the wind tunnel power setting as a function of time.

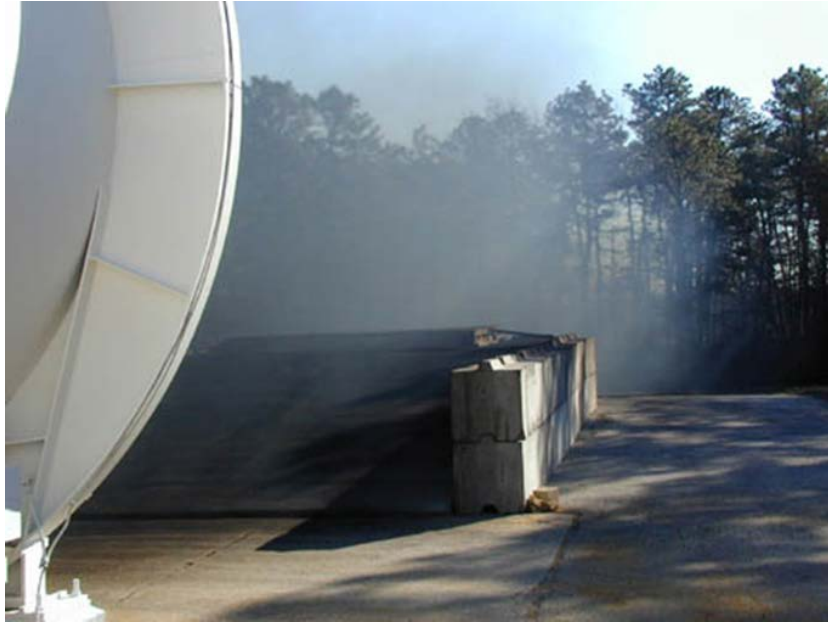
Figure 34. Wind Tunnel Jet Blast at 100% Rated Speed

Between November 16 and November 30, 2000, FAA personnel exposed the test bed to a series of 14 cycles, which was equivalent to 1 year of LGA jet blast. Figure 34 shows one cycle of jet blast testing at the wind tunnel at 100% rated speed. Inspection of the test bed during and after the series of tests indicated the JBR system resisted blast forces without displacement or damage.
