**DOT/FAA/TC-18/18**

# **Development of Engineered Materials Arresting Systems From 1994 Through 2003**

May 2018

Final Report

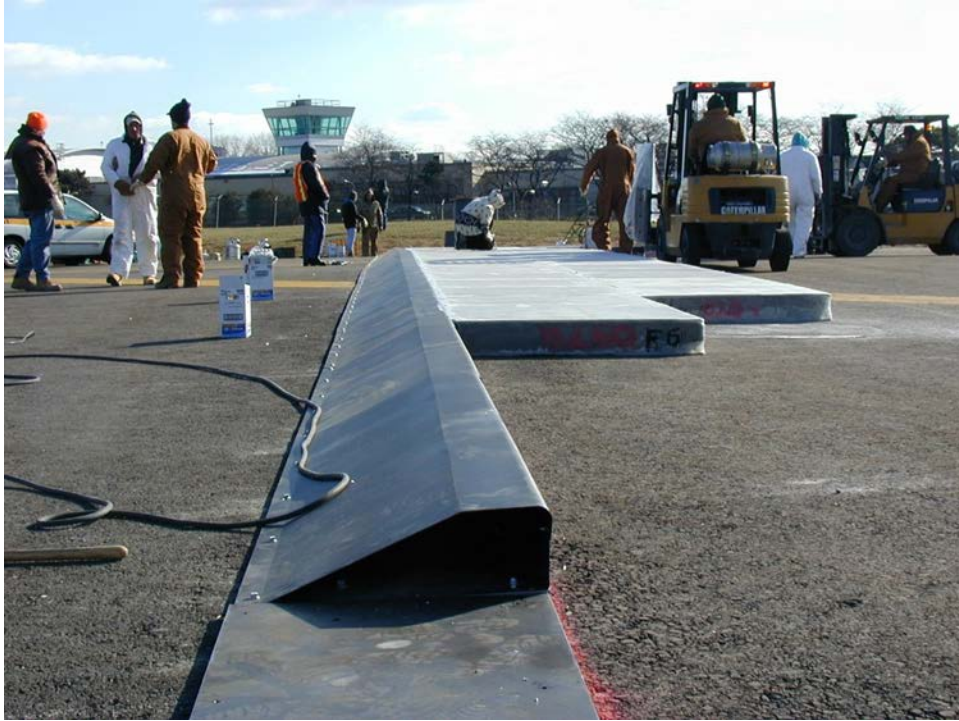
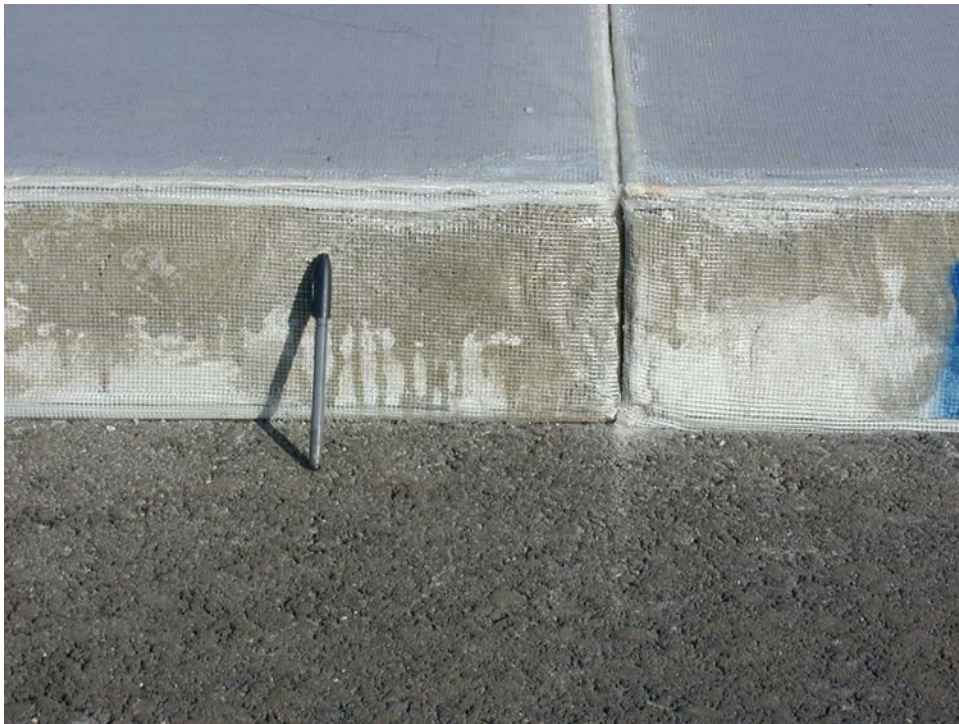
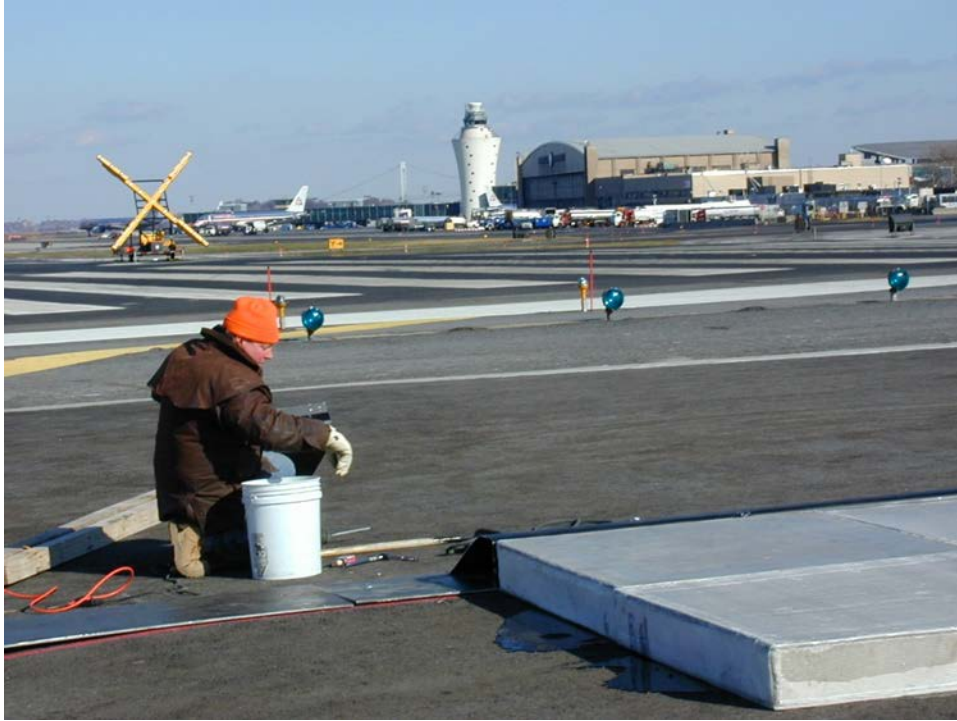
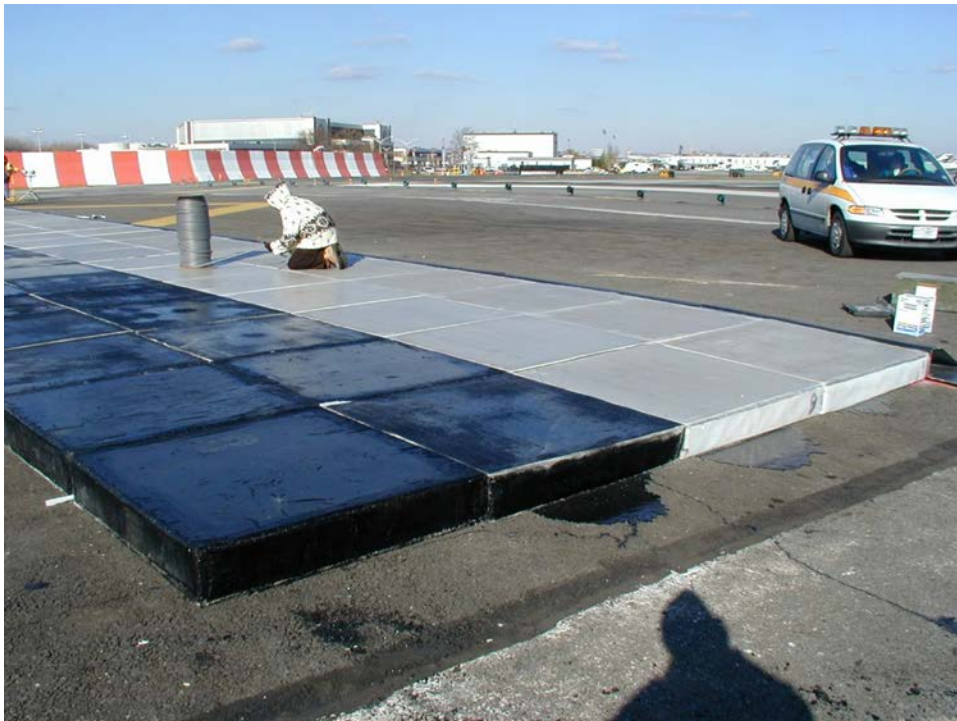
On December 9, 2000, ESCO personnel installed four rows of JBR blocks across the overrun area for LGA Runway 22. Each row was 148 ft across with a nominal 8 in. height. The first row started 75 ft from the departure end of Runway 4. The leading edge was protected by a metal debris deflector. The tops of the blocks in the first two rows were sealed with polyurethane, and the third and fourth rows were sealed with an asphalt-based coating. All blocks were adhered to the base with hot asphalt. All joints were filled with backer rod and caulk. Figures 35 through 38 show the installation sequence.

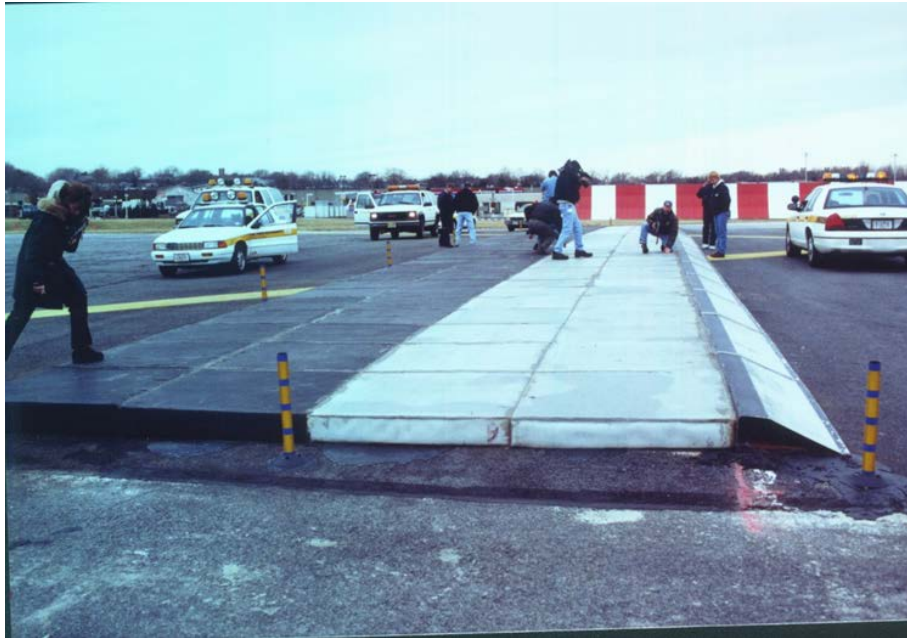
Figure 39. Visual Inspection of JBR Demonstration Blocks

On February 15, 2001, ATRD personnel conducted a site visit to the demonstration bed. Visual and tactile inspection indicated the blocks were in sound condition. There was no evidence of displacement, delamination, or loose blocks. The coating system appeared intact. The paint on the debris deflector shield was worn away in several locations. Figure 39 shows the condition of the blocks after more than 2 months of exposure to Runway 4 traffic. Figure 40 shows a view from behind the Runway 22 localizer as an aircraft departs Runway 4.

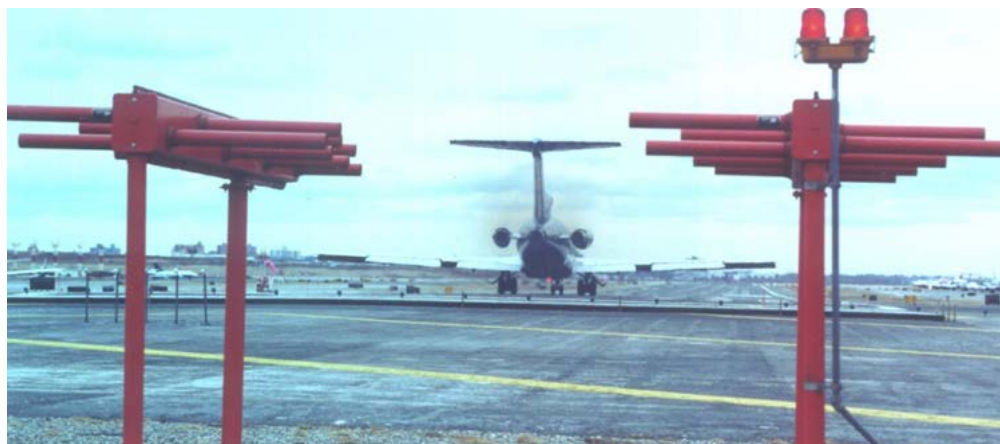
Figure 40. Dark Horizontal Strip is the Rear Face of the JBR Demonstration Bed (Runway 22 localizer is in the foreground.)

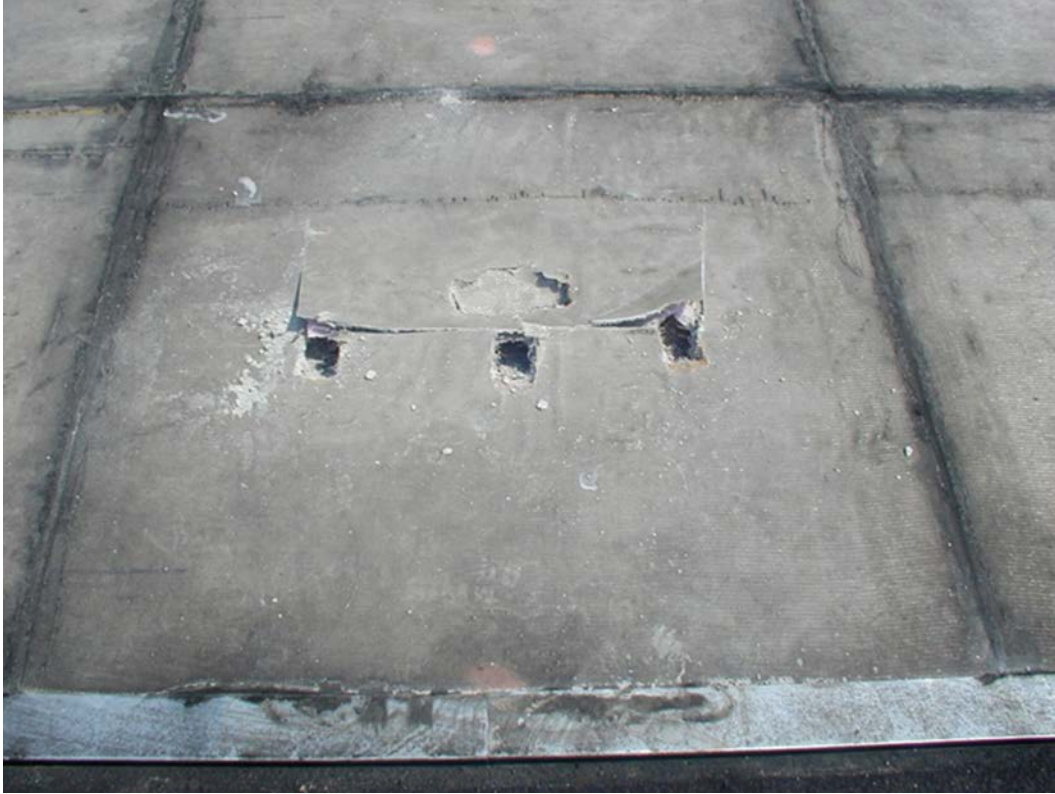
Figure 42. Intentional Damage to JBR System

In May 2001, FAA and ESCO personnel intentionally damaged JBR blocks and exposed these sections to maximum jet blast for 5 minutes. The objective was to categorize the modes of failure of the damaged test bed under severe conditions. Figure 42 shows the damaged sections that included surface punctures and saw cuts at different angles through the JBR surface material. Figure 43 shows removal of a full-depth section of the test bed.

After 5 minutes of jet blast testing, video documentation confirmed that the JBR blocks were not susceptible to a domino effect mode of failure. The surface punctures did not increase in size, but the loose material was merely blown out. The saw cuts did not lead to surface separations at the cuts. The section that was removed did experience some removal of additional loose material, but the adjacent blocks remained intact. The test concluded that if the JBR system does sustain damage in an operation setting that there is limited risk that portions of the bed will break loose and pose collateral damage as FOD.

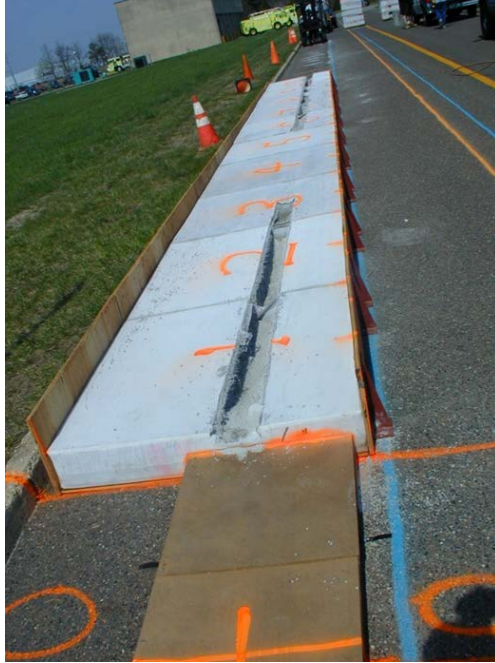
Figure 44. Wheel Ruts From the Small-Wheel Test Through the JBR Blocks

During the first test, at 15 kt, the wheel entered the leading edge of the bed and crushed the top layer of the JBR coating without difficulty. The wheel bounced three times within the bed before exiting it. Figure 44 shows the wheel ruts from the small-wheel test through the JBR blocks. The back half of the bed had been removed, and the photograph does not show the other two sections where the wheel bounced out of the bed.

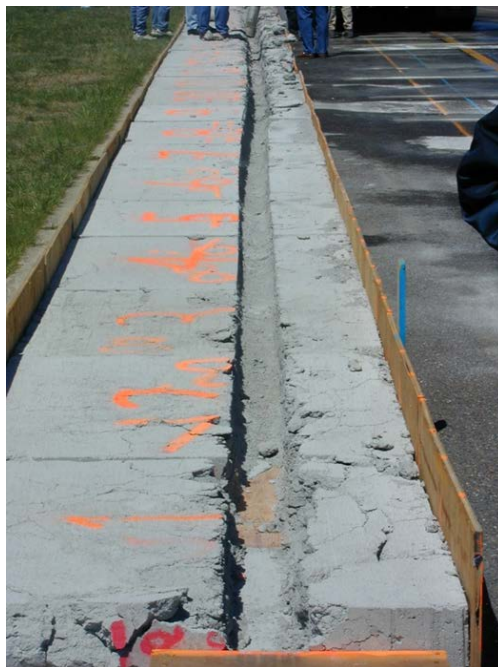
Figure 45. Wheel Ruts From the Small-Wheel Test Through the Non-JBR Blocks

The second test, at 30 kt, tested the same setup and configuration as the first test, but this time used non-JBR-coated cellular cement blocks. The wheel bounced slightly as it entered the bed, but not enough to raise the wheel out of the bed. Figure 45 shows that the wheel stayed in the bed for the full 100 ft.

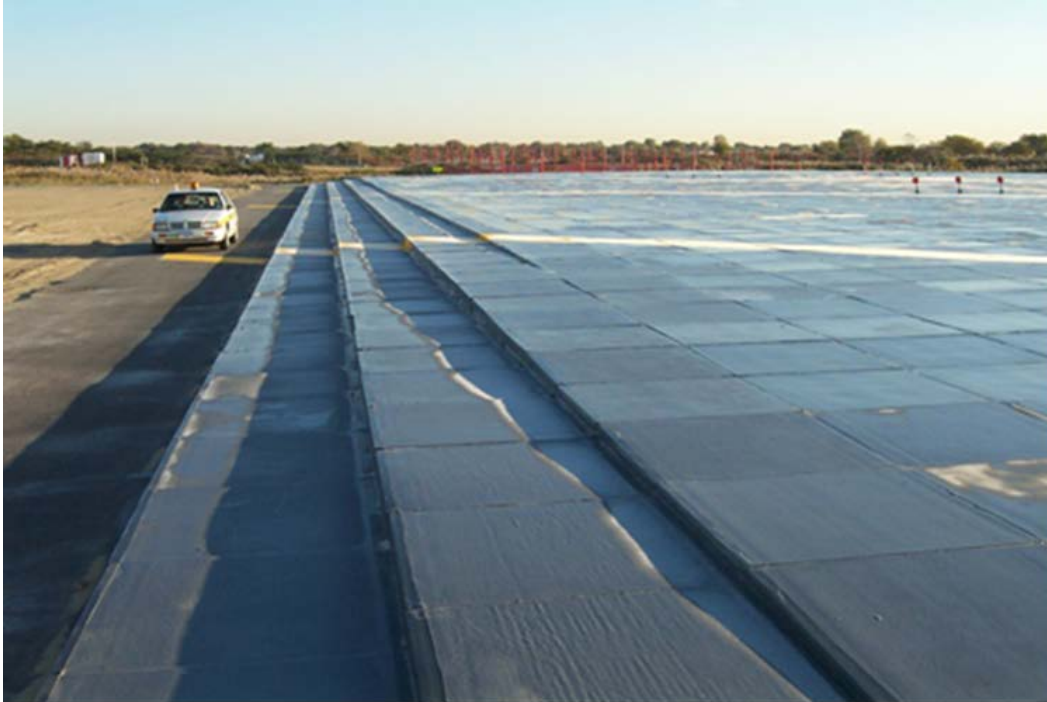
Figure 46. The JBR EMAS Replacement at JFK

By 2002, the EMAS maintenance had become very expensive and time consuming. In addition, loose pieces of arrestor system material posed an increasing FOD risk. The PANY&NJ personnel decided to replace the EMAS to coincide with the decision to widen JFK Runway 4R/22L from 150 ft wide to 200 ft wide. The new EMAS would be expanded to cover the full 200-ft-width and use the newly developed and tested JBR blocks with factory-applied moisture protection. The new EMAS construction started in July 2002 and was completed in September 2002. Figure 46 shows the completed JBR EMAS replacement at JFK.

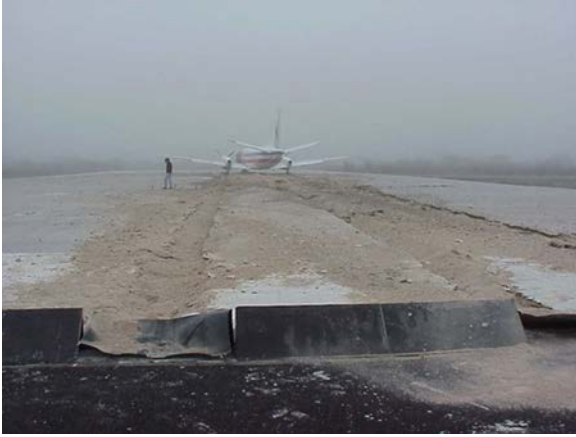
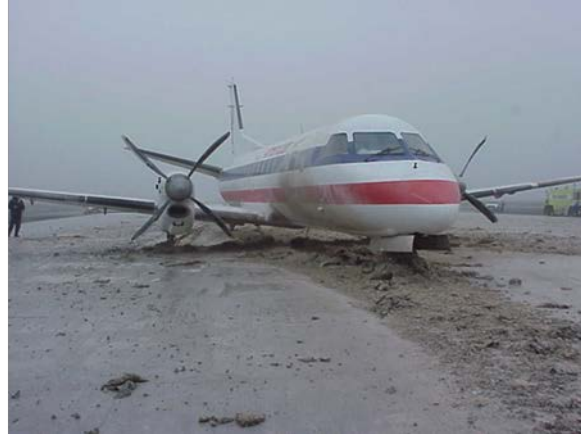
Figure 47. Saab 340B Aircraft in JFK Runway 4R EMAS

On May 8, 1999, a Saab 340B landed long on JFK Runway 4R. The aircraft touched down at a speed of 157 kt with only 1400 ft of remaining runway. The pilot applied reverse thrust and maximum braking but traveled off the end of the runway and entered the EMAS at 75 kt. The aircraft traveled approximately 248 ft into the 400 ft-long EMAS. Figure 47(a) shows the crushed debris deflector, crushed cellular cement, and three sets of wheel ruts that trace the path of the aircraft. Figure 47(b) also shows the nose gear fully penetrating the 30-in.-deep EMAS. The aircraft sustained minimal damage to the nose gear, fuselage, and propellers. Twenty seven passengers and three crew members were unharmed, and one passenger was injured exiting the aircraft. The NTSB concluded that without the EMAS, the aircraft would have traveled 500 to 1000 ft beyond the end of Runway 4R and likely entered Thurston Basin, the site of the 1984 DC-10 overrun accident [9]. The PANY&NJ personnel extracted the aircraft and repaired the EMAS.

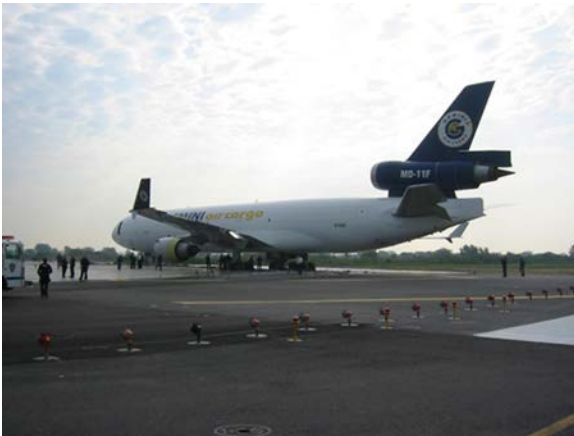
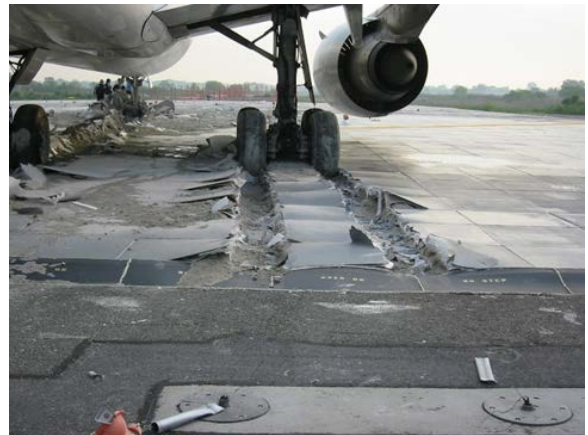
Figure 49. The MD-11F Overrun at JFK Runway 4R

On May 30, 2003, an MD-11F overran JFK Runway 4R after landing. Figures 49(a) and (b) shows the final location of the aircraft relative to the end of the runway. These photographs show the mode of failure of the JBR EMAS. The nose gear of the aircraft traveled 115 ft into the EMAS, and the main gear traveled 35 ft into the system. The nose gear entered the EMAS in a yaw position, while the gear rolled through the system under a braking action condition. There were no reported injuries to the two crew members. Five main gear tires and the right nose gear tire were damaged as well as several threshold light fixtures. The PANY&NJ personnel repaired the EMAS following the accident.
