**DOT/FAA/TC-18/51**

# **Non-Destructive Evaluation Methods for Detecting Major Damage in Internal Composite Structural Components**

February 2019

Final Report

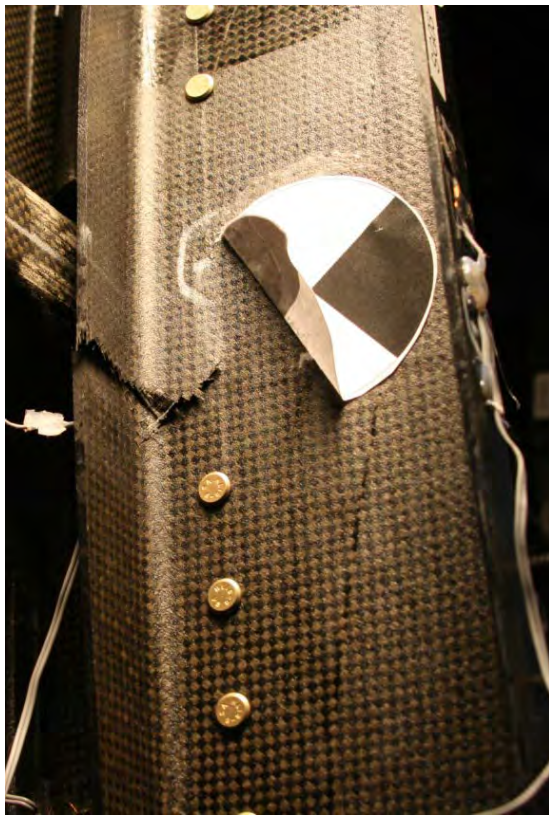
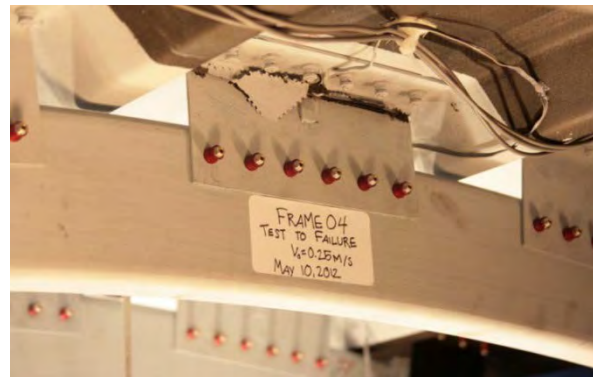
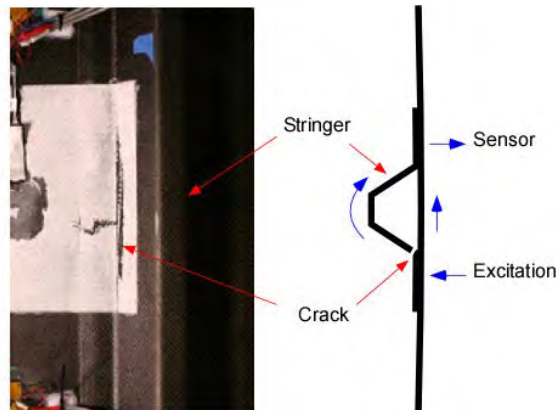
**Figure 1. Internal damage modes of interest: (a) cracked frame developed in UC San Diego blunt impact specimen frame02, (b) crushed shear tie, and (c) stringer heel cracks**

Composite panels were fabricated using Cytec X840/Z60 12k unidirectional tape and X840/Z60 6k plain weave fabric prepreg materials with ply layups, as listed in Table 1. All parts were laid up by hand at UC San Diego and were autoclave cured at San Diego Composites under a 176.7°C cure temperature. Panels were quasi-statically or dynamically loaded to induce different types of damage from various impact cases. A few of the major damage modes generated are shown in Figure 1.

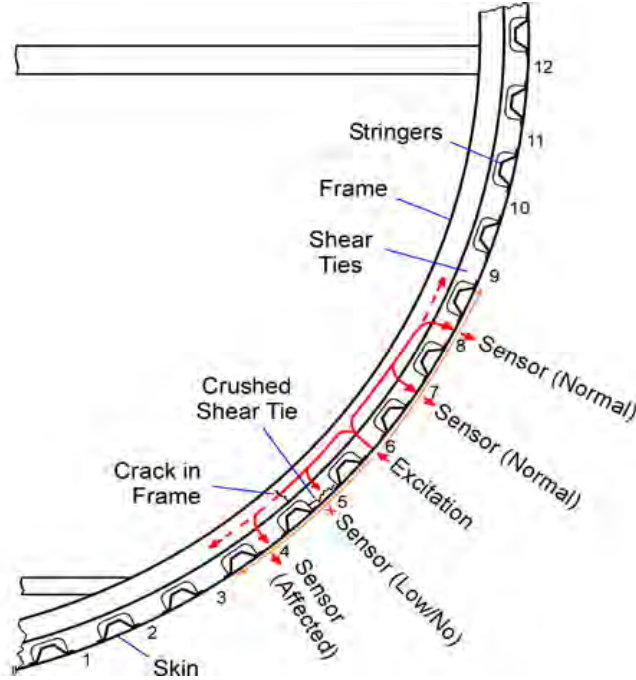
**Figure 4. Schematic of pitch-catch approach from outside only**

Because of the practical requirement of one-sided external inspection and of wide-area coverage, a pitch-catch approach was chosen for the ability of UGWs to penetrate through the structure's multiple joined parts. As Figure 4 shows, an ultrasonic actuator sends the excitation from the outside skin, and the excited wave propagates through the different components and travels back into the skin where it can be collected from an ultrasonic sensor. The received signal contains information about the overall stiffness and structural integrity of the specimen it traveled through; therefore, energy and time-related characteristics can be extracted and interpreted for the inspection of the covered area.

For the pitch-catch detecting method shown in Figure 4, the frequency range below 200 kHz was experimentally determined to deliver strong wave transmission through the panel for the distance of 305 mm between the actuator and the receiver. Frequency sweep tests below 200 kHz were performed on each subcomponent of the panel, specifically C-frames and shear ties, to study changes in UGW data output when waves propagate through damaged components in comparison to pristine components.

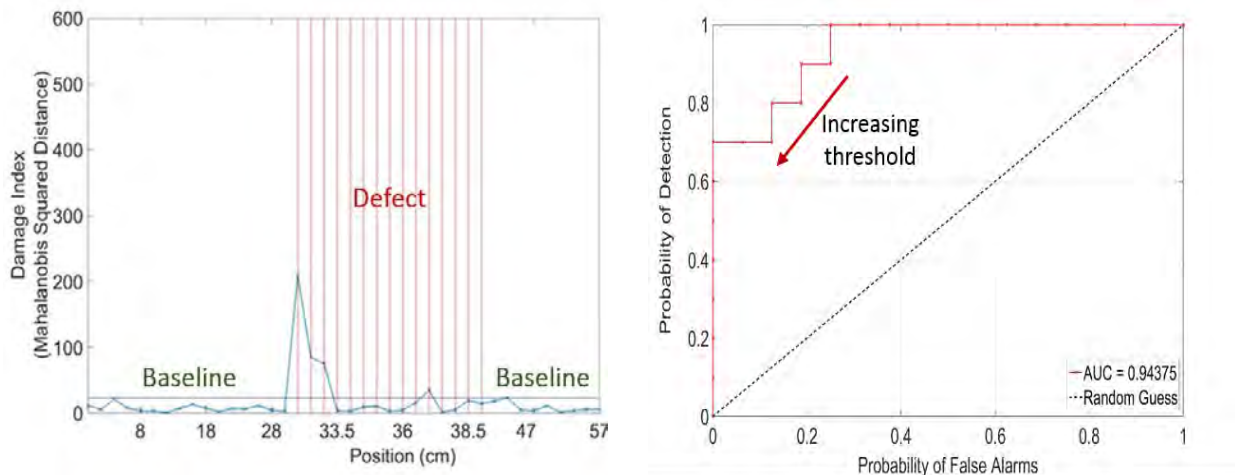
**Figure 6. Schematic of damage detection analysis: (a) DI plot and (b) ROC curve**

Finally, the damage detection performance of the technique needs to be assessed. For this purpose, receiving operating characteristics (ROC) curves (see Figure 6b) were computed for a quantitative evaluation of the technique, and a practical metric for the user to understand and choose the achievable tradeoff in the damage-detection phase, and to further assist in the decision-making process. For each defect type, at varying DI thresholds, the probability of detection (POD) was computed as a function of the probability of false alarms (PFA). A ROC curve located in the top left corner of the plot and an area under the curve very close to 1 are indicative of a good detection performance. A 1:1 slope line in the ROC graph indicates a random guess.

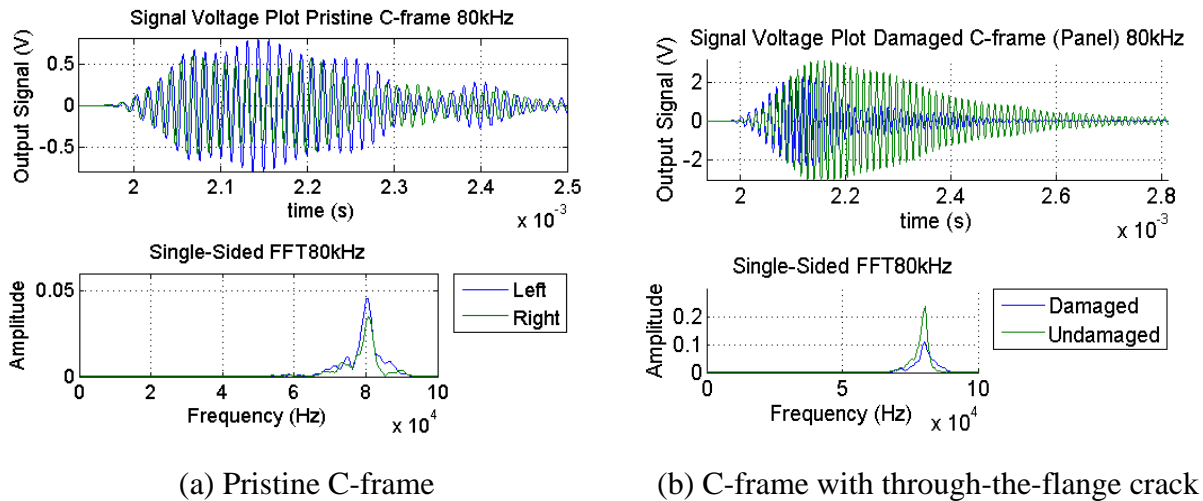
**Figure 8. Initial C-frame UGW test result comparison: (a) pristine C-frame and (b) C-frame with through-the-flange crack**

For excitation, a five-cycle Hanning windowed sine tone burst signal was generated through a built-in Arbitrary Waveform Generator on the PicoScope 4824. The Piezo Linear Amplifier amplified the excitation signal, and the received signals were averaged for an improved signal-to-noise ratio. Experimental results in Figure 8a show a small variance in left versus right measurements for the pristine C-frame due to the splice joined layout in the C-frame. Figure 8b shows a much more noticeable difference in FFT amplitude due to significant attenuation in UGW of nearly 55% when the wave interacts with the flange damage on the C-frame (see Figure 7b).

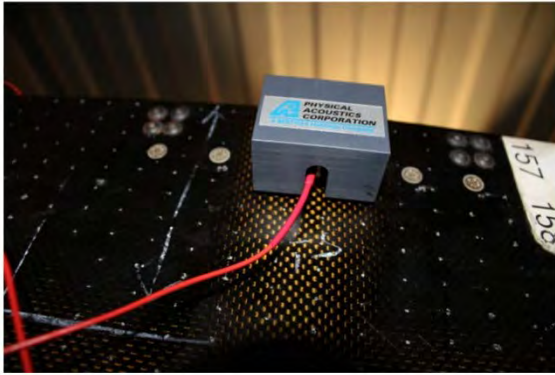
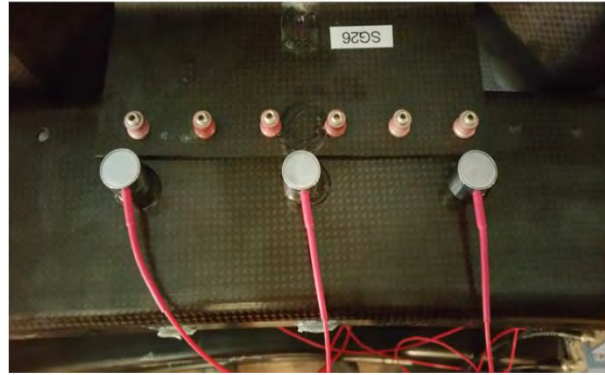
**Figure 9. Shear tie test setup: (a) R15s transmitter fixed on exterior skin using magnetic hold down, (b) R15s receivers on C-frame, (c) undamaged shear tie for baseline, (d) partially cracked shear tie at the corner, and (e) complete crack along the bolt lines**

Second, shear ties with different damage severity from the Frame02 panel were investigated to understand wave attenuation through shear tie cracks (see Figures 9c, d, and e). For this experiment, the same method of excitation as the C-frame test was generated from the exterior skin, where the shear ties are joined to the skin via countersunk bolts (see Figure 9a). Receiver sensors were located on the C-frame to collect UGWs propagating through the shear tie (see Figure 9b). The actuator and receivers for this test were Mistras R15s transducers with a narrowband frequency and 150 kHz resonance. These tests showed differences in the transmitted waves through different damage levels in the shear ties. Figures 10a and 10b show the comparison of UGW test results for a shear tie at 50 kHz and 150 kHz excitation, respectively. Comparing A<sub>0</sub> mode time-gated wave results between shear tie 11 (pristine) and shear tie 06 (partial corner crack), 150 kHz tests show a higher UGW attenuation of approximately 78%, whereas 50 kHz tests showed lower attenuation of 18% due to the presence of damage. A higher frequency appears to be more suitable to detect damage, but it was found that UGW frequencies higher than 80 kHz do not propagate very efficiently through the internal structure as compared to the exterior skin propagation (see section 4.2.3 “Conjoined Stringer Panels”).

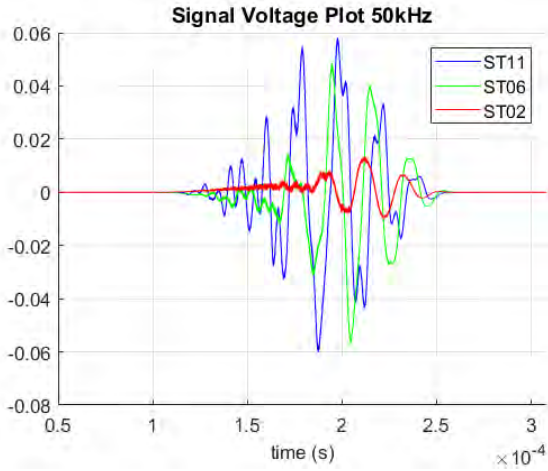
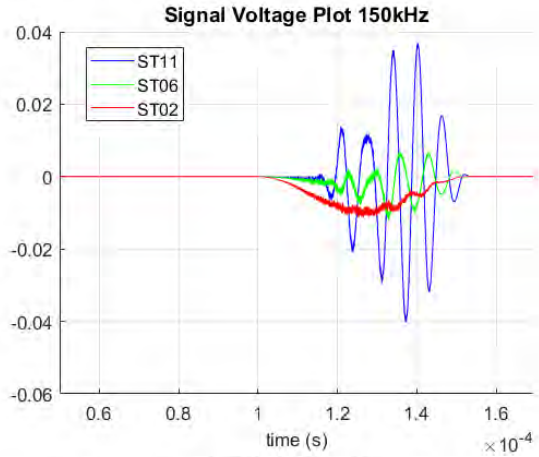
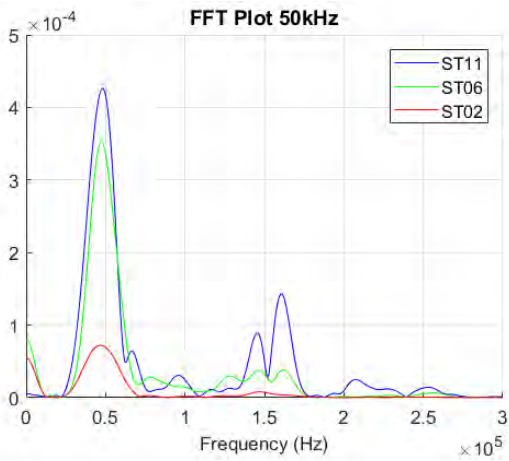
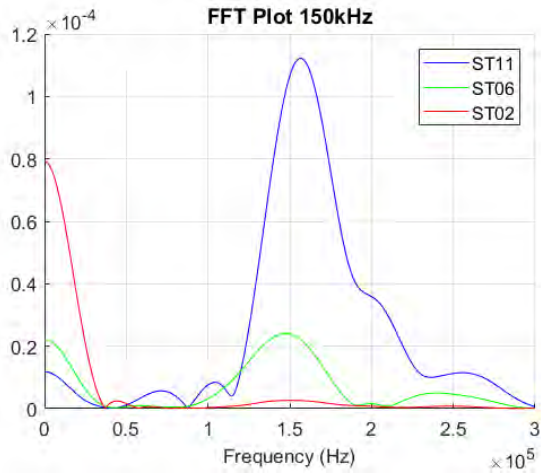
(a) Signal and FFT result 50kHz

(b) Signal and FFT result 150kHz

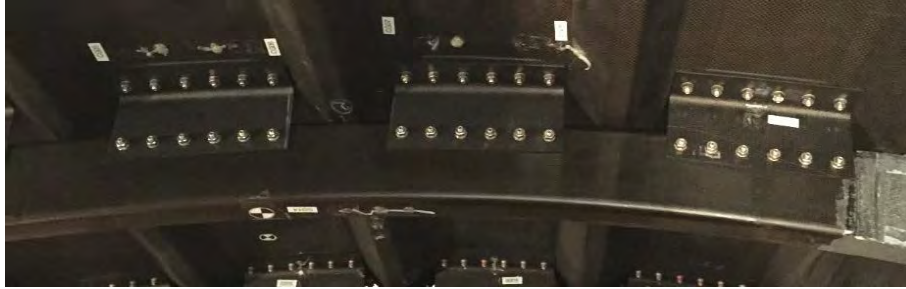
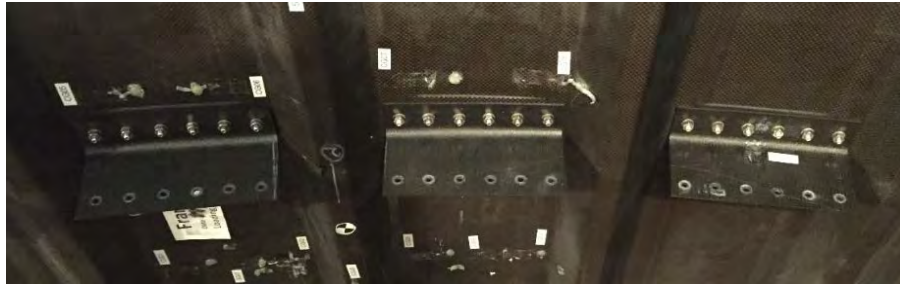
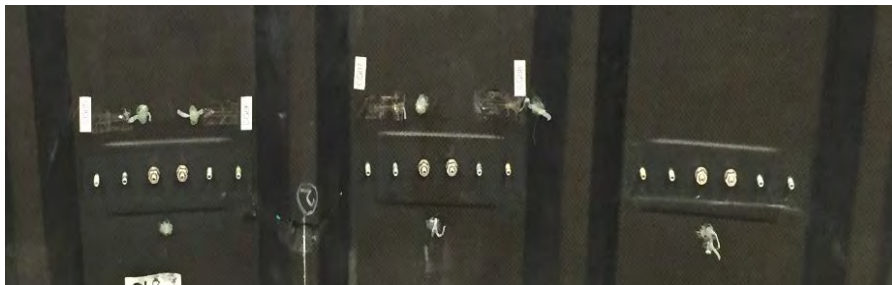
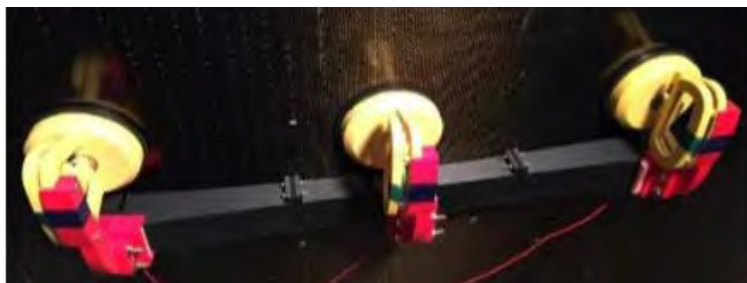
**Figure 11. Different levels of disassembly for UGW tests: (a) full assembly with C-frame and shear ties, (b) C-frame only removed, (c) C-frame and shear ties removed, and (d) 3D-printed hold-down mounts for transducers on outer skin**

Tests performed with Frame02 panel subcomponent parts assembled and disassembled helped to understand wave energy leakage into the internal structural components versus transmission within the skin only. UGW tests were performed first on the full assembly (skin with C-frame bolt joined by shear ties), then again after removal of the C-frame only, and finally again after the removal of shear ties (see Figure 11). Transducers were consistently fixed in place throughout these assembly and disassembly tests using a 3D-printed hold-down mount, as seen in Figure 11d. Figure 12 shows UGW test results at 150 kHz and the intensity increase for each disassembled part: a 43% increase when only the C-frame was disassembled, and a 63% increase when the shear ties were disassembled for skin-only wave propagation. Test results could be related to how much energy was drawn into the internal composite stiffening components. It was noted that 86% of the energy leaked into the internal structure when the skin-only wave energy was compared to the fully assembled panel.

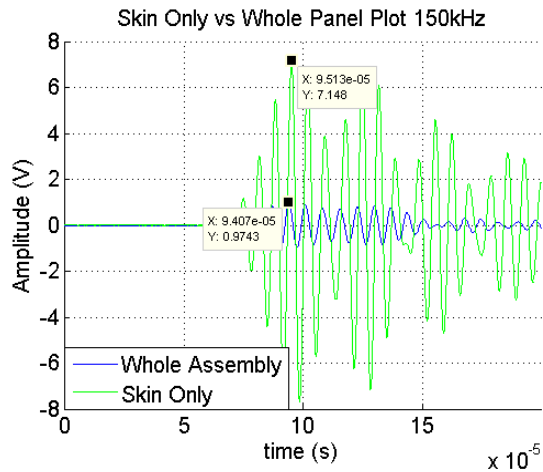
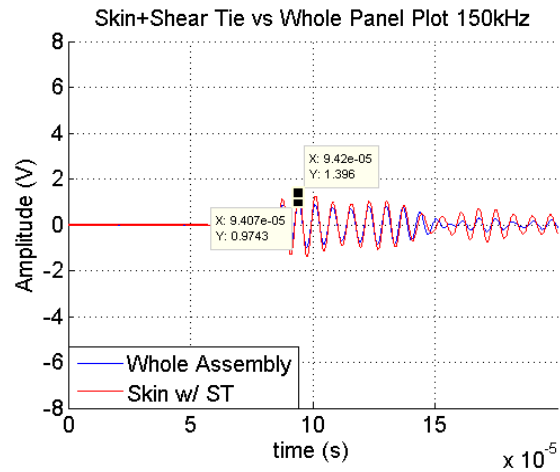
**Figure 12. Assembling/disassembling test results: (a) skin-only vs. whole assembly and (b) skin and shear ties vs. whole assembly**

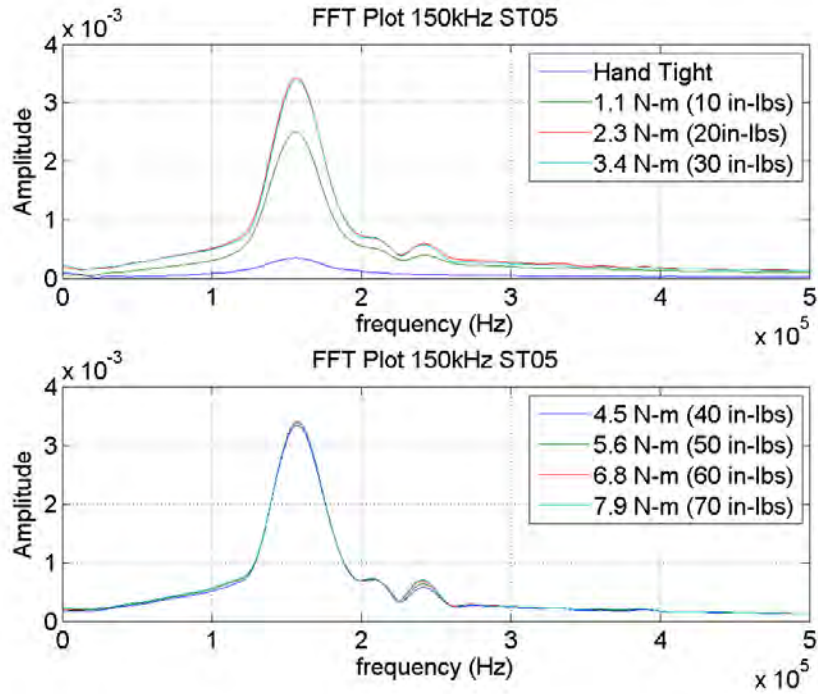
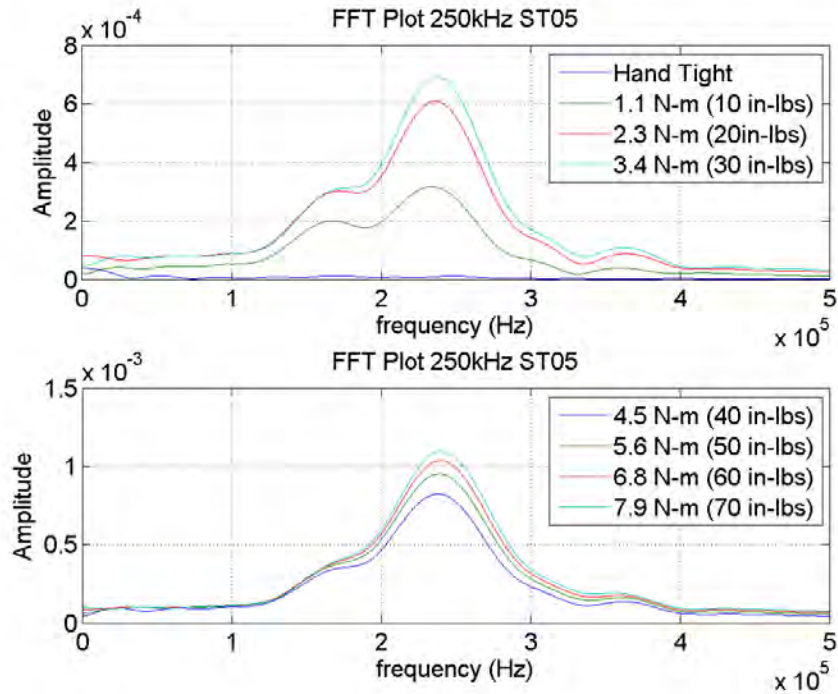
**Figure 13. Bolted-joint test results: (a) bolted-joint difference torque wave transmission at 150 kHz and (b) bolted-joint difference torque wave transmission at 250 kHz**

From the previous Frame02 panel assembly and disassembly experiments, originally bolted Hi-Lok™ collars were replaced with common industry nuts to allow for easier assembly, disassembly, and adjustment of the fastening torque level. Nuts were tightened back to the same torque of 7.9 N-m applied to the Hi-Lok™ collars (HL70-8), and wave transmission through various bolt torque levels were compared. The same test setup was used as in Figures 9a and 9b; bolt torque levels of 2.2 N-m and higher did not have much influence on wave transmission through the bolt-joined composite skin to C-frame for frequencies of 150 kHz and lower (see Figure 13a). For frequencies of 150 kHz and lower, experiments showed a slight drop in the UGWs amplitude as the torque level went beyond certain strengths for each swept frequency. UGW transmission through bolt-joined aluminum plates in an experiment by Bao et al. [8] shows a similar behavior at 320 kHz, in which measurements showed a slight amplitude decrease at 2.7 N-m torque compared to 2.3 N-m.

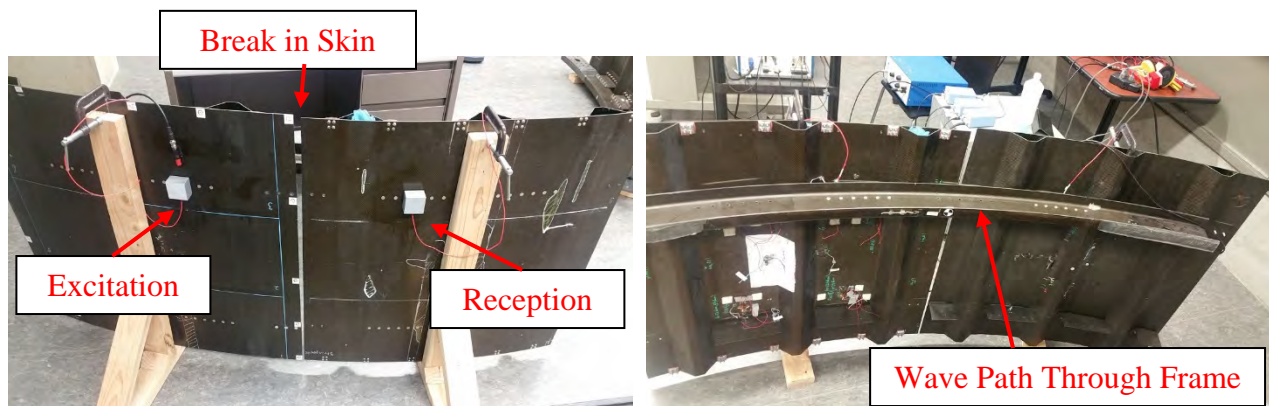
**Figure 14. Conjoined stringer panels**

Although the assembly and disassembly test showed that a significant amount of energy leaks into the internal structure, it was still unclear how much of the internally transmitted waves transfer out back to the skin side. To investigate wave transmission through the internal structure only, two smaller stringer panels were joined by a single C-frame, leaving a break in the skin (see Figure 14). By conjoining two panels, skin discontinuity exists and only the waves transmitted through the internal components (through the frame) arrive at the receiver transducer. As seen in Figure 14, the transmitter and receiver attach to the skin on each panel at the center of each shear tie. For a better comparison of the internally transmitted UGW behavior at different frequencies, UGW test results from Pico Sensors (the transmitter and the receiver) were investigated instead of the narrowband frequency R15s sensors. Figure 15 shows that the UGWs transmitted through the internal structure at 50 kHz had much higher energy than the UGWs at 150 kHz. Similarly, additional frequency sweep test results show frequencies lower than 80 kHz give a strong internal wave energy transmission. Therefore, it would be best to use an excitation frequency lower than 80 kHz to better investigate UGW propagation through the internal components (through shear ties and frames), which is a necessary condition for detecting damage in those components.

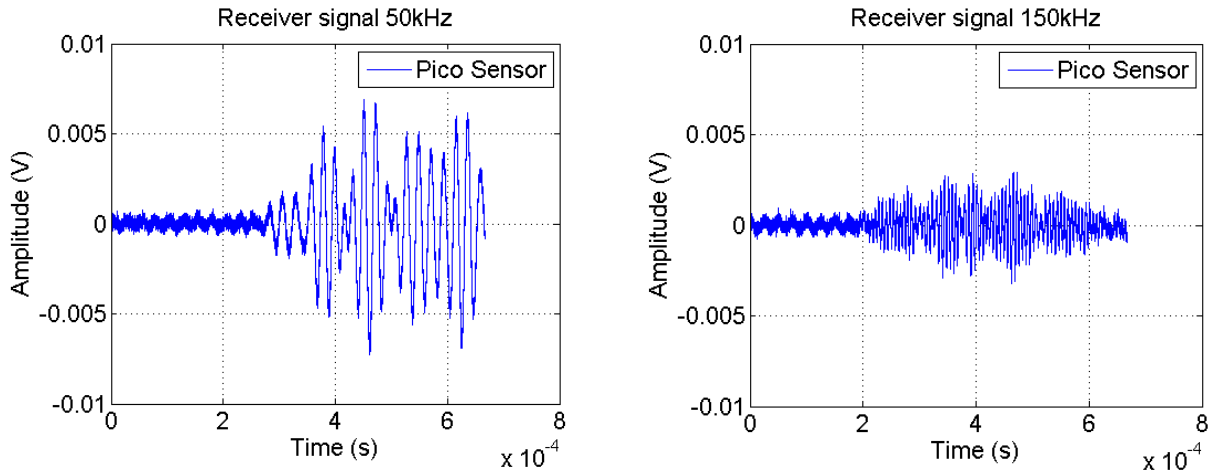
**Figure 15. Conjoined stringer panels result**

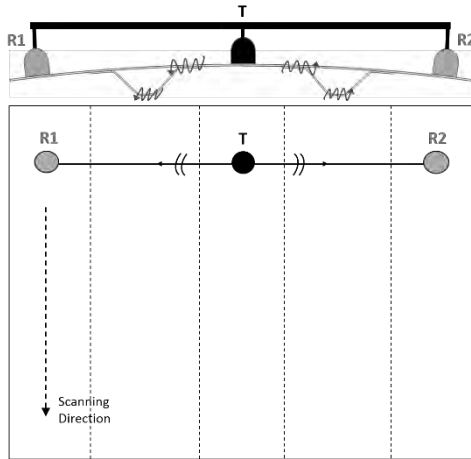
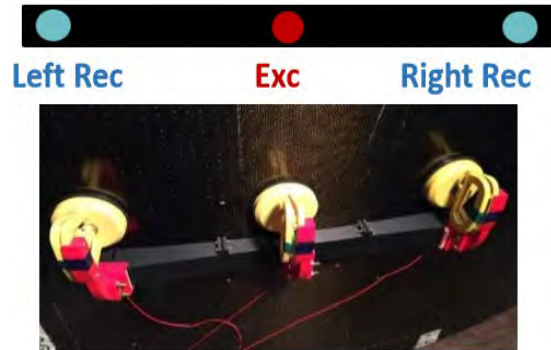
**Figure 16. Contact defect-detection technique: (a) schematic and (b) test setup**

Building on what was learned in the previous studies, and to enable inspecting across long distances while penetrating multiple interfaces in a composite material, Mistras R15s narrowband PZT contact transducers were centered at 150 kHz (one for actuation and two for reception). Conventional ultrasonic gel couplant was used, and the differential approach was employed (see Figure 16) to compensate for coupling variations and other changes not associated with damage. Scans performed on the structure across two stringers, as the schematic in Figure 16 shows, used a 3D-printed sensor hold-down mount for consistent contact pressure.

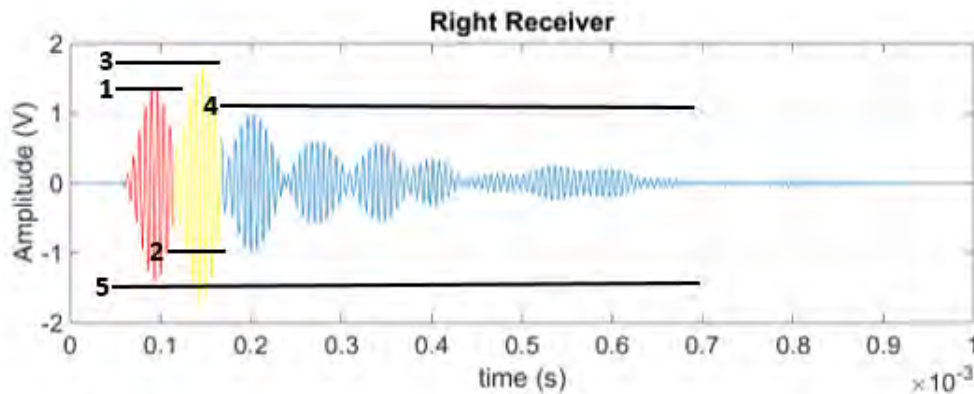
**Figure 17. Typical signal from contact technique with gated wave packets**

After scanning the area of interest, the data post-processing was done using Matlab. Every test signal was time-gated in five possible wave packets exploited in different ways and combinations, as shown in Figure 17 (see packets 1–5).

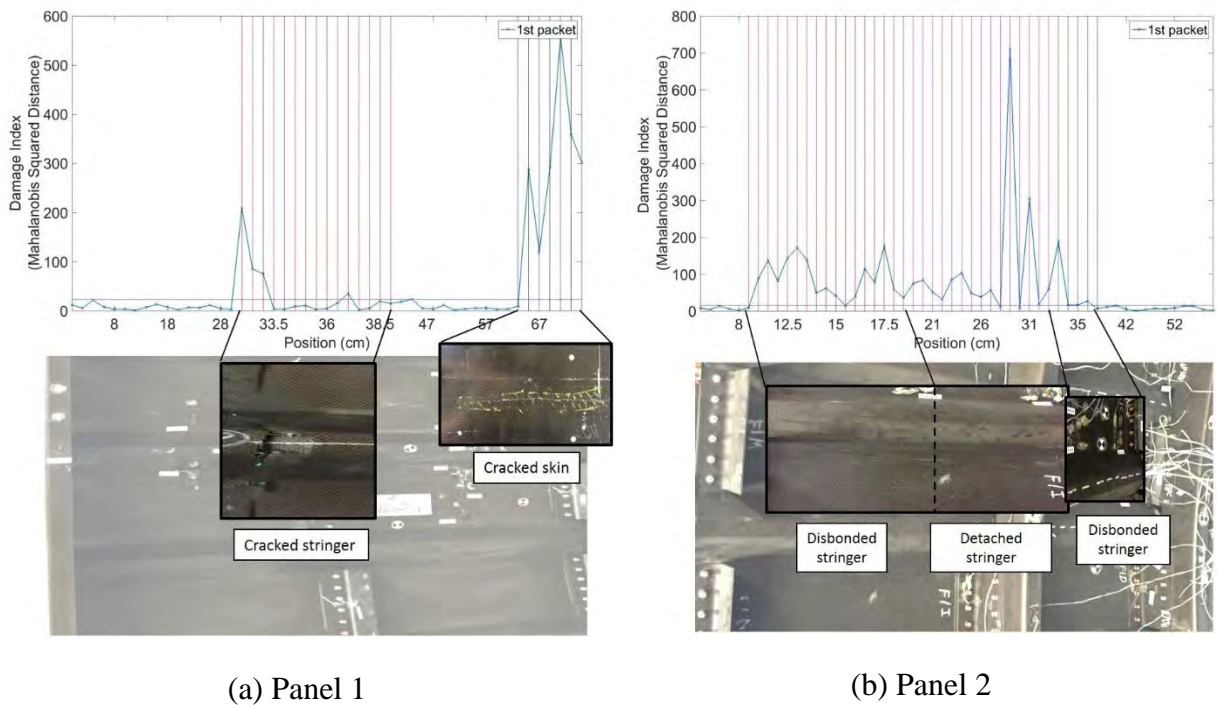
**Figure 18. Contact defect-detection technique DI**

The results shown in Figure 18 used the first wave packet in which the colored vertical lines represent the defective areas. The DI increased in correspondence with the detected cracked skin, stringer damage, and detached stringer from skin. The DI was correctly found to be very low for pristine locations.

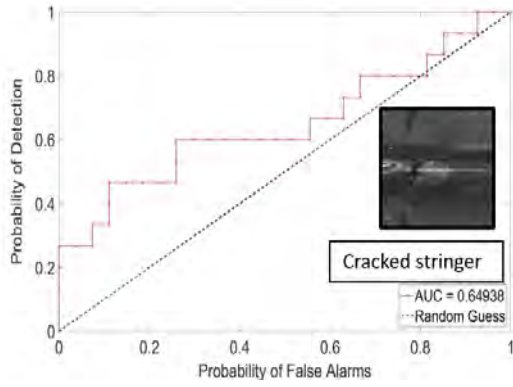
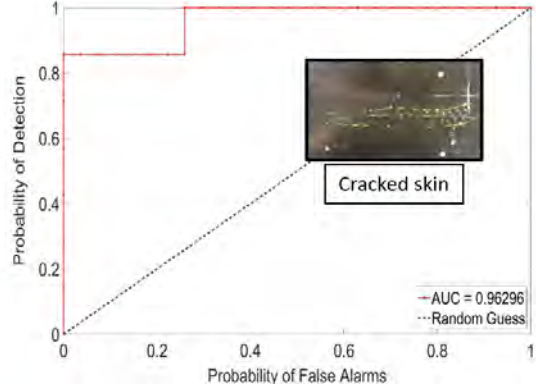
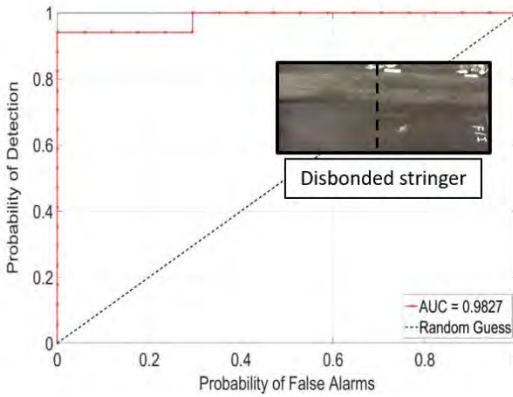
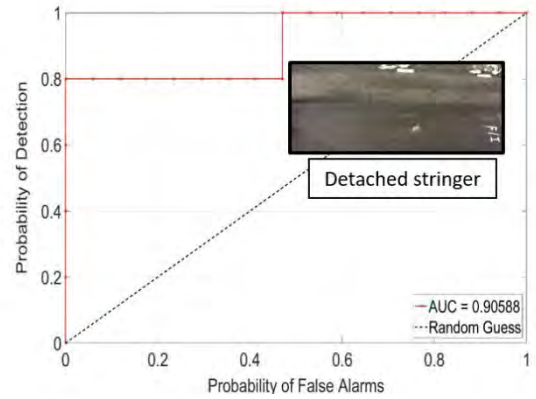
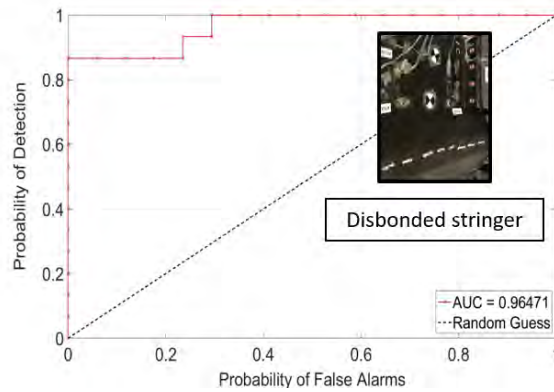
(a) Cracked stringer (Panel 1)

(b) Cracked skin (Panel 1)

(c) Disbonded stringer (Panel 2)

(d) Detached stringer (Panel 2)

(e) Disbonded stringer (Panel 2)

The performance of the contact-based defect-detection technique was assessed with the ROC curves for Panel 1 (Frame02) and Panel 2 (Frame01), as shown in Figure 19. The disbonded stringer represents an internal disbond of the stringer from the skin, whereas the detached stringer represents a more severe detachment of the stringer from the skin.

For Panel 1, the defect detection of the cracked stringer was achieved with a POD of 60% and 25% of PFA (see Figure 19a). This “ok” quality of detection was because of the size and orientation of the defect and the use of the first wave packet in the signal for the MOA. The  $S_0$  mode was dominated by an in-plane displacement component that did not penetrate the structure as much as the  $A_0$  mode. Especially for defects existing within the internal components, the  $S_0$  mode was not well-suited and other modes are preferred. The detection of this kind of defect can be improved by focusing the analysis on an anti-symmetric mode and using sensors that are more sensitive to the out-of-plane displacement. The cracked skin defect detection achieved a very good performance, with a 86% POD and 0% PFA or a 100% POD, accepting a 26% PFA (see Figure 19b). This result confirmed the sensor sensitivity and the wave packet interaction with different defects at different locations within the structure and positioned at different orientations with respect to the scanning direction.

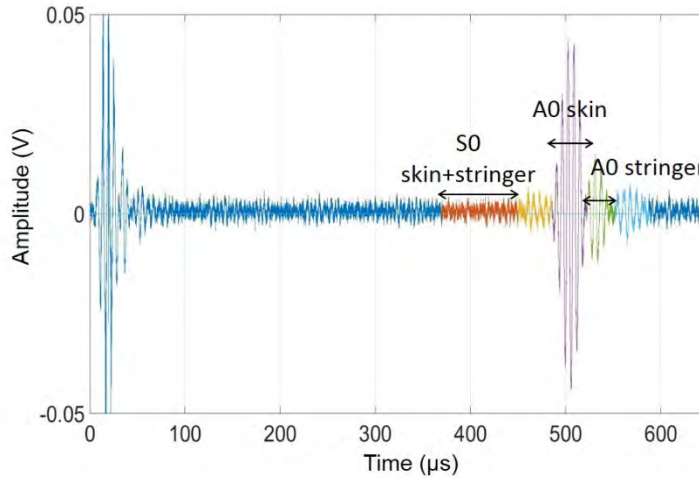
**Figure 21. Typical signal from non-contact technique with gated wave packets**

It was possible to isolate, with the aid of the previously extracted wave propagation and velocity information, the  $S_0$  and  $A_0$  modes, penetrating into the skin and into the stringer, as shown in Figure 21.

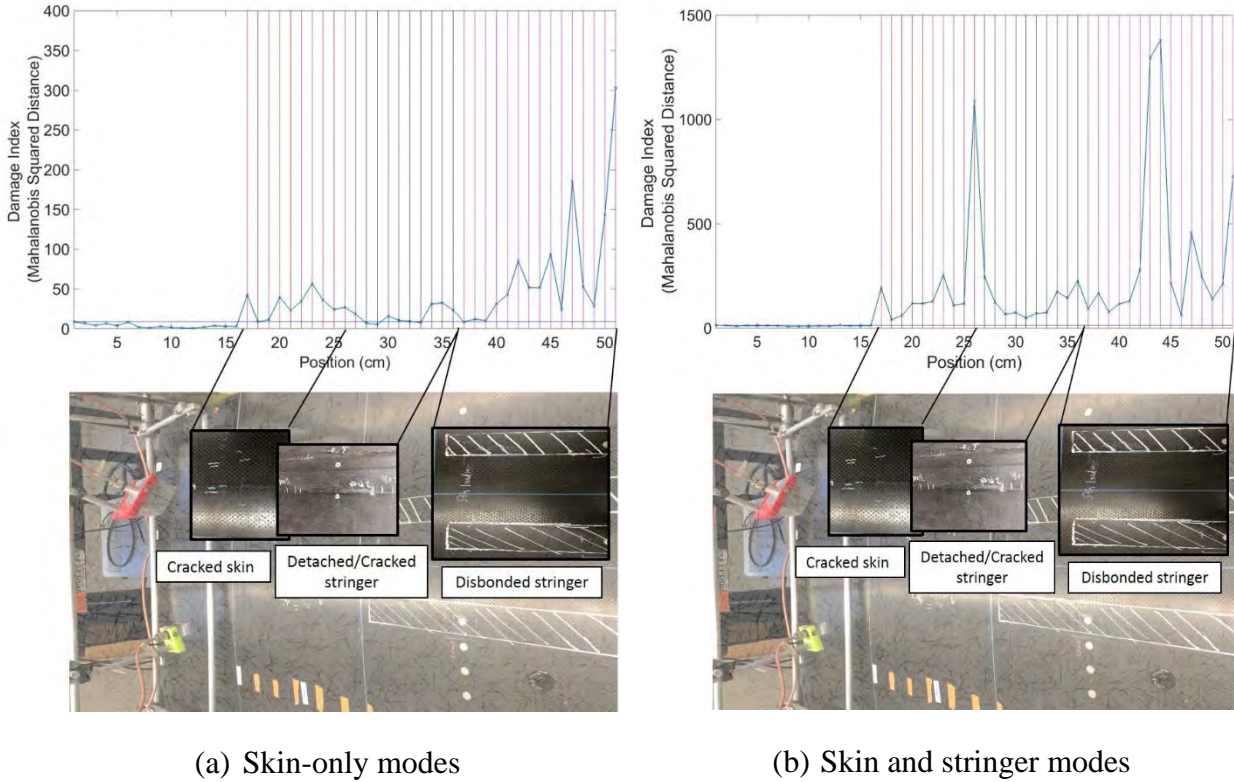
**Figure 22. Non-contact defect-detection technique DI: (a) skin-only modes and (b) skin and stringer modes**

Figure 22 shows the DI test results in terms of MSD, computed and plotted along the scanning positions for the Stringer03 Panel.

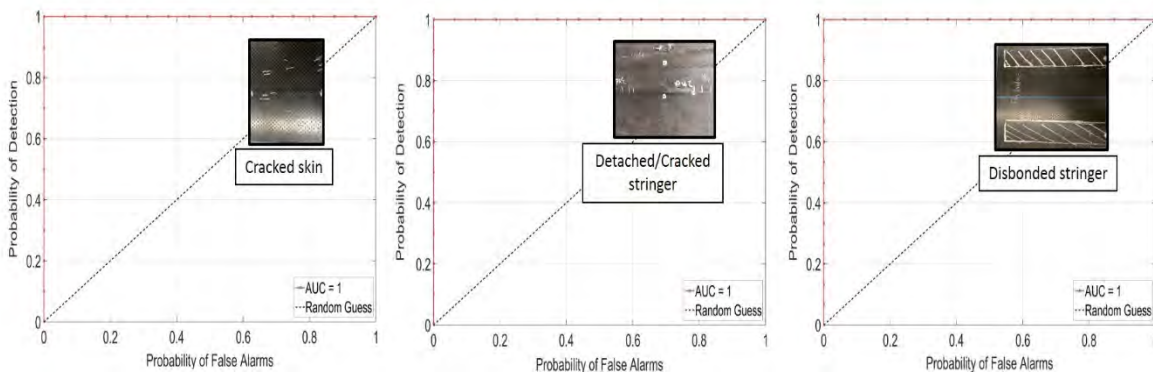
**Figure 23. Non-contact defect-detection technique ROC curves for various defect types: (a) only skin modes and (b) skin and stringer modes**

The performance assessment of the non-contact defect detection technique includes the ROC curves for Stringer03 Panel (see Figure 23). The technique performance was very good when using only skin modes (see Figure 23a). The cracked skin and the disbonded stringer defect achieved a 100% POD with less than 10% PFA and a worse performance for the detached/cracked stringer defect (e.g., 100% POD with 25% PFA or 70% POD with 0% PFA). The results improved dramatically when adding stringer mode wave-propagation content (see Figure 23b), reaching a perfect detection for all defect types (100% POD with 0% PFA).

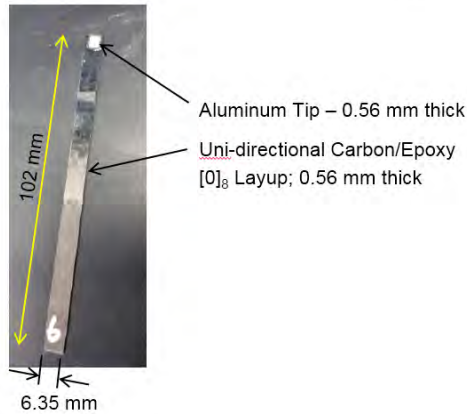
(a) Mini-impactor structure

To have a significant amount of wave energy transmitted through the internal structures comparable to skin-propagated wave energy, a frequency less than 80 kHz is optimal based on the previous conjoined stringer panels experiment. Development of a mini-impactor helped to generate high-energy broadband frequency excitation that can penetrate better into the internal structure. An additional benefit of higher energy excitation is less (or no) amplification of the received signals and higher signal-to-noise ratio. The mini-impactor was manufactured from a unidirectional carbon fiber composite strip body with a metal tip, as shown in Figure 24.

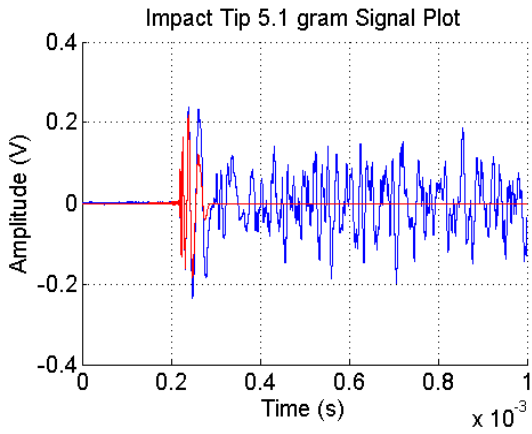
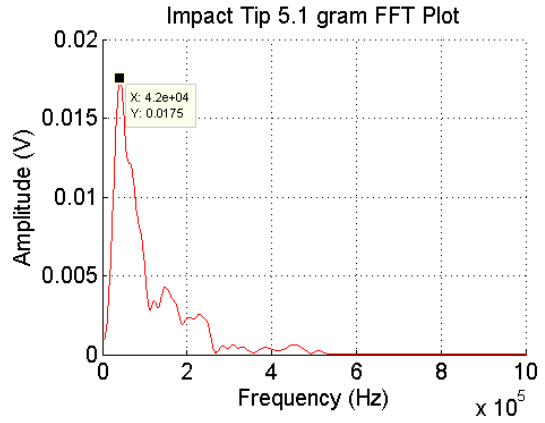
**Figure 26. Mini-impactor experiment on aluminum plate test results**

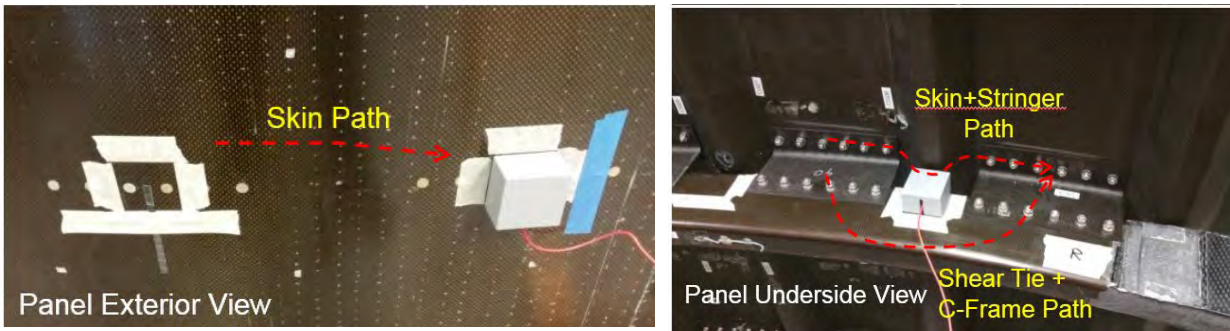
**Figure 27. Mini-impactor experiment on Frame02 panel**

Tests of the mini-impactor on the Frame02 panel confirmed that the low-frequency 42 kHz waves can achieve transmission through the internal structure. Figure 27 shows the Frame02 panel test setup with receiver transducers (Mistras R15s) placed on the external skin side and on the C-frame at midpoint along the internal side of the wave path. Test results of the mini-impactor on the Frame02 panel, shown in Figure 28b, clearly show a significant amount of energy propagating into the panel's internal wave path when the excitation was generated using the mini-impactor. Figure 28c clearly shows low-frequency wave intensity loss when the C-frame was disassembled from the panel. Therefore, this setup and excitation technique has high potential for detecting breaks in the frame or other damage along the internal structure wave path.

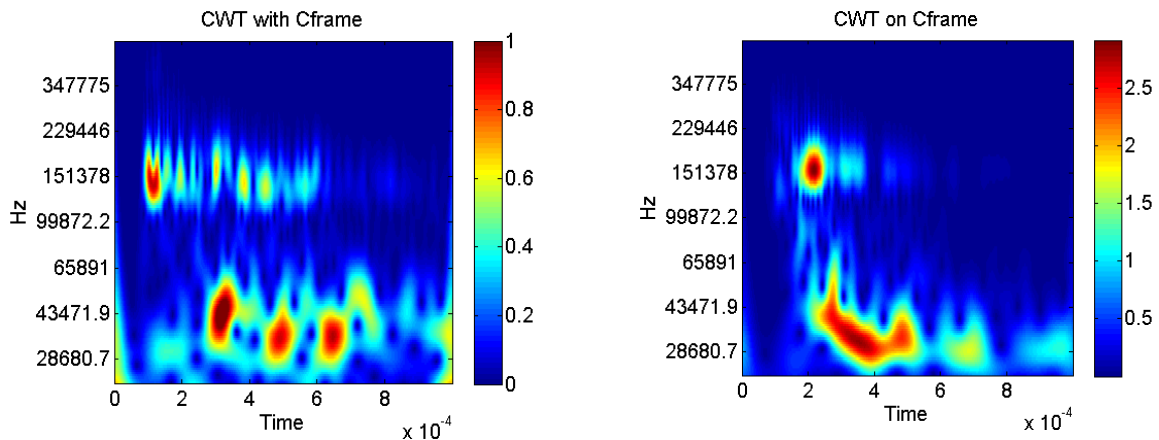
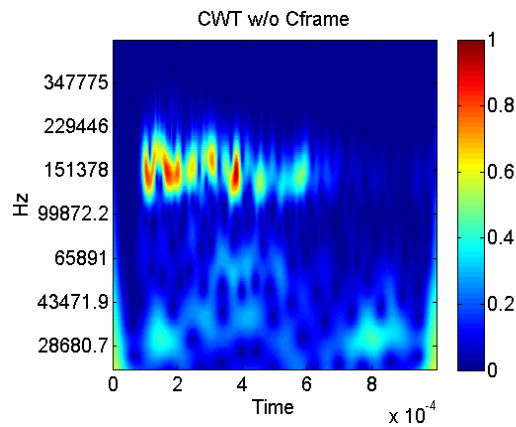
(a) Panel with C-frame, received on skin

(b) Panel with C-frame, received on C-frame

(c) Panel without C-frame, received on skin

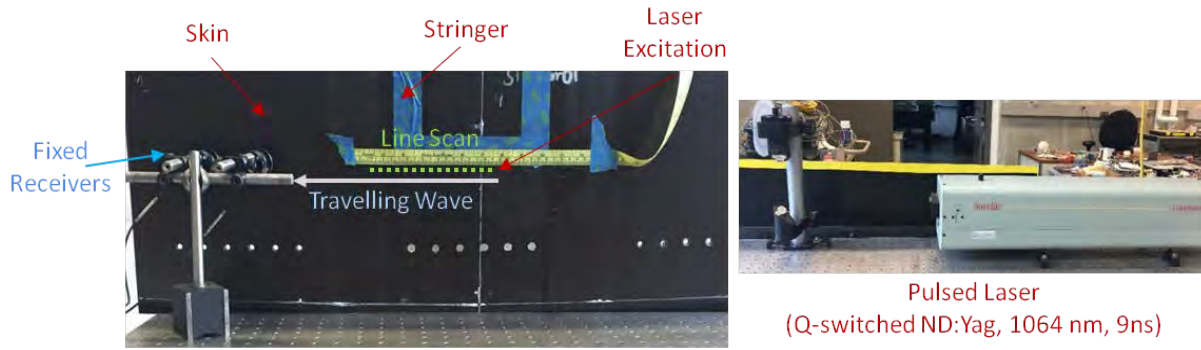
**Figure 30. Laser scanning test setup on composite panel**

A 2D FFT can be used to extract phase-velocity dispersion curves for a given structure. A multiple input, single output or single input, multiple output configuration is needed, using fixed broadband capacitive air-coupled transducers (BAT, from Microacoustics) for reception and a pulsed laser excitation (Q-switched ND:Yag, 1064 nm, 9 ns duration). Test results for a laser impulse sent along a line of 64 points (nodes) with a 1-mm resolution appear in Figure 30. Similar tests repeated on an aluminum plate appear for purposes of comparison. The time signal on the first point of the line scan, node 1, appear in Figure 31 for two receivers. The respective FFT for one receiver for the A<sub>0</sub> and S<sub>0</sub> gated modes appears in Figure 32.

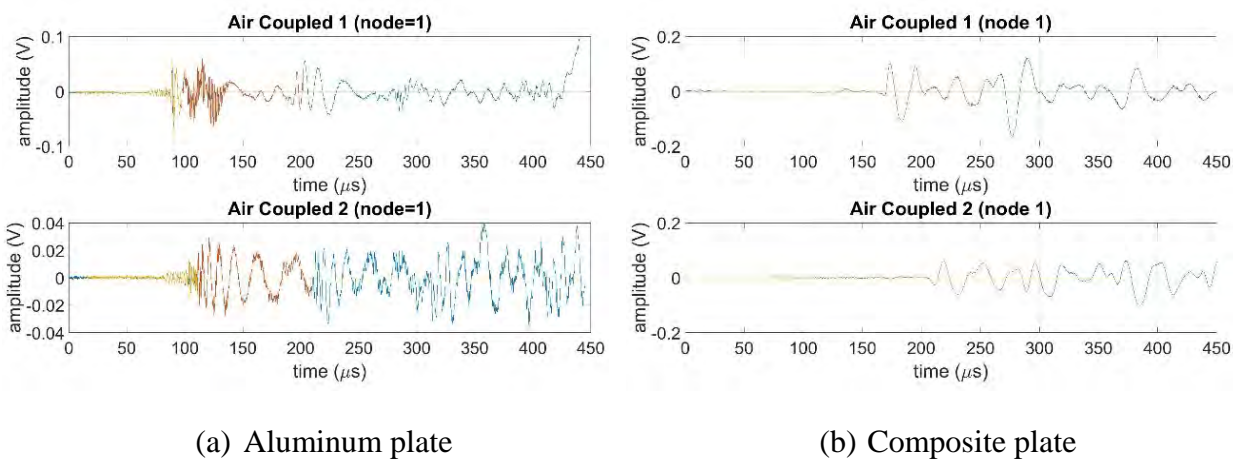
**Figure 31. Time signal at node 1 for two air-coupled receivers (top and bottom): (a) aluminum plate and (b) composite plate**

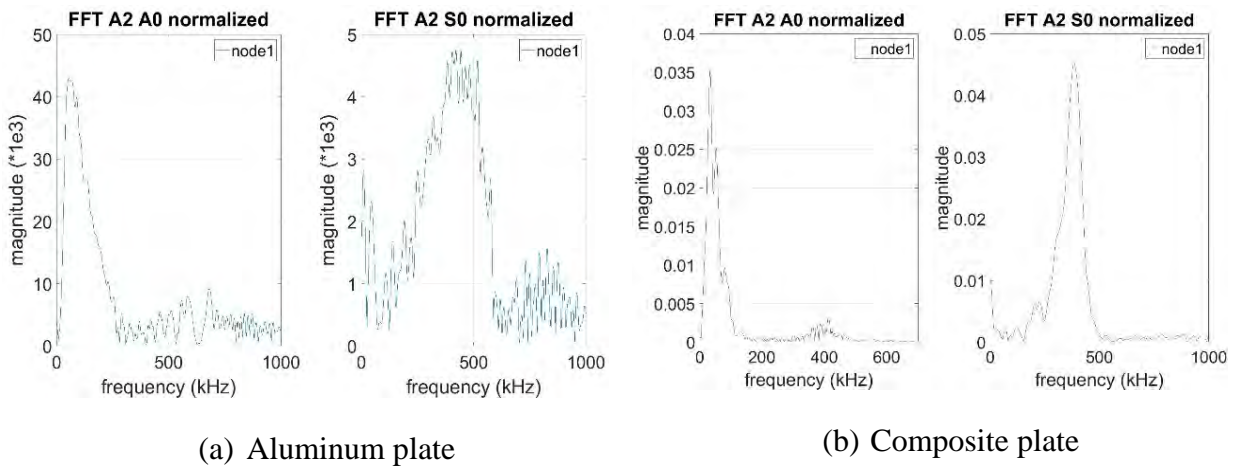
**Figure 32. FFT of signal at node 1 for A<sub>0</sub> and S<sub>0</sub> modes: (a) aluminum plate and (b) composite plate**

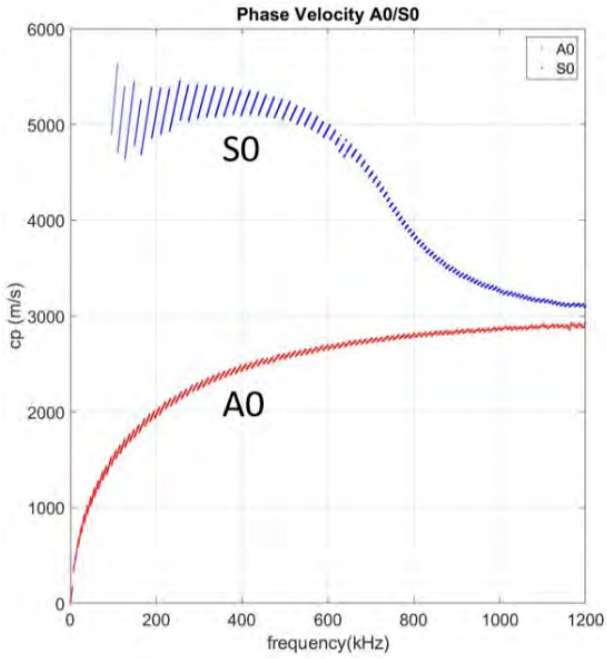
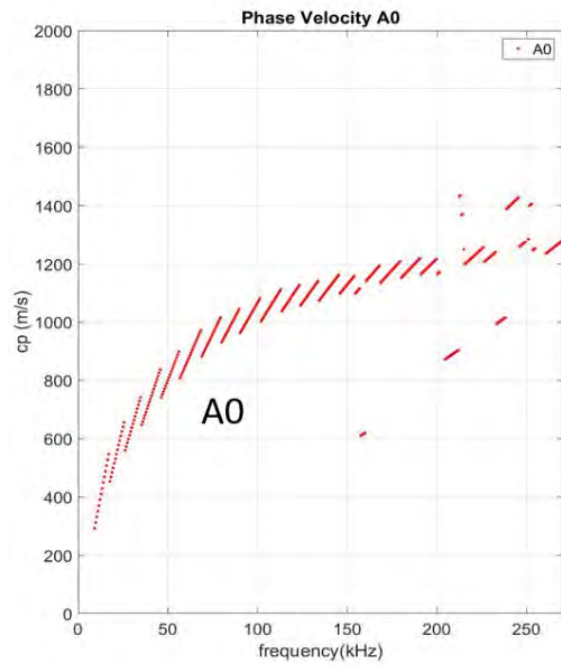
**Figure 34. Experimental dispersion curves (phase velocity): (a) aluminum plate and (b) composite plate**

The composite panel filters out most of the modes, especially at the higher frequencies. Plotting this information in a phase velocity vector, the following dispersion curves appear in Figure 34. Work is underway to improve the phase velocity dispersion curves extraction through gating, windowing, and space-time filtering. Group velocity dispersion curves retrieval is also under study using CWT. A preliminary result confirms the use of the  $A_0$  mode group velocity as 1600 m/s for 170 kHz in the gating of the defect-detection analysis performed and shown in Figure 35d.
