DOT/FAA/TC-19/19

Surface Marking Durability Study: Phase I

June 2019

Final Report

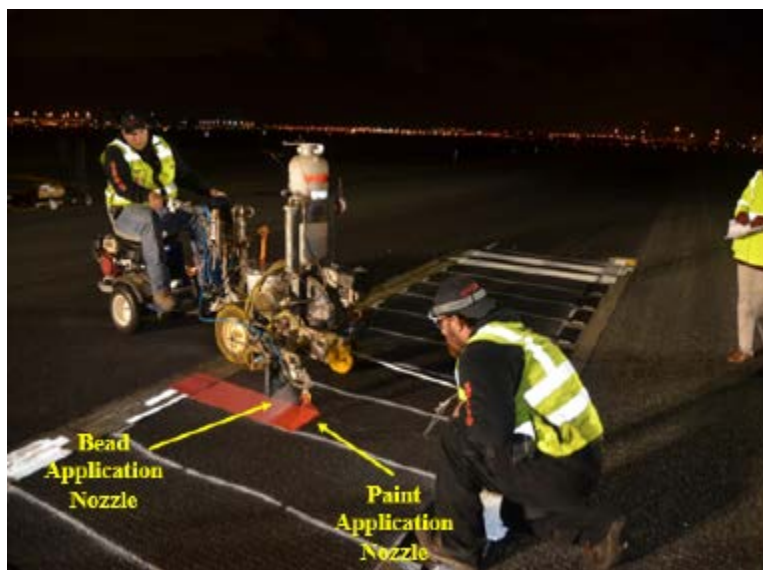
Figure 2. Red Waterborne Type I Marking Installation at EWR

Waterborne Type I, II, III, and MMA markings were installed using equipment with two application nozzles. As the applicator progressed along the marking area, the leading nozzle applied the paint while the rear nozzle applied beads at the desired rate [2]. Figure 2 shows the installation of red Waterborne Type I paint at EWR.

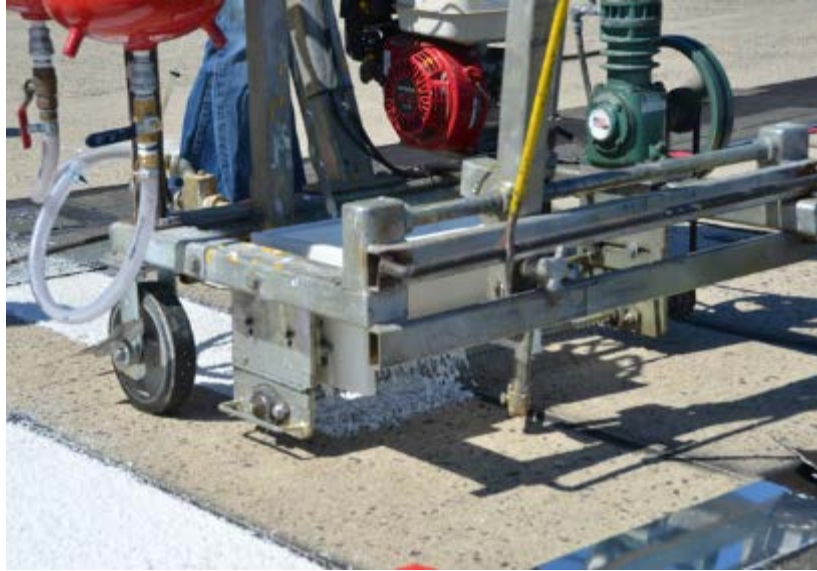
Figure 3. White SMMA Marking Installation at ACY

SMMA markings were installed using a push-style applicator. To produce the desired structured characteristic of the marking, the applicator was equipped with an attachment with multiple holes that caused the paint to splatter on the surface. This resulted in a thicker, three-dimensional marking. Figure 3 shows the installation of a white SMMA marking at ACY.

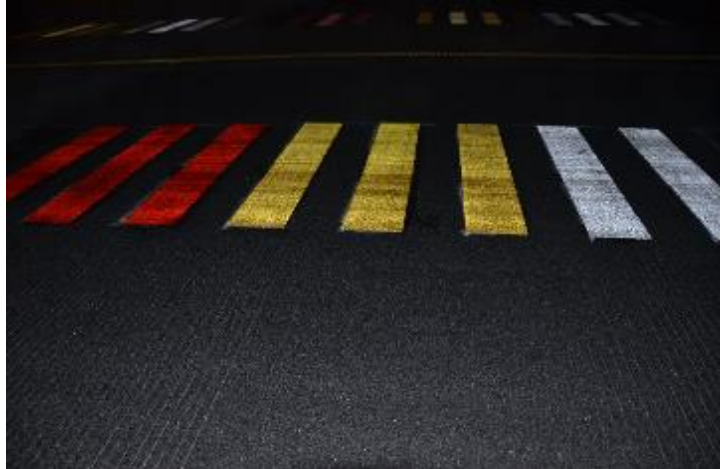
Figure 66. Rubber Deposits on Preformed Thermoplastic Surface Markings One Week After Installation

The surface marking test deck at EWR was located on a high-speed turnoff taxiway frequently used by various aircraft types. Within one week of installation, the surface markings began to accumulate rubber deposits. Figure 66 shows the Preformed Thermoplastic markings with rubber deposits one week after installation.

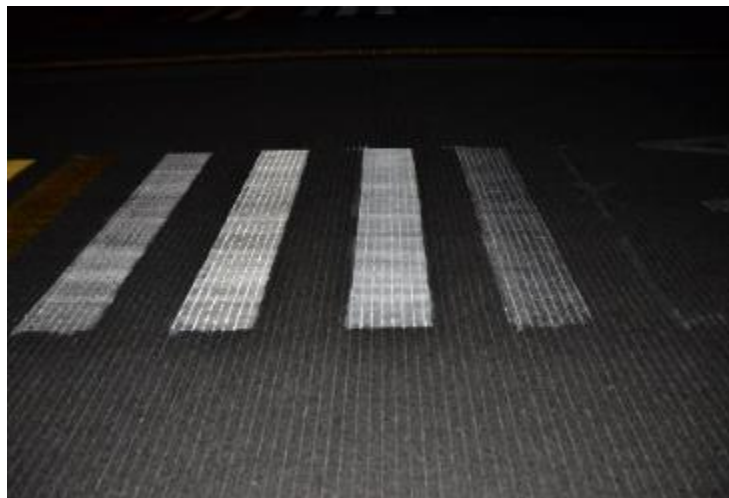
Figure 67. Rubber Accumulation on White Waterborne Type III Surface Markings—July 2017

As discussed in section 4.1, rubber deposit accumulation on the markings likely contributed to a decrease in retro-reflectivity readings, and rubber buildup removal likely caused the readings to rebound. Figure 67 shows the white Waterborne Type III surface markings in July 2017. As shown, the markings were somewhat obscured by rubber deposits. When the image was taken, all the white Waterborne Type III markings were below the proposed retro-reflectivity minimum of $100 \text{ mcd/m}^2/\text{lx}$. Rubber removal occurred approximately one week later, and follow-up readings were taken approximately one month later. By the next data collection, all the white Waterborne Type III markings recovered above the proposed retro-reflectivity minimum.
