**DOT/FAA/TC-19/3**

# **Cyclic Plate Testing of Reinforced Airport Pavements— Phase I: Geogrid**

February 2019

Final Report

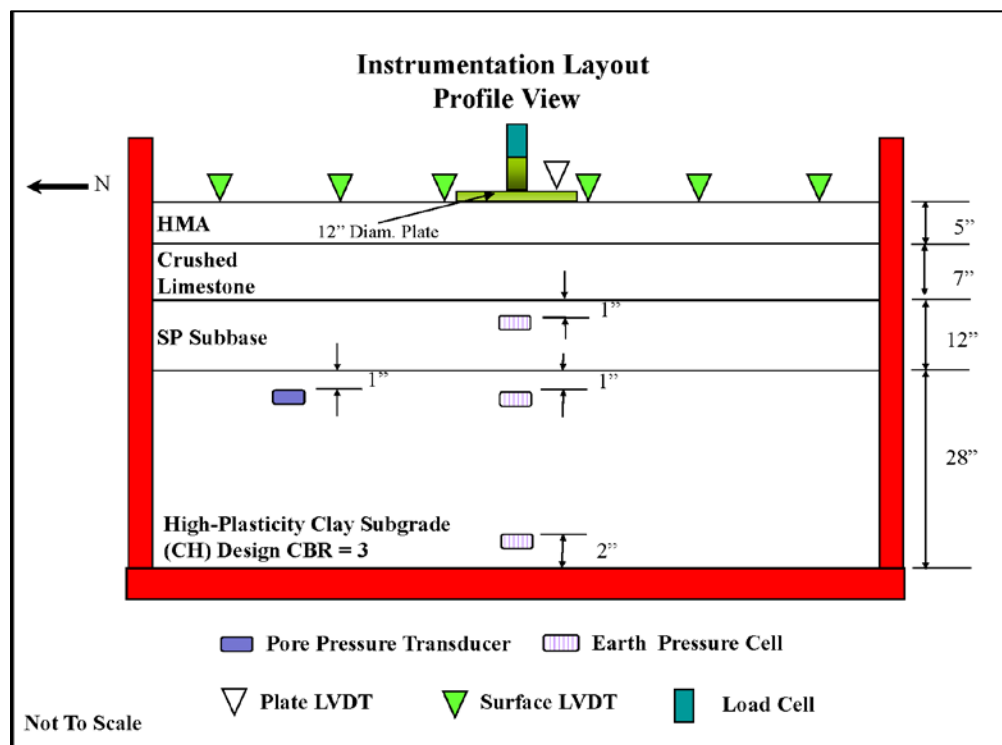
Figure 9. Pavement Sensors for a Typical Test Item, Profile View

Instrumentation was placed at several locations within the pavement structure to obtain pavement response parameters. Response parameters of interest included deflections, stress, and strains at various locations in the pavement structure. Vertical stress was measured just below the base-subbase interface, just below the subbase-subgrade interface, and at a depth of approximately 26 in. below the subbase-subgrade interface. Elastic deflections and permanent deformations were measured along the centerline at the pavement surface. The loading actuator also contained a linear variable displacement transducer (LVDT) that was used to measure vertical deflections during testing. Finally, pore pressures and temperature were measured near the top of the subgrade during the construction, testing, and post-test phases. A profile view of the sensor layout is depicted schematically in figure 9. Note that all instrumentation installation depths in figure 9 are approximations intended to illustrate a typical test item. Final earth pressure cell (EPC) installation depths are discussed in section 4.7.1.

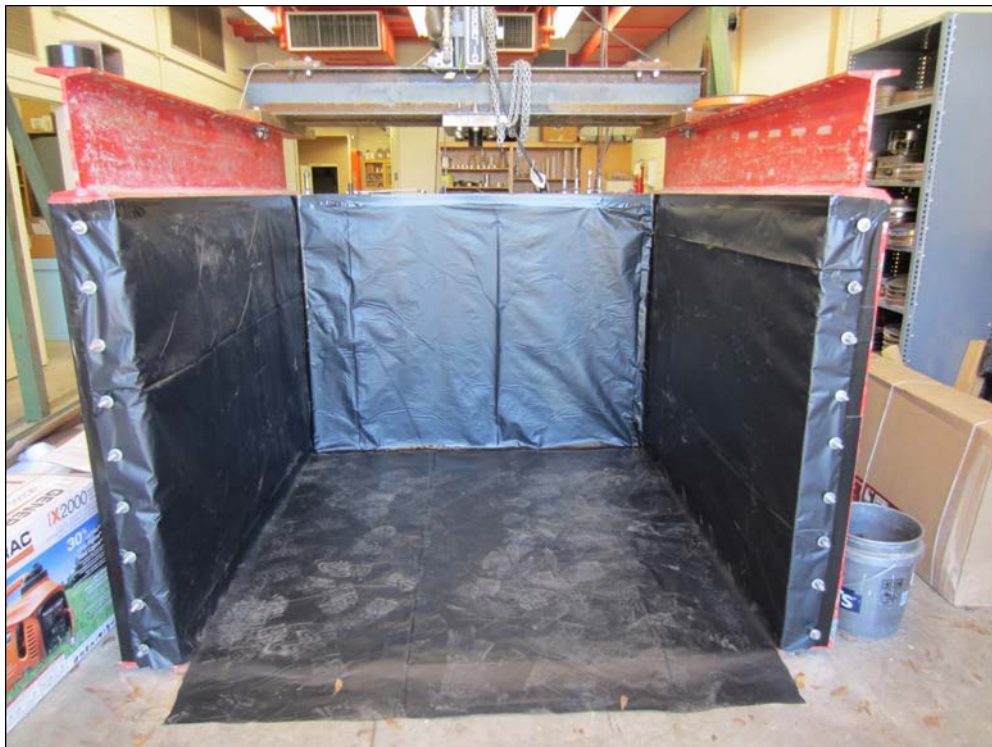
Figure 10. Lined Box-Testing Facility

A 6-ft-square, 4.5-ft-deep, reinforced steel box was used as a containment facility for laboratory pavement structures. The box-testing facility was composed of 1-in.-thick steel plates reinforced with 1/4-in.-thick, 6-in.-square, structural steel tubing along the bottom and three sides of the box. The front of the facility was composed of removable 1/4-in.-thick, 6-in.-square structural steel tubing. The front of the facility was removed to aid in the construction process. The tubes were bolted to the containment facility one layer at a time as construction proceeded, simplifying the process of placing and compacting the soil materials within the test facility.

Prior to placement of the soil, the containment facility was lined with polyethylene to minimize moisture migration and desiccation of the test items during construction and testing. Figure 10 shows the lined box facility before placement of soil materials.

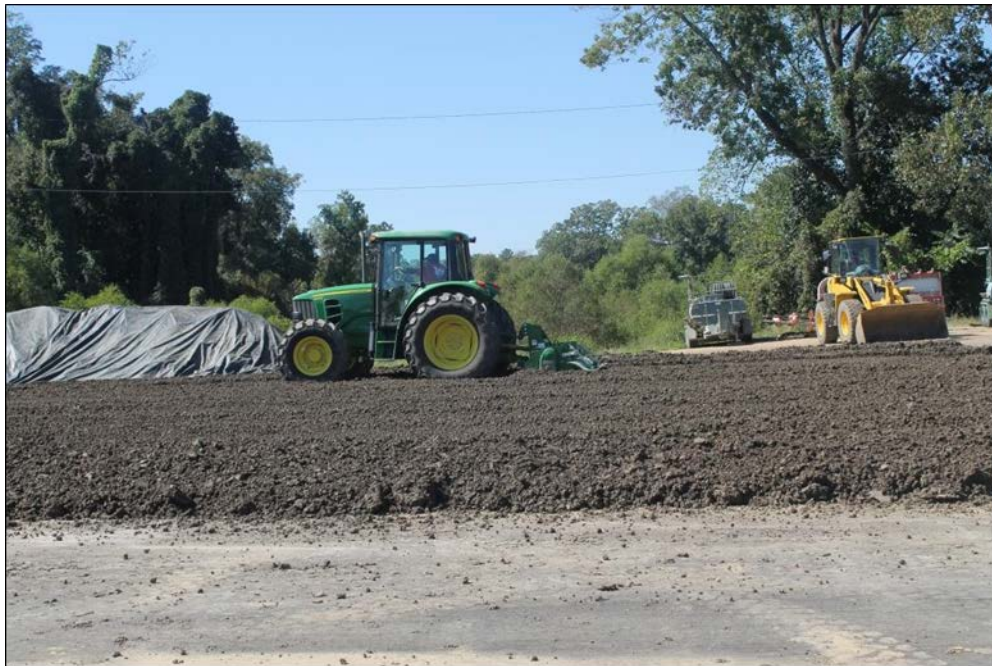
Figure 11. The CH Material Processing

The subgrade materials were spread out in a 12-in.-thick lift on a soil-processing strip. Subgrade soils were allowed to dry until reaching the desired moisture content. The soil was periodically pulverized using a rotary mixer, as shown in figure 11. The clay was mixed and pulverized in an iterative manner to break down the larger clay pieces and bring about moisture equilibrium. Upon reaching the desired moisture content, the clay was hand spread in the containment facility in thin lifts. Each lift was compacted using a pneumatic compactor, as shown in figure 12. Lift thicknesses were monitored and controlled by using a rod and level to take elevation readings during construction, as shown in figure 13. The readings were taken at the same locations for all pavement layers and test items. Figure 14 depicts the exact locations where the rod and level measurements were taken during construction for each pavement layer of each test item. The summarized average thickness data for all constructed layers are shown in table 5.

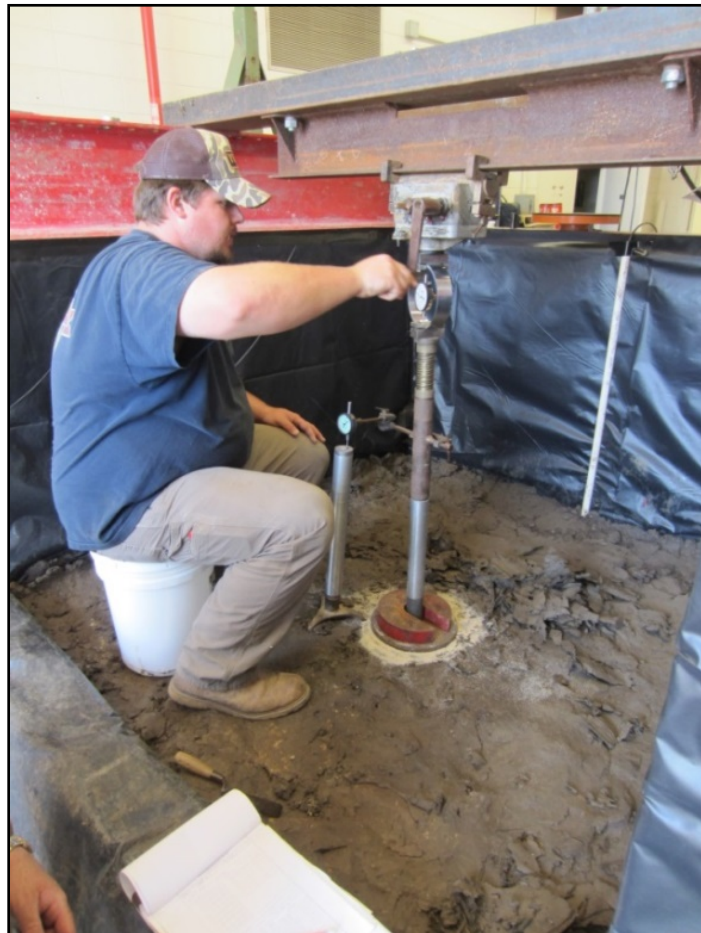
Figure 15. The CBR Testing on the CH Subgrade

Dynamic cone penetrometer (DCP) tests were performed upon compaction of the subgrade layers for each test section. The results from the DCP tests were used to verify constructed subgrade consistency and validated the subgrade strength. Results from DCP tests performed after each test item was fully constructed are presented later in section 4.5. In-field CBR tests were performed at the subgrade surface according to ASTM D4429 [8], as shown in figure 15. Post-construction CBR values are summarized in table 7.

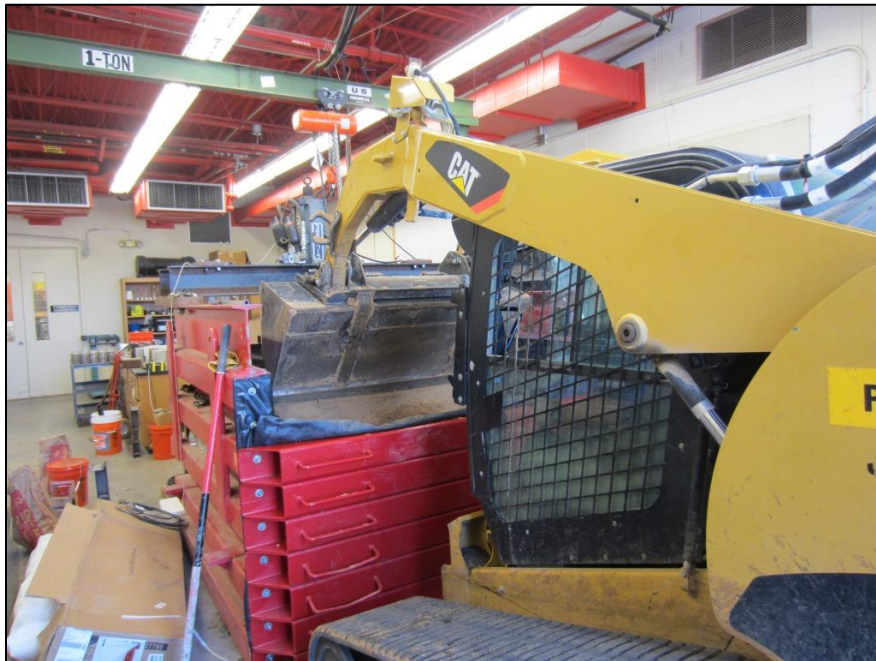
Figure 16. Subbase Material Placement

The granular subbase material was placed using a skid-steer loader, figure 16, and spread by hand over the subgrade in the testing box to the desired thickness. Each lift was compacted using a vibratory plate compactor, as shown in figure 17. After compaction, each lift was surveyed with a rod and level to ensure the targeted lift thickness was obtained. Figure 18 shows the survey points of the compacted and leveled subbase material surface. The thickness data for each test item is summarized in table 5. These thicknesses are average thicknesses from survey data obtained at the surface of the subgrade, subbase and base layers.

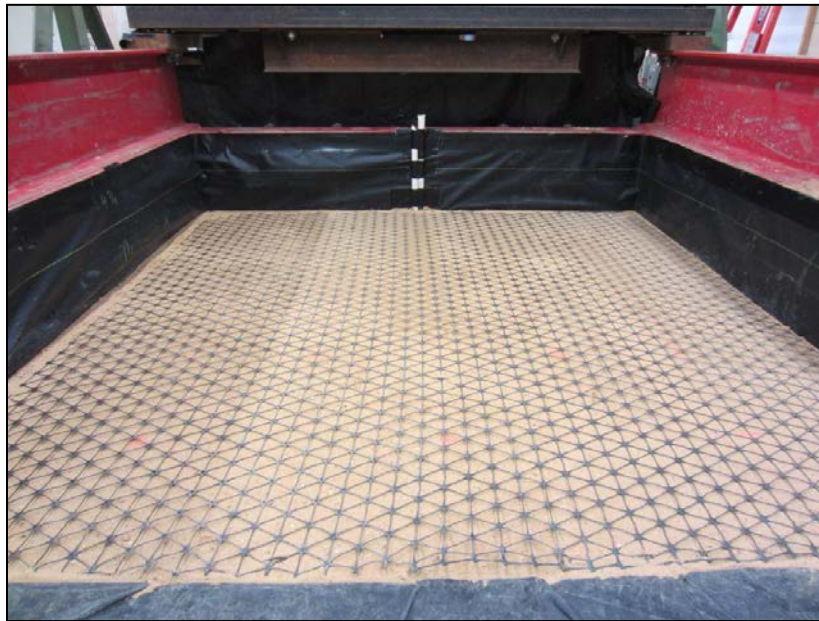
Figure 19. Prepared Surface Prior to Placement of Crushed Limestone Materials

For each test item, the appropriate geogrid was trimmed to the required dimensions for placement in the test box. The geogrid was pulled taught to prevent kinking during placement. Figure 19 shows the subgrade and geogrid surface prior to placement of the crushed limestone base.

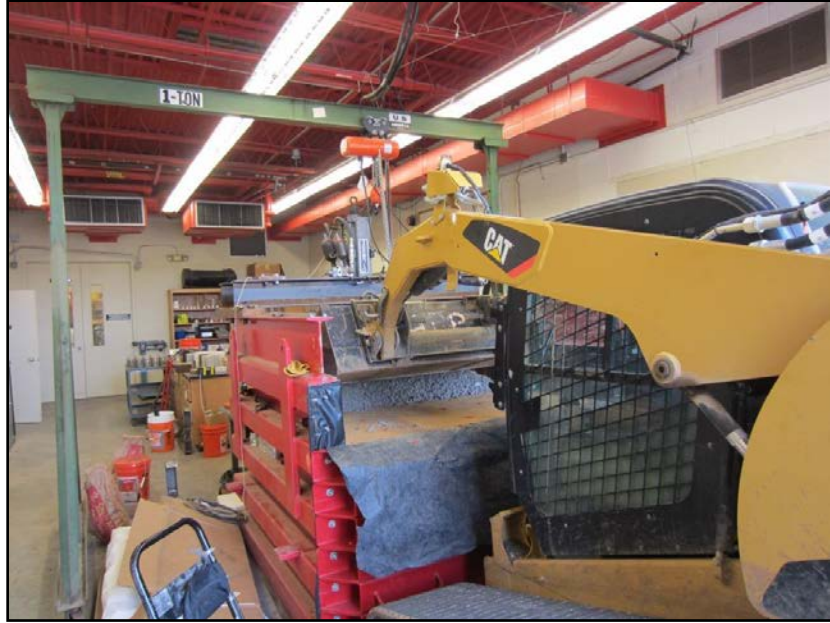
Figure 20. Placement of Base-Course Material

The 610 crushed limestone aggregate was placed using a skid-steer loader, figure 20, and spread by hand over the geogrid surface in the testing box to the desired thickness. Each lift was compacted using a vibratory plate compactor, as shown in figure 21. After compaction, each lift was surveyed with a rod and level to ensure the targeted lift thickness was obtained. The thickness data for each test item are summarized in table 5. These are average thicknesses from survey data obtained at the surface of the subgrade, subbase, and base layers.

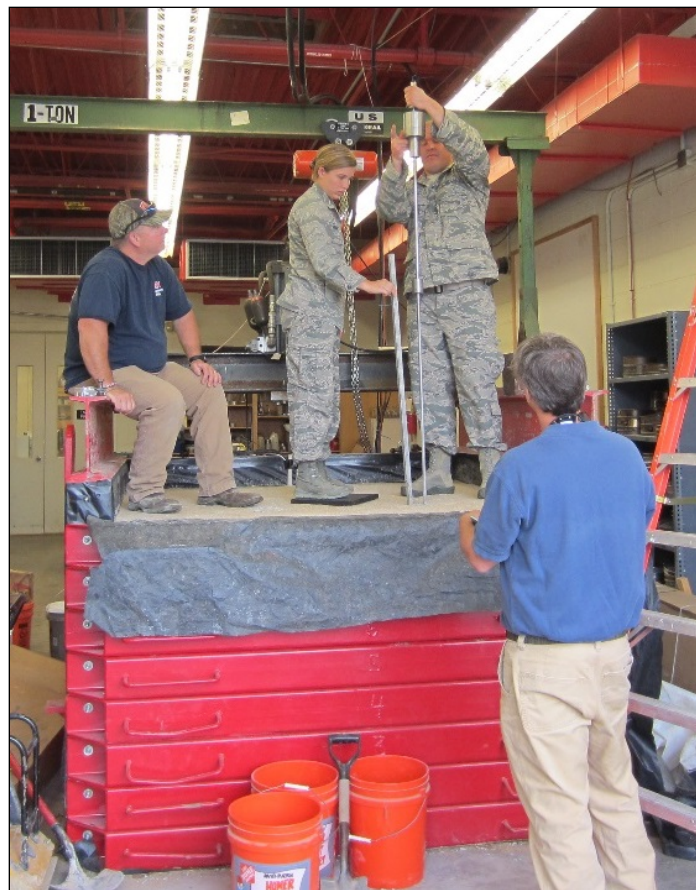
Figure 22. The DCP Testing at the Surface of the Base Course

DCP tests were performed after compaction of the base course, as shown in figure 22. The U.S. Army Corps of Engineers Dual-Mass DCP was used. The large (17.6 lb) hammer was used at the surface, and the small (10.1 lb) hammer was used in the subgrade zone. Raw data was analyzed using Webster’s general equation relating DCP Index (mm/blow) to CBR strength (%) [9 and 10]. The DCP data are shown in figures 23 through 26 for items 1, 2, 3, and 4, respectively. These DCP results incorporate all pavement layers excluding the surface HMA layer. The interface between the different layers is clearly defined in the DCP results. In-field CBR tests were performed at the base surface according to ASTM D4429 [8]. Post-construction CBR values are summarized in table 10.

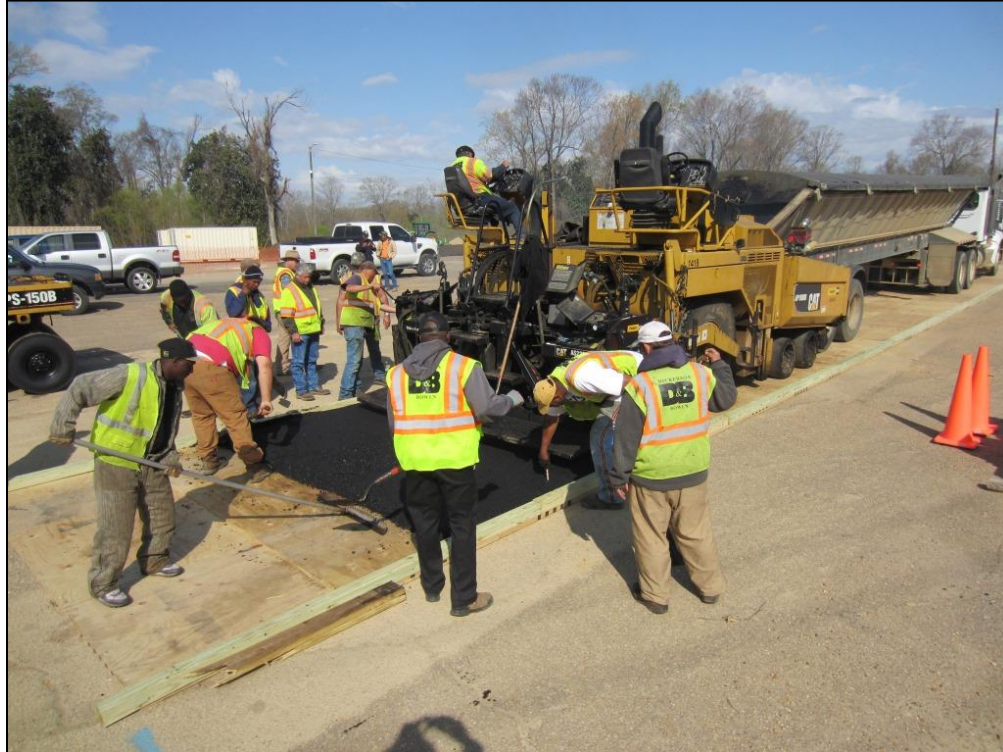
Figure 27. Initial HMA Placement

The asphalt concrete layer used for this project was a locally available dense-graded HMA that met the design requirements for an MDOT HT 12.5-mm mixture with a PG 67-22 binder. To reduce variability in the placement of the HMA in the test box, the HMA was placed in a 12- by 100-ft HMA section and subsequently cut into 5.5-ft-square slabs to be placed in the testing box. The HMA was placed in two lifts; the first lift was 3 in., and the second lift was 2 in. making a final nominal thickness of 5 in. A unique construction method was used to facilitate the movement of the HMA slabs after placement. To transport the HMA slabs to the testing box, the HMA was constructed over 1.5 in. of plywood, as shown in figure 27.

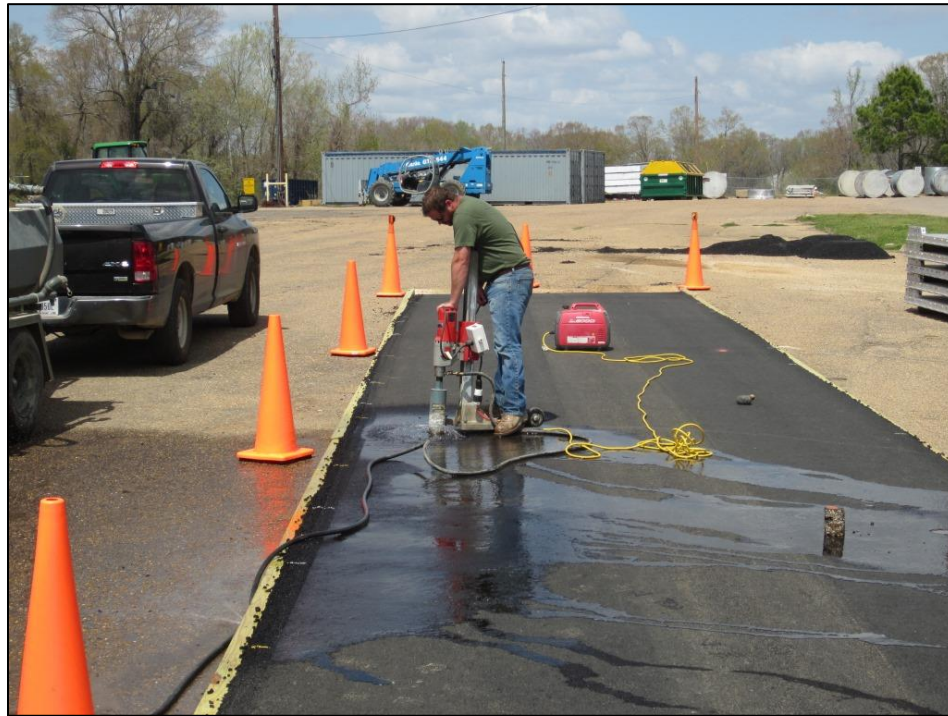
Figure 28. Coring of Placed HMA

Upon compaction of the final lift, cores were taken to evaluate the placed HMA properties, as shown in figure 28. Laboratory tests were run on each of the cores as well as samples taking from the paver during construction. The laboratory test results are summarized in table 11 and the field core densities are summarized in table 12. As previously stated, the section was cut into 12 separate 5.5- by 5.5-ft slabs. Each slab was then moved to a covered storage facility to minimize oxidation effects on the HMA, as shown in figures 29 and 30. The HMA slabs were stored under cover for 9 weeks prior to conducting the first box test. This was to let the HMA cure and try to eliminate variability between the test items in HMA stiffness.

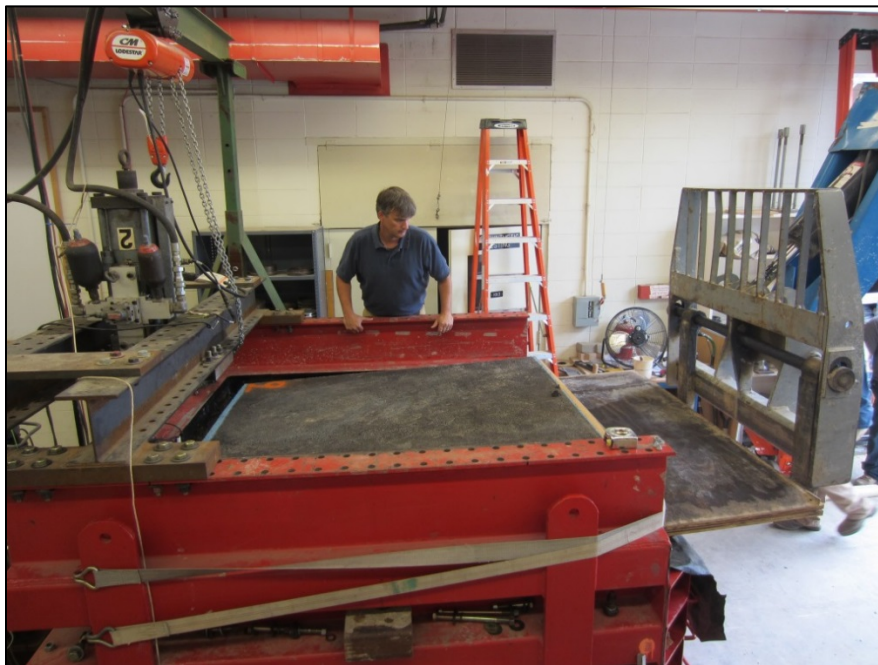
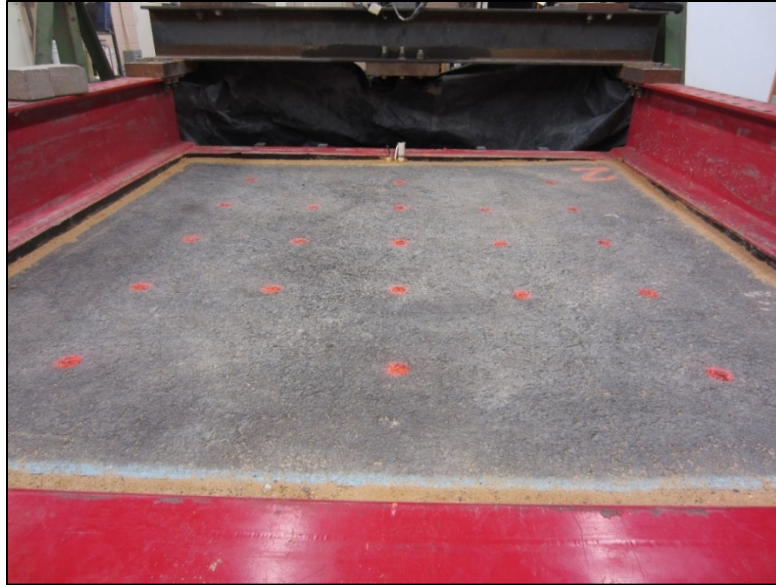
The individual slabs were placed as the surface layer for each individual test by use of a telehandler. The slabs were brought from storage to the testing box, and the HMA was carefully moved from the plywood to the testing box and placed on top of the base course, as shown in figure 31. Survey readings were taken to get final overall thicknesses of each test section. Also, initial baseline surface deformation readings were taken. Figure 32 shows a test item fully constructed prior to testing.

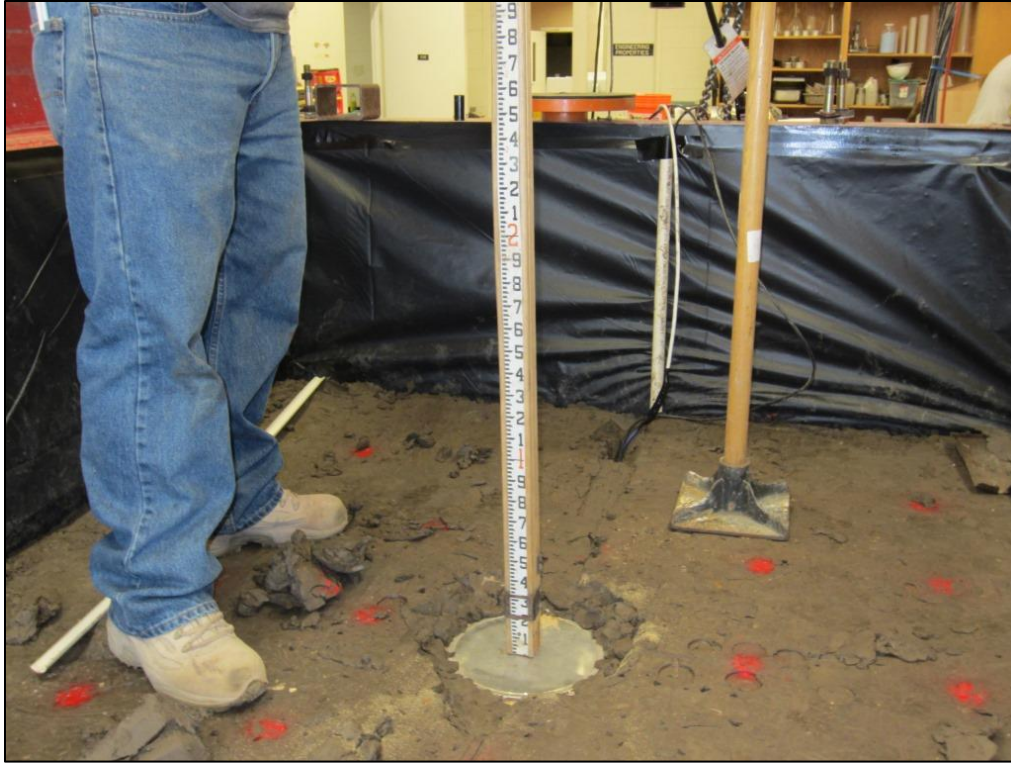
Figure 35. Determining Elevation of Installed EPC

After compaction of the lift associated with each EPC, the subgrade was excavated by hand to place the EPC. Soils were carefully removed to ensure that the EPC was placed at the desired depth within the pavement profile. A thin lift of sand was placed beneath the EPC to ensure adequate contact between the bottom of the EPC and the clay subgrade as well as make certain the EPC was level. The clay surface was hand tamped as it was replaced to prevent the inclusion of voids. The subgrade surface was recompact using the pneumatic hammer in the zone surrounding the EPC prior to placement of the subsequent lift. The elevation of the EPC surface was obtained prior to being recovered with soil, figure 35. The embedment depths of the installed EPCs are summarized in table 13.

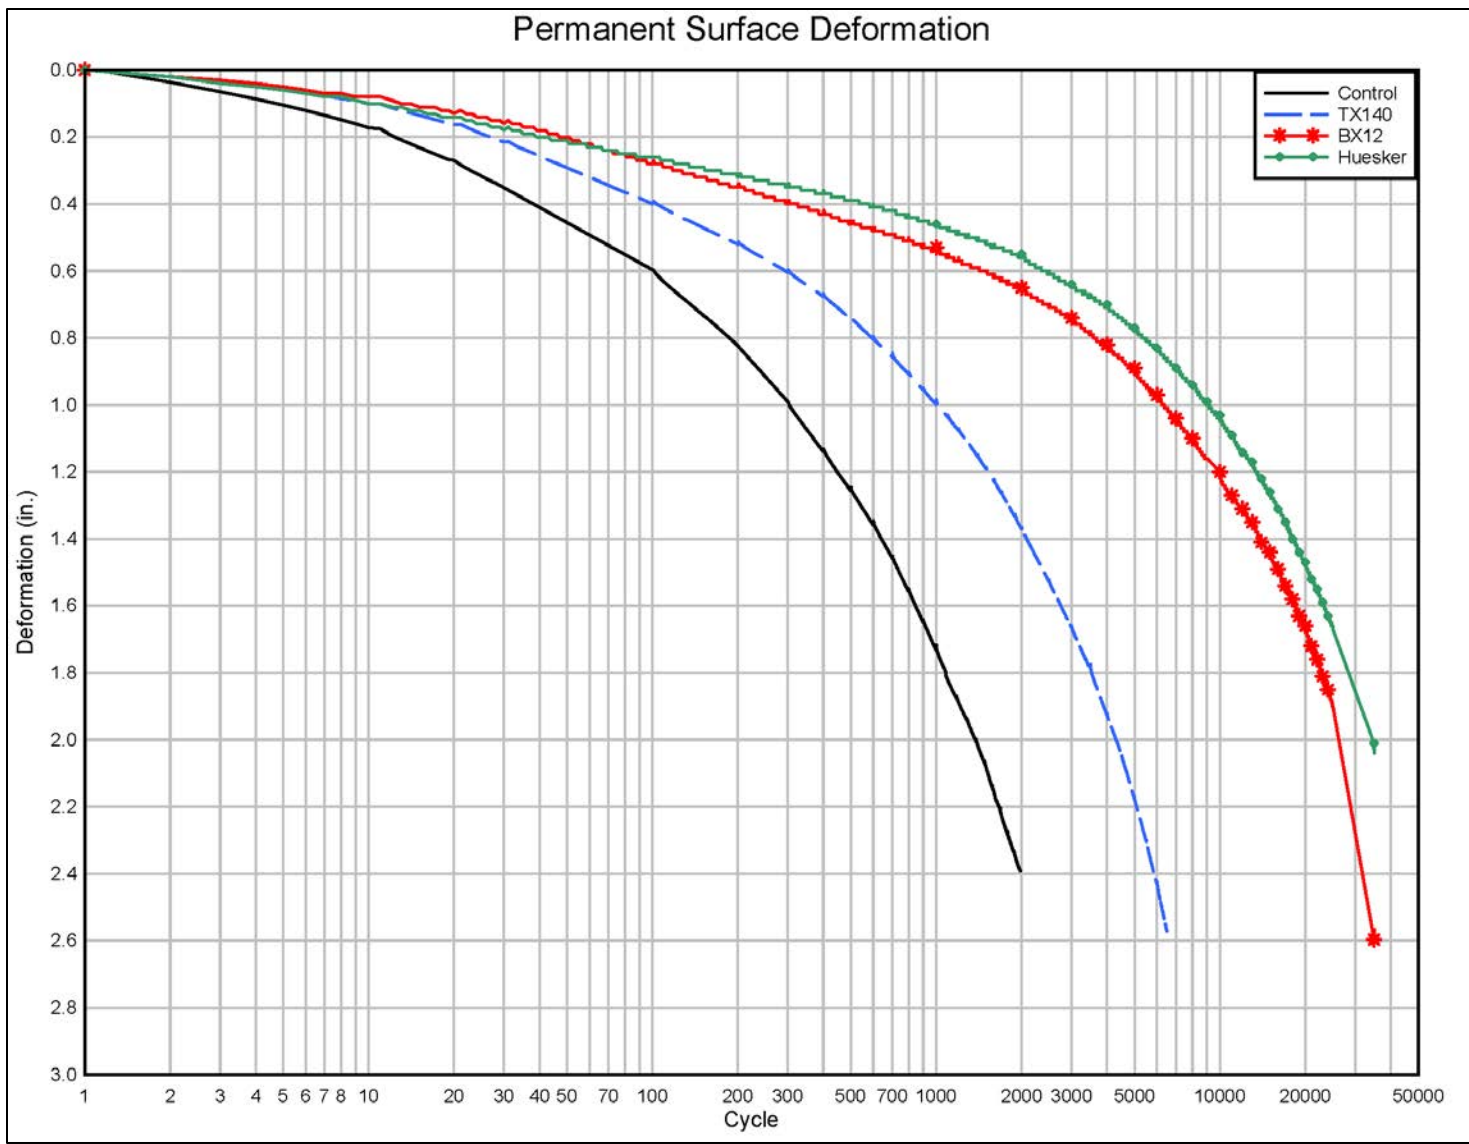
Figure 39. Permanent Surface Deformation

Table 14 presents the load level required for each test item to reach 2 in. of permanent surface deformation. As defined in AASHTO Designation R50-09 [3], the TBR is defined as the ratio of the number of load cycles of a reinforced pavement to reach a defined failure state, to the number of loads for the same unreinforced section to reach the same defined failure state. Two separate TBR values were calculated based on the load levels required to produce 1- and 2-in. permanent deformations in the surface of the test items. A summary of the TBR values is also presented in table 14. It should be noted that the TX140 test item only had a 6-in. base course compared to all the other items that had approximately 7-in. base-course thicknesses. Therefore, it is prudent to compare the TX140 to the control item but not the other geogrid-reinforced items. The permanent deformations measured at the plate for all items tested are graphically shown in figure 39.

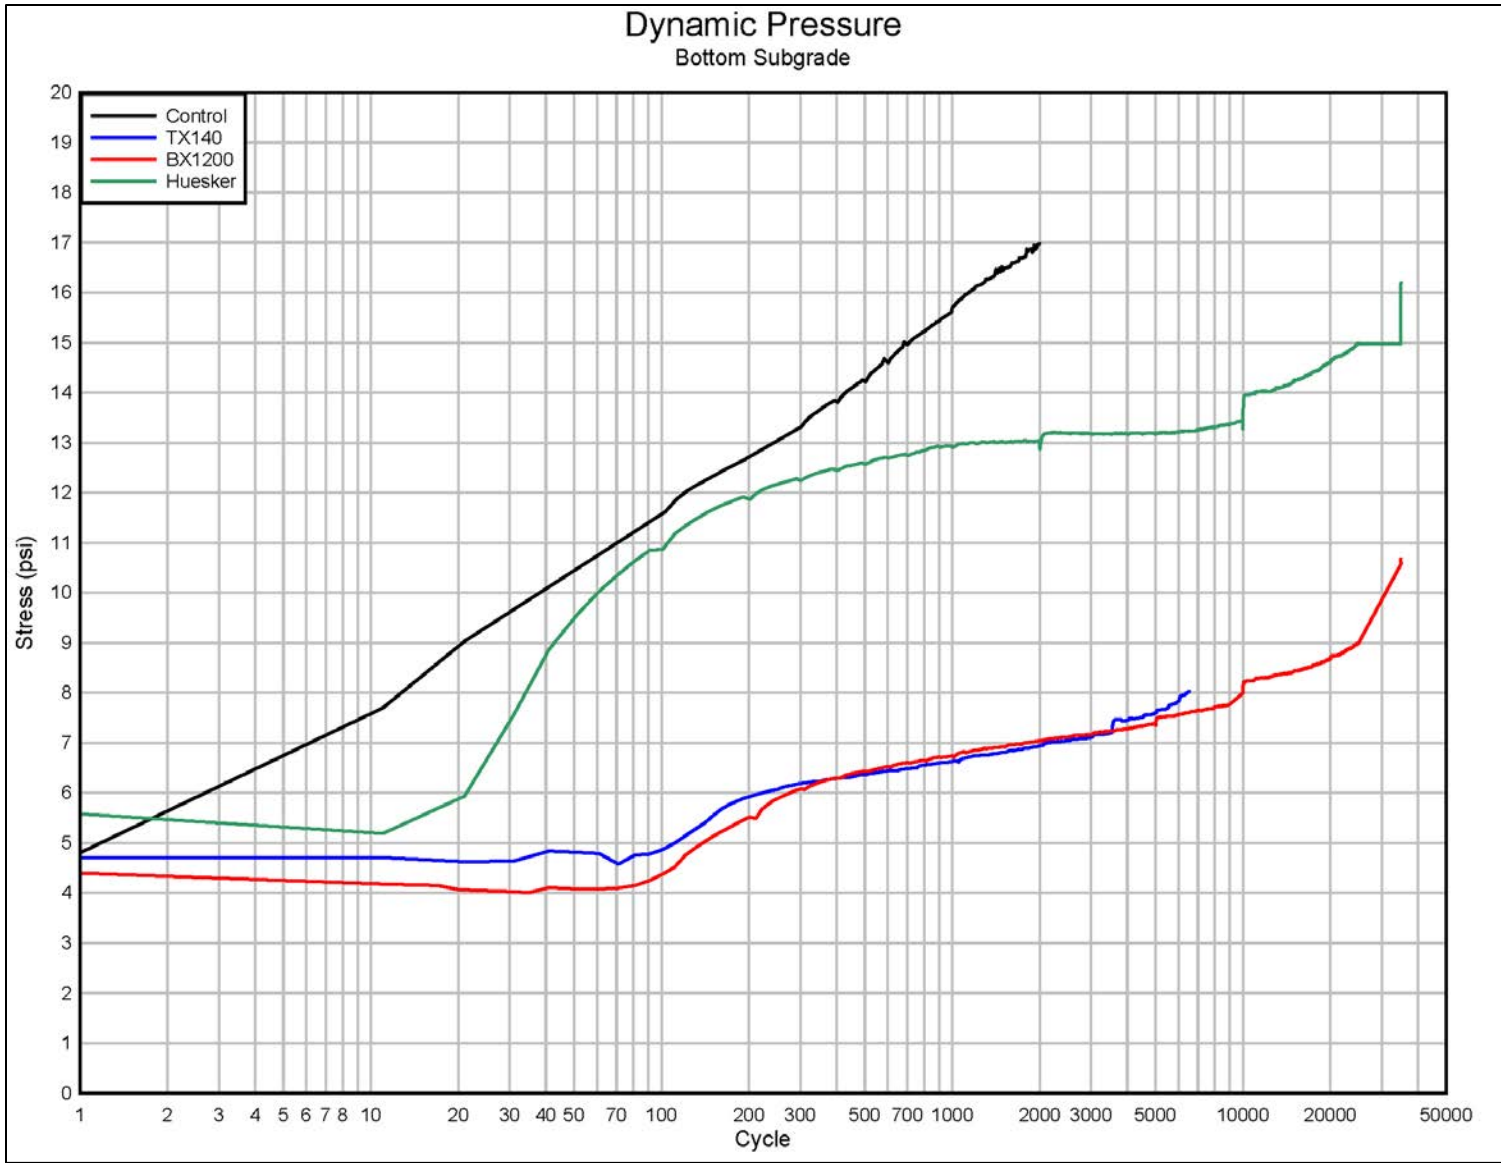
Figure 40. The EPC Response in the Bottom of the Subgrade

The response from the EPCs installed in the bottom of the subgrade layer is presented in figure 40. EPC readings from the top of the subgrade are shown in figure 41. Responses from the EPC installed in the top of the subbase layer are displayed in figure 42.
