Impact Testing of Inconel 718 for Material Impact Model Development

*J. Michael Pereira, Duane M. Revilock, and Charles R. Ruggeri
Glenn Research Center, Cleveland, Ohio*

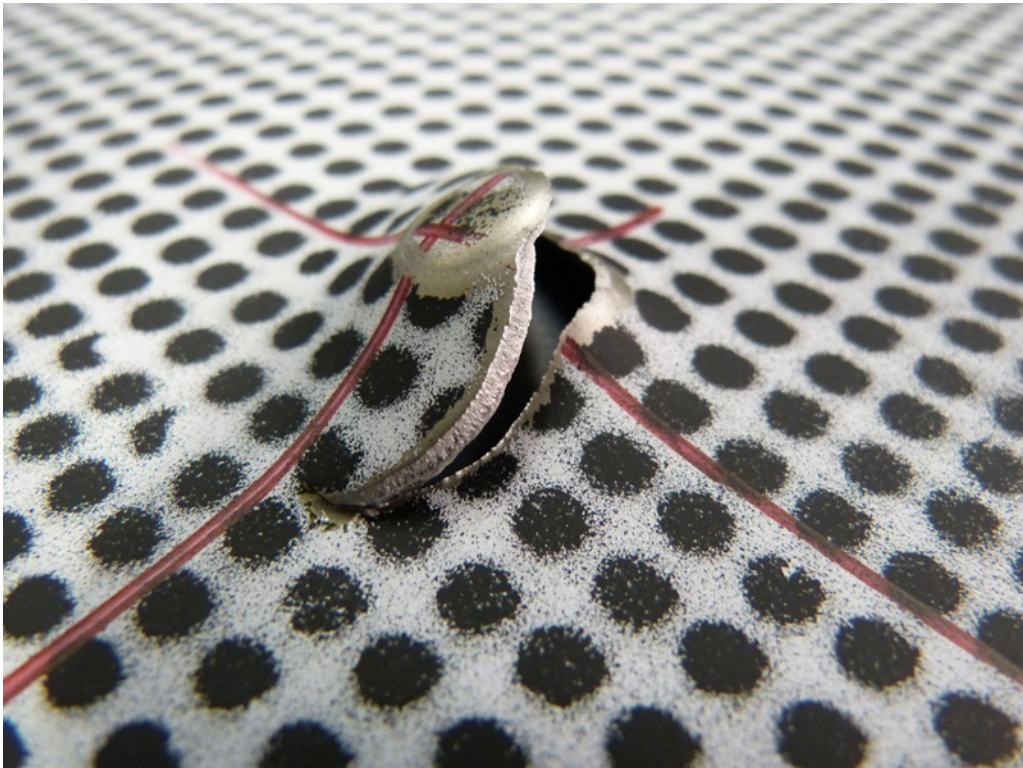
Figure C.18.—DB236 posttest rear view closeup.

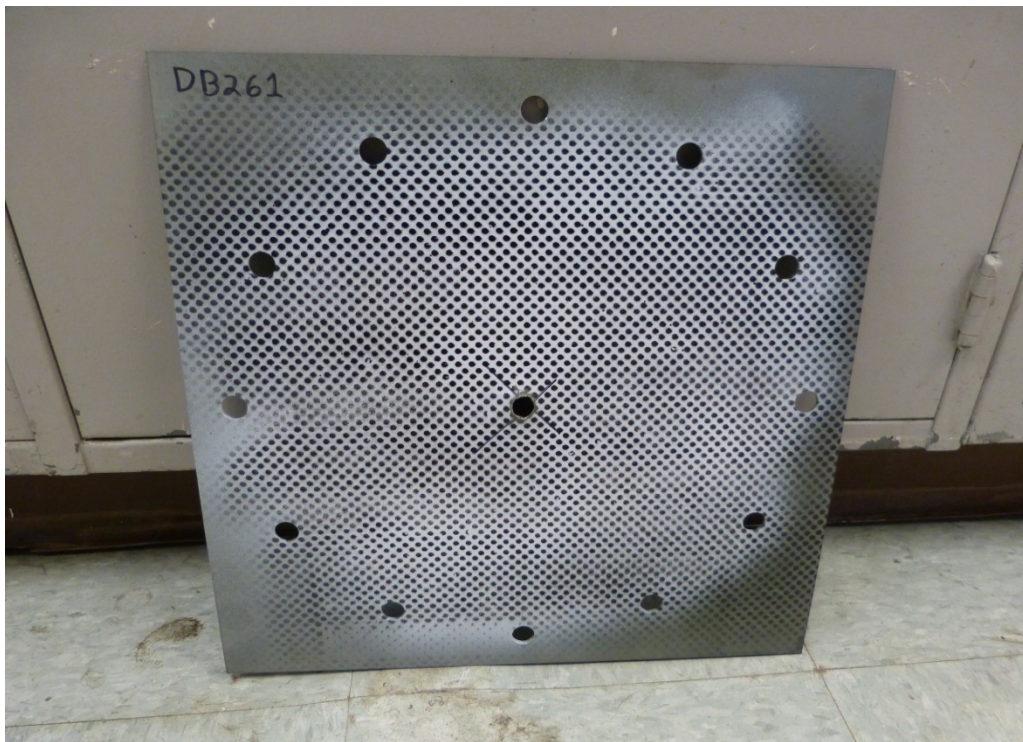
Figure C.113.—DB261 posttest rear view.
