Impact of Lithium Battery Vent Gas Ignition on Cargo Compartment Fire Protection

November 2016

DOT/FAA/TC-TN16/34

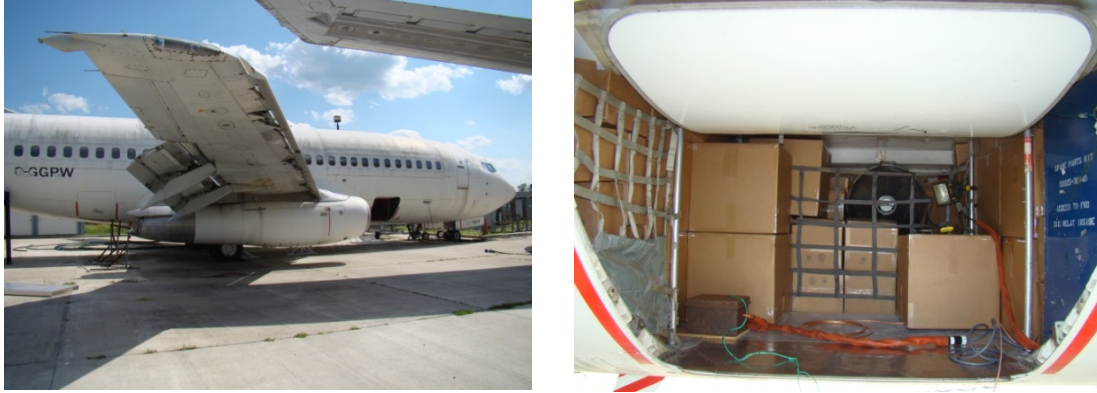
Figure 2. The 737 forward cargo compartment

Tests were conducted in two test articles. First, tests were carried out in a 10.8 m³ pressure chamber to determine the relationship between the volume of lithium battery vent gases and the pressure rise in the chamber. Next, tests were performed in a 737 forward cargo compartment with a volume of approximately 10.48 m³ to determine the pressure rise and corresponding number of lithium-ion batteries required to dislodge the compartment pressure relief panels or damage the cargo liner. In each of the tests, pressure rise was measured with a 0–30 psia Honeywell pressure transducer and recorded with a data collection system at approximately 50 Hz.

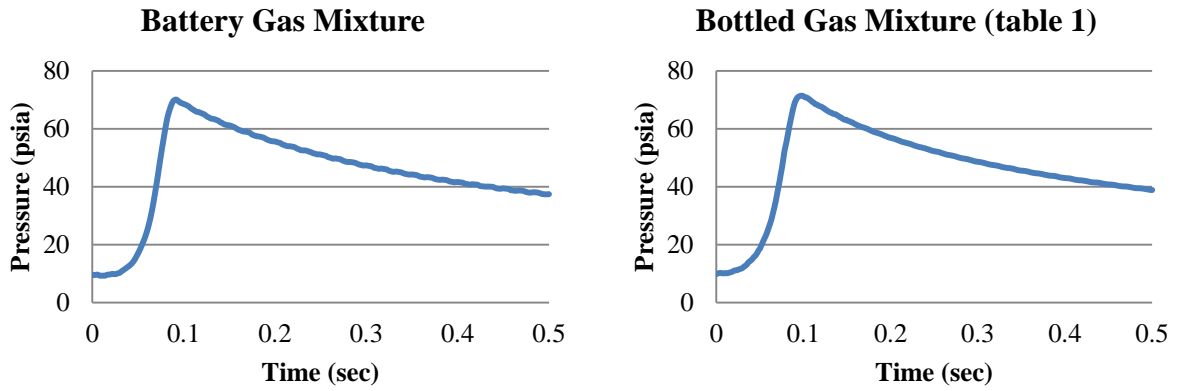
Figure 5. Comparison of pressure rise between actual gas and bottled gas

The flammable gas used for the tests was metered by an Environics gas divider that was connected to a gas cylinder containing a flammable gas mixture similar to what was measured from battery cells (see table 1) [1]. The concentration of the gas mixture added to the balloon was 21.7% battery gas and 78.3% air, shown previously to be the concentration near the peak pressure rise [1]. Gas was added to the balloon at one liter per minute until the desired volume was attained. To verify that the pressure rise from the bottled gas was similar to the pressure rise from the vented battery gas, a comparison was made in a 21.7 liter combustion sphere. The battery gas was obtained by inducing thermal runaway in LiCoO_2 cells and using partial pressures to achieve a 21.7% concentration in the combustion sphere [1]. On ignition, the pressure rise profiles from the actual battery gas and the bottled gas mixture were nearly equal (see figure 5). Therefore, the bottled gas was used in subsequent tests to represent the flammable gas mixture vented by LiCoO_2 cells in thermal runaway. To prevent stratification of gases within the balloon, a fan was directed toward the balloon to shake it and mix the gases. Figure 6 shows the balloon setup immediately prior to ignition.

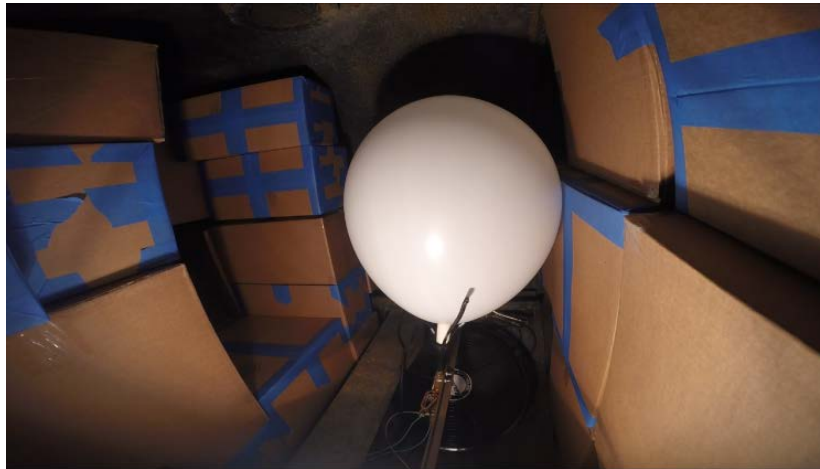
Figure 6. Balloon rig in pressure chamber immediately prior to ignition

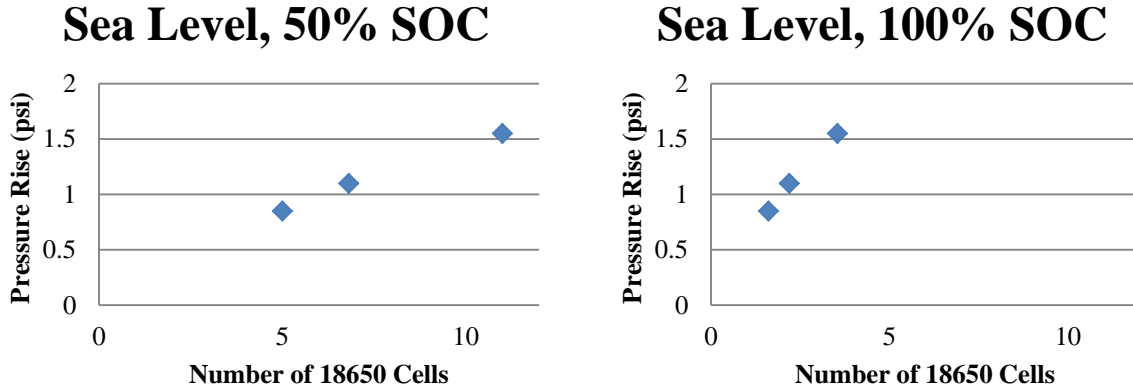
Figure 9. Pressure rise in chamber at sea level

Tests were conducted in the 10.8 m³ pressure chamber at sea level pressure and at a pressure of 10 psia, which roughly corresponded to cabin pressure at altitude. The results showed a nearly linear increase in pressure rise with the equivalent number of batteries corresponding to the gas mixture volume (see figures 9 and 10). The slope of the line is greater at 100% state of charge (SOC), which reflects the increase in gas volume with SOC [1]. Moreover, the number of cells required to achieve a given pressure rise decreases with altitude. Table 4 shows that the pressure

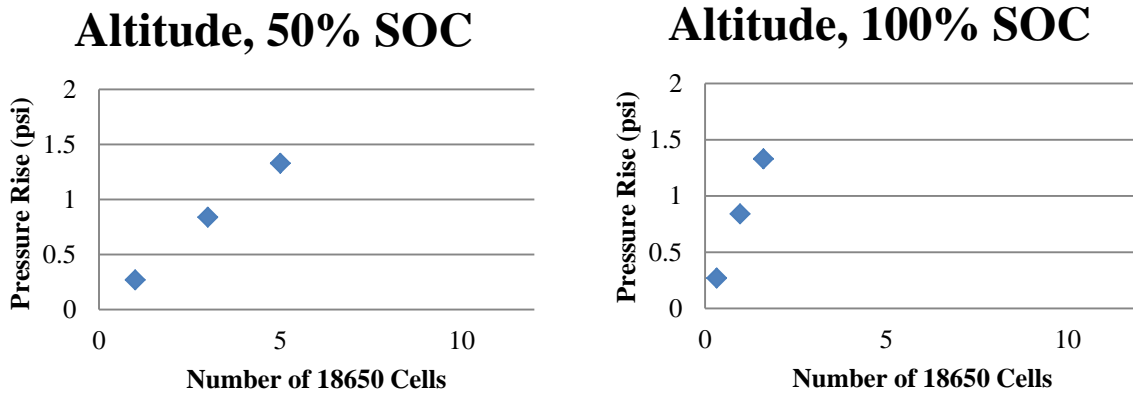
Figure 10. Pressure rise in chamber at altitude

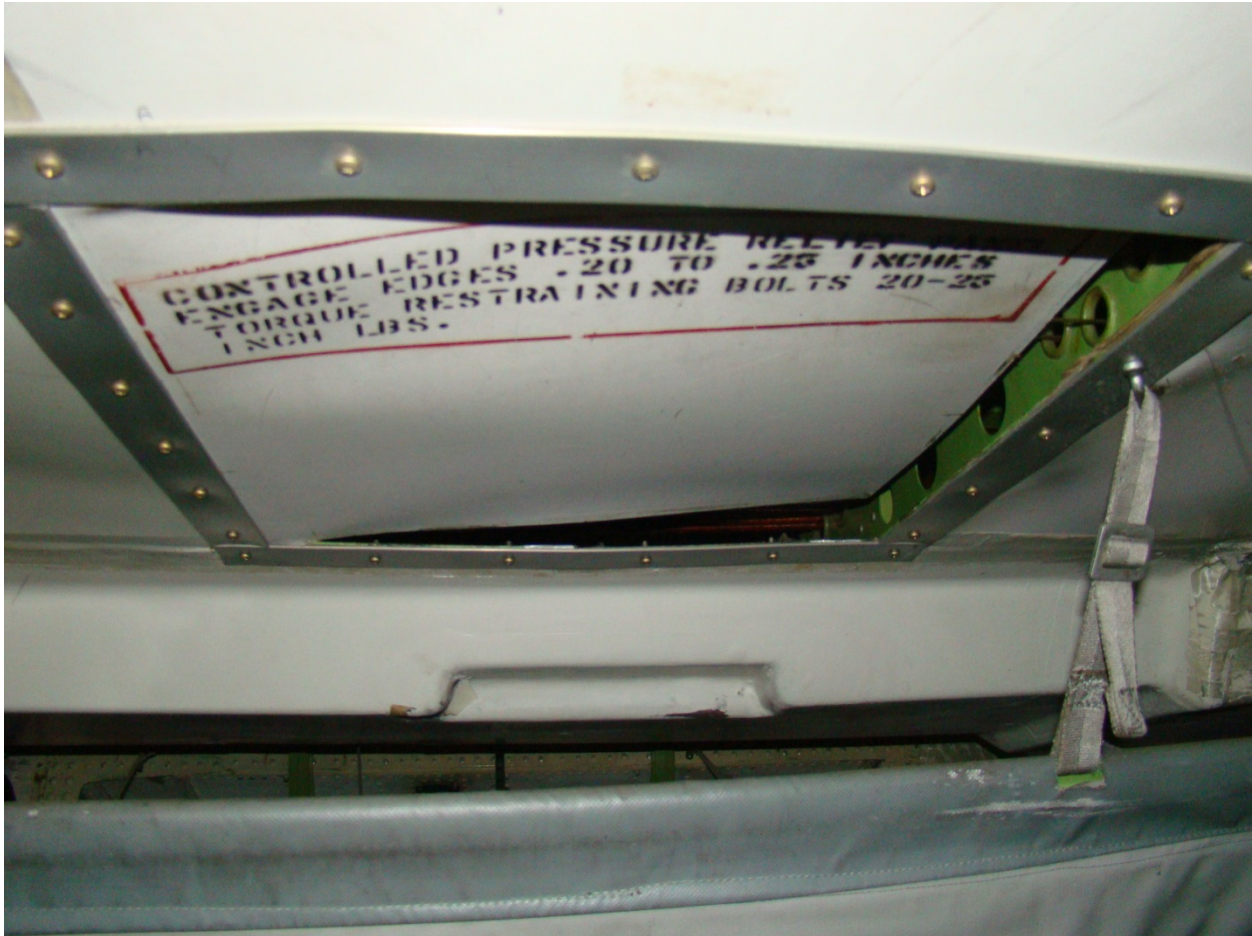
Figure 12. Pressure relief panel above the door after a 6.4 cell at 100% and a 20 cell at 50%

The test with the greatest bottled mixture gas volume, corresponding to 6.4 cells at 100% SOC or 20 cells at 50% SOC, produced a pressure rise of 1.2 psi that completely dislodged the forward and aft panels and also dislodged the third panel above the door (see figure 12). In addition, a section of cargo liner was damaged as a result of the test.
