## **Runway Approach Hold Area Signage and Marking Study**

June 2017

DOT/FAA/TC-TN17/32

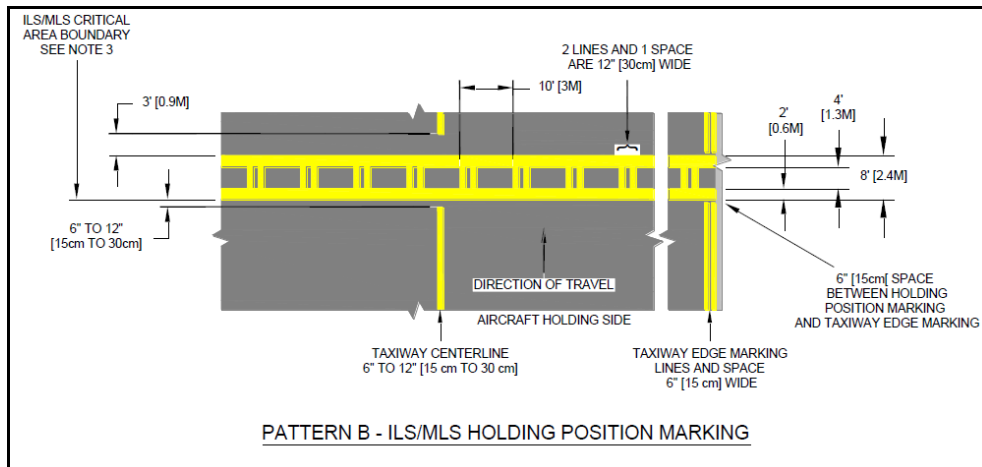
Figure 5. Pattern B Surface Marking [4]

The Pattern B instrument landing system (ILS)/microwave landing system (MLS) holding position marking was recommended by the Approach Hold Workgroup to be positioned adjacent to approach hold signage. Unlike the Pattern A surface marking, the Pattern B marking allows pilots and vehicle operators to cross the marking unless specifically instructed by ATC to hold short. This matches the Aeronautical Information Manual (AIM) definition of an approach

holding position more so than the Pattern A marking, which requires all individuals to hold short unless an explicit instruction is issued to cross the marking [8].

Figure 4 shows examples of the signage and markings recommended by the SRM panel. As shown, the signage includes “Runway XX DEP” in addition to the approach runway. The surface marking will be the Pattern B surface marking shown in figure 5.

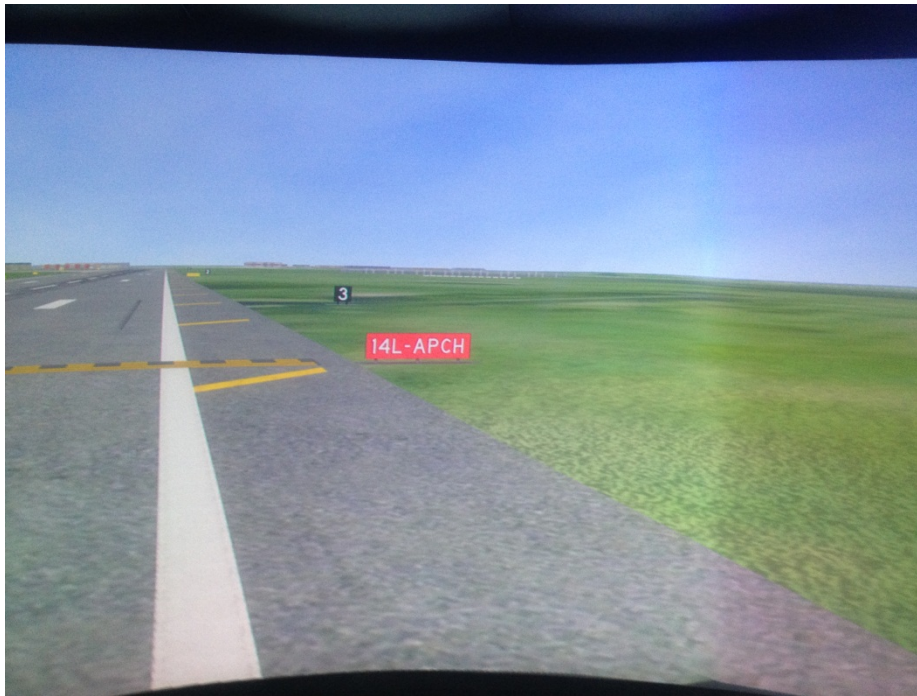
Figure 6. Simulated Standard Approach Signage and Markings Example

Examples of the signage and markings viewed by subjects are shown in figures 6 and 7. Figure 6 shows the standard configuration of runway approach signage and surface marking, while figure 7 shows the simulated version of the signage proposed by the Approach Hold Workgroup. Each sign was evaluated on both runways and taxiways.

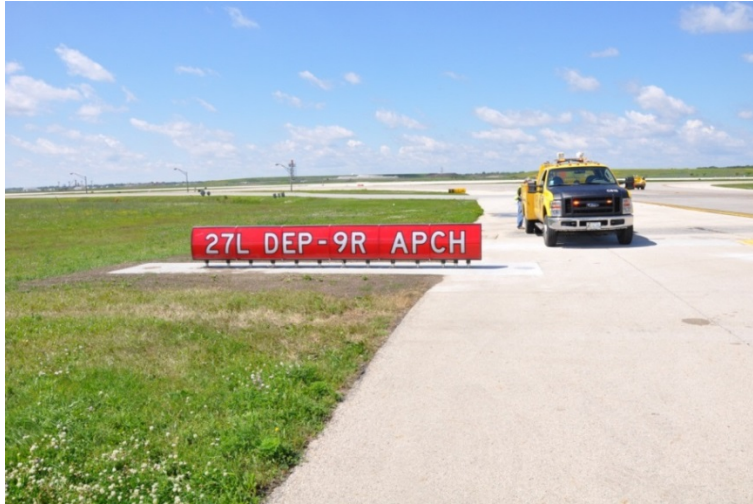
Figure 9. Installed Proposed, Connected Signage at ORD

Two variations of signs were installed. The first, shown in figure 9, consisted of one, size 2, six-module sign unit. The second variation, shown in figure 10, consisted of a pair of separate, size 2, three-module sign units with the legend text split between the units. The connected, six-module sign was 218 inches long, exceeding the 145-inch maximum length specified in AC 150/5345-44J, “Specifications for Runway and Taxiway Signs” [9].

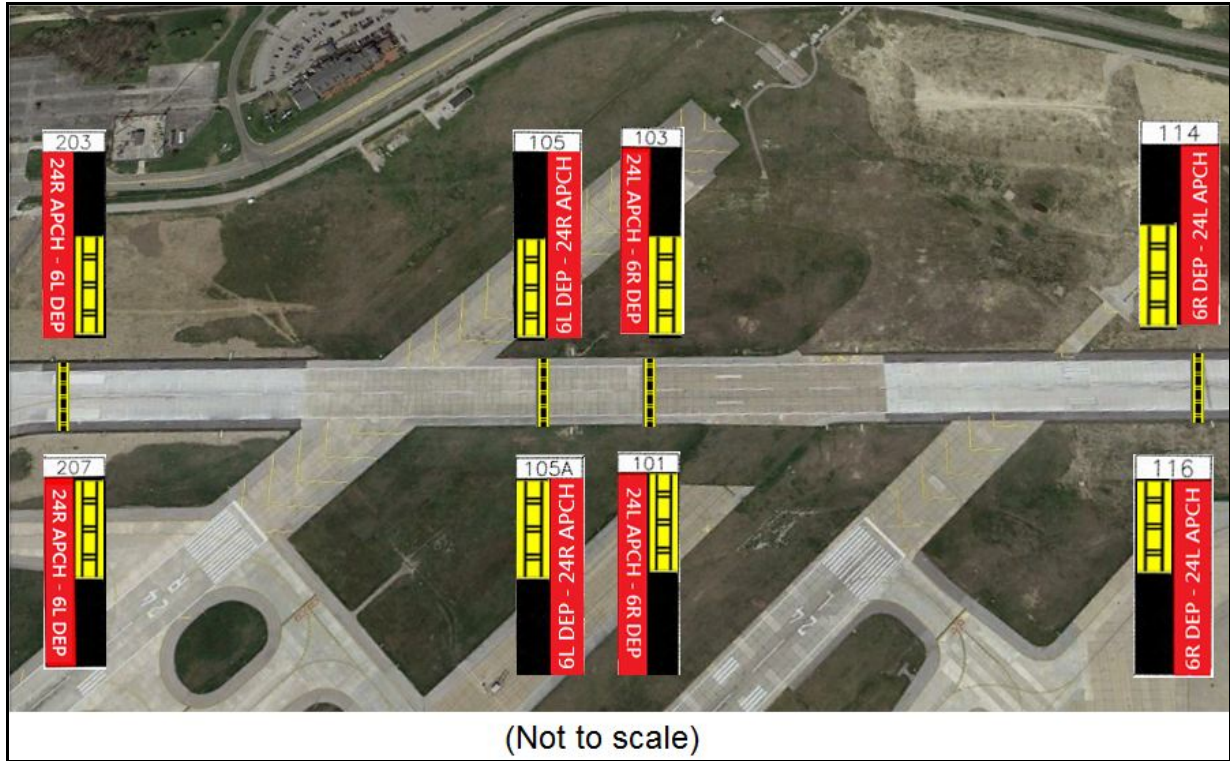
Figure 11. Signage and Markings Evaluation Locations at CLE

CLEVELAND-HOPKINS INTERNATIONAL AIRPORT. The second airport included in the evaluations was Cleveland-Hopkins International Airport (CLE). The signage and markings evaluated were located at the positions shown in figure 11. These consisted of four pairs of signage positioned on each side of RWY 10-28. The signs were size 2 panels with nonstandard, reduced, 9.5-inch legend text. This legend text size was used to determine if reduced-size legend text would be viable for use when space was not available to expand the sign units. A photo of the signage evaluated at CLE is shown in figure 12.

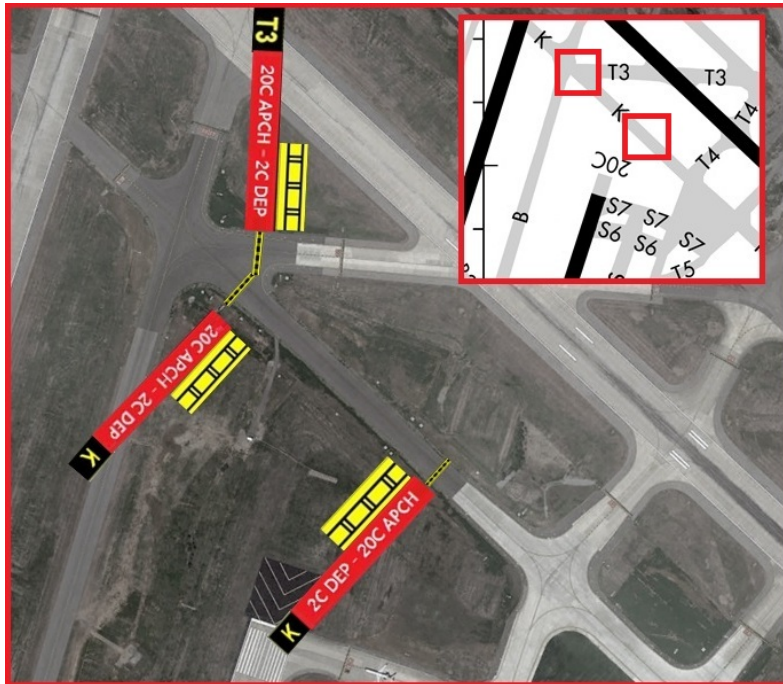
Figure 13. Signage and Markings Evaluation Locations at BNA

NASHVILLE INTERNATIONAL AIRPORT. The third airport included in the evaluation was BNA. This evaluation consisted of installing signage and markings in the approach holding positions for the RWY 20C approach and RWY 2C departure, at the location shown in figure 13. All signs were size 3 modules. As shown in figure 14, the signs featured nonstandard, 11.5-inch legend text size to determine if this would be a viable alternative for airports lacking space for sign unit expansion. Similar to ORD and CLE, surveys were conducted to collect data from pilots and vehicle operators at the airport. ATC representatives at the airport were also interviewed to gather their feedback.

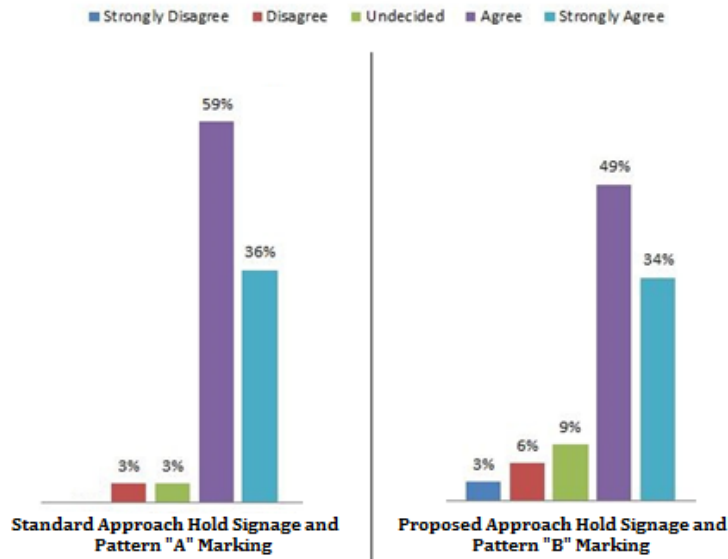
Figure 15. Simulation Results: Sign and Markings General Understanding

SIMULATION EVALUATIONS. For the simulation evaluations, the level of understanding for the signage and markings was consistent between the current signage and markings and the proposed signage and markings. As indicated in figure 15, a slightly higher percentage of subjects (95%) agreed the meaning of the existing APCH signs and runway holding position markings were understandable compared to the proposed signs and markings (83%). This was expected because of the increased familiarity individuals had with the current approach signage compared to the new signage and markings being viewed for the first time.

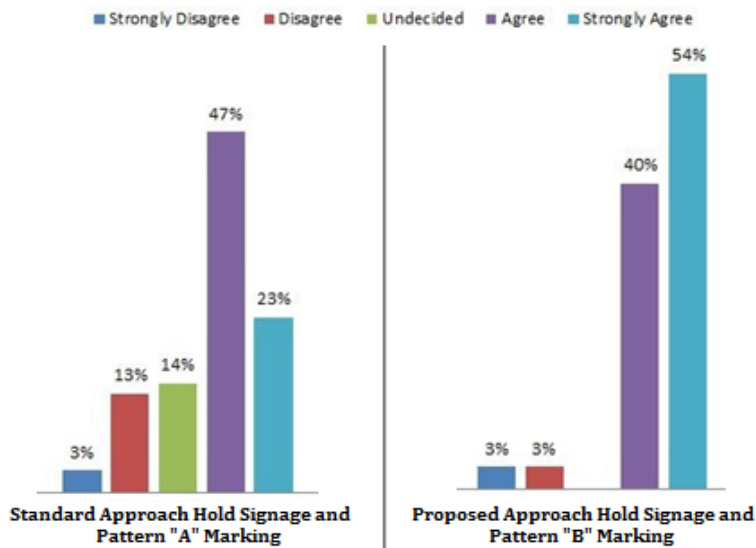
Figure 16. Simulation Results: Logical Consistency

Throughout the simulations, subjects were instructed by ATC to hold short at certain approach hold locations, but at other locations they were not provided with any holding instructions. As shown in figure 16, 94% of subjects reported the proposed signage and markings were logically consistent with these ATC instructions compared to 70% for the current signage and marking.

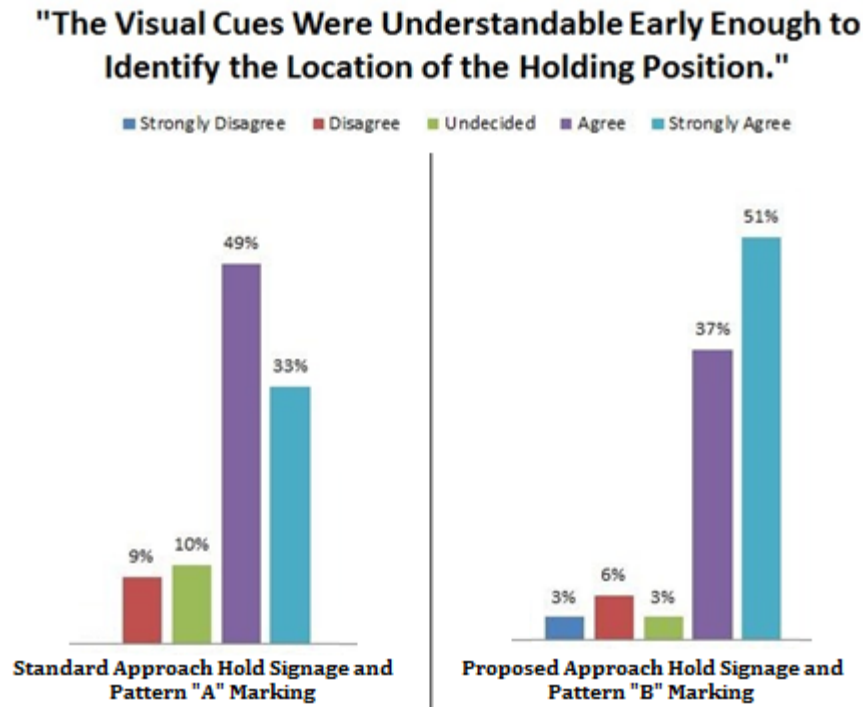
Figure 17. Sign and Markings Comprehension Time

Furthermore, as shown in figure 17, results from the simulations indicated the proposed signage and markings were more likely than the current signage and markings to be understood early enough to identify the location of the hold position.

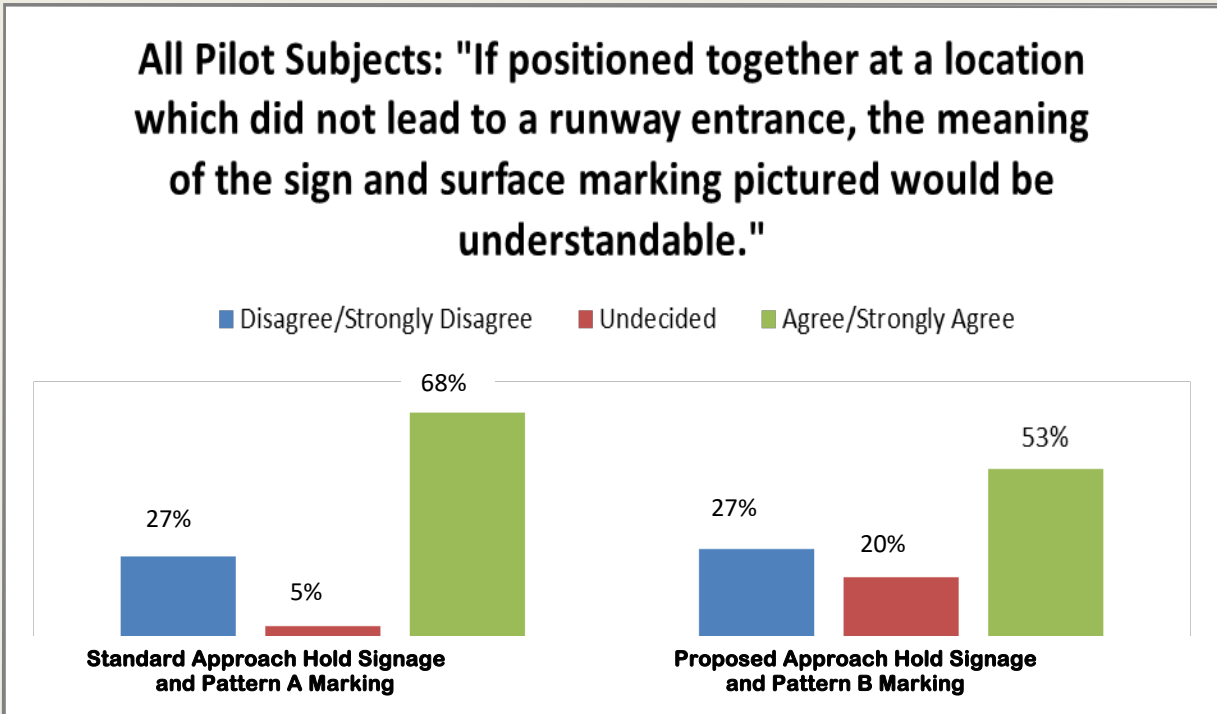
Figure 18. Airport Results: Signage and Markings Understanding

Survey results for overall understanding of the proposed signage and markings was lower than for the current signage and marking. Figure 18 shows the level of agreement that the signage and markings were understandable fell from 68% to 53%. However, the level of disagreement that the signage and markings were understandable remained unchanged, with a greater percentage being undecided. This indicates that the lack of familiarity with the signage and markings is likely a significant factor contributing to the lack of understanding among some pilots. It is expected that as pilots are trained under the new guidance for the signage and marking, they will become more knowledgeable of their meaning.

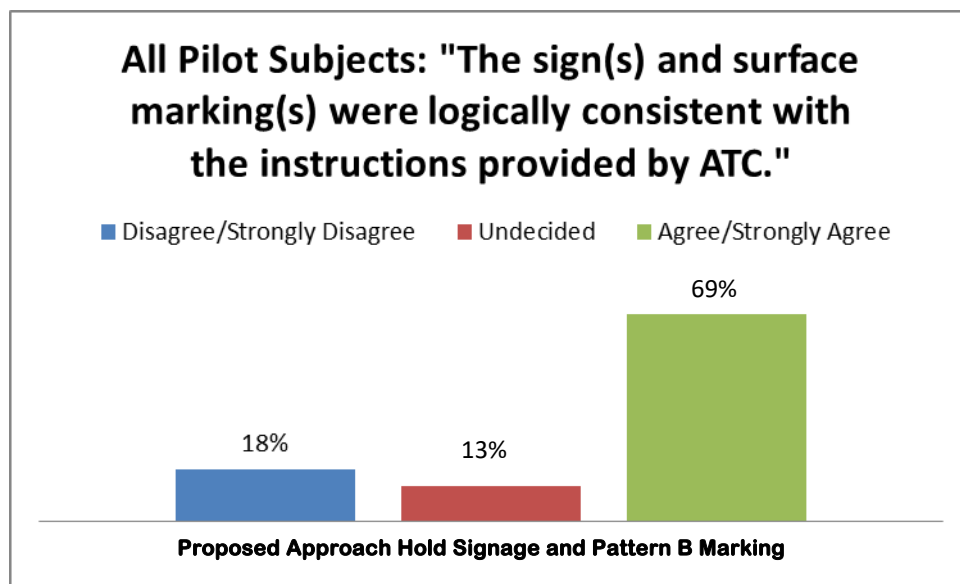
Figure 19. Airport Results: Logical Consistency

As shown in figure 19, the level of agreement with the statement, “The sign(s) and surface marking(s) were logically consistent with the instructions provided by ATC,” was 69%. This indicates that a majority of the pilots thought there was logical agreement between the signage and markings and the ATC instructions, but some confusion remained among just under a third of the pilots.

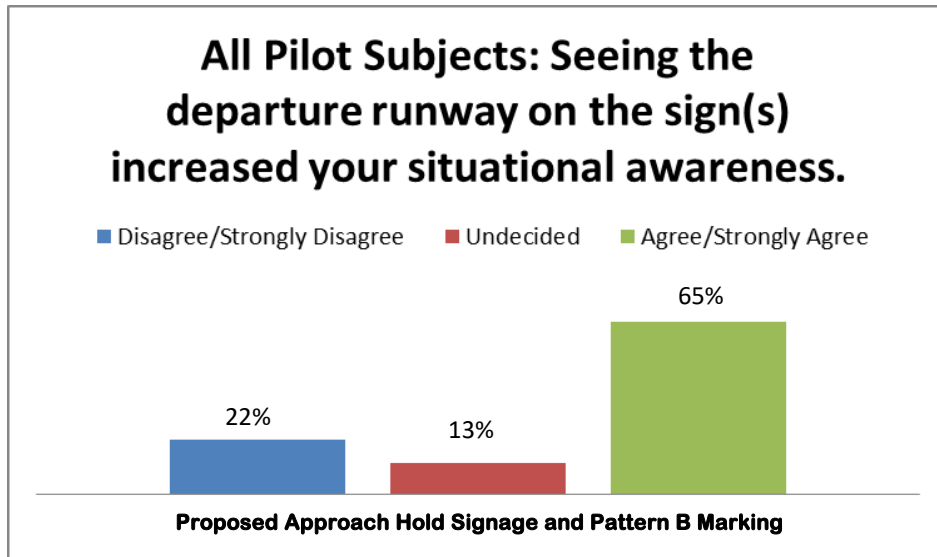
Figure 20. Airport Results: Situational Awareness

Pilots taking part in the airport evaluations were also asked to respond to a statement regarding the situational awareness benefits of the new signage compared to the existing signage. As shown in figure 20, 65% of pilots were in agreement that the inclusion of the departure runway information increased their situational awareness. However, 22% disagreed that the departure runway improved situational awareness, and 13% were unsure whether their situational awareness was increased relative to the current approach hold signage standards.

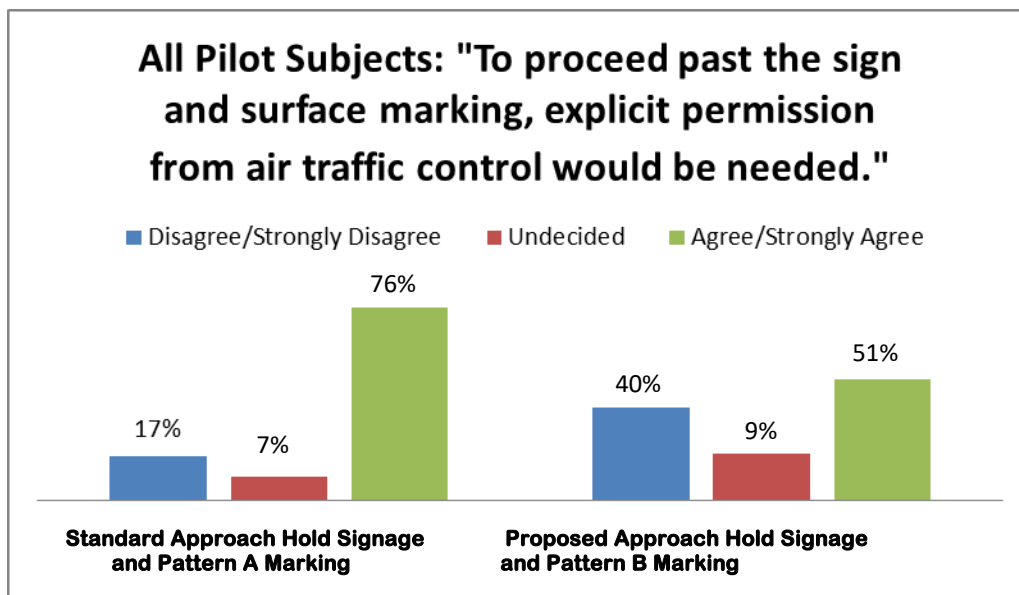
Figure 21. Airport Results: Approach Holding Requirements

As shown in figure 21, the rate of disagreement with the statement, “To proceed past the sign and surface marking, explicit permission from ATC would be needed,” increased from 17% to 40%. This indicates some pilots would be less likely to hold short when not given explicit instructions to do so. Furthermore, the level of agreement with the statement fell from 76% to 51%. However, 16% of pilots reported being undecided regarding the statement. These results indicate that ATC workload will likely decrease when the signage and markings are adopted, but further training and guidance may be necessary to inform pilots that holding short at approach hold areas is only required when instructed by ATC.

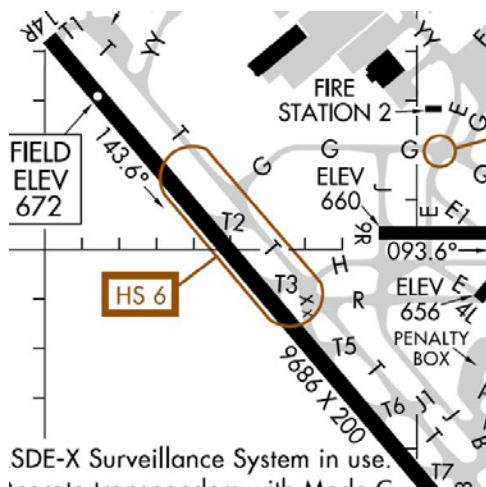
Figure 22. Hot Spot 6 at ORD

RUNWAY INCURSION DATA. As described in The SRM Risk Assessment: Pilot Confusion section of this technical note, one of the risks identified by the SRM panel was the occurrence of runway incursions. It was found that seven Category C runway incursions occurred during the study at a location where the proposed approach hold signs and markings were installed. All the runway incursions that occurred during the study occurred at one approach hold area at ORD. This approach hold area, protecting RWY 9R-27L, is shown in figure 22. This approach hold area is identified as Hot Spot 6 (HS6). A hot spot is defined by the FAA as, “A location on an airport movement area with a history of potential risk of collision or runway incursion, and where heightened attention by pilots and drivers is necessary.” [10] Therefore, the complex taxiway geometry likely was a contributing factor for these events. Since runway approach hold incident data were not tracked prior to the study, it was not possible for researchers to compare the number of past events. It should be noted that no runway incursions were recorded during the first 6 months of the study (July 2014- January 2015), and none were reported after June 2015. The reason for the runway incursions occurring within this timeframe are not known, but could potentially be a result of changes in ATC procedures beyond the scope of the study.

Air traffic controllers at ORD reported prior to the research effort they would instruct pilots to hold short of specific taxiways, such as at TWY T or TWY G, to avoid the problems caused by the use of APCH holds. One source of confusion in communications was related to the use of the terms “approach” and “departure.” These can be confused with the approach and departure ends of the runway itself rather than the approach and departure protected areas. The controllers reported that this is mainly an issue where pilots must decide whether to continue on a given taxiway or to turn onto another taxiway. For instance, some pilots mistakenly turned onto TWY J and hold short of Runway 9R when told to “hold short 9R approach” (under the assumption that this meant hold short of the approach end entrance to Runway 9R). This resulted in the need for extra coordination between the ground controller and local controller for authorization to cross the runway. The controllers said the confusion was not an issue for aircraft on TWY T taxiing southbound, because there are no opportunities to turn off of the taxiway before reaching the approach hold location on this taxiway.
