DOT/FAA/AM-02/19

# **General Aviation Pilot Performance Following Unannounced In-Flight Loss of Vacuum System and Associated Instruments in Simulated Instrument Meteorological Conditions**

Final Report

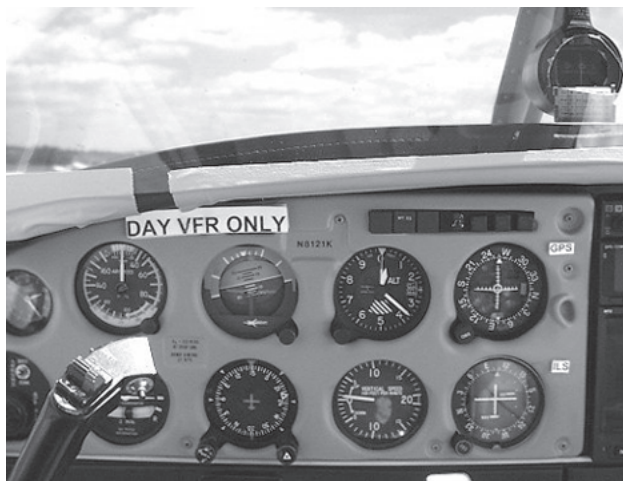
**Figure 1.** Archer instrument panel.

*Aircraft.* The two aircraft used were a simple (Piper Archer PA-28) (see Figure 1) and a complex (Beechcraft Bonanza A36; see Figure 2) airplane. Each was equipped with all Federal Aviation Regulation - FAR - required items for a single-pilot IFR flight. Polarized material was placed across the lower portion of the windscreen and left side window of each aircraft (see Figure 3) so that approximately the lower two-fifths of the windscreen was covered. The Francis hood used to simulate IMC (see inset, Figure 3) contained the same polarized material in the eye openings, oriented 90° to

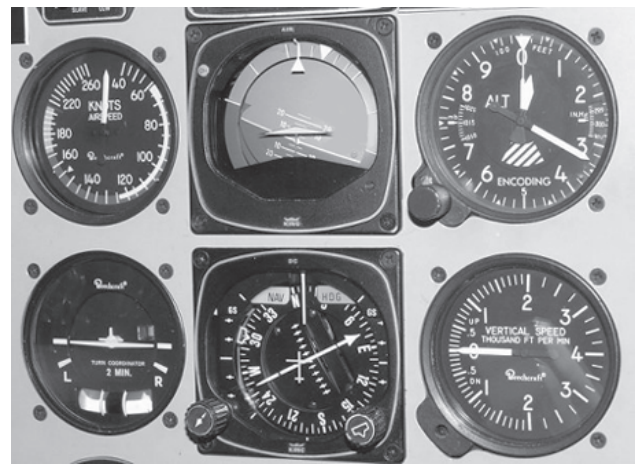
**Figure 2.** Bonanza instrument panel.

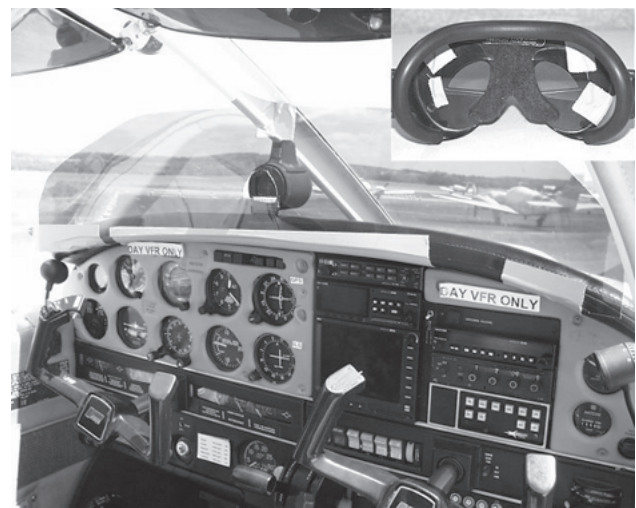
**Figure 3.** Polaroid material across windscreen of Piper Archer with (inset) Francis hood.

the windshield material. This arrangement allowed the pilots to see inside the cockpit, but eliminated the outside view immediately above the glare shield.
