# Reactive Solutions

An FHWA Technical Update on Alkali-Silica Reactivity

Volume 4, Issue 2 / July 2011

## An Update on Ongoing Field Trials – Part 1

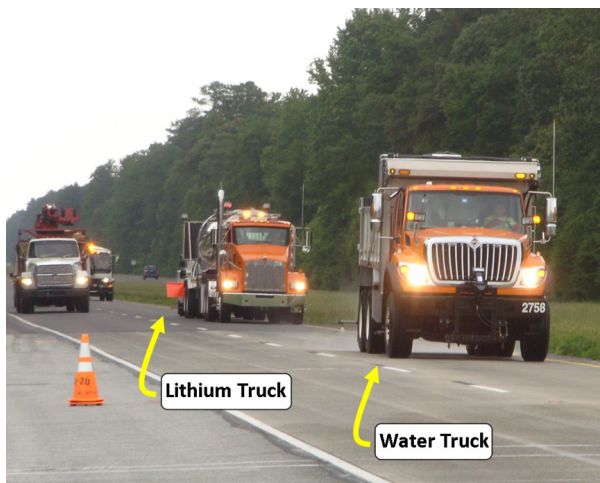
Figure 1. Treatment of concrete pavement in Georgetown, Delaware. Water application (first vehicle) followed by lithium application (second vehicle). Third vehicle with second pass of water not shown.

In June 2009, the pavement was prepared for the topical lithium treatment. The topical treatment consisted of a water pass (at 1 gal/1000 ft<sup>2</sup>) to pre-wet the concrete surface (as per the manufacturer's recommendation), followed by the lithium treatment (at 1.5 gal/1000 ft<sup>2</sup>), and ended with a final water pass (at 1 gal/1000 ft<sup>2</sup>), as shown in Figure 1. This treatment regimen was repeated the following day to complete the total lithium application of 3 gal/1000 ft<sup>2</sup>.

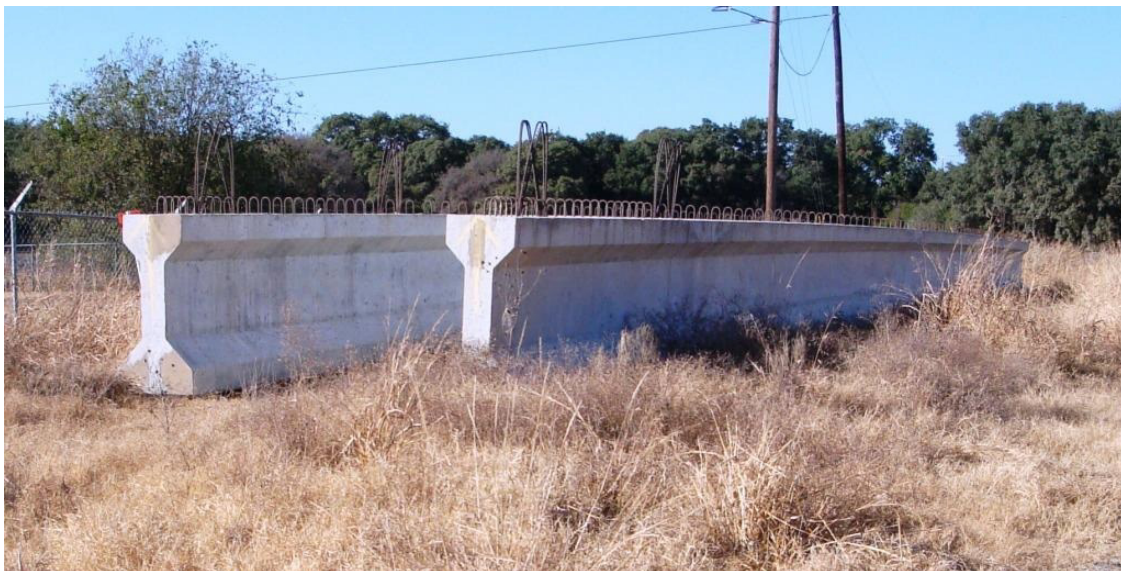
Figure 2. View of precast girders in New Braunfels, Texas, prior to treatment. Only two out of four girders are shown.

Four girders, located in New Braunfels, Texas, were set aside for treatment and evaluation. It was decided to treat half of each girder topically with silane, leaving the untreated half as a control.

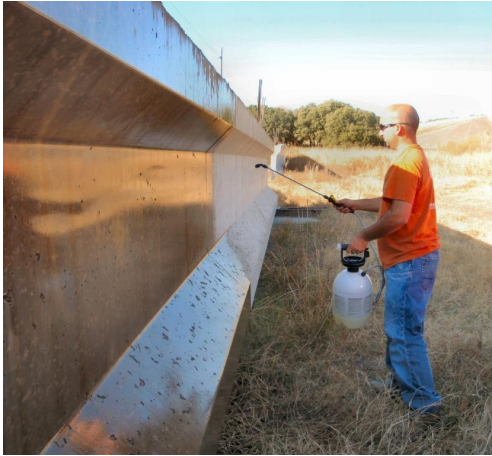
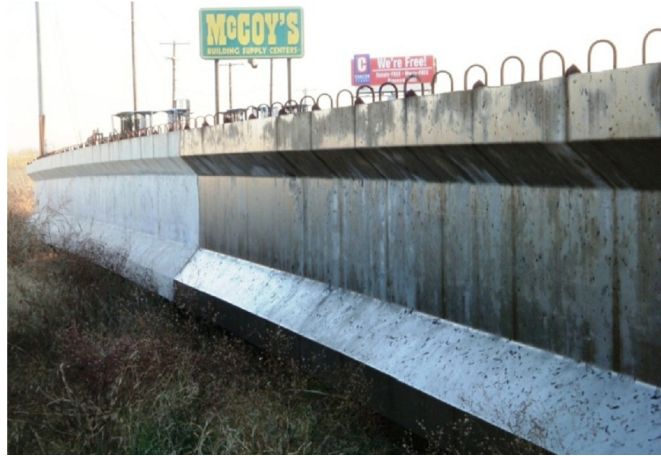
Figure 3. Topical application of silane using a handheld garden sprayer (left); view of girder after treatment (right). Only half of each girder was treated with silane.

In December 2010, the girders were treated and instrumented with humidity sleeves and tubes for future internal humidity measurements. Since TxDOT had already instrumented the girders with steel pins for expansion measurements, no additional pins were drilled into the girders.

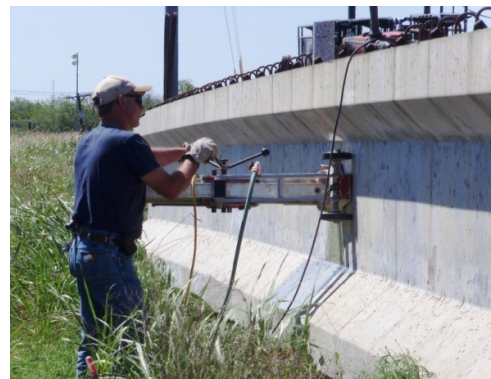
Figure 4. TxDOT worker extracting cores for further testing.

The first monitoring visit was conducted in April 2011, and expansion and humidity measurements were collected for all girders. Expansion measurements were collected using the FHWA comparator device, as well as TxDOT's comparator. In addition, the team requested additional cores be extracted from the control section for further petrographic testing.

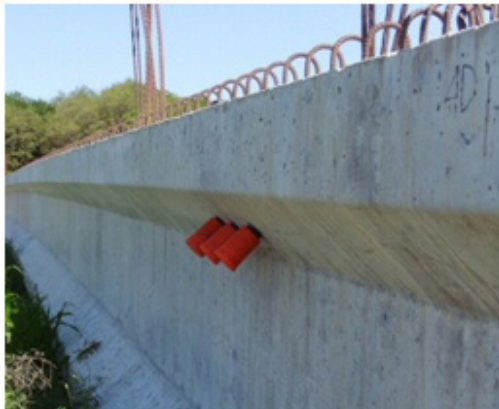
Figure 5. Humidity probes enclosed in plastic covers.

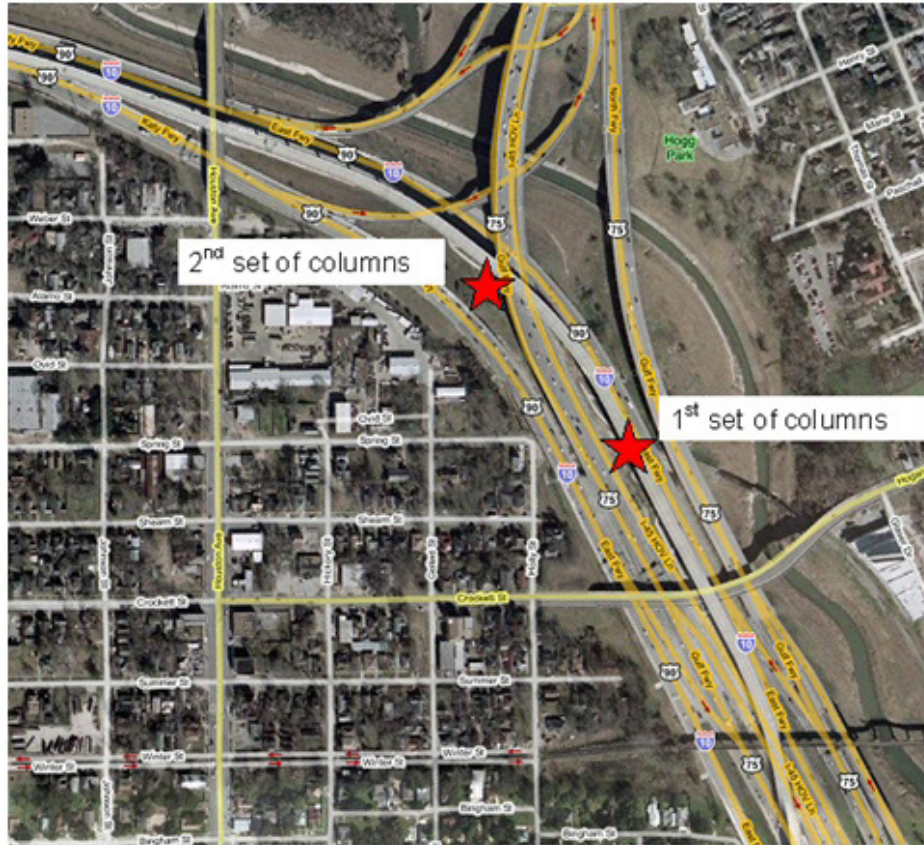
Figure 6. Location of columns in Houston treated under the FHWA Lithium Implementation Program.

In March 2006, a series of columns in Houston, Texas was treated with various methods under FHWA's Lithium Implementation Program, a previous effort performed to evaluate the use of lithium nitrate as a preventative and mitigative method for ASR. The treatment site, located near the intersection of Interstate 10 and Interstate 45 (shown in Figure 6), had been monitored during the length of the Lithium Implementation Program contract, which ended in 2009. However, FHWA felt it would be beneficial to continue monitoring the columns under their ASR Development and Deployment Program.

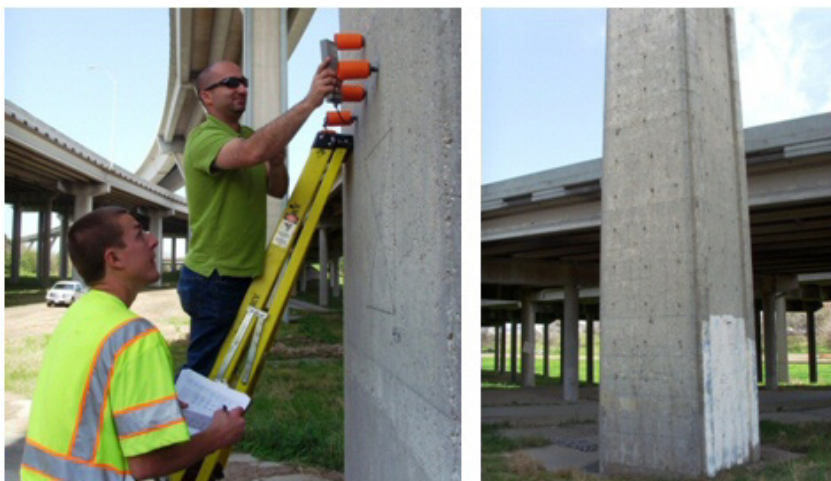
Figure 7. Conducting humidity measurements on a treated column (left); view of a column treated electrochemically with lithium nitrate (right).

Two sets of five columns each were selected for treatment under the Lithium Implementation Program. A total of eight columns (four columns from each set) were treated using the following methods: 1) electrochemical lithium treatment on media-blasted concrete surface; 2) vacuum treatment with lithium; 3) topical silane on media-blasted concrete surface; and 4) topical silane on painted concrete surface. Two columns, one from each set, were left untreated as controls. All treatments were completed in May 2006. The

In March of 2011, a visit was arranged to conduct monitoring activities in Houston. The columns were instrumented prior to the treatments with expansion pins, humidity tubes and sleeves. Therefore, no additional instrumentation was needed. However, the grids marked for crack mapping measurements had weathered and were redrawn. Expansion, humidity, and crack mapping data were collected.

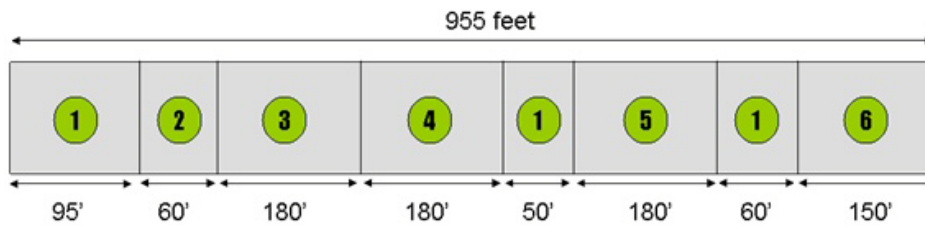
Figure 8. Schematic of treatment plan (southbound, showing one side). However, the northbound side is scheduled to receive “mirror” treatments.

In early 2010, a site visit was conducted to visually survey a stretch of bridge walls along the I-89/Dog River Bridge located near Montpelier, Vermont. As a result of the visit, cores were extracted in May 2010 and a petrographic report was performed in July 2010; the results of the petrographic report confirmed the presence of ASR in the bridge walls. It was decided, along with the Vermont DOT representatives, to treat the bridge walls with a series of sealers and coatings to determine the efficacy of each material in mitigating the ASR. Both the northbound and southbound bridge walls would be treated with three different sealers (as determined by the research team) and one additional sealer generally used by the Vermont DOT. Figure 8 and Table 1 below show a schematic of the treatment sections and materials used.

Treatment Number	Treatment Type
1	100% silane, followed by elastomeric paint
2	Control
3	40% silane
4	100% silane
5	Elastomeric paint
6	Contractor’s treatment (silane)

Table 1. Treatment details (corresponding to Figure 8).

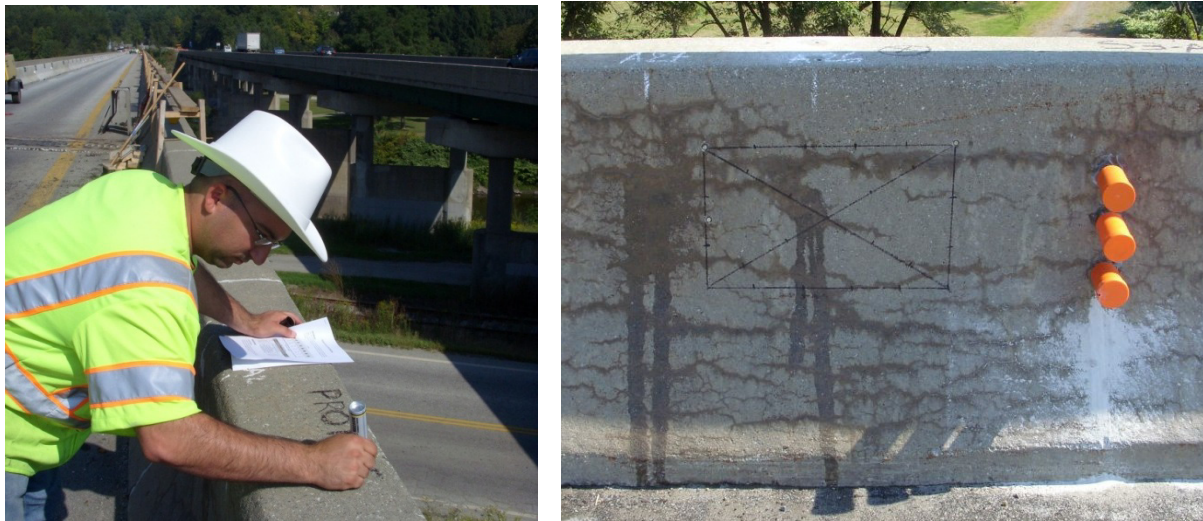
Figure 9. Worker labeling the treatment on the bridge wall (left); instrumentation site with crack mapping, expansion, and humidity sites for data collection (right).

The elastomeric paint is an acrylic coating material that bridges cracks and has shown promise in suppressing ASR expansion in Jersey barriers in Illinois. Therefore, FHWA’s project team was interested in trying this material to compare its efficacy against the two silane materials used in this field trial. In August 2010, the bridge was instrumented for expansion, crack mapping, and humidity readings. Due to ongoing construction on the bridge, only the northbound section was

instrumented in early August; however, the southbound section was instrumented later that month for expansion, crack mapping, and humidity measurements as well.
