# EVALUATING PERFORMANCE OF CONCRETE OVERLAYS FOR PAVEMENT REHABILITATION

November 2020  
Final Report

Project number TR202003  
MoDOT Research Report number cmr 20-012

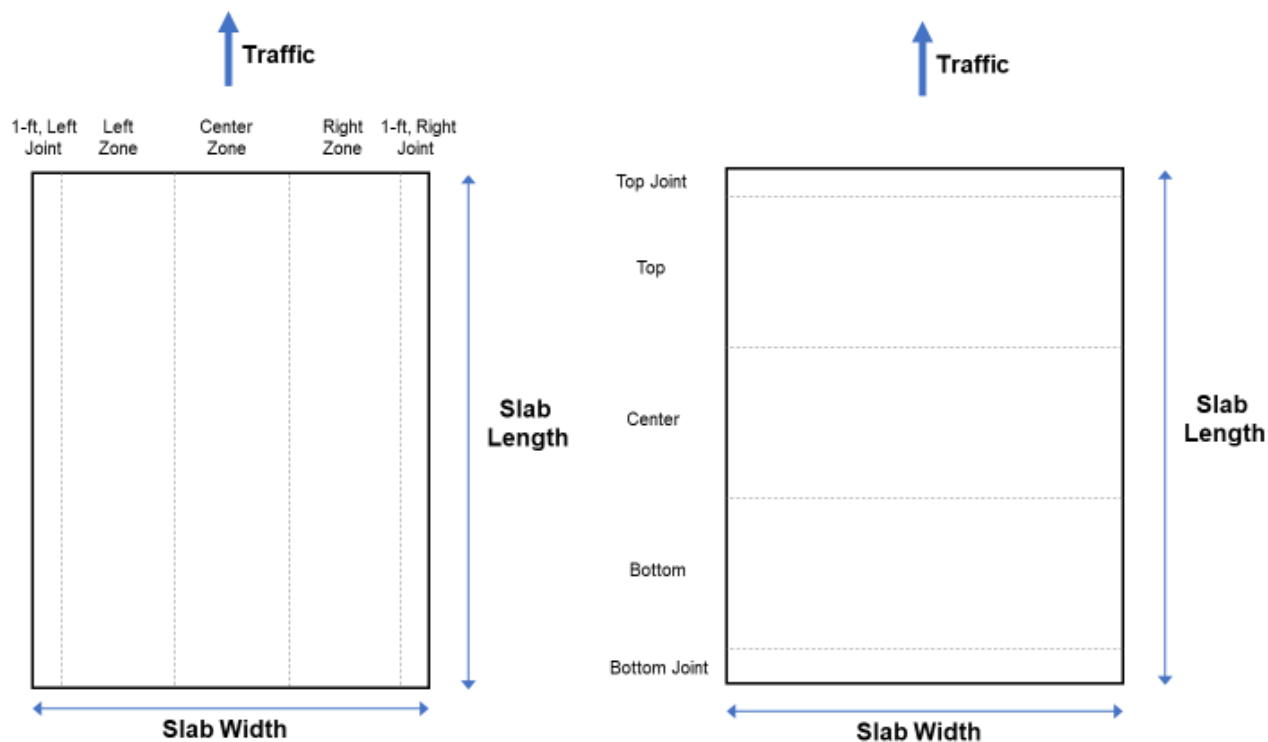
**Figure 2-2. Longitudinal and transverse cracking zones for UBOL slabs and BBOL panels not including joint zones.**

Aside from the standard LTPP distresses, diagonal cracking was defined as a custom distress type that was documented during the video surveys. A diagonal crack is a hybrid between a corner break and a longitudinal crack, and is identified as a longitudinal crack that starts at least 3 ft apart from a corner of the slab and it wanders into one of the longitudinal joints (instead of progressing longitudinally). It is similar to a corner break except that it does not generally intersect both joints at a 45-degree angle.

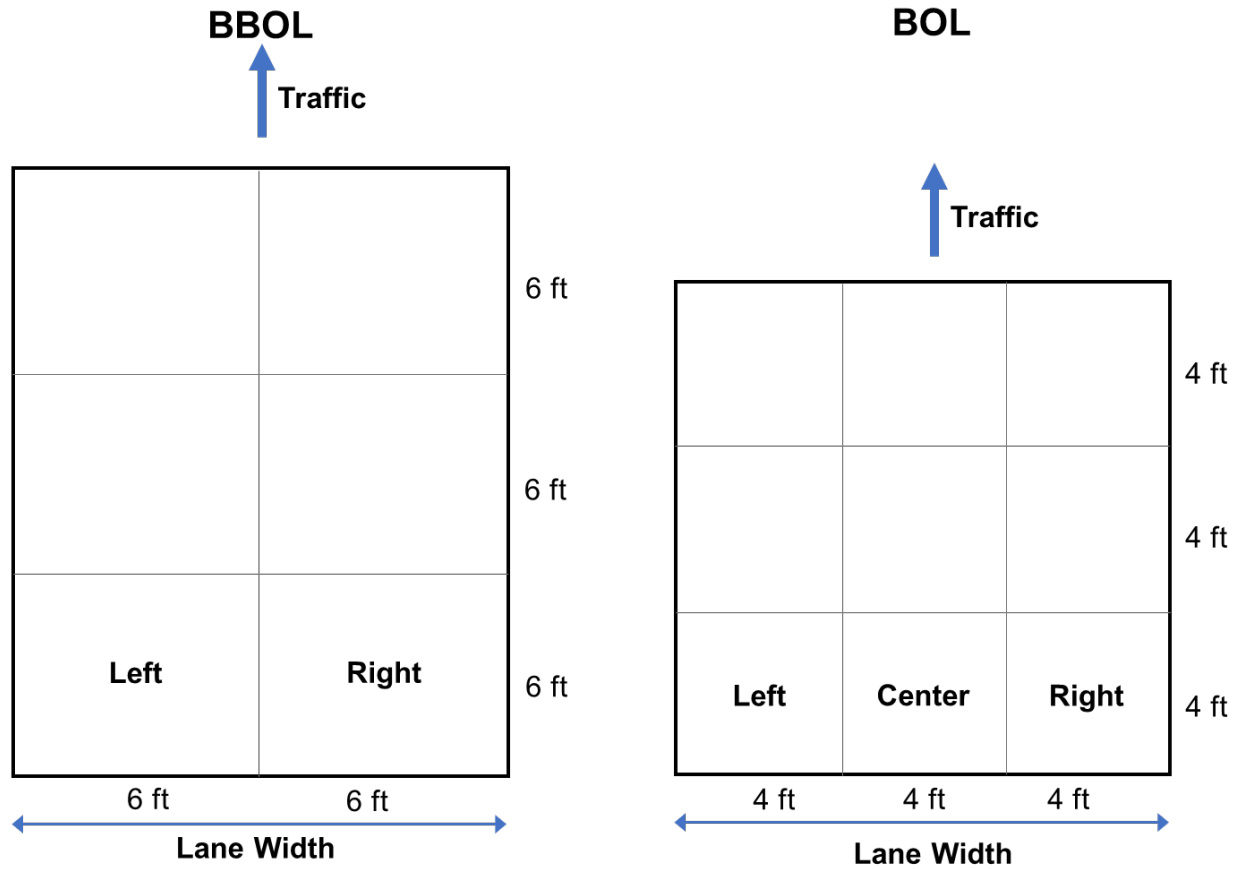
Figure 2-3. Panel location for BBOL and BOL projects.

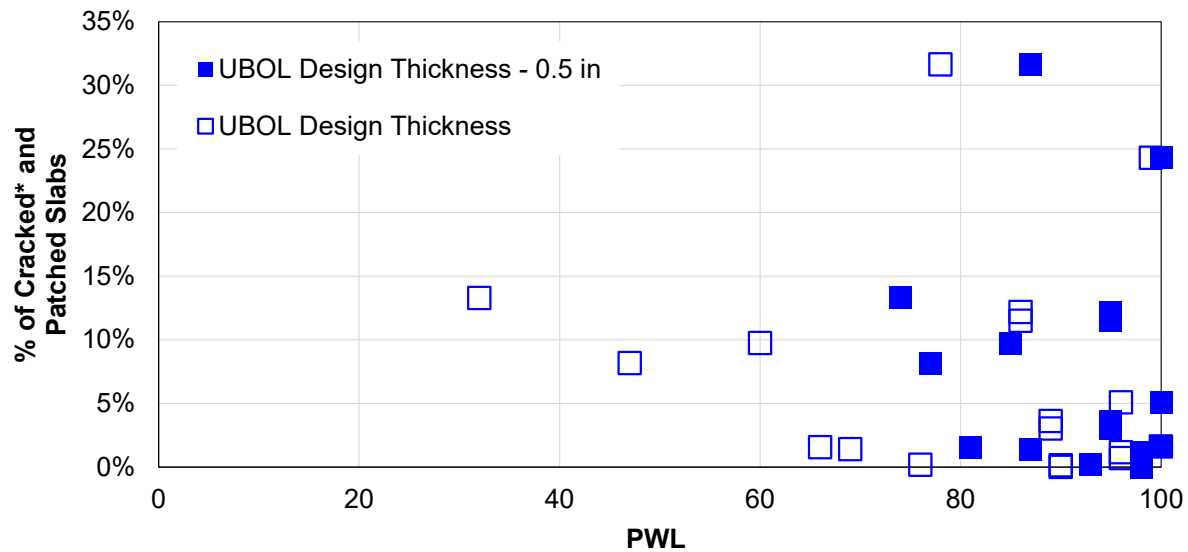
**Figure 3-1. Comparison of concrete overlay thickness PWL to cracked and patched slabs for UBOL projects (\* cracked slabs includes shattered slabs, longitudinal, transverse, diagonal, and corner cracking).**

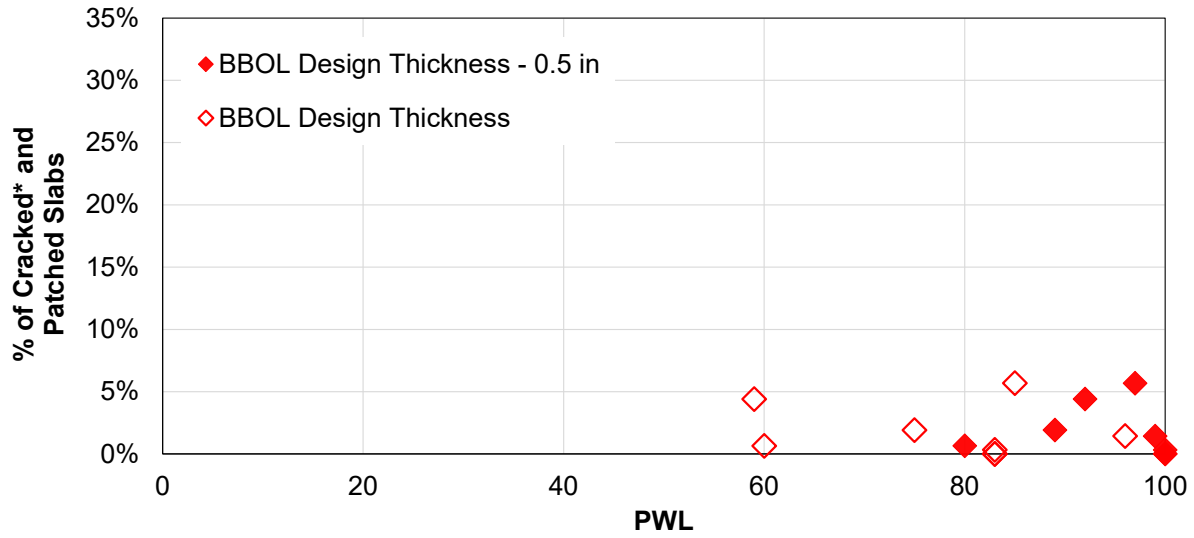
**Figure 3-2. Comparison of concrete overlay thickness PWL to cracked and patched slabs for BBOL projects (\* cracked slabs includes shattered slabs, longitudinal, transverse, diagonal, and corner cracking).**

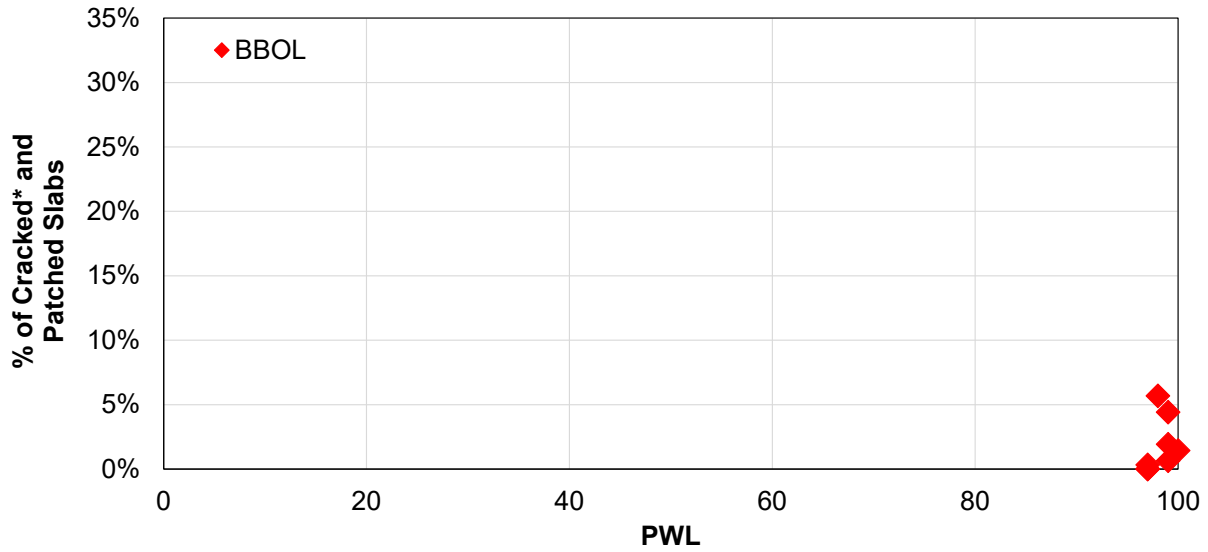
Figure 3-4. Comparison of PCC strength PWL to cracked and patched slabs for BBOL projects (\* cracked slabs includes shattered slabs, longitudinal, transverse, diagonal, and corner cracking).

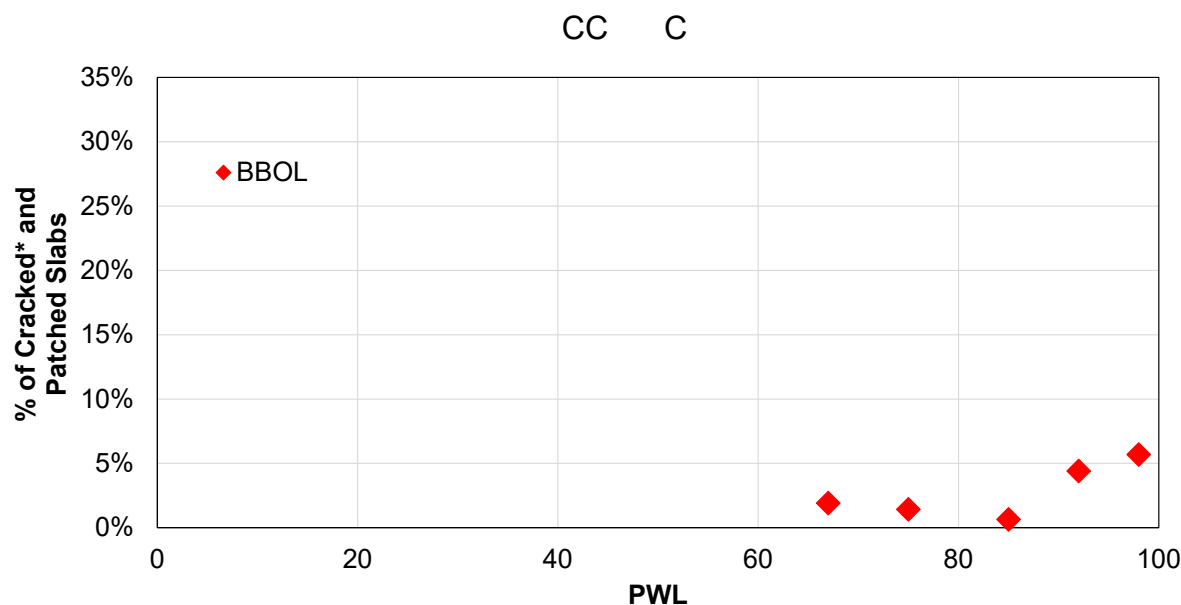
**Figure 3-6. Comparison of PCC air content PWL to cracked and patched slabs for BBOL projects (\* cracked slabs includes shattered slabs, longitudinal, transverse, diagonal, and corner cracking).**

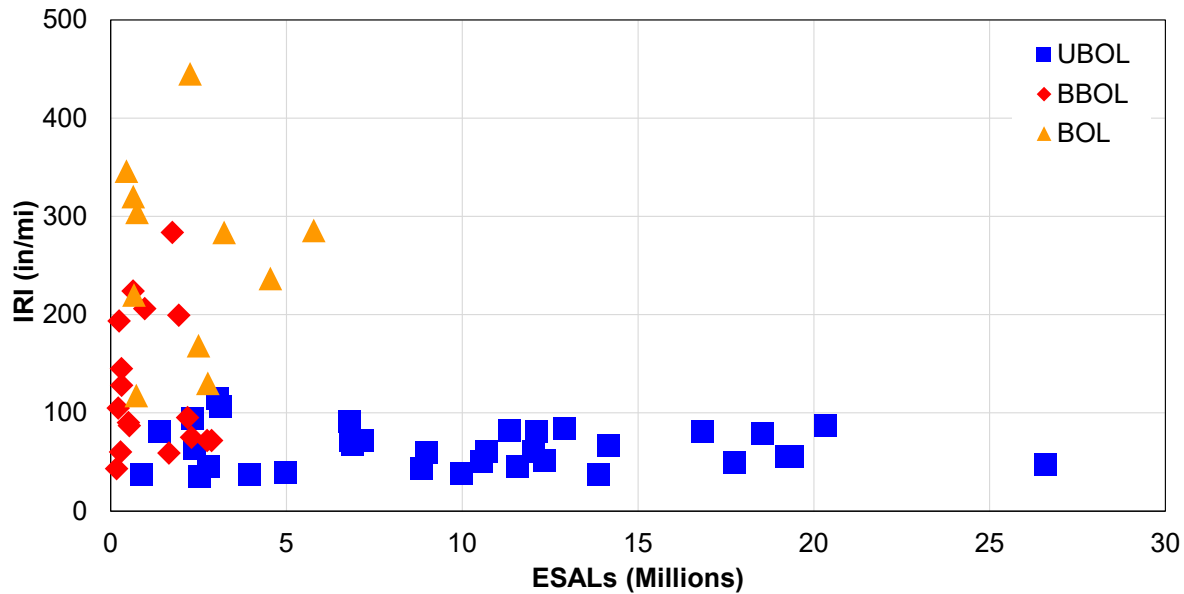
Figure 3-7. ESALs versus 2018 mean project IRI.

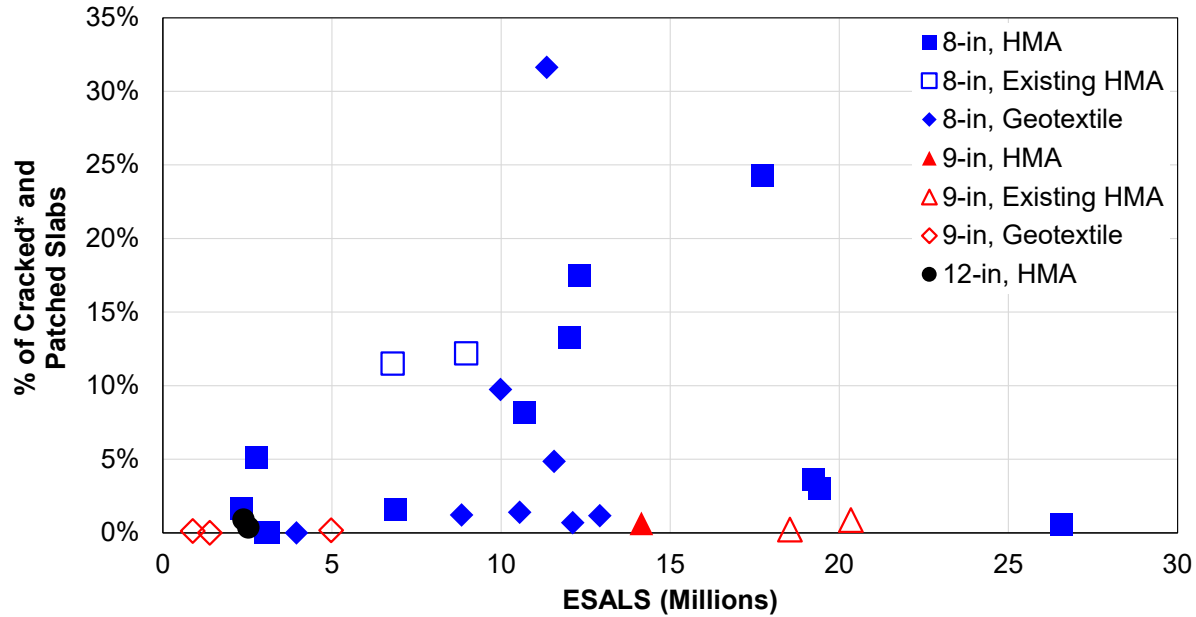
Figure 3-9. Interlayer type and slab thickness versus cracked and patched slabs for UBOL projects (\* cracked slabs includes shattered slabs, longitudinal, transverse, diagonal, and corner cracking).

most likely due to a lack of support in the outer portion of the driving lane. Generally, UBOL projects with geotextile interlayers exhibit less cracking than the existing or new HMA interlayer. Only two of the geotextile projects had cracking levels greater than 5%.

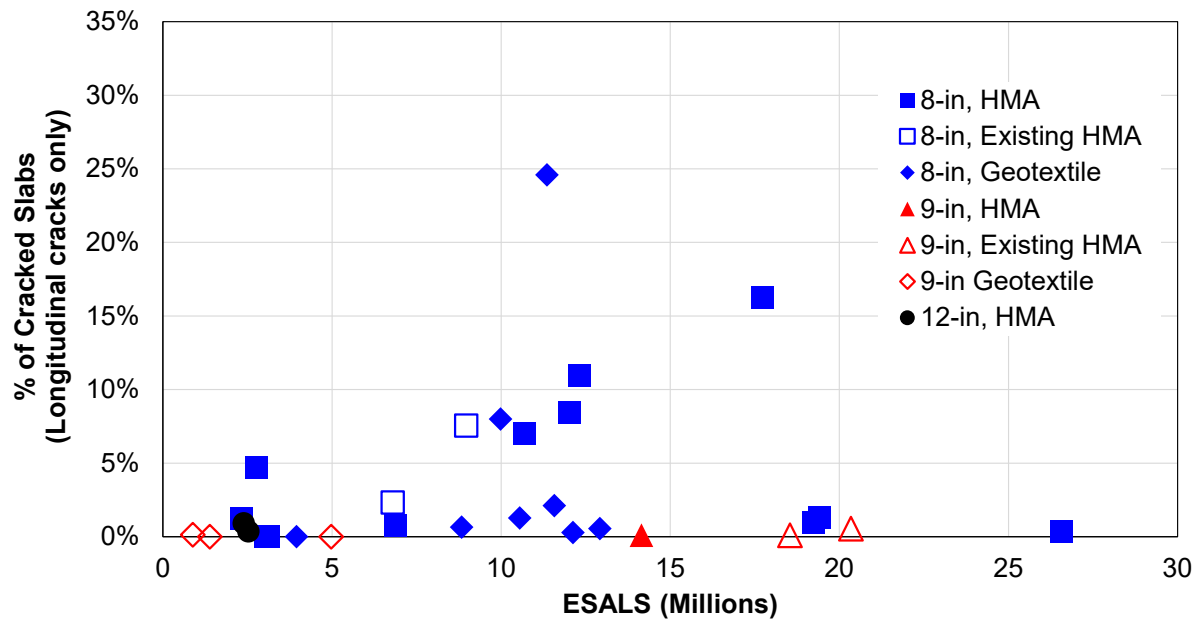
Figure 3-10. Interlayer type and slab thickness versus longitudinal cracked slabs for UBOL projects.

Referring to figures 3-10 and 3-11, the increased slab thickness results in fewer slabs with longitudinal and transverse cracking, respectively.

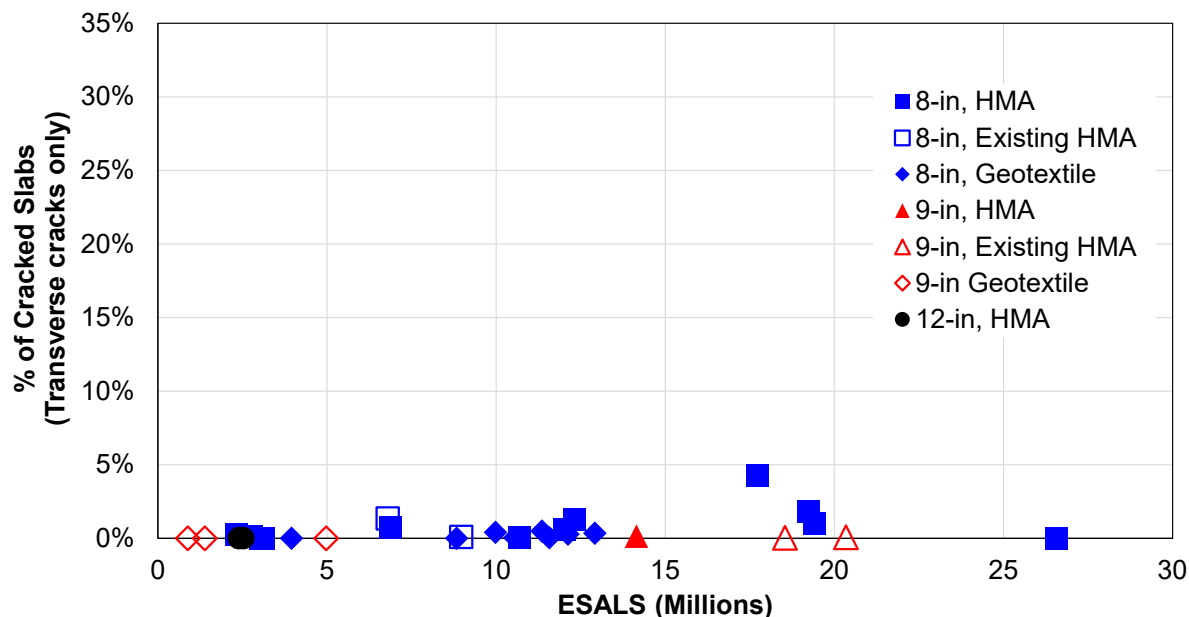
**Figure 3-11. Interlayer type and slab thickness versus transverse cracked slabs for UBOL projects.**

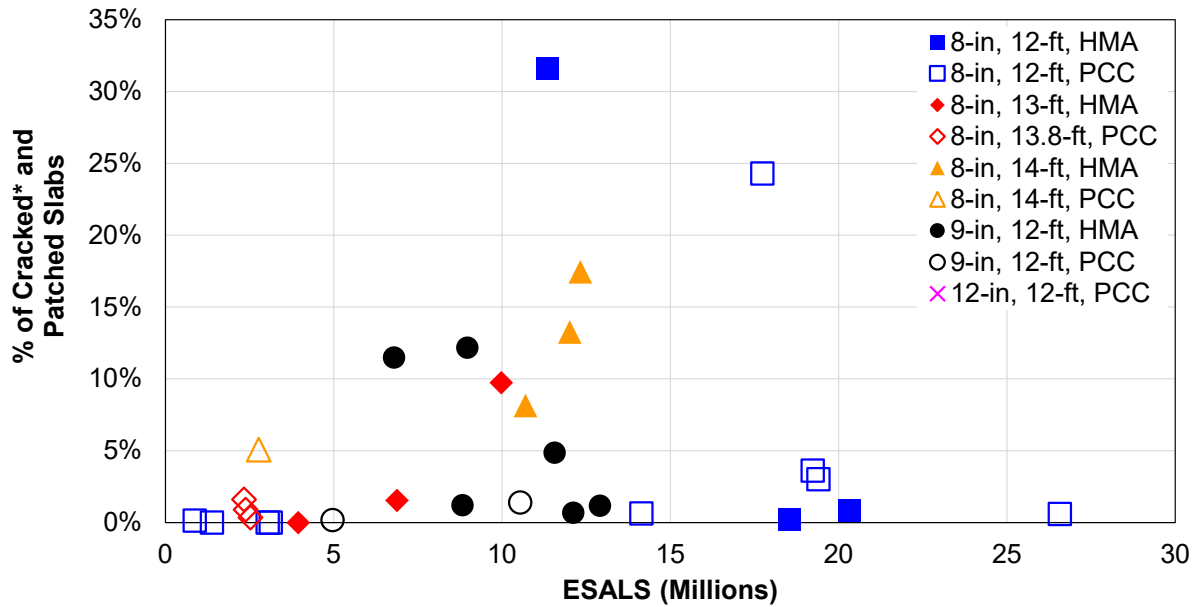
Figure 3-15. Slab thickness, slab width and shoulder type versus cracked and patched slabs for UBOL projects (\* cracked slabs includes shattered slabs, longitudinal, transverse, diagonal, and corner cracking).

MoDOT’s UBOL projects were either constructed with HMA or PCC shoulders. PCC shoulders tend to have slightly better performance than HMA.

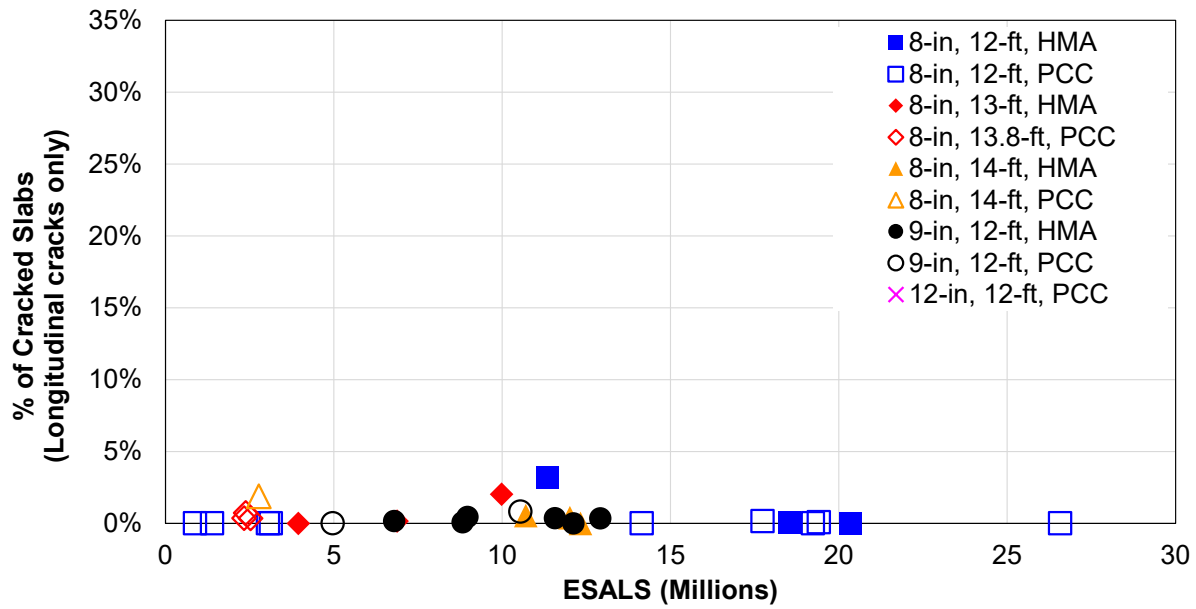
Figure 3-19. Left wheelpath—slab thickness, slab width and shoulder type versus longitudinal cracked slabs for UBOL projects.

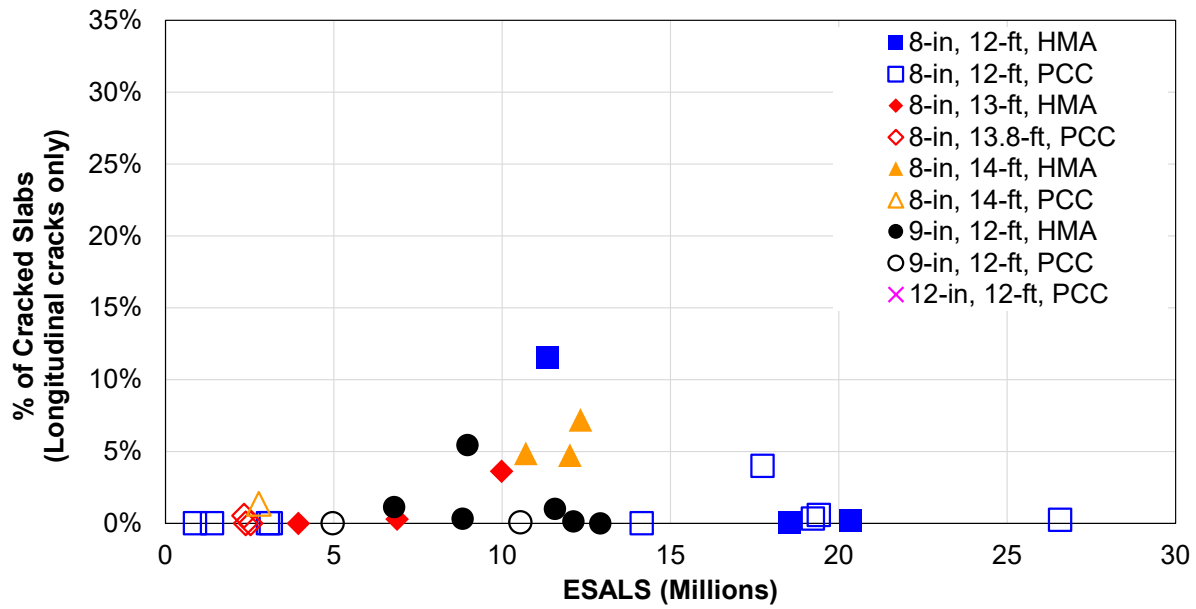
Figure 3-21. Right wheelpath—slab thickness, slab width and shoulder type versus longitudinal cracked slabs for UBOL projects.

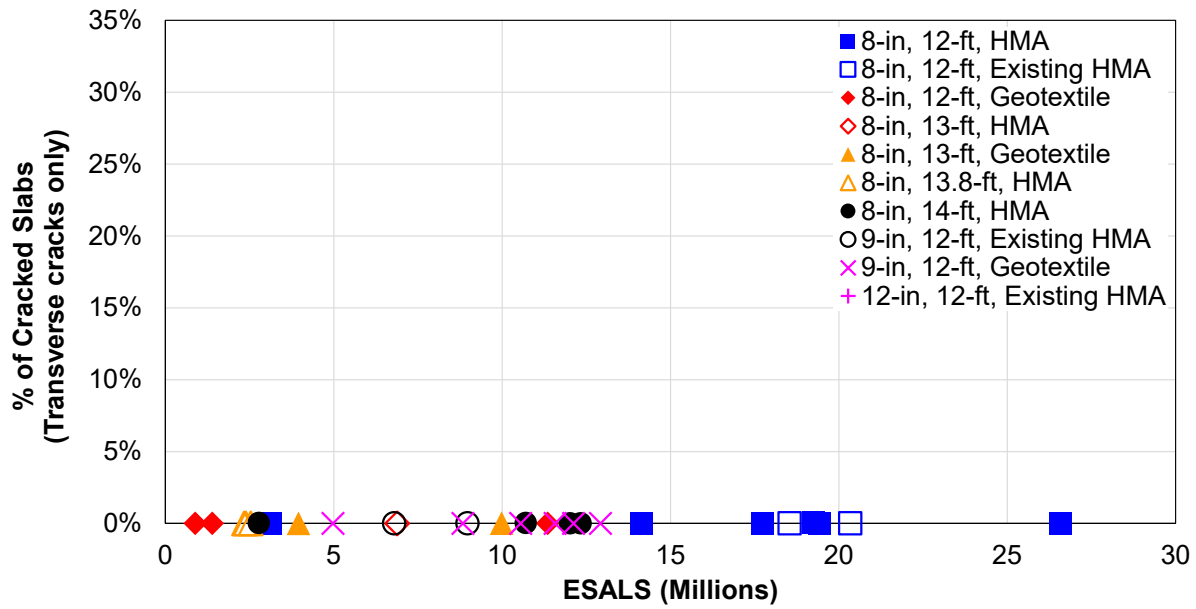
Figure 3-23. Bottom-joint-transverse cracked slabs versus slab thickness, slab width, and interlayer for UBOL projects.

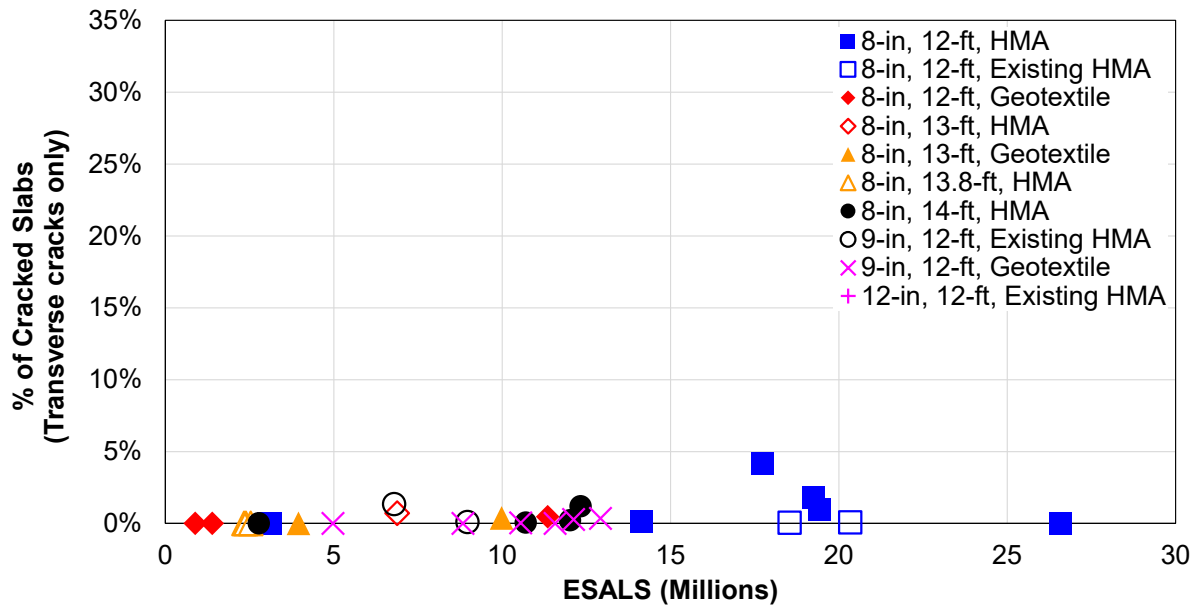
Figure 3-25. Middle—transverse cracked slabs versus slab thickness, slab width, and interlayer for UBOL projects.
