## Henderson Point Connector (US HWY 90)

### GREEN INFRASTRUCTURE TECHNIQUES FOR COASTAL HIGHWAY RESILIENCE

April 2018

**FHWA-HEP-18-042**

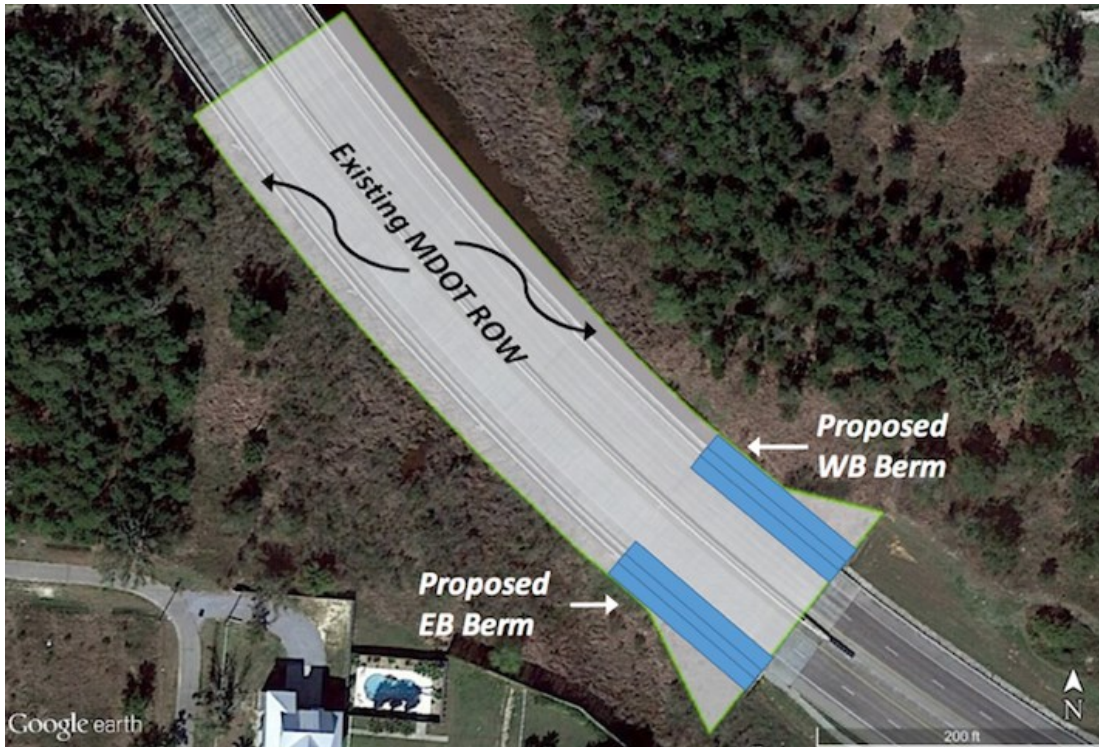
**ES 1. General location overview showing the existing MDOT right-of-way and proposed westbound (WB) and eastbound (EB) berm locations relative to the bridge approach and bridge spans. (Map Credit: Google Earth; Map©2018Google)**

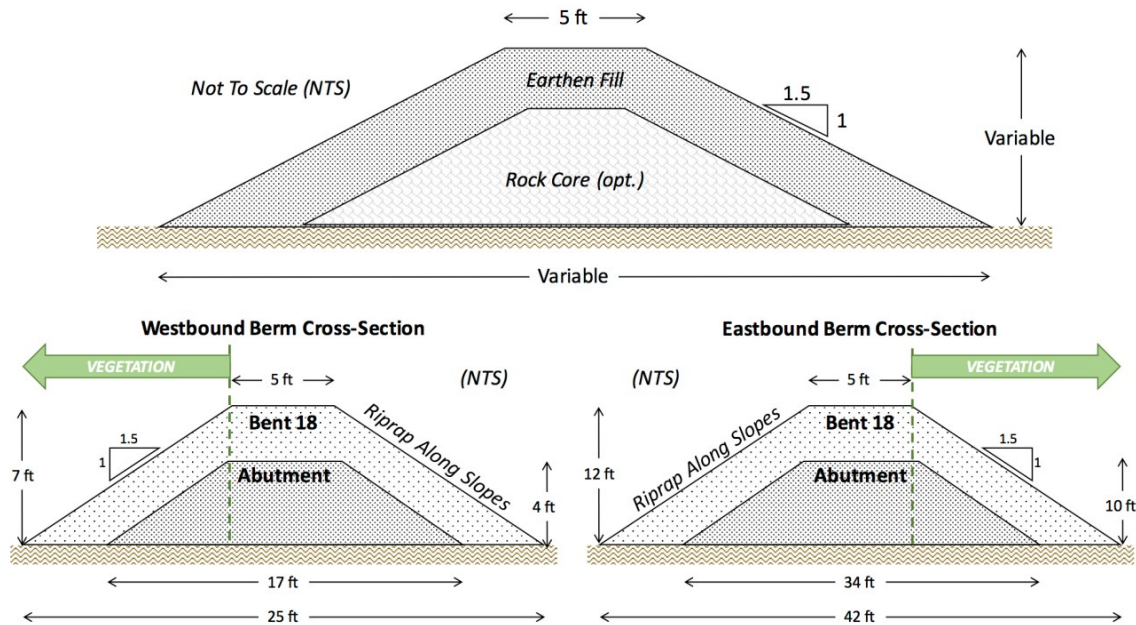
ES 2. Proposed berm cross-sections.

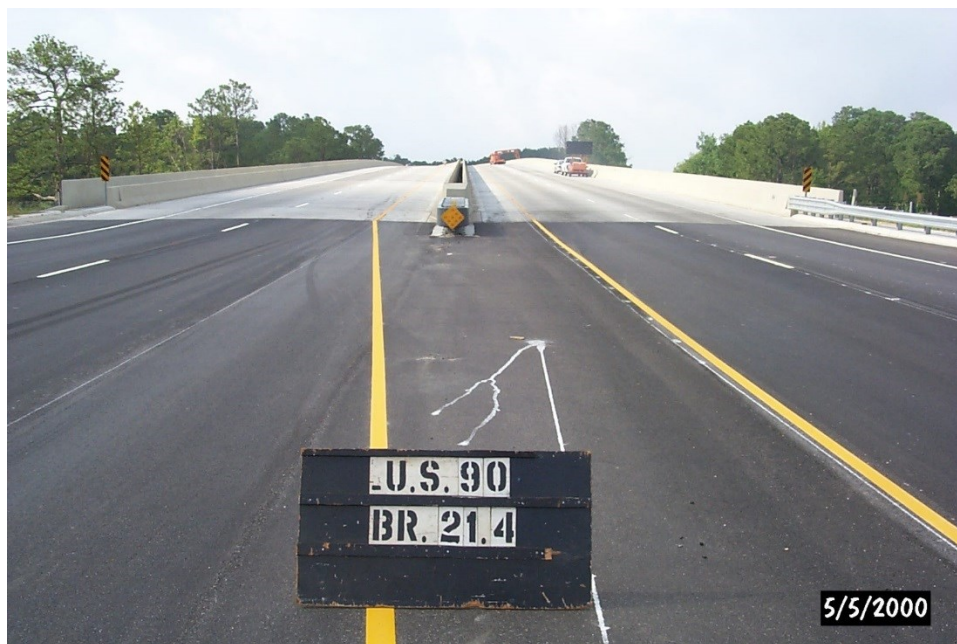
Figure 1. Image showing the Henderson Point bridges shortly after their construction (Photo Credit: MDOT).

The bridges are approximately 2250 feet in length, with eighteen 125-foot (38m) pre-stressed concrete beam spans and a 48-foot deck width. The end bent elevations are approximately +10 feet (NAVD88). The bridge attains its highest elevation at approximately +30 feet (NAVD88).

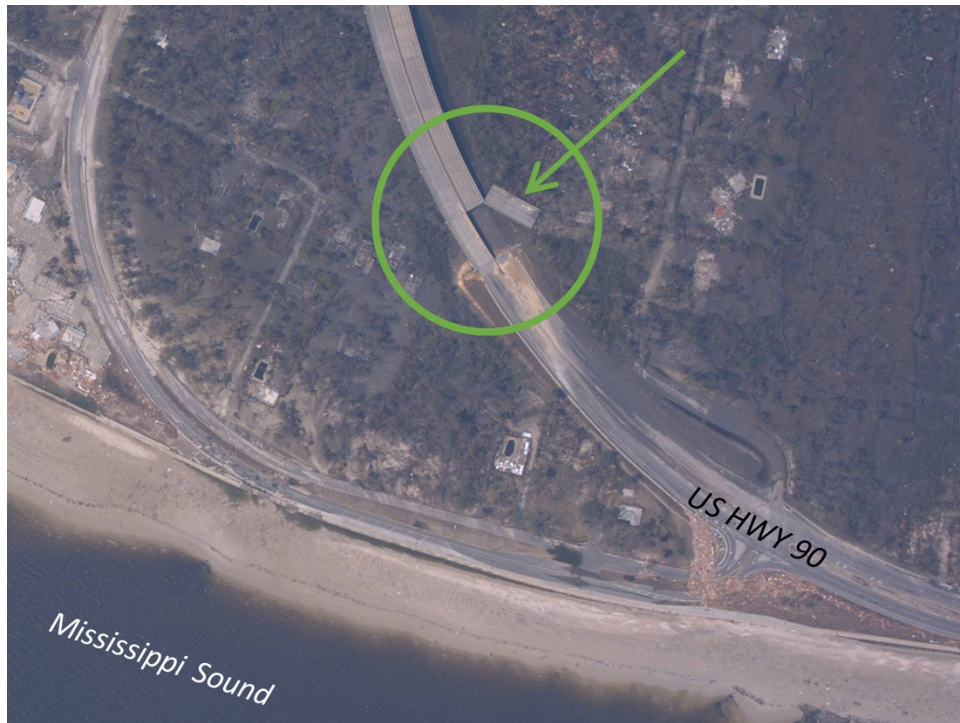
Figure 3. Image showing damage to Henderson Point bridges during Hurricane Katrina (Photo credit: NOAA).

The Henderson Point bridges, as well as surrounding areas, were directly damaged by hurricane storm surge and waves during Hurricane Katrina in August 2005. In addition to erosion of the approach embankment, the lowest elevation westbound span was completely displaced (to the east) from the bent beams as shown in Figure 3 and Figure 4. The lowest elevation eastbound span was displaced laterally (to the east) a few inches. More specific information about the coastal flood hazard vulnerability of this location is provided in the subsequent section, including flood elevations sustained during Hurricane Katrina as well as the estimated 1% annual chance (100-yr return period) flood elevation.

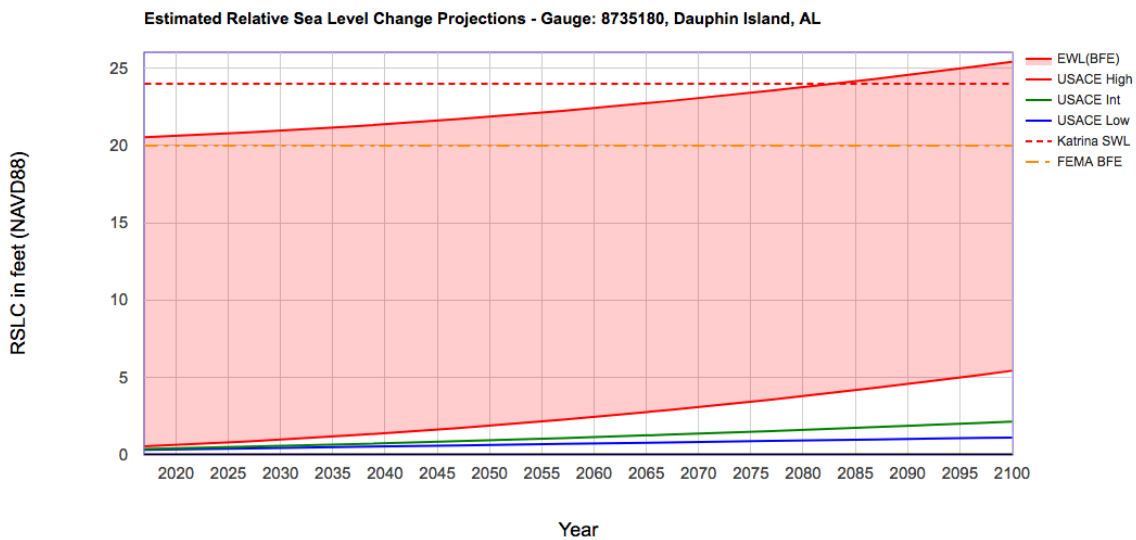
Figure 8. Relative sea level rise projection of the Henderson Point BFE under the USACE high SLR rate scenario. The dashed orange line shows the elevation of the current BFE. The red dashed line shows the still water elevation experienced during Katrina. The blue and green lines show USACE low and intermediate projections of relative sea level rise, respectively. The red shaded region shows the change in the extreme water level (EWL), in this case the existing BFE, over time with the lower limit (lower red line) indicating the future relative sea level rise under the USACE high scenario.

An example of the BFE modeled on the USACE high SLR rate scenario is shown in Figure 8. The years corresponding to this intersection of critical elevations for the high, intermediate, and low SLR rate scenarios are 2083, 2156, and 2409, respectively. Assuming that future damage to the bridge in its current condition requires an event producing a still water elevation equal to or greater than Katrina's +24 feet, these represent the years at which future sea levels increase the current 1% annual chance flood hazard elevation to that tipping point or threshold for damage. In other words, the 1% annual chance flood hazard elevation may result in damage to the bridge as early as the year 2083 or as late as 2409. Between now and 2083, the bridge may be damaged by an event having an impact greater than the 1% annual chance flood but a storm less intense than Katrina. Sea level projections beyond the year 2100 are uncertain, making it difficult to determine with confidence the actual years when the intermediate and low SLR rate scenarios may impact the bridge.

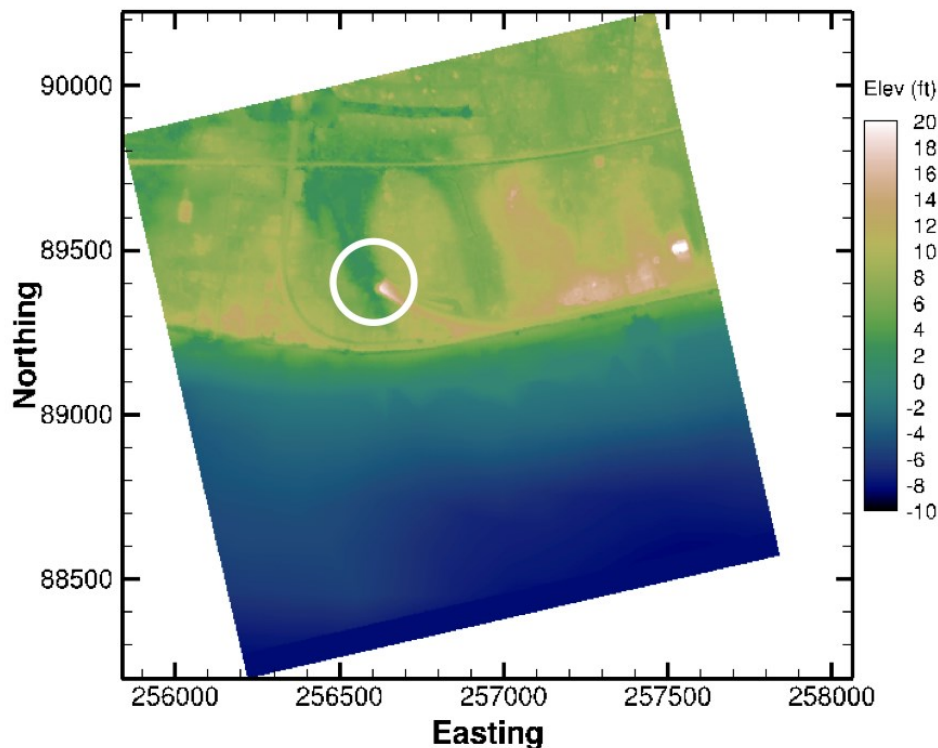
Figure 11. XBeach grid of Henderson Point showing elevation contours (feet, NAVD) and the location of the bridge failure (circle).

Ranging (LiDAR) digital elevation data, with a final horizontal spacing of approximately 13 feet (4 meters) between model grid points. This resolution was suitable for representing the approach embankment and surrounding terrain features of interest, including the HWY 90 roadway alignment and other nearby features. The ADCIRC+SWAN mesh and XBeach grid are shown in Figure 10 and Figure 11. The XBeach simulation results are described in the following section of the report.

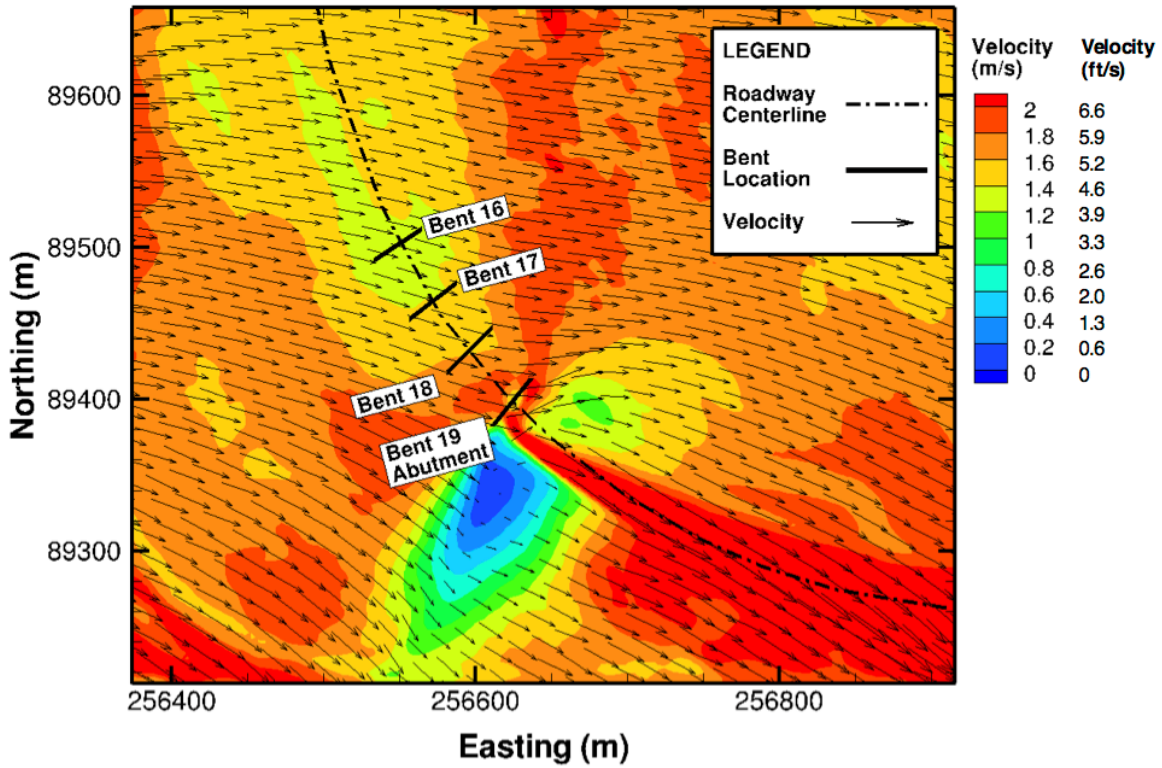
Figure 14. XBeach hydrodynamic model results showing maximum flow velocity magnitude (colors) and direction (vectors) in the bridge vicinity. The span that failed was in between Bent 18 and Bent 19 to the right of the roadway centerline.

The most likely, primary contribution to span displacement at this bridge was the hydrodynamic load, or drag force, due to strong currents near the abutment. The presence of the abutment and approach embankment caused

a local increase in velocity, with values exceeding 6 ft/s, near the displaced span. The velocity at the next highest westbound span, further from the abutment, was less than 5 ft/s. The drag force on the girders, barriers, and deck of the displaced span would have exceeded the full weight of the span by more than 30%, not accounting for reduced weight due to buoyancy. The drag forces on the other spans were all substantially smaller as shown in Table 2. Furthermore, the displaced span moved in the same direction as the velocity orientation (to the east). The adjacent eastbound span was also displaced laterally, but only by a few inches. It was at a higher elevation and therefore was less susceptible to large increases in flow velocity due to convergence under the bridge spans. The hydrodynamic loads on the eastbound span were approximately 42% of the span weight, or 73% of the reduced span weight. The drag force is the only contributing factor that explains why and how one span failed and the other adjacent spans did not. It also explains why the span was displaced to the east. While not definitive proof of the exact cause of failure, the large drag-induced hydrodynamic forces constitute a potential vulnerability not typically considered for coastal bridges.

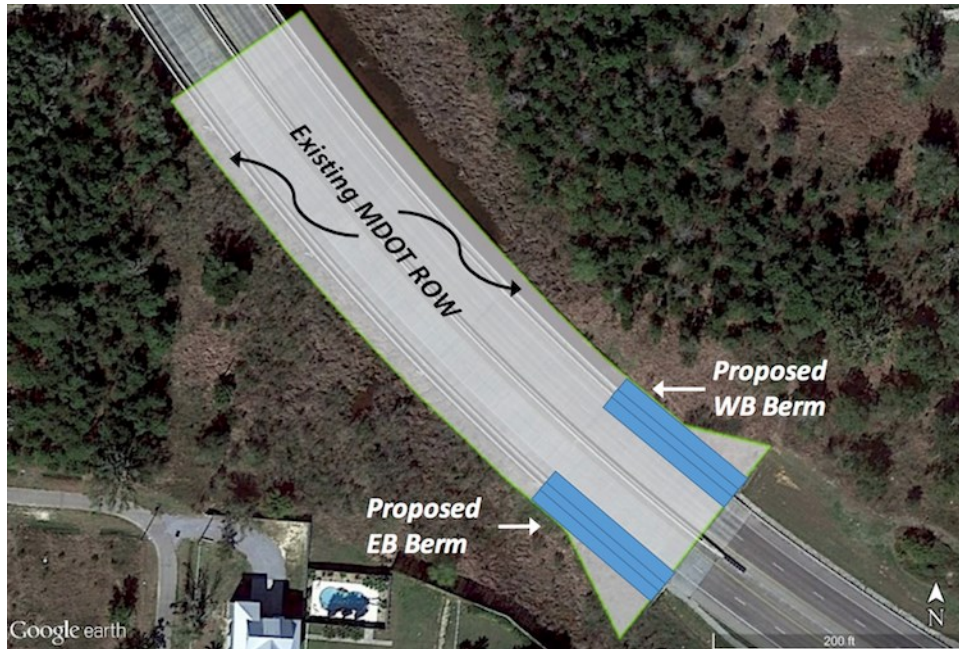
Figure 15. Overview image showing MDOTs existing right-of-way and the locations of the proposed berms adjacent to the lowest spans. (Photo credit: Google Earth; Map©2018Google)
