Report No. UT-20.23

EVALUATION OF BRIDGE DECK TREATMENTS ALONG I-15 IN NEPHI, UTAH

Utah Department of Transportation
Research & Innovation Division

**Final Report
May 2020**

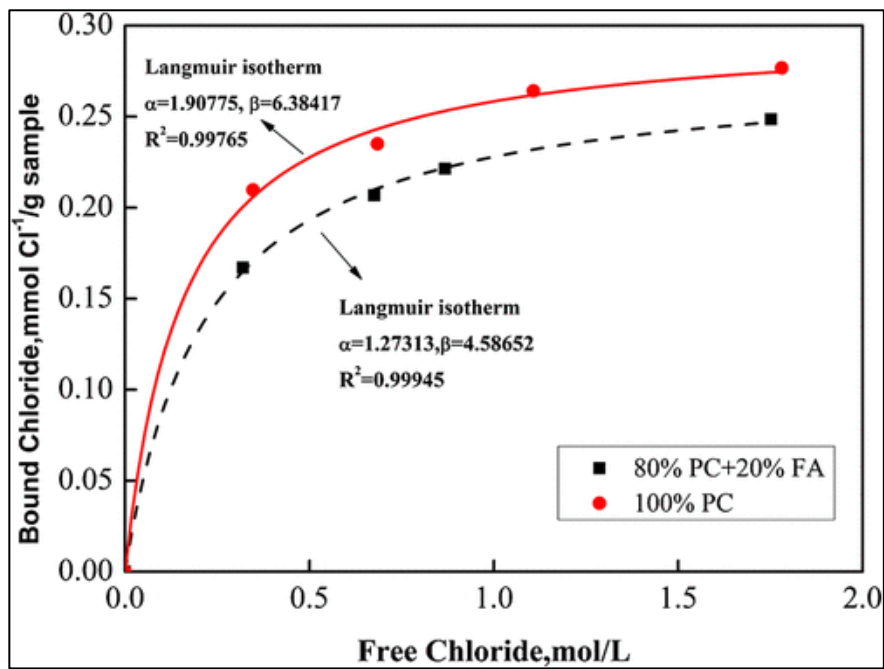
Figure 2.2.3.2 Reduction of Concrete Binding Capacity Using 20% Fly Ash (ASCE 2017)

Binding capacity is also a relevant property for ion diffusion because the pore structure of concrete is not inert to chlorides, which can become captured within the concrete pore structure through physical or chemical bonds [11]. This capture of chloride ions that have begun to diffuse into the concrete matrix decreases the rate diffusion and complicates mathematical or mechanical modeling. Once the steady state condition of the chloride binding has been reached, the effect of binding capacity is no longer observed and diffusion occurs as normal. The substitution of cementitious materials in the concrete mix design primarily affects binding capacity; Figure 2.2.3.2 shows how a 20% substitution of fly ash over Portland cement reduces the total binding capacity of the concrete. However, the complete quantification of cementitious material substitution in concrete mix design on chloride binding is still not fully understood [11,12,13].

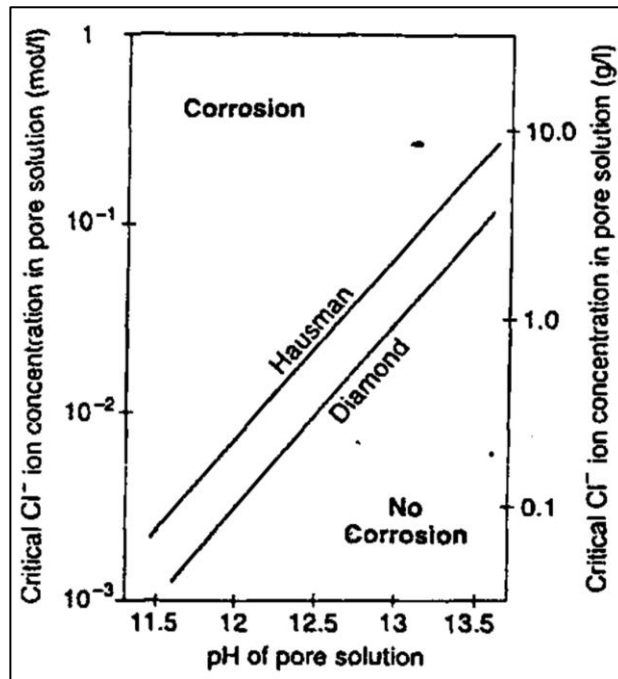
Figure 2.2.3.3 Critical Chloride Concentration vs. pH (Hausman and Diamond 1986)

most susceptible to the onset of corrosion. As a result there is a conflict between the continuity of the ferric oxide film and the deterioration of the ferric oxide film by Cl^- ions [14,15]. While the critical Cl^- ion concentration is a function of pore solution pH and Cl^- ions as demonstrated in Figure 2.2.3.3, for the purposes of service life prediction it is recommended that Cl^- ion concentration be smaller than 0.2% of the cement content of the concrete mix [16].

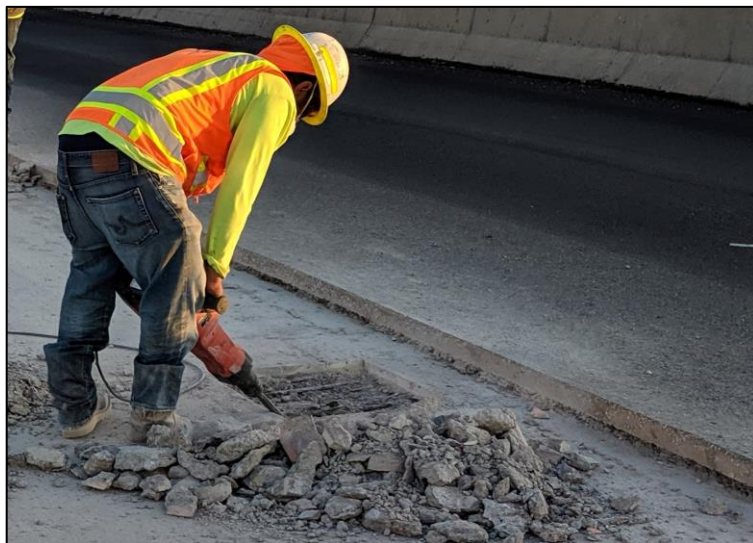
Figure 2.4.1.1 Chipping a Structural Pothole Patch (UDOT 2017)

Structural pothole patching is a conventional method of repair for localized delamination or spall defects in bridge decks. Structural patching is characterized by the replacement of lost or deteriorated concrete with equal or comparably strong structural concrete. The process involves sounding the deck for defects, removing the deteriorated concrete, and patching the concrete while ensuring a sufficient bond. Per current UDOT requirements, the removal of unsound concrete to be patched is only to be done with 1 inch maximum saw cuts and 30 pound maximum jackhammers, or with localized hydrodemolition. The concrete patch material must be thoroughly bonded to the substrate concrete through proper surface preparation. To ensure adequate surface preparation, the UDOT standard specification for structural pothole patching requires the use of sand blasting, compressed air cleaning, and pressure washing. [30].

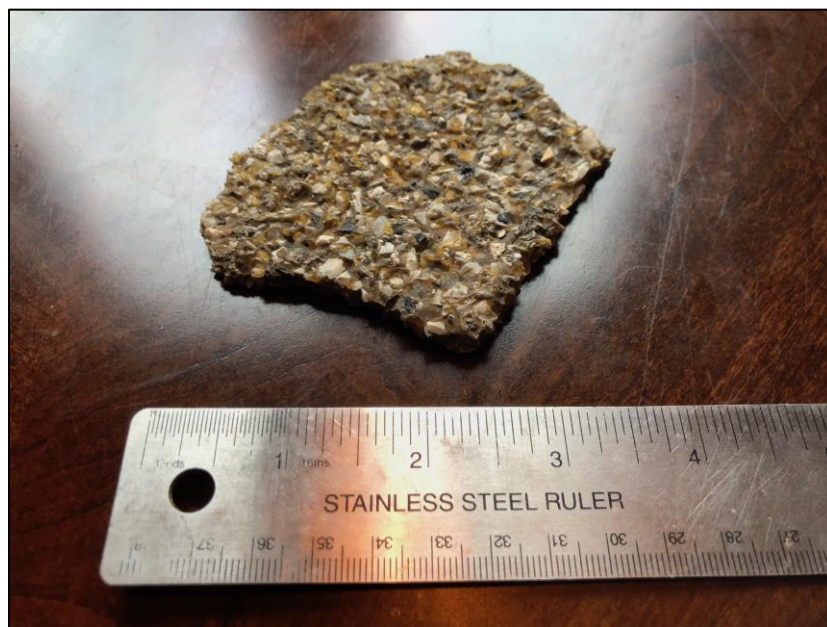
Figure 2.4.3.1 Sample of Thin Bonded Polymer Overlay (Mikulich 2020)

TBPOs seal the concrete and protect from ingress of chloride ions. They are composed of an epoxy-urethane co-polymer or a modified epoxy polymer that are embedded with a broadcast aggregate wearing surface. TBPOs are typically placed in two lifts with a total overall thickness of 3/8 inch thicknesses, thereby resulting in quick application, in addition to low additional dead loads [32]. UDOT uses TBPOs to protect against chlorides, to improve skid resistance, to form a physically protective wearing surface, and to provide a smooth ride surface [33].

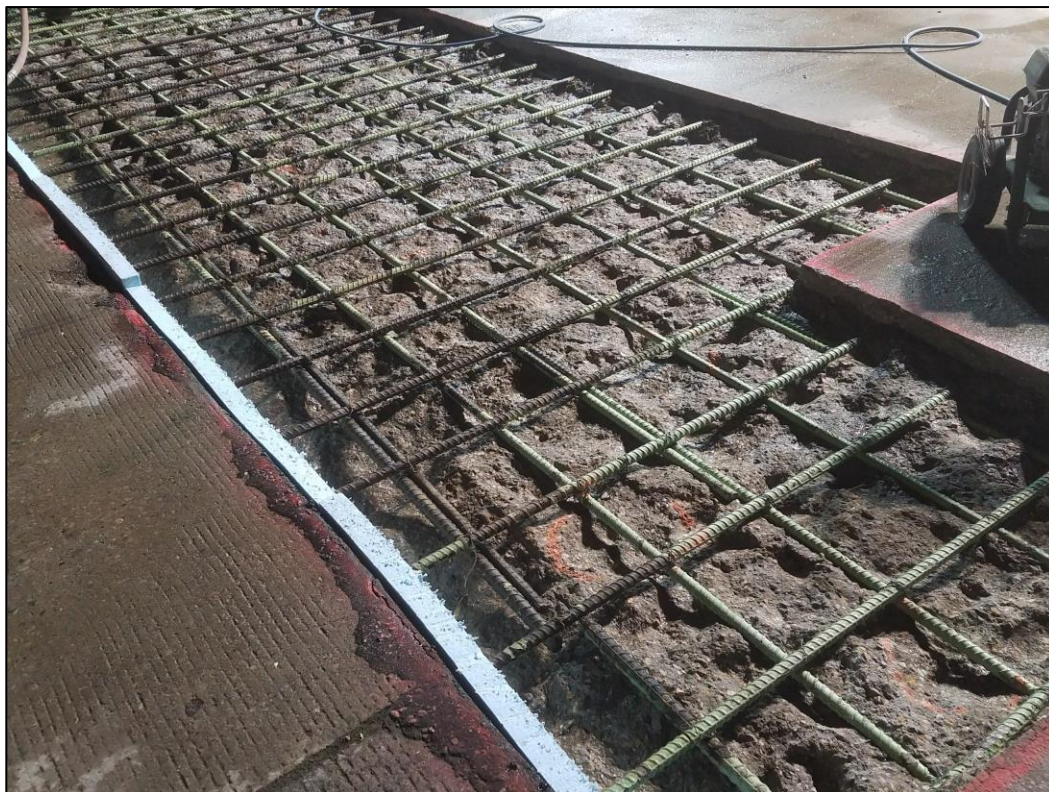
Figure 2.4.4.1 Localized Partial-Depth Hydrodemolition (UDOT 2017)

Hydrodemolition uses pressurized water operating between 10,000 to 40,000 psi with flow rates of 6 to 100 GPM in order to remove localized or widespread areas of chloride-contaminated concrete. This method of concrete removal was first developed in the early 1980s for bridge deck repair from chloride-induced defects and is now a widely implemented method of rehabilitation across North America and Europe [34]. Hydrodemolition procedure is impacted by variables such as the aggregate size, concrete strength, uniformity of strength, the size and spacing of reinforcement, and the defects present. Weaker or defective concrete will be removed at a faster rate, thereby requiring operator control to maintain uniform depth removal [34,35].

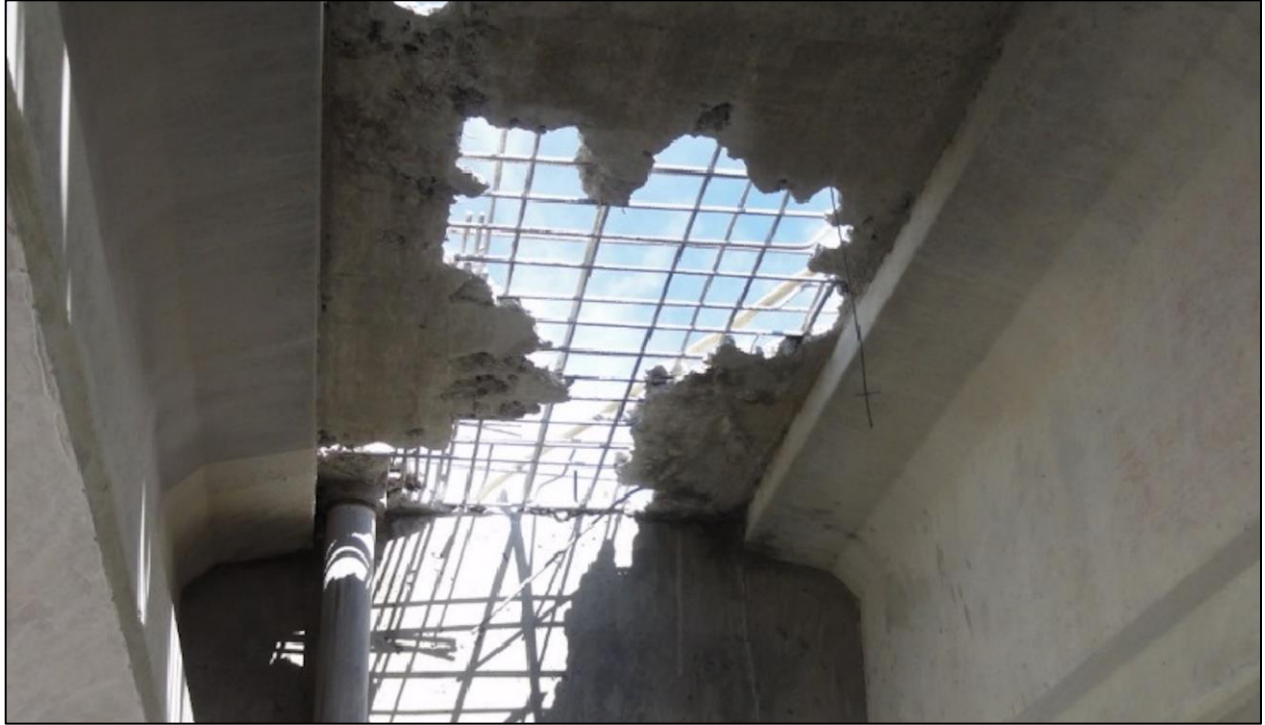
Figure 2.4.4.2 Severe Hydrodemolition Blow-Through (Roper 2018)

There are also several limitations of hydrodemolition. It is easy for water to leak through existing cracks that lie below the repair depth. In some cases, this is severe enough to cause unanticipated full-depth removal at localized areas, also known as blow-throughs, an example of which is shown in Figure 2.4.4.2. These blow-throughs can be difficult to patch and form for new concrete placement, resulting in messy or inadequate concrete bonds on the deck underside.

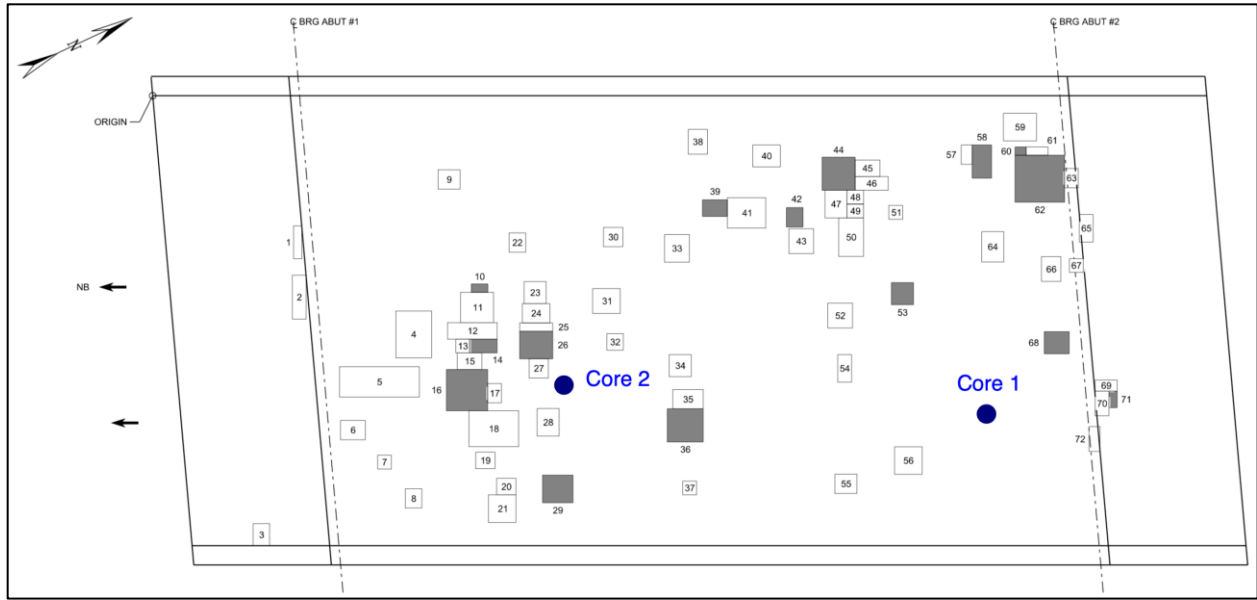
Figure 3.2.1 Example of Core Locations over Deck Survey for 3F 433 (UDOT 2019)

Four cores were taken from each of the multi-span bridges OC 717, 3F 448, 1F 449, and 1F 450, while two cores were taken from each of the single-span bridges. Under the judgment of the third party consultant, the locations and quantity of the cores were taken to provide representative data of each bridge deck that captures potential variance in chloride concentrations at the surface. Multi-span bridges doubled up this procedure so that cores are taken from each span. Cores were taken from sound concrete, and sampling occurred from July 10th, 2019 until July 17th, 2019. The core locations are overlaid on the NBI deck surveys, such as Figure 3.2.1, and presented in Appendix B.

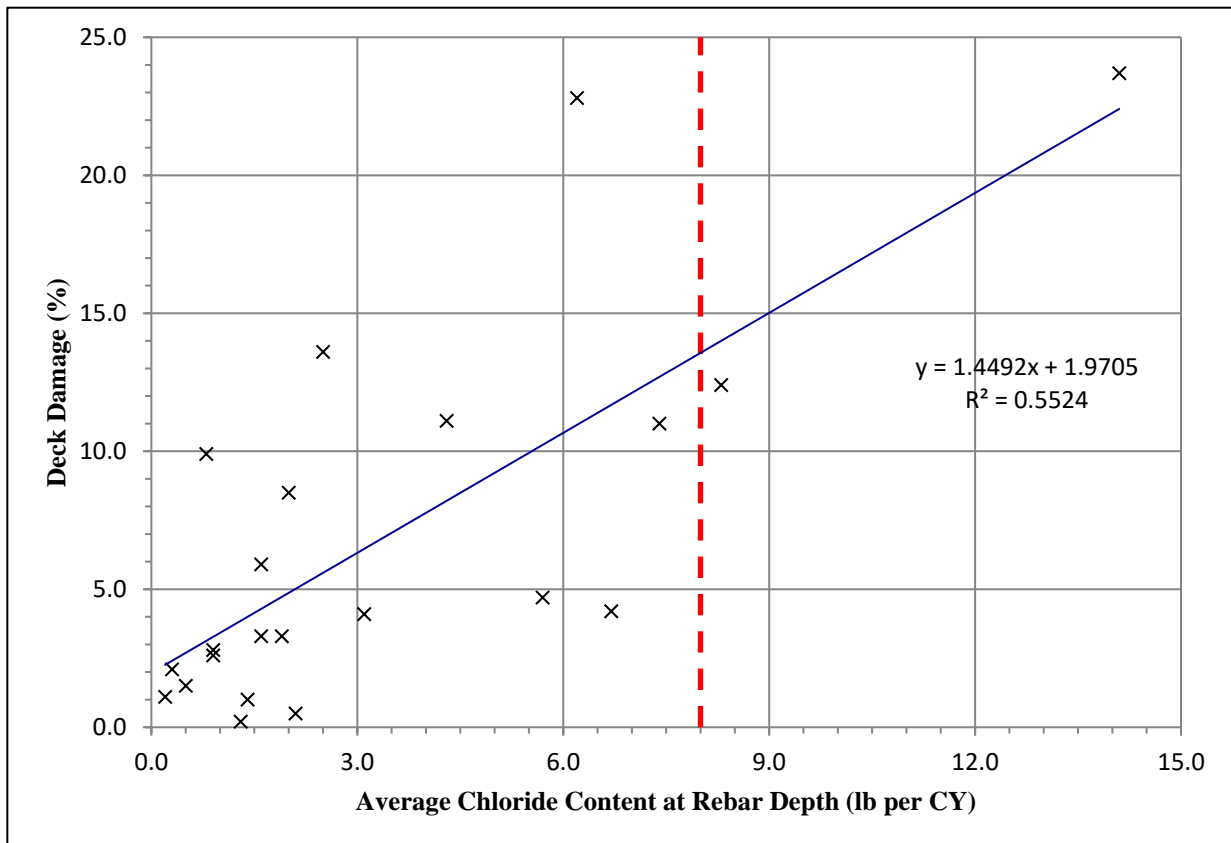
Figure 4.2.1 Linear Regression for Chlorides and Total Damage (Mikulich 2020)

The analysis began with the known quantities for deck area, delaminations, and sound patches. Total damage was calculated as a percentage of deck area using delaminations and sound patches. Chlorides at the rebar depth were calculated for each bridge by averaging the values of the rebar depth slices of the two or four cores taken at each bridge. Total damage quantities varied between 0% to 25% and average chlorides at rebar depth varied between 0 lb per CY to 15 lb per CY, with the critical chloride threshold widely accepted as 2.0 lb per CY for black bar and 8.0 lb per CY for epoxy coated bar. All twenty-two bridges were constructed with epoxy-coated rebar, therefore the 8.0 value is the threshold that was examined. Chlorides were graphed against deck damage with the regression performed in Figure 4.2.1.

A regression model (Figure 4.2.1) of average chlorides at rebar depth versus total damage suggested a correlation with the coefficient of 0.55. As a result, there was initial indication of some degree of relevance in the chloride data as a metric for damage in reinforced concrete bridge decks. It was found that 8.0 lb per CY is a potentially useful critical value, as decks with greater than 8.0 lb per CY of chlorides at the rebar depth have a 20% chance to experience more than 10% damage. A series of one-way ANOVA tests with all available independent variables using damage as the result, total and delamination only, confirmed the statistical significance of the chloride data. The corresponding P Values of 0.036, 0.041, 0.034, 0.035 as shown in Figure 4.4.4.1 concluded that chlorides were the most statistically significant of all available independent variables. However, due to the high variability in chlorides among cores taken from the same deck, there must be a greater understanding of what quantity and location of cores are needed in order to have confidence that the chloride data is truly representative of a bridge deck.

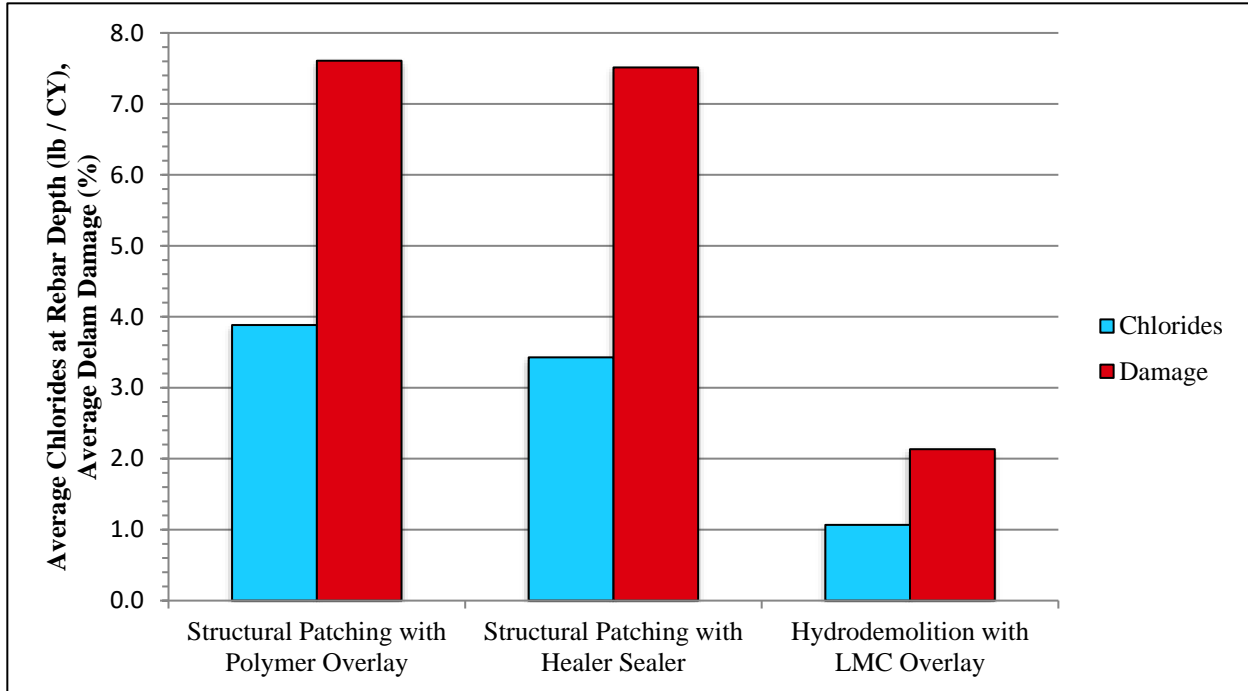
Figure 4.3.1 Treatment Comparison Overview (Mikulich 2020)

A graphical comparison was developed by averaging the chlorides at the rebar depth and by averaging the delamination damages for all bridges that shared a given treatment. Delamination damage is used in this section of the analysis as opposed to total damage because total damage includes the sound patches, which are a result of the structural patching treatments. These averaged chlorides and delamination damages are metrics for treatment success, with lower chlorides and delamination damage corresponding to more successful treatment. Figure 4.3.1 demonstrates the graphical comparison of the three treatments using these metrics.

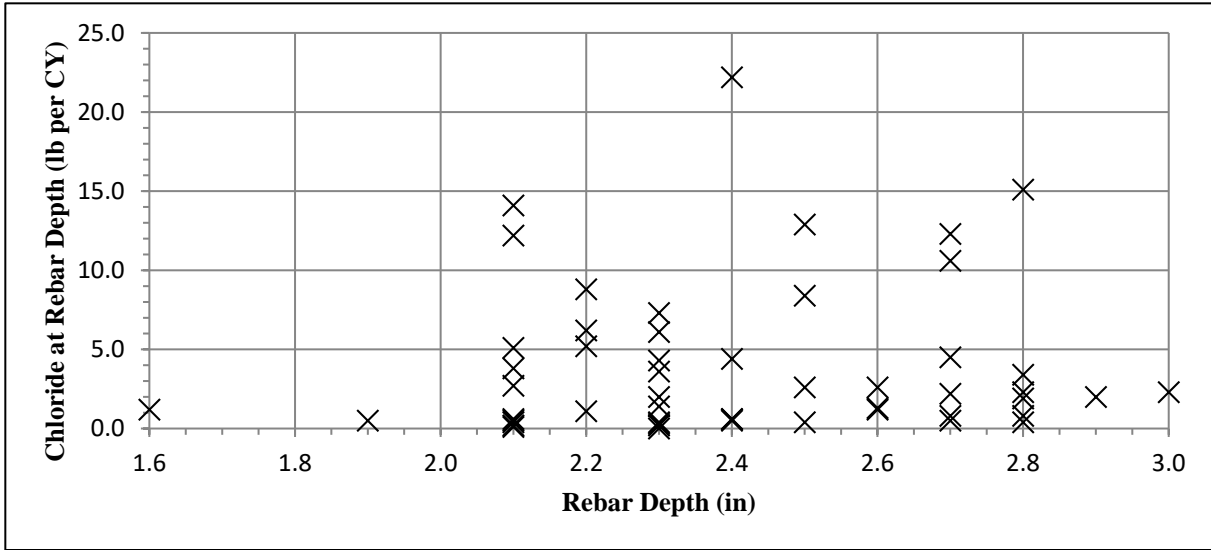
Figure 4.4.1.1 Lack of Correlation Between Rebar Depth and Chlorides (Mikulich 2020)

Figure 4.4.1.1 illustrates no significant linkage between the rebar depths and the chloride concentrations at those rebar depths. If significant linkage was observed, the figure would have a clear negative trend where chloride contents decrease with increased rebar depth. A regression on this data confirmed there is no correlation. These results indicated that variance in bridge deck rebar cover among the samples is not a significant independent variable in regards to their present damages, and therefore does not need to be accounted for when evaluating the success of the various treatments and overlays.

Through a series of graphical data interpretations, regression models, ANOVA tests, and Chi-Squared tests (Figures 4.4.1.1, 4.4.2.2, 4.4.2.5, 4.4.3.1, 4.4.4.1) it was concluded that the presence of recent structural patching and the number of spans were significant variables at or near a 95% confidence interval. All other variables excluding chlorides and treatments were insignificant at or near this interval. The significance of the number of spans suggests that bridges with higher numbers of spans degrade at comparatively faster rates; however, due to the low degrees of freedom in the number of spans and a very small sample size of multi-span bridges, a much more comprehensive data set is needed to have confidence in this variable's significance and conclusion. Ultimately no significance could be concluded from deck condition prior to treatment. Data on rebar depth was not significant in the determination of chlorides or damage; however, this is likely due to lack of variation among rebar depths in this study combined with comparatively high variations in chloride data at equal depths.

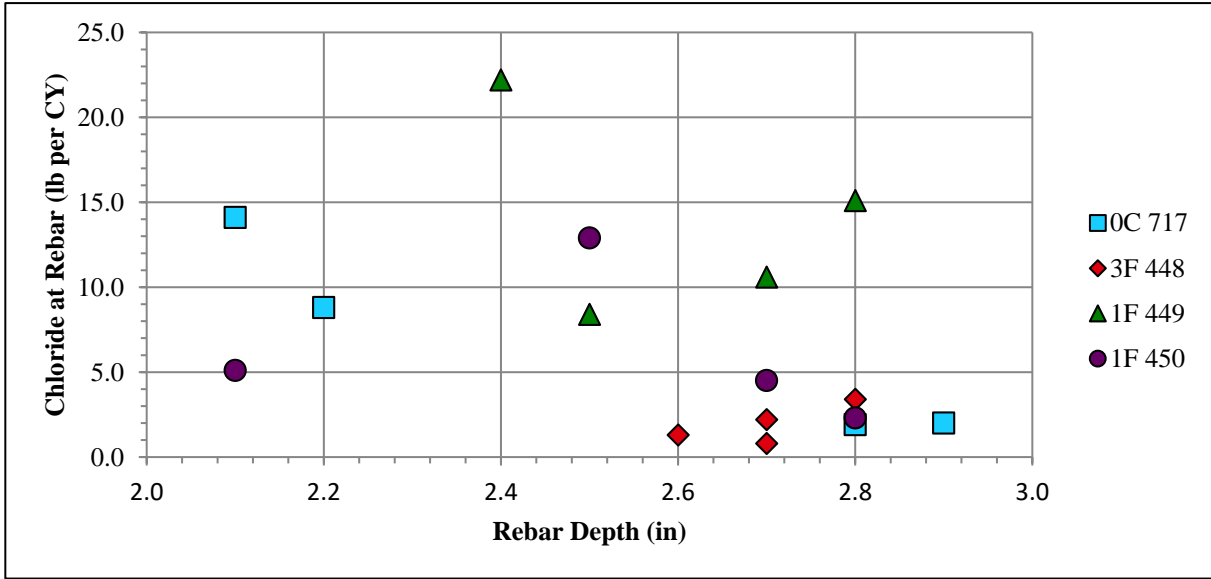
Figure 4.4.1.2 Difference in Multi-Span Bridge Chlorides at Rebar Depth (Mikulich 2020)

The range in chlorides at rebar depth was also examined to investigate if data followed the fundamental assumptions of diffusion mechanisms. The assumption was that different locations at the same depth are exposed to similar chloride concentrations at all locations because the application of chlorides across the deck surface was assumed as uniform. However, the data showed that this is likely untrue. When the four multi-span bridges' rebar depths were graphed against their chlorides at rebar depth in Figure 4.4.1.2, it became clear that the chloride data did not match the assumption that concentrations are uniform throughout each layer.

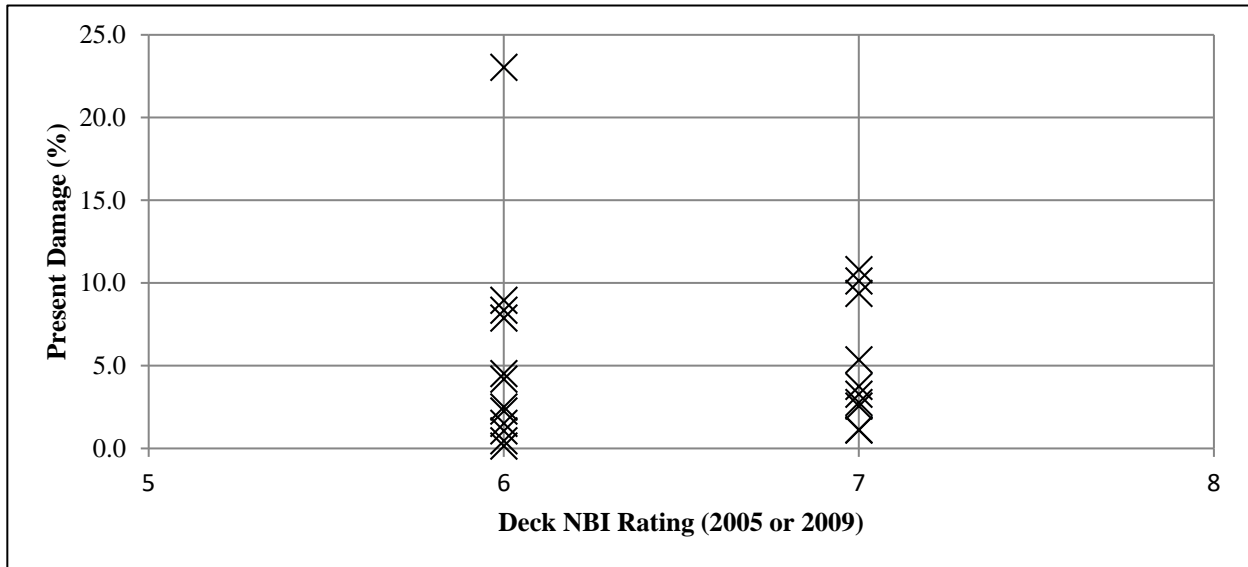
Figure 4.4.2.2 Present Damage and Deck NBI Rating Prior to Treatment (Mikulich 2020)

This was not observed when the deck NBI ratings from 2005 or 2009 were graphed against their current damage in Figure 4.4.2.2. Naturally the data will have a much weaker trend due to the inherent nature of the treatments performed and the passage of time, but it was expected that prior damage would be a significant factor in determining future damage. All regressions on this data showed a near zero correlation, indicating that prior damage had no impact on current damage.

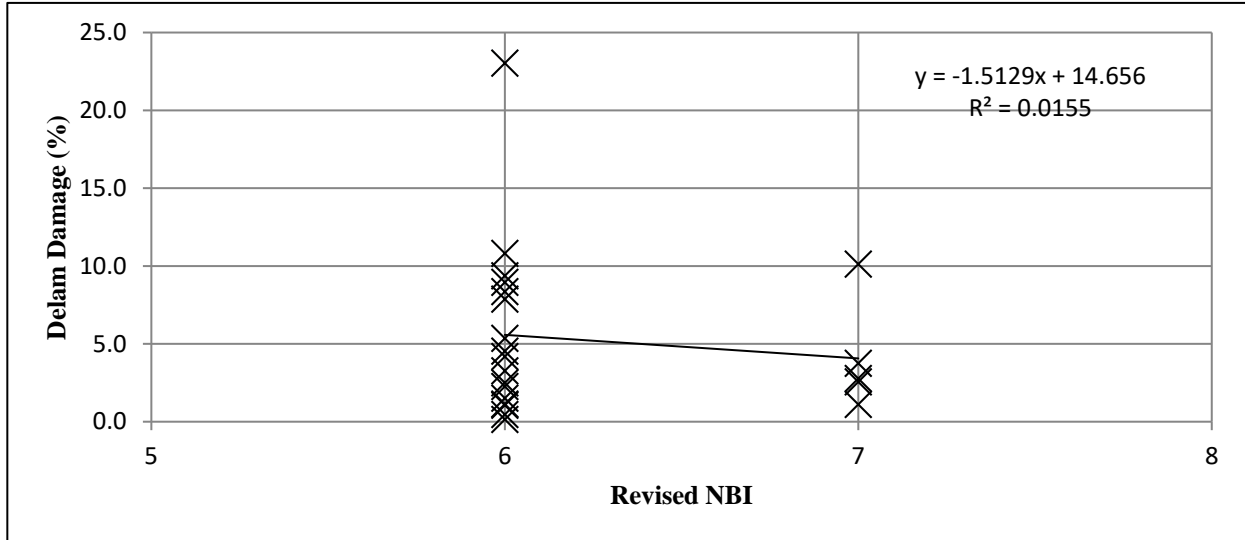
Figure 4.4.2.5 Regression of Damage and Revised NBI Deck Rating (Mikulich 2020)

Figure 4.4.2.5 graphs the revised NBI deck ratings against the present quantities of delamination damage. It is expected that decks in better condition prior to treatment will generally have lower amounts of damage seen today.

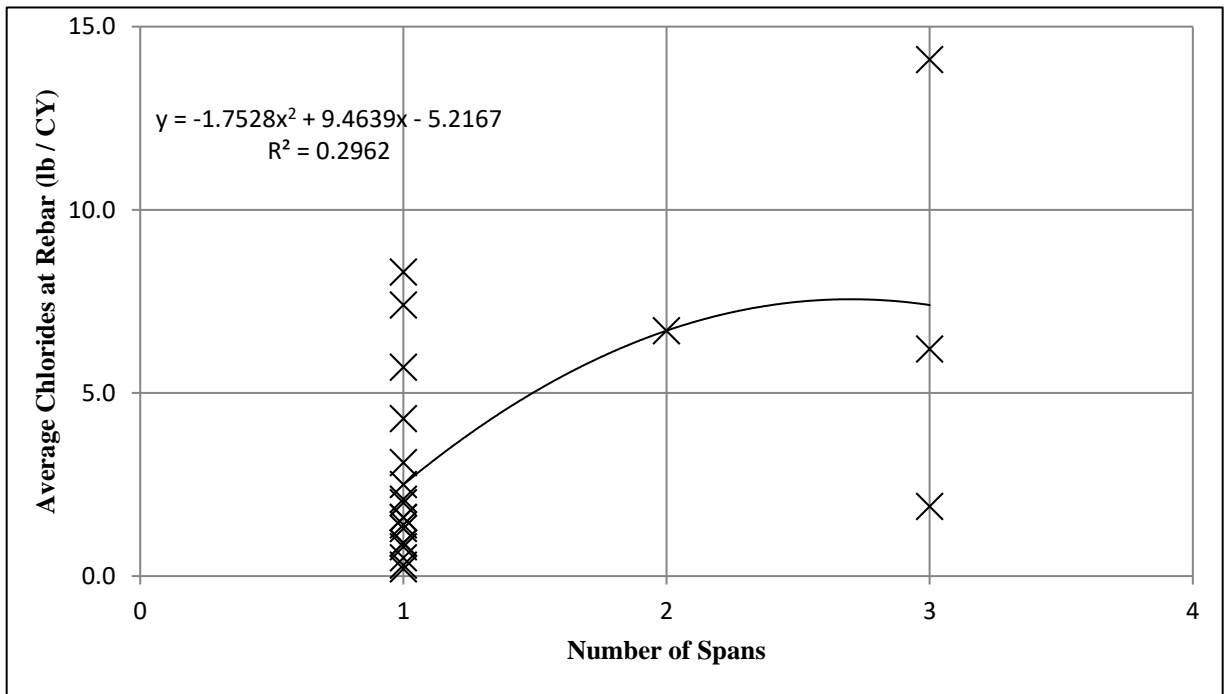
Figure 4.5.1.1 Colinearity Between Spans and Chlorides (Mikulich 2020)

Figure 4.5.1.1 showed that the correlation coefficient between spans and average chlorides at rebar was 0.296. This indicates little colinearity between these variables and that it was therefore valid to assume they functioned as independent variables within the ANOVA tests.

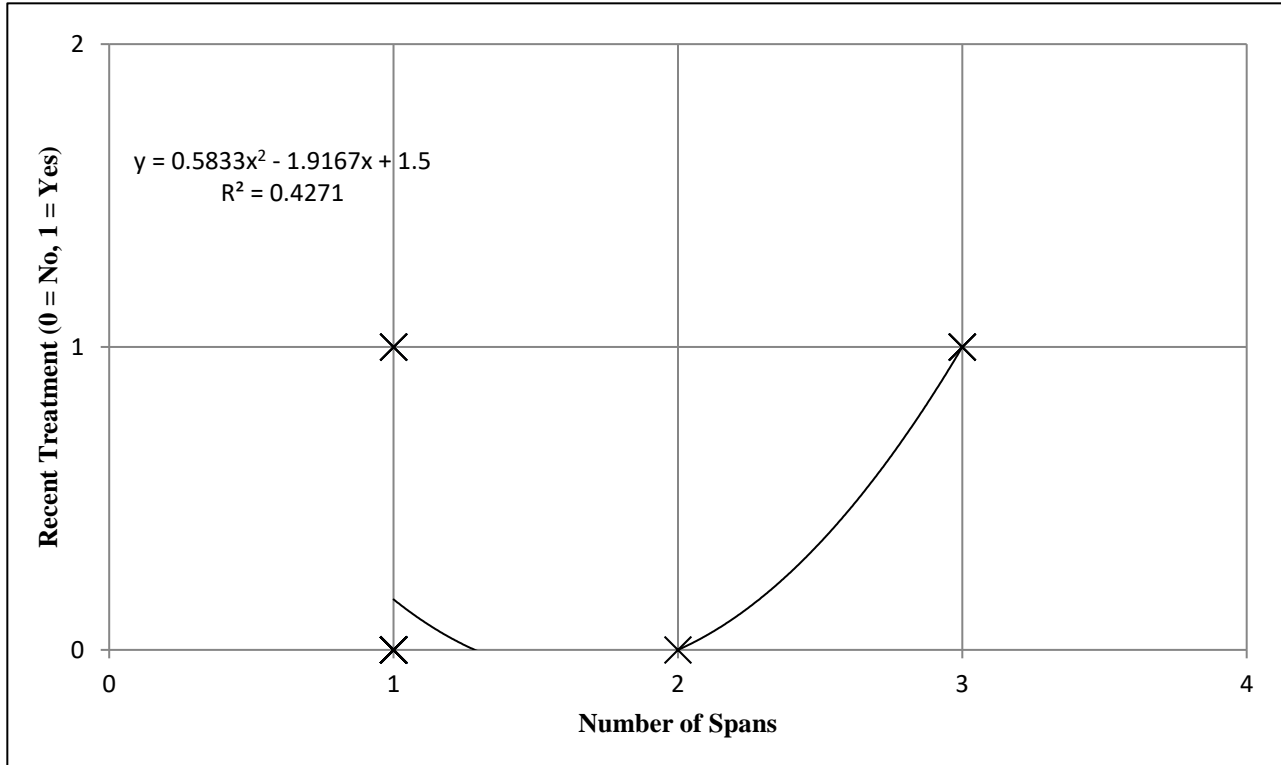
Figure 4.5.1.2 Colinearity Between Spans and Recent Treatment (Mikulich 2020)

Recent treatment is a potentially significant variable and may have a collinear relationship with the number of spans due to the nature of the two variables. Figure 4.5.1.2 and its correlation coefficient of 0.427 indicated that there is some degree of correlation, but not enough to warrant a deeper investigation of the relationship between these two variables.
