September 2021
Report No. 21-024

Improved Load Rating Procedures for Deteriorated Steel Beam Ends with Deteriorated Stiffeners

University of Massachusetts Amherst

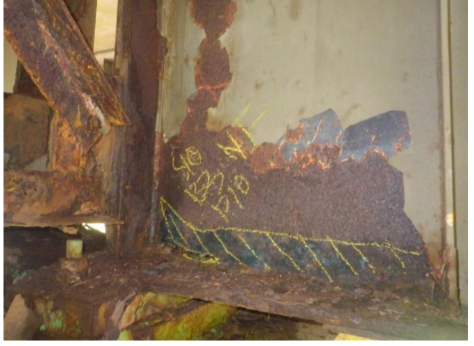
<p>Adopted from N-06-020-3U1-DOT-NBI (District 5, City of New Bedford)</p>
<p>Short description: Corrosion height (CH_1) and length (CL_1) are the two geometric characteristics of W2 pattern. The damaged area is located at the web bottom and expands along the longitudinal axis of the beam. The photograph on the right shows a typical case of W2.</p>

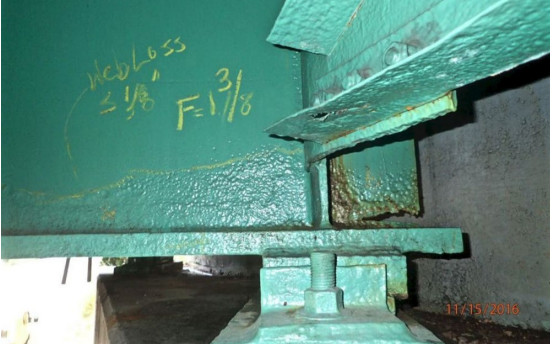
Table 2.4: Web corrosion pattern W3 for C1 configuration

<p>Adopted from M-05-006-47X-DOT-NBI (District 5, Town of Marion)</p>
<p>Short description: The W3 corrosion pattern for C1 configuration is a combination of W1 and W2. The damaged area is equally high along the two sides of the bearing stiffener. The photograph on the right shows a typical case of W3.</p>

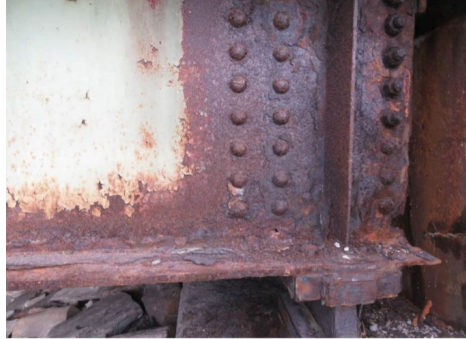
Table 2.5: Web corrosion pattern W4 for C1 configuration

<p>Adapted from F-07-045-4PH-DOT-NBI (District 3, City of Framingham)</p>
<p>Short description: Two corrosion heights (CH_1, CH_2) and two corrosion lengths (CL_1, CL_2) have been introduced to describe the W4 deterioration scenario, where the damaged area with varying deterioration height extends along both sides of the bearing stiffener. The photograph on the right shows a typical case of W4.</p>

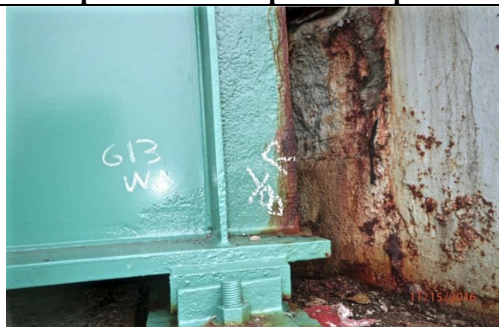
Table 2.6: Web corrosion W5 for C1 configuration

<p>Adapted from M-05-006-47X-DOT-NBI (District 5, Town of Marion)</p>
<p>Short description: Two corrosion heights (CH_1, CH_2) and a corrosion length (CL_1) have been introduced to describe the W5 deterioration scenario. The damaged extends along both sides of the bearing stiffener, with different height at each domain. The area between the stiffener and the outer web edge is considered corroded along the whole length. The photograph on the right shows a typical case of W5.</p>

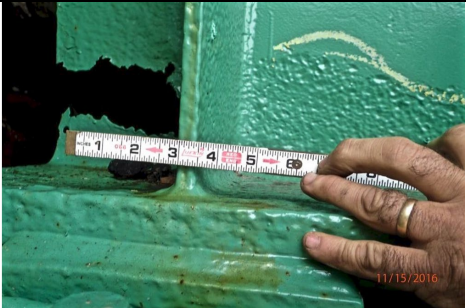
Table 2.7: Web hole pattern H1a for C1 configuration

<p>Adopted from M-05-006-47X-DOT-NBI (District 5, Town of Marion)</p>
	<p>Short description: H1a is a case where a hole appears at the lower part of the web; it initiates at the web edge and extends longitudinally at the domain behind the bearing stiffener. HH is the height of the hole, and HL is the length of the hole. HH is expressed normalized to web depth (d_w) and HL normalized to c, where c is defined in the sketch on the left. The photograph on the right shows a typical case of H1a.</p>

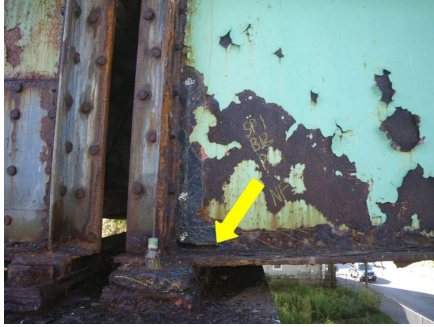
Table 2.9: Web hole pattern H2 for C1 configuration

<p data-bbox="894 604 1373 663">Adopted from N-06-020-3U0-DOT-NBI (District 5, City of New Bedford)</p>
<p>Short description: H2 is a case where the hole appears just in front of the bearing stiffener and expands along the longitudinal beam axis. HH is the height of the hole, and HL is the length of the hole. Both parameters are expressed normalized to web depth (d_w). The photograph on the right shows a typical case of H2.</p>

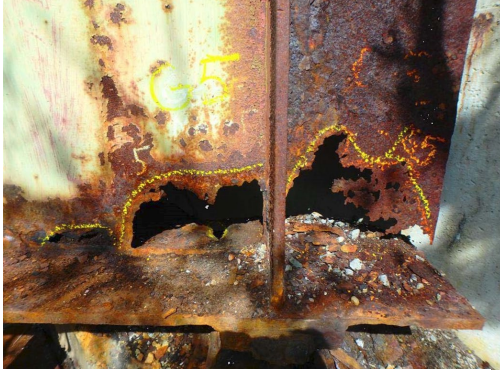
Table 2.10: Web hole pattern H3 for C1 configuration

<p data-bbox="894 1323 1382 1381">Adopted from W-29-057-4QE-DOT-NBI (District 6, Town of Weston)</p>
<p>Short description: H3 is a case where a hole appears at the bottom of the beam. The hole initiates from the outer web edge and expands with similar height beyond the bearing stiffener. HH is the height of the hole, and HL is the length of the hole beyond the stiffener. Both parameters are expressed with respect to the web depth (d_w). The photograph on the right shows a typical case of H3.</p>

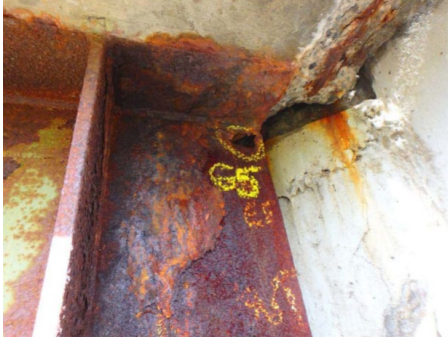
Table 2.11: Web hole pattern H4 for C1 configuration

<p data-bbox="894 611 1382 674">Adopted from W-29-057-4QE-DOT-NBI (District 6, Town of Weston)</p>
<p>Short description: H4 is a similar to H1a case, but it is differentiated in terms of location. Parameter b is employed to describe the hole location in respect to the web bottom and is expressed as a percentage of web depth (d_w). HH is the height of the hole, and HL is the length of the hole. HH and HL are expressed with respect to the web depth (d_w) and c respectively. The photograph on the right shows a typical case of H4.</p>

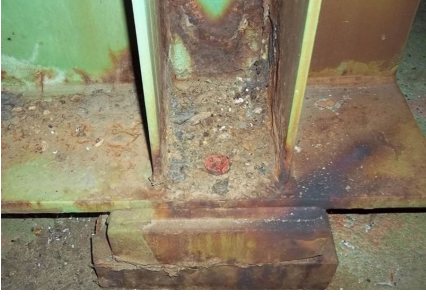
Table 2.12: Web corrosion pattern W1 for C2 configuration

<p data-bbox="889 730 1364 787">Adopted from S-35-013-3YB-DOT-NBI (District 5, Town of Swansea)</p>
<p>Short description: Corrosion height (CH_1) is the unique parameter of W1 pattern, which describes web section loss along the whole length of the domain between the bearing stiffeners. The photograph on the right shows a typical case of W1.</p>

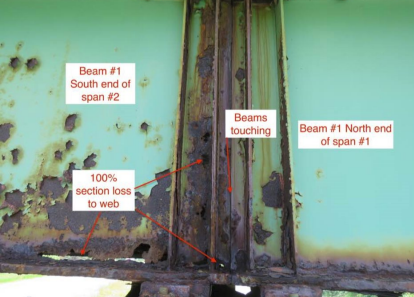
<p>Beam #1 South end of span #2</p> <p>Beams touching</p> <p>Beam #1 North end of span #1</p> <p>100% section loss to web</p> <p>Adopted from W-46-011-3YK-DOT-NBI (District 5, Town of Wrentham)</p>
<p>Short description: Two corrosion heights (CH_1, CH_2) and a corrosion length (CL_1) have been introduced to describe the W4 deterioration scenario, where the damaged area with varying deterioration height, initiates from the outer web edge and expands beyond the two bearing stiffeners. The photograph on the right shows a typical case of W4.</p>

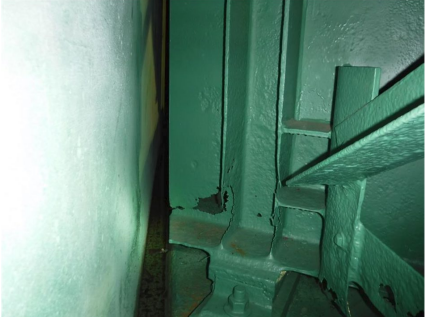
Table 2.16: Web hole pattern H1 for C2 configuration

<p>Adopted from W-46-008-3VL-DOT-NBI (District 5, Town of Wrentham)</p>
	<p>Short description: H1 is a case where a hole appears at the lower part of the web. It initiates either at the web edge or the outer stiffener and extends longitudinally at the domain between the stiffener and the web edge. HH is the height of the hole, and HL is the length of the hole. HH is normalized with respect to web depth (d_w) and HL with respect to c. The photograph on the right shows a typical case of H1.</p>

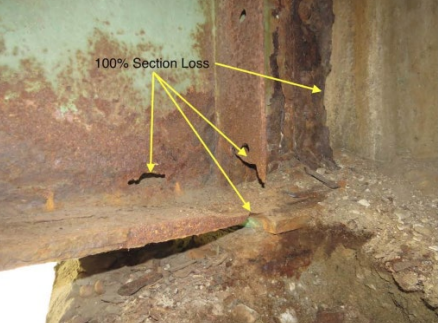
Table 2.18: Web hole pattern H3 for C2 configuration

<p data-bbox="906 1318 1390 1377">Adopted from W-44-063-1LA-DOT-NBI (District 5, City of Worcester)</p>
<p>Short description: H3 is a case where the hole appears in front of the inner bearing stiffener and expands along the longitudinal beam axis. HH is the height of the hole, and HL is the length of the hole. Both parameters are expressed with respect to the web depth (d_w). The photograph on the right shows a typical case of H3.</p>

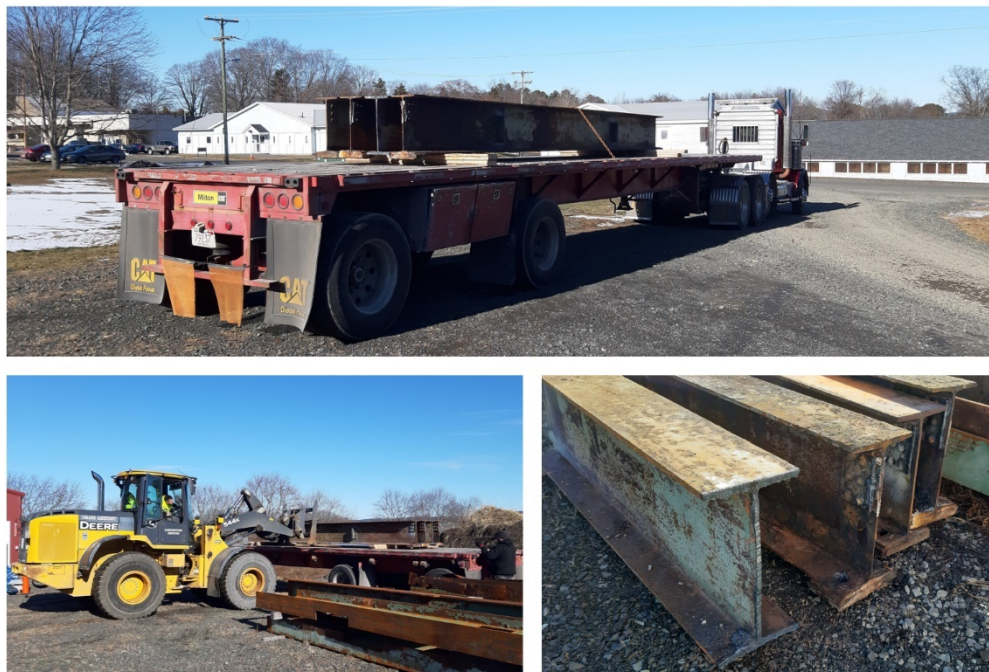
Figure 3.2: Delivery, unloading, and storage of first set of corroded beams

On January 9, 2020, four beam segments were delivered to the Brack Structural Testing Laboratory at the University of Massachusetts. The research team coordinated with UMass Construction Services to unload and place the beams into the backyard of the laboratory (Fig. 3.2).

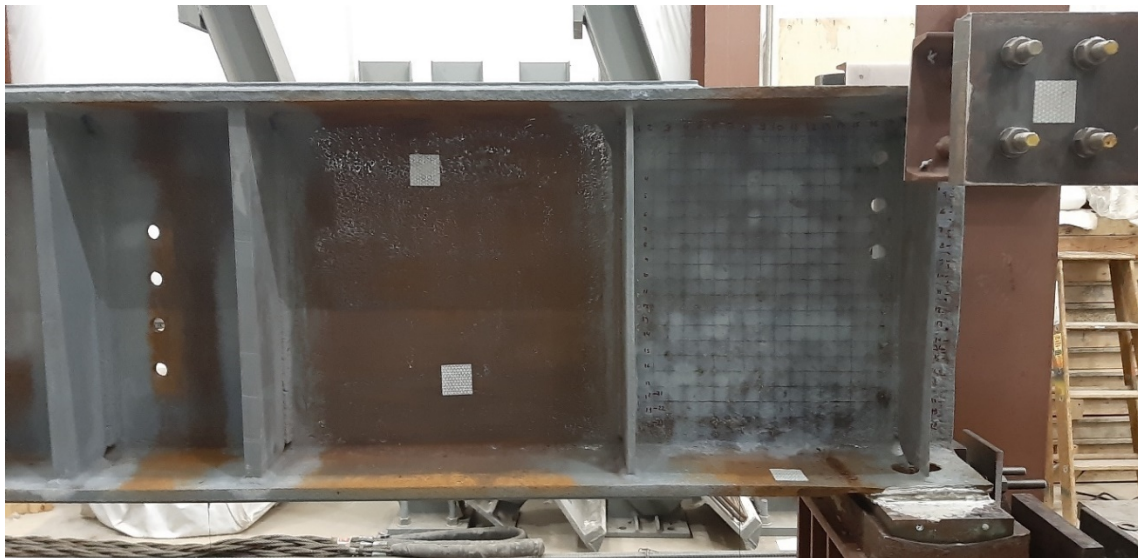
A photograph of the actual specimen is presented in Fig. 3.7. Observation of the same figure revealed perforations resulting from the removal of the riveted plates along the web. Additional perforations were found at the bottom flange, where anchor rods were passing through to restrict the girder in in-service conditions. Their existence prevented the bearing stiffeners from transferring load to the bottom flange along their whole width.

Figure 3.7: Corroded end of Specimen A

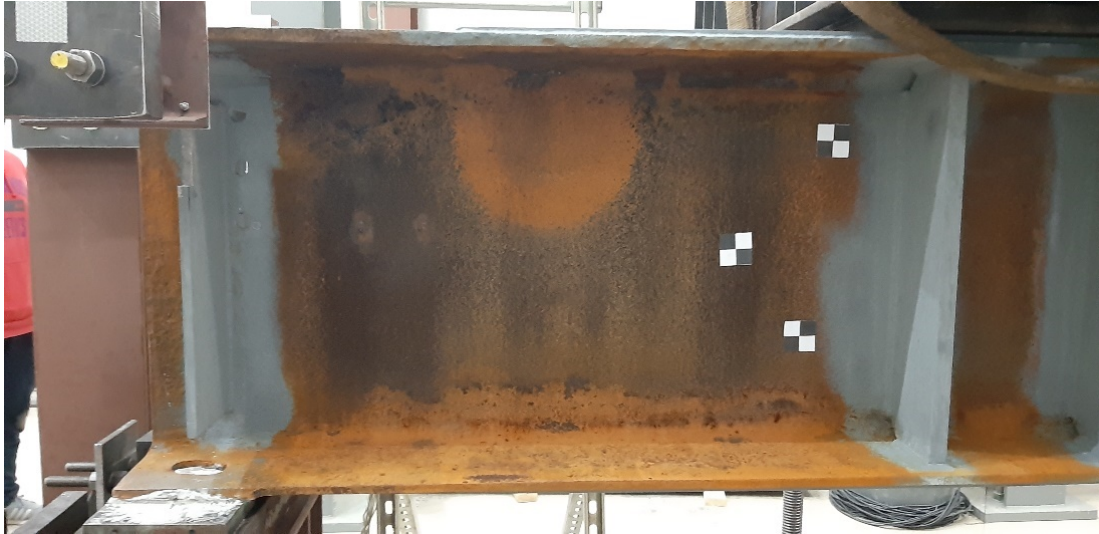
Figure 3.12: Corroded end of Specimen B

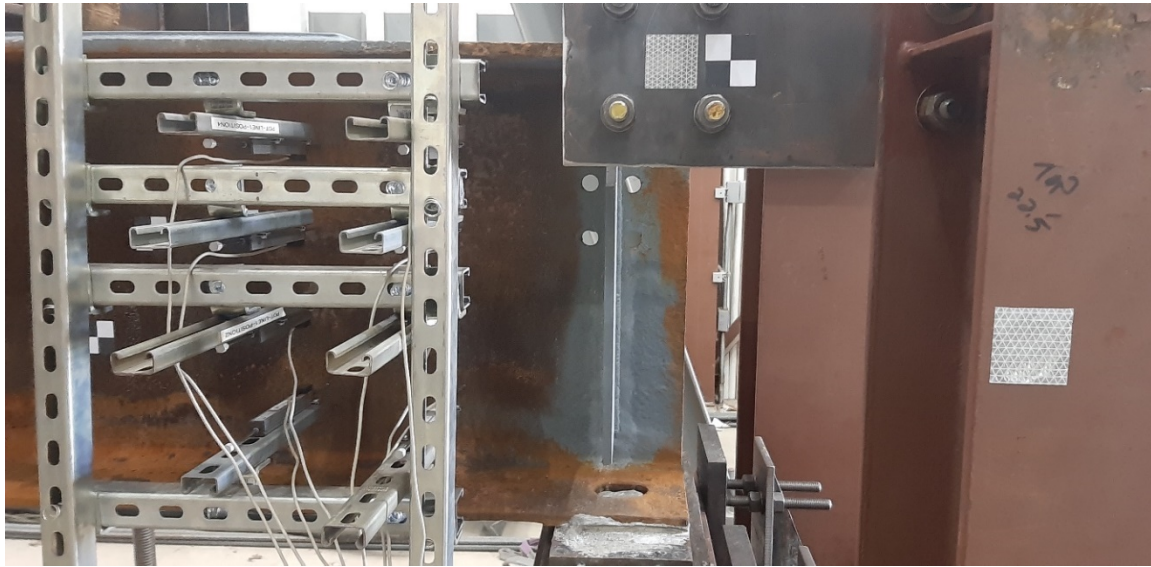
Figure 3.15: Instrumentation configuration at tested end of Specimen B

The exact experimental and instrumentation configurations are illustrated in Figs. 3.14 and 3.15, respectively.

Fig. 6.6a presents the lateral displacements as they were measured by the eight potentiometers for two different loads: 155.1 and 172.3 kip (0.9, and 1 F_u , where F_u is the failure load). Two columns of instruments had been installed, with four potentiometers each. The first column was placed to record the sideways deflection profile close to the partial stiffener (red), while the second one was placed 8 inches toward the inner side of the beam (blue), Fig. 3.15.

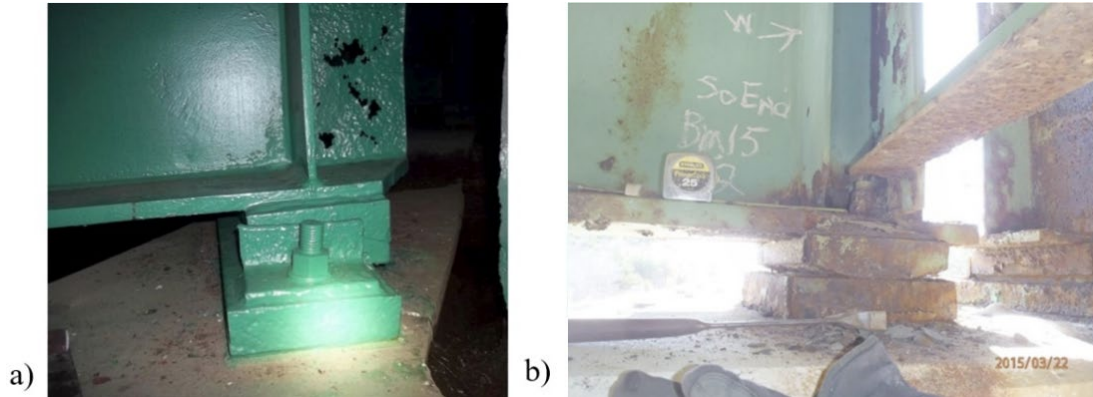
Figure 4.9: a) Expansion and b) fixed bearing types commonly found supporting corroded plate girders in Massachusetts

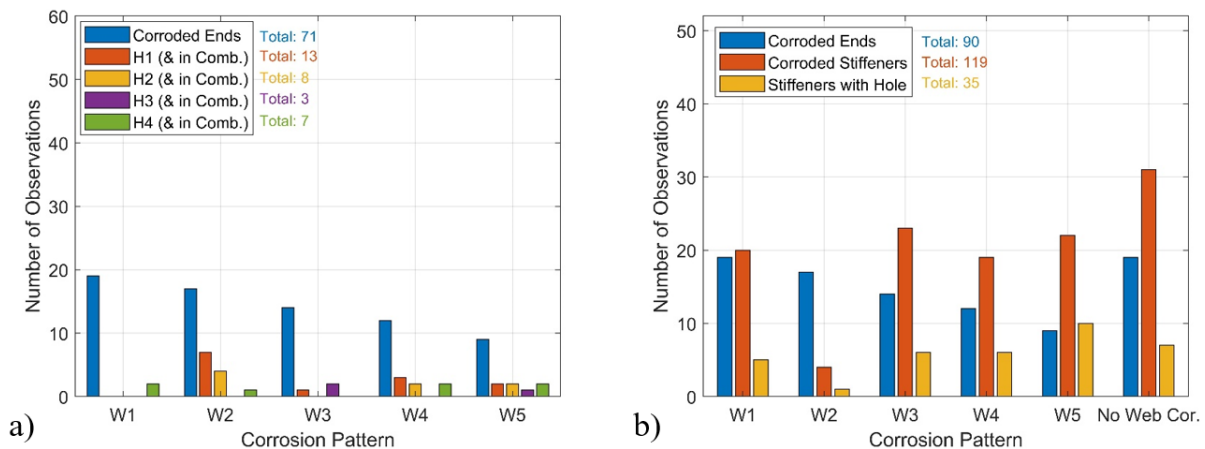
Figure 5.2: Web corrosion in correlation with a) web holes and b) stiffeners condition for C2 configuration

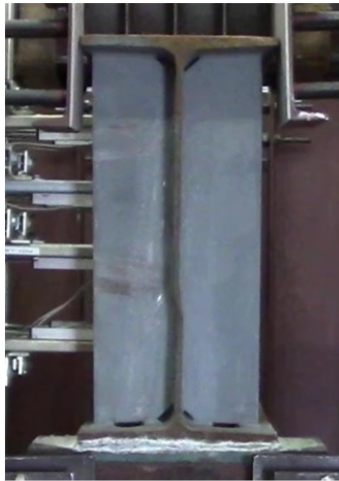
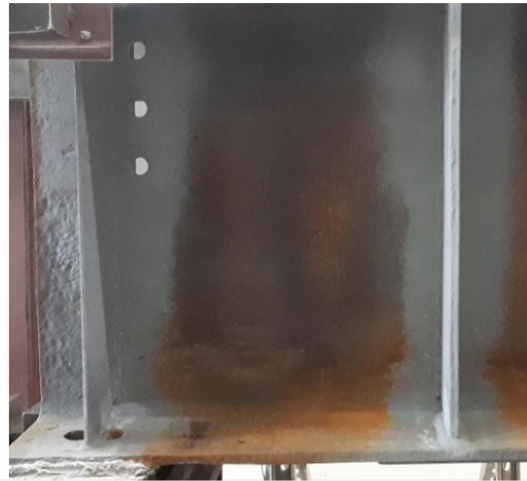
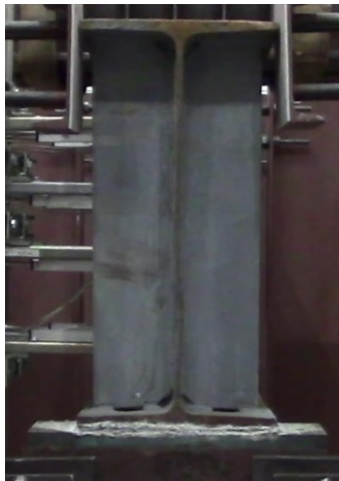
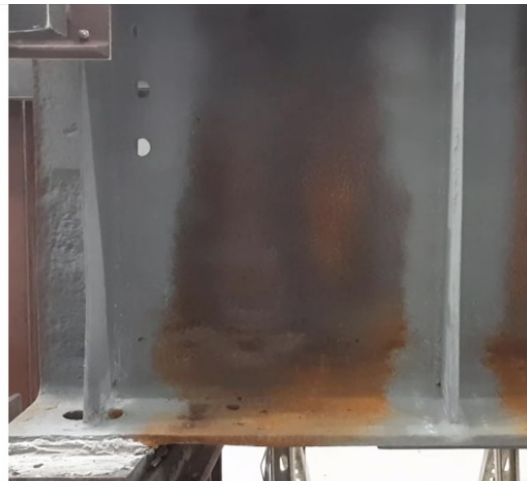
Furthermore, Fig. 6.1a illustrates a relatively linear response of the specimen until failure, where a sudden capacity drop occurred. This behavior is consistent with the macroscopic observation of the specimen, where no large deformations were noticed prior to the sudden failure. The whole experimental process was captured by two cameras (Figure 6.2). The first camera recorded the plane of the web (side view of the beam), while the second camera recorded the beam profile. These photos illustrate the girder's deformation at the initial condition before loading, followed by deformations observed at different steps of the experimental procedure (points from A and B, Fig. 6.1a).

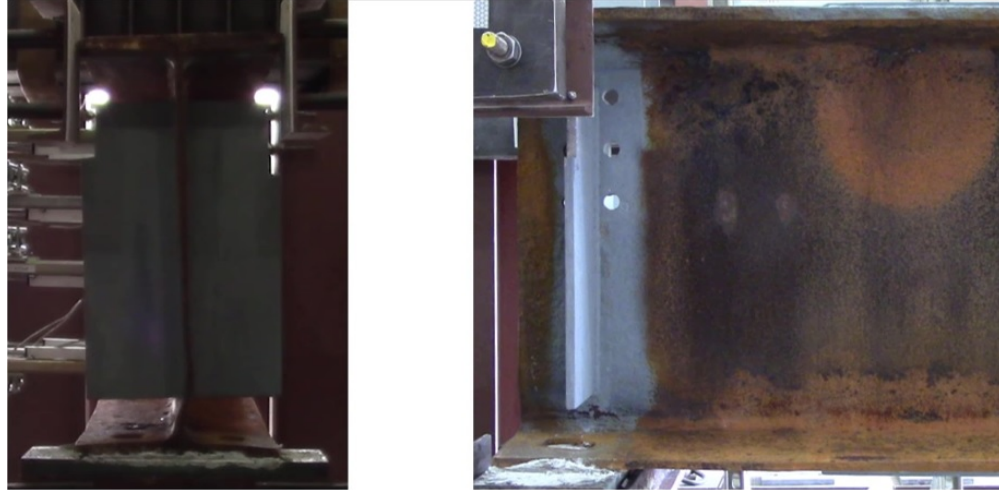
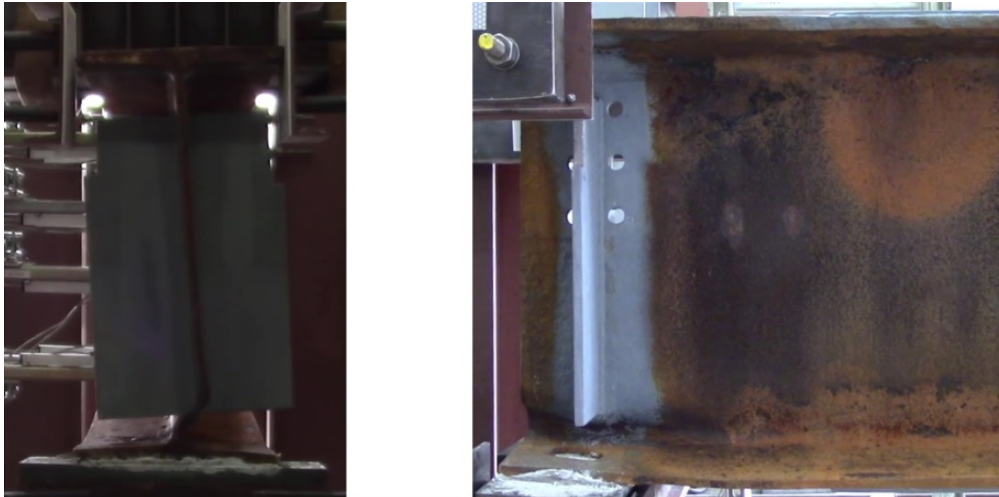
In Fig. 6.5, the deformation of the corroded end is presented, using images captured from two cameras that recorded the experimental process. The first camera recorded the plane of the web (side view of the beam), while the second camera recorded the beam profile. These photos illustrate the girder's deformation at the initial condition before loading, followed by deformations observed at different steps of the experimental procedure (Points A and B, Fig. 6.4a).

The riveted plate in Fig. 3.3 was removed prior to the partial stiffener welding, revealing perforations at the upper part of the web (Fig. 6.5). Other than that, visual observation did not reveal significant deficiencies or deformations, before loading initiation. At Point A, which corresponded to 90% of the maximum applied load, the cameras' captures did not depict any significant variation in specimen's geometry, strengthening the linear response presented in Fig. 6.4a.

At Point B, where the undertaken load reached the magnitude of 172.3 kip, the whole web seemed to translate laterally along the same direction, with peak displacements concentrated at the bottom unstiffened part of the web. It is worth noting that, according to the remaining thickness profile derived from point clouds (Fig. 6.5b) capturing both web surfaces, the bottom web part coincided with a region of section loss.

Figure 6.5: Side-by-side images showing side view of web and profile view of beam during experiment (A and B correspond to Fig. 6.4a)

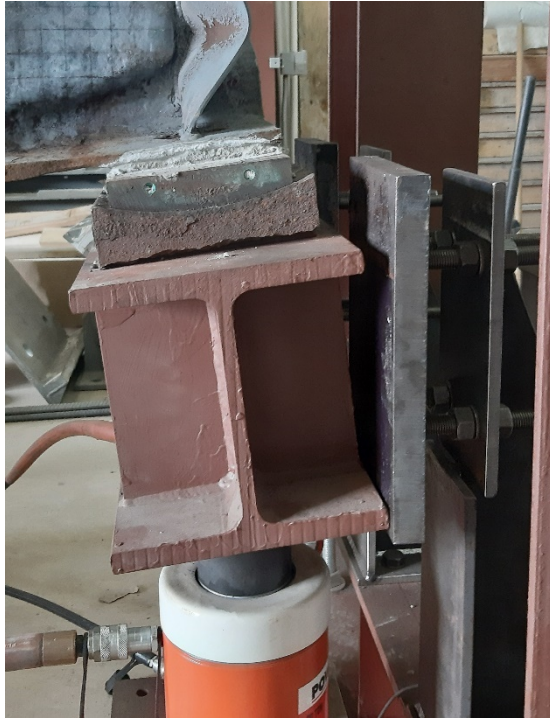
It is worth noting that both experiments were terminated due to extensive post-peak inclination of the load spread beam installed between the hydraulic jacks and the actual bridge bearing (Fig. 6.7). The developed rotation was closely related to the cups that were installed on the top of the jacks' pistons and were meant to absorb the rotation at the same location. Their existence was preferred to avoid damaging the equipment, in case the developed rotation generated by distortion of the specimen exceeded the capacity of the bridge bearing, resulting in rocking phenomena between the load transfer beam and the pistons. However, a side effect of this configuration was that, potentially, it deactivated the operation of the actual sliding plates by absorbing the majority of the generated rotation. Even though pit corrosion was removed and grease was added at the interface between the two sliding plates, it seems that the reduced resistance of the recently fabricated cups provided less resistance, preventing the researchers from exploring the efficiency of the actual bridge bearing.

Figure 6.7: Both experiments terminated due to inclination of load spread beam, located between hydraulic jacks and bridge bearing

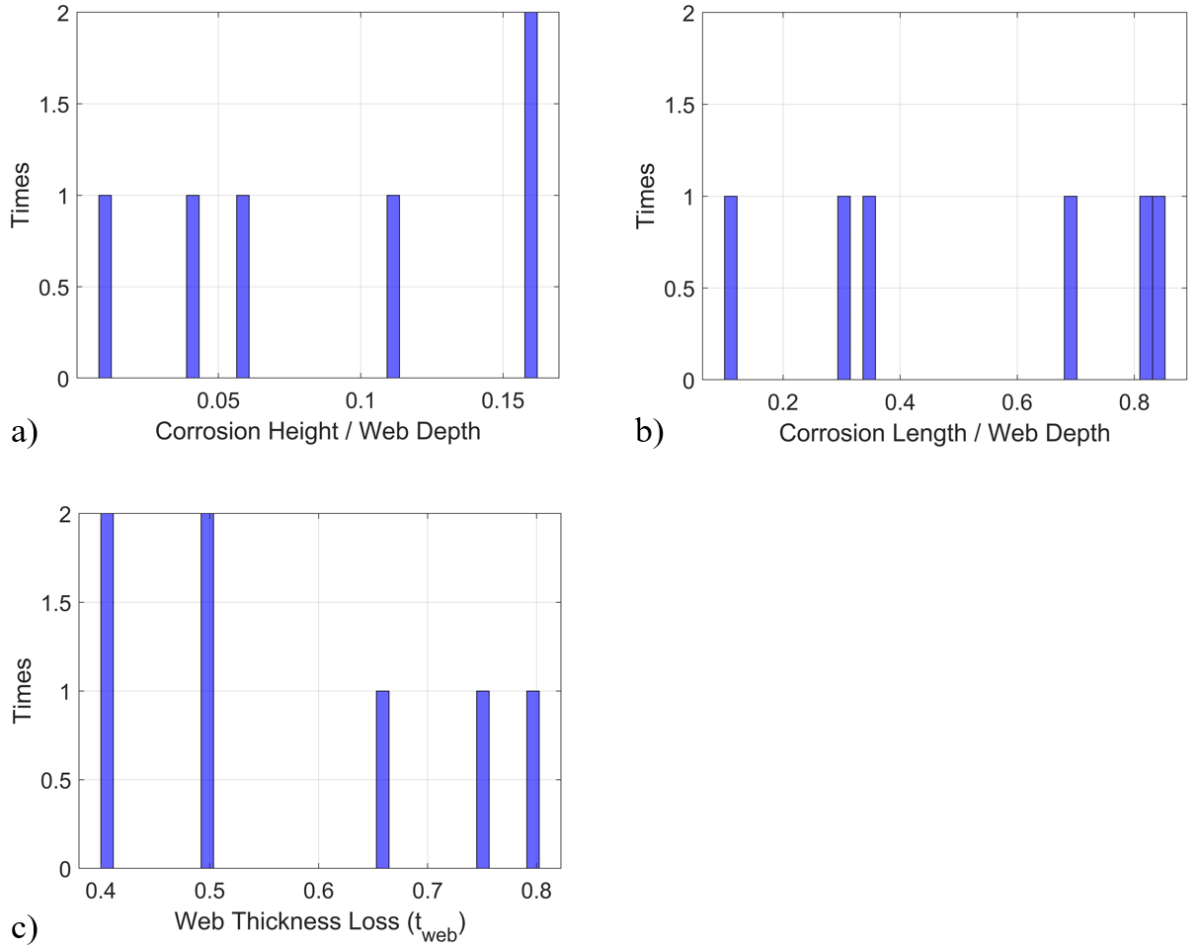
Figure 12.7: Distribution of deterioration characteristics for W3 corrosion scenario for beams with unique stiffener above bearing

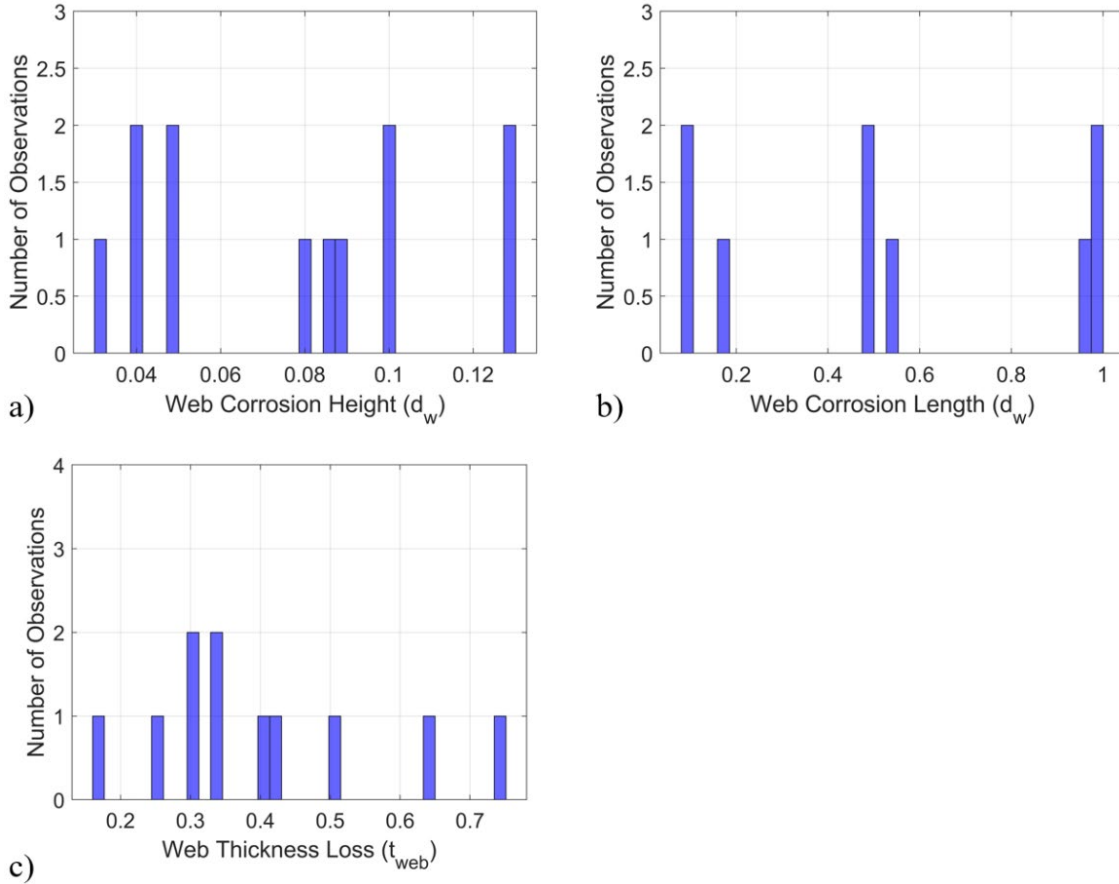
Figure 12.23: a) Corrosion height; b) length; and c) section loss of W3 corrosion pattern for beams with two bearing stiffeners
