DOT/FAA/TC-20/19

Aircraft Rescue and Firefighting Strategies and Tactical Considerations for New Large Aircraft: Update

September 2020

Final Report

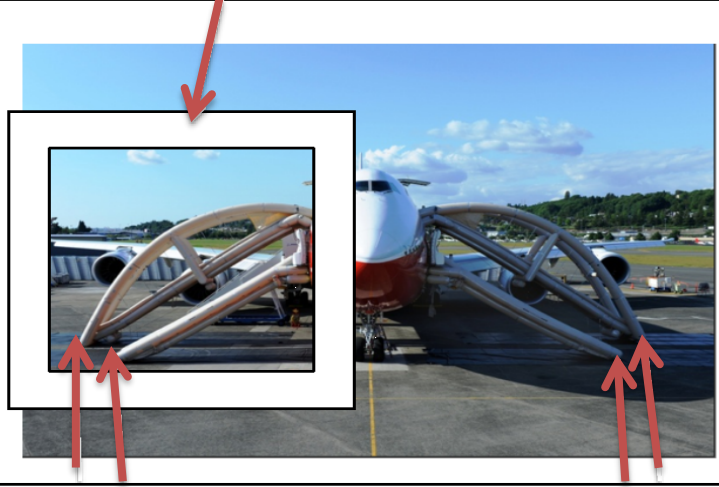
ARFF Vehicles Approaching Aircraft With Slides Deployed are Faced with Multiple Obstructions Which will Effect Application of Foam Blankets or Rapid Interior Access

Higher Sill Heights from Upper Deck Doors touch the ground further away from Fuselage

Figure 5. Forward View of B-747-8I Evacuation Slides
(Image courtesy of MikeJamesMedia.com)

The slides from a two-deck aircraft, such as a B-747-8I, block access to most of the forward portion of the fuselage (figure 5). There is no change in the number of exit doors or evacuation slides in the B-747-8I as compared to the B-747-400. As shown in figure 6, there are five main deck emergency exits and one on the upper deck. These slides are detachable and available as rafts for water incidents. The overwing exit includes a ramp slide, which takes evacuating passengers aft over the wing.

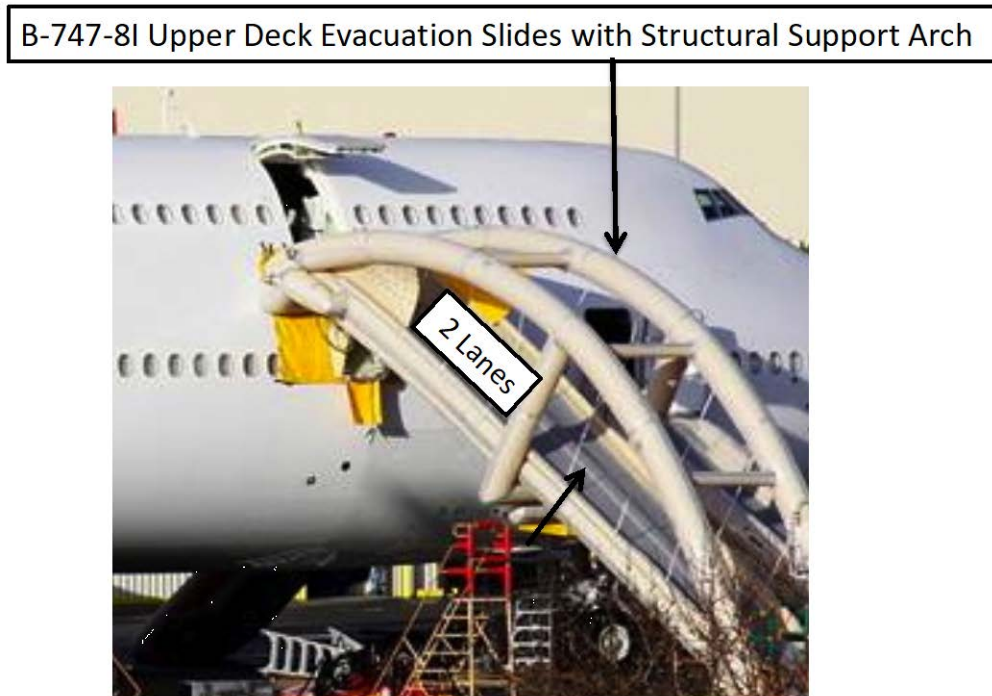
When the “additional” 12 ft of slide deploys due to aircraft angle, the wind resistance requirement is reduced by 3 knots. Although deployments of these slides during strong winds are not documented in the NTSB database, the additional arch structure designed to stabilize the slide may also act as a sail.

Figure 7. Structural Support Arch on B-747-8I Upper-Deck Slides
(Photograph courtesy of Paine Field Blog 1-5-2012)

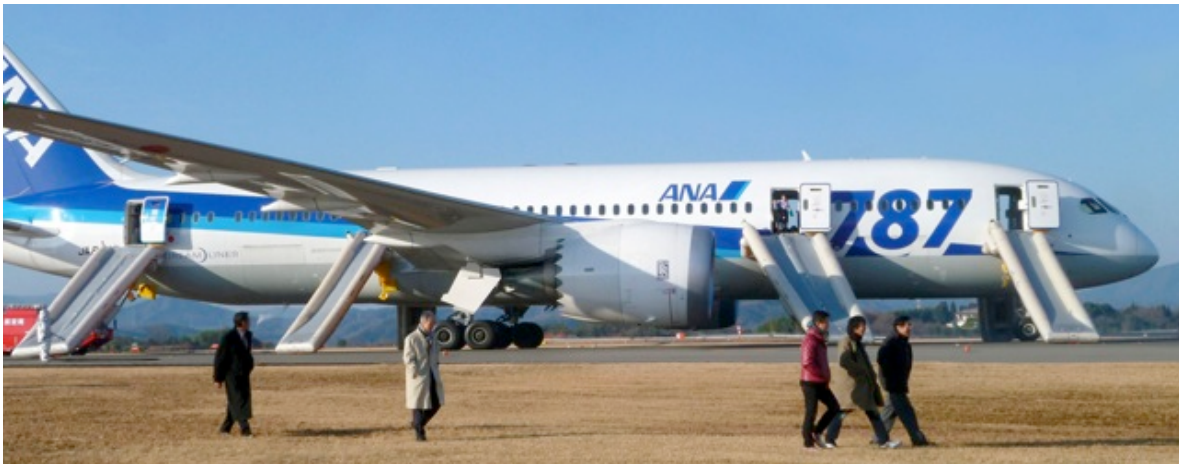
Figure 9. Evacuation Slides Deployed From ANA B-787
(Passenger Photograph courtesy of Japan's Kyodo News)

The B-787 has four evacuation slides on each side of the aircraft. Doors R and L 1 and 3 are equipped with single-lane slides. As shown in figure 9, doors R and L 2 and 4 are equipped with double-lane slides. These detachable slides are available as rafts for water incidents.

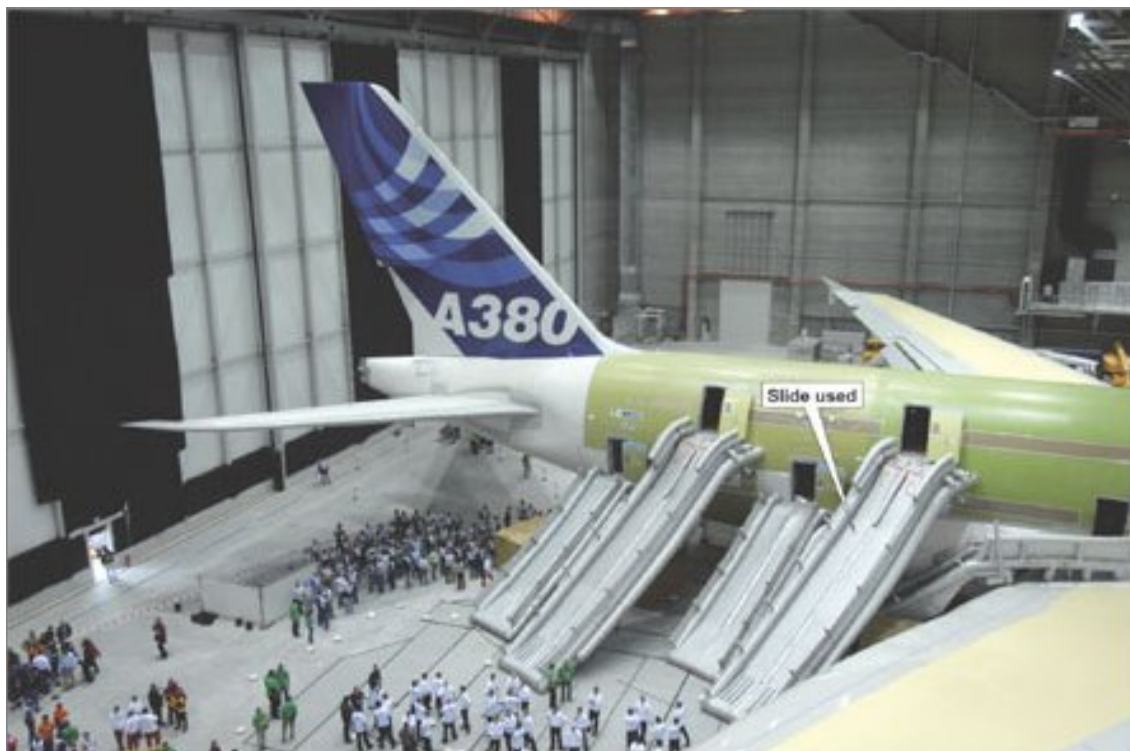
The ability of ARFF vehicles to approach the points aft of the wing is limited, and the overwing ramp slide disappears from view behind the upper-deck, double-lane slide. Each slide on the A380 is equipped with a reentry line, installed to provide direct access for ARFF crews to both the main and upper decks. This may be a physically challenging and not always practical as a method of access, but it is an available feature. Each evacuation slide is also equipped with three emergency lights.

Figure 11. Approach View of A380 With Slides Deployed (Photograph courtesy of Airbus)

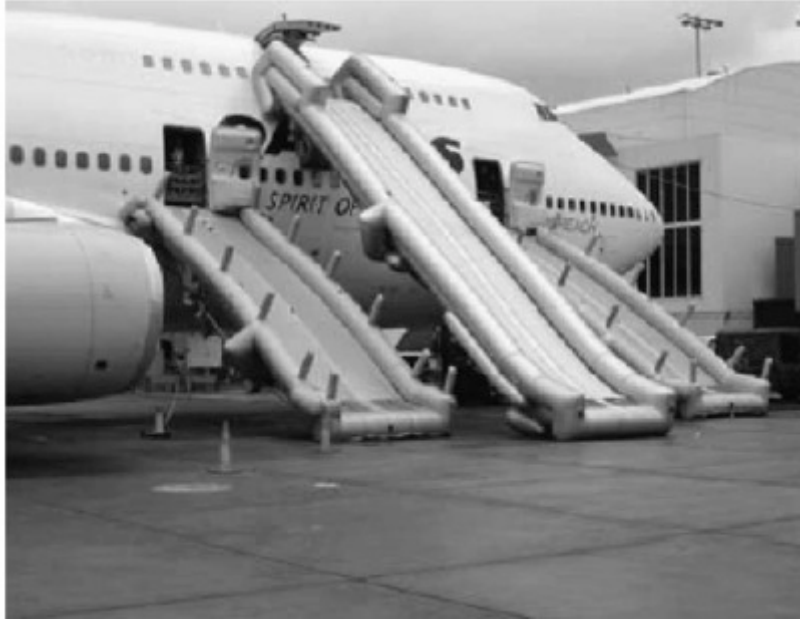
Figure 15. Slide Emergency Evacuation of a B-747-438—View 1
(Photograph courtesy of Australian Transport Safety Bureau)

During the B-747-438 evacuation, the L2 and R4 slides did not deploy. The upper-deck, right-slide deployed, but it was reported to be blocked by a vehicle. Ground crews freed vehicle from the slide and turned it to the correct position with respect to the ground. Upper-deck passengers used the stairway to the main deck and evacuated via the main-deck slides. The copilot evacuated from the upper-deck, right-side slide and was carrying a 6.6-lb fire extinguisher. The copilot reported he could not control his ascent, and he let go off the fire extinguisher while sliding. He landed heavily on his shoulder and fractured his collar bone. There was a total of 350 passengers and 14 crew members onboard. Four serious injuries occurred, including one to a crew member during the emergency evacuation. Figures 15 and 16 show the slide deployment after the Sydney evacuation. In figure 16, a deflated ramp slide is visible. The slide deflated 32 seconds after it was inflated. The failure occurred while a woman wearing high-heeled shoes was on the slide. She fractured a vertebra when she landed hard on the concrete apron. The Transportation Research Board was not able to conclusively determine the cause of the slide failure, but it did confirm the slide was used successfully by several passengers before the failure occurred. (Evacuate..., 2005)

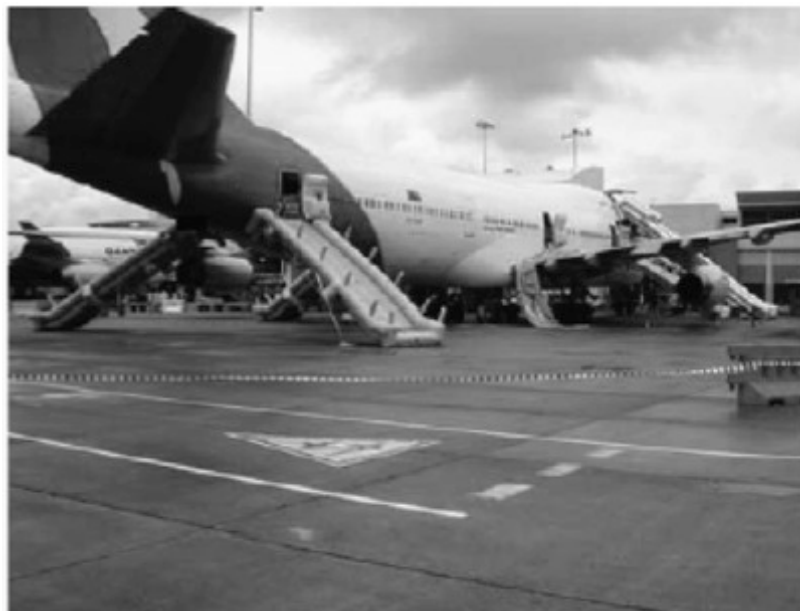
Figure 16. Slide Emergency Evacuation of a B-747-438—View 2
(Photograph courtesy of Australian Transport Safety Bureau)

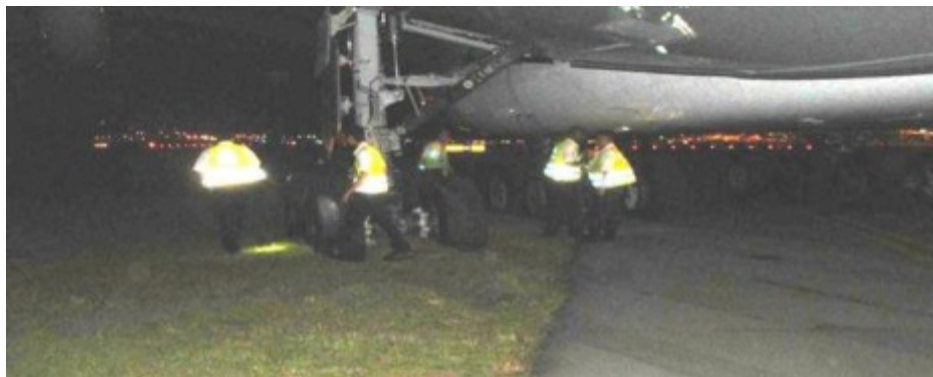
Figure 17. The SQ Flight 221, A380 Off Pavement

The first A380 evacuation on record occurred at SIN on January 10, 2010. Singapore Airlines (SQ) Flight 221 became disconnected prematurely from a push-back tractor, and the aircraft rolled off pavement and into the soft turf adjacent to Terminal 3. The aircraft was deplaned and recovered from the grass strip, as shown in figures 17 and 18.

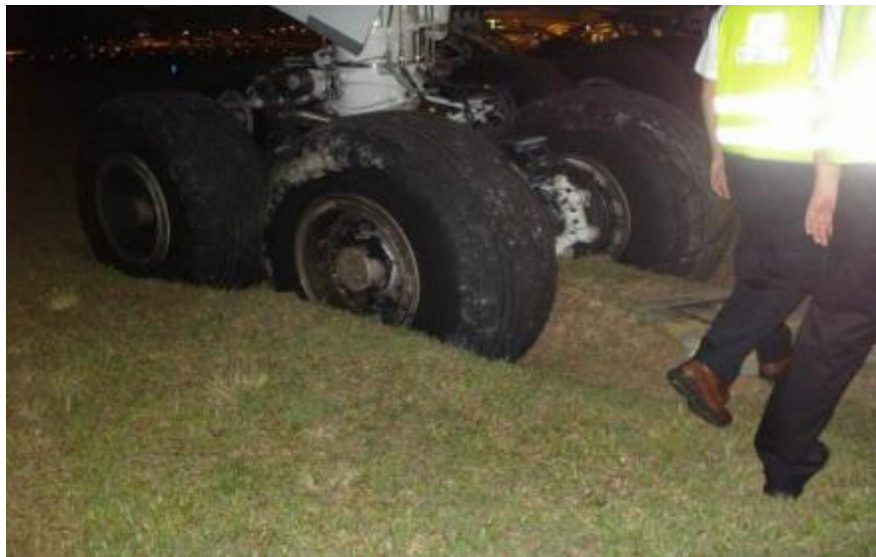
Figure 18. Gear of SQ Flight 221, A380 Off Pavement

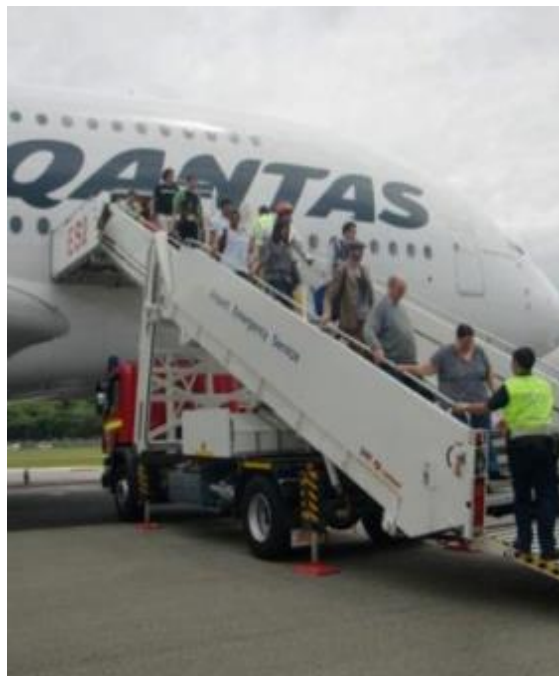
Figure 19. Deplaning Passengers From QF 32

The events that unfolded in this incident certainly would have justified the pilot to order evacuation by slides; however, despite the combination of events, he elected to deplane the passengers over air stairs provided by the CAG AES, on the scene, as shown in figures 19 and 20.

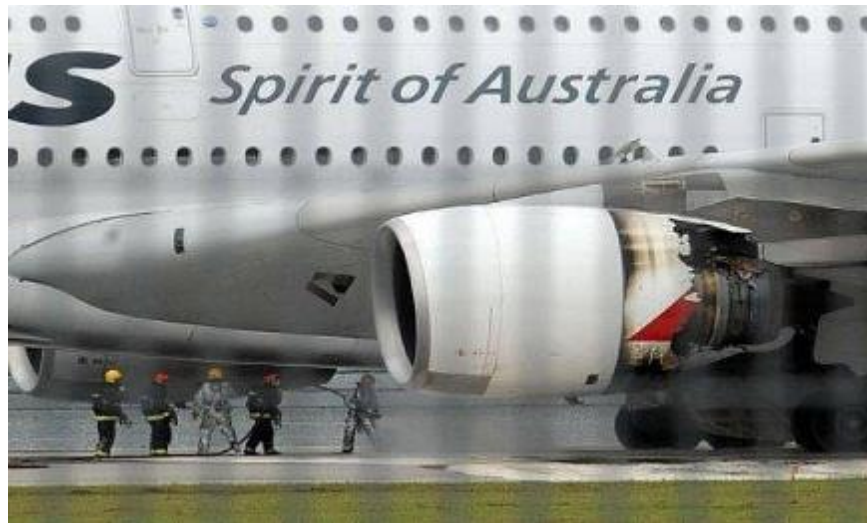
Figure 20. Number 2 Engine of QF 32

The second evacuation of an A380 also occurred at SIN (Australian Transport Safety Bureau (ATSB), 2013). The incident on November 4, 2010, unfolded as Qantas Flight (QF) 32 left Singapore bound for Sydney, Australia. The A380 suffered an uncontained engine failure of its Number 2 engine just 6 minutes into the flight. The flaps and landing-gear doors were inoperable, and the Number 2 engine was on fire. The pilots used gravity to lower the landing gear.

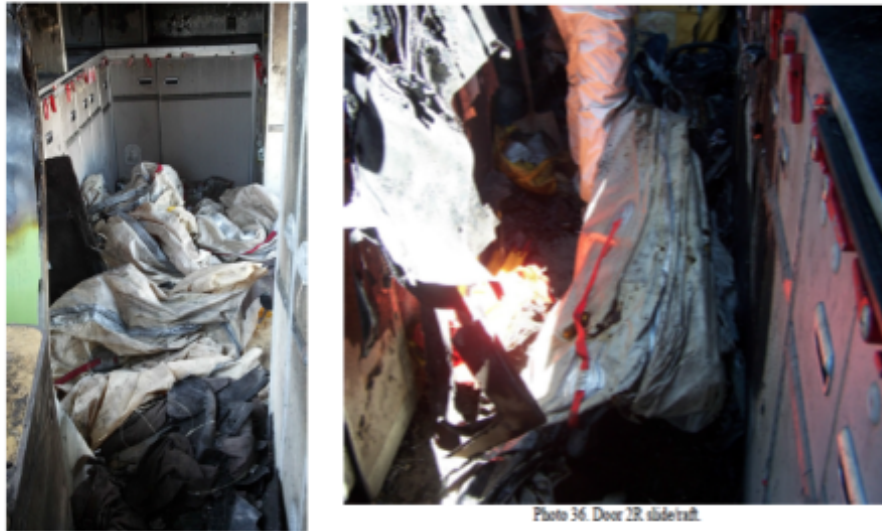
Asiana 214 – Interior Slide Deployment – B-777-200ER

Photo 33. Galley forward of door 1R and 1R slide/raft.

Photo 34. Door 1R slide/raft.

Figure 21. Asiana 214 B-777-200ER—Interior Slide Deployment
(Image courtesy of NTSB (2014a))

Figure 21 shows the two doors that were blocked by the slide that inflated inside the aircraft (NTSB, 2014a). In these photos, the slides are no longer inflated, but the slide material still represents a serious obstruction and source of entanglement for rescuers. A firefighter doing a hands-and-knees search in a dark, smoked cabin confronted by the inflated, tangled slide would be confused, unless trained for that possibility.

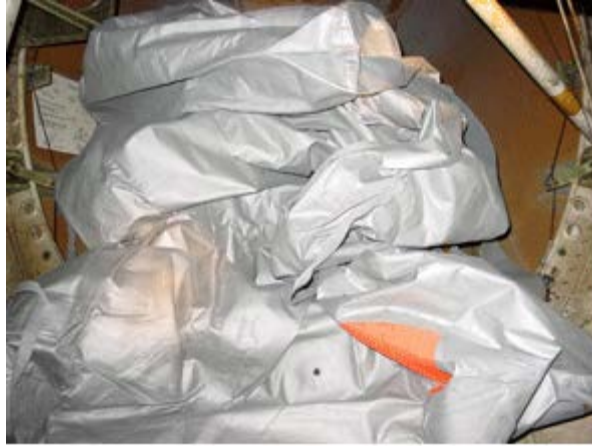
On July 7, 2008, an MD-81 (owned by Midwest Express) chartered by Presidential Candidate Barack Obama experienced a slide deployment inside the tail cone while in flight. None of the passengers onboard heard the slide deployment. As shown in figure 22, upon landing the slide was found partially inflated in the tail cone with an empty inflation bottle. There was evidence that there was a handrail broken and marks consistent with rubbing on the elevator control cables. The evidence of the inflated slide rubbing on the elevator control cables is consistent with a potential cause of flight control problems. Based on the image provided in figure 22, removal of the tail cone for firefighter access to the passenger cabin or for use as a ventilation point is not likely until the inflated slide can be deflated and removed. (NTSB, 2009)

Figure 22. Evacuation Slide Deployment MD-81—Tail Cone
(Image courtesy of NTSB)

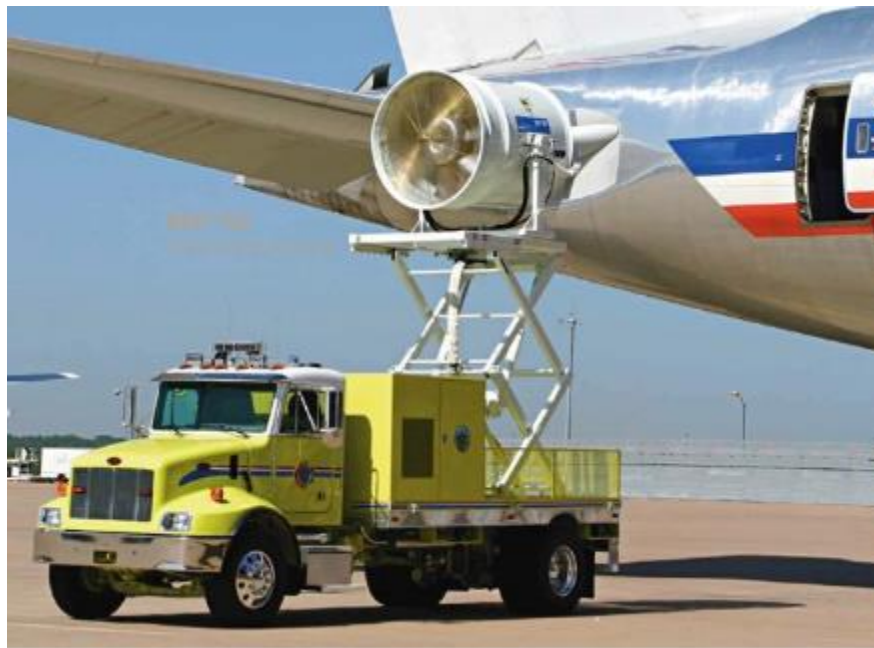
Figure 23. The DFW Mobile Ventilation Unit
(Image courtesy of DFW Fire Rescue)

At least one manufacturer of PPVs offers a large capacity mobile ventilation unit that can be raised into position to ventilate an aircraft. As shown in figure 23, Dallas/Fort Worth International Airport (DFW) has a large-capacity mobile ventilation unit. The PPV shown will move 150,000 cubic feet per minute.

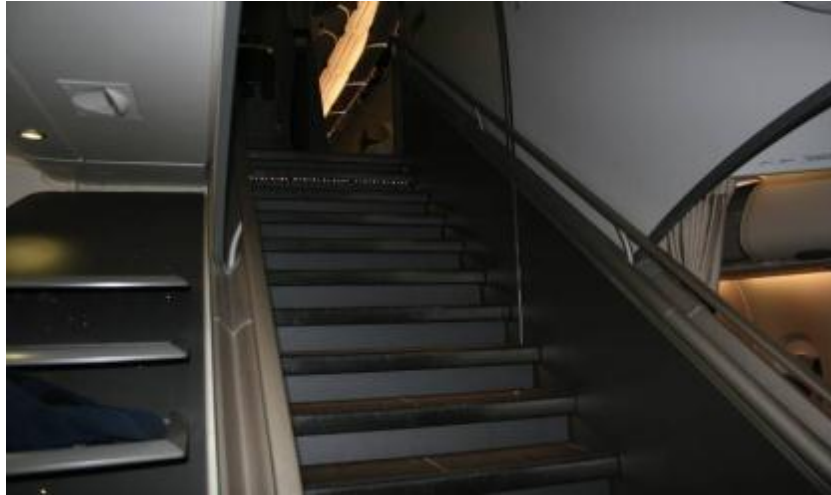
Figure 24. Forward Stairway Between Decks on Air France A380
(Photograph courtesy of FAA)

openings and interior stairs connecting the main- and upper-deck cabins located forward and aft, as shown in figures 24 and 25. Both aircraft have operable escape windows in the cockpit. The A380 also has service elevators located in the middle and rear galleys, as shown in figure 26. Ventilation always occurs on these aircraft. Controlling the airflow as part of the ventilation strategy will be an essential component to successful interior firefighting operations.

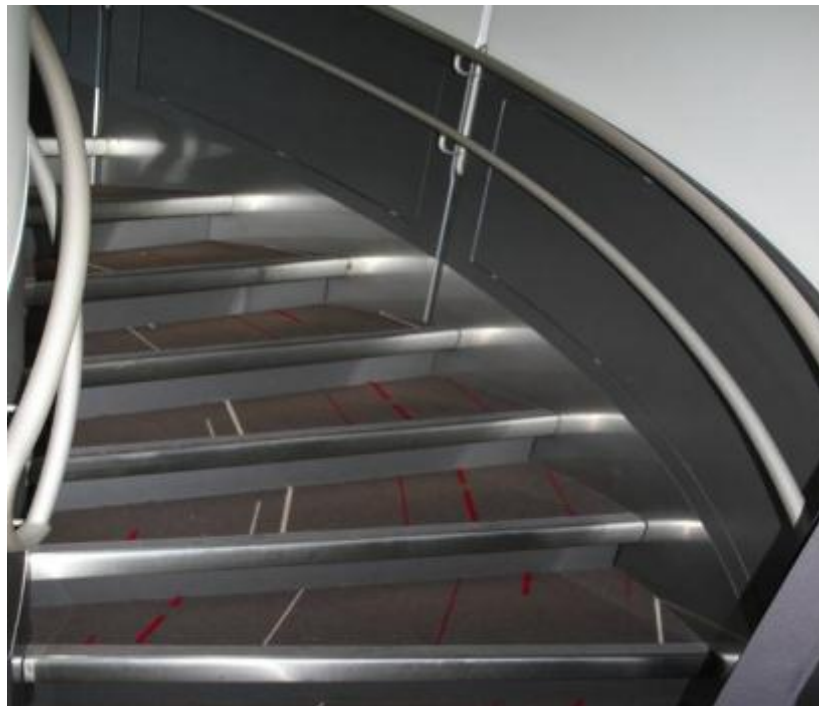
Figure 25. Rear Stairway Between Decks on Air France A380
(Photograph courtesy of FAA)

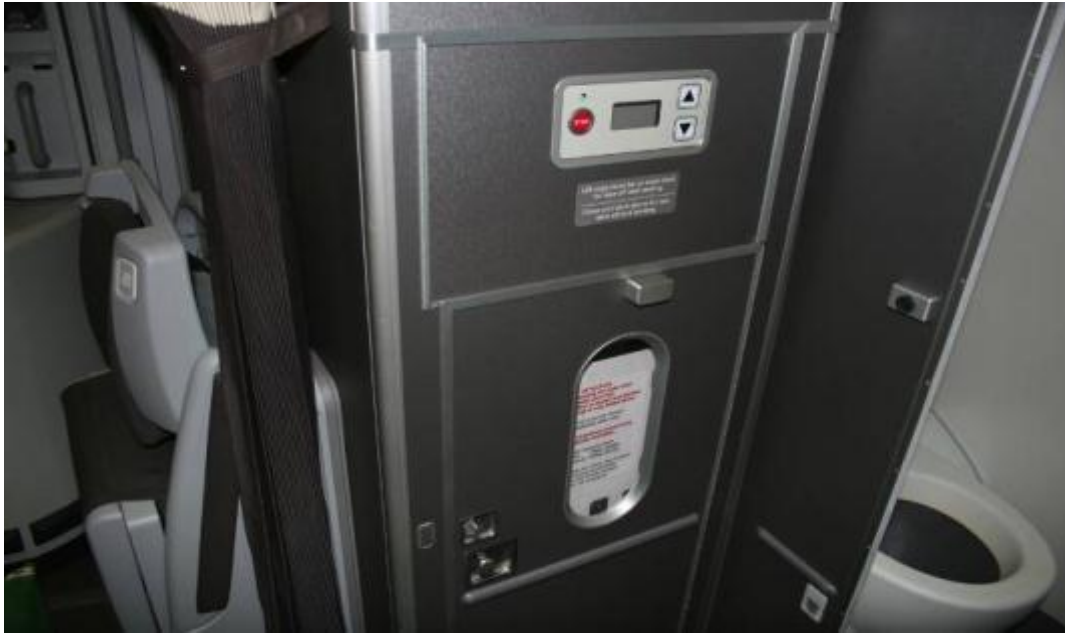
Figure 26. Service Elevator on Air France A380
(Photograph courtesy of FAA)

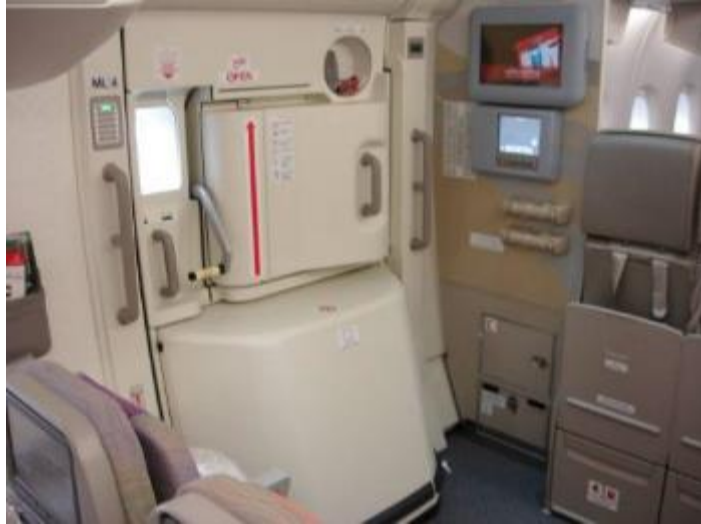
Figure 32. The A380 ML4 Door, Interior View: Type A Passenger Door With Slide Container
(Photograph courtesy of FAA)

- six Type A upper-deck passenger doors,
- eight Type A main-deck passenger doors with slide containers (figure 32), and
- two Type A main-deck emergency exits without slide containers.

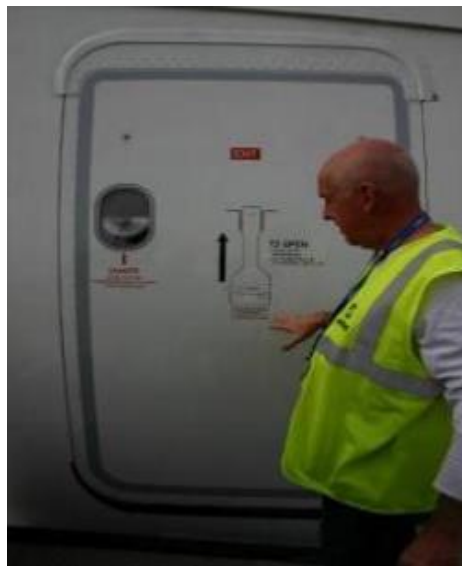
Figure 33. The A380 ML1 Door, Exterior Operation View
(Photograph courtesy of FAA)

The designations for the doors have a prefix M for main-deck doors, or U for upper-deck doors. Hence, the forward door on the main deck left side is designated ML1 (figure 33), and the rear door on the upper deck on the right side is designated UR3.

1. Verify the cabin pressure status. If the red indicator light is flashing in the window, the cabin is still pressurized. If the cabin is still pressurized, communications with the cockpit is the best method for depressurization. If the cockpit crew is unresponsive (overcome) the outflow valves can be forcibly opened.
2. Verify the emergency evacuation slide status by looking through the window indicator.
3. Push the outer door flap and grab the door control handle.

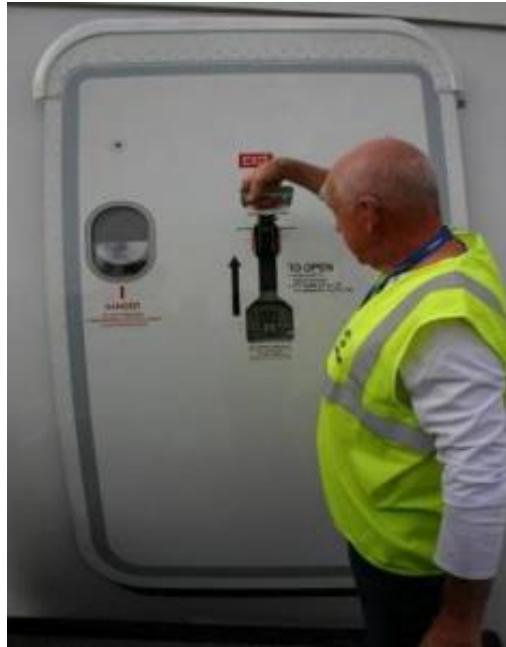
Figure 34. The A380 ML1 Door, Exterior Operation Demonstration—Step 6
(Photograph courtesy of FAA)

4. Lift the door control handle. This will lift the door and expose the OPEN/CLOSE buttons.
5. Press and hold the OPEN button. The door will start swiveling.
6. Lift the handle fully and ensure it is aligned with the green bar, as shown in figure 34. The handle should stay in the raised position when released.
7. With the handle raised, the door is unlocked, and the OPEN/CLOSE buttons are fully exposed, as shown in figure 35.

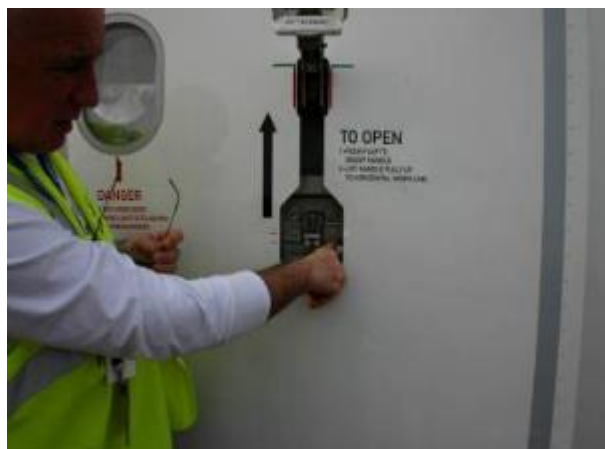
Figure 35. The A380 ML1 Door, Exterior Operation Demonstration—Step 7
(Photograph courtesy of FAA)

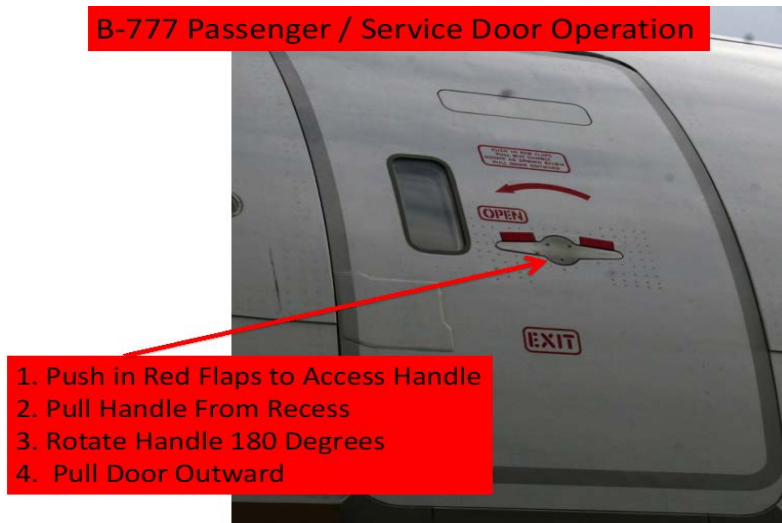
Figure 36. The B-777 Passenger/Service Door Operation
(Photograph courtesy of FAA)

The B-777-200 series has four passenger/service doors on each side of the aircraft. The B-777-300 series has an additional passenger/service door over the wing on each side, as shown in figure 36. All passenger/service doors operate the same way, as shown in figures 36-38. On the B-777-200, this includes the (R1, L1), (R2, L2), (R3, L3), (R4, L4). The B-777-300 has an additional passenger/service door located at the overwing position. In this version, the overwing exit is designated at (R3, L3) and the doors located aft of the wing beacon (R4, L4) and (R5, L5).

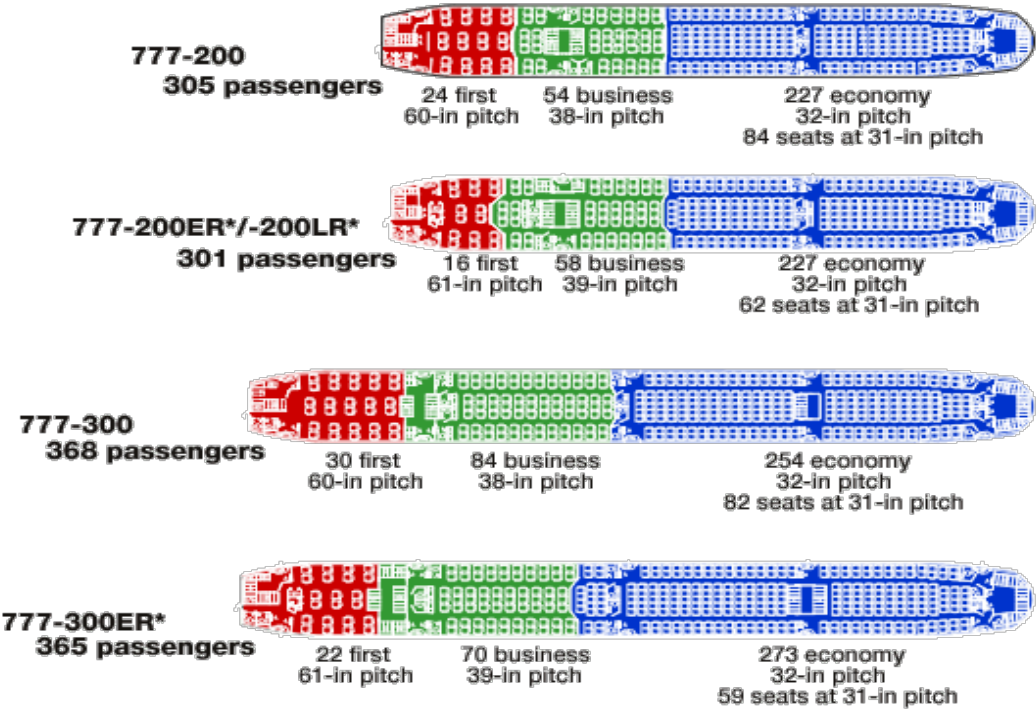
Figure 42 provides an overview of the differences in four versions of the B-777. The most obvious difference is in the overall size. The B-777-300 has seating capacity for an additional 80 passengers over the B-777-200. The B-777-300 is 242 ft 4in., which is 33 ft longer than the B-777-200. With most ARFF vehicles carrying 200 ft of preconnected hand lines, this is an important distinction. The entry point for a fire attack team must be selected to allow the hand lines to meet the objective.

Figure 42. Capacity Differences in B-777 (Courtesy of Boeing)

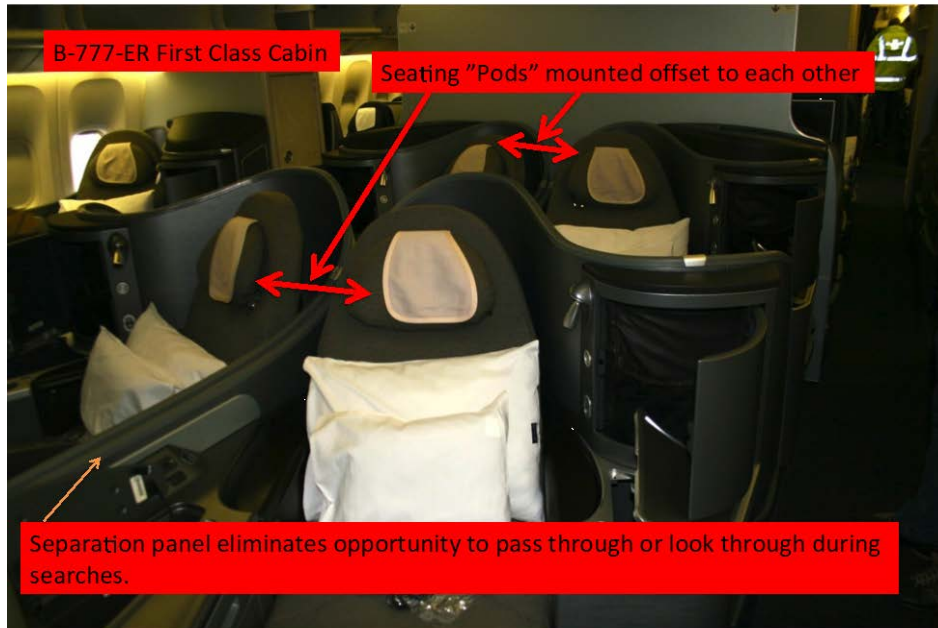
Figure 43. Offset Seating Pods in B-777-ER First-Class Cabin
(Photograph courtesy of FAA)

Another difference is the seating configurations between the B-777-200 and the B-777-200ER. When moving into the ER configuration, some customers who choose first and business class are willing to pay more for seats that turn into beds and provide other comforts. The international business - and first-class seats are often referred to as pods. These pods sometimes face in opposite directions and include privacy panels that passengers can raise and lower electronically (figures 43-46). In a darkened, smoke-filled cabin, a firefighter who was expecting standard rows of aircraft seats would find this confusing during a search. To provide perspective, figure 47 presents a firefighter’s typical view from a search position in a traditional cabin.

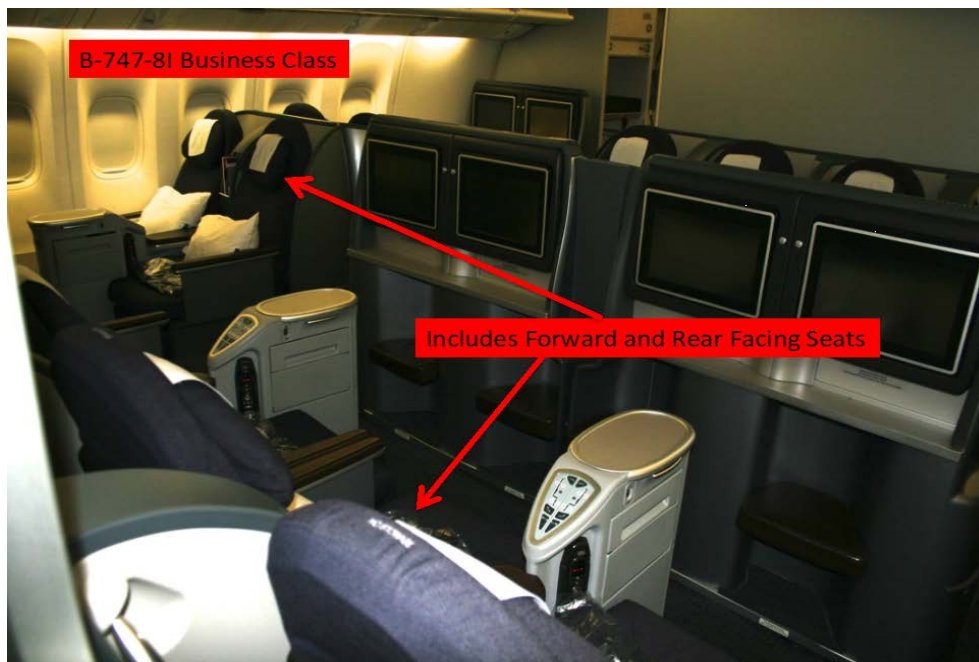
Figure 44. Opposite-Facing Seats in B-747-8I Business-Class Cabin
(Photograph courtesy of FAA)

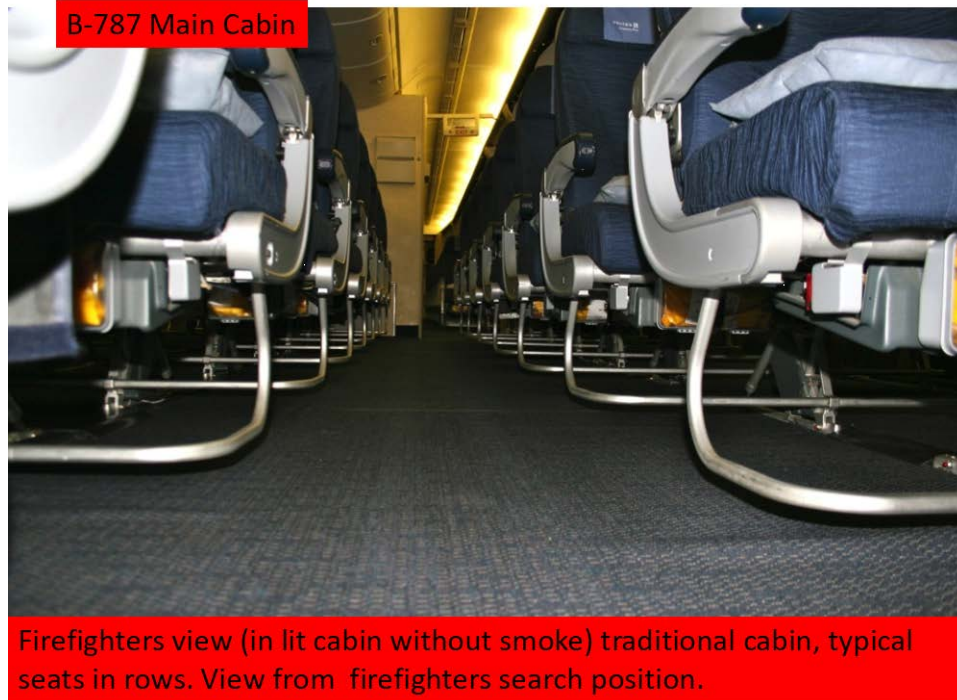
Figure 47. Typical Firefighter View in Traditional B-787 Main Cabin Without Smoke
(Photograph courtesy of FAA)

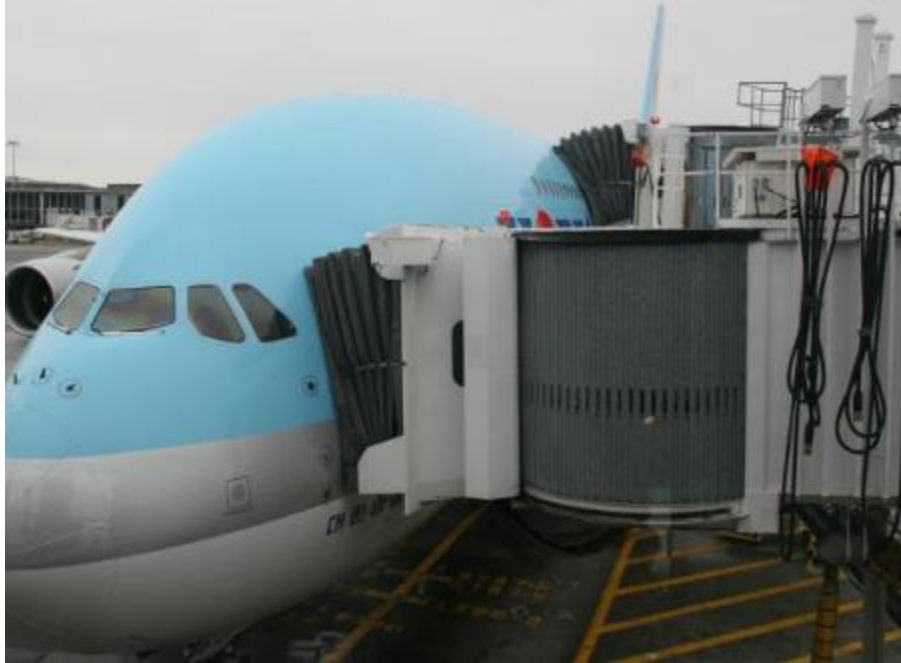
Figure 48. Korean A380 With Two Jet Bridges Extended at JFK
(Photograph courtesy of FAA)

An NLA at the gate may have additional encumbrances blocking accessibility for ARFF vehicles. The left side of the aircraft may have one to three jet bridges attached to the aircraft. One jet bridge blocks a significant area for access by ARFF vehicles. That blocked area is proportionately increased with the typical A380 boarding arrangement, which uses two jet bridges, one for each deck. Figure 48 shows an example of two jet bridges extended to an A380 at John F. Kennedy International Airport (JFK) and illustrates the restricted access by ARFF to the left side of the aircraft. Several airports in the world already have or plan to have a third jet bridge to certain gates. This number will fluctuate with the number of NLA in service at various airports.

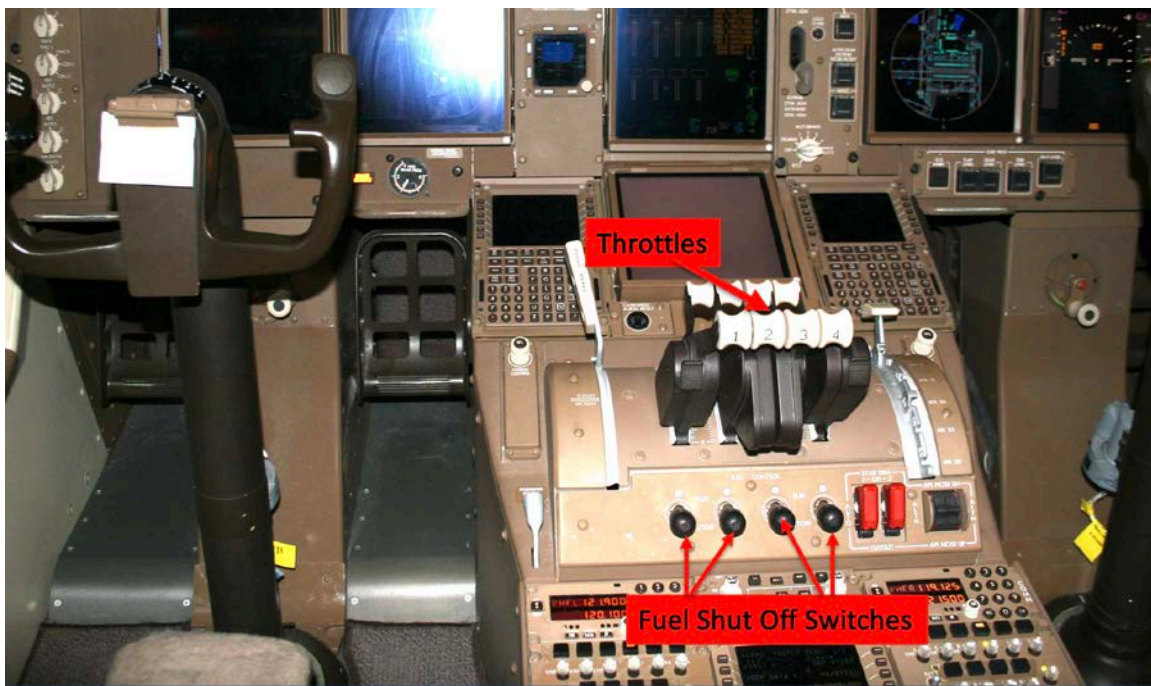
This fact that “idle” engine speed can move the aircraft forward 30-35 knots, reinforces the importance IPA puts on setting the brakes. This has not typically been taught to ARFF. A firefighter will always secure the parking brakes in a car before performing extrication and would never think of running the fire pump on a structural pumper without setting the maxi brake.

Figure 50. The B-747-81 Throttles and Fuel Shutoff Switches
(Photograph courtesy of FAA)

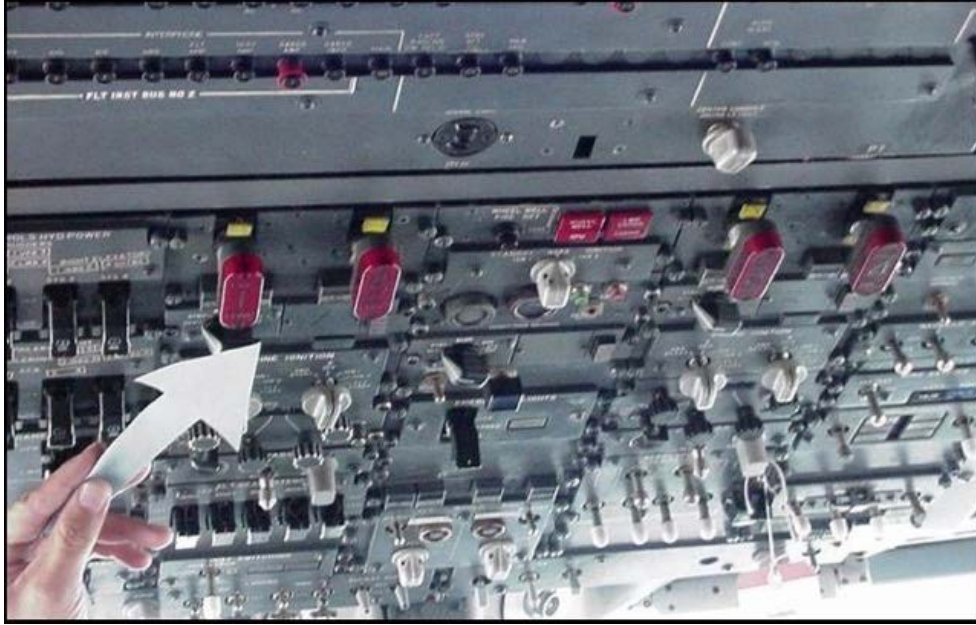
Figure 51. The B-747 Fire Handles
(Photograph courtesy of IPA)

- 4) Extend the ring finger -“four is FIRE HANDLES”- Meaning pull or push each of the fire handles - on the center pedestal in a Boeing, pull straight out on the overhead panel on the Airbus, or use an arcing push movement on the overhead panel for a Douglas/Boeing type jet such as DC-8s or MD-10/11s. Additionally, it is imperative that the APU FIRE HANDLE be shut down as well. For Boeing and Airbus, an additional lever or button must be moved to unlock the FIRE HANDLE from its stowed position. IPA emphasizes the operation of these handles task about 20+ items to move manually and electronically to shut down an engine, but the following are the key points. These levers only ARM Engine fire bottles normally armed with Halon gas bottles for engine fires. One must push an additional button or switch to ACTIVATE actual fire bottles, if in fact there is an engine fire. Normally there are two bottles per engine and agent cannot be sent over the centerline of the jet to an opposing side engine. Additionally, firing a bottle if ARFF has already opened the cowling will not produce a desired result. The clean agents used in engine firefighting systems are flooding agents and require an enclosed environment to be effective.

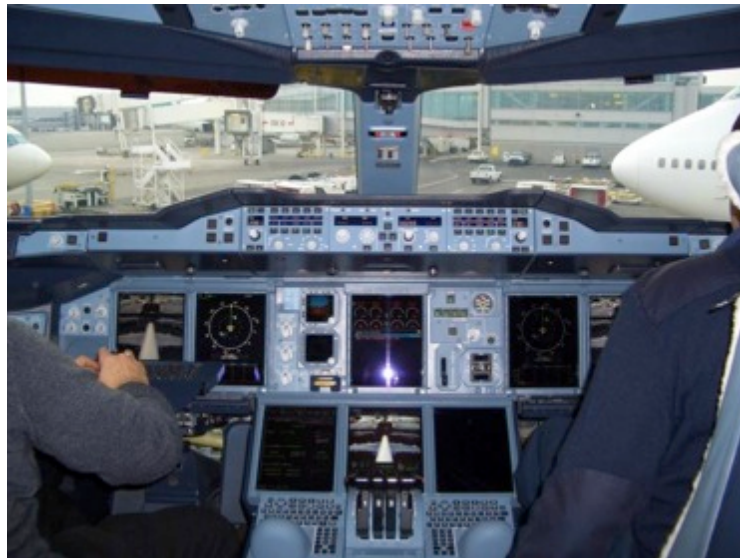
Figure 52. Training to Shut Down and Secure the Aircraft

The cockpit (figure 52) is not the normal comfort zone for ARFF personnel. On some live fire-training props, ARFF personnel are accustomed to dashing into the cockpit and selecting the only three switches in the cockpit (Throttles – Bottles – Batteries). After a pilot safely gets an aircraft on the ground, they must accomplish an emergency evacuation checklist. This is not taught as a memory item. There are up to 16 steps on modern aircraft. If the cockpit is full of smoke and heat, firefighters need to think about how many items on that checklist that the pilot performed before evacuating from the heat and toxic fumes and gases from which their survival instinct was telling them to escape. For the safety of emergency responders and the scene, it makes good sense for ARFF to learn these few memory items to secure the scene.

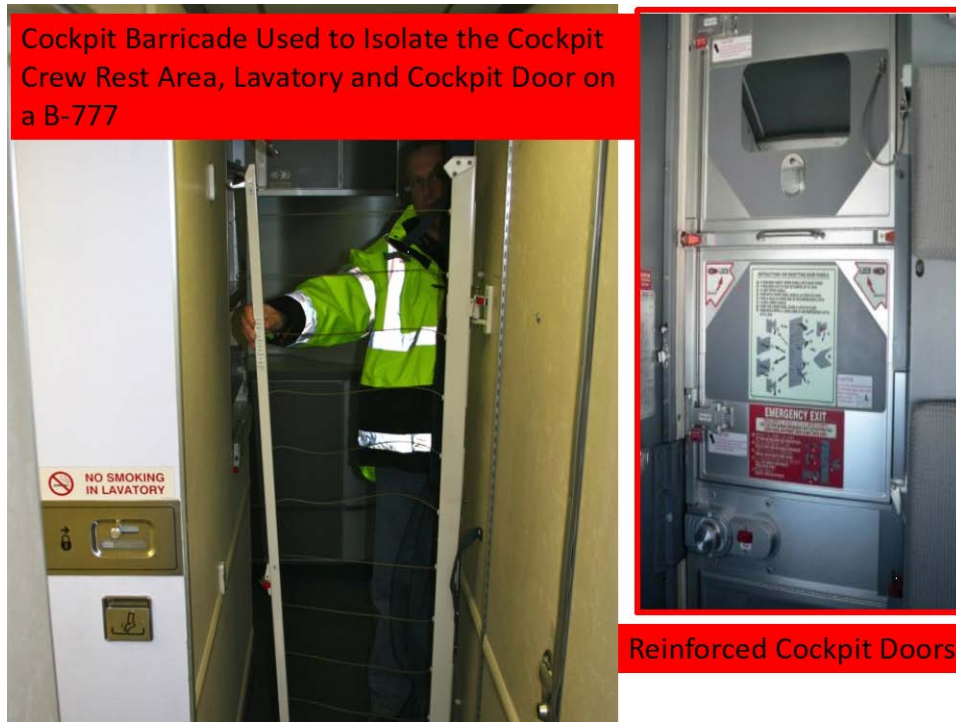
As shown in figure 53, gaining access to the cockpit is not always simple. The accident or incident may have compromised the aircraft structure, blocking access to the cockpit. There are also the intentional obstructions that are designed to keep unauthorized people out of the cockpit. Also shown in figure 53, some aircraft are equipped with physical barricades to separate the passenger cabin from the flight deck. These barricades are routinely retracted and stowed during landing, but awareness of this type of equipment is essential for ARFF.

Figure 53. Reinforced Cockpit Barricade and Doors on a B-777

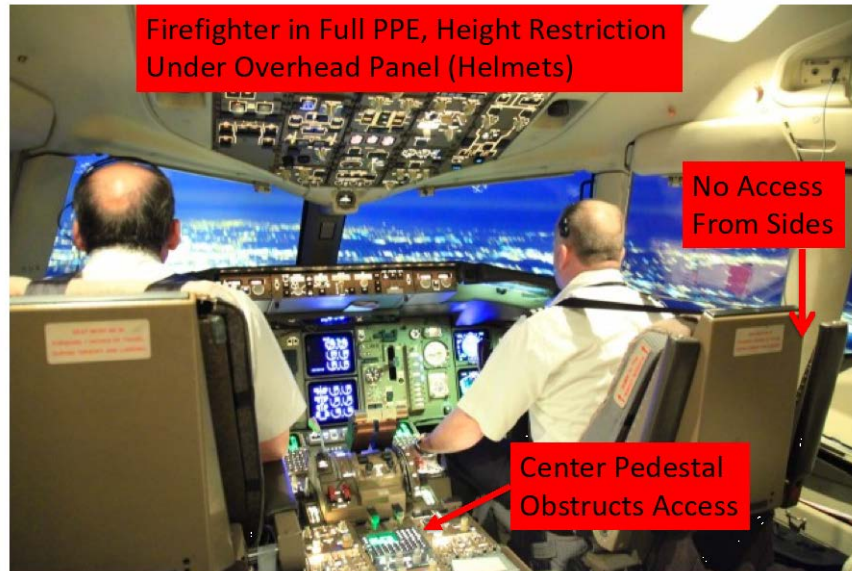
slumped forward. Gaining access to them for primary and secondary surveys or for a rapid removal can be extremely difficult. As shown in figure 54, access from either side of the right and left seat is restricted. While there is still power to the aircraft, care must be taken not to accidentally operate any switches or controls. Working over the center pedestal or reaching over the seated crew will increase the risk of hitting switches on the console or with a helmet overhead.

Figure 54. Examples of the Restrictive Access to the Flight Crew and Controls for a Firefighter in Full PPE

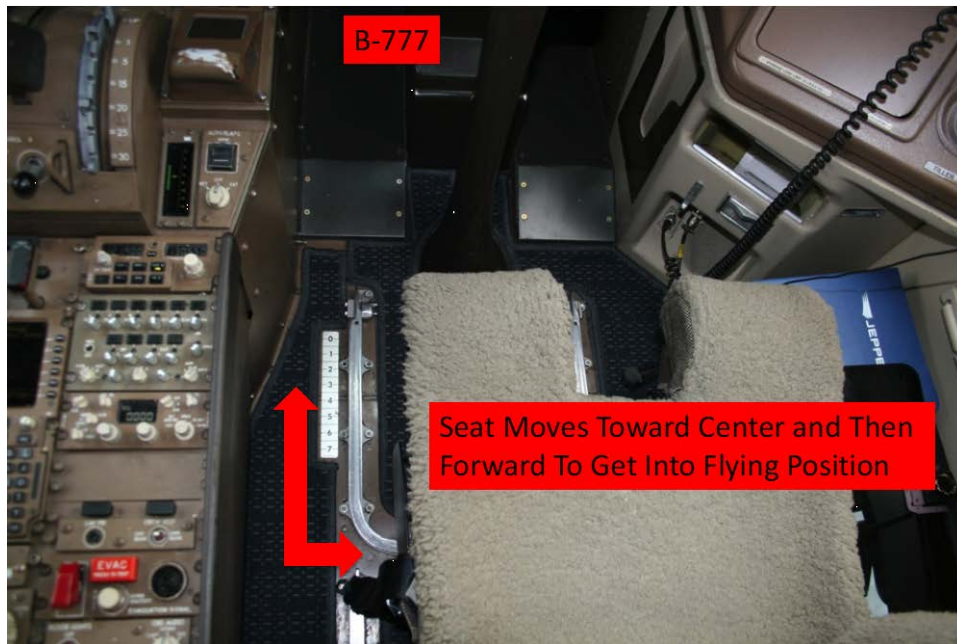
down, the electric seat controls will not work. In “flying position,” the captain and first officer are belted into their seats with a five-point restraint. Aircraft familiarization in the cockpit for ARFF must include seat operation and movement. As shown in figure 55, their seats slide inboard and forward to comfortably position their feet on the pedals and be within view and reach of all the necessary gauges and controls. The seats move on tracks, and the controls are designed to be operated by the officer seated in the position, not a rescuer coming in from behind. There are numerous challenges in cockpit rescue. Once in the cockpit and faced with providing medical care, the rescue crew needs to gain access to the patient. As with extrication of a driver following an automobile crash, among the first steps is to slide the seatback. This provides clearance for the chest and gets their feet out from under the pedals. This is also true in getting access to a cockpit crew member, but it may be significantly more difficult.

Figure 55. Example of Essential Aircraft Cockpit Familiarization for ARFF Showing Seat Operation and Movement in a B-777

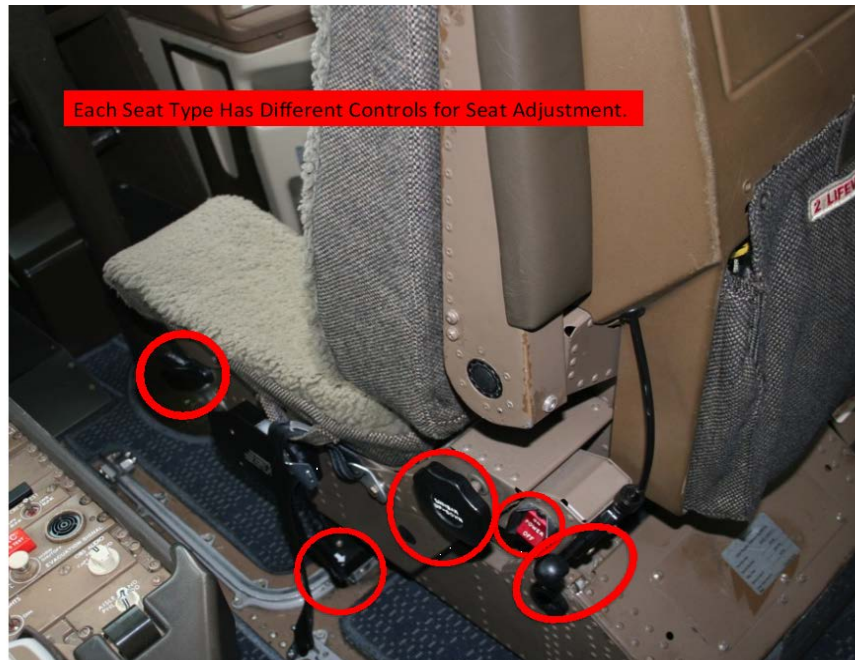
There are a variety of seat styles, each having different switches and controls. To slide a seat forward, it first follows a track and moves closer to the pedestal (inboard). When the seat slides aft, it also slides outboard slightly, providing just enough room for the pilot to maneuver between the seats. Developing an understanding of seat controls and movement during training will improve the success and reduce the time needed to remove a pilot during an emergency. As shown in figure 56, there are multiple controls for each seat, and each seat is different. Usually, the control that manipulates the seat recline function will be located outboard, on the window side of each seat. The controls used to manipulate the seats along the rail (fore and aft) are on the inboard or throttle quadrant pedestal of each seat.

Figure 56. Example of Seat Controls That Vary Among Aircraft and Carriers
