DOT/FAA/TC-20/19

Aircraft Rescue and Firefighting Strategies and Tactical Considerations for New Large Aircraft: Update

September 2020

Final Report

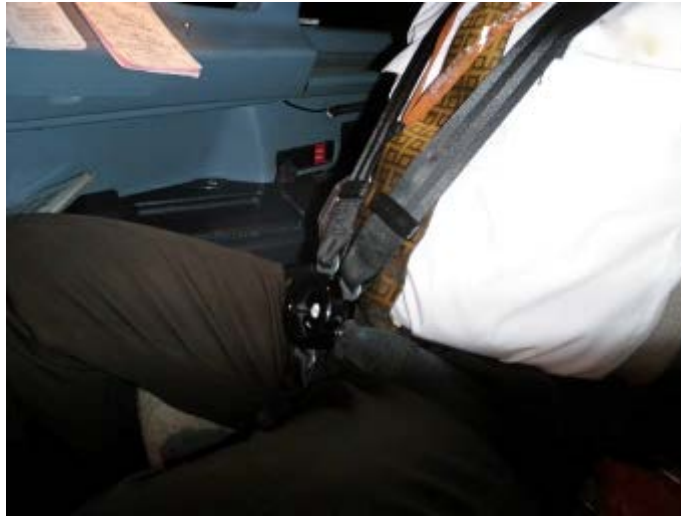
It is recommended that an incapacitated pilot be kept secure in their five-point restraint until the seat has been moved aft and outboard so they do not slide or slump into a less manageable position. Removal of the cockpit crew seatbelt should be a simple maneuver if the rescuers are familiar. The typical five-point restraints (figure 58) are tied into a center hub buckle. By rotating the release in either direction, four of the belt connection points will release and the fifth stays with the outboard lap belt, releasing the seat's occupant from the restraint.

Figure 58. Five-Point Restraint
(Photograph courtesy of IPA)

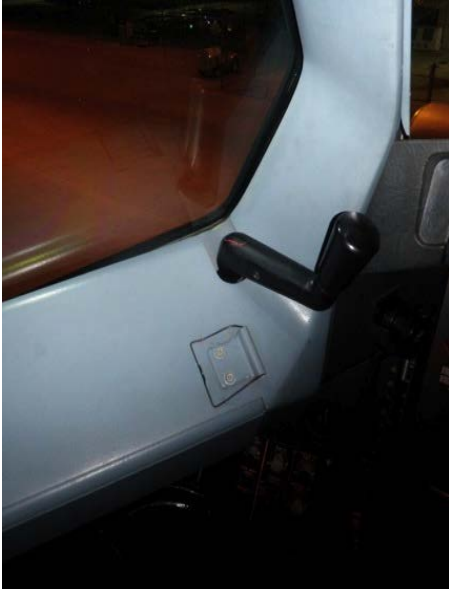
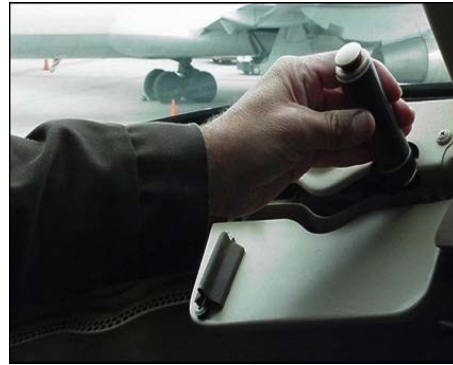
Aircraft familiarization training in the cockpit should also include window operation, as shown in figure 59. ARFF personnel may need to open or close cockpit windows as part of a ventilation strategy. The cockpit escape equipment associated with the windows should also be reviewed if the firefighter needs an emergency exit point. Not all cockpit windows operate the same way. There will always be a release and an operating handle or lever. A review of the window operating procedures for each aircraft is important.

Figure 59. Cockpit Window Operation
(Photograph courtesy of FAA)

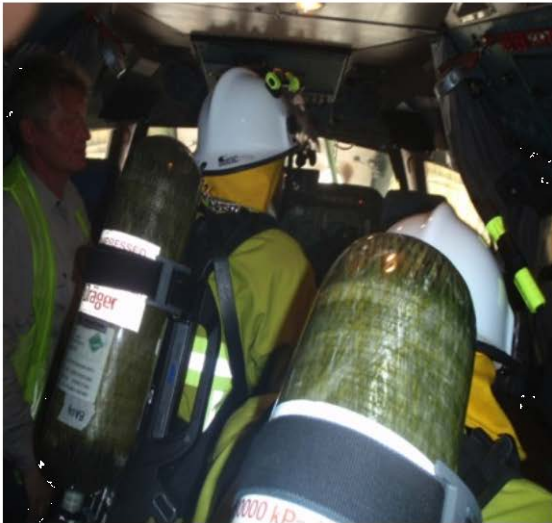
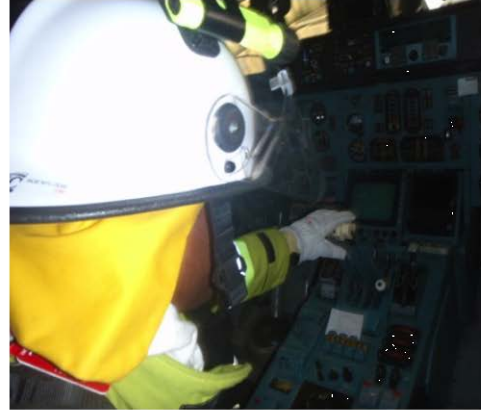
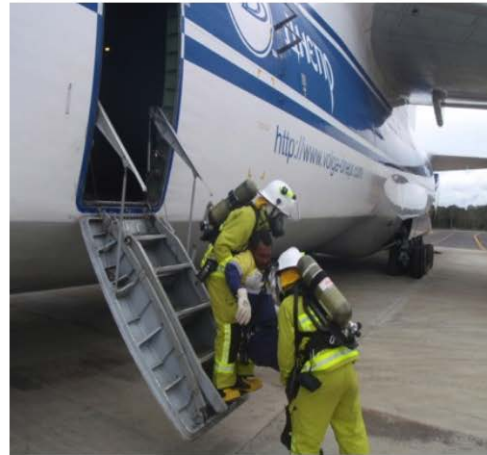
Cockpit familiarization should be completed by all ARFF personnel. Finding switches and controls to secure the aircraft in a dark, smoke-filled cockpit without prior training is time consuming and potentially dangerous. Training evolutions supervised by airline personnel with firefighters in full PPE will not only help develop the necessary skill sets, but also serve as awareness training for rescuers as to the difficulty of this job. Figure 60 shows firefighters in full PPE training on cockpit shutdown and pilot extraction.

Figure 60. Cockpit Training and Pilot Extraction
(Images courtesy of Jack Kreckie Photographs)

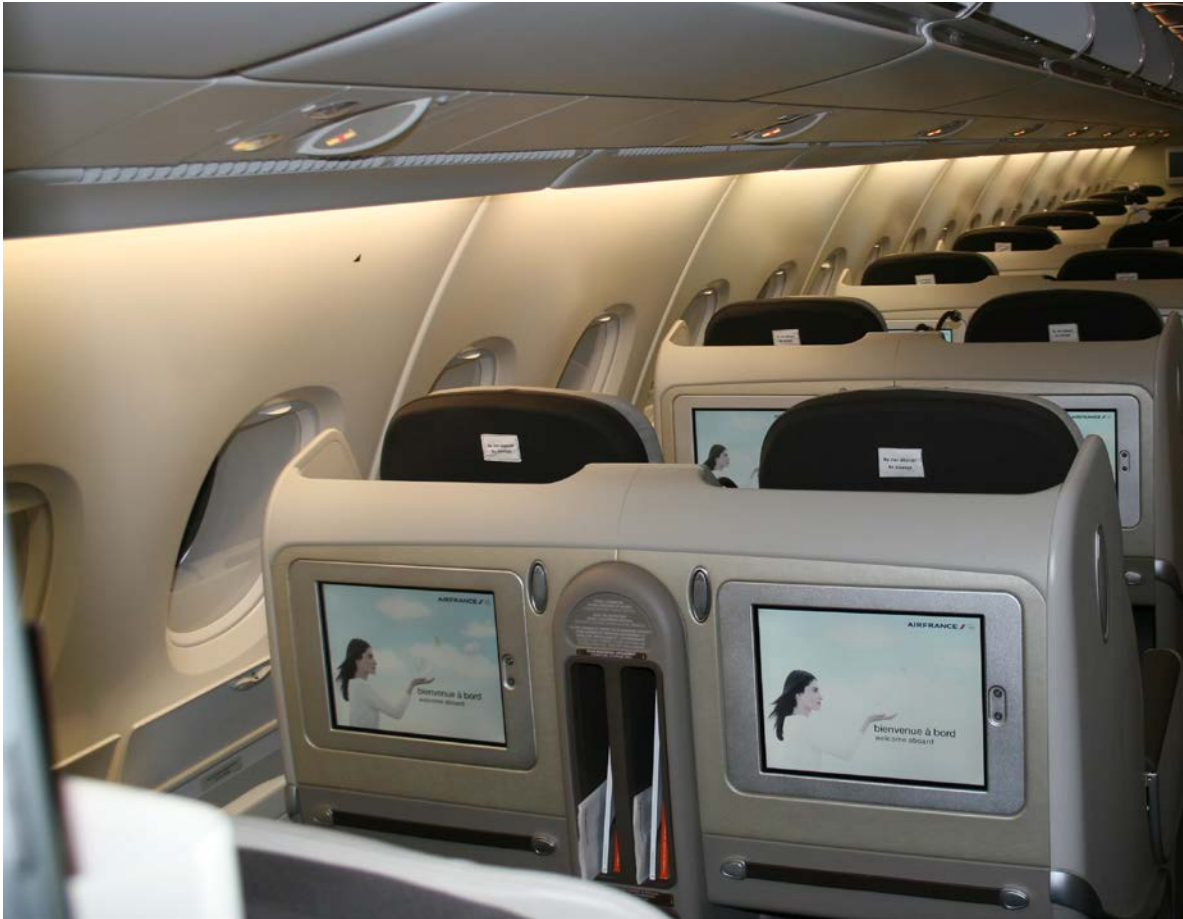
Most interior fires on intact aircraft can be expected to be in avionics, galleys, lavatories, or areas housing electrical equipment. There is a tremendous amount of electrical equipment in the interior cabins of the aircraft, primarily in the personal entertainment system components, as shown in figure 61. The heat generated by normal operation of this equipment on the A380 requires using air conditioning on the upper deck to maintain the comfort levels of passengers.

Figure 61. Seatback Electronics in Air France A380 Business-Class Cabin
(Photograph courtesy of FAA)

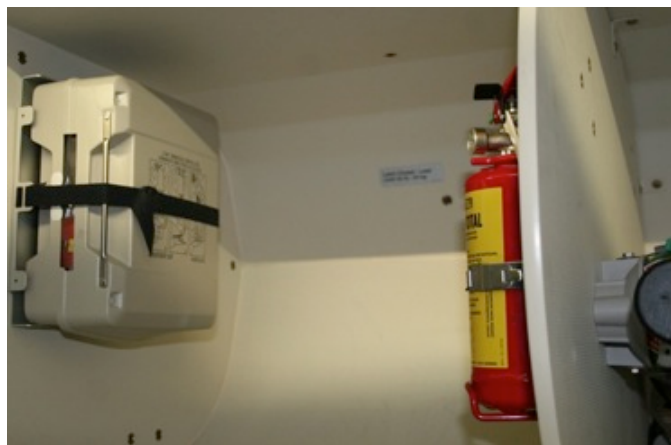
As shown in figure 63, usually fire extinguishers are co-located with other pieces of emergency equipment such as first aid kits, flashlights, oxygen, gloves, and defibrillators.

Figure 63. Fire Extinguisher Mounted in Overhead Bin on B-747-8I
(Photograph courtesy of FAA)

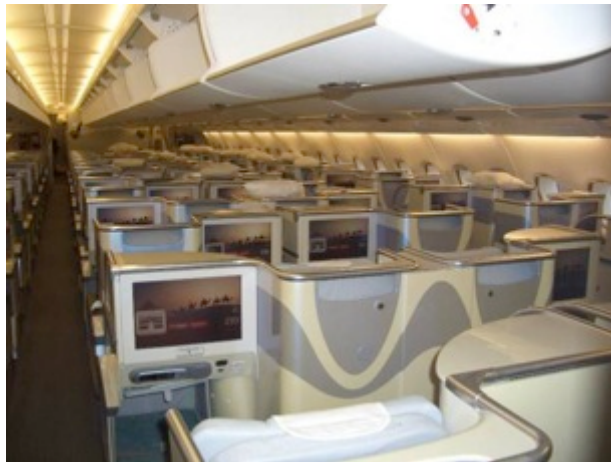
Figure 66. Business-Class Cabin, Seatback Entertainment Systems
(Photograph courtesy of FAA)

Most interior fires on intact aircraft can be expected to be in avionics, galleys, lavatories, or areas housing electrical equipment. There is a tremendous amount of electrical equipment in the interior cabins of the aircraft, primarily in the personal entertainment system components, as shown in figure 66. The installed displays in seatbacks and seating pods are not typical sources of cabin smoke or fire. The display does not generate a great deal of heat; however, the equipment mounted in the E&E compartment that serves as a satellite television receiver and transmitter to the seatback-mounted displays does generate heat. This equipment is a more likely source of an odor or smoke. As shown in figure 67, avionics or E&E compartments are not only full of heat-generating electronics, batteries, and wiring, but they are also extremely restrictive to the movement of firefighters wearing PPE. The low headroom in the compartment requires firefighters to crawl. The mounted equipment provides a number of snag points. This compartment meets the criteria for a “confined space” as defined by the Occupational Safety and Health Administration (OSHA), 29 CFR 1910.146 (OSHA Permit-Required Confined Spaces, 1999).

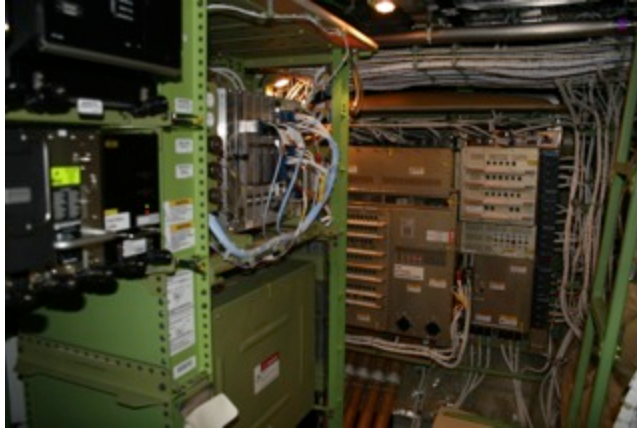
Figure 67. Avionics Compartments
(Photograph courtesy of FAA)

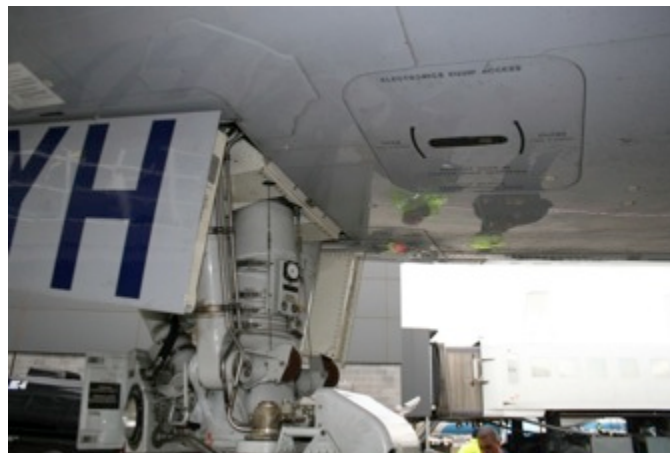
For firefighters, entry to the avionics compartment (or E&E bay) for fires or investigations is nearly always through the access hatch under the aircraft aft of the nose gear (figure 68). This position provides a direct path into E&E with a small ladder. For the NLA described in the report, a folding A-frame ladder, (which is carried on many ARFF trucks) is a perfect access solution. Once the hatch is open, clean agent can be discharged, or physical entry can be made.

Figure 68. Access Hatch to E&E Compartment on B-747-8
(Photograph courtesy of FAA)

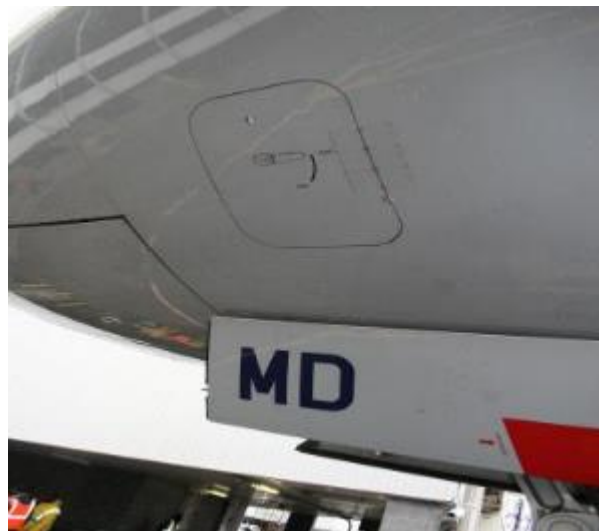
- The main avionics bay contains most of the aircraft computers and the electrical power center. This bay can be accessed from three locations: the forward cargo compartment, through the floor hatch in the cockpit, and the exterior of the fuselage. Figure 71 shows the exterior access hatch to the avionics bay.
- The upper avionics bay contains the emergency electrical power center, the network server, and most of the in-flight entertainment systems. The bay is accessible through a locked door in the bulkhead on the upper deck at the top of the forward stairs. In some configurations, a hinged portion of the leaning rail must be lifted to access the space.
- The aft avionics bay is only accessible through a hatch on the outside of the aircraft. Equipment in the aft avionics bay includes the trolley lift control center.

Figure 71. Access Hatch From Forward Fuselage Left Side to Main Avionics Bay (Photograph courtesy of FAA)

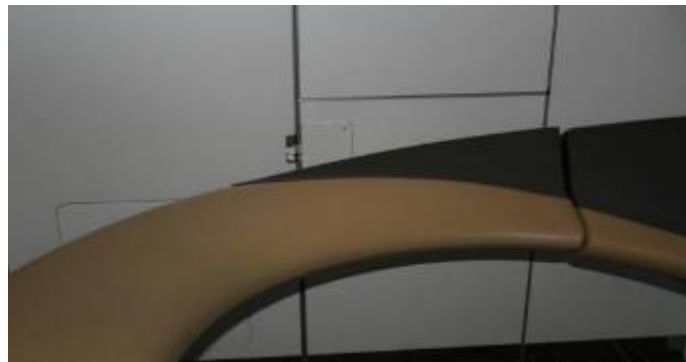
The access points to the upper avionics bay are always in the same location aboard the aircraft, but due to the different configurations, they are not easily identifiable. The access point is on the right side of the aircraft on the upper deck. When ascending the forward staircase, turn left at the top of the stairs. The space in front of that access door is used for different functions in every configuration. It may be a lounge area, rest room, or detailed for any function that suits the needs of the air carrier. Figures 72 and 73 show the access door in a lounge area. There is a leaning rail around the entire space. This rail is hinged in front of the door and needs to be raised to open the door. There is no method for locking the rail in the open position, so it drops back into place when released. Figure 74 shows the access door in a lounge not equipped with the rail, and figure 75 shows the access door inside a lavatory. Once inside the upper avionics bay, the equipment mounting will be almost identical on all A380s.

Figure 72. Access to the A380 Upper Avionics Bay From the Landing at the Top of the Forward Stairs (Photograph courtesy of FAA)

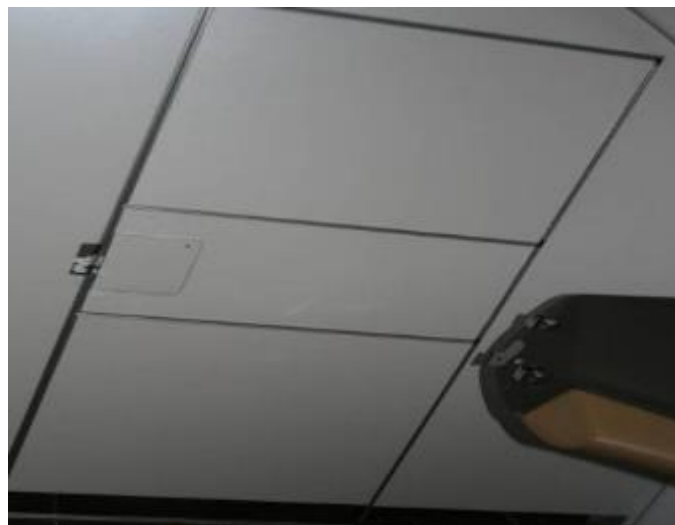
Figure 73. The A380 Upper Avionics Bay With Leaning Rail Raised, Exposing the Locked Door (Photograph courtesy of FAA)

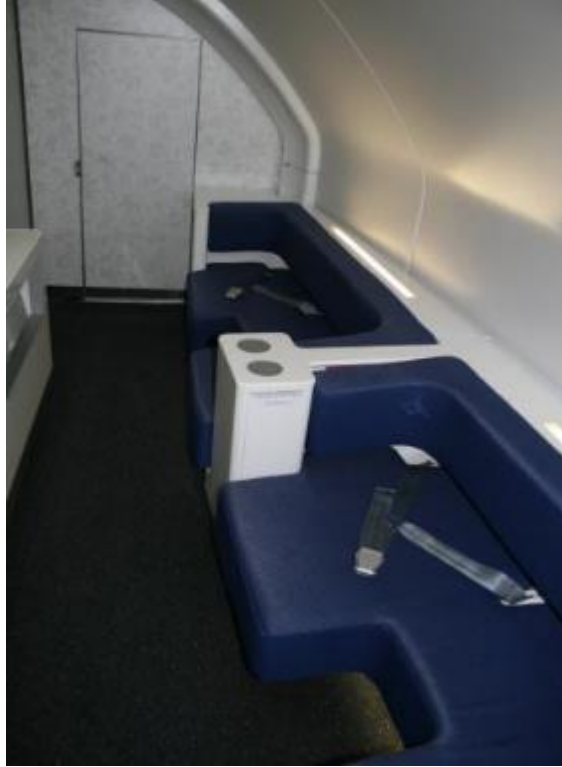
Figure 74. The A380 Access to Upper-Deck Avionics From Lounge/Seating Area
(Photograph courtesy of FAA)

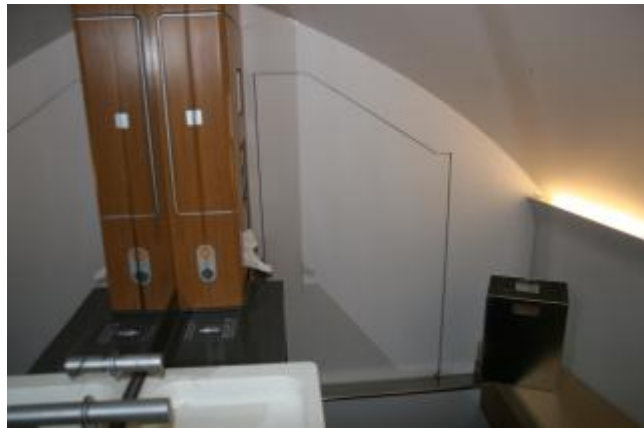
Figure 75. Access Point to A380 Upper-Deck Avionics Through the Lavatory
(Photograph courtesy of FAA)

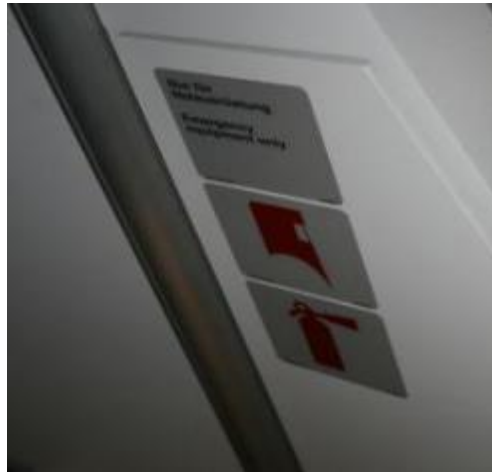
extinguish lavatory fires. Portable fire extinguishers and smoke hoods are located throughout the cabins, as shown in figure 76.

Figure 76. Typical Labels on Compartments Used to Store Fire Extinguishers and Hoods
(Photograph courtesy of FAA)

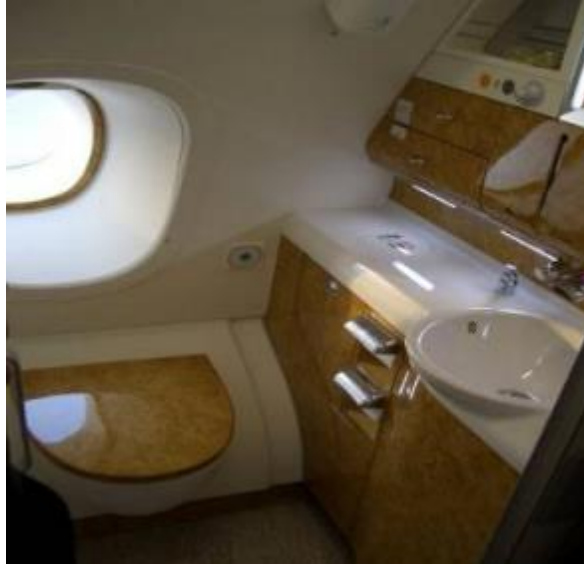
There are 17 lavatories on the A380: 10 on the main deck, and 7 on the upper deck. Some lavatories that are on an outside wall have a window, as shown in figure 77. This is important to keep in mind for penetration considerations. Emirates Airlines include two showers for their first-class customers, as shown in figure 78. These are located on either side of the forward part of the first-class cabin, but they do not have windows like the lavatories do. If a lavatory fire exceeds the ability of the waste bin suppression system or occurs on the ground when the cabin is not attended, it should be treated as any small interior fire. The size of an aircraft lavatory could be compared to a residential closet, and locking mechanisms are shown in figure 79. As the largest passenger aircraft, the A380 has the greatest number of lavatories. The number of lavatories is scalable to the size of the aircraft and the number of seats. The number and location of the lavatories, the methods of gaining access, direction of door swing, etc., are all training considerations when preparing for interior searches or firefighting.

Figure 77. Upper-Deck Lavatory on Emirates A380

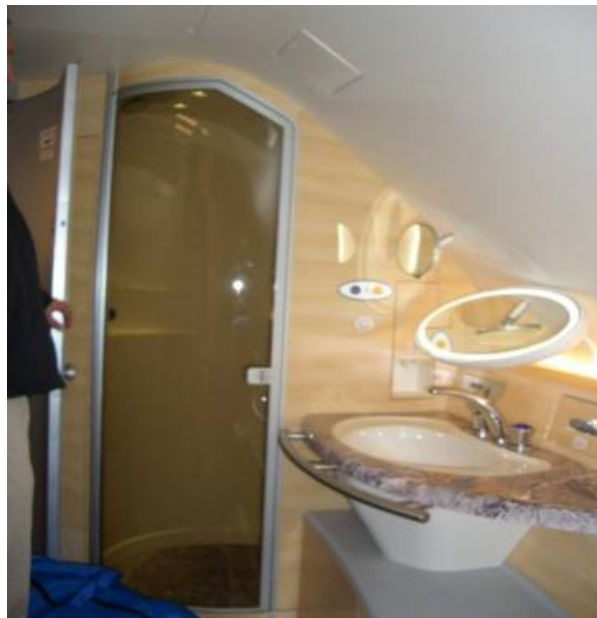
Figure 78. First-Class Lavatory/Shower on Emirates A380

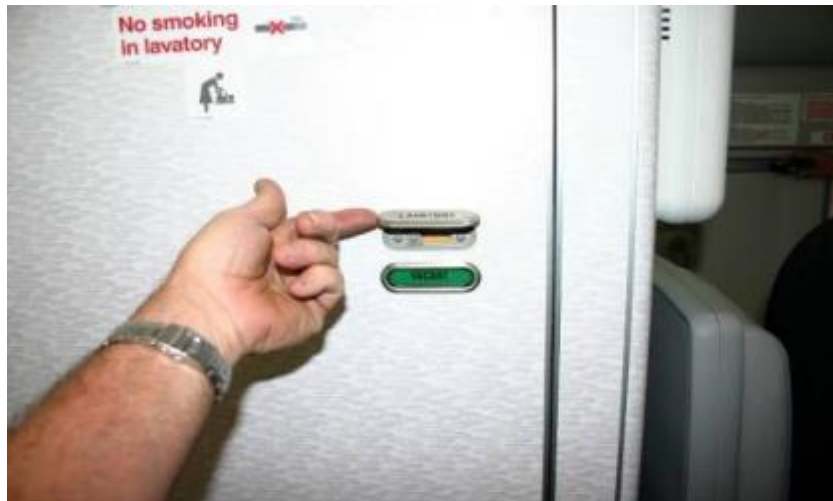
Lavatory doors have privacy locks comparable to residential privacy locks in a home. As shown in figure 79, raise the panel above the indicator to expose the lock release on the A380.

Figure 79. Lavatory Door Locks
(Photograph courtesy of FAA)

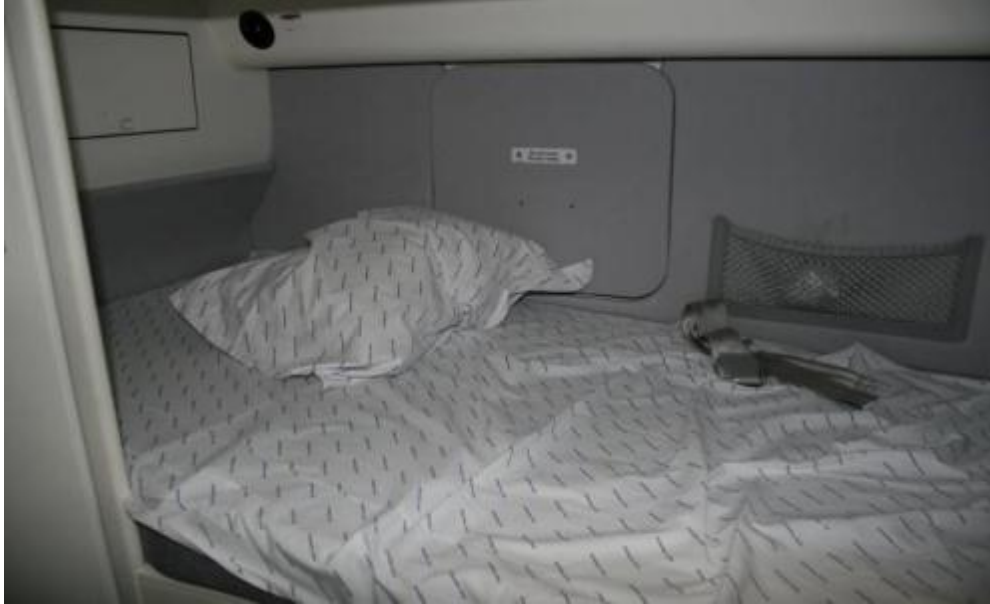
Airbus offers a wide variety of A380 configurations. In addition to the main and upper-deck cabins, additional spaces in the lower deck may be occupied. Currently, Qantas and Air France are using the lower-deck cabins for crew rest facilities, as shown in figure 80. While these compartments are not expected to be occupied during takeoff and landing, it is important to note that there have been numerous incidents of aircraft fires at the gate area that require fire departments to do a complete search of the aircraft for occupants. In these situations, it is very possible that crew members or cleaning personnel could be in these crew rest facilities during a fire emergency.

Figure 80. Lower-Deck Cabin Crew Rest Facility, Individual Bunk (Air France)
(Photograph courtesy of FAA)

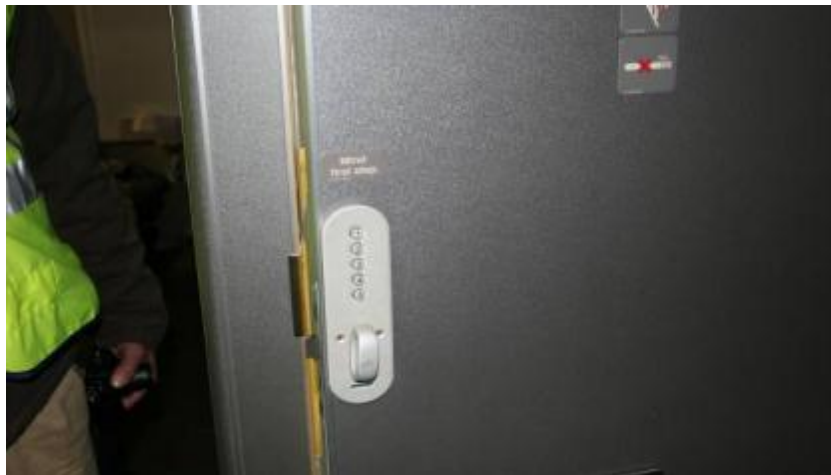
As new aircraft are built, this space may be used for additional functions. The crew rest facilities may be crew rest modules installed in the forward portion of the aft cargo compartment, or in the aft portion of the forward cargo compartment. Primary access is from the main deck through a locked door, as shown in figure 81. Inside the door is a steep set of stairs (best if used as a ladder) leading into the crew rest facility, as shown in figure 82.

Figure 81. Access Door From Main Deck to Lower-Deck Crew Rest Facility (FAA Photograph)

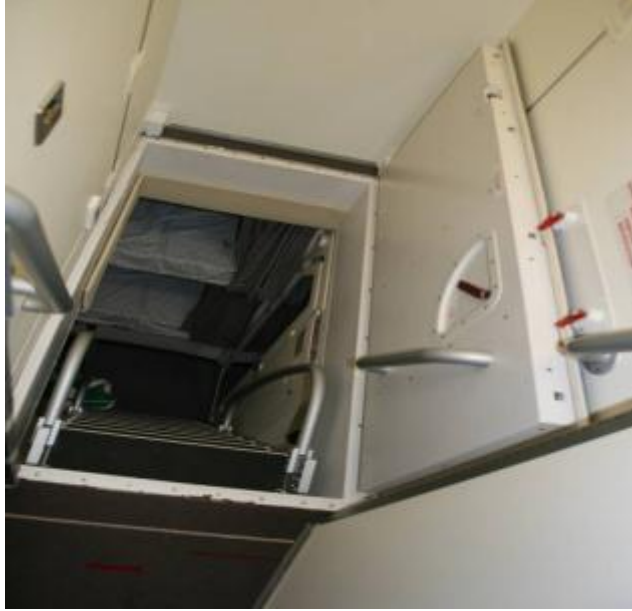
Figure 82. Access Ladder to A380 Lower-Deck Crew Rest Area
(Photograph courtesy of FAA)

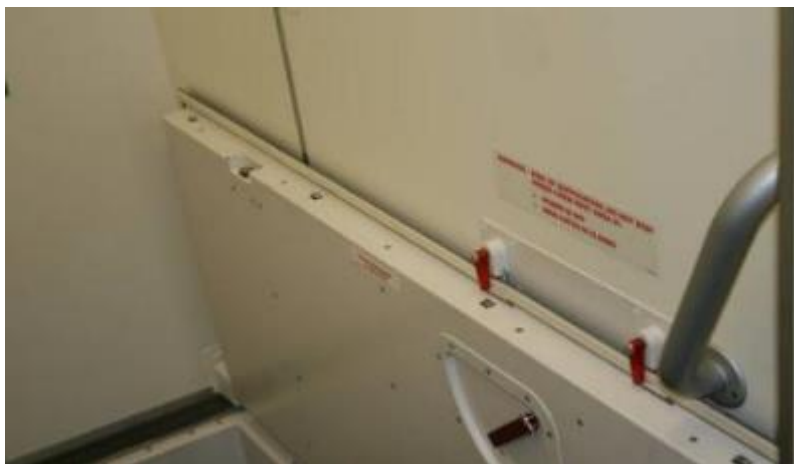
When the lower-deck crew rest facility is not installed or in use, the airtight hatch door is closed and locked, as shown in figure 83. This access door is opposite M3R door on this aircraft.

Figure 83. Airtight Hatch Door to A380 Lower-Deck Crew Rest Area
(Photograph courtesy of FAA)

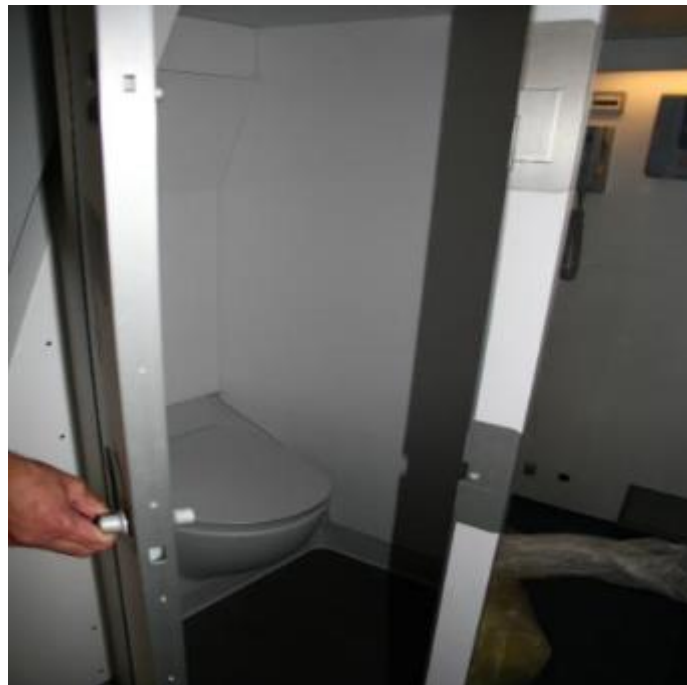
Figure 85. Lower-Deck Crew Rest Area Lavatory, Lufthansa A380
(Photograph courtesy of FAA)

The lower-deck crew rest facility (figure 84) includes 12 sleeping areas, which are protected by 7 smoke detectors and a fixed fire-suppression system. Some lower-deck crew rest areas may be equipped with a small lavatory, as shown in figure 85.

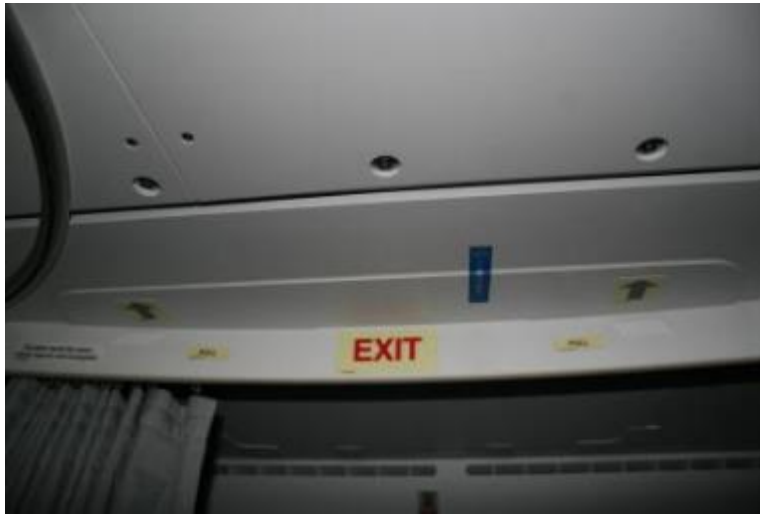
The secondary exit from the lower-deck crew rest facility is designated by an exit sign, as shown in figure 86. The overhead panels in a designated bunk area are removable to access the escape hatch leading into the main-deck cabin.

Figure 86. Secondary Exit From Lower-Deck Crew Rest Facility, Lufthansa A380
(Photograph courtesy of FAA)

To use the emergency exit from the lower-deck crew rest facility, the overhead access panel above a bunk must be removed. These panels and the directions for removal are clearly identified with instructional labels.

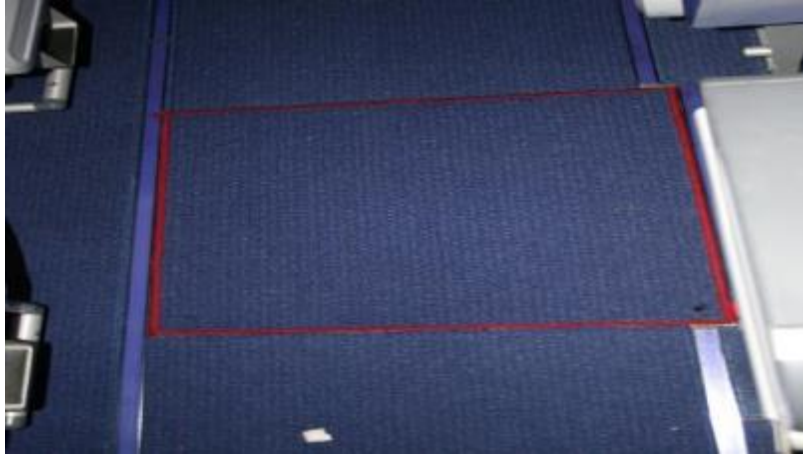
If the lower-deck crew rest facility is in the aft portion of the forward cargo compartment, as in the Lufthansa configuration, the escape hatch will be in the middle of the left aisle floor. In this example, Lufthansa uses a red outline on the carpet around the hatch to make it more visible, as shown in figure 87.

Figure 87. Emergency Escape Hatch From Lower-Deck Crew Rest Facility, Lufthansa A380
(Photograph courtesy of FAA)

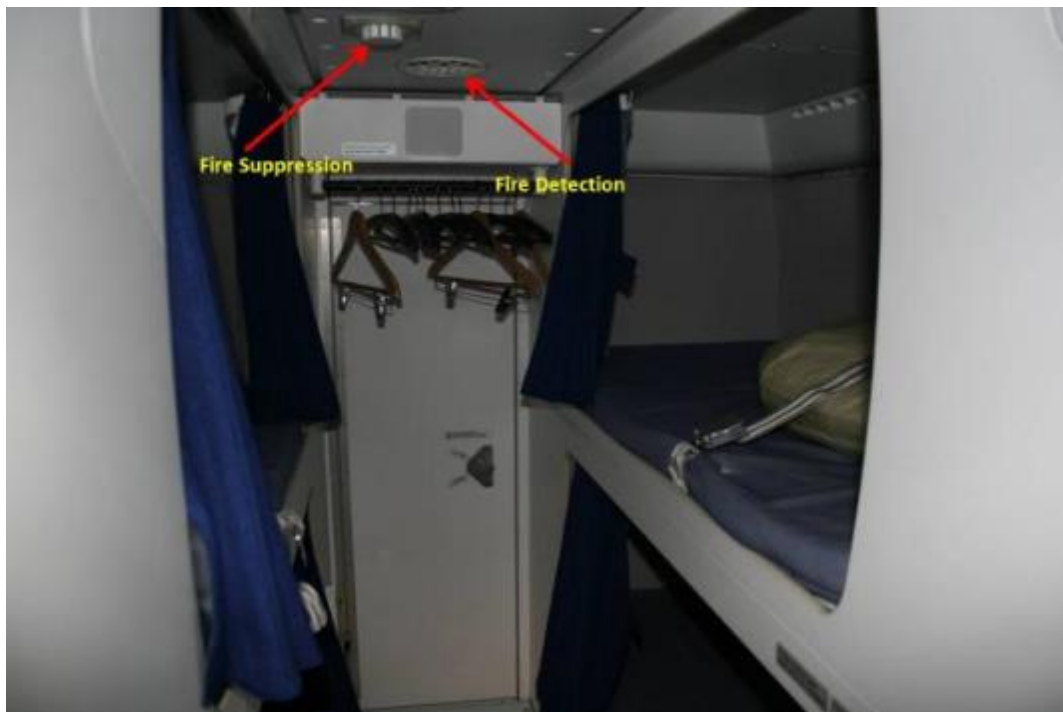
The lower-deck crew rest facilities are protected by smoke detectors and a fire-suppression system, as shown in figure 88. A fire in the lower-deck rest area that is not controlled by the fixed suppression system will need to be fought from the inside. Before advancing hand lines down the main access ladder, the escape hatch in the main deck will need to be opened with horizontal ventilation to an open door to relieve smoke in the main cabin. Familiarity with these spaces learned during aircraft pre-fire planning is essential to prepare entry teams.

Figure 88. Lower-Deck Crew Rest Area Fire Detection and Suppression
(Photograph courtesy of FAA)

It would be impractical to advance a handline larger than 1.75 inches into this area due to the narrow ladder, tight turns, and narrow passageway. Ventilating this space would be critical to relieve the heat and smoke trapped in the space.

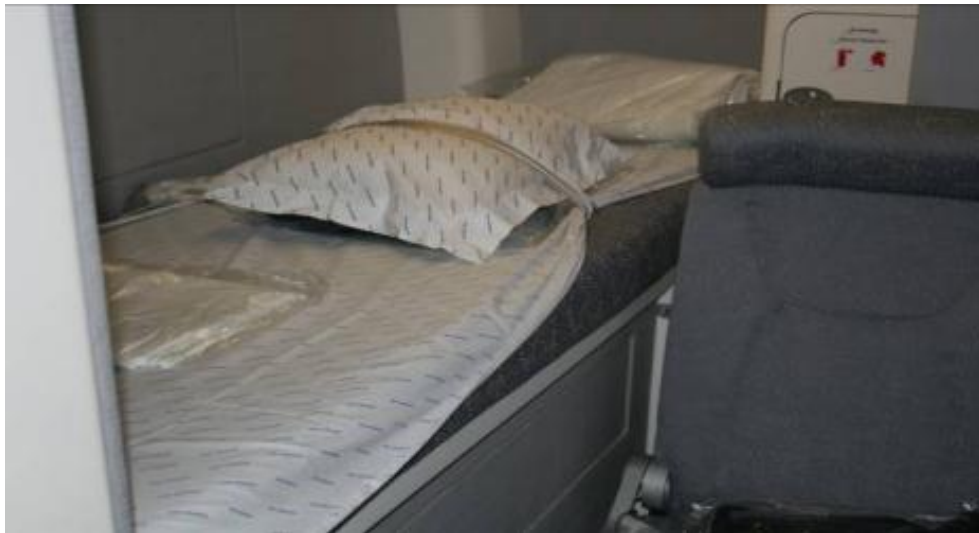
Most carriers flying A380s have their flight crew rest facilities just aft of the cockpit, within the secured area of the secure cockpit door, as shown in figures 89 and 90.

Figure 89. Main-Deck Flight Crew Rest Facility Located Aft of Cockpit
(Photograph courtesy of FAA)

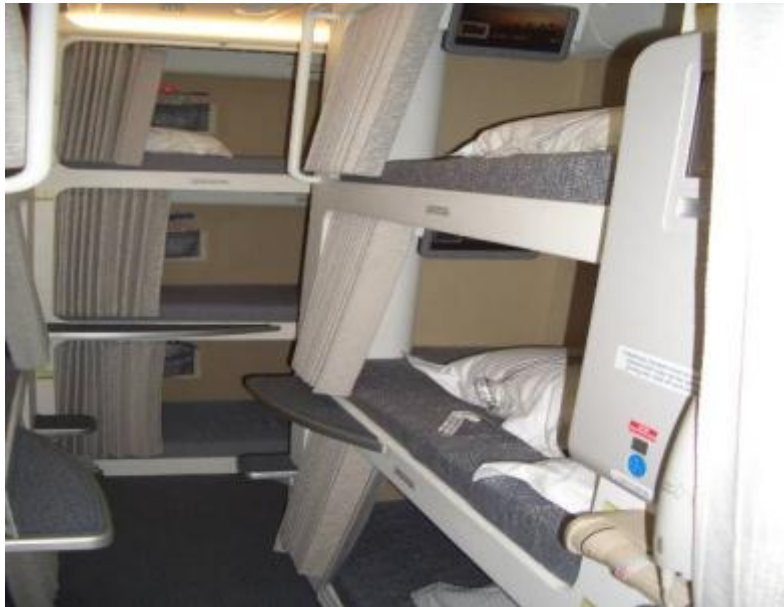
In the Emirates configuration, both the flight and cabin crew rest facilities on the A380 are together in the aft of the main deck, as shown in figures 91 and 92.

Figure 91. The A380 Cabin Crew Rest Facility (Emirates) (Photograph courtesy of FAA)

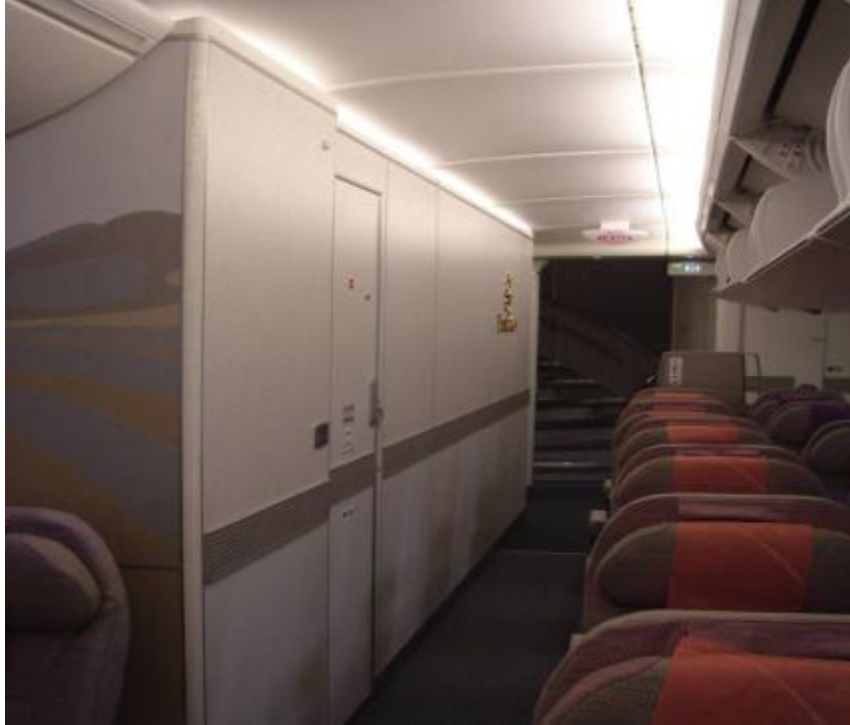
Figure 92. The A380 Crew Rest Area on Main Deck Aft (Emirates)
(Photograph courtesy of FAA)

It should also be noted that there is no fixed fire-suppression system in these main deck crew rest facilities, but they do have smoke detectors and a portable fire extinguisher.

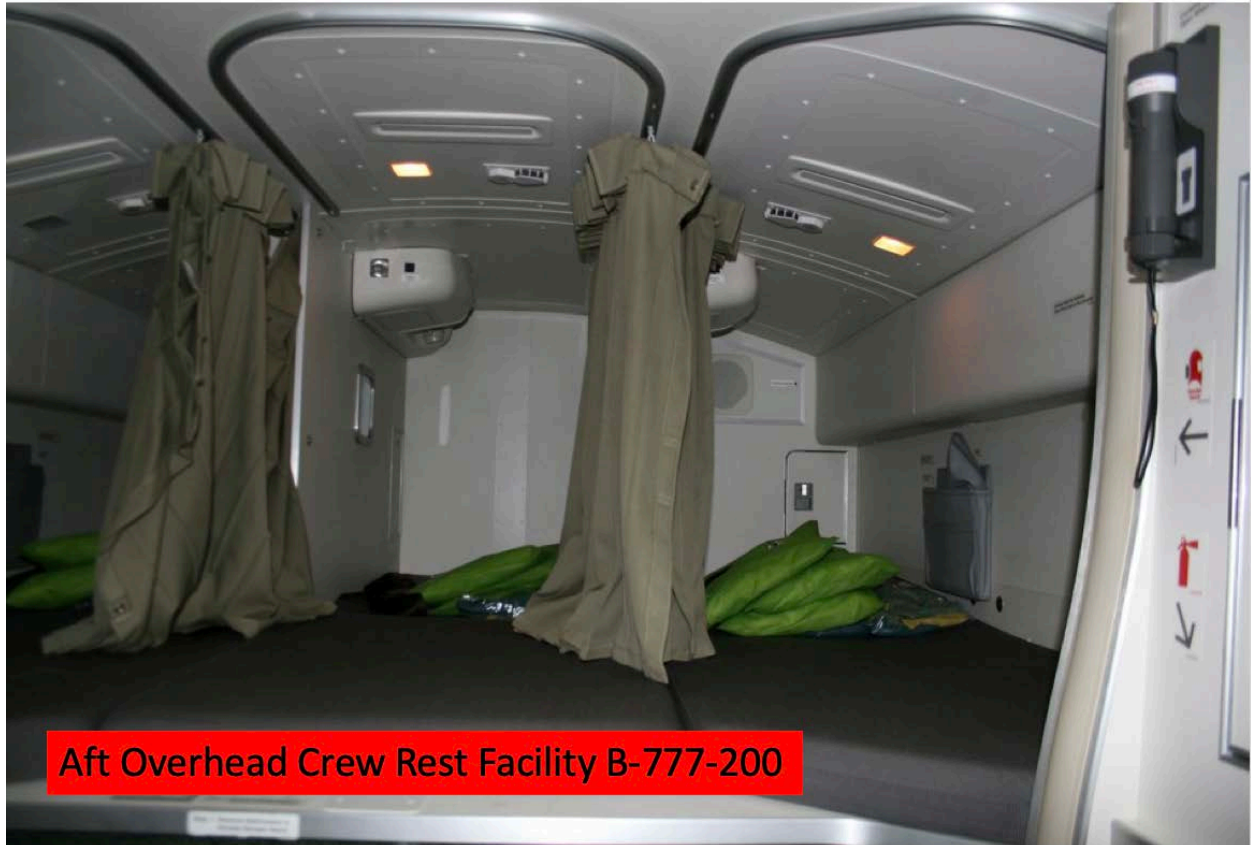
Figure 95. Overhead Cabin Crew Rest Area B-777
(Photograph courtesy of FAA)

Crew rest facilities can be positioned in several areas of the aircraft, based on customer (airline) preference. As a rule, the cockpit crew rest facility will be located near the cockpit. It may be on the same deck just outside the cockpit door, or overhead in the same area, with access through a locked door in the cross over aisle at the L-1 door. The example in figure 95 is a typical cockpit crew rest facility on a B-777. Only those qualified to occupy the cockpit are authorized to occupy the cockpit crew rest facilities.

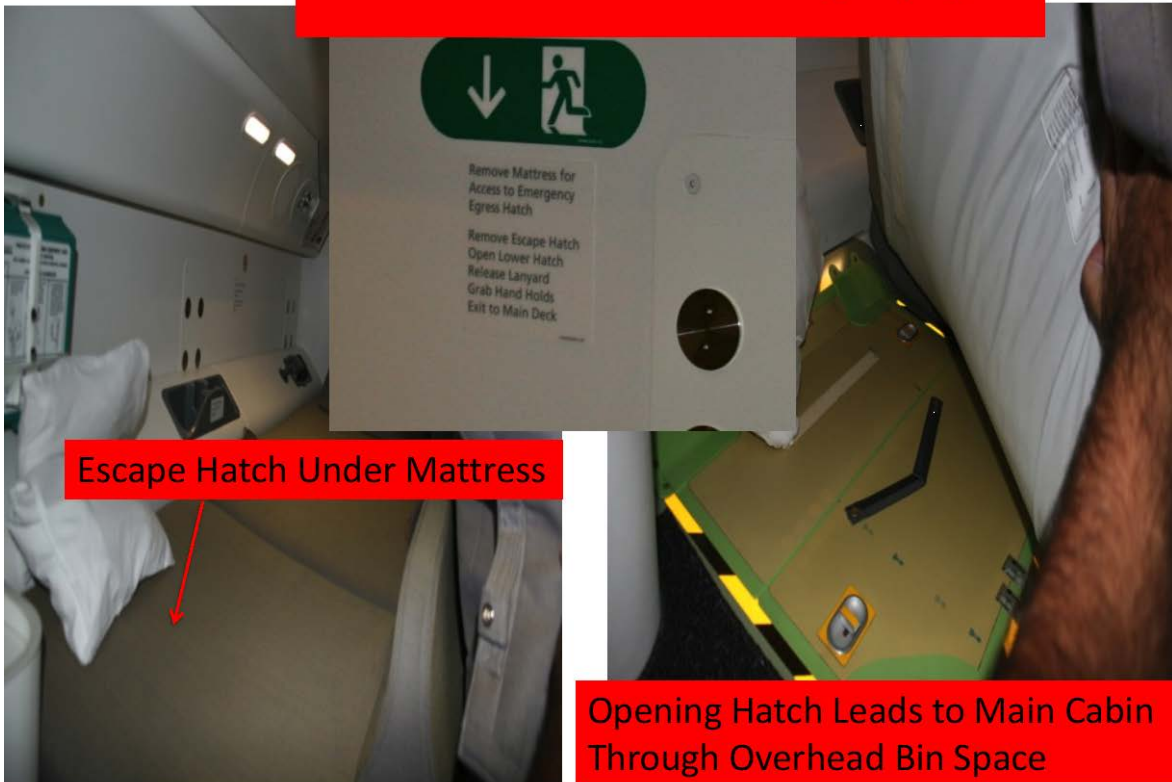
Figure 97. The B-787 Overhead Crew Rest Emergency Egress

Each crew rest facility that is in the overhead space or below deck will be equipped with a secondary exit. The secondary exit is designated by an exit sign, as shown in figure 97. In lower-deck crew rest facilities, the overhead panels in a designated bunk area are removable to access the escape hatch leading into the main-deck cabin.

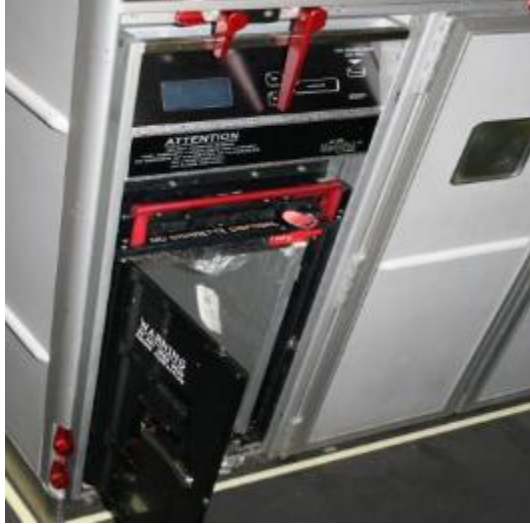
Figure 99. The A380 Galley Trash Compactor (Photograph courtesy of FAA)

There are at least two galleys on each A380, regardless of cabin configuration. Typically, one galley is aft near the rear stairway, and the second is midship. The galleys include trash compactors (figure 99), ovens (figure 100), and refrigerators (figure 101).

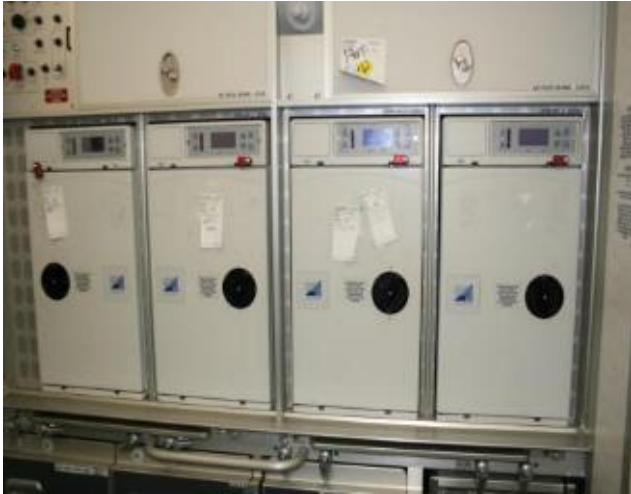
Figure 100. The A380 Midship Galley Ovens (Photograph courtesy of FAA)

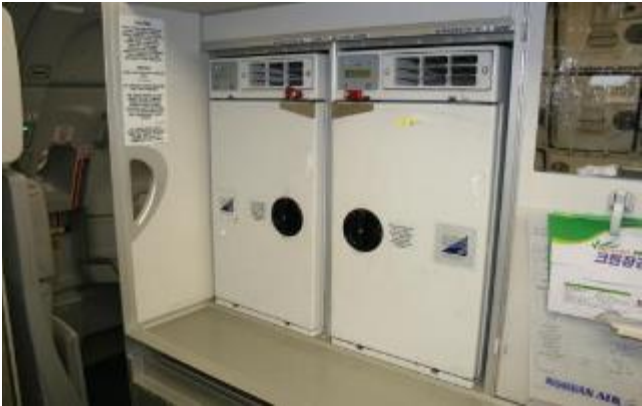
Figure 101. The A380 Galley Refrigerators (Photograph courtesy of FAA)

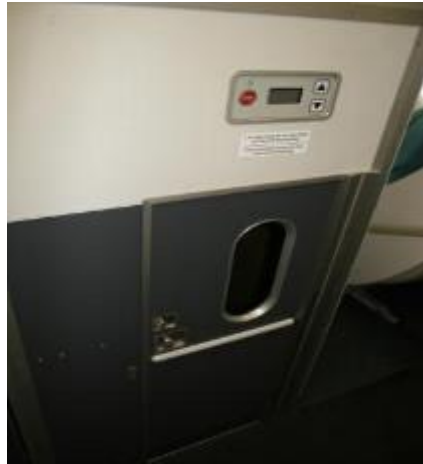
Figure 102. The A380 Galley Service Elevator (Photograph courtesy of FAA)

Each galley has a service elevator (figure 102) to move carts between decks.

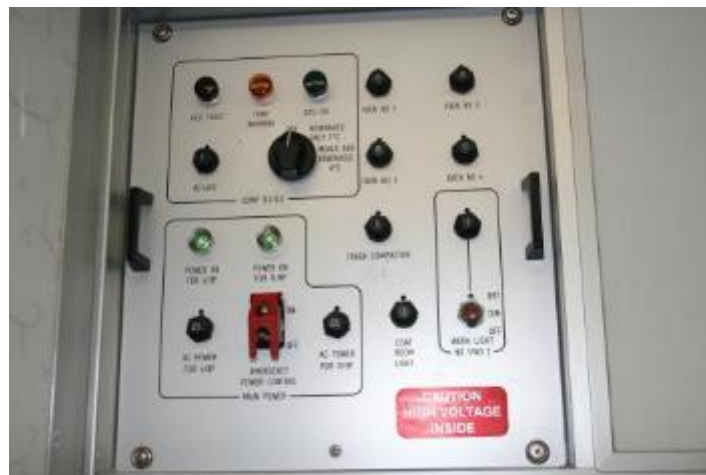
Figure 103. Galley Electrical Panel, Including Emergency Power Shutoff (Photograph courtesy of FAA)

A galley fire is likely to be electrical. If the aircraft is still energized, there are local power panels (figure 103) in each galley. The emergency power shutoff on the galley electrical panel should be secured before any firefighting effort. Thermal imaging cameras (TICs) or handheld infrared thermometers are excellent tools for identifying the source of an odor or smoke in a galley.

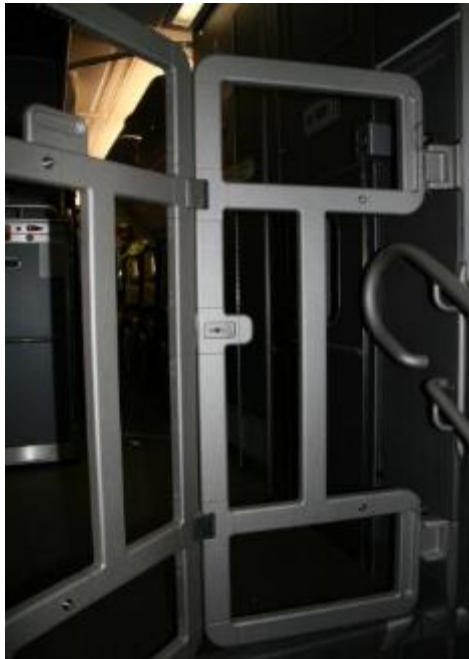
Figure 104. Gate at Top of Rear Service Stairs, A380 Upper Deck
(Photograph courtesy of FAA)

Curtains and gates are used during flight to discourage passengers from passing between decks and classes. Figure 104 depicts a gate that may be installed at the top of the rear stairs. (The A380 rear stairs ascend spirally.) If approaching the stairs from the lower (main) deck, the stairs will turn to the left before reaching the upper deck. As shown in figure 105, looking up the rear stairs from the lower deck will not provide a visual of conditions on the upper deck without climbing the stairs. The rear stairs are primarily used for service, and not intended for passenger use.

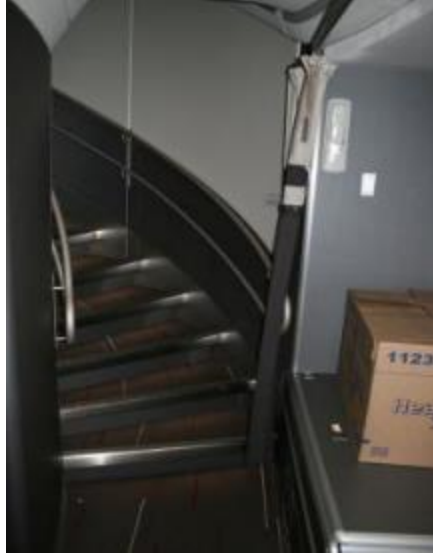
Figure 105. Rear Spiral Stairs, A380 Main Deck Rear Service Stairs
(Photograph courtesy of FAA)

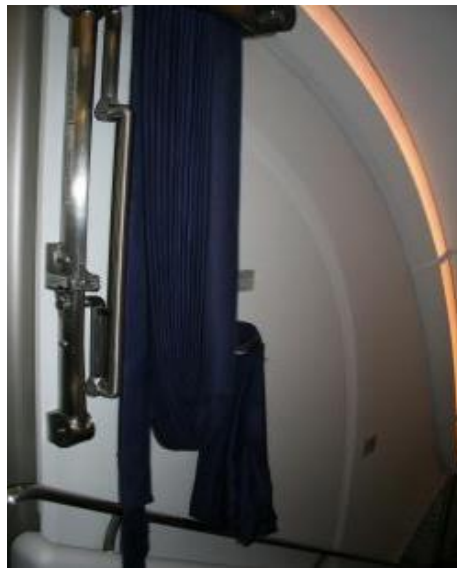
Figure 106. Gate and Curtain Stowed Position, A380 Main Passenger Stairs
(Photograph courtesy of FAA)

The forward stairs are designed for passengers to access the upper deck during boarding and to return to the main deck to deplane. These stairs are also equipped with a gate and a curtain, which are primarily used to discourage passenger movement between decks during flight. As shown in figure 106, when not in use, the gate and curtain are stowed in the open position at the top of the stairs on the right side when looking from the bottom of the stairs. As shown in figure 107, when open, the gate locks securely in place, and the curtain is open to block the view between decks. All gates and curtains should be in the open and secure stowed position during taxi, takeoff, and landing; however, this may not be the case if the aircraft sustained damage during an event.

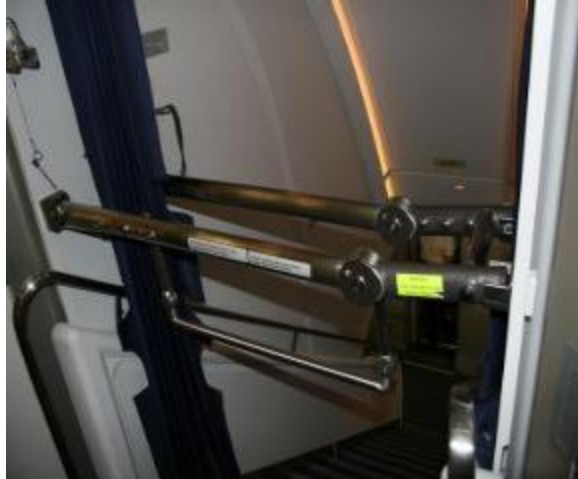
Figure 107. Gate in Operational Position, A380 Top of Main Passenger Stairs
(Photograph courtesy of FAA)

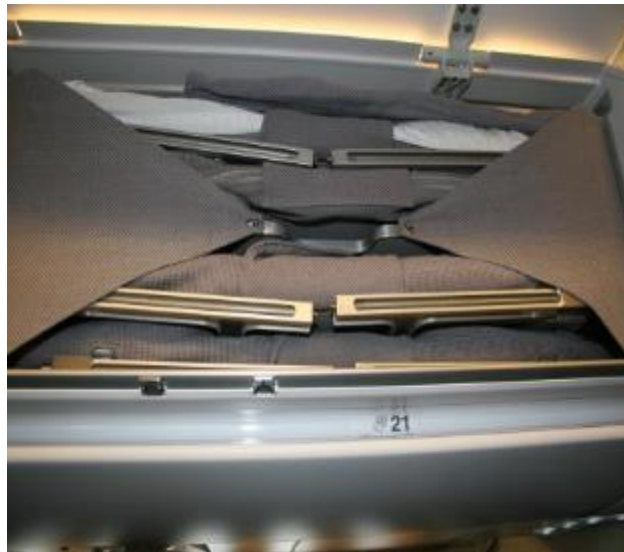
Figure 108. Folded Bed Storage in Lufthansa A380
(Photograph courtesy of FAA)

Some A380s might have another curtained area to provide privacy for an ill passenger. Figure 108 shows the Lufthansa configuration where a bed is folded and stored in the overhead compartment over the seats in row 21. The bed can be installed over a row of seats in a designated location. Once installed, a curtain can be pulled to give the person in the bed privacy, as shown in figure 109.

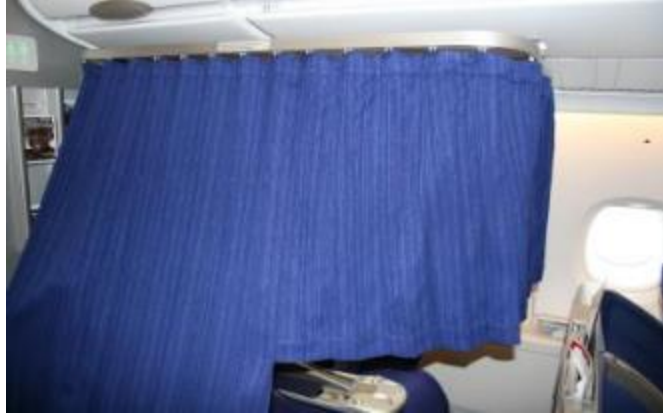
Figure 109. Privacy Curtain in Operational Mode A380
(Photograph courtesy of FAA)

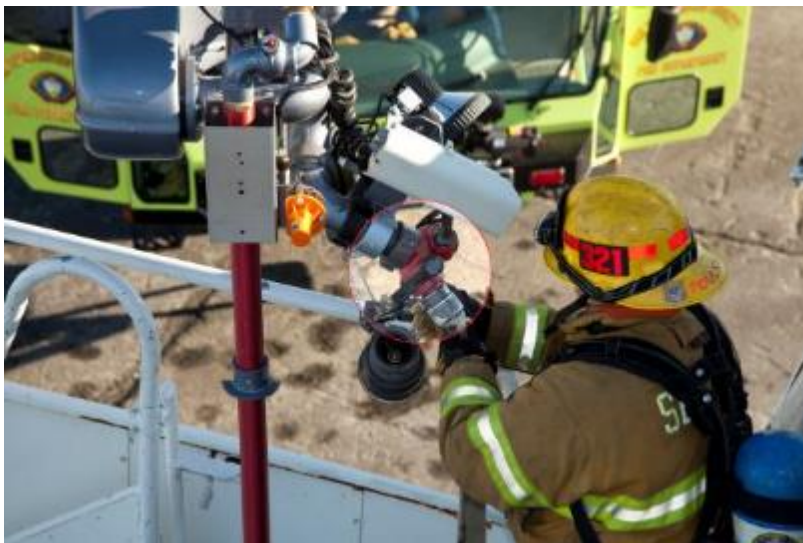
Figure 110. Firefighter Using the HRET Boom as a Waterway
(Photograph courtesy of FAA)
