DOT/FAA/TC-20/19

Aircraft Rescue and Firefighting Strategies and Tactical Considerations for New Large Aircraft: Update

September 2020

Final Report

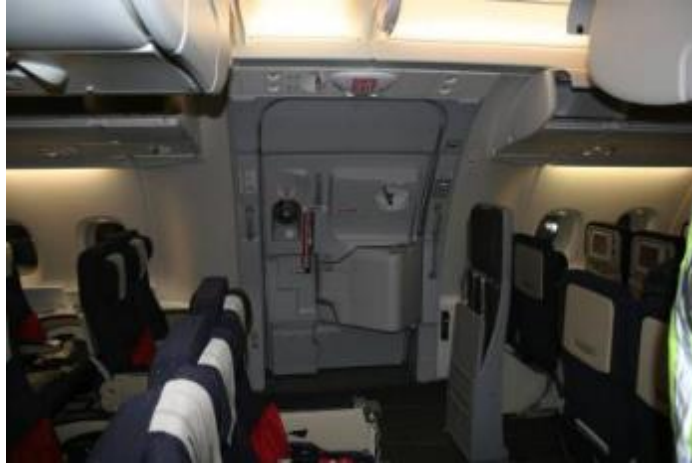
Figure 111. Obstructions to Direct Attack Through Entry Doors
(Photograph courtesy of FAA)

If an interior fire attack team enters through this door, obstructions eliminate the possibility of an immediate direct attack from the entry door position, unless the fire is in this immediate area. If the fire is accessible for a direct attack from the door position, firefighters should stay low, allowing the smoke and heated gases to escape through the top portion of the open door.

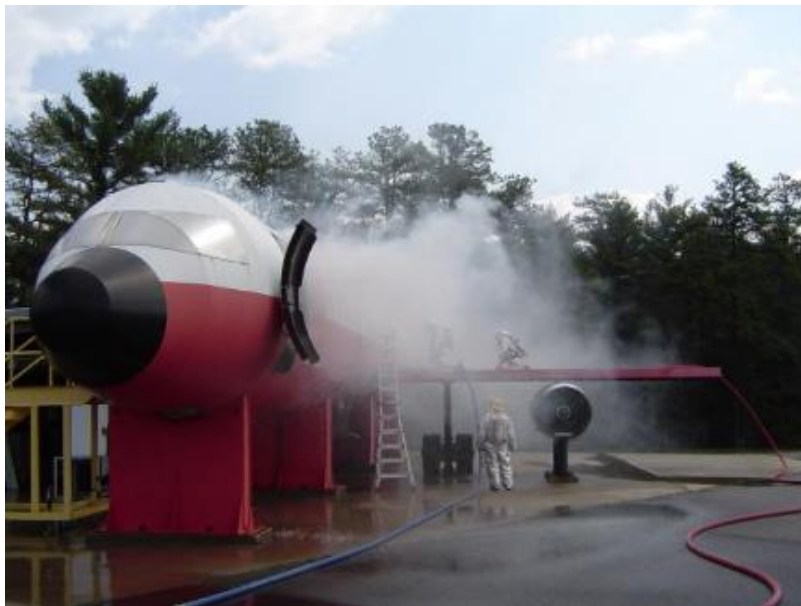
Figure 112. Fire Attack Resulting in Horizontal Ventilation During ARFF Training (Photograph courtesy of Jeremy Souza PVD ARFF)

Regardless of the type of attack, ventilation is an essential element to relieve the heat and gases from the space, making it safe for firefighter entry. Opening a door on the end of the aircraft toward which the interior attack teams are advancing, along with the water stream, will help ventilate the fuselage through the open doors. This is known as horizontal ventilation. In figure 112, firefighters demonstrate horizontal ventilation by initiating fire attack through the rear door and forcing the smoke out the front door.

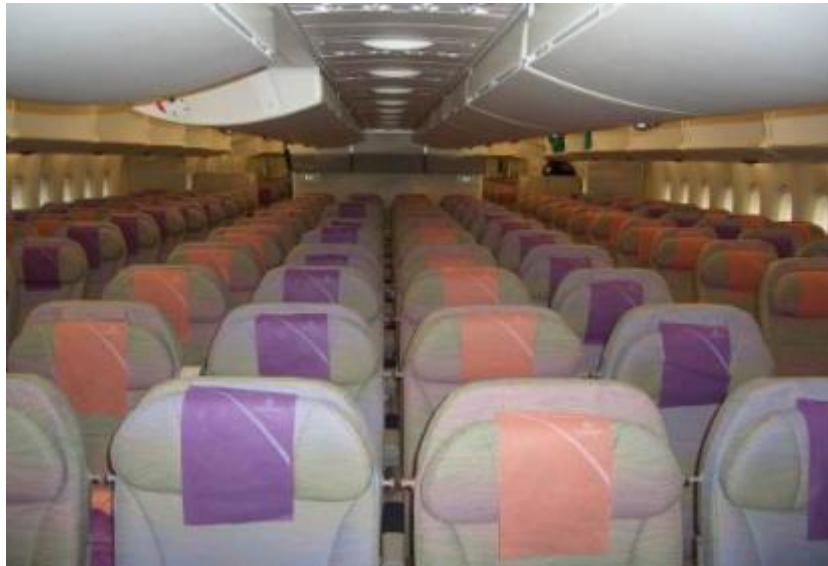
Figure 113. Depth of Each Seat Row
(Photograph courtesy of FAA)

Due to the depth of each seat row, a search in a smoke-filled environment is very time consuming. Firefighters should conduct a search from both aisles between members who have communications with each other and with the incident commander, with coordinated progression clearing one row at a time. More personnel can be used to coordinate a faster search. In preparing for entry to conduct search and rescue, firefighters must have a pre-determined search plan. As an example, four firefighters are about to enter a B-747-8I to search the economy cabin for occupants. The lead firefighter or officer should announce the configuration. For this aircraft, there are three seats on each side and four in the middle. The verbal description would be 3-4-3, holding up fingers, first three fingers, then four, then three again. There are two aisles and two firefighters would search each aisle. The first firefighter in should announce “Right,” indicating they will search the seats on the right side of the assigned aisle. The firefighter will reach to search three of the four seats on the right. This causes a one-seat overlap in the center section, as it is being searched from both sides. The second firefighter will announce “Left;” this serves as a confirmation that the first firefighter’s announcement was heard and announces their plan to search the three seats on the left. If any of the team find a victim, they should announce, “Got One.” The firefighter working the same aisle will go to the victim and both firefighters will take appropriate actions to determine if the victim is alive. If alive, they should be removed from the aircraft.

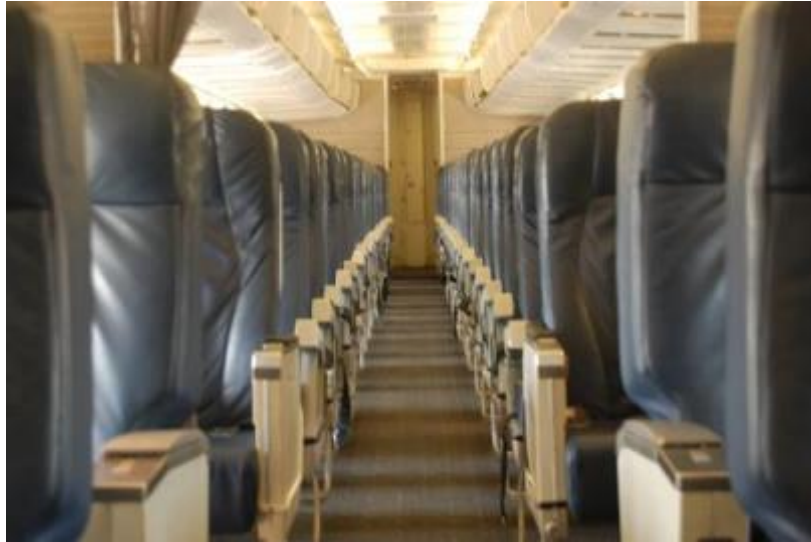
Figure 114. Normal Cabin View With Good Visibility (Photograph courtesy of FAA)

In a dark, smoke-filled cabin, visibility is zero. Figure 114 provides the view of an aircraft cabin in normal visibility. In a fire condition, the same space would simply be black. Figure 115 provides the view of the same cabin through a TIC when blacked out with smoke. When using a TIC, thermal images of anything with a heat signature different from the ambient temperatures become apparent.

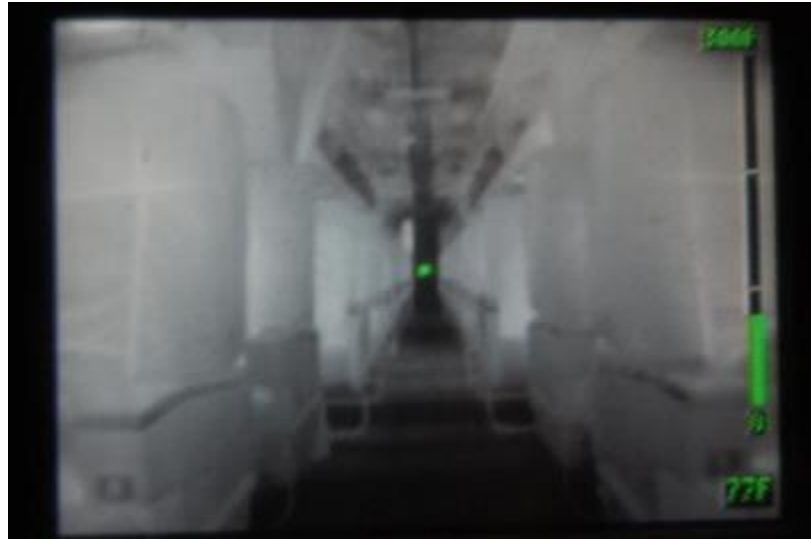
Figure 115. Same Normal Cabin View Through a TIC (Photograph courtesy of FAA)

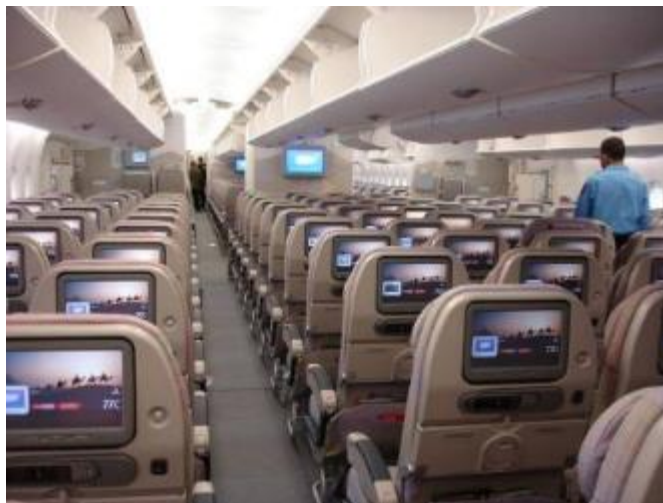
Figure 116. Overhead Compartments Located Over Every Seated Position
(Photograph courtesy of FAA)

The overhead storage bins are fastened directly to structural components and are designed to carry the weight of the contents, as shown in figure 116. A hard landing, structural damage, weight shift, introduction of additional weight from water, or exposure to fire, may affect the integrity of the mounting system. Firefighters must remain aware of this possibility on any aircraft. If the mounting system fails, the loaded overhead bin will certainly cause injury if it landed on a

firefighter or occupant. Fortunately, the design of the cabin builds in a relative level of protection. The seatbacks will likely absorb most of the energy of a falling overhead bin. Contents may spill out and potentially strike a firefighter or occupant. The addition of the bins and the spilled contents will complicate passage in the aircraft. Firefighters in the aisle, particularly in a crawling position, would have a fair amount of protection from a falling bin. An exception is when the compartments are over the center-section seating pods, as in some carriers' business- and first-class cabins.

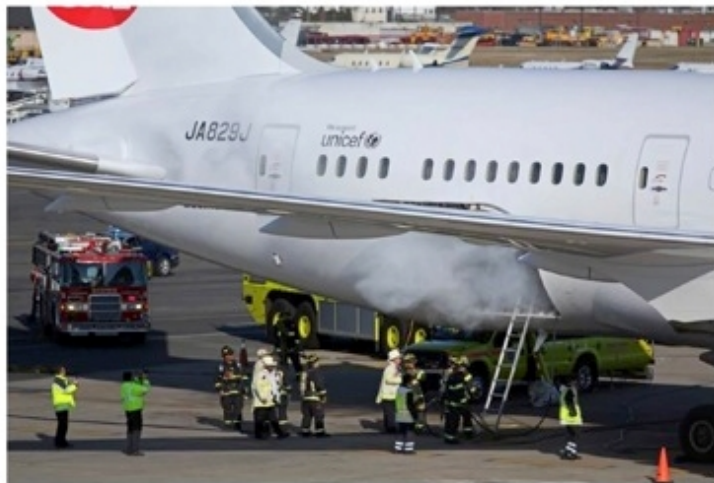
Figure 117. The JAL B-787 Battery Event at BOS
(Photograph courtesy of NTSB (2014b)—Original Source: The Boston Herald)

The first significant ARFF event concerning installed lithium-ion aircraft batteries occurred at Boston Logan International Airport (BOS) on January 7, 2013 (figure 117). According to the NTSB accident report detail (NTSB, 2014b), cleaning personnel on the Japan Airlines (JAL) B-787-8 discovered smoke in the aft cabin. At about the same time, a maintenance manager in the cockpit noticed that the APU had shut down automatically. A mechanic then opened the aft E&E bay and found heavy smoke and a fire with two distinct flames at the electrical connection on the front of the battery case. The NTSB states:

The NTSB determines that the probable cause of this incident was an internal short circuit within a cell of the APU lithium-ion battery, which led to thermal runaway that cascaded to adjacent cells, resulting in the release of smoke and fire. (NTSB, 2014b)

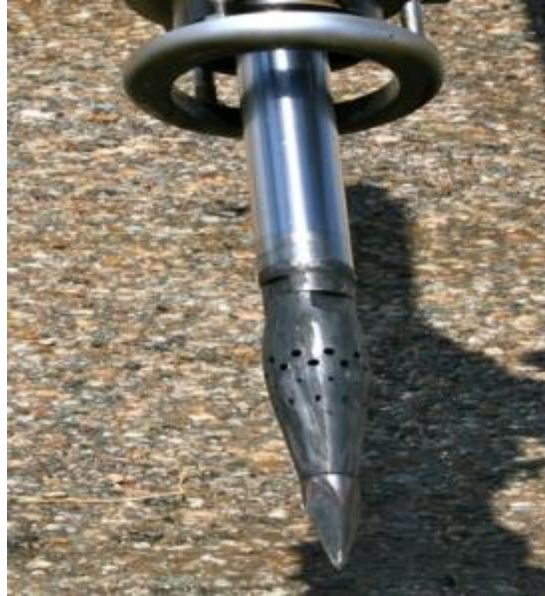
Figure 120. Agent Discharge Holes on Rosenbauer Stinger ASPN
(Photograph courtesy of FAA)

Among the tactical considerations are the ASPN’s limitations; its greatest limitation is its length. The length determines how far into the fuselage the ASPN can reach during piercing. As shown in figure 120, the ASPN’s agent discharge holes are along the shaft. Only those holes that are exposed inside the space can discharge and contribute to cooling and extinguishment. The ASPN length limitations are depicted in figure 121. This figure is of a B-777 cabin, but the representation would be similar in any wide-body aircraft.

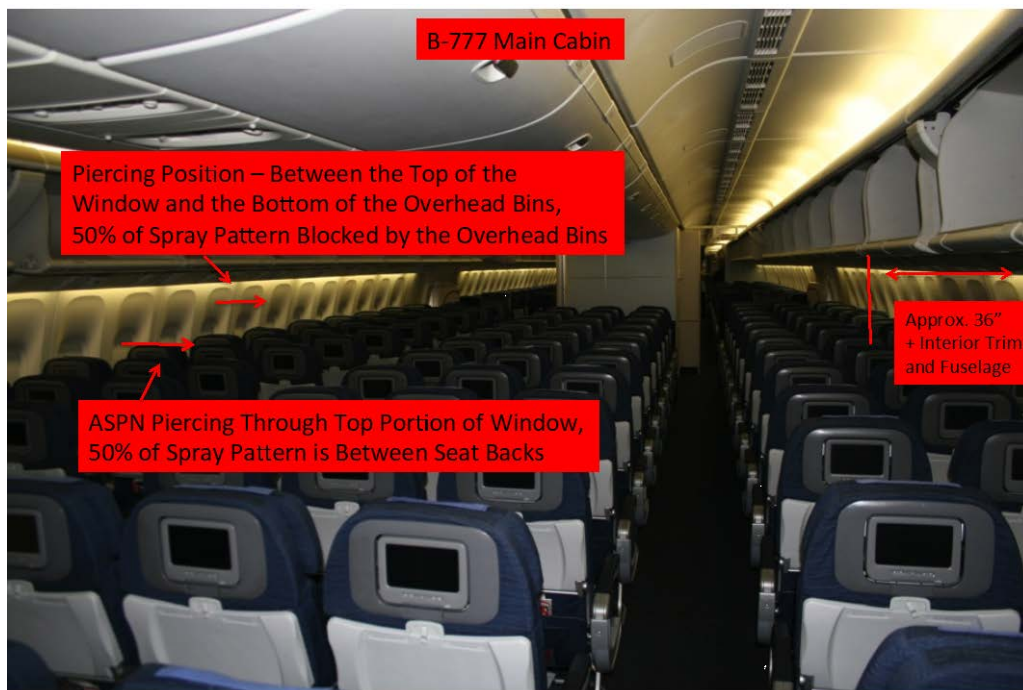
Figure 121. Limitations of the ASPN in a B-777 Main Cabin
(Photograph courtesy of FAA)

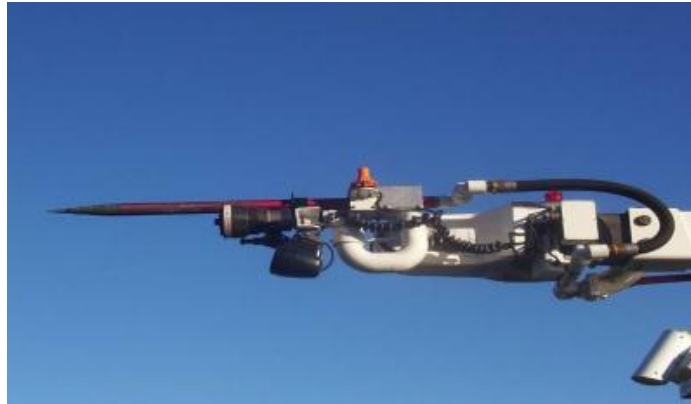
Figure 122. The HRET Using Boom Hydraulics for Penetration
(Photograph courtesy of FAA)

aircraft with service at the airport. There are currently two different types of piercing technology available for use on ARFF vehicles. The first uses boom hydraulics, with the piercing tip aligned with the boom, as shown in figure 122. Once in position, the boom is extended forward and the ASPN pushes through the fuselage. Once fully through the fuselage skin and interior trims, the discharge holes on the ASPN are exposed to the interior of the fuselage and provide a wide spray pattern inside the aircraft to extinguish the fire.

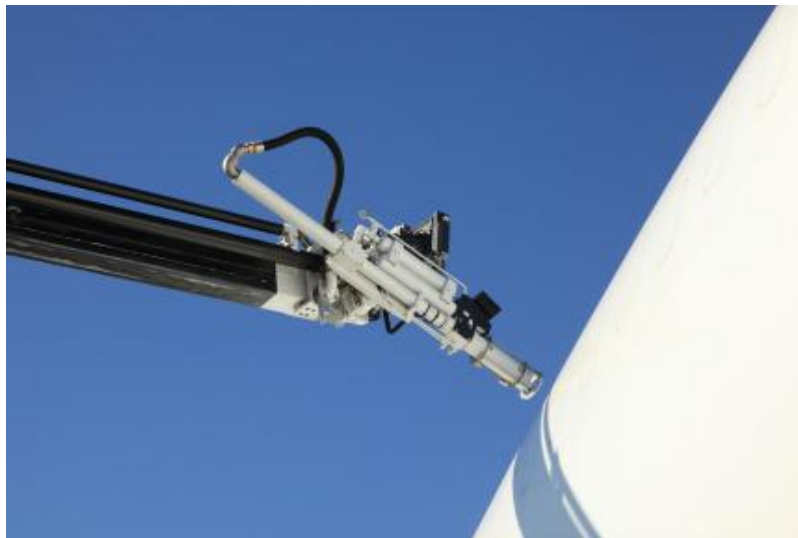
Figure 123. The HRET Using Hydraulic Accumulators for Penetration
(Photograph courtesy of FAA)

The second technology uses hydraulic accumulators, as shown in figure 123. In this application, the boom, which is not as dependent with being aligned with the piercing tip, fires the tip quickly through the skin and interior trims rather than pushing through. The ASPN is stored within a tube prior to firing.

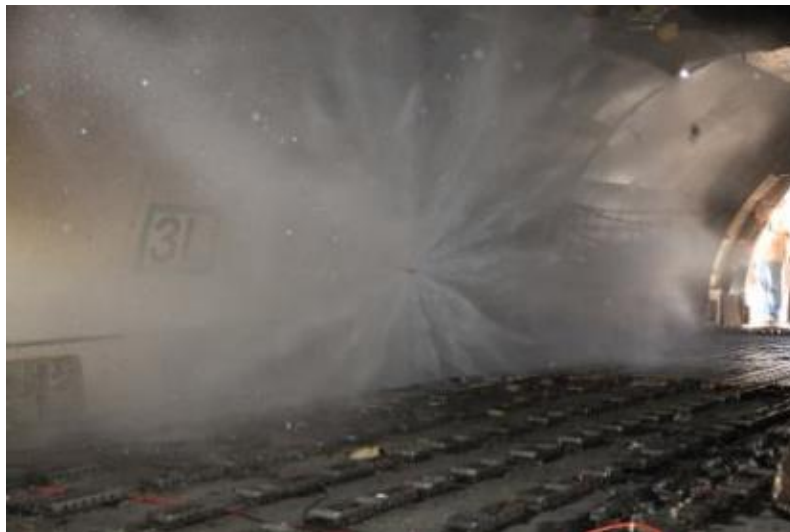
Both types of technology provide a very similar discharge pattern through the ASPN, as shown in figure 124. This pattern inside an enclosed fuselage covers a large area and provides a great deal of cooling.

Figure 124. Discharge Pattern of ASPN on HRET (Photograph courtesy of FAA)

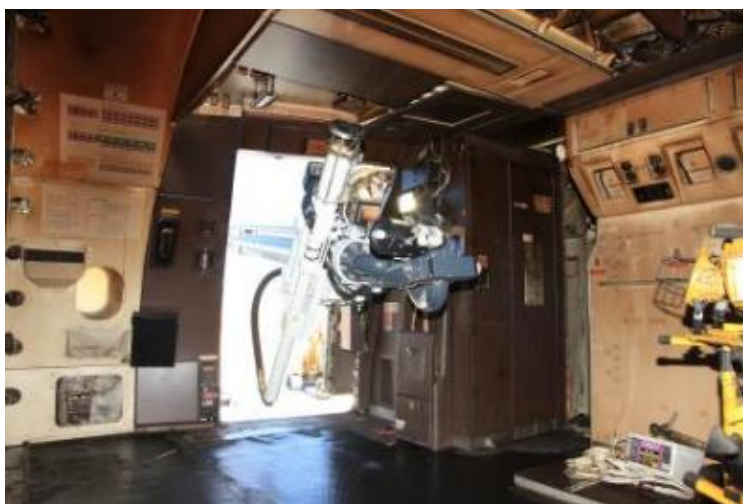
The HRET can be positioned at an aircraft door for interior firefighting. On certain doors, HRETs can be positioned inside the aircraft using the boom-mounted lighting, optics, and turret for evaluation and interior firefighting, as shown in figure 125. There is currently no requirement to mount the boom-mounted lights and optics on the forward portion of the boom, which is capable of rotating and moving up and down. To use the boom as described here for interior inspection/evaluation, the HRET would need to be set up with lights and cameras mounted on the portion of the HRET that can be remotely directed.

Figure 125. Testing the FAA HRET (Photograph courtesy of FAA)

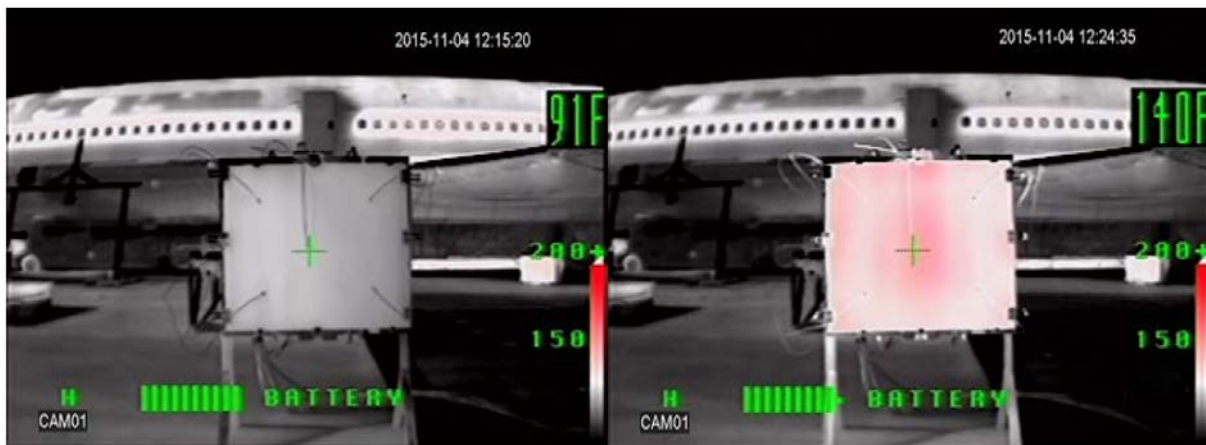
Figure 128. Hot Spot Identification for Carbon Fiber (Photograph courtesy of FAA (2017))

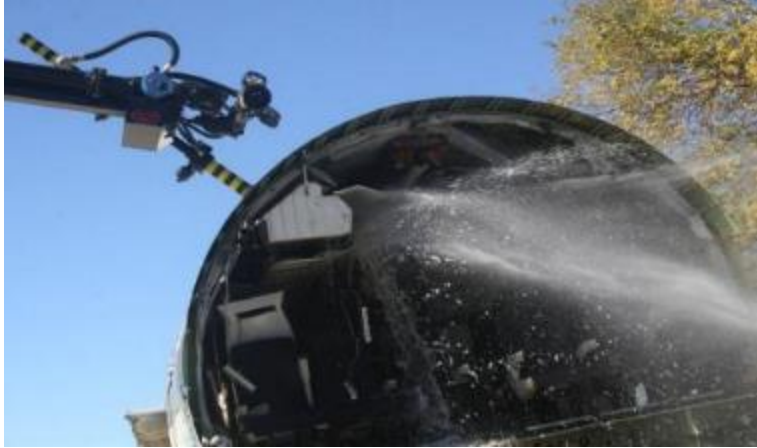
Piercing into the overhead storage bins will reduce the effectiveness of the spray pattern. In tests conducted by the FAA (FAA, 2010a), piercing into the overhead compartment still introduced agent into the aircraft cabin; however, the pattern and effectiveness were significantly reduced. In each test, the storage compartment door was opened, or partially opened, either by the stream force or by the contents being pushed against the door by the piercing tip, as shown in figure 131.

Figure 131. Testing to Understand the Effect of Piercing the Overhead Bin
(Photograph courtesy of FAA (2010))

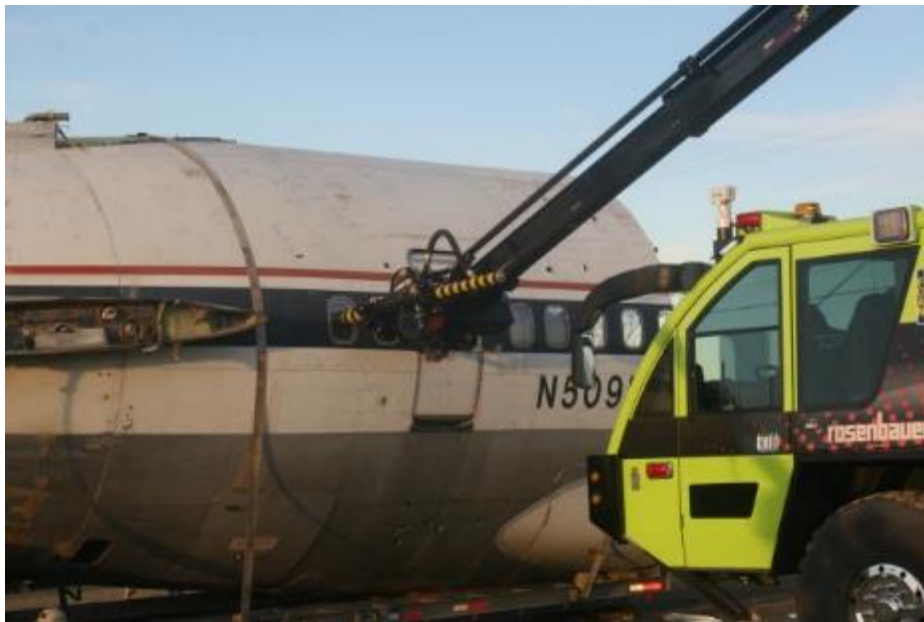
The piercing tip can effectively remove aircraft cabin windows. Positioning the piercing tip and slowly extending the tip and pushing the window will cause the window mounting clips to break, forcing the window to drop into the aircraft cabin. Although the windows can be penetrated rather easily on most aircraft, as shown in figure 132, the seats can block 50% or more of the effective fog spray. A removed window could be used as part of a ventilation strategy or, if deemed appropriate, as a position from which to launch fire attack.

Figure 132. Window Removal Using an HRET (Photograph courtesy of FAA (2010))

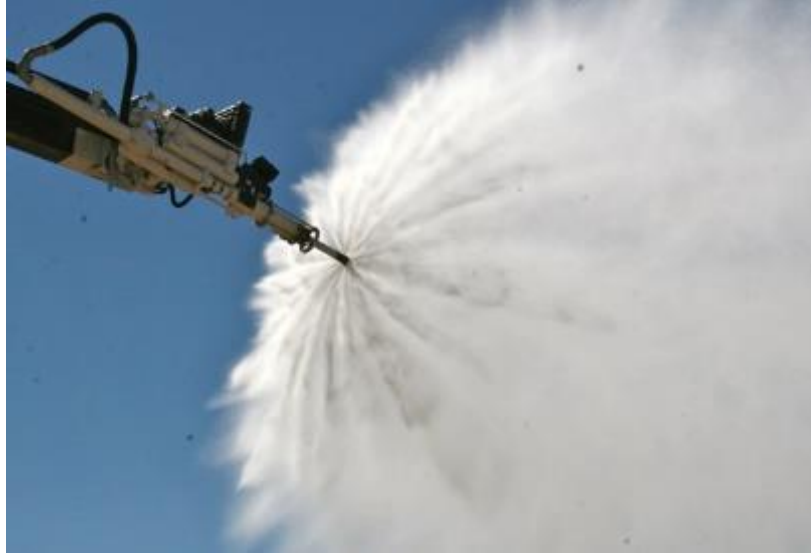
Once a decision has been made to launch a fire attack, an assessment will help determine which agent or what flow rate is applicable to the situation. The ASPN flow rate is approximately 500 gpm, and the water discharged is, by design, a spray pattern (figure 133). In certain tactical scenarios, this is the perfect tactic to deploy, creating steam and rapidly lowering the interior temperatures. In terms of agent conservation, a flow rate of 250 gpm certainly extends the period that an ARFF vehicle can maintain sustained firefighting operations based on tank capacity. As compared to the flow rate of the HRET-mounted turret discharging 100 gpm, the ASPN can sustain flow from the ARFF vehicle reservoir four times as long.

Figure 133. The ASPN Spray Pattern on Rosenbauer Stinger (ASPN)
(Photograph courtesy of FAA)

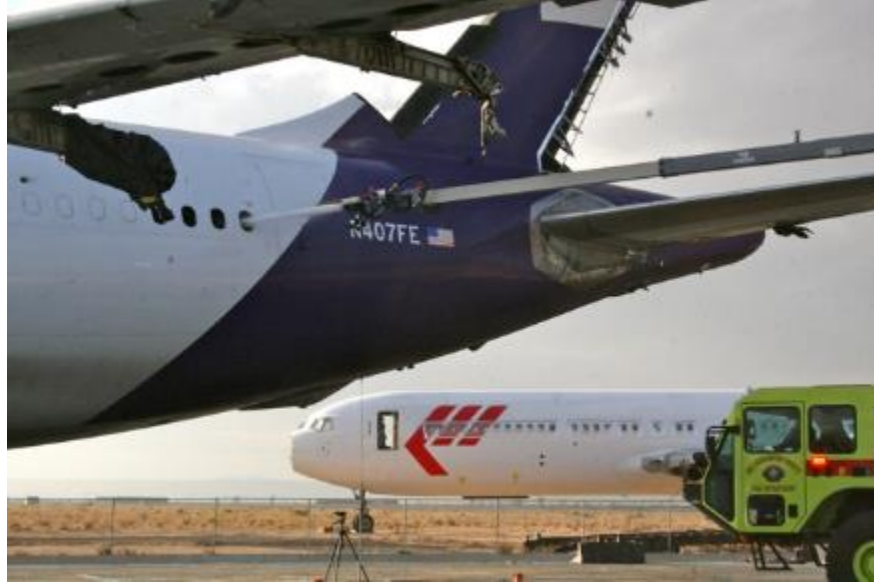
In a different scenario, a direct attack with a high-volume master stream may be the most effective method. The removal of an aircraft window using the ASPN is a relatively simple task. Once removed, the HRET-mounted turret can be directed to discharge 1000 gpm through the opening (figure 134). The operator can position the boom near the window or an opening of the fuselage. This is a much more accurate method of directing a master stream than from a deck gun used in structural firefighting. Although the nozzle reaction will initially move the boom, once flow is constant, the stream can be directed into the target area and maintain position. The HRET does not require deployment of stabilizers or any other delays in deployment. The ability to direct a master stream into an aircraft, even in a high position, can be achieved rather quickly by a trained operator. A fast knockdown is always preferable.

Figure 134. The HRET Turret Discharge (1000 gpm) Through Window Removed by ASPN
(Photograph courtesy of FAA)

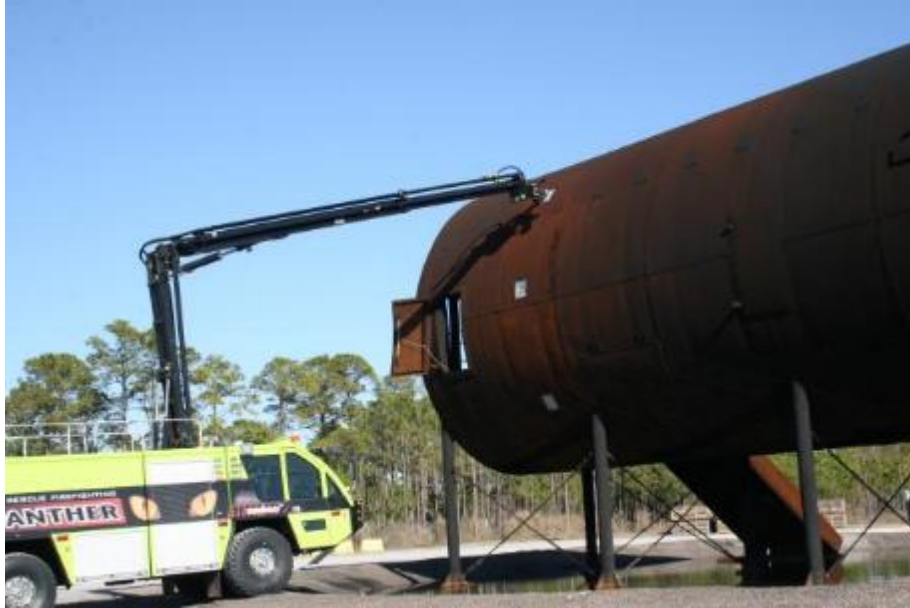
The standoff position is the distance between the front bumper of the ARFF vehicle and the fuselage, as shown in figure 135. To pierce higher on a fuselage, as may be required for the upper deck of a B-747 or A380, the operator must position the ARFF vehicle closer to the fuselage to have a reduced standoff position. From this reduced standoff position, the operator's view is significantly reduced. Their reference points for position and alignment are achieved by looking up through the top of the windshield at a 50- to 60-degree angle. The piercing location for upper-deck piercing uses the same reference points as for main-deck cabin piercing. The ideal position is between the top of the seatbacks and the overhead storage bins. The reference point is 10" to 12" above the top of the upper-deck cabin window. This reference point is on the steeper angle of the fuselage curve, and beyond the widest point or midpoint of the fuselage. As the standoff position of the ARFF vehicle reduces, so does the operator's view of this piercing location. FAA testing has found that not only does the view of that piercing location diminish, but due to the steeper angles of the curve, the driver's perception to determine when the ASPN is level is severely compromised (FAA, 2010a).

Figure 135. Standoff Position and Approach for Upper-Deck Piercing
(Photograph courtesy of FAA)

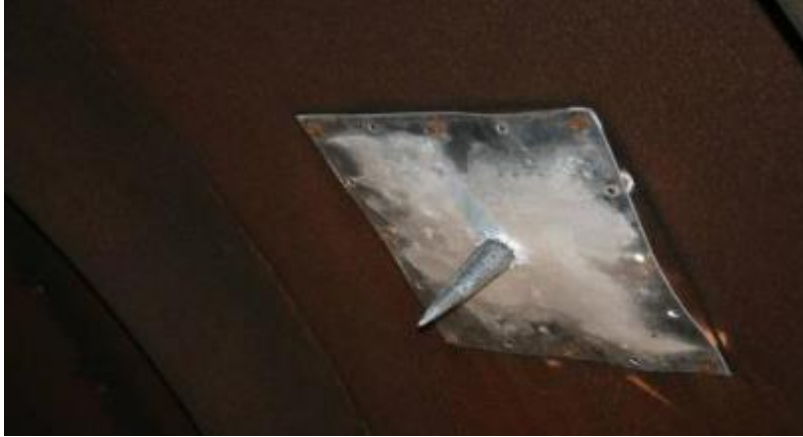
Figures 136 and 137 show the ASPN angle during FAA piercing tests where a skilled operator repeatedly pierced at this angle, although confident that the orientation of the ASPN was level. The downward angle reduced the effectiveness of the pattern, and the seats blocked about 50% of the spray.

Figure 136. Piercing an Upper Deck, Angled Down (Photograph courtesy of FAA)

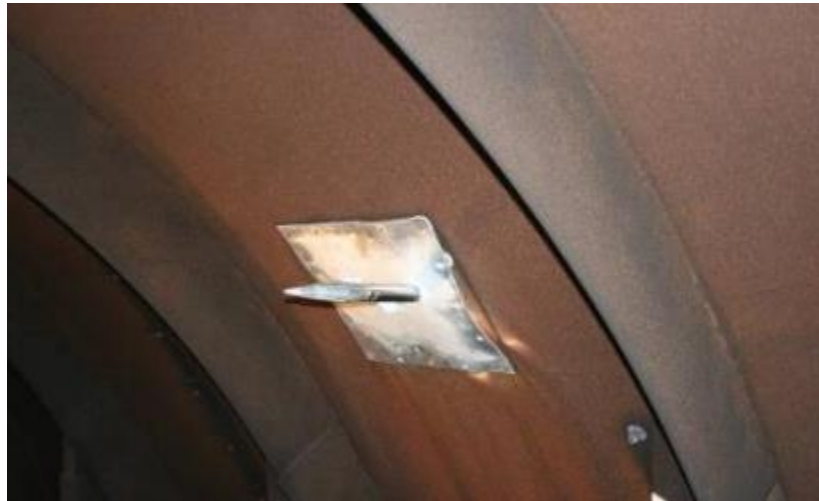
Figure 137. Proper Piercing Angle on Steeper Slope of Fuselage (Photograph courtesy of FAA)

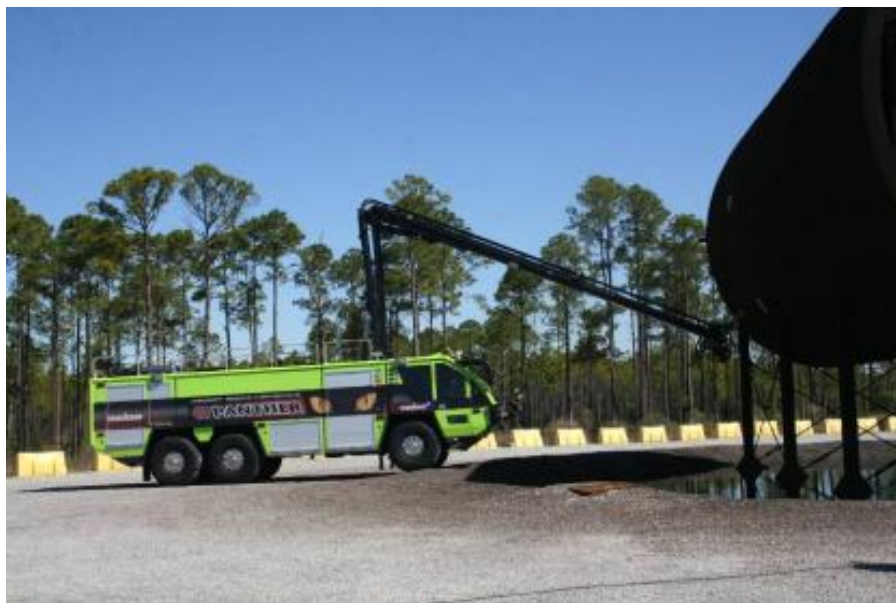
Positioning the ARFF vehicle at the greatest distance from the aircraft that the HRET can be effective increases the driver's view and accuracy in piercing position and angle. Figure 138 shows an ARFF vehicle with HRET operating at the furthest possible point of the recommended standoff position. The driver has achieved greater safety through distance and a full view of the piercing operation. Developing proficiency in positioning the vehicle in the proper standoff position requires repetitive training.

Figure 138. Positioning With Increased Standoff Distance (Photograph courtesy of FAA)

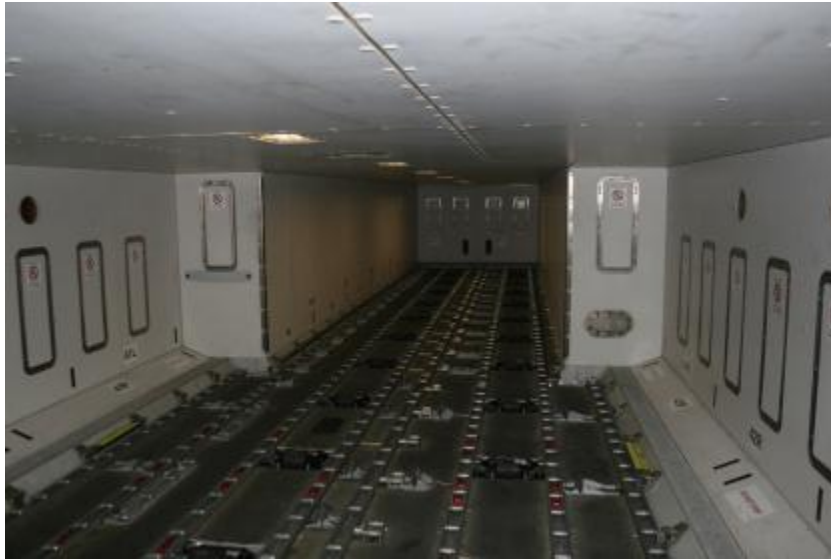
Figure 139. Forward Portion of Aft Cargo Compartment, Known as the Tunnel
(Photograph courtesy of FAA)

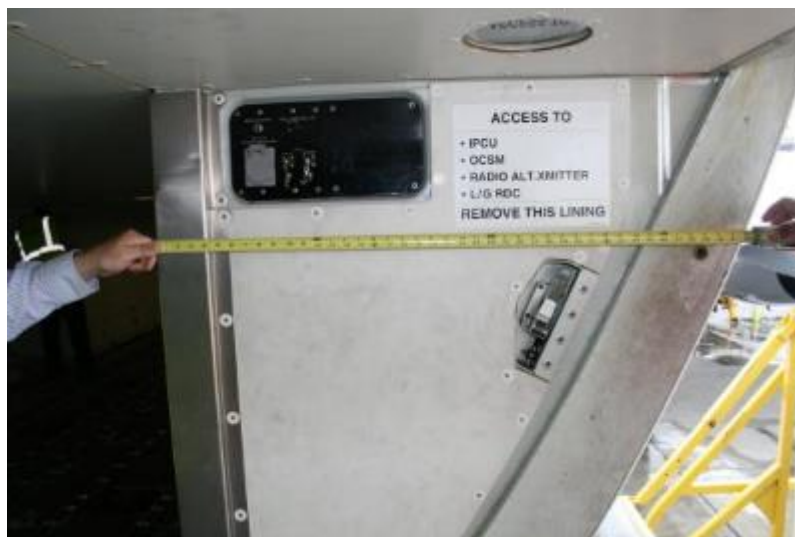
Piercing through the cheek area for a fire in the lower cargo compartment on a large frame aircraft is not an effective strategy because the ASPN is not long enough to pass through the cheek area and into the cargo compartment. Figure 141 shows a measurement of the cheek area immediately inside the rear cargo compartment door of the A380. At that position, the cheek area is 42 in. at the narrowest point on the A380. However, if the fire is in the cheek area, an HRET with an ASPN may be highly effective. It may be difficult to determine whether a fire is burning in the cargo compartment or in the cheek area. One of the best indications would be blistering paint or other signs of heat on the skin.

Figure 141. Cheek Area Inside Rear Cargo Compartment (42 in.) (Photograph courtesy of FAA)

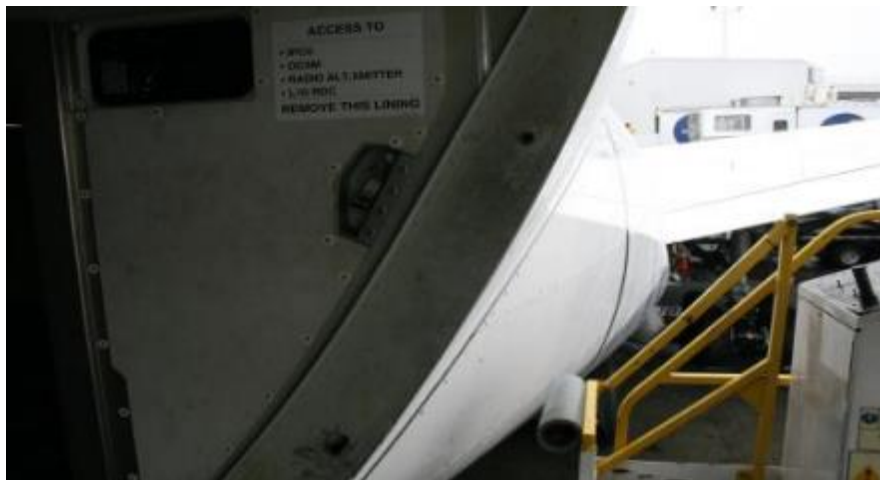
The flare of the wing fairing, looking forward from the rear cargo compartment, is shown in figure 142, and the outside view is shown in figure 143.

Figure 142. Flare of Fairing Between Cargo Compartment and Wing
(Photograph courtesy of FAA)

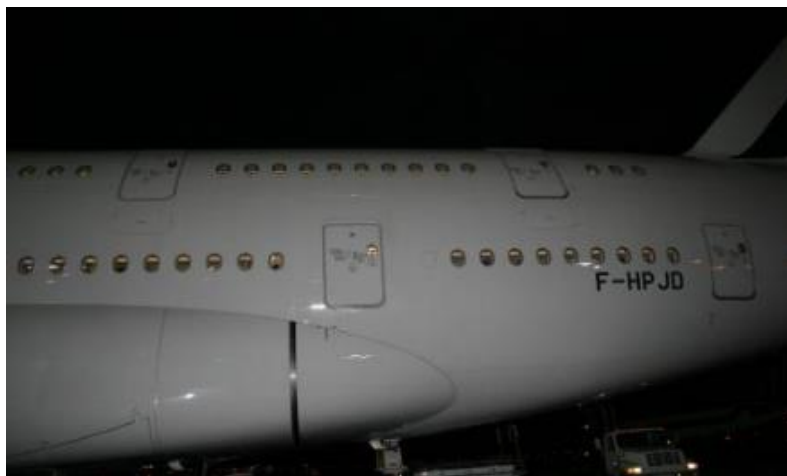
Figure 143. Outside View of Wing Fairing Flare
(Photograph courtesy of FAA)

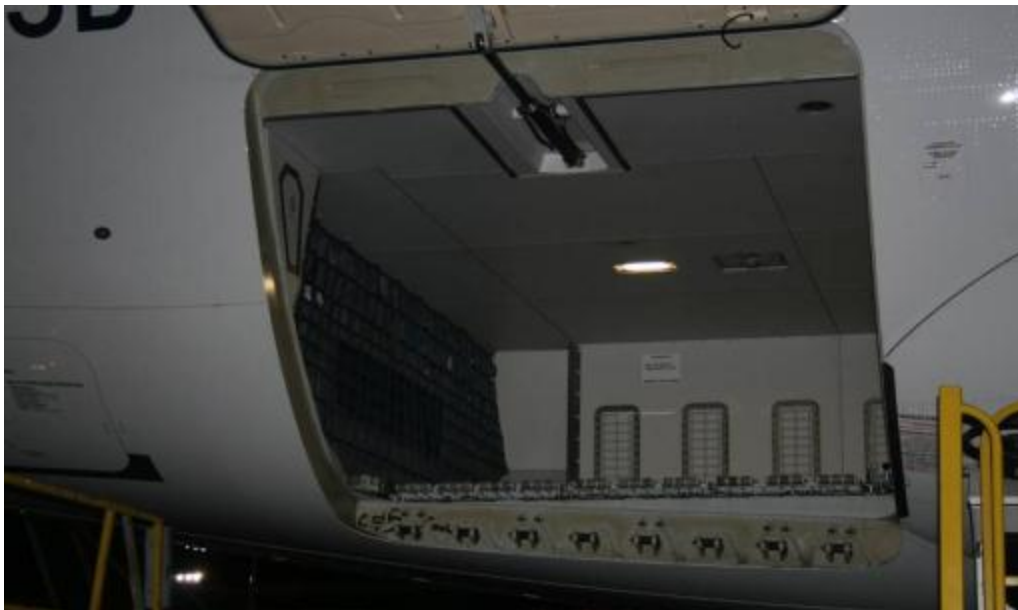
Access into the lower rear cargo compartment can be achieved through the bulk cargo compartment, which is the furthest aft door on the right side of the aircraft. This compartment is used for hand-loaded luggage, and it is equipped with a door that easily opens manually. Once inside, it may be necessary to remove luggage, but the door and compartment allow direct access into the lower rear cargo compartment. The bulk cargo compartment and the aft cargo compartment are separated by a cargo net, as shown in figure 144.

Figure 144. Aft Cargo Compartment With Cargo Net Separating the Bulk Cargo Compartment
(Photograph courtesy of FAA)

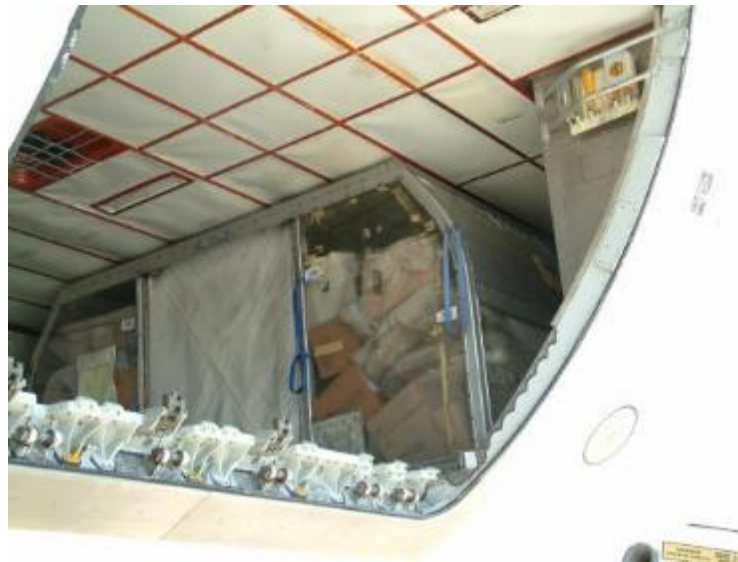
Figure 145. A ULD in Position in Lower Cargo Compartment (Photograph courtesy of FAA)

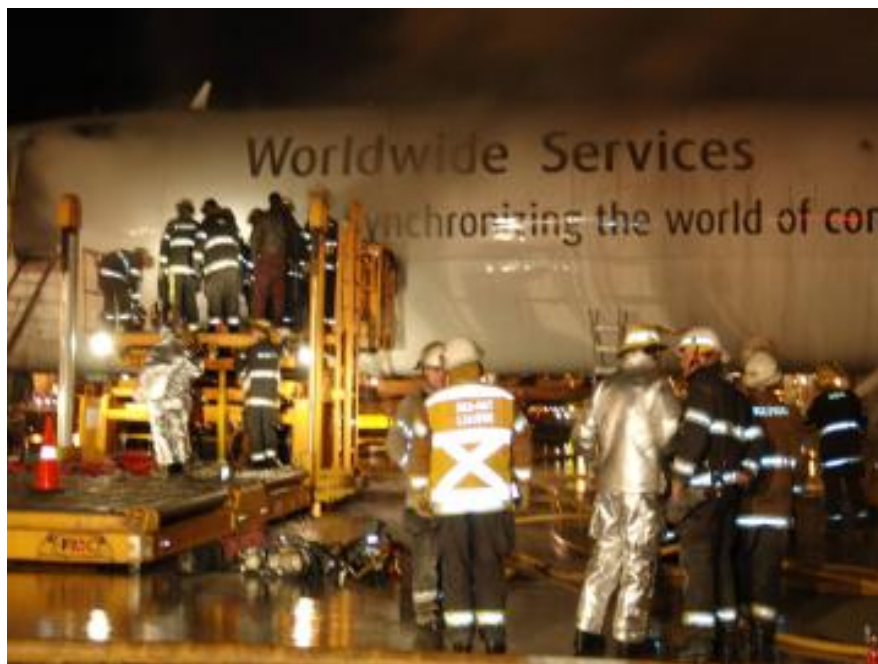
Forcible entry on a cargo door is not an option. The construction, locking mechanisms, and the size and weight of the door make it impractical. In February 2006, firefighters were challenged with forcible entry on the main cargo door on a Douglas DC-8 (UPS 1307), which landed at Philadelphia International Airport (PHL) with a cargo fire onboard. The rescue company's attempts to force the door by cutting the locking mechanisms proved futile (NTSB, 2007), as shown in figure 147. The A380 door is larger, heavier than, and just as formidable as the DC-8 door.

Figure 147. Philadelphia Firefighters Attempt Forcible Entry on a DC-8 Cargo Door

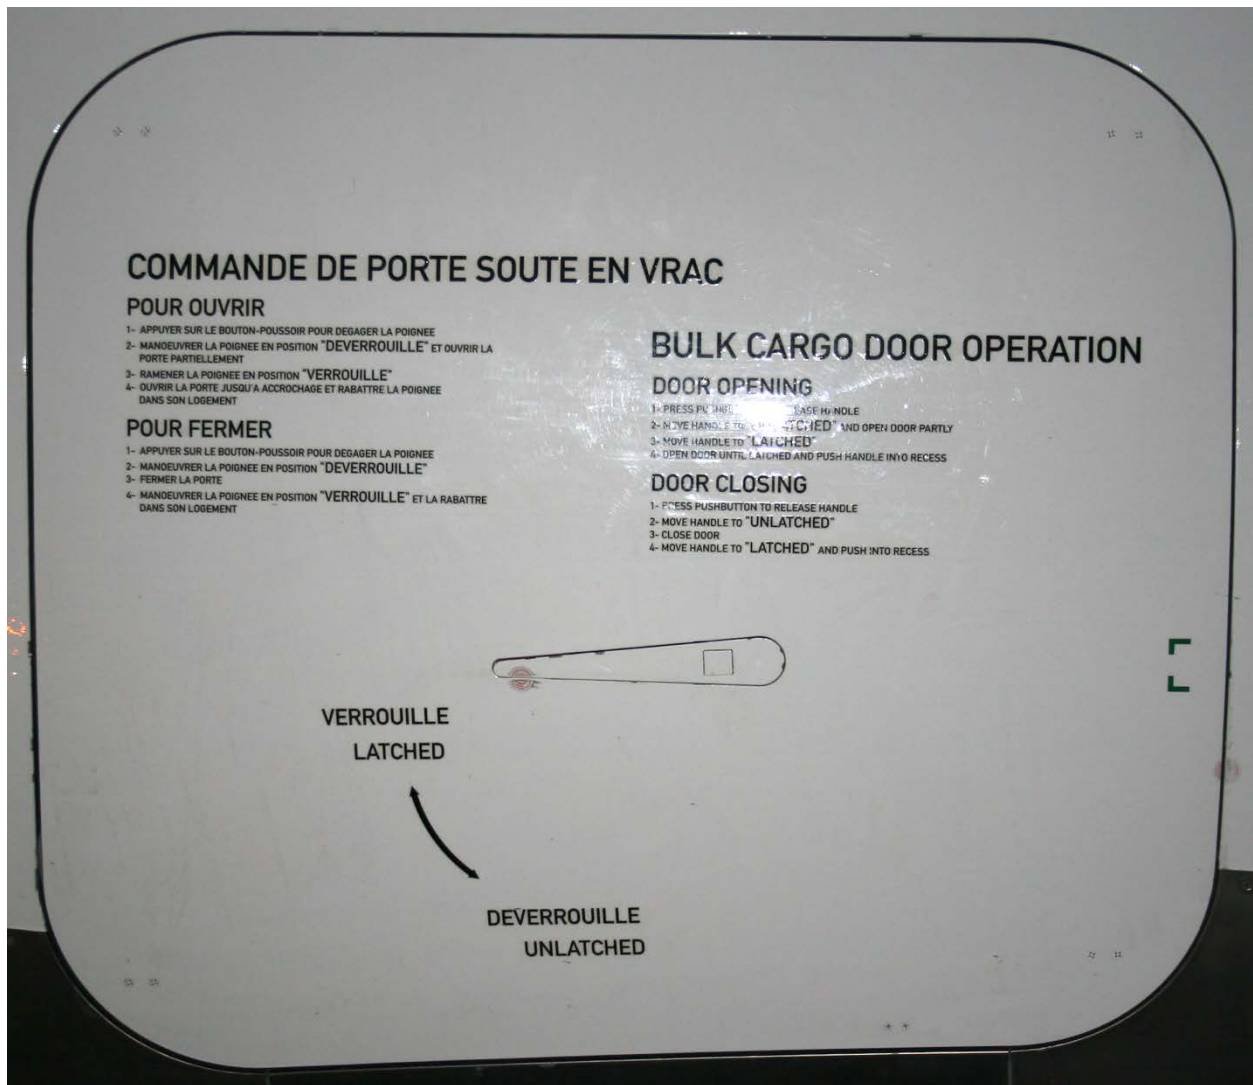
Figure 148. Bulk Cargo Door Operation (Photograph courtesy of FAA)

Bulk Cargo Door Operation—Door Opening

1. Press push button to release handle.
2. Move handle to UNLATCHED, and open door partially.
3. Move handle to LATCHED.
4. Open door until latched and push handle into recess.

The doors can be operated hydraulically with the toggle switches available on the cargo door control panel, which is located to the right of the forward and aft cargo door. If the power to the aircraft has been secured, electrical operation of the door is not an option. The bulk cargo door can be manually operated; procedures are shown on the fuselage or adjacent to the door, as shown in figures 148 through 150.

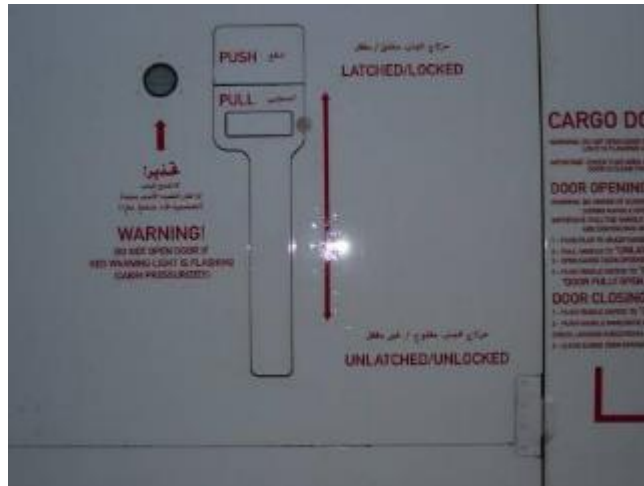
Figure 149. Forward Cargo Door Operation (Photograph courtesy of FAA)

Forward Cargo Door Operation—Door Opening

ENSURE RED WARNING LIGHT INDICATING PRESSURIZED CABIN IS NOT FLASHING

1. Push in flap to grasp handle.
2. Pull handle to UNLATCHED/UNLOCKED.
3. Open cargo door operation access panel.
4. Push toggle switch to OPEN position until the green light is on.

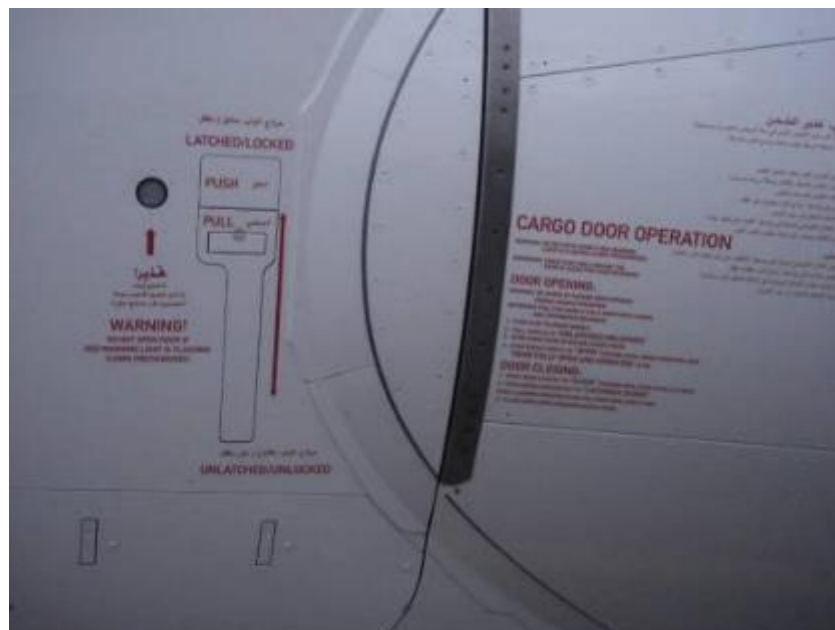
Figure 150. Aft Cargo Door Operation (Photograph courtesy of FAA)

Instructions for operating the aft cargo door are the same as the forward door.

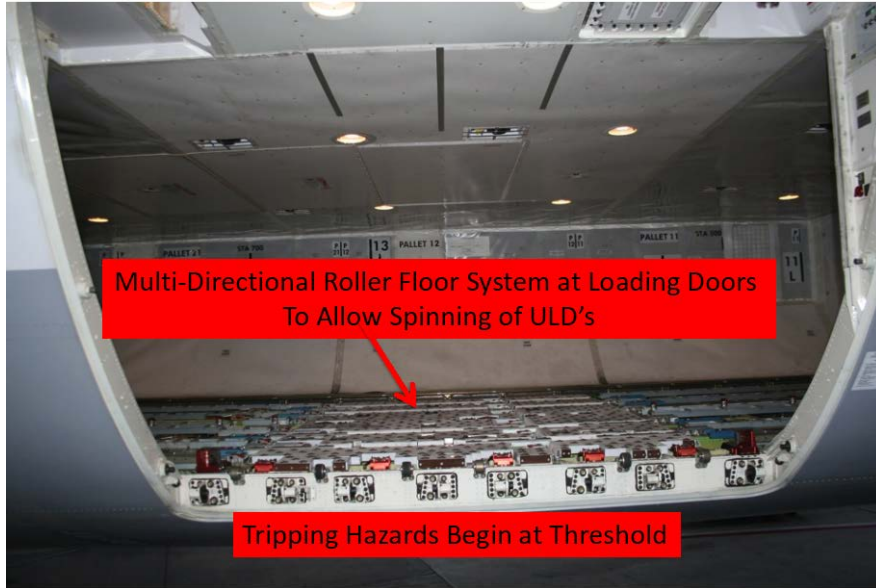
Figure 151. Cargo Door Opening—B-747-8I (Photograph courtesy of FAA)

In a lower cargo bay, the hazards to firefighters begin at the threshold, as shown in figure 151. The entry point at the main cargo door has several pieces of hardware that must be stepped over and avoided. At the sill, the fixed portion of the door locking mechanism is the first obstruction that will snag a fire hose being brought into a space. The first section of the floor system (immediately inside the door) is a roller system used to spin ULDs being loaded so they can be pushed into position. These rollers can be extremely dangerous to safe footing. Once inside, there is limited head clearance. Most firefighters wearing a helmet will need to crouch to fit in the space.

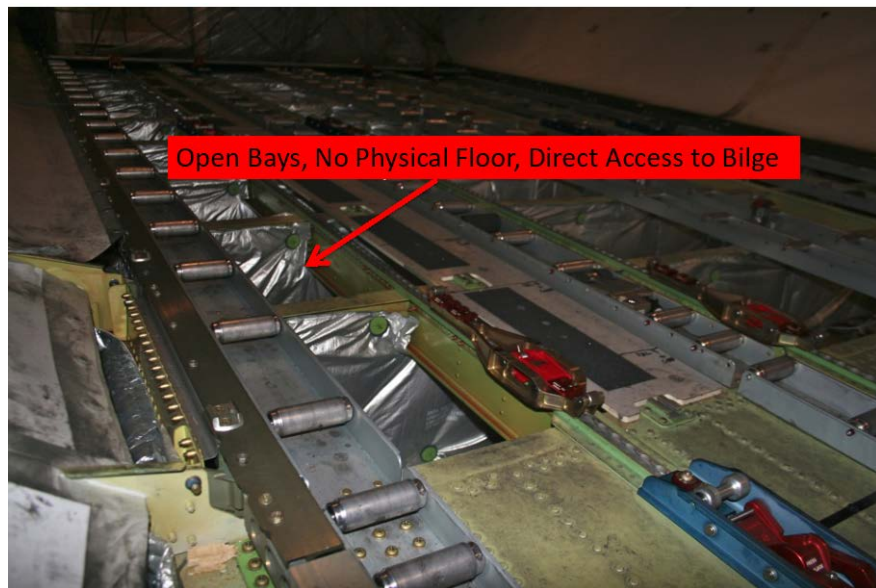
Figure 152. Open Bays in Cargo Floor—B-747-8I (Photograph courtesy of FAA)

Walking across the cargo floor is a very slow process. In addition to rollers and tripping hazards, some cargo floors may even have openings without any walkway (figure 152). Stepping into one of these areas in the dark could result in a drop of 1 ft or more.

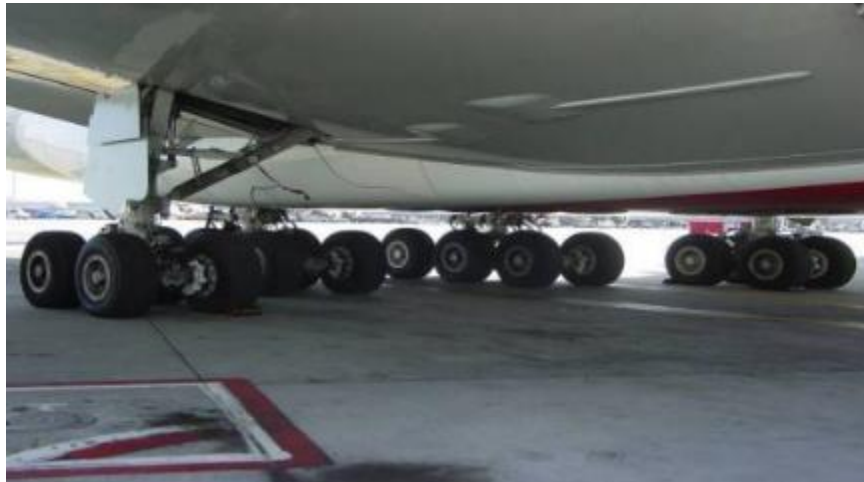
Figure 157. The A380 WLG and BLG—View From Front
(Photograph courtesy of FAA—Taken from right side of aircraft)

The A380 has 22 wheels, as shown in figure 157, and:

- One set of nose landing gear (NLG)
- Two sets of wing landing gear (WLG)
- Two sets of body landing gear (BLG)

What firefighters commonly refer to as the main gear are specifically called WLG and BLG. The WLG, BLG, and NLG wheels are numbered for identification, the numbering starts from the left side (just like engines), and then moves aft. NLG are numbered 1 and 2, and the first row of main gear on the A380 is the WLG. From left to right, the wheels are referred to as 1, 2, 3, and 4, as shown in figure 158. The next row of WLG starts with 5 on the left side, followed across as 6, 7, and 8. The BLG rows follow suit, with numbering starting on each row at the left.

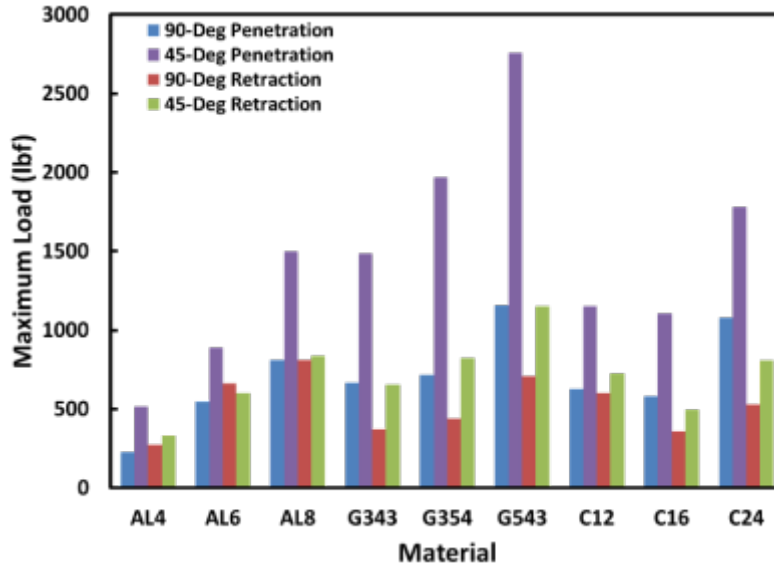
Figure 166. Comparison of GLARE and Aluminum Penetration Forces
