DOT/FAA/TC-20/19

Aircraft Rescue and Firefighting Strategies and Tactical Considerations for New Large Aircraft: Update

September 2020

Final Report

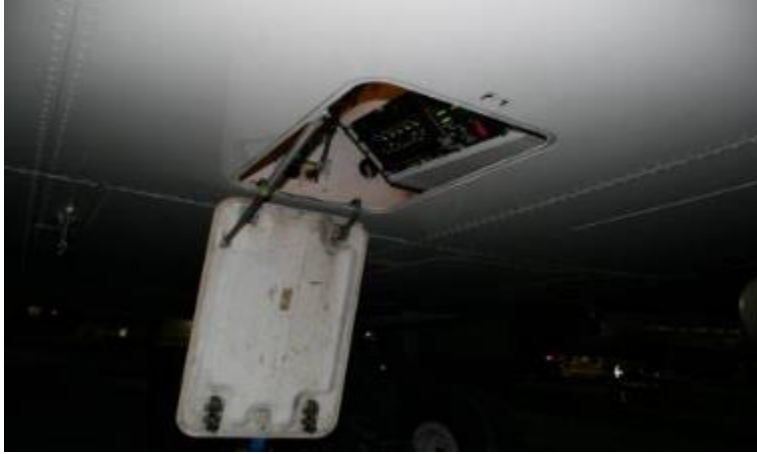
Figure 168. Refuel/Defuel Panel
(Photograph courtesy of FAA)

The APU is located in the tail of NLA. The APU emergency shutdown switches are located in the cockpit, the maintenance nose gear panel, and the refuel/defuel panel, as shown in figures 167 through 170. The APU fire-suppression system is designed to activate automatically when a fire is detected if no action is taken or if the aircraft is left unattended.

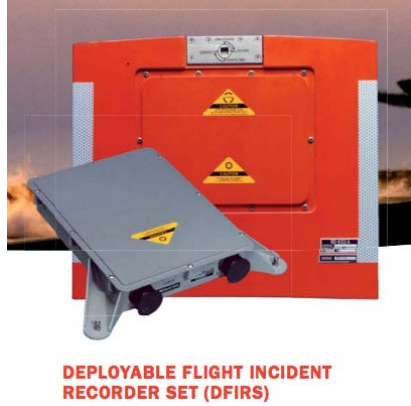
Figure 172. The DFIRS, Including a Deployable Incident Recorder and Bus Interface Unit
(Image courtesy of DRS Technologies)

As shown in figure 172, the orange DFIRS is full of foam, which allows it to remain afloat.

Airbus has announced that they will be installing deployable flight incident data recorder set (DFIRS) on A350 and A380 aircraft. The device is manufactured by DRS Technologies. According to Airbus, the DFIRS is mounted in such a way that its face is integrated to the aircraft skin, flush to the aircraft shape. The release is spring loaded through a crash-activated squib. Once released (as shown in figure 171), there is no ejection option, but rather a release of the DFIRS from its mounting position.

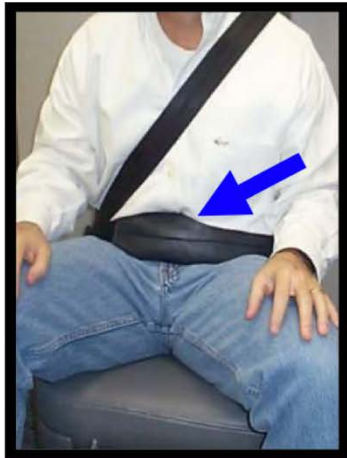
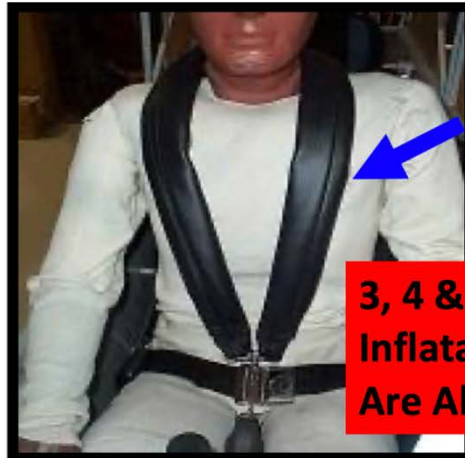
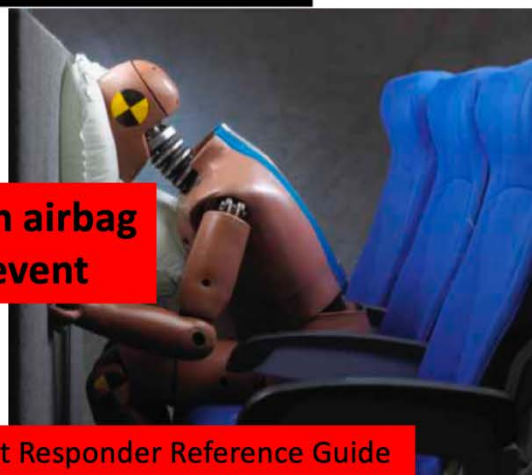
Figure 173. Seatbelt Airbags and Inflatable Restraints
(Photographs courtesy of AmSafe (2009))

Inflatable Lap Belt

**3, 4 & 5 Point
Inflatable Restraints
Are Also Available**

**Designed to deploy an airbag
In a significant crash event**

Most aircraft manufacturers offer the installation of seatbelt airbags as an option. The FAA has provided guidance for first responders who encounter airbags at aircraft incidents. This information can be found at http://www.faa.gov/aircraft/gen_av/first_responders/media/mod5/mod5.htm (FAA, n.d.). Airbag systems in aircraft guidance begins on Slide 26. Within this guidance, information is provided to describe aircraft airbag operation, configuration, hazards, and disengagement methods. On their website, seatbelt airbag manufacturer, AmSafe, Inc., indicates that they offer a variety of airbag seatbelt systems, including lap belt, and three-, four-, and five-point restraints (figure 173) (AmSafe, 2009). Aircraft customers can order any configuration for installation. Both Boeing and Airbus offer seatbelt airbags as an option to their customers, and firefighters should be familiar with the equipment and the hazards created.

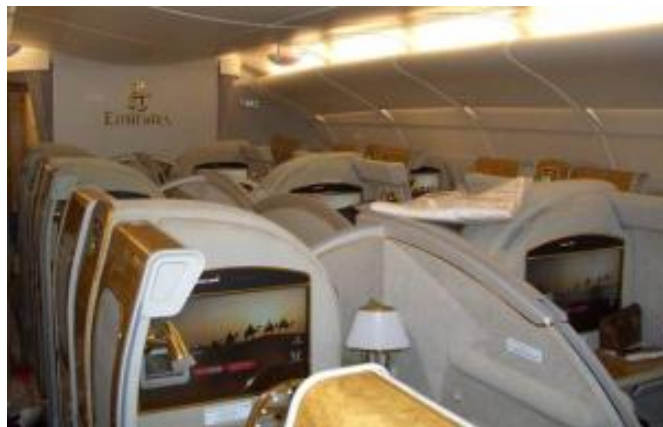
Figure 174. First-Class Suite: Emirates

First-class suites are quite intricate with a variety of detail features to improve comfort and privacy for the passenger. Figure 174 shows the Emirates first-class suite.

SQ, Lufthansa, and Emirates are among the operators currently using first-class suites with partitions that passengers can close for privacy. This same configuration is used in SQ B-777s employed on longer routes in business- and first-class cabins. By closing the partition and raising a divider that separates adjoining suites, the passenger enjoys what amounts to a personal suite, complete with widescreen television, cold drinks, vanity mirror, fold-out table, bed, and an assortment of comfort controls. On the aircraft visited for this research, Qantas, Korean Air, and Air France chose designs that are closer to the traditional style of first-class seats, as shown in figure 175. These seats convert to beds with many comfort controls and features, but the suites do not have closing partitions and, therefore, are more open. Search and rescue operations may be hampered by the need to reach into each seating pod to check for incapacitated victims. To that end, each partition is electronically controlled, rendering them inoperable if the aircraft power is disconnected. No information is available regarding whether the doors can be forced open with the power off. It is possible to look over the walls of the suite, and this requires the firefighter to stand

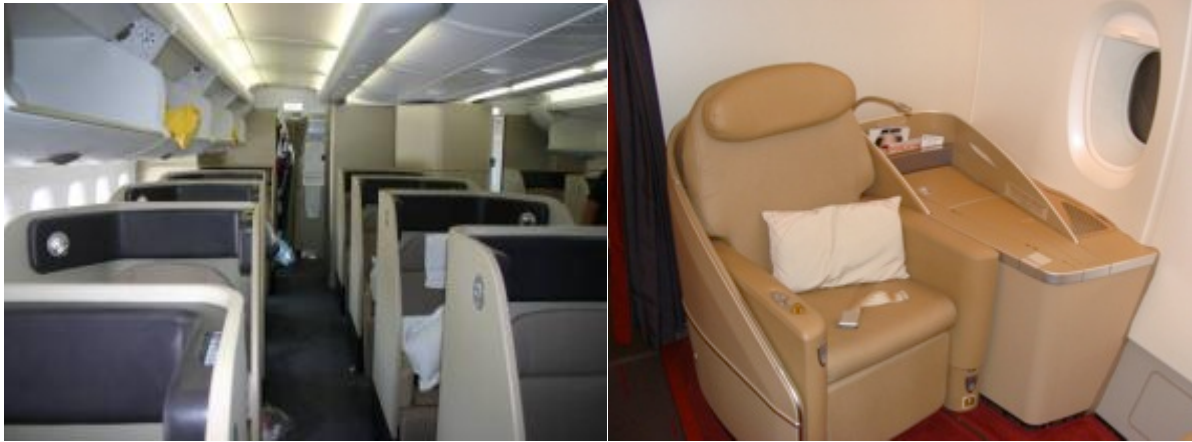
Figure 175. First-Class Cabins: Qantas (a) and Air France (b)

Cabin configurations may be unique to each aircraft. In some cases, carriers are using different configurations on like aircraft based on the route and seating class designs for each route. Airlines routinely change their configuration to match customer demand for a seating class on their routes. Figures 175 through 179 highlight the difference in first-class cabins, as well as show the amenities available that would pose considerable hindrance to ARFF crews.
