DOT/FAA/AM-08/4  
Office of Aerospace Medicine  
Washington, DC 20591

# **Field Evaluation of Whole Airliner Decontamination Technologies – Wide-Body Aircraft With Dual-Use Application for Railcars**

February 2008

Final Report

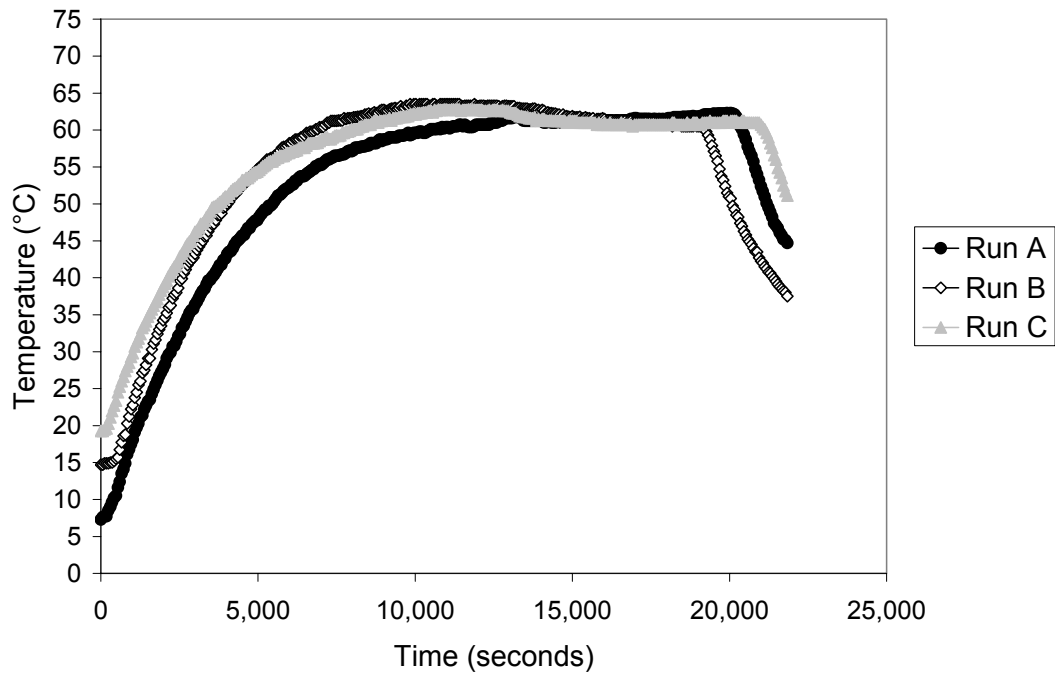
**Figure 1.** Profile from an armrest towards the rear of the cabin

It proved possible to heat the majority of the 747 cabin to close to 60°C and hold fairly near to this temperature for an extended period with the use of two thermal decontamination units (Figure 1). However, in some cases regions, it was not possible to hold at 60°C for 2 hours, as stipulated in the protocol (Figure 2). Surface temperatures in other locations (e.g. adjacent to the inlet) were found to exceed 65°C, with a maximum temperature of 71°C being observed where the incoming air stream impinged on the cabin (Figure 3). The two thermal decontamination units appeared to be well matched to the thermal mass of the 747, whereas a single unit had a rather larger heating capability than that required for a DC-9.

Cabin temperature on multiple cabin surfaces exceeded the desired 60°C. This was due to one of the two units having to be operated at 65°C and the second at 85°C, due to on-site power limitations. It must be noted that the present trials were conducted on a very tight schedule and budget. It is likely that given a longer lead time, more proving runs, and additional resources, the temperature control issues can be addressed.

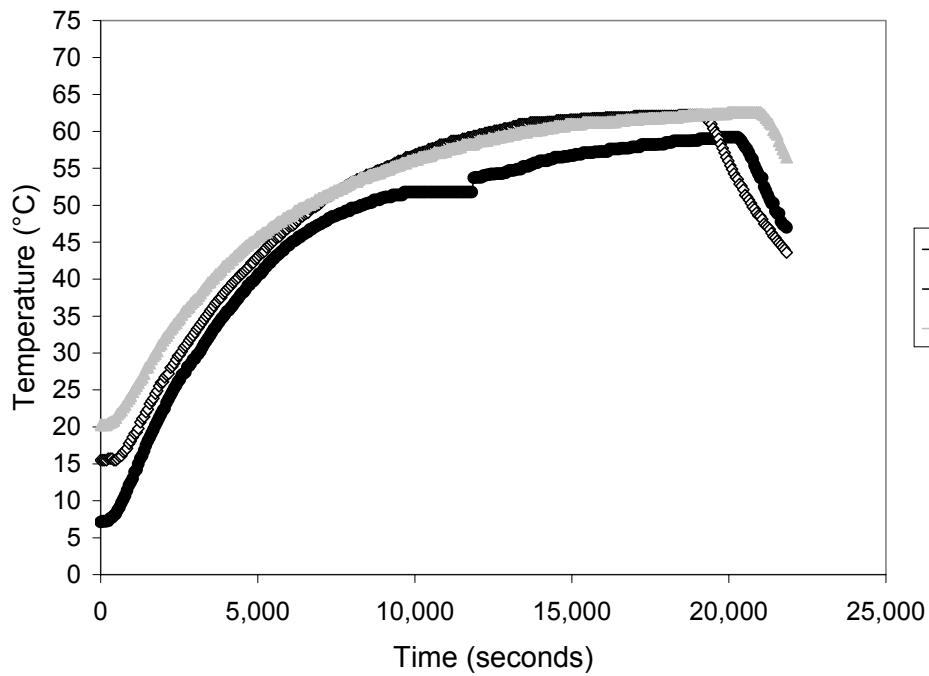
**Figure 2.** Profile from an armrest towards the front of the cabin

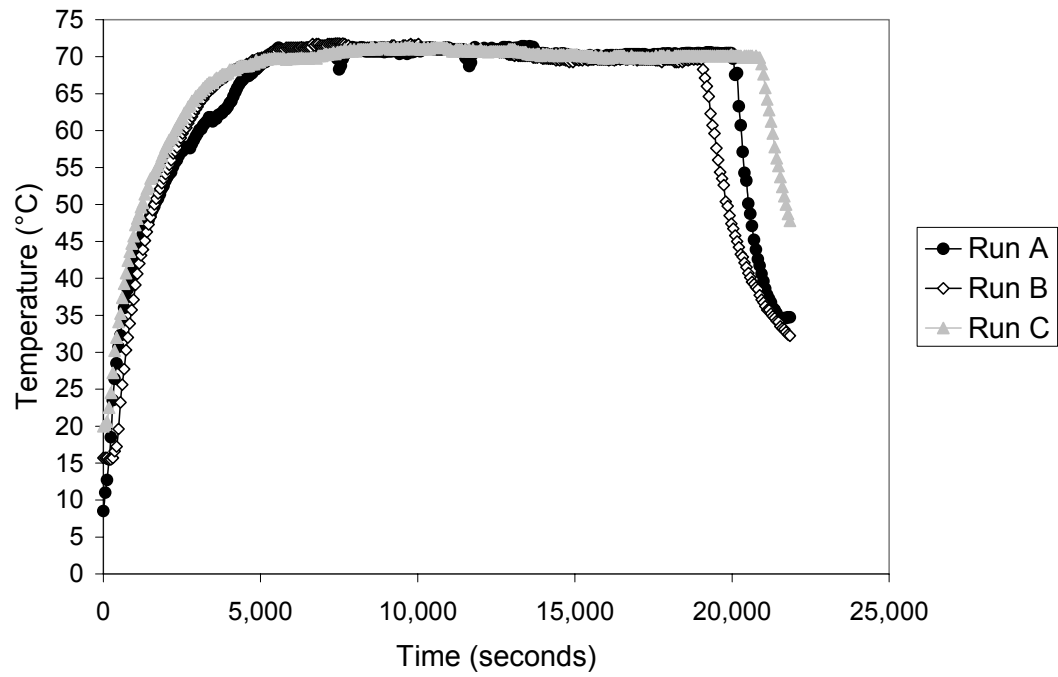
**Figure 3.** Profile from an overhead area adjacent to inlet

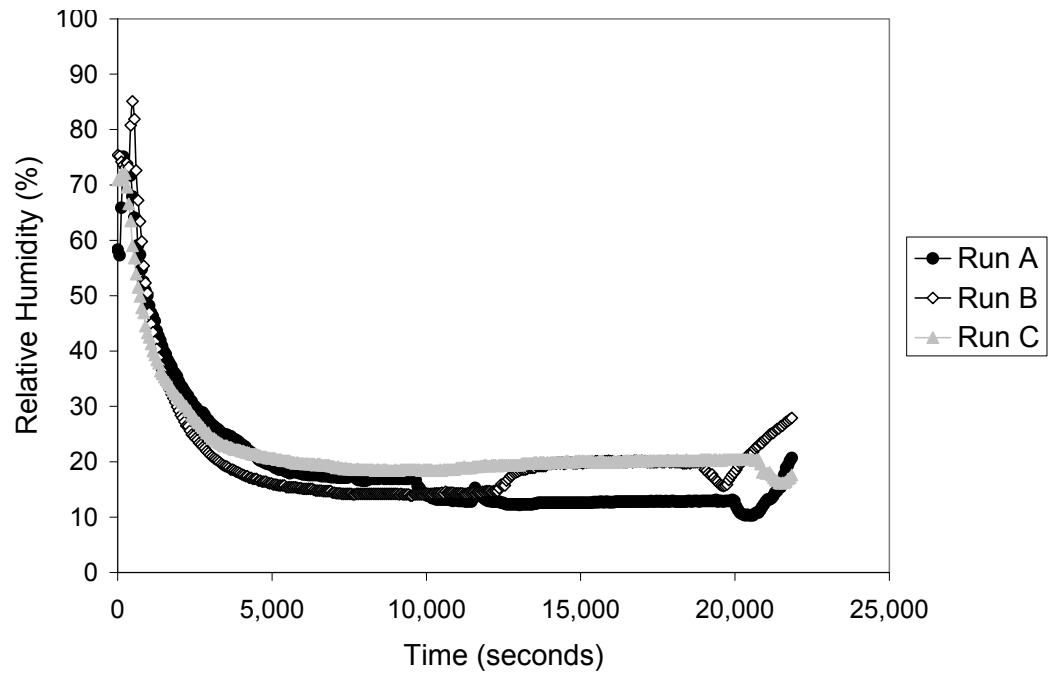
**Figure 4.** Relative humidity profile from the rear of the cabin

Using the 100 kW steam generator, it was not found possible to bring the cabin RH to above 20% (Figures 4 and 5).

Failure to reach a humidity of  $\geq 30\%$  RH for rapid antiviral efficacy (Rudnick et al., 2006) was disappointing. However, this does not appear to be a fundamental problem with the system but a matter of exceeding the capacity of the existing steam generator to humidify a wide-body aircraft. This is an issue that can be addressed easily in the future.

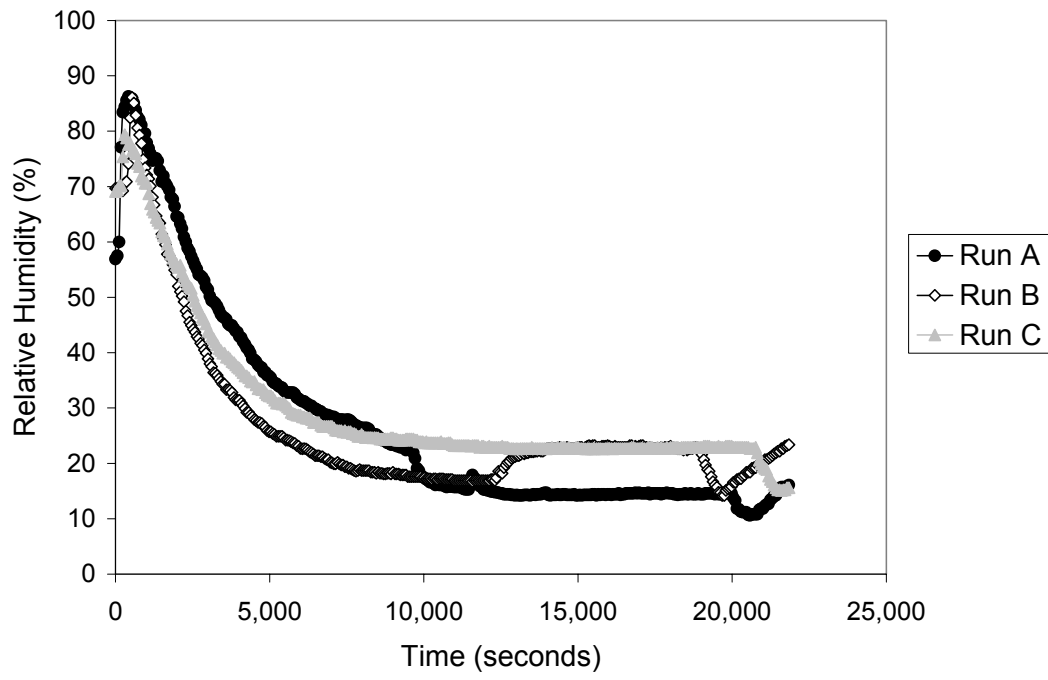
**Figure 5.** Relative humidity profile from the front of the cabin
