# Performance Benefits of Fiber-Reinforced Thin Concrete Pavement and Overlays

*A pooled fund project administered by the  
Minnesota Department of Transportation*

Report No. NRRA202106

## FINAL REPORT

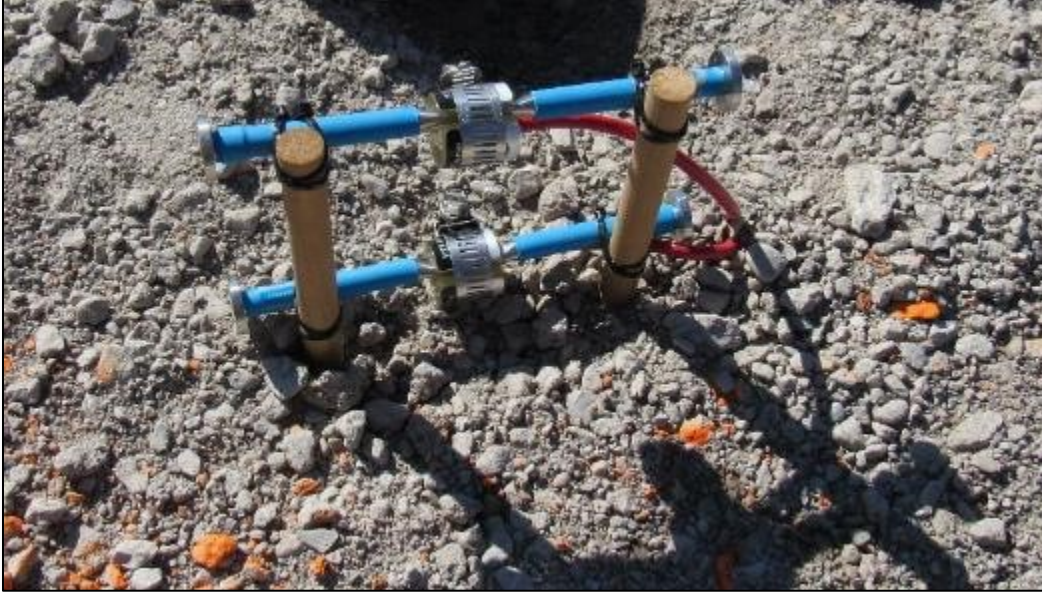
Figure 2-6. Photograph of a vibrating wire (VW) sensor.

Vibrating wire (VW) sensors were installed in all the cells to measure the strains caused by responses to environmental-based changes within the slabs. A photograph of a vibrating sensor is shown in Figure 2-6. The raw data from this type of sensor is converted to estimate the environmental strain exerted on the concrete due to the change in the moisture state, temperature and temperature gradient, freezing of underlying layers, and joint locking. Data was collected from VW sensors every 15 minutes.

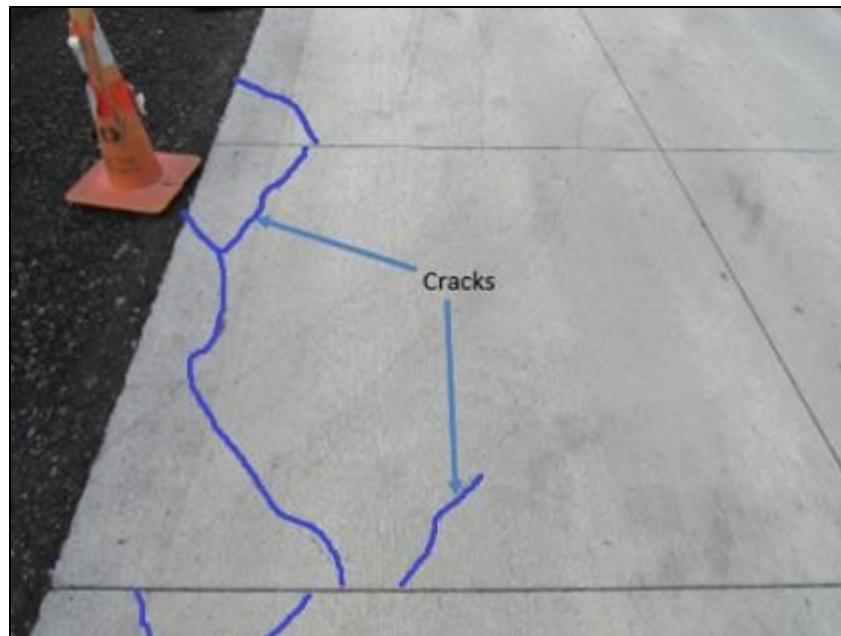
Figure 3-1. Cell 139 after exposure to construction trucks.

**Cell 139** was inadvertently exposed to early loads from construction trucks that were using the crossover segment to access other cells under construction, resulting in many early-age cracks. Placement of shoulder materials with heavy equipment may have also caused some of these early cracks to form. Figure 3-1 shows a picture of a couple of such early-age cracks in this cell. These cracks continued to develop and propagated with age and MnROAD truck loadings, which eventually led to the shattering of many slabs by the end of the summer of 2018, as shown in Figure 3-2. Besides that, there was a considerable amount of depression along the outer wheel path at some locations; this distress looked like rutting that occurs in asphalt pavements. Because of this cell's significantly different distress pattern compared to other cells (slab shattering vs fatigue cracking), Cell 139's crack data was not included in studying fibers' influence on the development of fatigue cracks. The distress survey sheet for this Cell is provided in the Appendix.

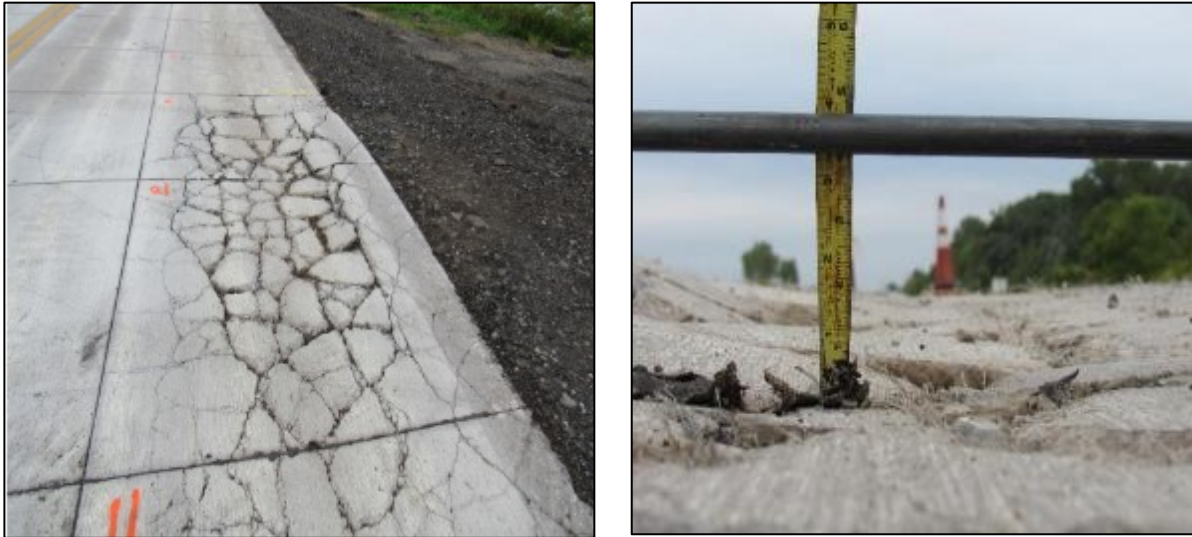
**Figure 3-2: Shattered slabs and depression along the wheel path in Cell 139 after MnROAD truck loadings.**

Due to the occurrence of the high severity distresses (slab shattering and depression along the wheel path), 14 of the 44 slabs in the inside lane of Cell 139 were replaced on September 27, 2018. The replacement slabs were 4 inches thick, with eight of them containing fiber reinforced concrete and the other six with plain concrete. The fibers used in the replacement slabs were different and laterally stiffer than those used in 2017, as shown in Figure 3-3. The dosage of the fiber was 5.5 lbs./cy, which corresponds to a 30% residual strength ratio. The replacement slabs have performed well, with only one crack noticed in the spring 2020 distress survey.

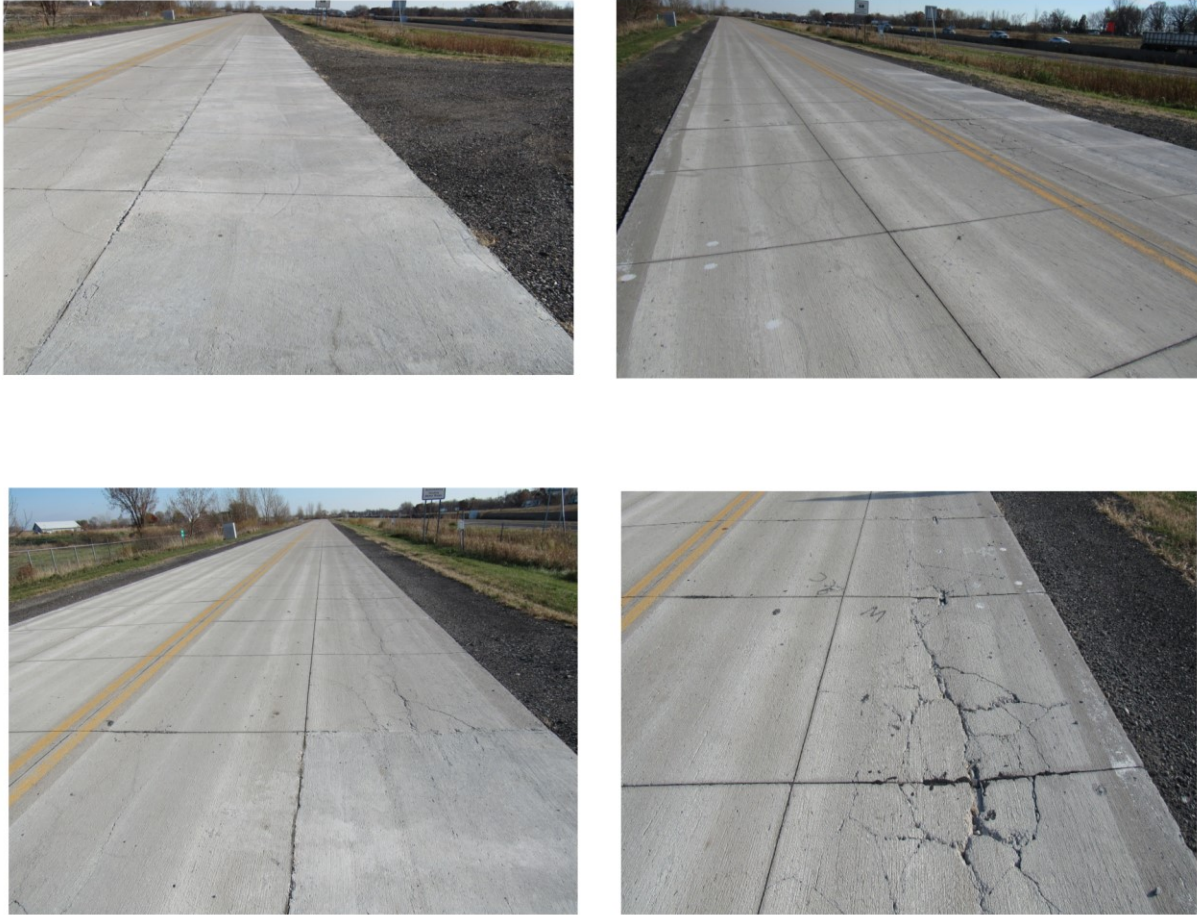
**Figure 3-4. A few photographs of Cell 139 during October 2019.**

On the other hand, unrepaired (original) slabs continued to develop distress with traffic load and age, with primary longitudinal and secondary transverse and diagonal cracks. Based on the December 2019 distress survey data, it was found that as much as 75% of the slabs had cracked in Cell 139 after 114,000 ESALs were applied to them. Figure 3-4 shows four photographs of Cell 139 taken in October 2019. The unrepaired slabs eventually failed and became undrivable in the middle of the third year of service (2020).

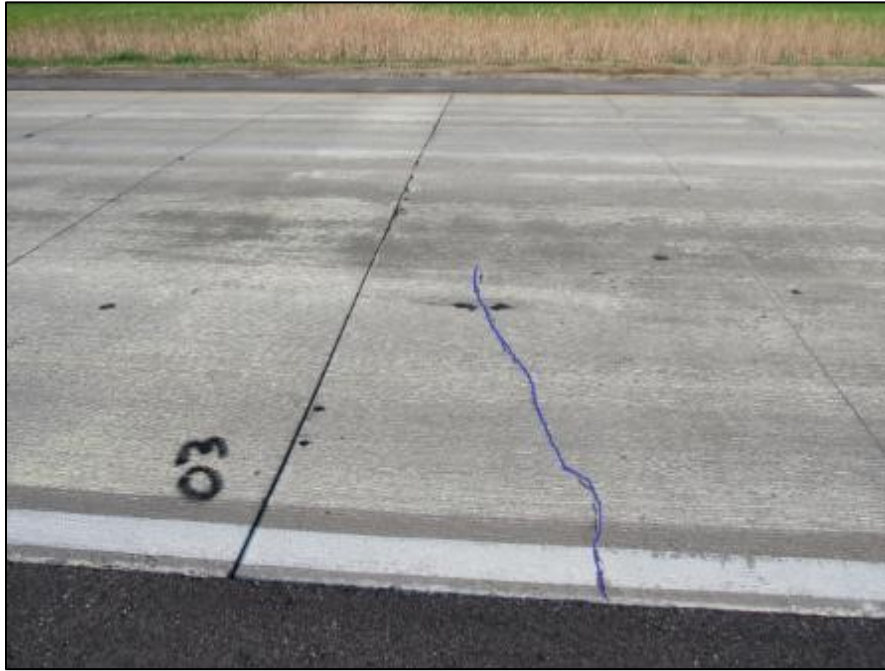
**Figure 3-8. Transverse crack in Cell 506 (control, non-FRC) observed in the year 2018.**

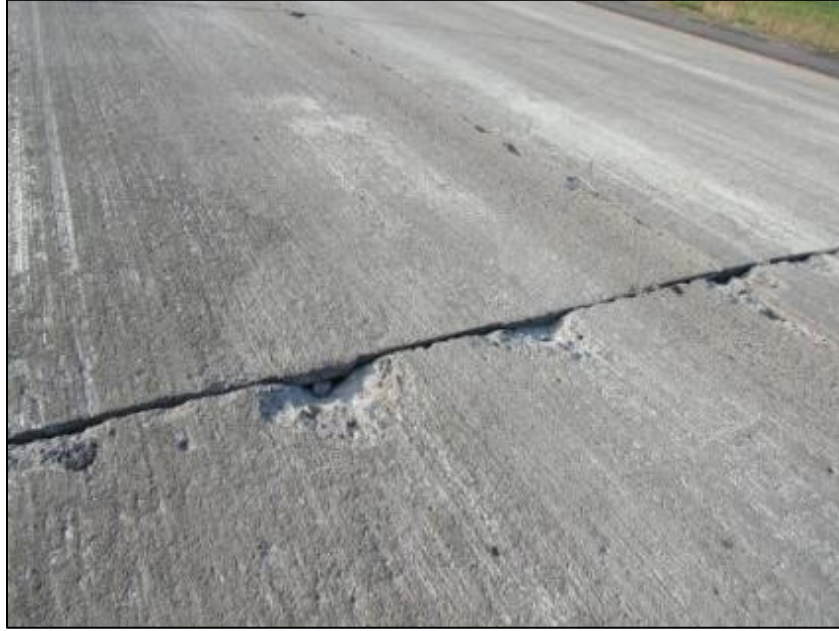
Figure 3-9. Spalling in Cell 506 (control, non-FRC) observed in the year 2018.

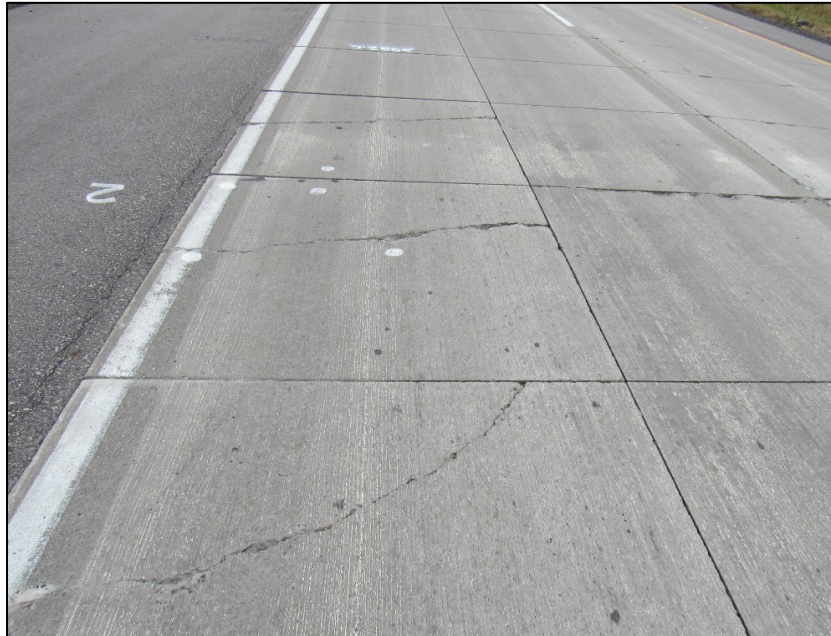
Figure 3-10. Photographs of transverse and diagonal cracks in Cell 506 (October 2019).

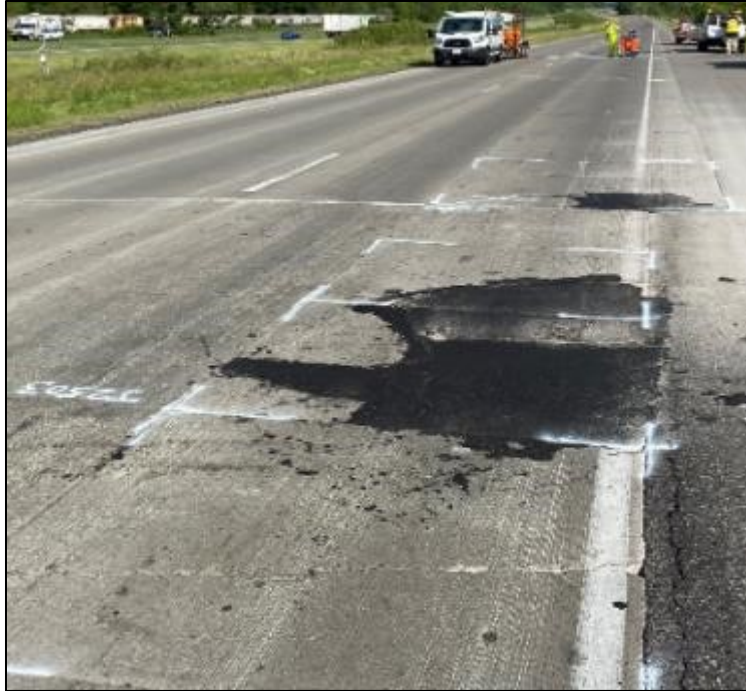
Figure 3-11. Cell 506 before replacement on June 2020.

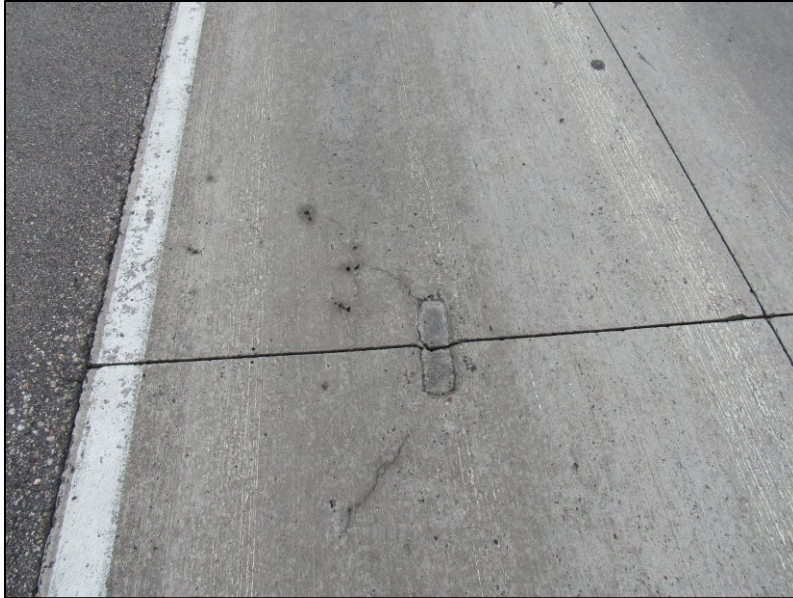
**Figure 3-15. Narrow cracks in Cell 806, originated at the location of the joint opening sensor.**

Cells 706 and 806, which were constructed with fiber dosages of 8 and 11.7 lbs./cy, respectively, did not experience any cracks or spalling before October 2019 except for a couple of narrow cracks in Cell 806 originating at the location of a joint opening sensor (Figure 3-15). The March 2020 distress survey did not report any additional cracks for these two cells.

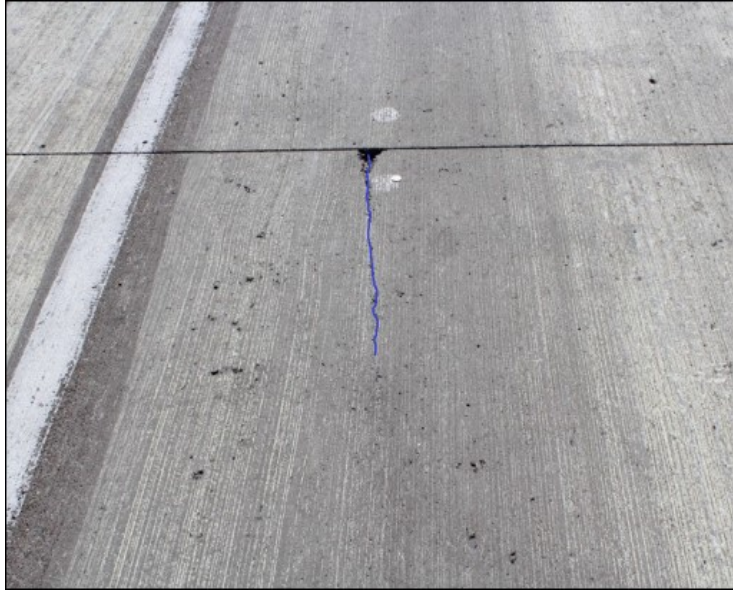
Figure 3-17. Longitudinal crack in Cell 705 (2018).

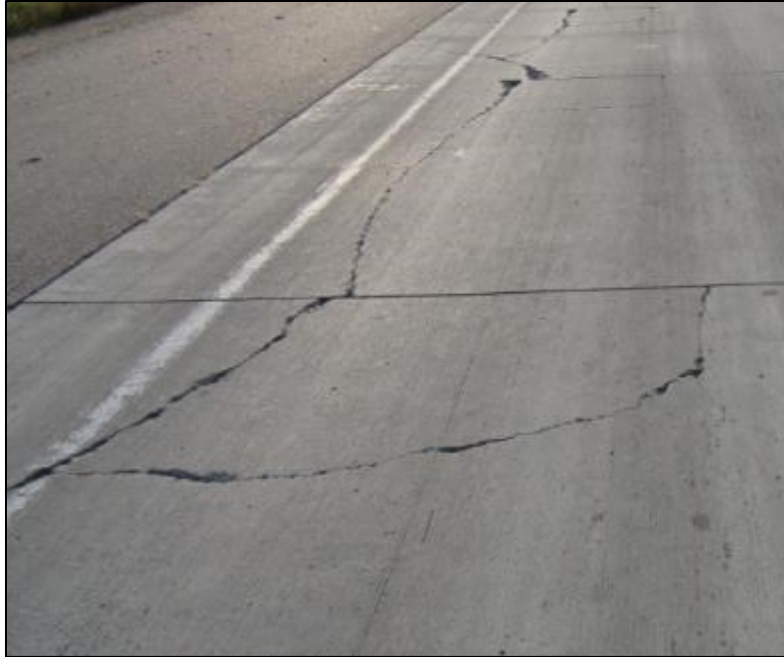
**Figure 3-21. Photograph of Cell 705 before replacement on September 2020.**

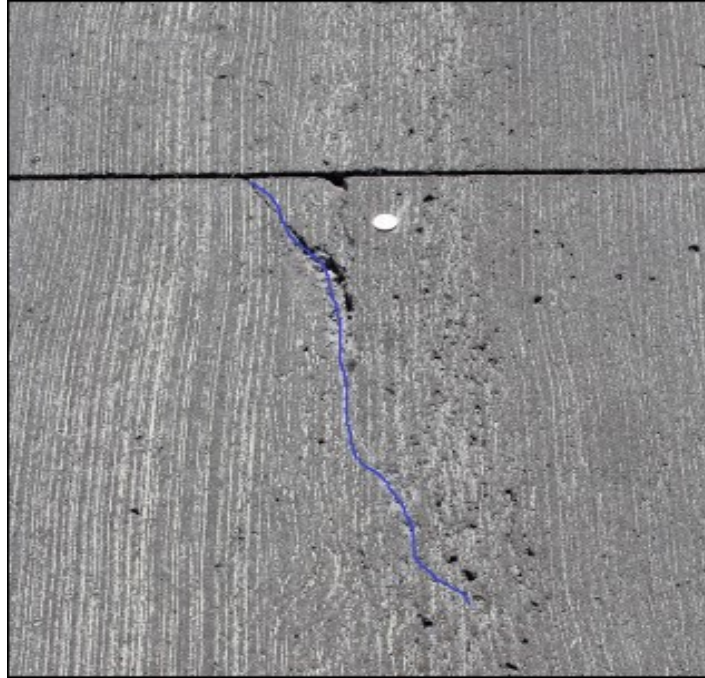
**Figure 3-22. Longitudinal crack in Cell 805 (2018)**

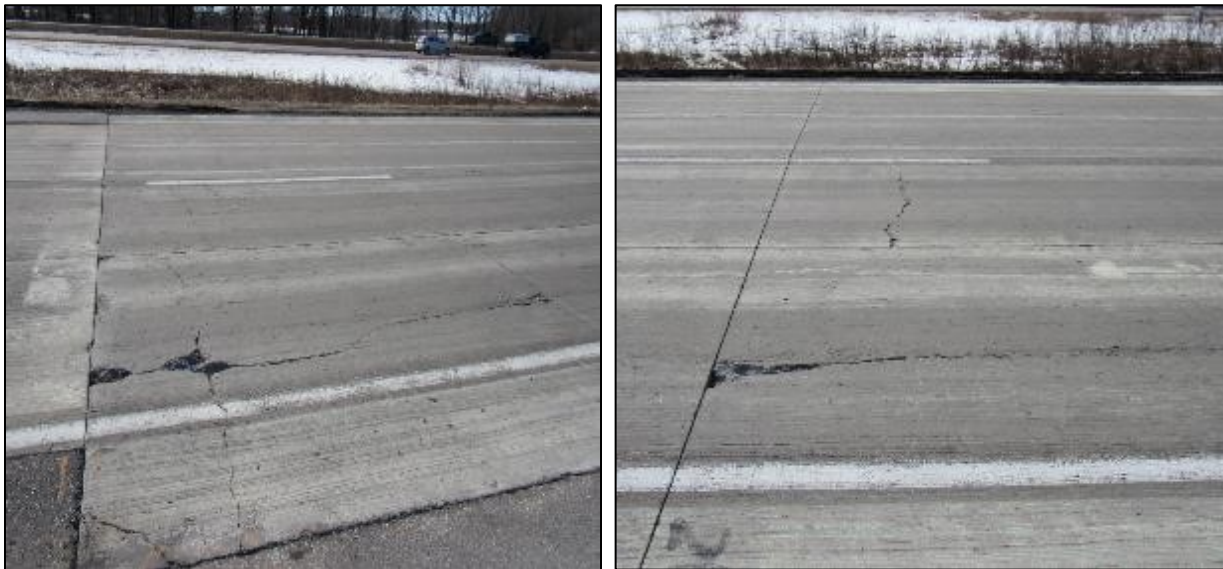
Figure 3-25. Photographs of observed cracks in Cell 805 during April 2019.

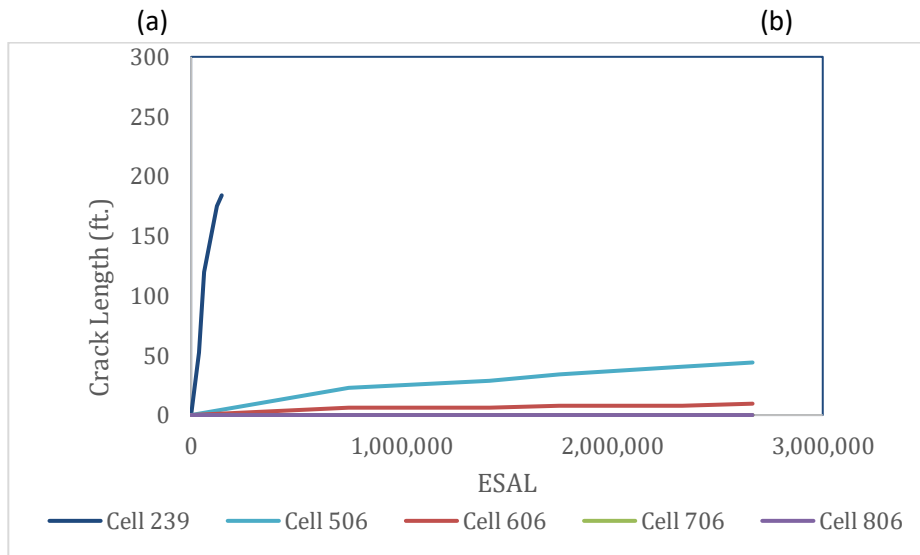
Figure 3-31: Crack length vs. ESAL for both lanes (a) 239; (b) 506,606,706, and 806; (c) 239, 506, 606, 706, and 806

While the number of cracks and the percentage of cracked slabs are good indicators to picture the overall cracking scenario, they do not however distinguish between the small, medium, or long cracks. Therefore, documenting the crack length may be a better approach (than percent cracked slabs) to quantify the crack progression and understand the rate of deterioration of the cracks. The crack length vs ESAL relationship can trace the crack propagation history. Figure 3-31 and Figure 3-32 compare the crack length between the cells for both lanes and the driving lane (only), respectively. The total crack length for ultra-thin Cell 239 was 184 feet compared to 44 feet for Cell 506 after three years of service. Only around 150,000 ESALs were enough to create a total of 184 feet in Cell 239, while the same level of ESALs only created around 10 feet cracks in the thin cells (only in Cell 506, which did not have any fiber).

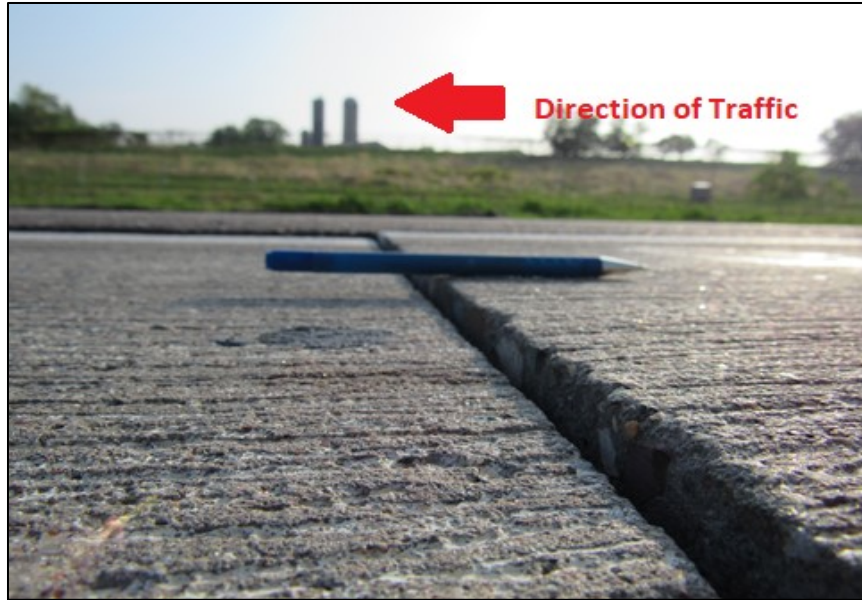
Figure 4-3. Photograph of faulting of Cell 506 (non-FRC). Note that the faulting shown in this photograph is exaggerated due to the broken corner in the slab on the leave slab.

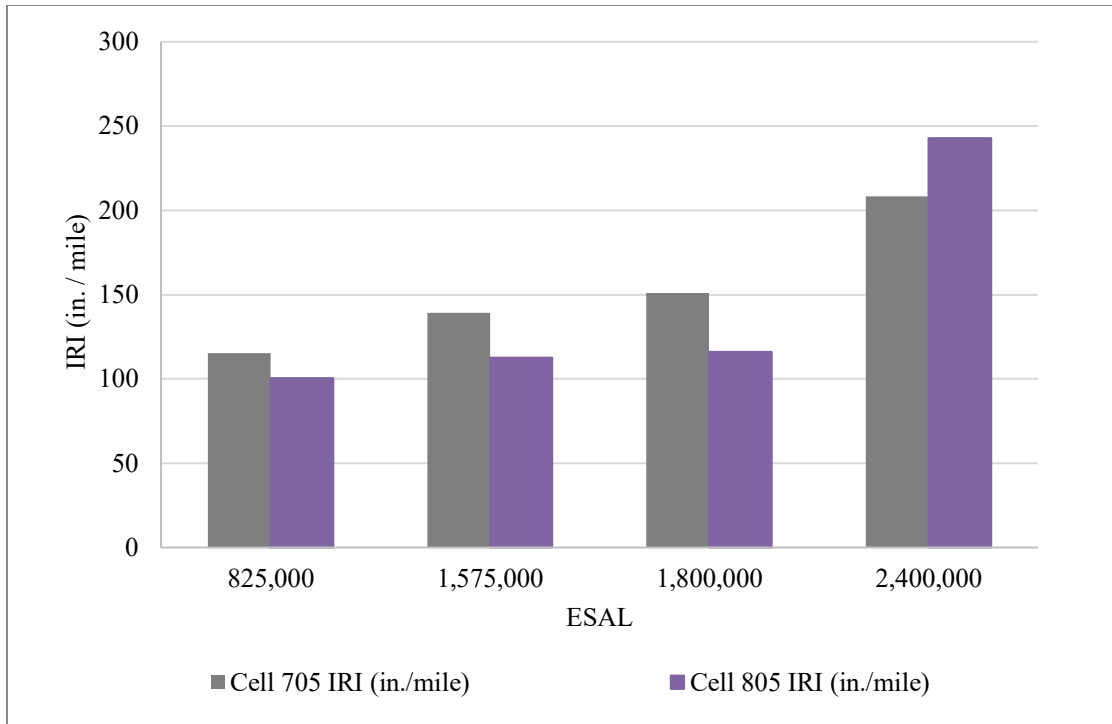
Figure 4-16: Variation of International Roughness Index (IRI) with respect to ESALs for Cells 705 and 805.

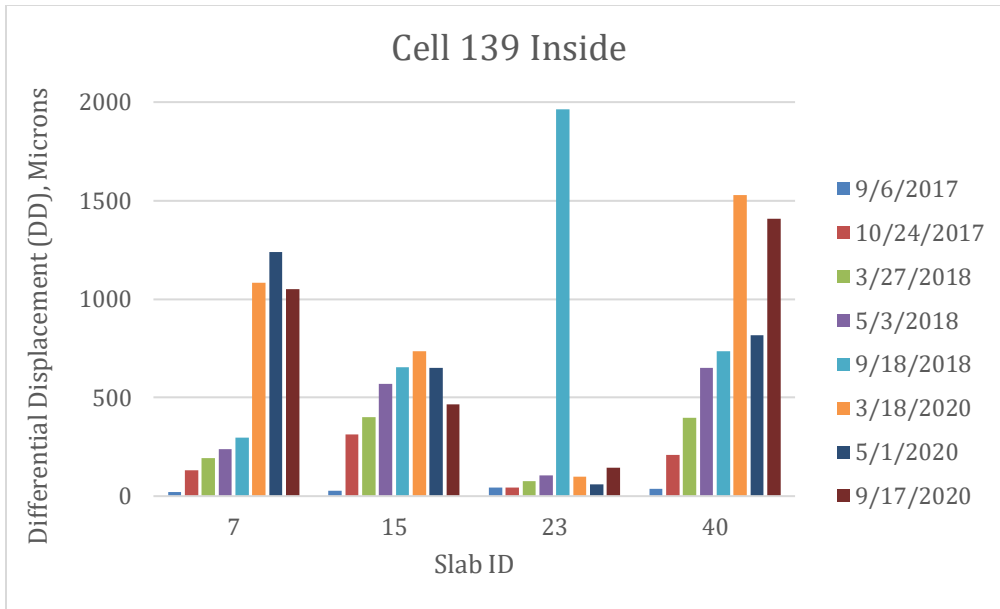
Figure 5-59. Differential displacement of Cell 139 inner lane.
