PERFORMANCE OF CONCRETE SEGMENTAL AND CABLE-STAYED BRIDGES IN EUROPE

1. Report No. FHWA-PL-01-019		2. Government Accession No.		3. Recipient's Catalog No.	
4. Title and Subtitle Performance of Concrete Segmental and Cable-Stayed Bridges in Europe				5. Report Date May 2001

14. Sponsoring Agency Code	
15. Supplementary Notes FHWA COTR: Donald W. Symmes, Office of International Programs					
16. Abstract <p>The main objective of the scanning activity was to evaluate the European inventory of prestressed concrete segmental and cable-stayed bridges. On average, European structures are a decade or two older than similar ones in the United States. Members of the scan team examined durability; identified possible future needs for maintenance, repair and retrofit, and replacement; and compared trends and current practice.</p> <p>The team visited four countries: Switzerland, Germany, Denmark, and France. Representatives from Norway and the United Kingdom also met with the team.</p> <p>In general, segmental and cable-stay technology and developments in Europe and the United States are moving in parallel directions. Early performance problems from the 1960s and 1970s have been eliminated th

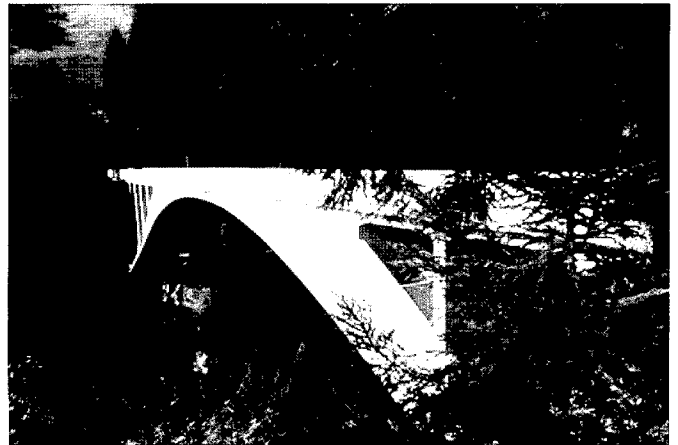
Figure 1. The Salginatobel Arch Bridge, with its reinforced concrete arch, was built in 1929 in Switzerland by Robert Maillart.

One of the very first reinforced concrete bridges with a fairly large span is the spectacular Salginatobel Bridge, an arch bridge that was conceived and built by Robert Maillart in 1929 in the mountains of Switzerland.² It has a span of 90 m (295 ft) and rise of 13 m (42 ft 8 in) and carries a local, single-lane road high above a precipitous gorge (figures 1, 2, and 3). In 1991, it was recognized as an International Historic Civil Engineering Landmark by the American Society of Civil Engineers (ASCE). Subsequent to a recent period of renovation and rehabilitation, the scan team was able to visit and examine this bridge closely. It is a classic example of

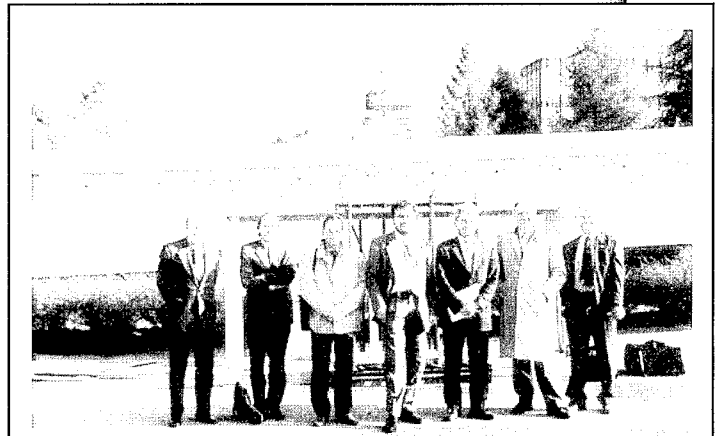
Figure 4. I-Girder from demolished bridge under test at ETH, Switzerland. Hosts [left to right]: Peter Matt, Aurelio Muttoni, Franco Lurati, Thomas Vogel, and Peter Marti.

Measures have been introduced to prevent or mitigate corrosion damage in new construction, including careful application of waterproof membranes and overlays, with attention to water flow and sealing of possible avenues for chloride penetration. In addition, grouting is now very carefully controlled with vents, at all high points, and additives to reduce bleed and the consequent formation of voids. Re-grouting is used, where appropriate and necessary, if and when voids are suspected. The grout itself is a simple mixture of water and cement with a bleed-reducing additive. Currently, routine inspection and extensive use of electrical potential mapping are used to check for any such damage to existing structures. Testing of I-girders removed from structures confirms the structural adequacy of post-tensioned technology (figure 4).

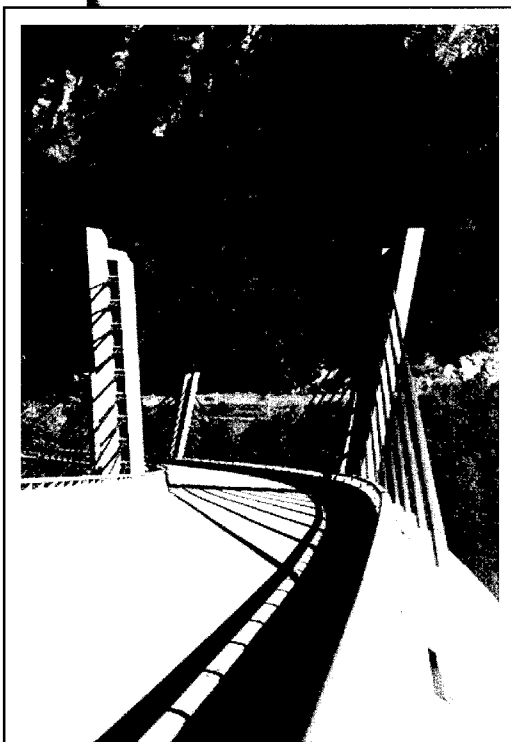
Figure 6. On the Sunniberg Bridge, short pylons rise away from the deck to accommodate the curve of the highway.

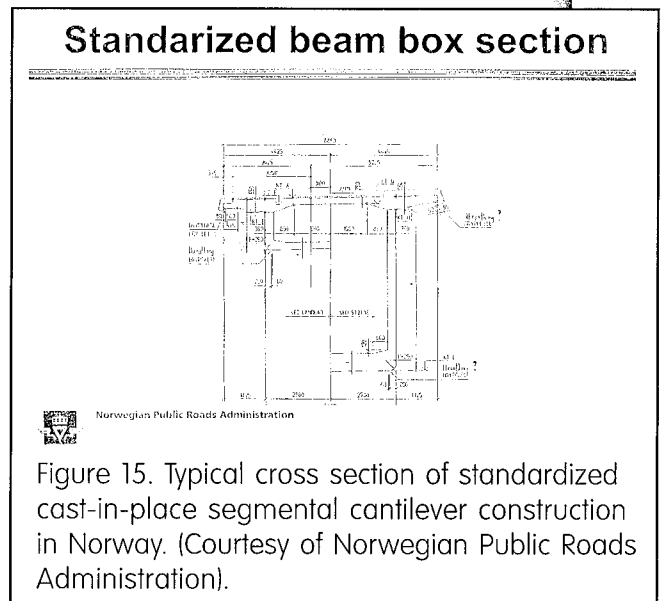
Figure 15. Typical cross section of standardized cast-in-place segmental cantilever construction in Norway. (Courtesy of Norwegian Public Roads Administration).

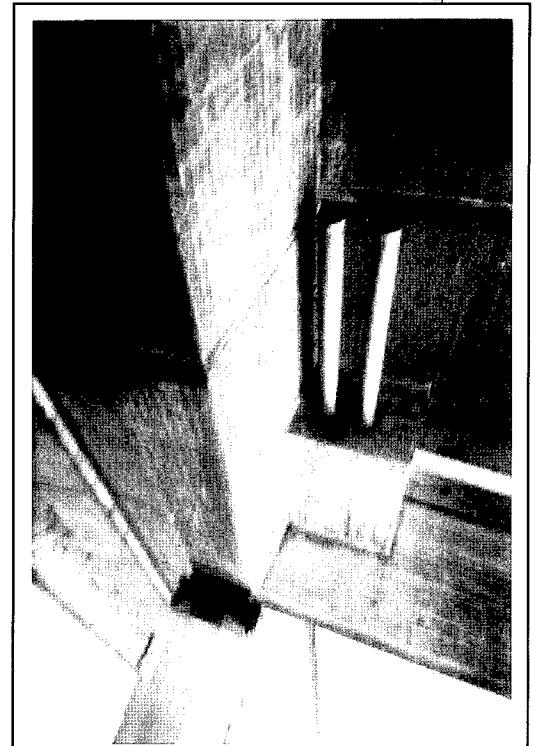
Figure 24. Anchor block for external tendon retrofit to continuous, post-tensioned concrete viaduct (L124 extension of A59), near Cologne, originally built with tendon coupling joints at the quarter points.

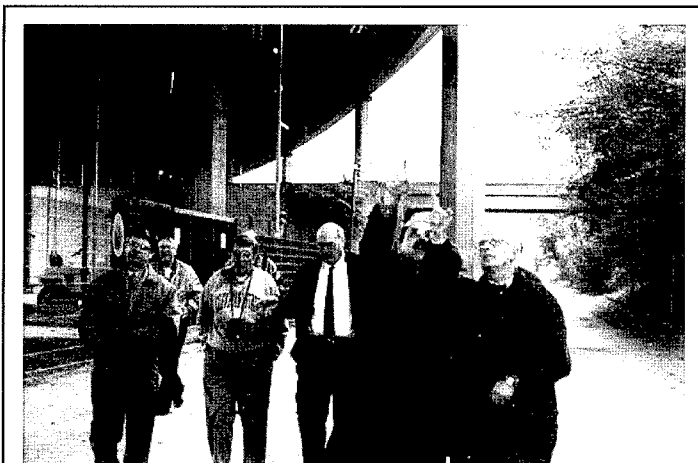
Figure 25. German hosts and members of the scan team examine the external tendon retrofit to the L124 viaduct near Cologne.

The rehabilitation and retrofit of structures with coupling joints spurred the development and installation of external tendons. Experience led to a preference for concentric, straight, unbonded tendons, to provide an extra stress of 1 to 1.5 N/mm² (140 to 220 lbf/in²) (figures 24, 25, and 26). Typically, the extra prestress force can be kept to less than 3 MN (675 kips) per tendon, which can be achieved using up to twenty 15-mm (0.6-in) strands in up to five rows of four strands per tendon. Most external retrofit tendons are sheathed mono-strands in ungrouped, larger ducts. Details allow for de-stressing and re-stressing of these tendons, if necessary.

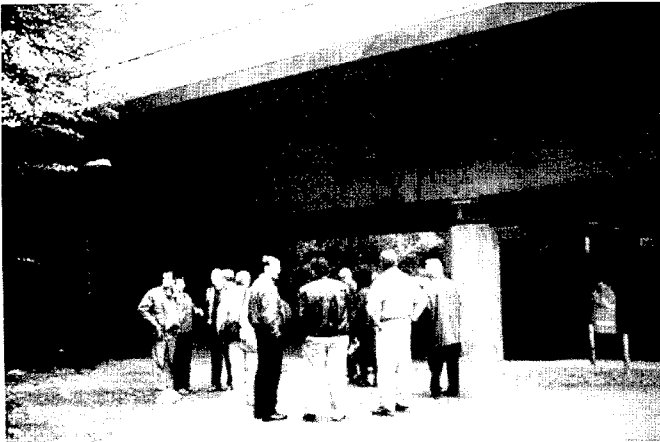
Figure 26. Scan team examines anchor blocks for external tendon retrofit of L124 viaduct.
