*Iowa Department of Transportation  
Research Project Number TPF-5(193) Supplement #101*

# **DEVELOPMENT OF IOWA DOT COMBINATION BRIDGE SEPARATION BARRIER WITH BICYCLE RAILING – PHASE II**

MwRSF Research Report No. TRP-03-408-20

July 17, 2020

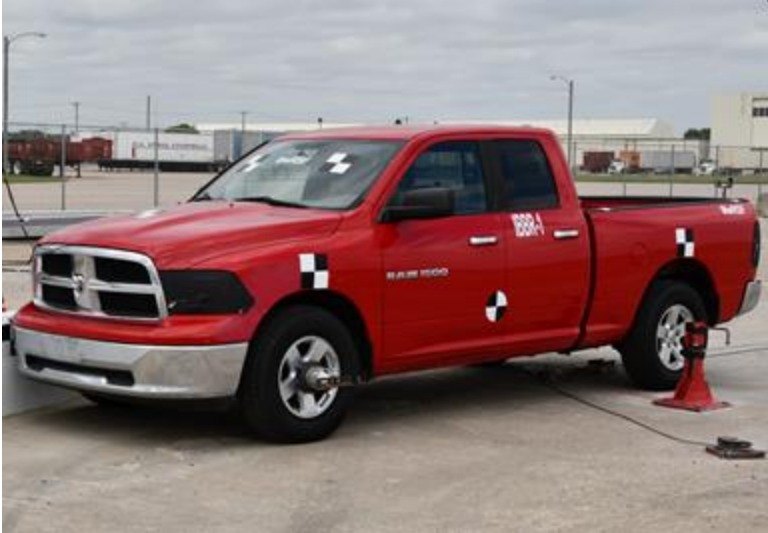
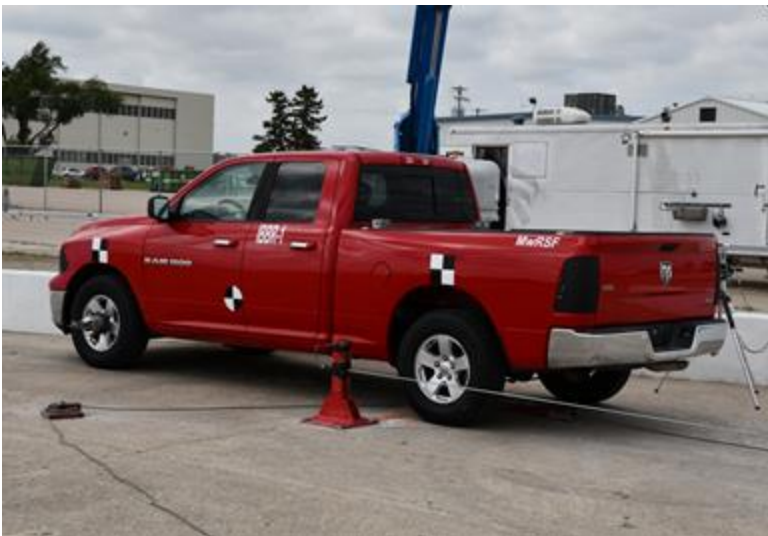
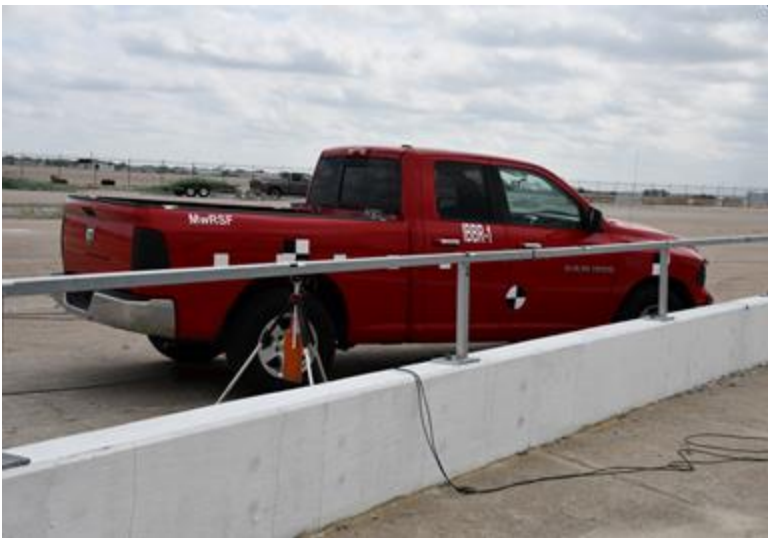
Figure 20. Test Vehicle, Test No. IBBR-1

For test no. IBBR-1, a 2011 Dodge Ram 1500 Quad Cab pickup truck was used as the test vehicle. The curb, test inertial, and gross static vehicle weights were 4,986 lb (2,262 kg), 4,980 lb (2,259 kg), and 5,138 lb (2,331 kg), respectively. The test vehicle is shown in Figures 20 and 21, and vehicle dimensions are shown in Figure 22. It should be noted that the front overhang distance is  $\frac{1}{2}$  in. over the recommended MASH dimension, but it was not believed that this would affect the crash test results.

23. Round, checkered targets were placed at the c.g. on the left-side door, the right-side door, and the roof of the vehicle.

The front wheels of the test vehicle were aligned to vehicle standards except the toe-in value was adjusted to zero such that the vehicles would track properly along the guide cable. A 5B flash bulb was mounted under the vehicle's right-side windshield wiper and was fired by a pressure tape switch mounted at the impact corner of the bumper. The flash bulb was fired upon initial impact with the test article to create a visual indicator of the precise time of impact on the high-speed digital videos. A remote-controlled brake system was installed in the test vehicle so the vehicle could be brought safely to a stop after the test.

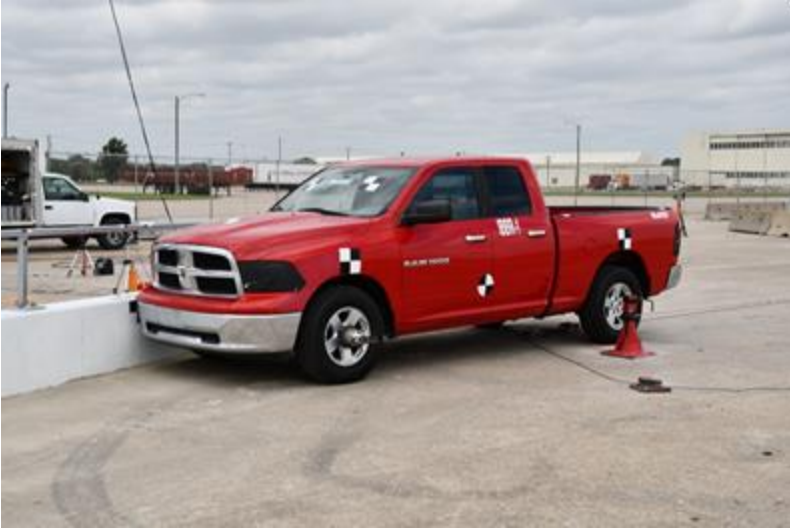
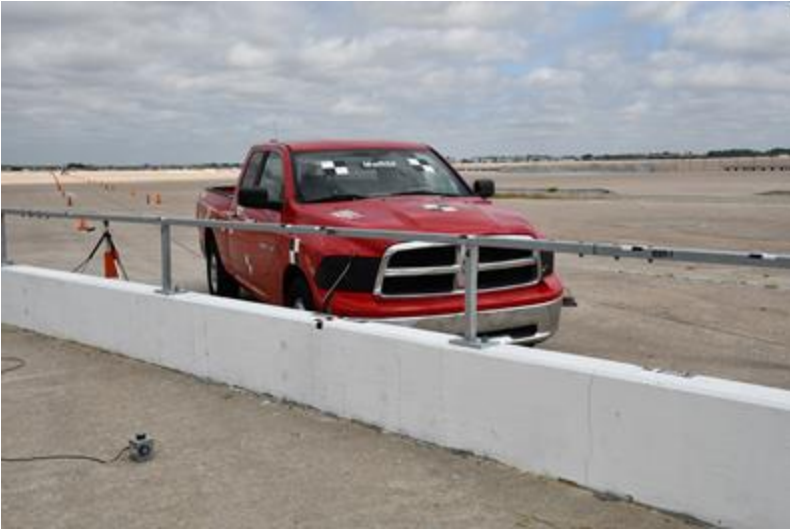
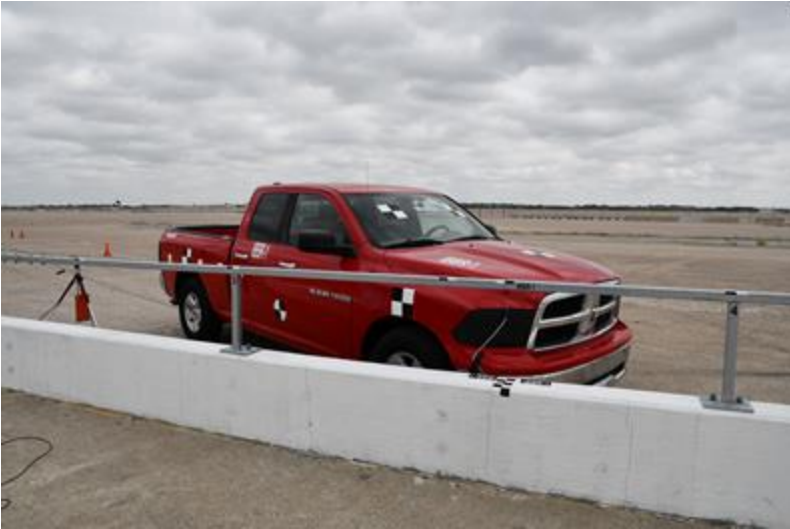
Figure 25. Impact Location, Test No. IBBR-1

Initial vehicle impact was to occur 46<sup>5</sup>/<sub>8</sub> in. (1,184 mm) upstream from post no. 4, as shown in Figure 25. The 4,980-lb (2,259-kg) quad cab pickup truck impacted the barrier at a speed of 45.3 mph (72.8 km/h) and at an angle of 25.6 degrees. The actual point of impact was 49<sup>3</sup>/<sub>8</sub> in. (1,254 mm) upstream from post no. 4. In the test, the vehicle was captured and redirected by the 24-in. (610-mm) tall parapet and bicycle railing. During the redirection of the vehicle, the right-front fender and right corner of the vehicle hood snagged on the vertical support post downstream of impact. The snag was sufficient to peel back and disengage the entire right-front fender and deform and tear the hood of the vehicle. However, the snag of the vehicle components did not pose a risk to the vehicle occupant compartment nor did it pose a hazard due to the velocity change or deceleration of the vehicle. Vehicle redirection was primarily facilitated by the parapet, and the only contact, outside of post snag, between the 2270P vehicle and the bicycle railing occurred when the vehicle's hood and the right-rear corner of the truck box made minor contact with the upper tube rail during tail slap. The vehicle came to rest 39 ft – 11 in. (12.2 m) downstream and 8 ft – 7 in. (2.6 m) laterally behind the barrier after brakes were applied.

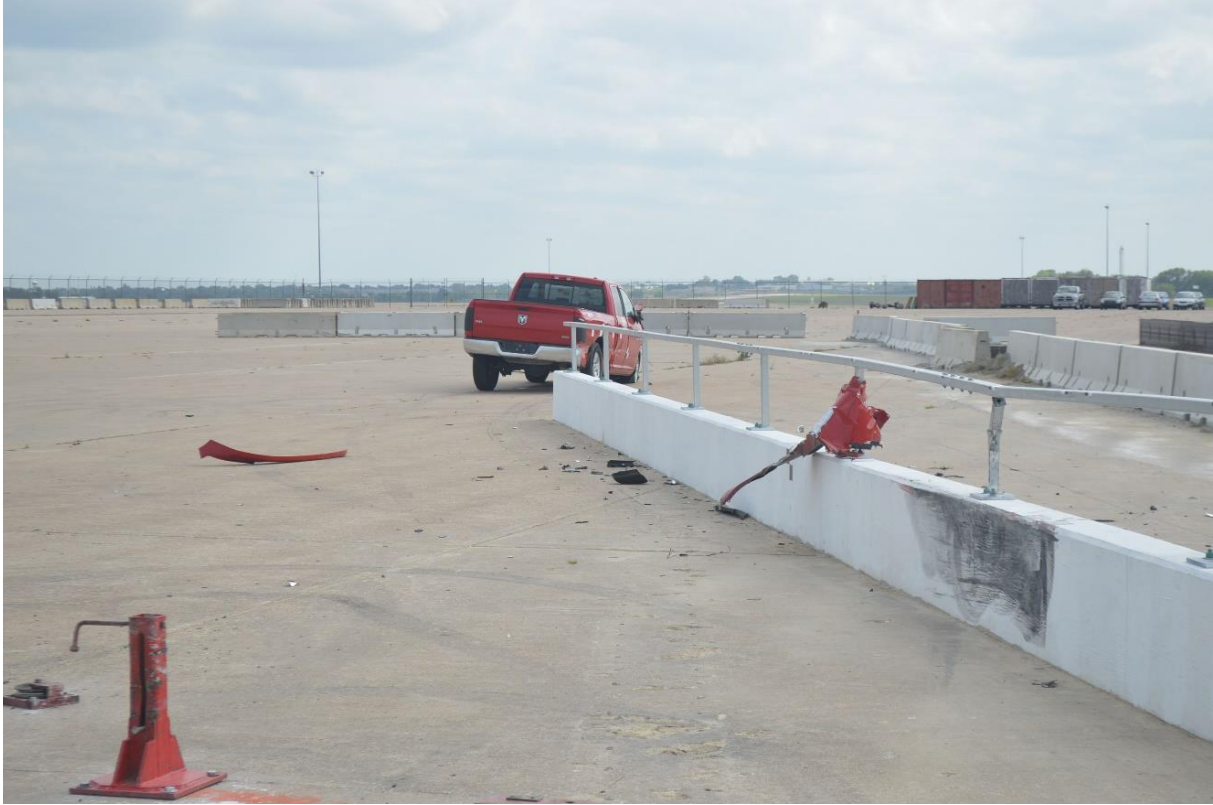
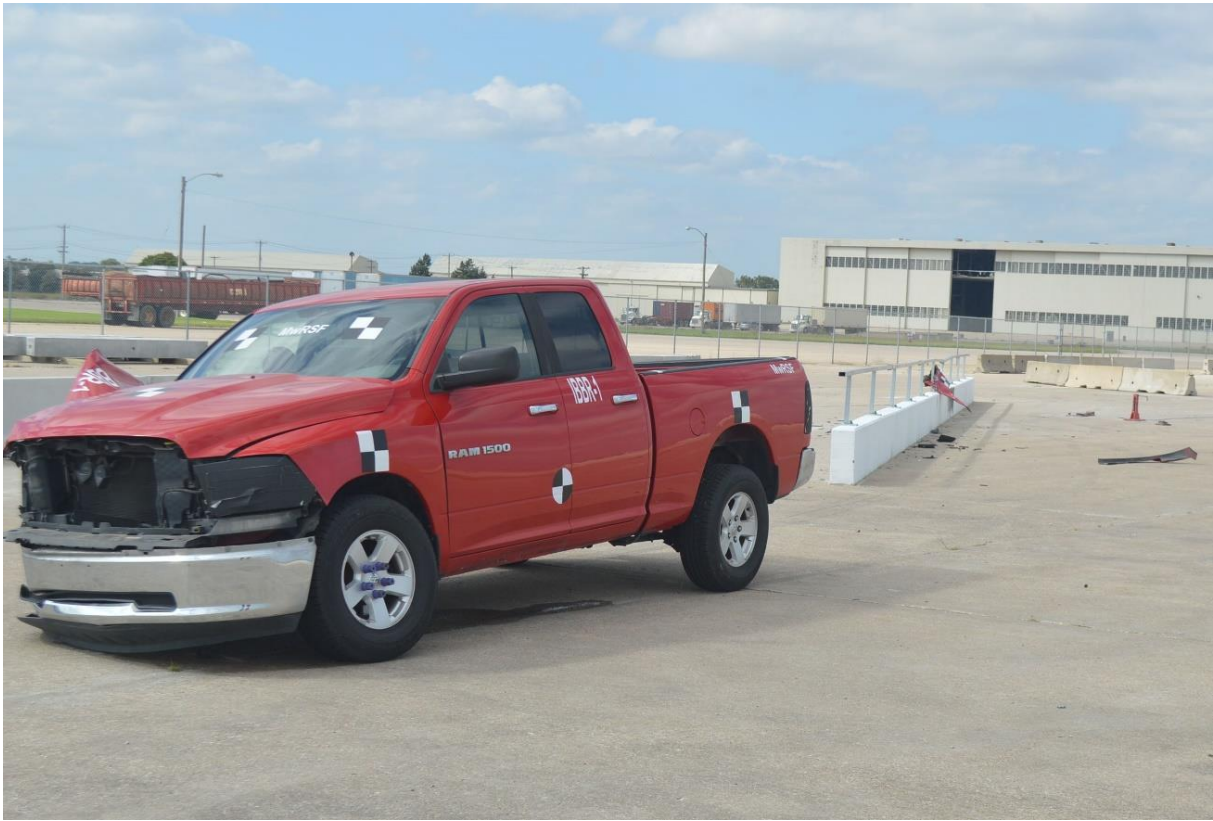
Figure 30. Vehicle Final Position and Trajectory Marks, Test No. IBBR-1

A detailed description of the sequential impact events is contained in Table 4. Sequential photographs are shown in Figures 26 through 28. Documentary photographs of the crash test are shown in Figure 29. The vehicle trajectory and final position are shown in Figure 30.

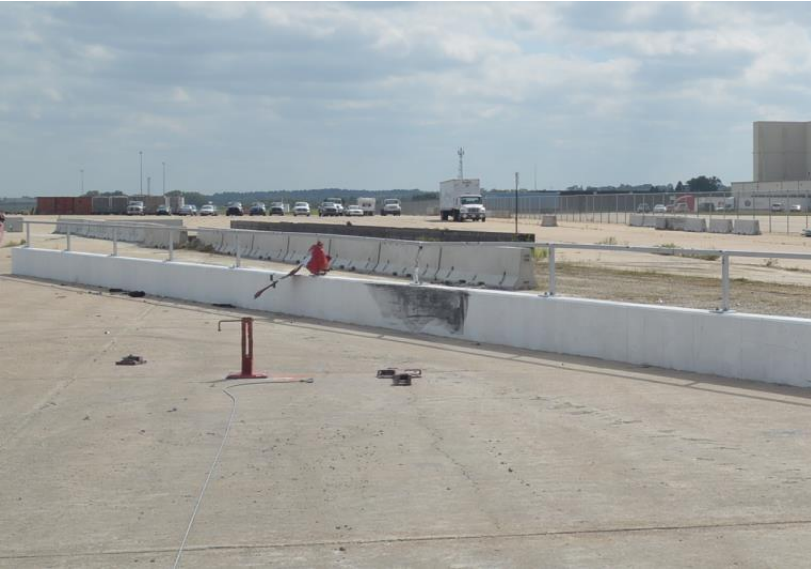
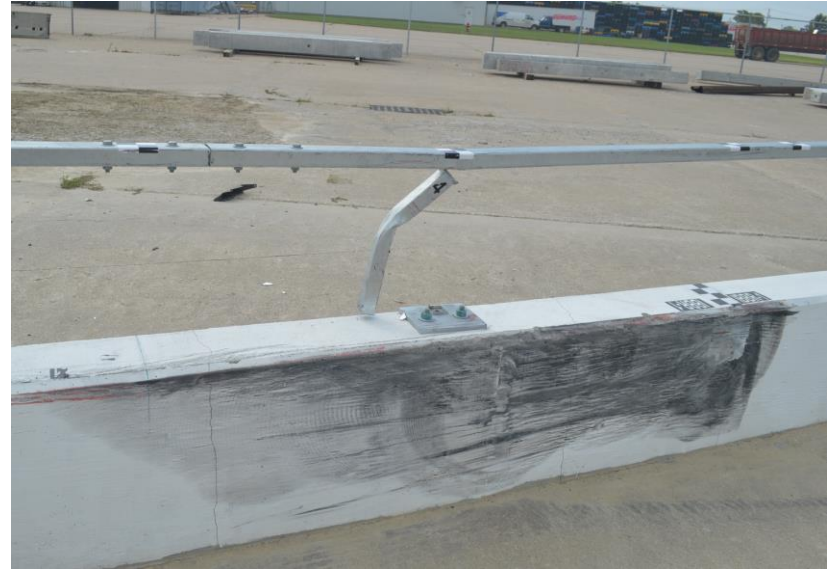
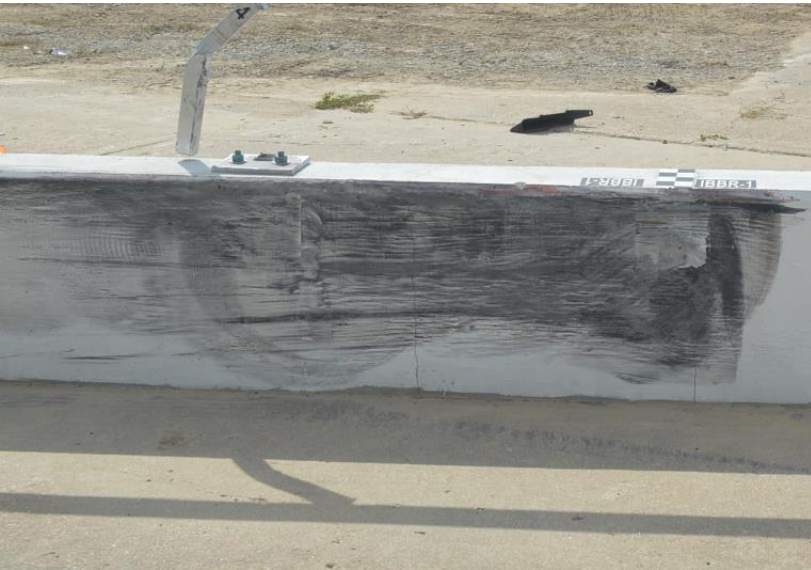
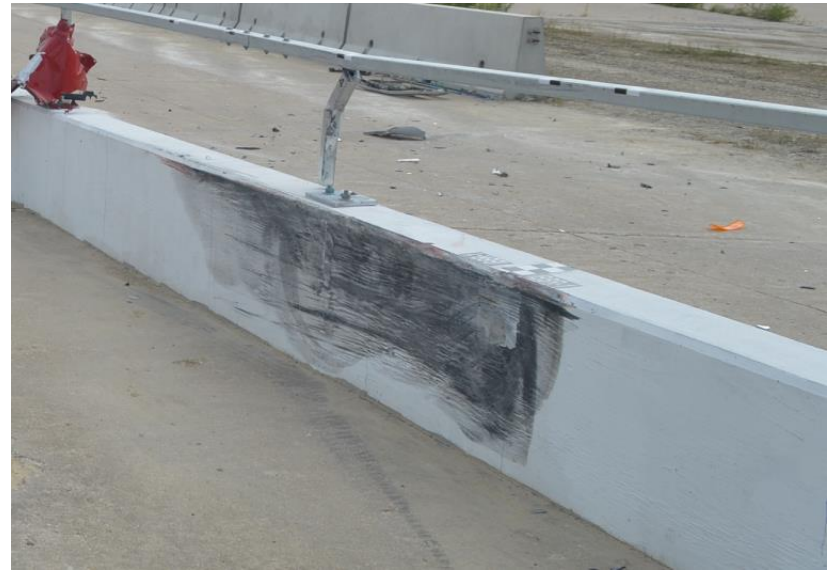
Figure 31. Front Side System Damage, Test No. IBBR-1

Damage to the barrier was minimal, as shown in Figures 31 through 34. Barrier damage consisted of contact marks on the front face of the concrete parapet, concrete spalling, and deformation of the bicycle rail. The length of vehicle contact along the barrier was approximately 15 ft – 1½ in. (4.6 m) which spanned from 4 ft – 10½ in. (1.5 m) downstream from the center of post no. 3 to the right-front fender contact with post no. 5.

Tire marks were visible on the front face of the concrete barrier between post nos. 3 and 5. Scuff marks were also found on the front and top face of the concrete barrier between post nos. 3 and 5 as well as on the bicycle rail in that region. Concrete spalling started 5 in. (127 mm) upstream from the impact point and continued downstream along the top front corner of the barrier for 65 in. (1,651 mm). A small 3-in. x 3¾-in. (76-mm x 95-mm) gouge in the concrete was found 7½ in. (191 mm) from the top of the barrier at the impact point. A 26-in. (660-mm) long contact mark was visible on the bicycle rail located 52½ in. (1,334 mm) upstream from the center of post no. 4. An 11½-in. (292-mm) long contact mark beginning 1 in. (25 mm) upstream from the center of post no. 4 was also found.

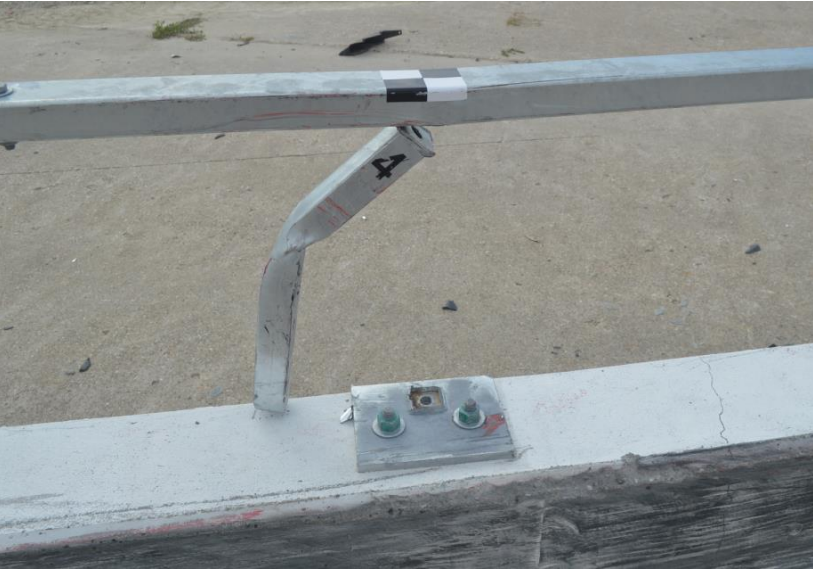
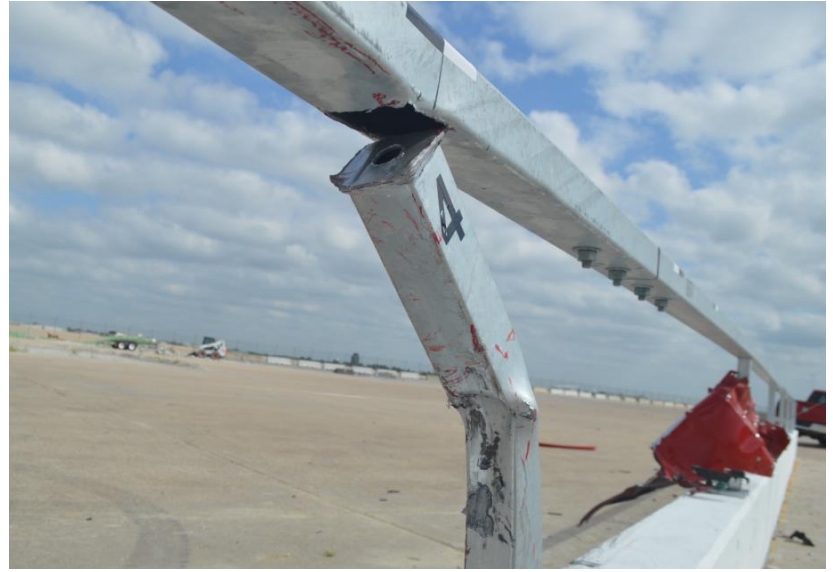
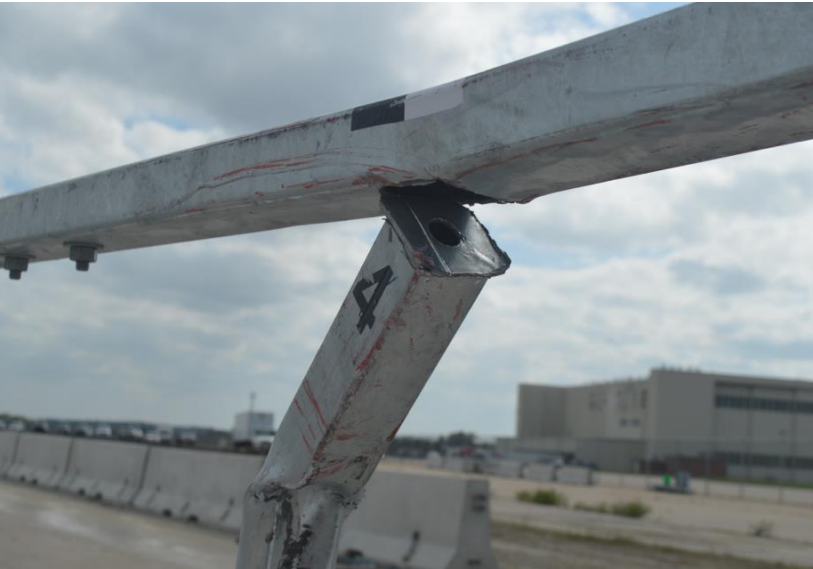
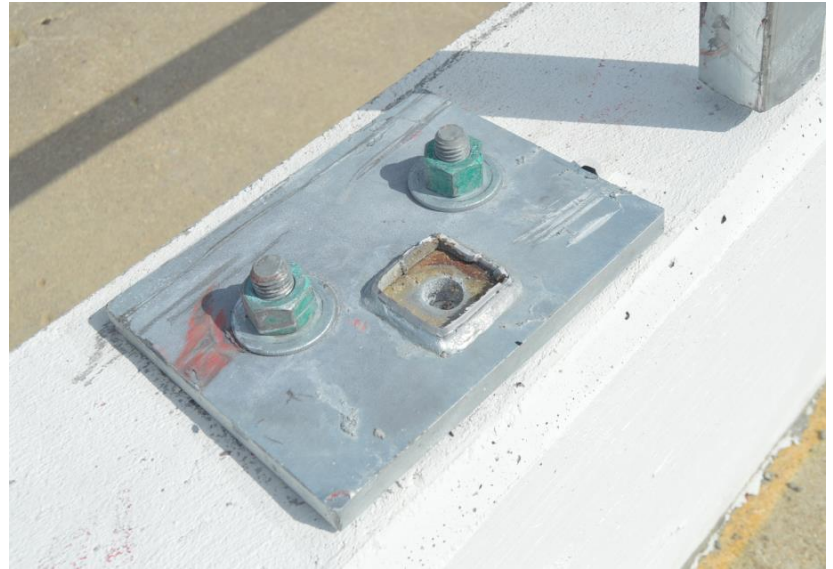
Figure 33. Post No. 4 Damage, Test No. IBBR-1

The bicycle railing section at post no. 4 was slightly bent downward and contact marks were visible on the bicycle rail on post nos. 4 and 5. Contact marks on the rail splice in between post nos. 4 and 5 and downstream from post no. 4 were also observed. Post no. 4 was fractured and deflected downstream. Post no. 4 had a fracture of the weld at the baseplate and fractured at the base material of the horizontal tube at the post to rail connection. A hinge in post no. 4 was located 13 in. (330 mm) from the bottom of the post. A 3-in. (76-mm) wide contact mark was visible on the top face of the base plate at post no. 4 that extended across the length of the plate. The anchor hardware at the base plate of post no. 4 was undamaged. Contact marks were visible on all faces of post no. 4, but only on the back and upstream faces for post no. 5. Note that post no. 5 was not permanently deformed. The right-front quarter panel of the vehicle snagged on post no. 5 and was removed from the vehicle. No impact damage or cracking was observed on the parapet. Additionally, no damage or cracking was observed at or adjacent to the anchor rods of the system.

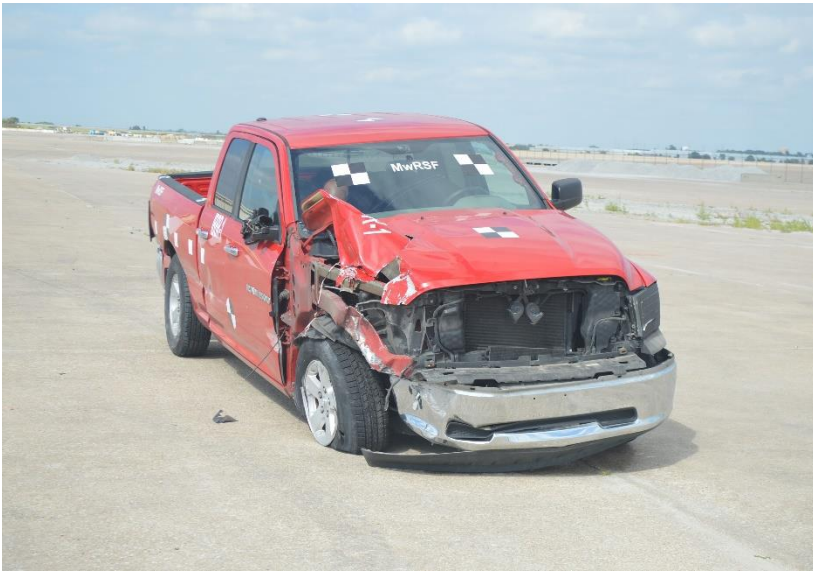
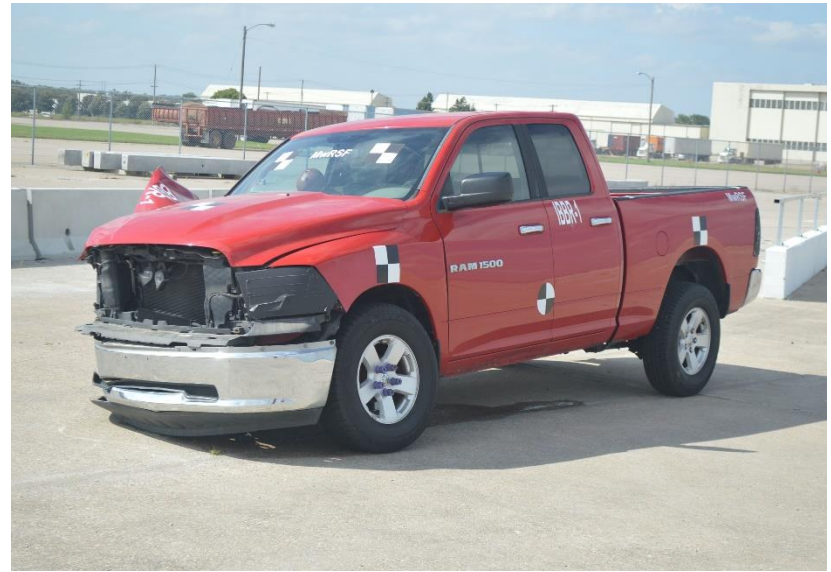
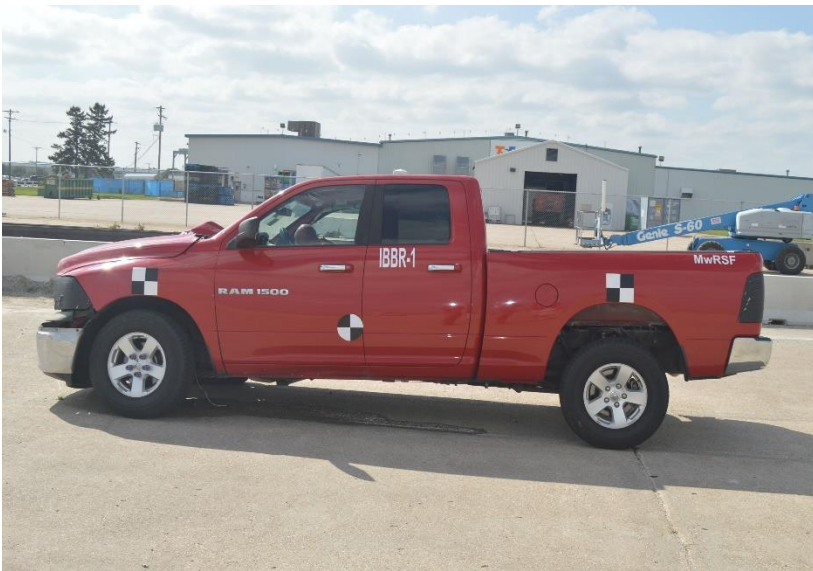
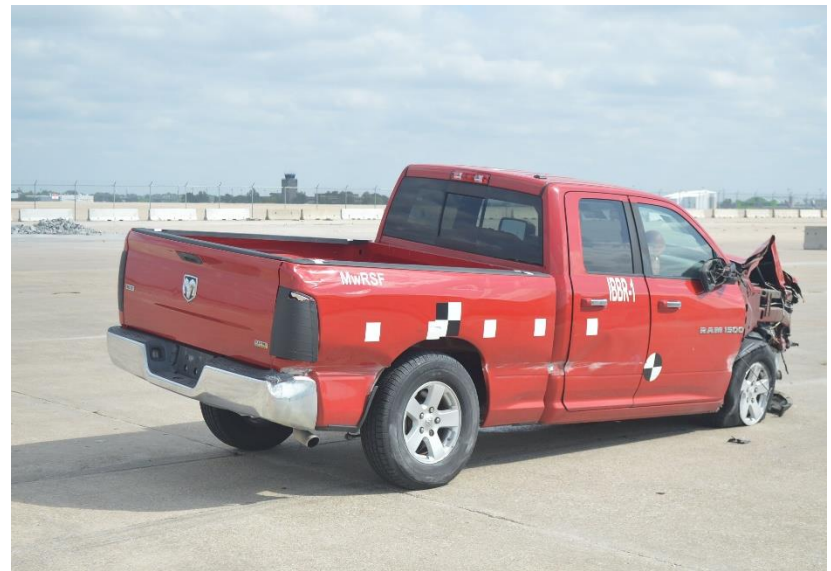
Figure 36. Vehicle Damage, Test No. IBBR-1

The damage to the vehicle was moderate and consisted mainly of crushing of the right-front vehicle structure, disengagement of the right-front fender, crushing and tearing of the vehicle hood, and contact marks along the side of the vehicle, as shown in Figures 36 through 39.

The majority of damage was concentrated on the right-front corner and right side of the vehicle where the impact had occurred. Denting and scraping were observed on the entire right side of the vehicle. The right-side mirror and casing were shattered and bent backward. The right side of hood was torn and folded up toward the windshield. The right side of the bumper was crushed inward and back. The grille was fractured and removed from the vehicle. The right-side headlight and fog light were removed from the vehicle. The right-front quarter panel snagged on post no. 4, impacted post no. 5, and was removed from the vehicle. The sub-body frame behind the right-front quarter panel was crushed into the engine area. The right-front tire was torn and deflated, and the right-front steel rim was deformed and had significant tearing. The right upper control arm was bent and pushed off its bushing and the right side of the radiator was pushed backward. Scuff marks were found on the right-rear tire, but the wheel assembly remained intact. The right side of the rear bumper was dented and scuffed. The left-front quarter panel was dented

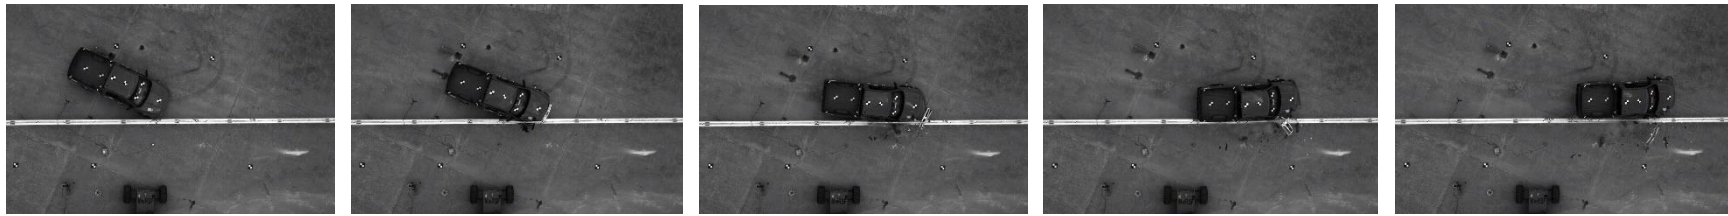
Figure 40. Summary of Test Results and Sequential Photographs, Test No. IBBR-1

The analysis of the test results for test no. IBBR-1 showed that the system adequately contained and redirected the 2270P vehicle with controlled lateral displacements of the barrier. A summary of the test results and sequential photographs are shown in Figure 40. Detached elements, fragments, or other debris from the test article did not penetrate or show potential for penetrating the occupant compartment, or present an undue hazard to other traffic, pedestrians, or work-zone personnel. Deformations of, or intrusions into, the occupant compartment that could have caused serious injury did not occur. The test vehicle did not penetrate nor ride over the barrier and remained upright during and after the collision. Vehicle roll, pitch, and yaw angular displacements, as shown in Appendix D, were deemed acceptable because they did not adversely influence occupant risk nor cause rollover. After impact, the vehicle exited the barrier at an angle of 6.2 degrees, and its trajectory did not violate the bounds of the exit box. Therefore, test no. IBBR-1 was determined to be acceptable according to the MASH 2016 safety performance criteria for test designation no. 2-11.

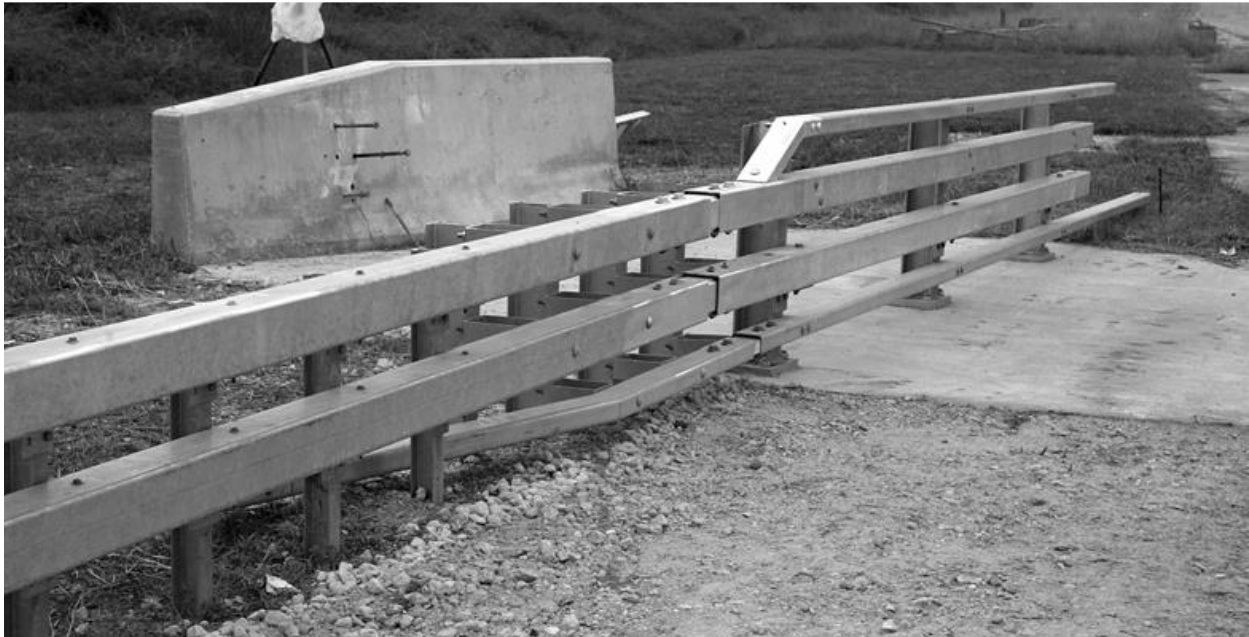
Figure 44. Box Beam Transition to Four-Tube Steel Bridge Rail [24]

TTI also performed testing and evaluation of a New York State Department of Transportation (NYSDOT) box-beam transition to four-tube bridge rail under NCHRP Report No. 350 test designation no. 3-21 [24]. The top tube of the four-tube bridge rail had a top mounting height of 42 in. (1,067 mm) and was tapered downward at a 2H:1V slope to attach to the top of the third tube of the bridge rail near the end of the bridge rail prior to the box beam approach transition, as shown in Figure 44. The third tube of the bridge rail had a top height of 32.7 in. (830 mm). In test no. 401021-7, a 2000P vehicle impacted the transition upstream from the tapered tube attachment at a speed of 62.1 mph (100.0km/h) and an angle of 24.4 degrees.

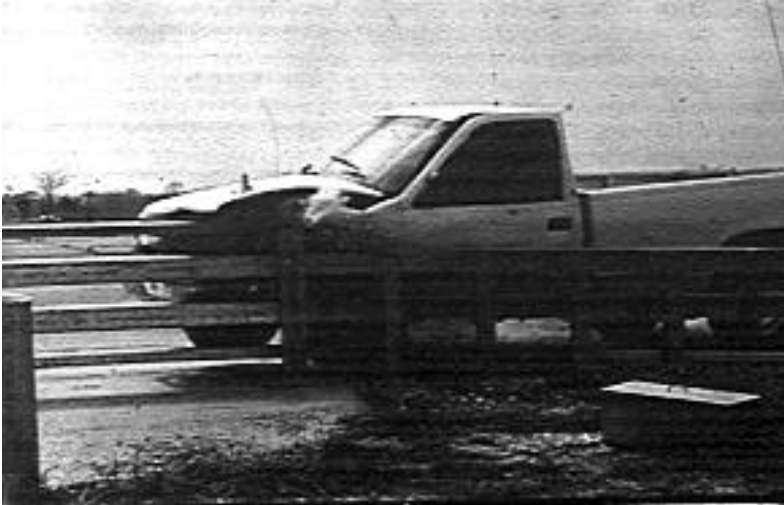
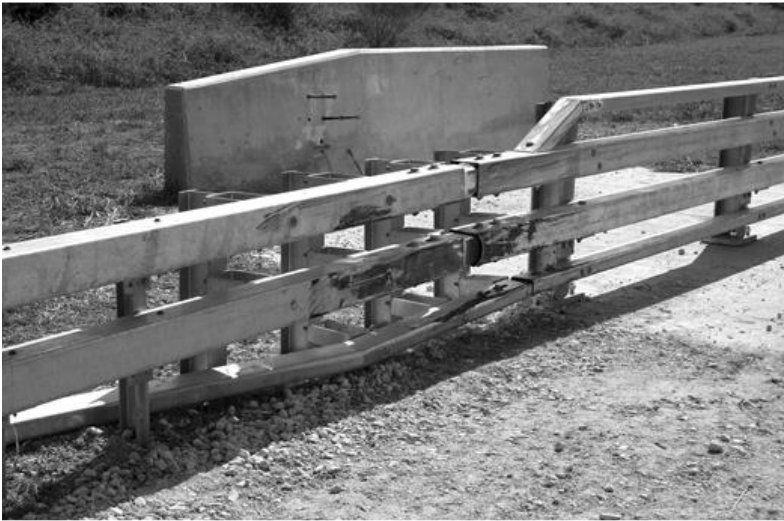
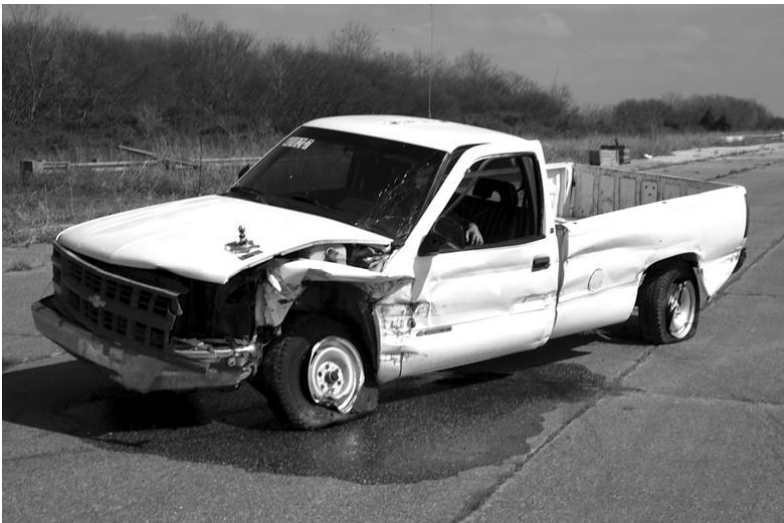
Figure 45. Tapered Tubular Rail Contact, Test No. 401021-7 [24]

During the test, the pickup truck traversed the sloped bridge rail tube with both the left-front fender and hood contacting the tube, as shown in Figure 45. However, this contact did not adversely affect vehicle redirection by the transition nor pose an occupant risk hazard. The 2000P vehicle was safely redirected and test no. 401021-7 was deemed acceptable under NCHRP Report No. 350 TL-3.

These two previous transition tests suggest that a 2H:1V slope for a vertical tube transition is capable of being crashworthy under NCHRP Report No. 350 TL-3. Thus, it was necessary to compare these installations to the low-height, vertical-face, traffic barrier with an attached crashworthy bicycle railing and determine if a similar slope could be applied. The two crash tested transitions had several differences when comparing them to the bicycle railing designed herein. The transitions had smaller lateral offsets between the tapered rail and the face of the adjacent thrie beam or tube rails than the system evaluated in test no. IBBR-1. The transitions were also tested at NCHRP Report No. 350 TL-3 rather than MASH TL-2. These two factors would tend to produce less vehicle interaction and snag on a 2H:1V sloped end tube for termination of the bicycling railing developed herein as compared to the two transition tests. Alternatively, the adjacent barrier height for the box beam transition and the thrie beam transition used in the TTI tests was at least 7.5 in. (191 mm) taller than the low-height parapet used in test no. IBBR-1. The height of the sloped tube end for the bicycle rail developed herein was 24 in. (610 mm) above the parapet, which is 9.3 in. to 10.5 in. (236 mm to 267 mm) vertically more exposed sloped rail than the previously tested TTI systems. These two factors would tend to produce more vehicle interaction and snag on a 2H:1V sloped end tube for termination of the bicycling railing developed herein as compared to the two transition tests. However, it was expected that the severity of the interaction of the vehicle with the vertically tapered end tube was more dependent on the 2H:1V slope than it was on the variation in exposed rail height. Thus, because the use of 2H:1V vertical tapers for termination of tubular rails was successful under NCHRP Report No. 350 TL-3, they would seem reasonable for use in the termination of the bicycling railing design herein under MASH TL-2 impact conditions.

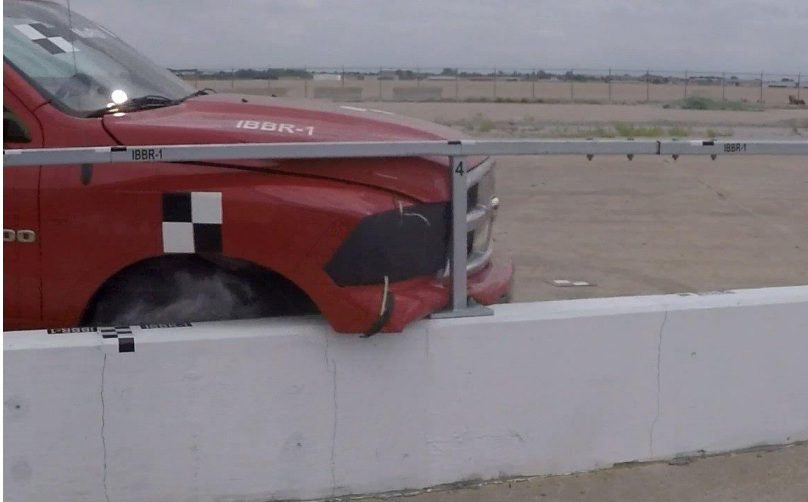
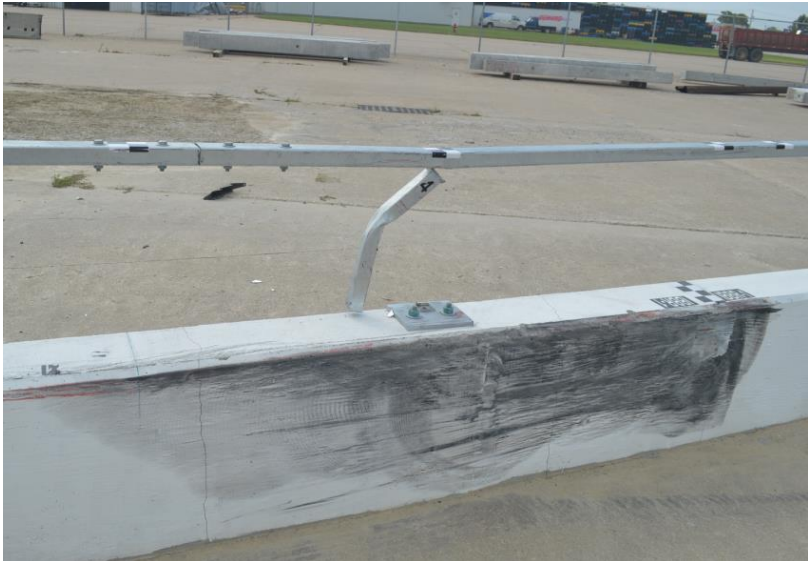
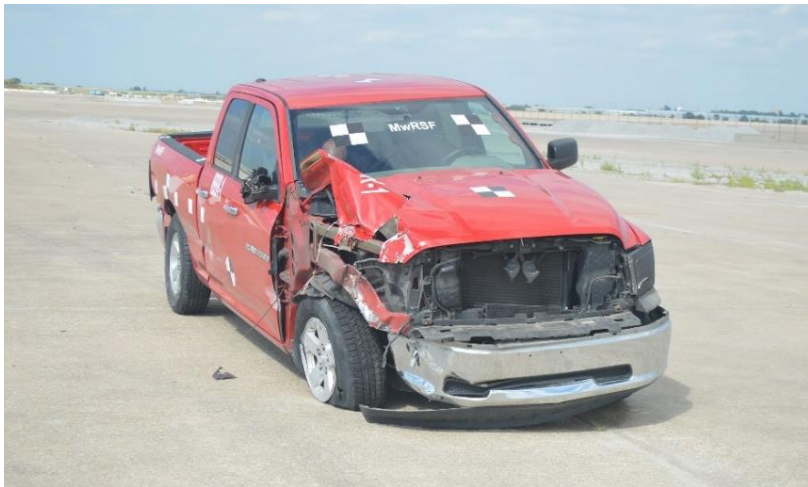
Figure 46. Vertical Support Post Contact, Test No. IBBR-1

The researchers also reviewed the snag and vehicle contact with the vertical support posts in test no. IBBR-1. During test no. IBBR-1, the vehicle fender and hood directly contacted the vertical support posts of the bicycle rail, which caused deformation and disengagement of the right-front fender of the pickup truck and disengagement of the post, as shown in Figure 46. This degree of vehicle snag on the vertical post did not cause an occupant risk or vehicle stability problem during the full-scale crash test. It seems reasonable that contact of an oncoming vehicle on a similarly anchored end termination tube sloped at a 2H:1V slope would pose similar or less concern for occupant risk and vehicle instability. While the vertically tapered termination tube would have a slightly increased cross section and slightly reduced lateral offset due to the size of the horizontal tube compared to the post used in the bicycle rail, the much lower slope of the tube (2H:1V versus vertical) would be expected to be safely traversable by an oncoming vehicle.

Based on the geometry data, the previous vertical tube transition slopes evaluated at TTI, and the results of the vehicle interaction the vertical post in test no. IBBR-1, the researchers believed that the use of a 2H:1V slope would be acceptable for termination of the bicycle railing. The 2H:1V slope would allow attachment of the horizontal top rail over a reasonable longitudinal distance. Additionally, the previous crash tests conducted at TTI under NCHRP Report No. 350 TL-3 suggested that a 2H:1V taper for vertical tube terminations was crashworthy and could potentially be applied to a slightly different scenario for a MASH TL-2 bicycling railing termination. Finally, the vehicle snag on traversal of the vertical post support post in test no. IBBR-1 suggested that a 2H:1V vertically tapered end rail would likely be traversable as well. It should be noted that for reverse direction traffic impacts or impacts on a downstream end termination, the sloped rail poses a risk due to the vehicle structure becoming wedged between the sloped rail and the top of the parapet. This will be further addressed in the subsequent section regarding the connection of the sloped rail to the parapet.
