Acurex Environmental Final Report FR-94-123

ALTERNATIVE-FUELED TRUCK DEMONSTRATION NATURAL GAS PROGRAM: CATERPILLAR G3406LE DEVELOPMENT AND DEMONSTRATION

January 31, 1995

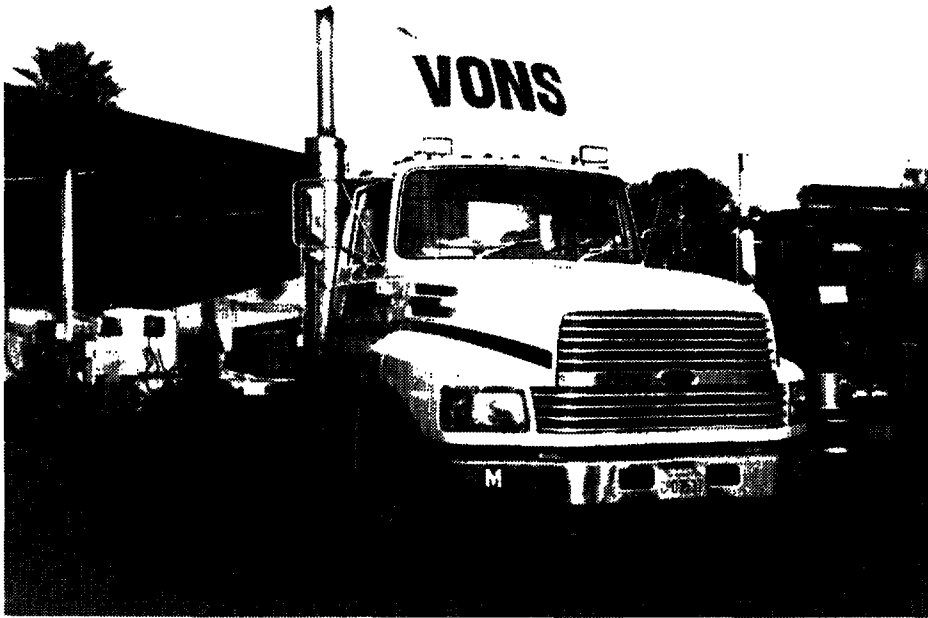
Figure 2-2. Tractor 9207 before its conversion

Following Vons' selection as a host site, an appropriate vehicle was selected into which the natural gas engine and fuel system could be installed. Vons purchased a fleet of 50 new 1992 Class 8 tractors just as the engine was being readied by Caterpillar. Vons equipment No. 9207, a 1992 Ford LTLA-9000 tractor equipped with a Caterpillar 3406B, 261-kW (350-hp) diesel engine, was selected for conversion to natural gas operation for this project. Figure 2-2 depicts tractor 9207 before its conversion. The specifications of this vehicle prior to and after its conversion are listed in Table 2-1.

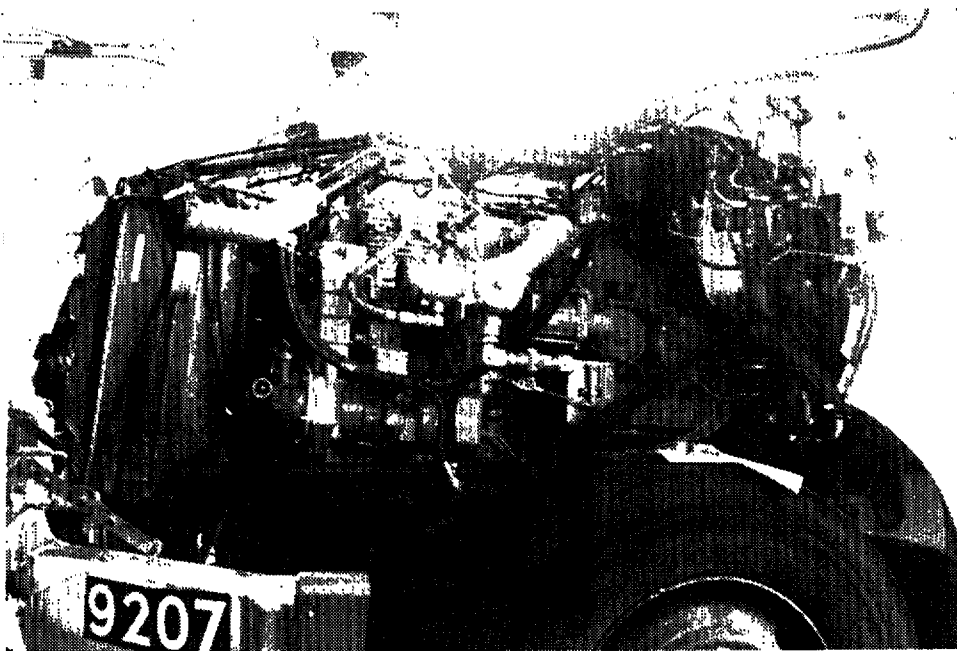
Figure 3-8. G3406LE engine installed in the tractor

The position of the turbocharger on the natural gas engine was different from that of the original diesel engine because of the space required for the waste gate. This affected the location and orientation of air inlet and exhaust outlet flanges. The standard under-the-hood air cleaner was located close to the turbocharger inlet. The turbocharger on the CNG engine interfered with the air cleaner in its standard location. For this reason, Ford engineered an air cleaner located under the radiator. The inlet for this system was on the left side of the hood with a mating boot connector on the left headlight housing, as shown in Figure 3-6. The redesigned air inlet system was not available during conversion of the vehicle, so a temporary system was installed. The interim system consisted of an air inlet and air filter behind the front bumper, and ducting to the turbocharger inlet, as shown in Figure 3-7. The air-conditioner drier and associated piping were also relocated due to their interference with the turbocharger. Figure 3-8 shows the engine installed in the vehicle.

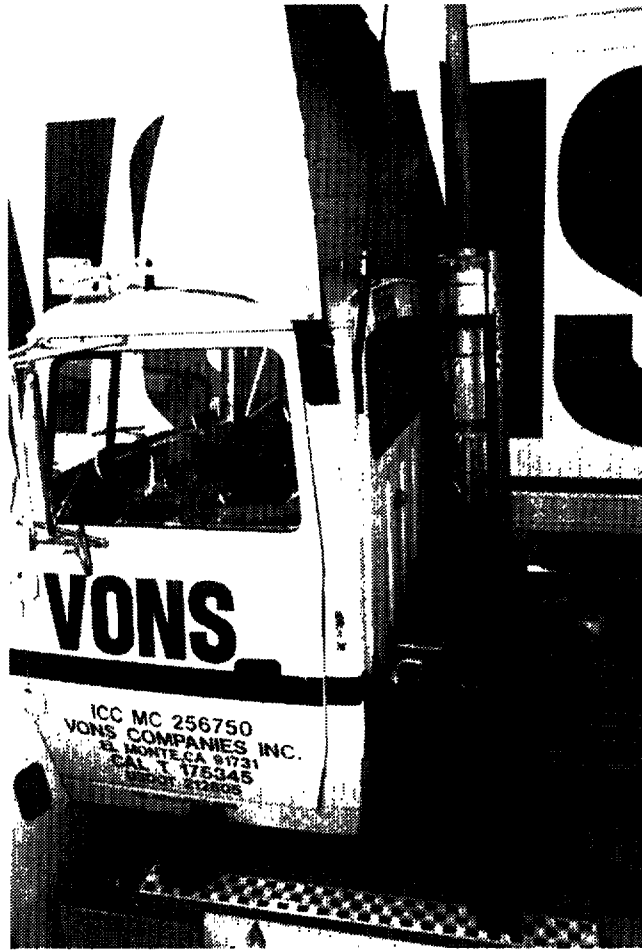
Figure 3-11. Heat insulation

During the first month of the field evaluation, Vons discovered that the CNG tractor's exhaust heat was higher than that of a diesel engine and had caused the deterioration of wires near the turbocharger and of the rubber seal around the rear cab window near the muffler. To remedy this situation, Vons replaced the affected items, installed a shield with insulation around the turbocharger, and added insulation to the muffler; this insulation is shown in Figure 3-11. No further heat deterioration occurred in these areas.

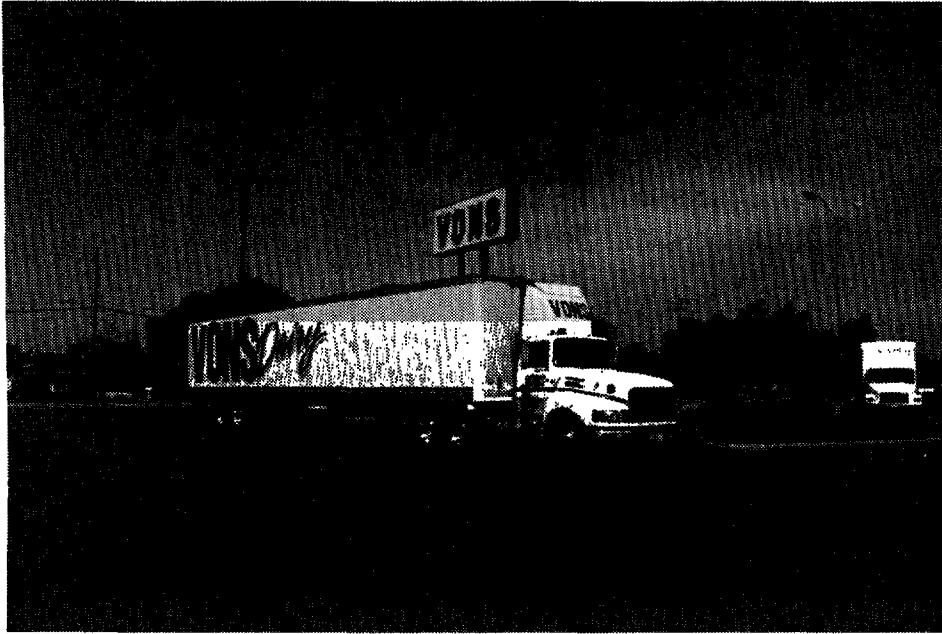
Figure 4-1. CNG tractor in service

The field evaluation phase of this project began on October 12, 1992, with the vehicle's inaugural voyage to Bakersfield, California, and ended with its final trip to Bakersfield on December 1, 1993. During this 14-month period, the vehicle accumulated 52,082 in-service km (32,369 in-service mi) and 829 engine hours. Table 4-1 summarizes the operating data gathered in the field evaluation. Overall uptime in Table 4-1 is defined as the number of days operated divided by the number of days the vehicle would have operated had it experienced no mechanical problems. CNG-specific uptime is defined as the number of days operated divided by the number of days the vehicle would have operated had it experienced no engine- or fuel-related mechanical problems. Figure 4-1 shows the CNG tractor in service.

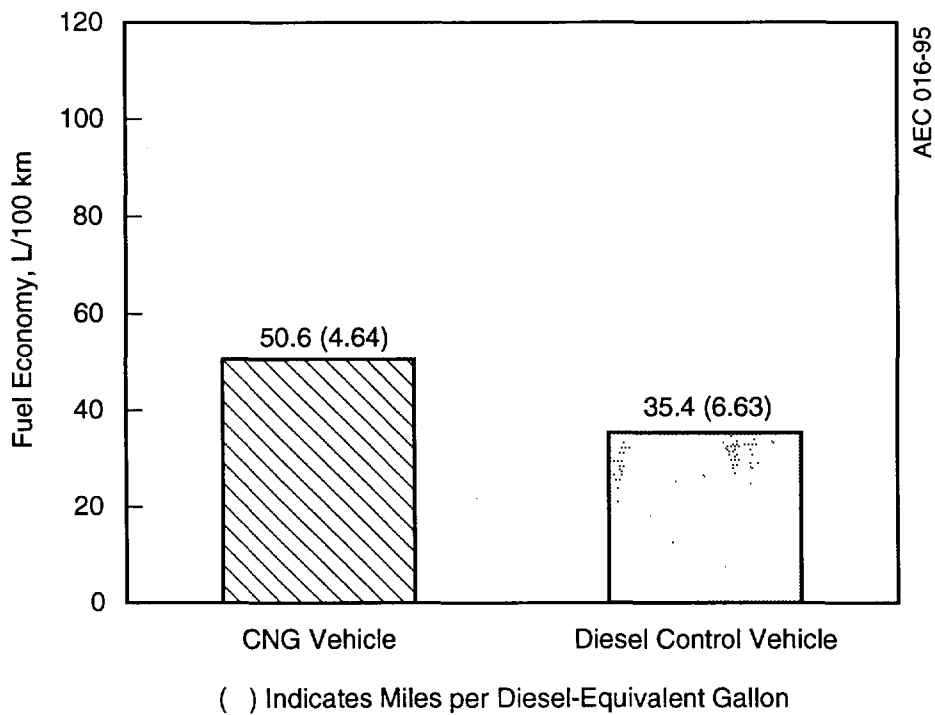
Figure 4-3. Fuel economy of the CNG and diesel tractors

Table 4-2 is a monthly chronology of the field evaluation, showing days of operation, significant occurrences, and explanations of downtime. Figure 4-2 shows the monthly mileage of the CNG tractor. The fuel economy of the CNG and diesel control tractors is shown in Figure 4-3.

The in-use fuel economy of the CNG tractor was disappointingly low at the beginning of the field evaluation. Observed fuel economy in the first 2 months of the field evaluation was 54.7 diesel-equivalent L/100 km (4.3 mi/diesel-equivalent gal), versus 35 L/100 km (6.7 mi/gal) observed for the diesel control vehicle during the same period. These observations compare to estimates made at the design stage of 39.1 L/100 km (6.0 mi/gal), for diesel tractors on this route, and 43.5 L/100 km (5.4 mi/gal), for the CNG tractor. The low fuel economy made it necessary to fuel the vehicle twice per trip, in Sun Valley and in Bakersfield. Several engineering improvements were implemented during the field evaluation, as described in Section 3.4. The net improvement in fuel economy, to 50.6 L/100 km (4.64 mi/gal), realized from these improvements could theoretically eliminate the need to refuel twice per trip on shorter round trips, e.g., 400 km (250 mi); however, this was not tested in practice because of the potential inconvenience of running out of fuel.

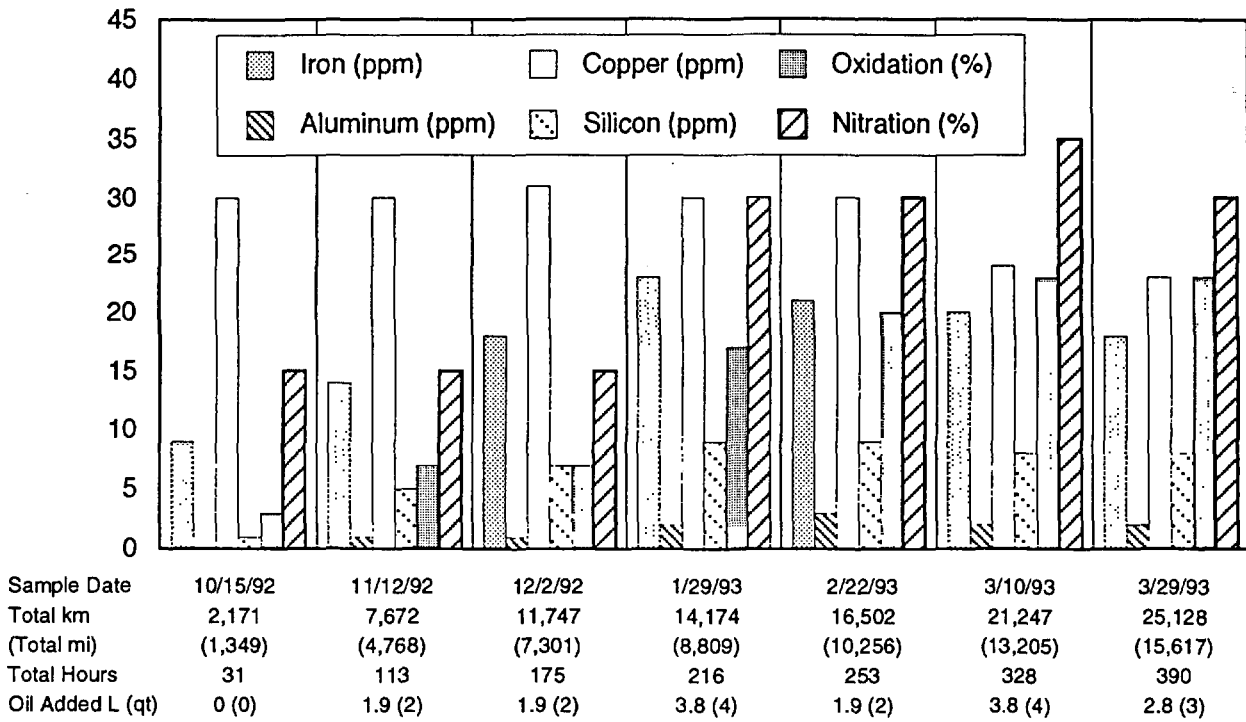
Figure 4-7. CNG tractor oil analysis history

Additional preventive maintenance practices were instituted for this vehicle, the most important of which was frequent, regular oil analysis. This was accomplished by drawing samples

of crankcase oil when the engine was hot, at operating intervals of approximately 50 hours; by measuring oil properties and contaminant levels; and by determining oxidation and nitration levels for each sample. Caterpillar requested the oxidation and nitration analyses to establish an oil drain interval for this engine. The crankcase oil showed no significant deterioration in more than 800 hours of operation, and was not drained during the course of the field evaluation. The oil analysis history of the CNG tractor is plotted in Figure 4-7. The high water content shown in an early sample was attributed to the sample being drawn when the engine was cold.

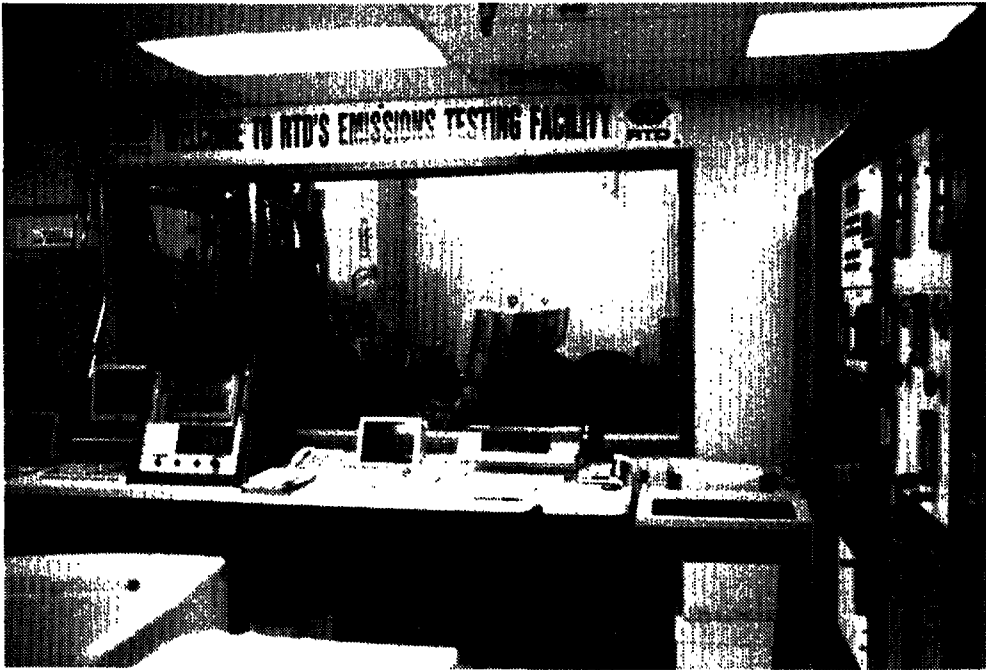
Figure 5-1. MTA Emissions Testing Facility

The ETF features a computer-controlled 477-kW (600-hp) DC motor/absorber. Torque is transferred to the twin 183-cm (72-in) rolls via a planetary gearset. The assembly is mounted on axial bearings; torque is supported by a load arm fitted with a load cell for torque measurement. Collection and measurement of exhaust emissions according to the constant volume sampling (CVS) principle begins in the dilution tunnel, which can be configured for flowrates from 28 m³/min to 113 m³/min (1,000 to 4,000 cfm). Ambient air is drawn through a filter bank into the dilution tunnel; full exhaust flow from the test vehicle enters the dilution tunnel immediately downstream of the filters. Total gas flow is controlled at a constant flowrate governed by the critical flow venturi (CFV) system; flowrate is manually selected prior to the test. The diluted exhaust sample is drawn from the center of the dilution tunnel, approximately 10 tunnel diameters downstream of the point where raw exhaust enters the tunnel. The dilute sample is drawn from the sampling probe through a temperature-controlled sampling line and sample oven. The sample flow is then split into several

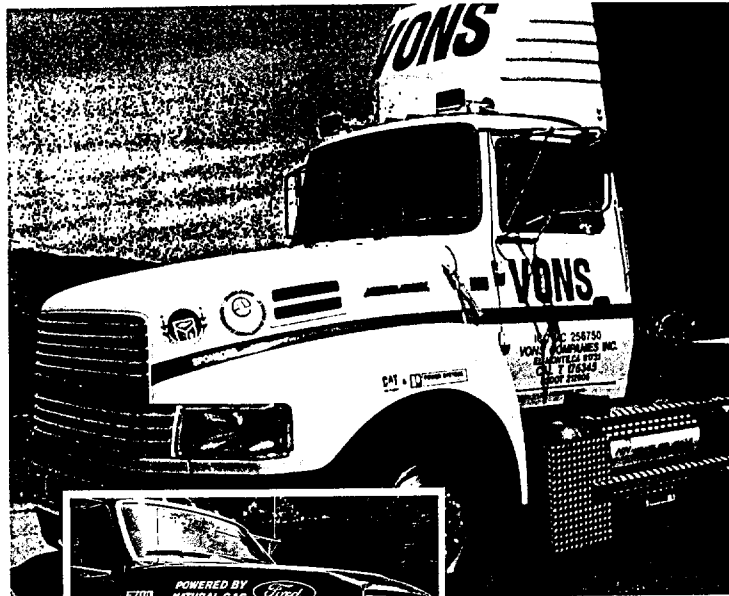
This AeroMax, operated by California supermarket giant Vons Companies, Inc., is powered by a Cat 3406 diesel, modified to operate on CNG (compressed natural gas). The red F-700G to the left is an experimental unit also powered by natural gas.
