DOT HS 813 195

November 2021

Classification of Level 2 Driving Automation Events Observed on Public Roads – Part 2

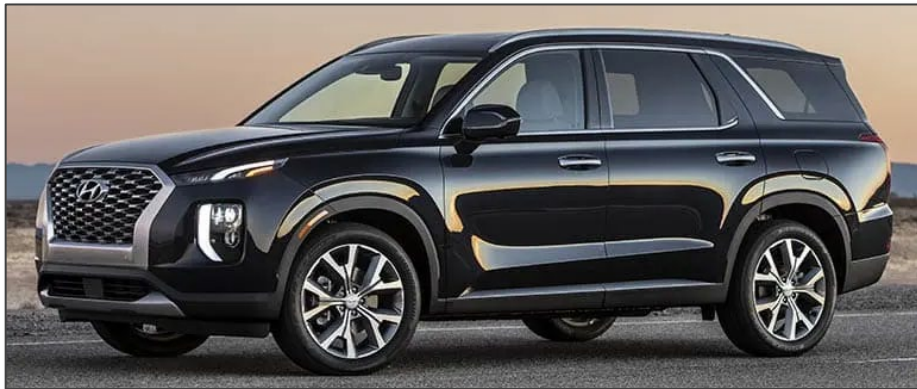
Figure 1. 2020 Hyundai Palisade

The level 2 driving automation system installed on the Hyundai Palisade (Figure 1) consists of "lane keeping assist," which can automatically steer to maintain lane position on roads that have two lane lines, and "Smart Cruise Control," which maintains speed and a set distance to the vehicle ahead. The vehicle was also equipped with a "Highway Driving Assist (HDA)" system that when enabled and operational, automatically adjusts the Smart Cruise Control set speed to the posted speed limit of roadways within the vehicle's operational design domain (ODD). According to the Hyundai Palisade owner's manual (Hyundai Motor America, 2020), HDA requires that (1) the vehicle is being driven on a highway, (2) Smart Cruise Control is operating, and (3) vehicle speed is under 95 mph (153 km/h).

Messages observed on the Hyundai Palisade's driver's display are detailed in Appendix 7.1. For the drives discussed in this report, Smart Cruise Control was set to the nearest (i.e., closest) headway.

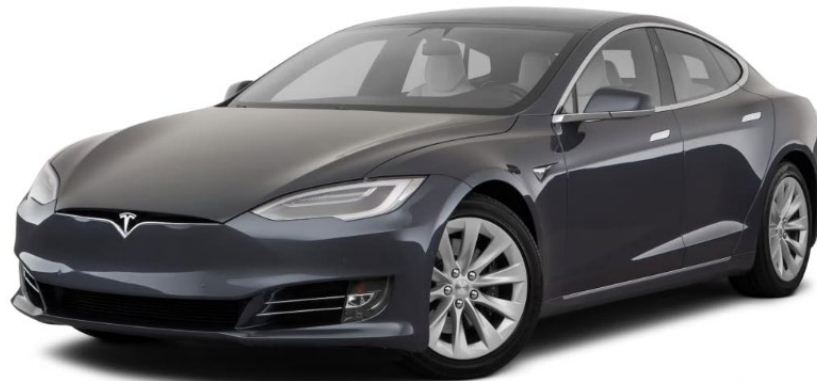
Figure 3. 2017 Tesla Model S

The Tesla Model S (Figure 3) was equipped with an optional suite of advanced driver assistance system (ADAS) technologies collectively named “Autopilot,” some of which enable level 2 driving automation. Before the drives described in this report were performed, an over-the-air update was used to update the Tesla Model S firmware to Version 10.0 Build 2019.32.12.1 on October 10, 2019. This was the latest available firmware available as the Tesla Model S drives were initiated, and it remained on the vehicle for the duration of testing described in this report. Although not directly related to the research, the vehicle’s automatic emergency braking was also set to “on,” and the forward collision warning system was set to “early.”

Messages observed on the Tesla Model S driver's display are detailed in Appendix 7.2.

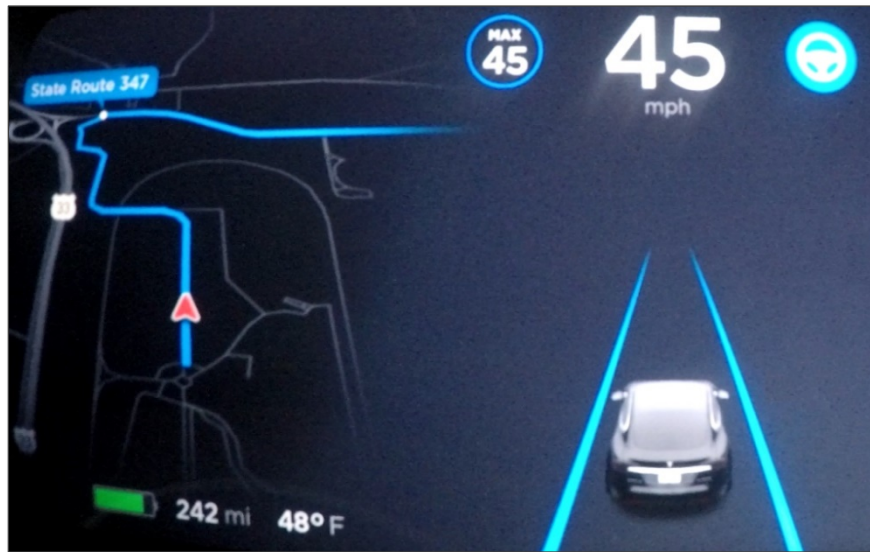
Figure 5. Driver's dash display of Navigate on Autopilot (rural route).

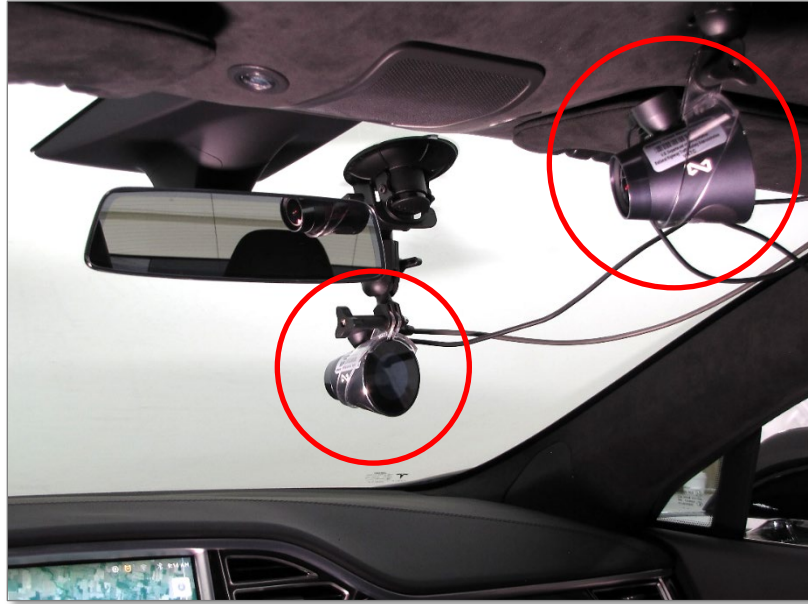
Two Waylens Horizon cameras were used to capture video and GPS data during testing. This equipment recorded GPS data at 10 Hz and video with a resolution of 1,080p at 60 frames per second. One camera was mounted on the windshield to record the forward view outside of the vehicle, and the second camera was mounted over the driver's shoulder to record driving actions (Figure 9).

Figure 9. In-vehicle camera placement.

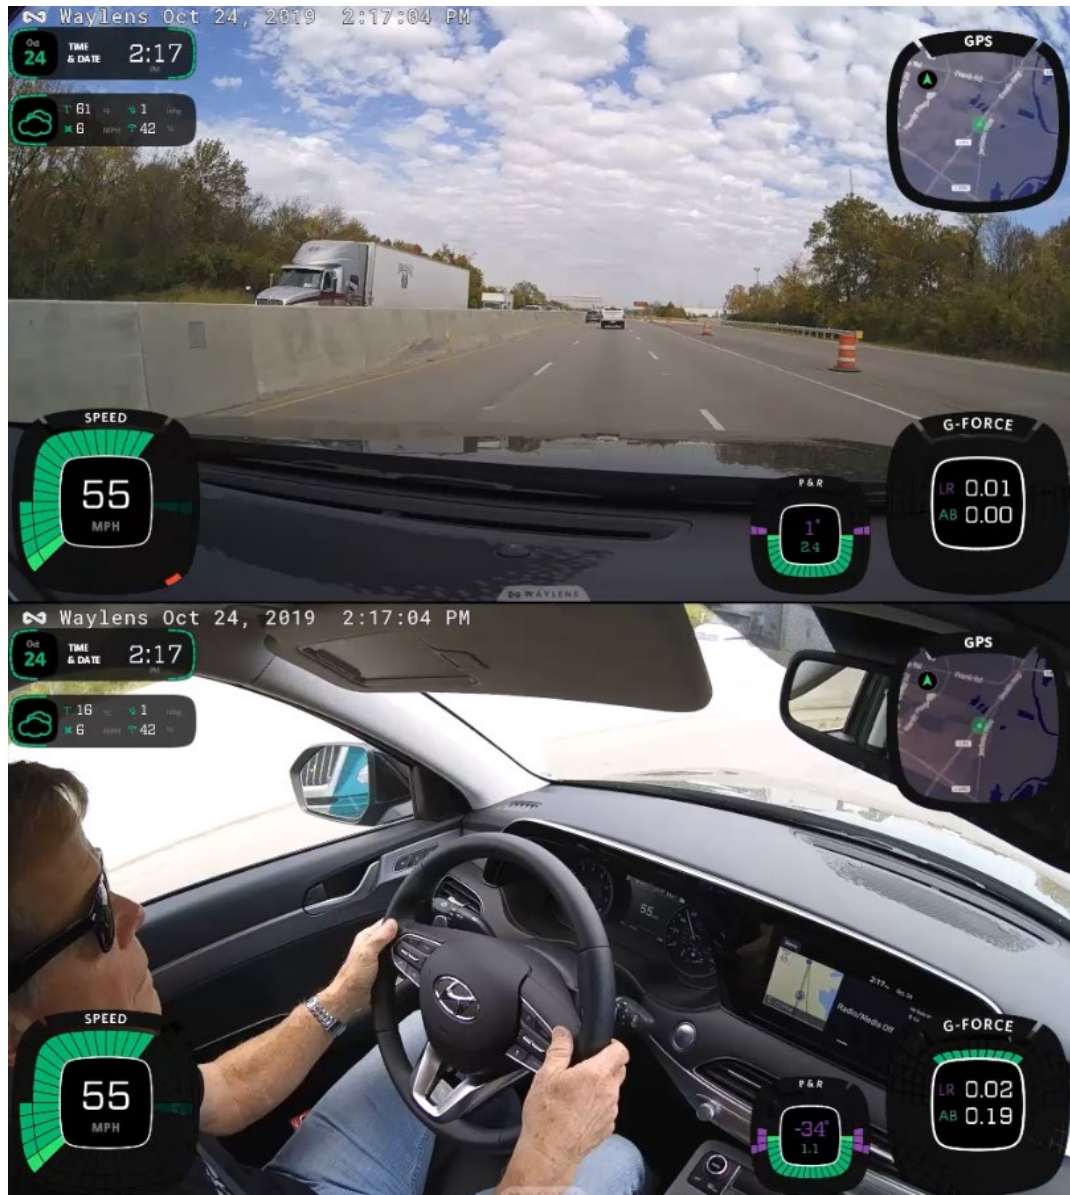
Video highlights from the two camera views were stitched together into a single split-screen video clip during data post processing (Figure 10). Drivers reviewed their own video highlights and classified the flagged events and roadway conditions in a spreadsheet using the guidelines described in Section 3 of this report.

Figure 10. Split-screen video clip example

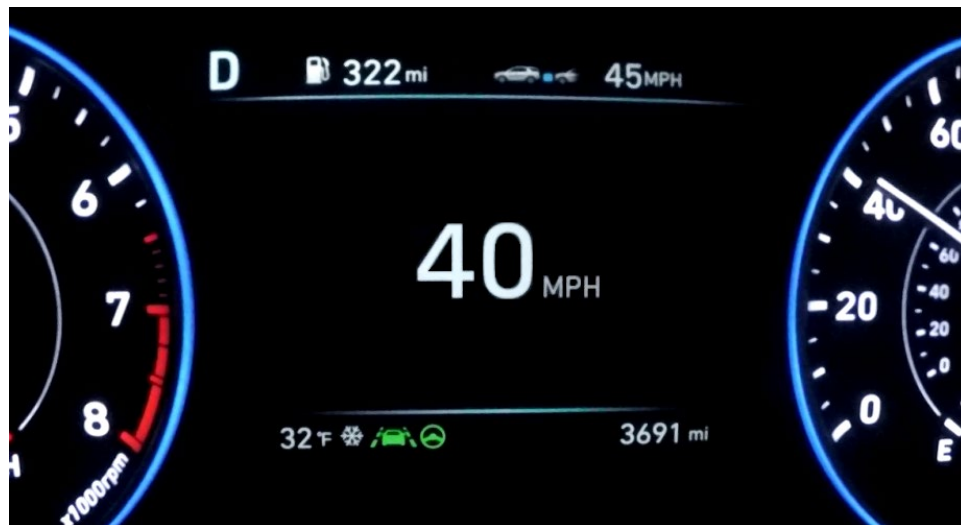
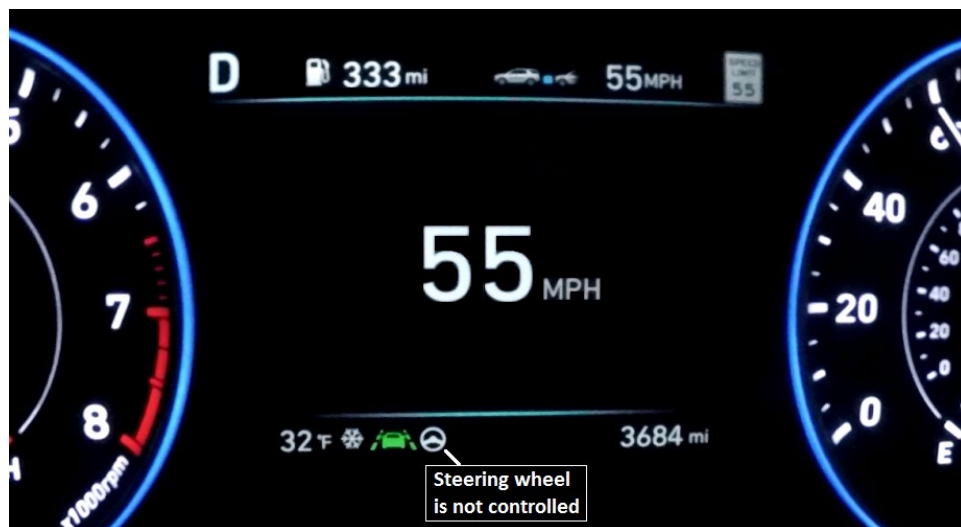
The Hyundai Palisade instrument cluster-based driver display is shown in Figure 14 and Figure 15. This image shows the level 2 driving automation system engaged.

Figure 14. Instrument cluster of Hyundai Palisade being driven in level 2 automation

Figure 15. Hyundai Palisade instrument cluster with icons labeled

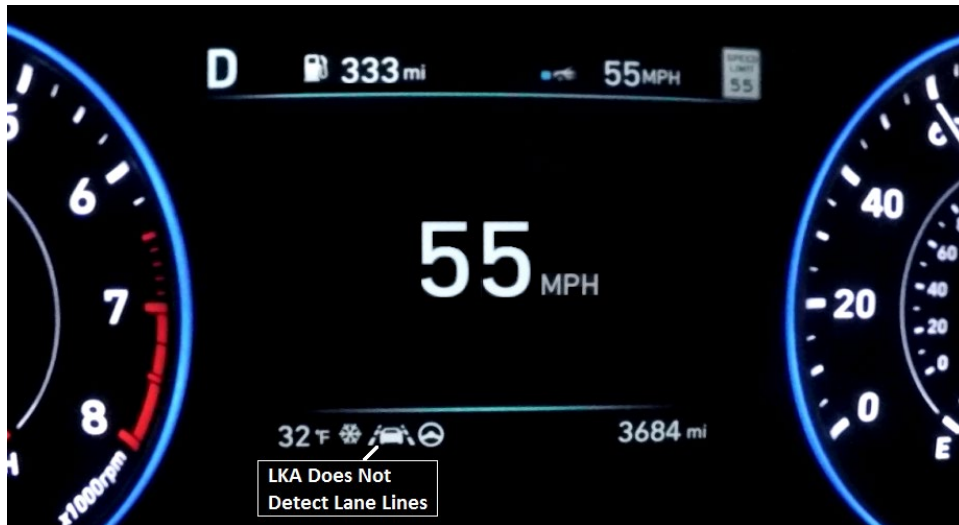
If the Hyundai Palisade LKA enabled and detects the lane lines, but the system is not available to actively control the vehicle's lane position, the steering wheel icon will turn white, as can be seen in Figure 16. This occurs if the turn signal is on or if the system alerts the driver to resume full manual control of the vehicle.

Figure 16. Hyundai Palisade display when LKA and steering wheel control are deactivated

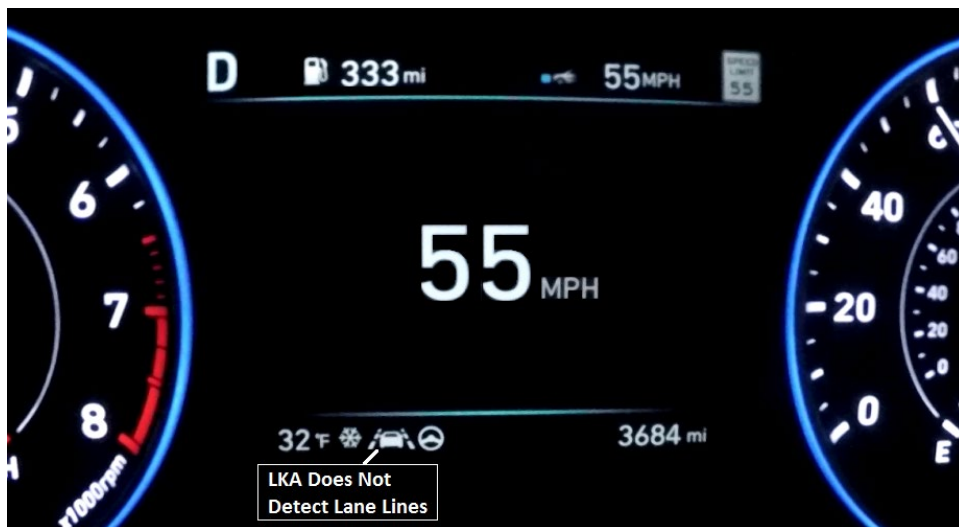
When the Hyundai Palisade LKA is enabled, but does not detect the lane lines, both the LKA and steering wheel icons turn white, as can be seen in Figure 17. This can happen if one lane line is degraded or disappears.

Figure 17. Hyundai Palisade display when LKA and steering wheel control are deactivated

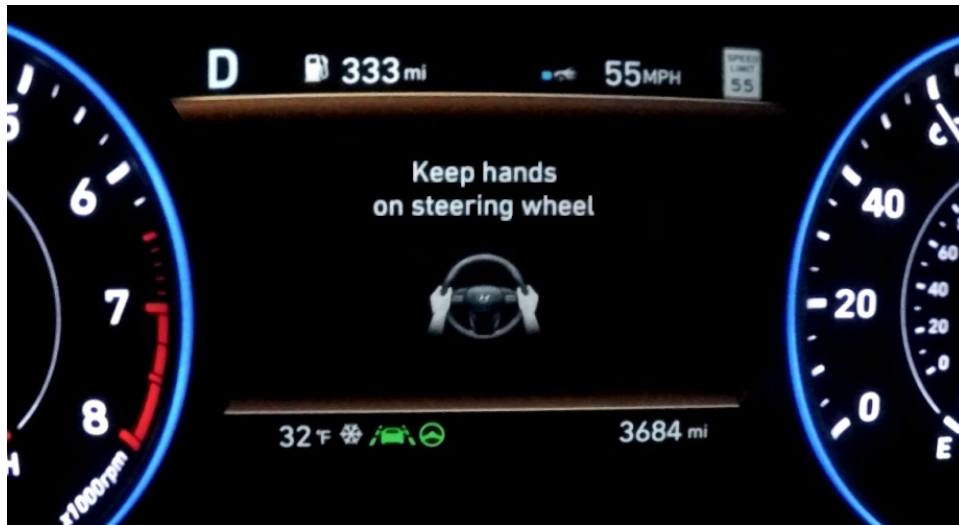
If the LKA system does not detect steering wheel input after 30 seconds, the driver receives a first “Keep hands on steering wheel” alert, as shown in Figure 18. This is accompanied by two audible beeps in close succession.

Figure 18. Hyundai Palisade's first LKA "hands on" alert message to the drive

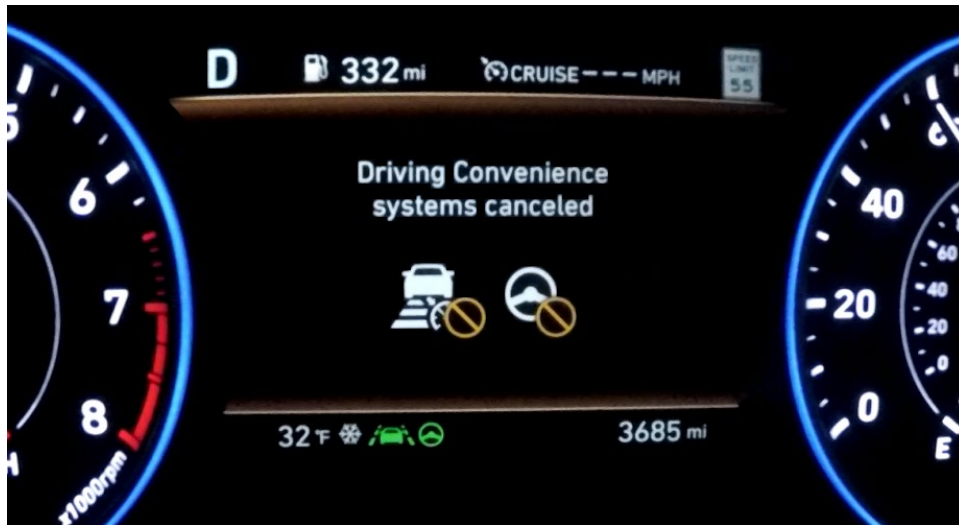
Ignoring this final warning leads to the system turning off level 2 automated driving and notifying the driver with the message shown in Figure 20. The system releases the throttle but maintains steering control to keep the vehicle in the lane.

Figure 20. Hyundai Palisade's "Driving Convenience systems canceled" notification

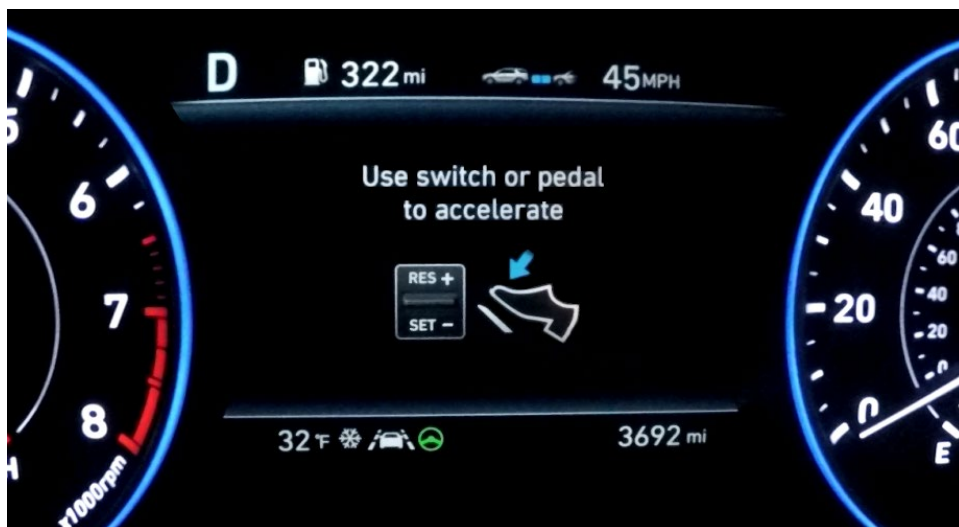
When Smart Cruise Control brings the vehicle to a stop, the message in Figure 21 is displayed. Note that the vehicle-to-vehicle distance icon displays a lead vehicle and the Hyundai Palisade is stopped. Also note that the LKA icon has turned white because it does not operate below 40 mph (64.4 km/h).

Figure 21. Message when Smart Cruise Control has brought the vehicle to a stop

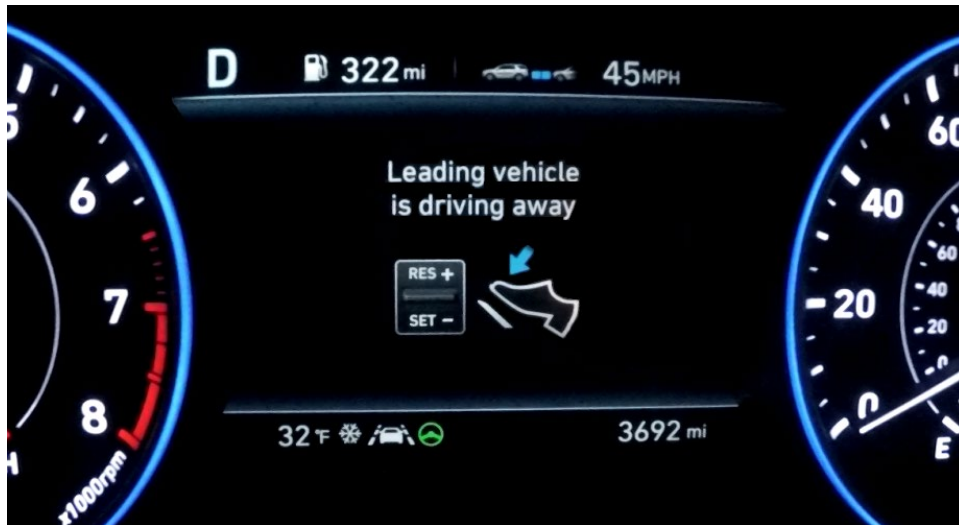
When the lead vehicle moves, Smart Cruise Control displays the message shown in Figure 22 and beeps.

Figure 22. Smart Cruise Control notification that a lead vehicle movement has been detected

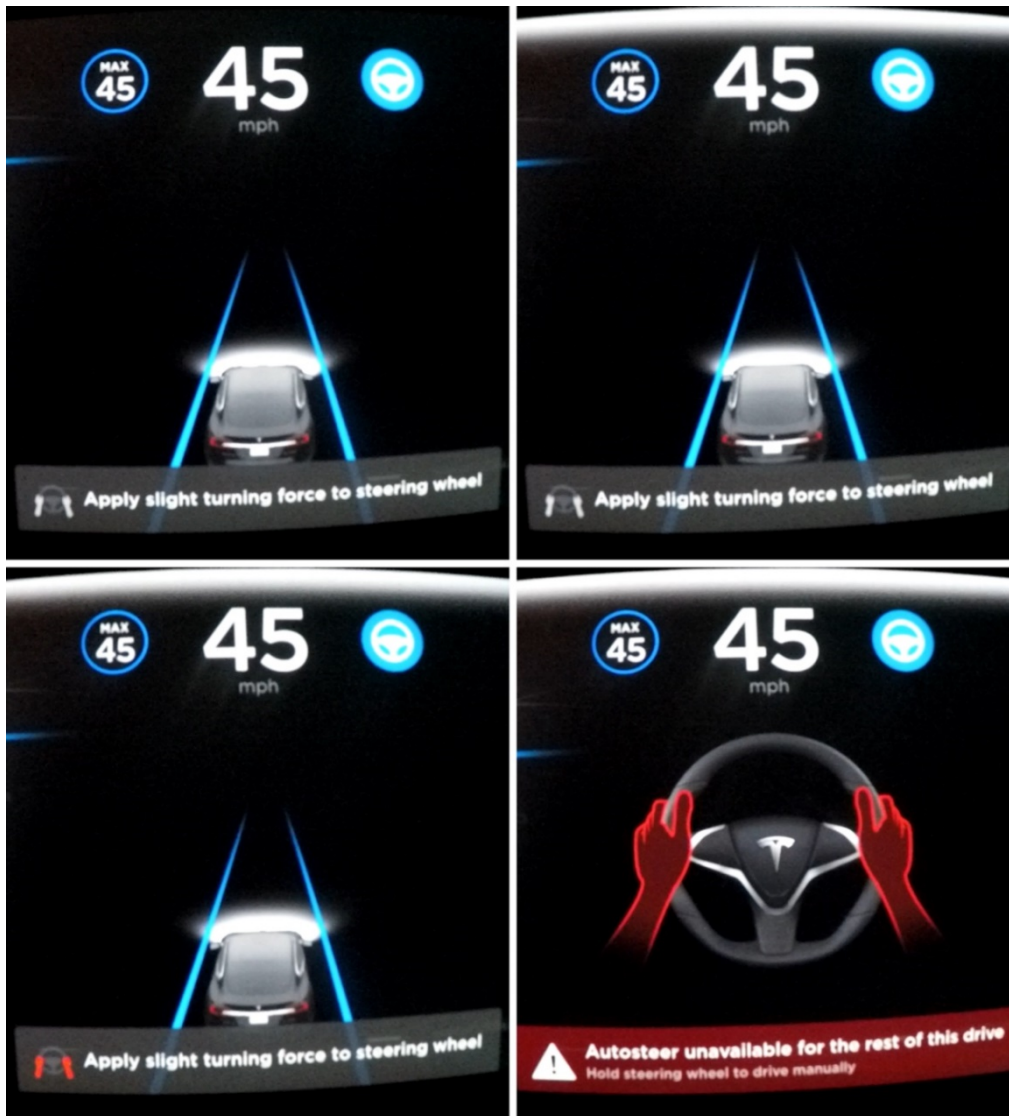
When Navigate on Autopilot determines the driver has not had their hands on the steering wheel for an extended period of time (typically between 12 to 25 seconds), the driver is warned to “Apply slight turning force to the steering wheel”, as shown in the upper left-hand image of Figure 24. Two seconds later, a solid white bar begins to slowly flash across the upper portion of

the display, as shown in the upper right-hand image of Figure 24. If the driver takes no action, the flashing frequency of the white bar increases for approximately 15 seconds. After that, the hands of the “Apply slight turning force to the steering wheel” warning turn red, as shown in the lower left-hand image of Figure 24, and two audible beeps are presented in close succession. Two sets of two audible beeps are issued 10 seconds later, followed 5 seconds later by constant beeping and a large steering wheel with red hands on it, as shown in the lower right-hand image of Figure 24.

Figure 24. The escalating messages observed when the driver’s hands remain off the steering wheel for an extended time

After the final message shown in Figure 24 is presented, the Traffic-Aware Cruise Control speed setting and the Autosteer steering-wheel indicator remain blue, but the vehicle begins to slow down, and lane position is not controlled. Once Autosteer becomes unavailable, any movement of the steering wheel causes the Autosteer steering-wheel indicator to disappear. Autosteer and Navigate on Autopilot will remain unavailable until the next ignition cycle. If the driver attempts to reengage the system without an ignition cycle, the message shown in Figure 25 appears.

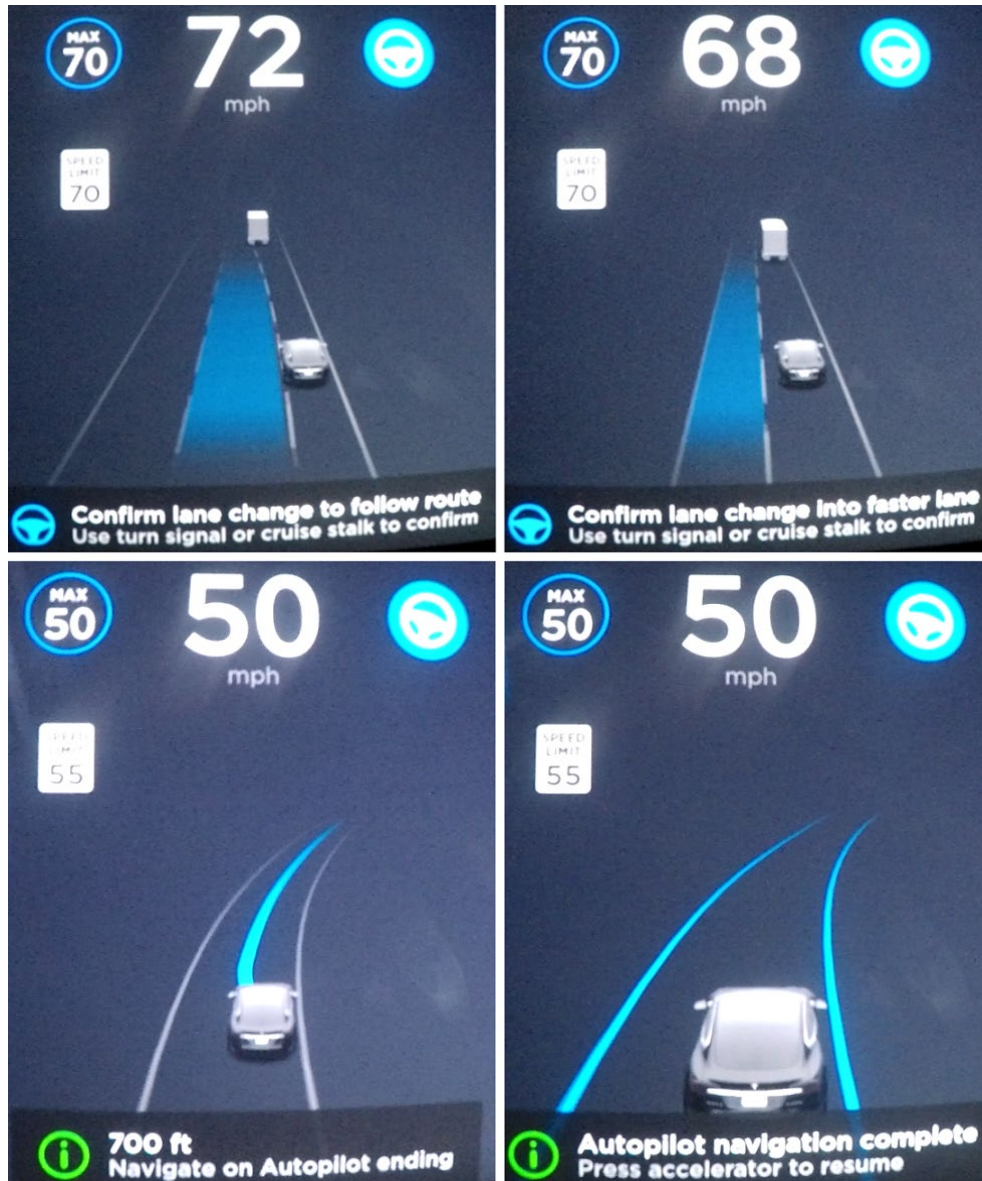
The Navigate on Autopilot feature is intended to assist the driver while the vehicle is being operated on a highway and is capable of suggesting automated lane changes. The two types of lane changes that Navigate on Autopilot suggests are (1) route-based lane changes designed to keep the vehicle on the navigation route, and (2) speed-based lane changes designed to keep the vehicle moving as close to the set speed as possible. Figure 27 shows the driver display images of the Navigate on Autopilot feature in operation.

Figure 27. Messages from the Navigate on Autopilot feature while in operation

In Figure 27, the upper left-hand image shows the driver message displayed during a route-based lane change, while the upper right-hand image shows the driver message displayed during a speed-based lane change. As was the case with the Auto Lane Change feature, the lane where the vehicle is moving to is shaded blue. As the vehicle approaches the driver-specified destination programmed into the vehicle's navigation system, an audible alert such as "In 1,000 feet, your destination will be on the right" is presented to the driver. Navigate on Autopilot visually notifies the driver of the distance that remains before it turns off (i.e., is automatically switched off), as shown in the lower left-hand image of Figure 27. Upon arrival, Navigate on Autopilot issues an audible tone and notifies the driver with the message shown in the lower right-hand image of Figure 27.

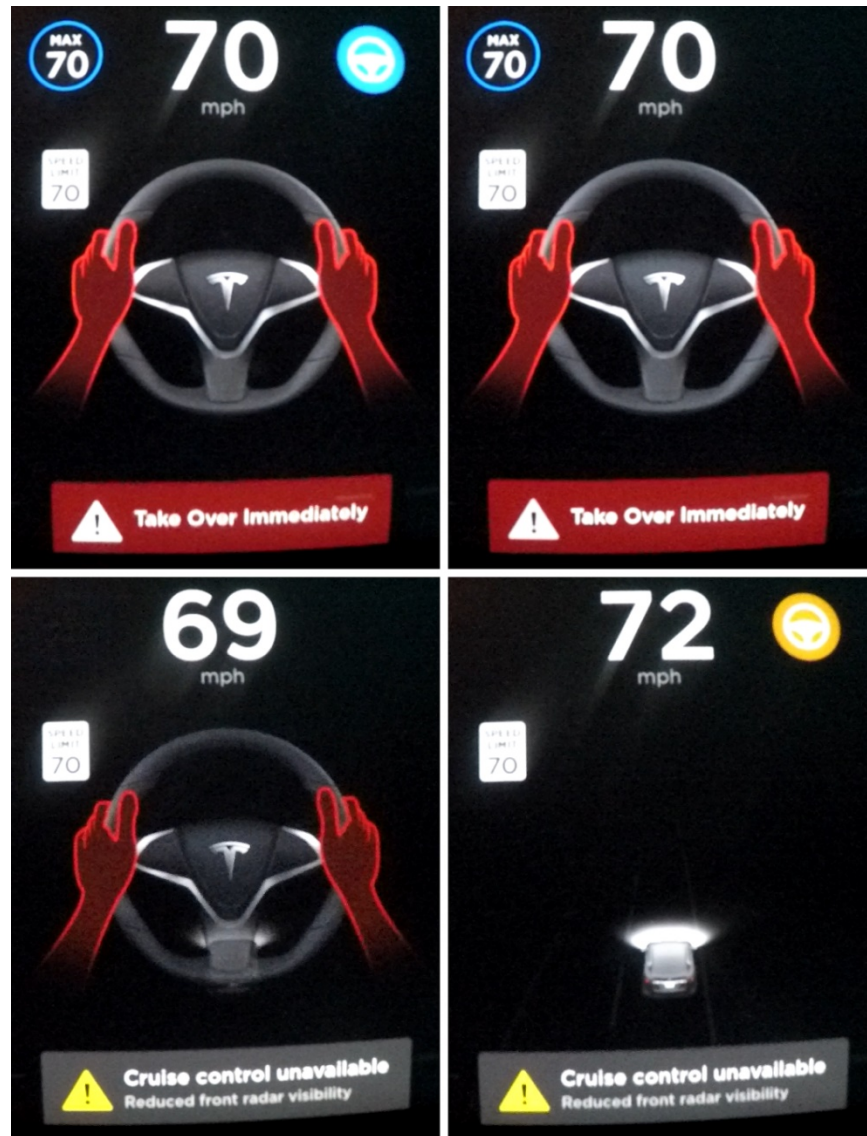
In some situations, Navigate on Autopilot will issue a "Take Over" request that requires the driver to resume full manual control of the vehicle. The upper left-hand image of Figure 28

shows this image presented to the driver when the vehicle first issues a “Take Over Immediately” warning. The Autosteer steering-wheel indicator disappears shortly after that, as seen in the upper right-hand image. The lower left-hand image of Figure 28 shows the image presented to the driver at the instant the vehicle cancels Traffic-Aware Cruise Control and Autosteer due to “Reduced front radar visibility.” If the driver attempts to reengage the system without an ignition cycle, a blinking, yellow Autosteer steering-wheel indicator appears, accompanied by an audible alert and the message shown in the lower right-hand image.

Figure 28. Take Over Request messages observed during Autopilot operation

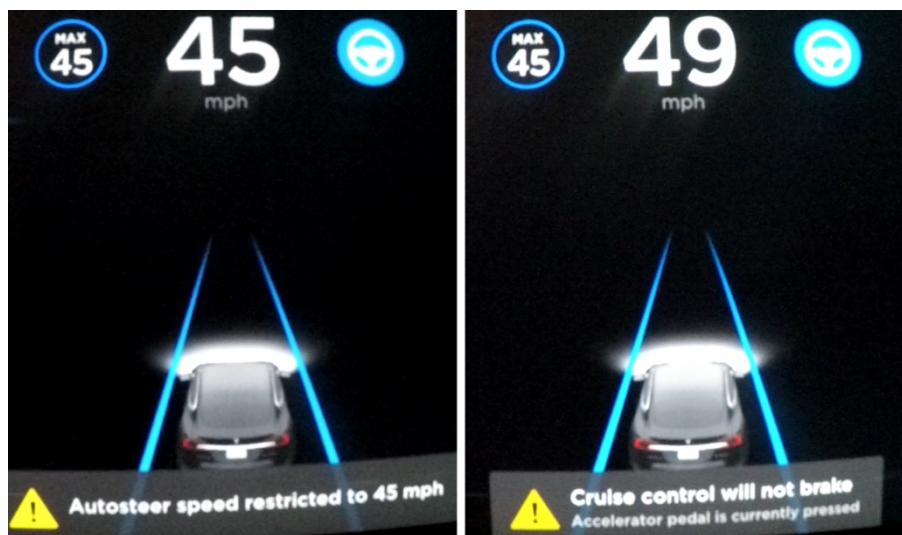
In situations where the speed limit cannot be detected when Autosteer is engaged, the vehicle's speed is limited to 45 mph (70 km/h). Figure 30 shows the driver display image when the speed of Autosteer is limited (left side image). If the driver decides to manually increase the speed using the accelerator pedal, a message that indicates Traffic-Aware Cruise Control will not apply the brakes (right side image) appears.

Figure 30. Messages displayed when the speed limit is unknown and the driver increases speed
