**GEORGIA DOT RESEARCH PROJECT 14-06**

**AN ENHANCED GDOT PAVEMENT  
PRESERVATION GUIDE WITH OPTIMAL  
TIMING OF PAVEMENT PRESERVATION**

1. Report No.: FHWA-GA-20-1406		2. Government Accession No.: N/A		3. Recipient's Catalog No.: N/A	
4. Title and Subtitle: An Enhanced GDOT Pavement Preservation Guide with Optimal Timing of Pavement Preservation			5. Report Date: January 2021

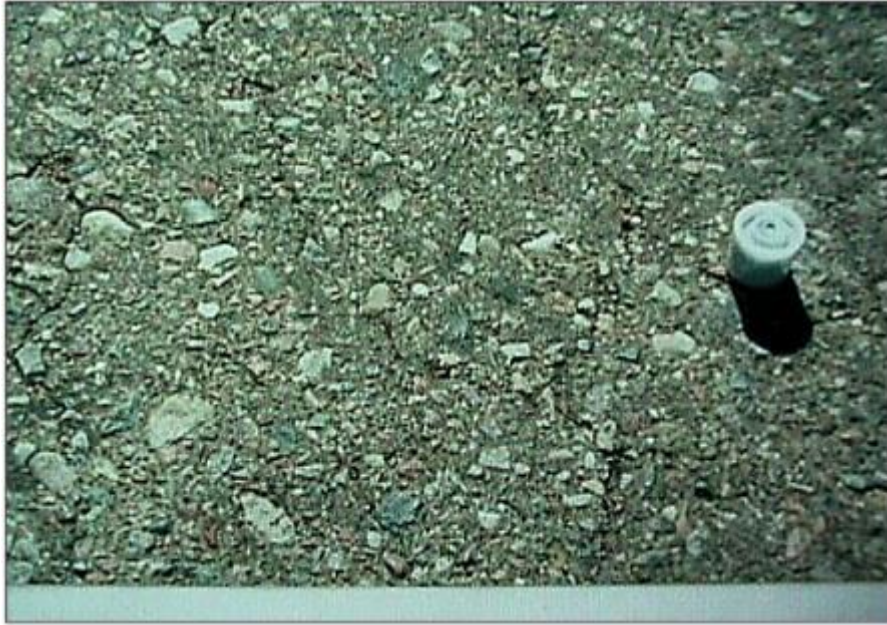
Figure 2, Figure 3, and Figure 4 show some typical situations where fog seals are suitable.

**Figure 2. Photo. Aged dense graded HMA.**

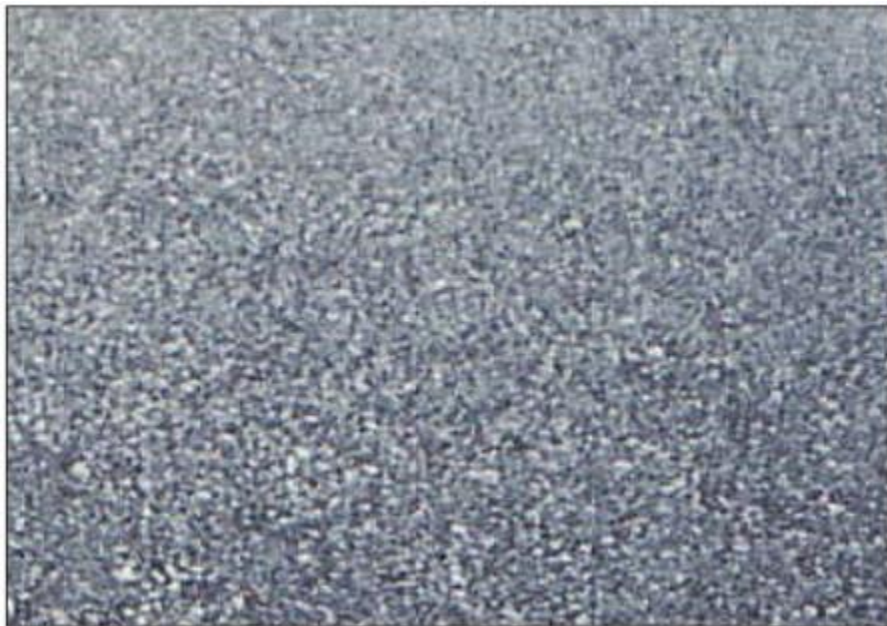
**Figure 3. Photo. Open graded HMA.**

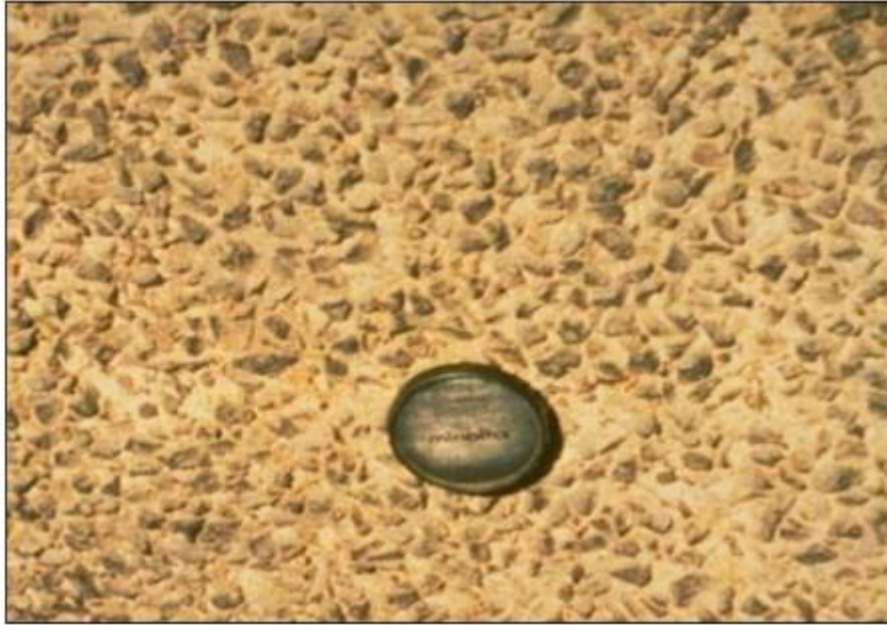
**Figure 4. Photo. Chip seal.**

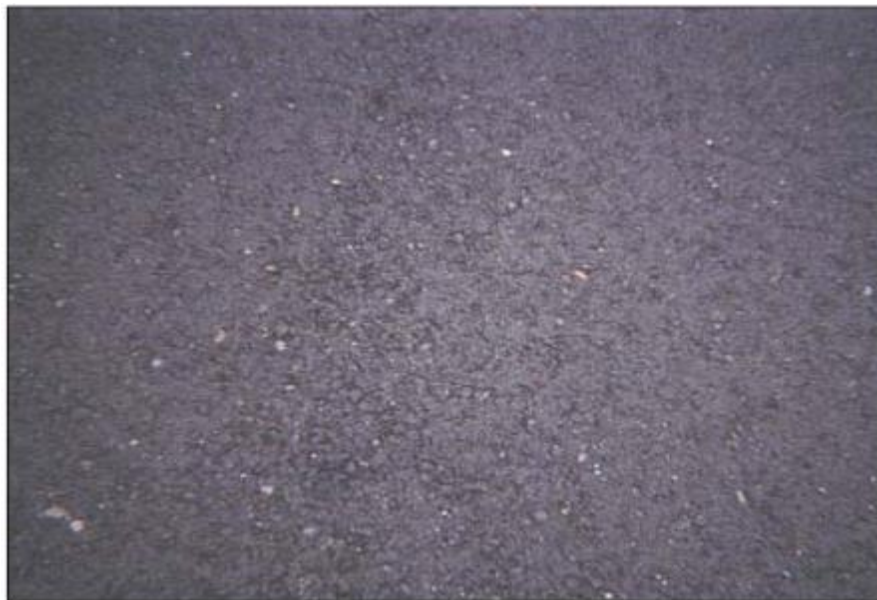
In contrast, dense graded HMA with closed surface texture is not suitable for fog seal (Figure 5).

**Figure 5. Photo. Dense graded HMA with closed surface texture.**

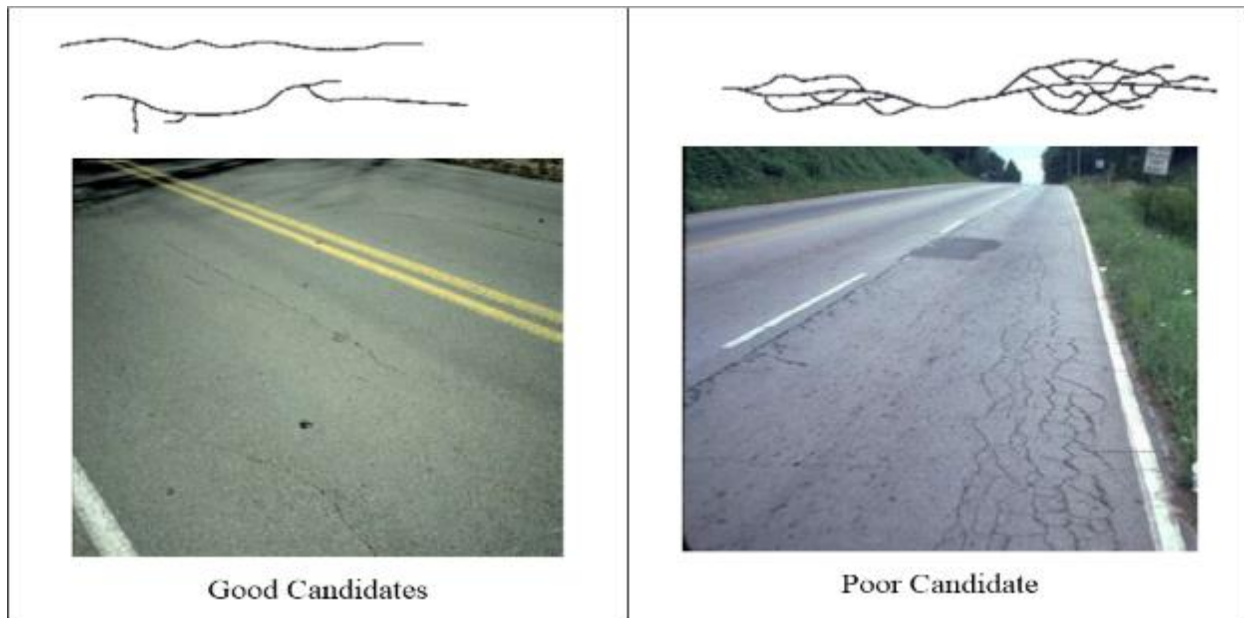
**Figure 6. Photo. Cracking Characteristics of Good and Poor Candidates (Decker, 2014; GDOT, 2007)**

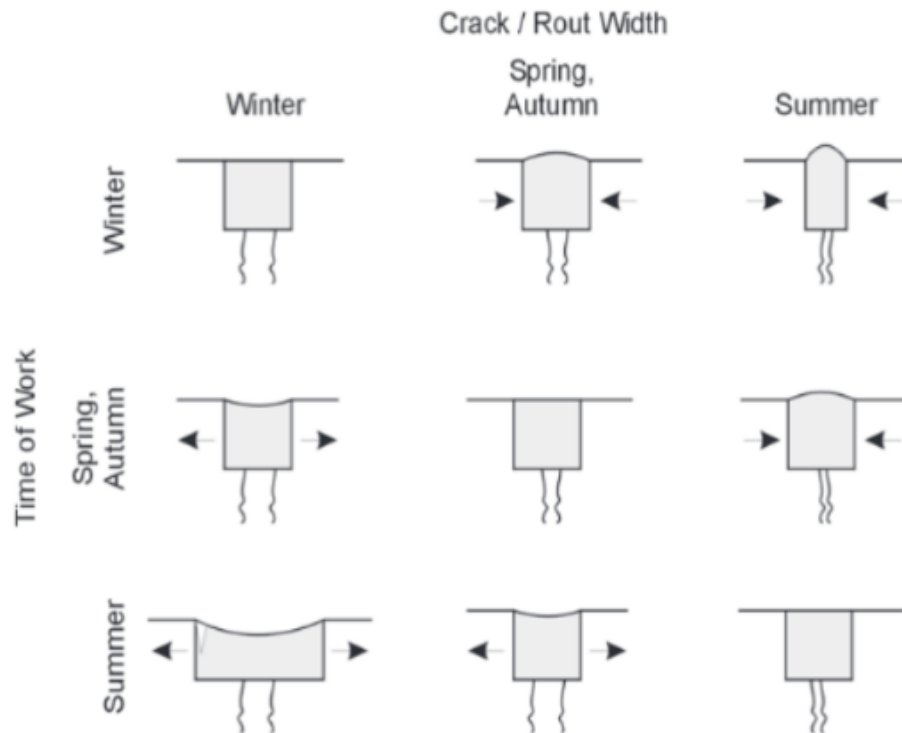
winter. Manufacturer and agency instructions and requirements specific to sealant use and ambient/surface temperature (typically 40 °F and rising) for routing and sealing should be followed. The application should not proceed if there is moisture on the pavement surface or in the cracks or if rain is imminent.

**Figure 7. Graph. Seasonal Impact on Sealing (Decker, 2014)**

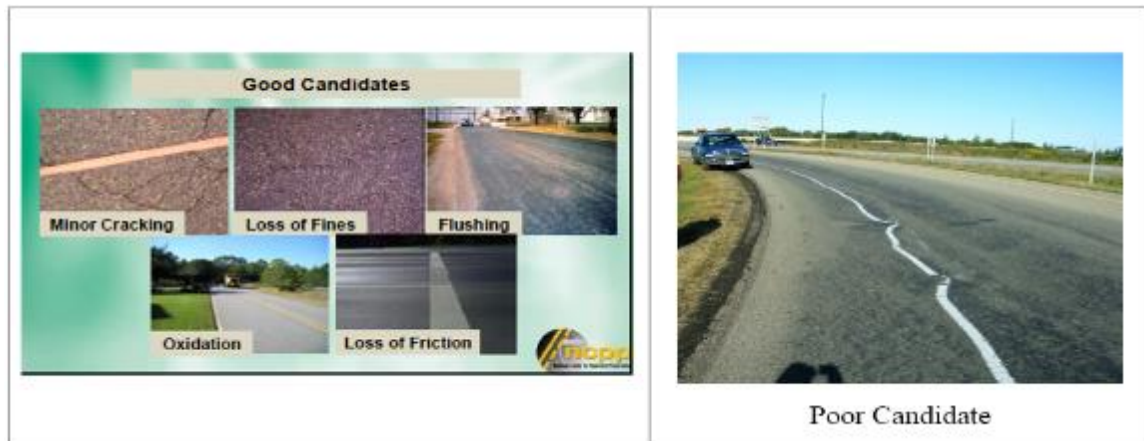
in the early stages of service, which can cause broken windshields if the chip seal is not properly constructed. Using modified binders and sand seals with the chip seal can alleviate some of these concerns. Good and poor candidates are shown in Figure 14, Figure 15, Figure 16:

**Figure 14. Photo. Chip Seal Good and Poor Candidates (NCPD)**

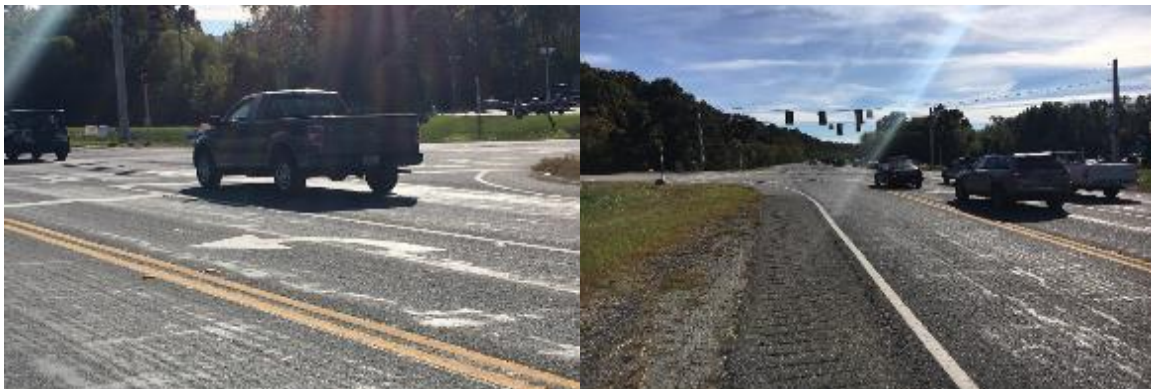
**Figure 15. Photo. Poor Candidates for Chip Seal**

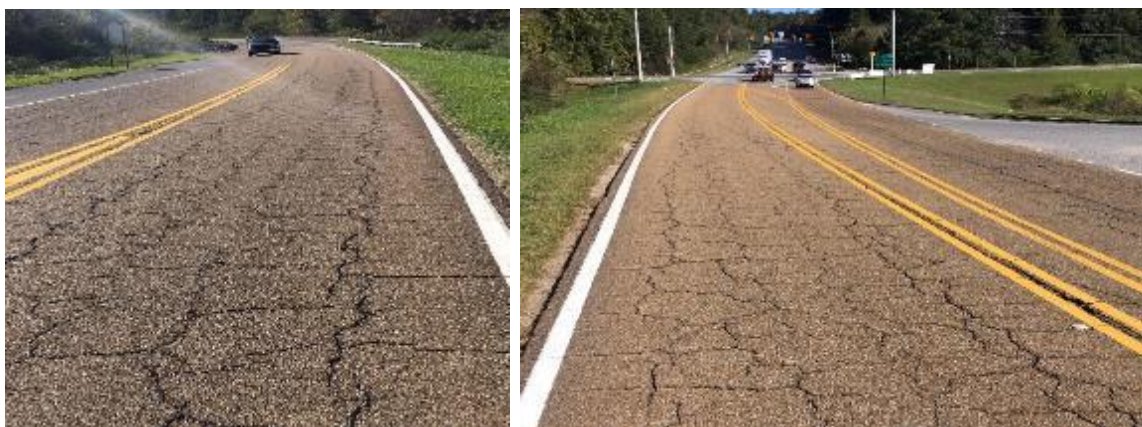
**Figure 16. Photo. Good candidates for scrub seal with cape overlay**

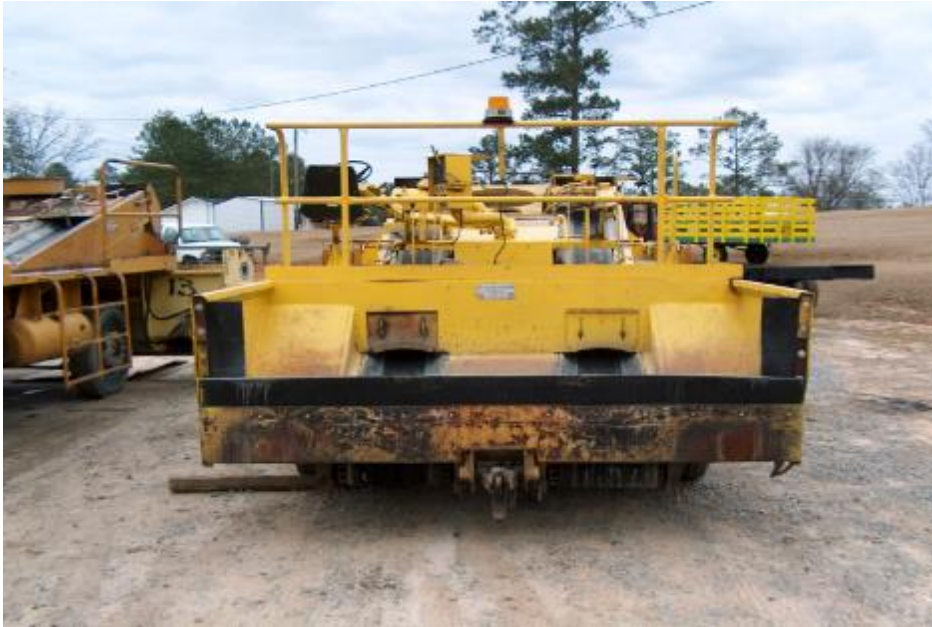
- 2) Truck movements on the fresh emulsion should be minimized.
- 3) The aggregate spreader should have a scalping screen to remove any large particles. The aggregate spreaders should be checked for proper calibration and wear. An aggregate spreader is shown in Figure 19:

**Figure 19. Photo. Aggregate Spreader**

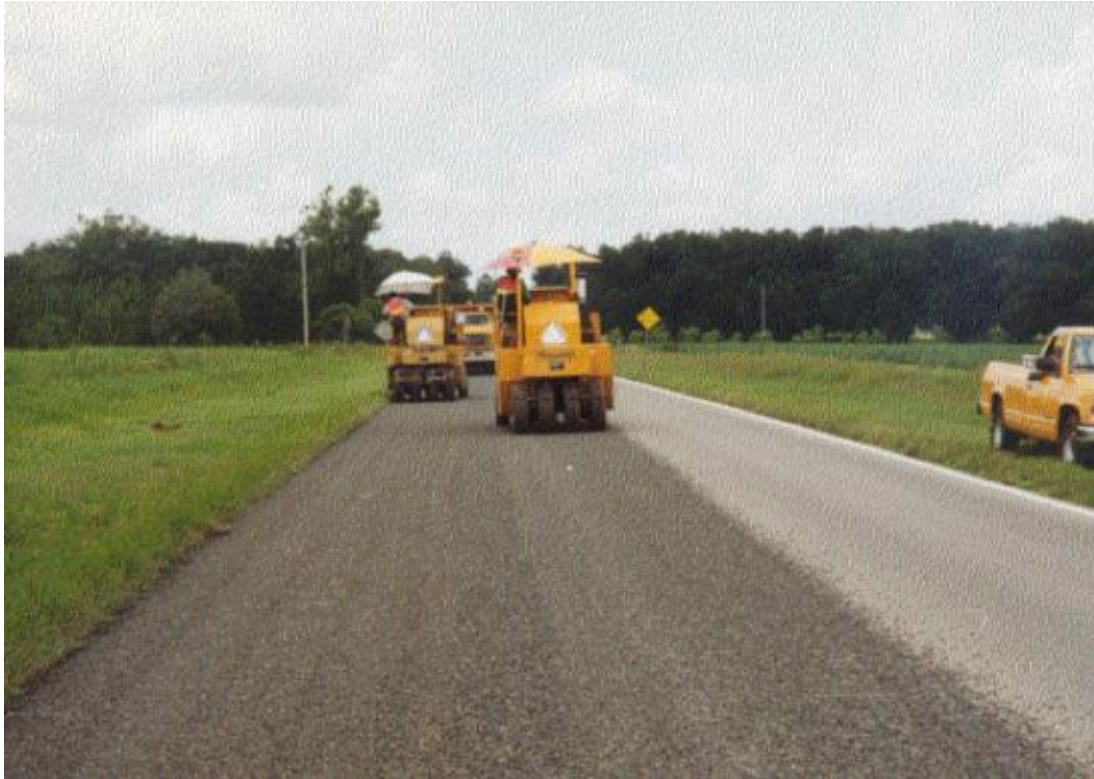
- 1) Rubber tire (pneumatic) rollers provide the initial compaction of the aggregate. A steel-wheeled roller may be used if it does not fracture the aggregate, but a minimum of two rubber-tired rollers are preferred. Rubber-tired rollers are shown in Figure 20.
- 2) The speed of rolling is a key consideration. In hot weather, rolling should be expedited to ensure proper embedment of aggregate. However, if rollers travel too fast, proper embedment will not be achieved.

**Figure 20. Photo. Rubber-tired Rollers**

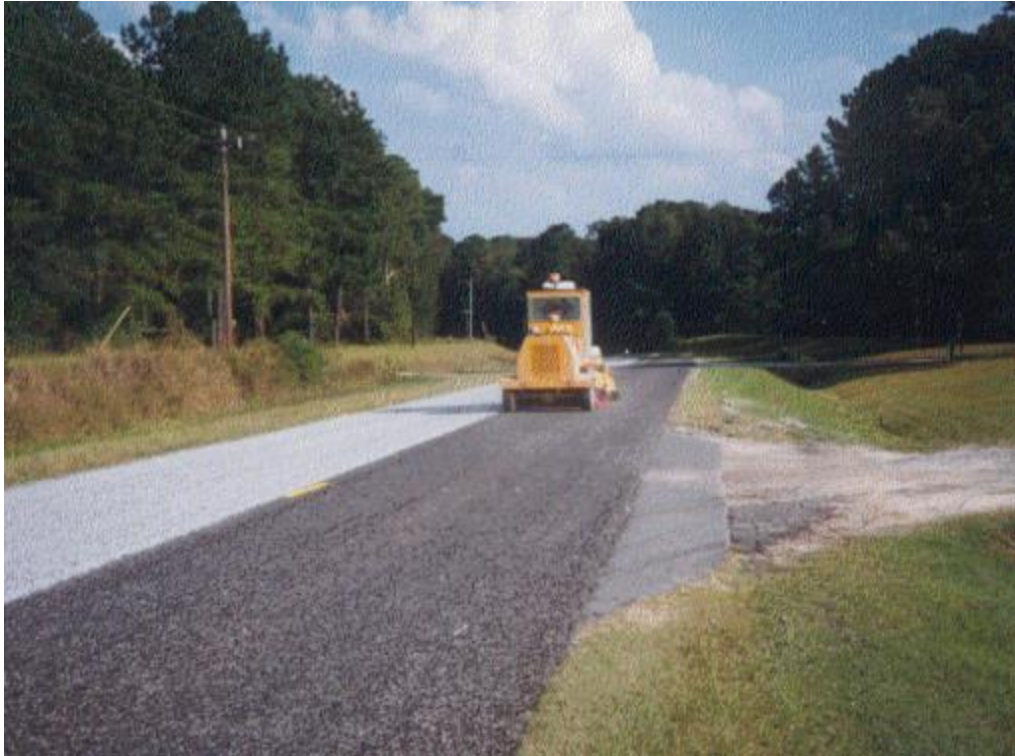
- 1) The new surface should be cleaned with a broom to remove any excess chips as soon as possible after rolling and before the pavement is opened to traffic. A power broom is shown in Figure 21.
- 2) During a multiple chip seal operation, sweeping is needed between the application of courses.
- 3) Care must be taken not to unseat bonded stone when sweeping.

**Figure 21. Photo. Power Broom**

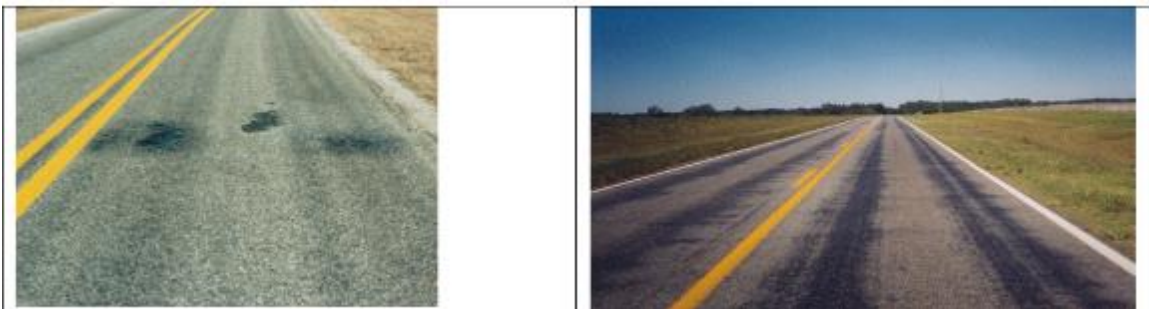
Bleeding is caused by uneven coverage of bituminous materials. Proper calibration and operation of the distributor should prevent bleeding. A bleeding joint and a bleeding wheel path are shown in Figure 22.

**Figure 22. Photo. Bleeding Joint and Bleeding Wheel Paths**

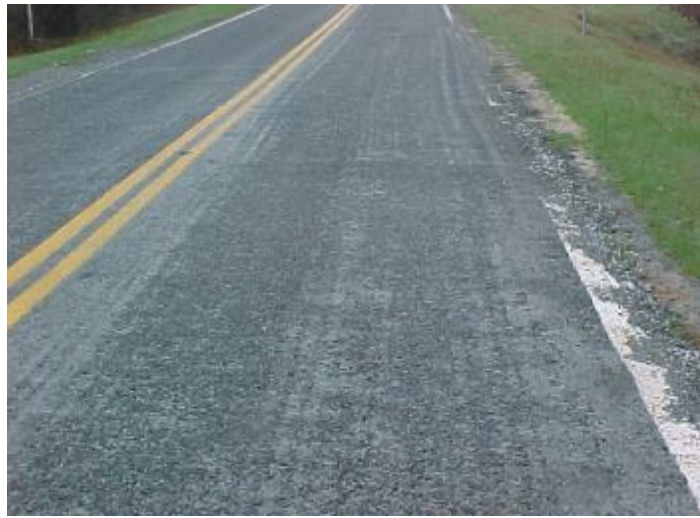
Streaking raveling is usually the result of allowing traffic on the chip seal too early. It will also result in loose stones, as shown on the edge of the shoulder in Figure 23:

**Figure 23. Photo. Streaking/Raveling**

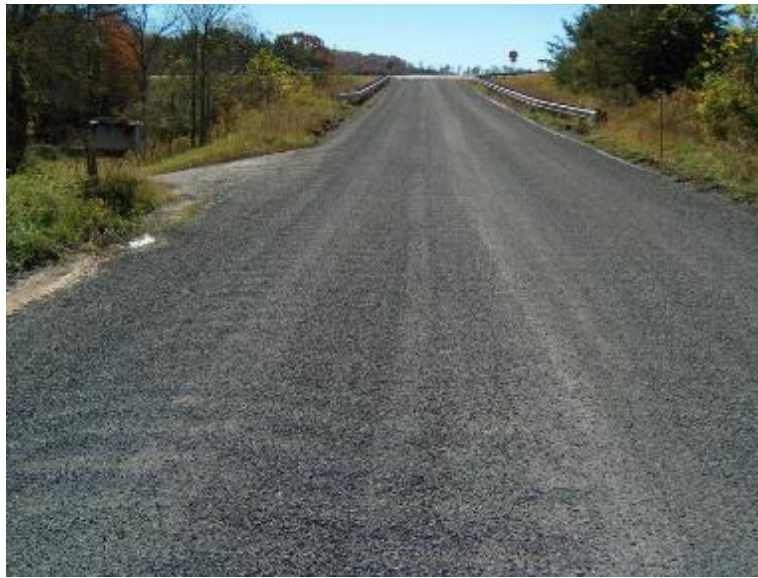
Corrugations can be the result of improper/excessive aggregate application rates. Corrugations are shown in Figure 24.

**Figure 24. Photo. Corrugations**

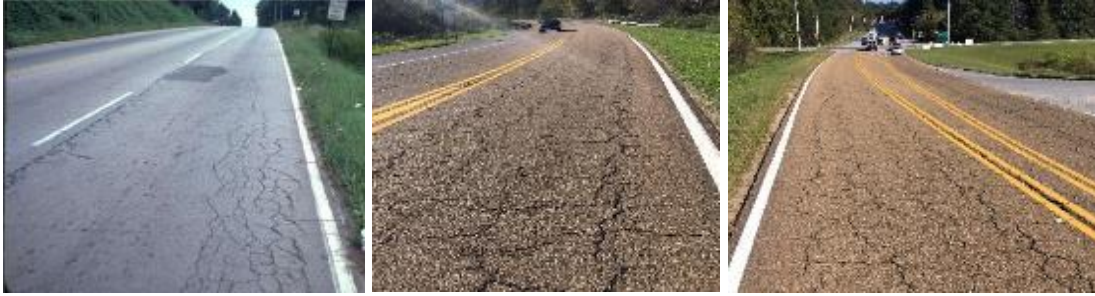
**Slurry seals** can seal and extend the life of an aged pavement. Pavements that are in good condition but on which the asphalt surface has oxidized are the best candidates for slurry seal. Slurry seal is not recommended for pavements with wide cracks (block cracking Severity Level 3 or 4) or alligator cracking (load cracking Severity Level 3 or 4) and/or excessive rutting (> 1/4 inch), or if the pavement is already exhibiting subgrade failure due to moisture (i.e. deep patching required). A slurry seal does not add structural capacity. Poor candidates for slurry seal are shown in Figure 25.

**Figure 25. Photo. Characteristics of Poor Candidates for Slurry Seal (GDOT, 2007)**

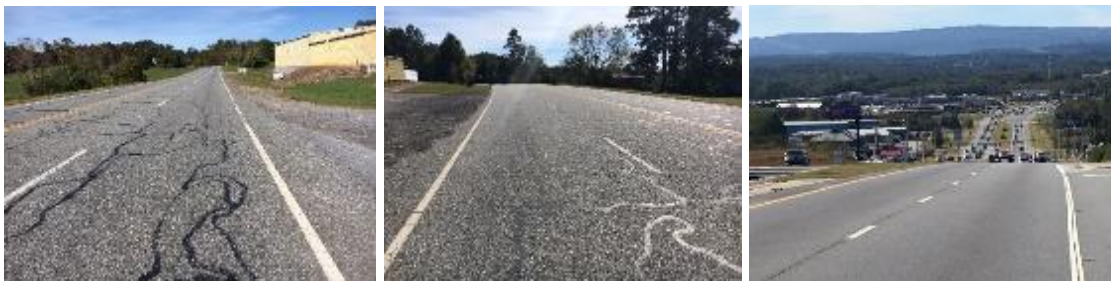
**Micro-surfacing** can be used on pavements that were considered for slurry seal but have higher levels of raveling or rutting than recommended for slurry seal. Pavements that are in relatively good condition but which have asphalt surfaces that have raveled, oxidized, or have become slightly rutted are the best candidates. Micro-surfacing is not recommended for pavements with wide cracks (block cracking Severity Level 3 or 4) or alligator cracking (load cracking Severity Level 4) and/or excessive rutting ( $>1/2$  inch), or if the pavement already is exhibiting subgrade failure due to moisture (i.e. deep patching required). Micro-surfacing, although it can be thicker than a slurry seal, still does not add structural capacity. Good candidates for micro-surfacing are shown in Figure 26.

**Figure 26. Photo. Good Candidates for Micro-surfacing**

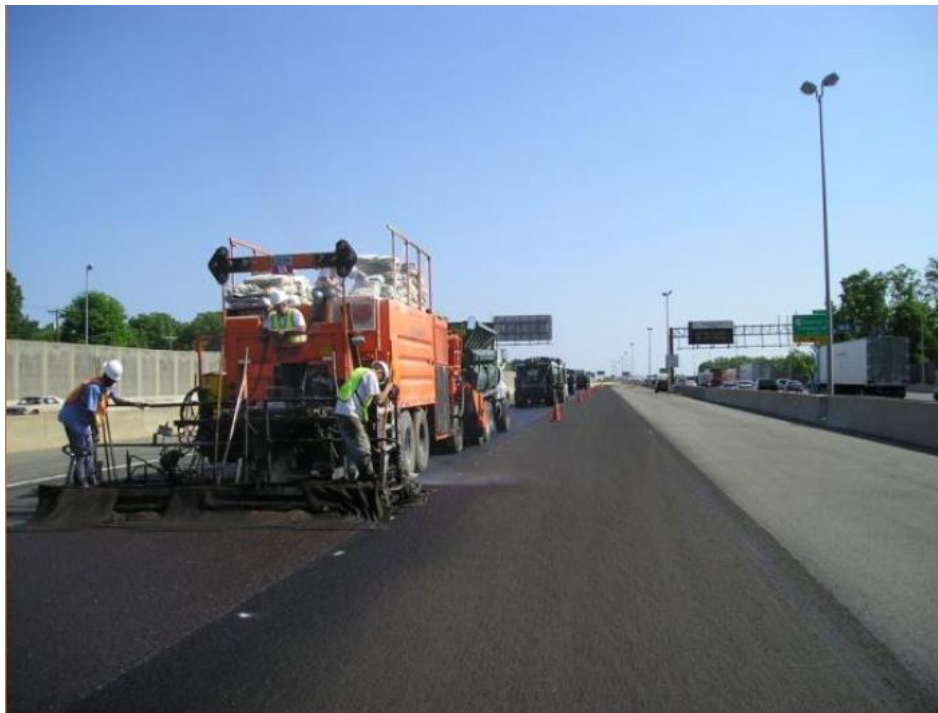
It is recommended that slurry seal be applied when the temperature is warm. The standard specification Section 427 provides seasonal limitations on the placement of slurry seal. The acceptable dates generally range from April to October, with the tightest time frames for the northern zones, and the widest range (April 1<sup>st</sup> to October 31<sup>st</sup>) for the southern zones. If there is moisture on pavement surfaces or in cracks or if rain is imminent, slurry seal should not be applied. Figure 27 shows the operations of slurry seal.

**Figure 27. Photo. Slurry Seal Operation (Source: Bill Evans, Ergon)**

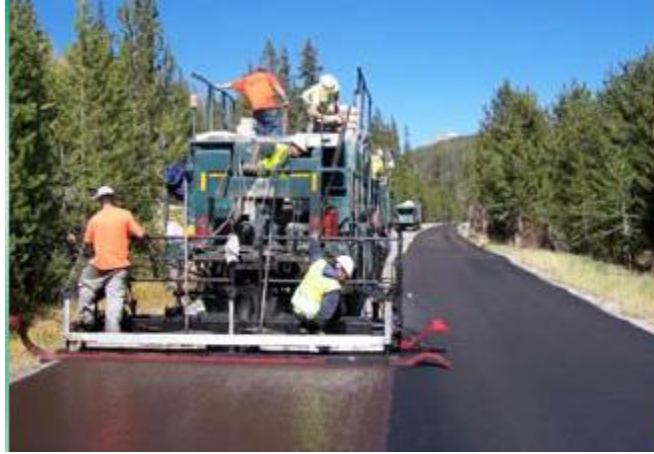
It is recommended that micro-surfacing be conducted when the temperature is warm. The standard specification Section 428 requires a minimum ambient and pavement temperature. If there is moisture on the pavement surface or in cracks or if rain or freezing temperatures are imminent, micro-surfacing should be accomplished. Figure 29 shows the operation of micro-surfacing.

**Figure 29. Photo. Micro-surfacing Operation (NCP, 2017)**

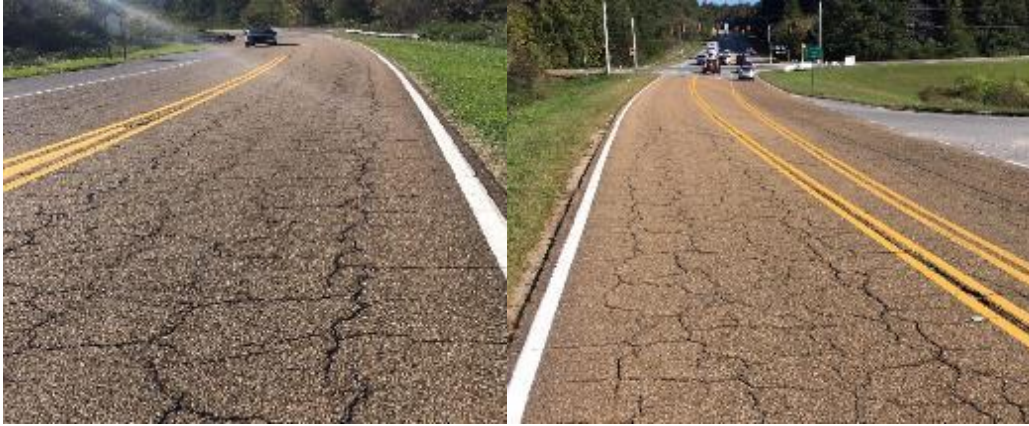
Therefore, when there are good structural conditions, selecting roads, including those with moderate or high severity levels, distresses for thin overlay maintenance is very important.

**Figure 32. Photo. Bad Candidates for Thin Overlay**

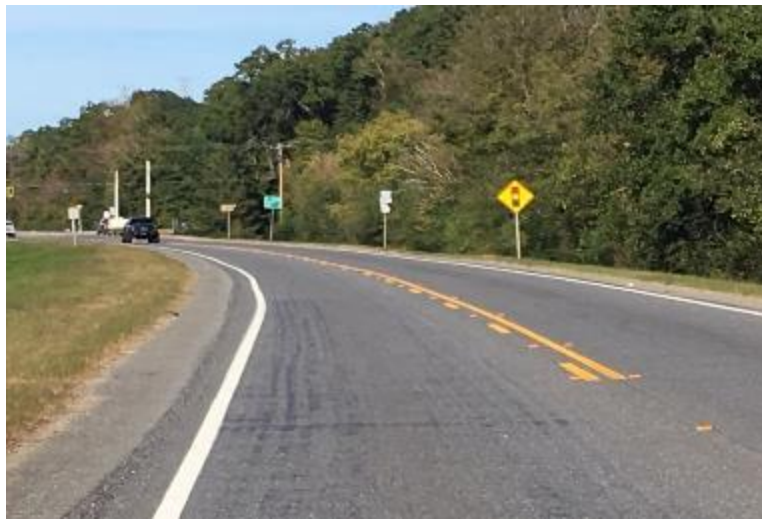
**Figure 33. Photo. Good Candidate for Thin Overlay**

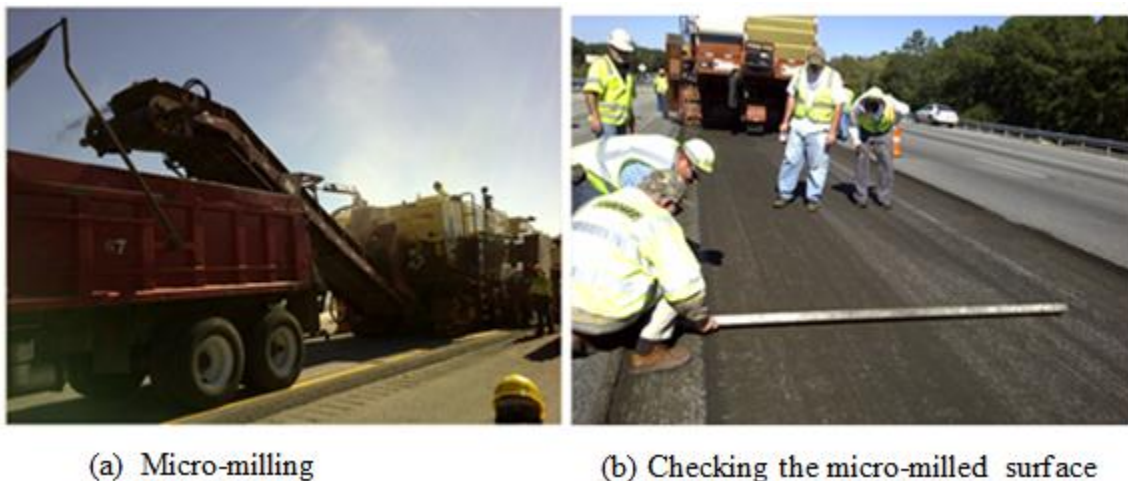
During the micro-milling operation, the micro-milling depth is measured frequently using a gauge, and the quality of the milled surface is visually inspected. The engineer also checks the slope and cross slope using a straight edge to ensure the milled surface aligns with the design.

Figure 35 shows the operation of micro-milling.

**Figure 35. Photo. Micro-milling Operation**

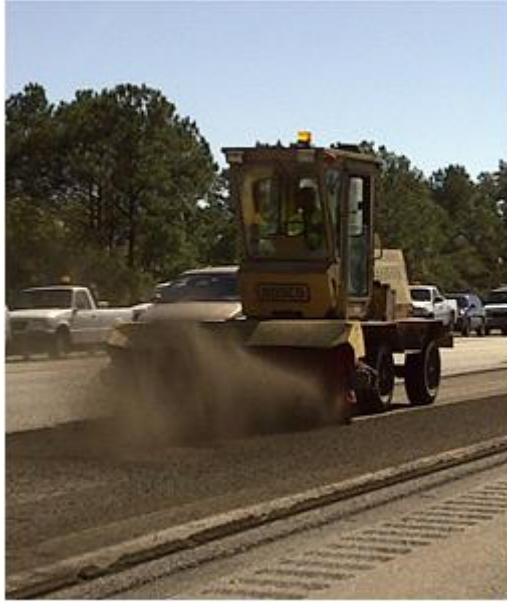
A clean milled surface free of loose aggregates, dirt, and dust is essential to ensure adequate bonding of the binder to the existing base layer. A cleaning process should immediately follow the micro-milling operation to remove loose aggregates and dust from the micro-milled surface. The contractor should sweep the surface dust using a power broom. Compared to cleaning a conventionally milled surface, the broom has to move slower to clean the micro-milled surface because the particles from the micro-milling operation are small. Figure 36 shows the operation of cleaning a micro-milled surface.

**Figure 36. Photo. Cleaning a Micro-milled Surface**

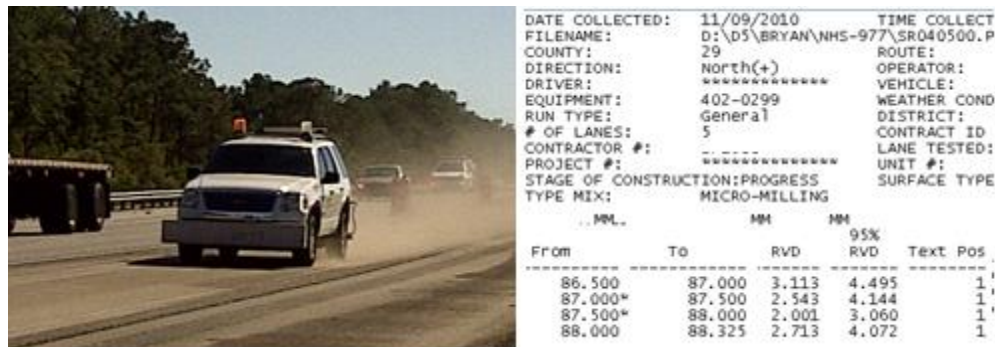
The RVD and IRI were measured on micro-milled surfaces using the laser road profiler to ensure quality. RVD is defined as the difference in height between the ridge (highest) and valley (lowest) points within the base length of 100.0 mm. Figure 37 shows GDOT's laser road profiler measuring the RVD and IRI. The following are the requirements for the micro-milled pavement surface texture:

- 1) Any areas exceeding 1/8 in (3.2 mm) between the ridge and valley of the mat surface or failing to meet pavement surface acceptance testing using the Laser Road Profiler shall require the underlying layer to be removed and replaced with material as directed by the engineer at no additional cost to GDOT. All corrective work shall be performed on a minimum 1000-ft section.

- 2) The indices for the smoothness of the milled surface measured have a target value of 825 mm/km and must not exceed the correction index of 900 mm/km.
- 3) The cross slope must be uniform, and no depressions or slope misalignments greater than 1/4 inch per 12 ft. (6 mm in 3.6 m) can exist when the slope is tested with a straightedge placed perpendicularly to the center line.

**Figure 37. Graph. Measure RVD Using GDOT's Laser Road Profiler**

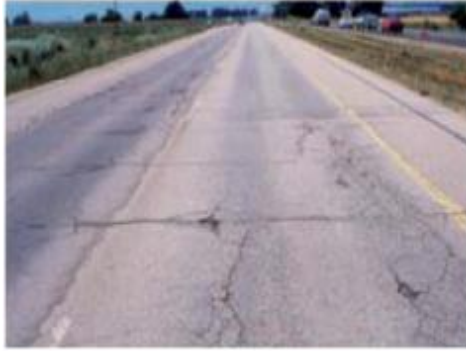
Asphalt intersections or asphalt pavements with mild to severe distresses from rutting and shoving (including PACES Severity Level 3 corrugation/pushing) are ideal candidates, shown in Figure 38, but it can be used on almost any type of asphalt pavement if properly designed.

**Figure 38. Photo. Ideal Candidates for White Topping (CP Tech Center, 2017)**

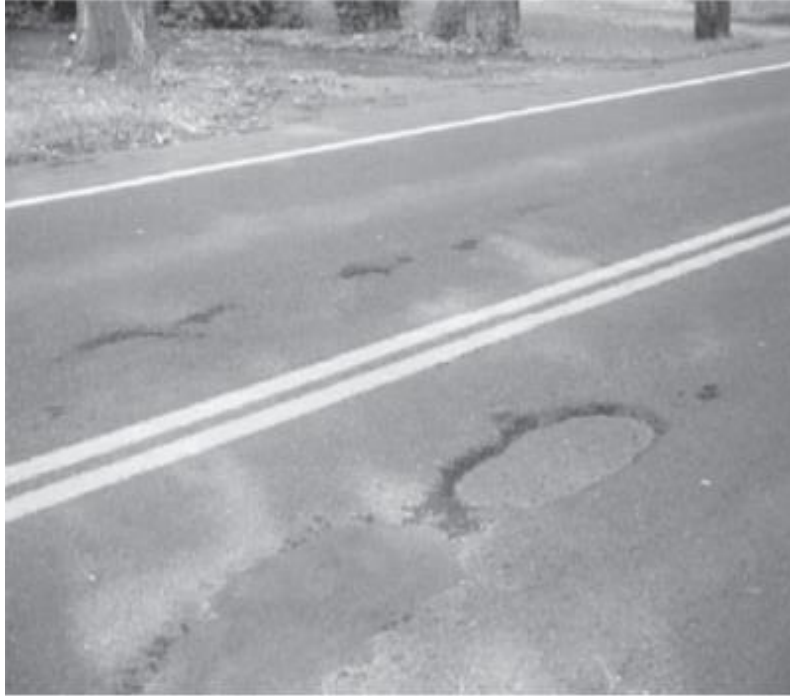
**Figure 40. Photo. Delamination of Surface Layer**

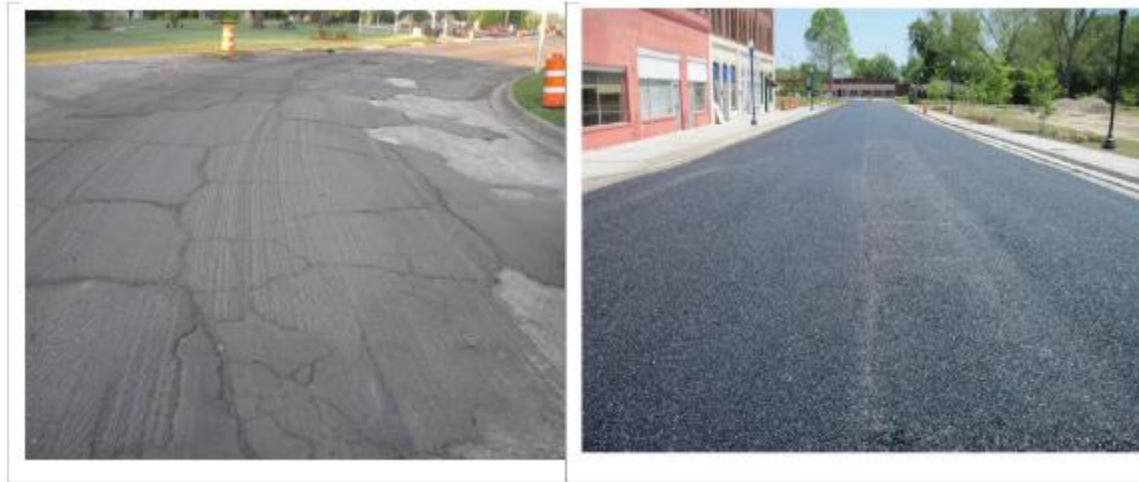
OGI is used as an interlayer for crack relief when milling and inlaying highly cracked pavements. Interlayers are intended to reduce reflective cracking from underlying pavement by dissipating the stress and movement from the underlying cracking. Projects that are candidates for an interlayer typically have higher levels of Types 2 and 3 cracking or minimal levels of Type 4 cracking. Heavily cracked pavements should be appropriately evaluated for more extensive rehabilitation prior to placing an interlayer, as not all movement can be arrested with an interlayer treatment. Figure 41 shows OGI project before OGI and after OGI.

**Figure 41. Photo. OGI Project (a) Before OGI and (b) After OGI (GDOT)**

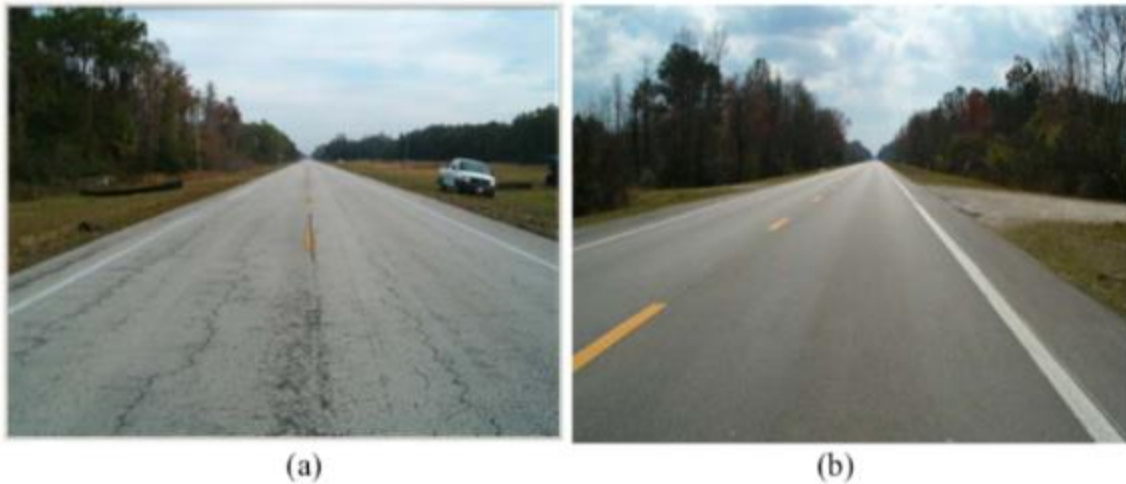
Figure 44 shows HIR project before HIR and 7 years after HIR.

**Figure 44. Photo. HIR Project (a) Before HIR and (b) 7 Years Later (NCAT, 2011)**

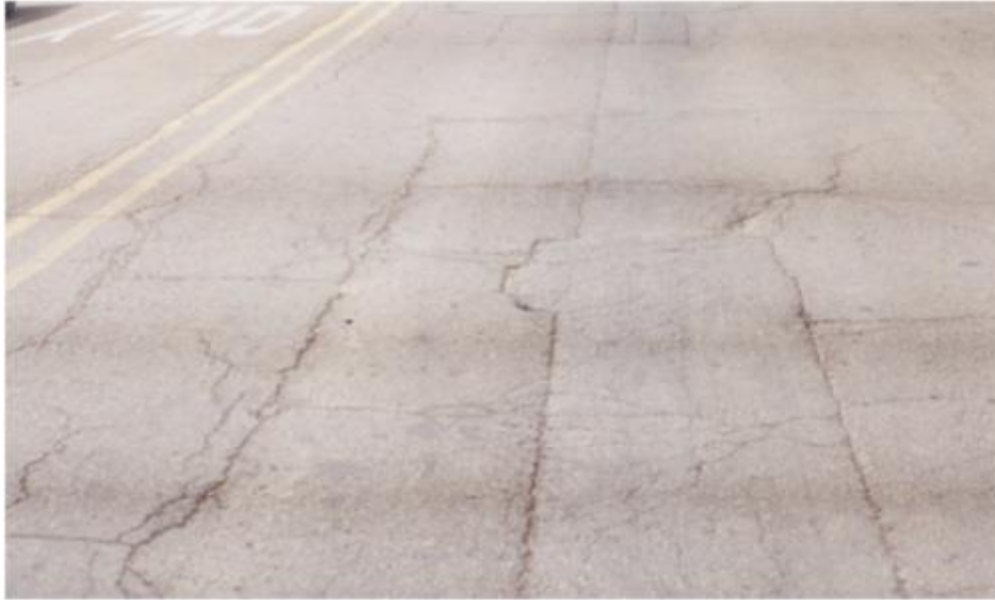
Asphalt pavements with distresses related to oxidization or non-structural raveling are ideal candidates. The pavements may have minor distresses from cracking (PACES Severity Level 1 or at most Level 2 block cracking), minimal rutting and shoving (PACES Severity Level 1 rutting), or very minimal patching. Pavements with high severity fatigue (alligator) cracking or structural distress, like base or subgrade failures, are not suitable candidates for HIR. Asphalt pavements that have had multiple crack seal treatments, also, may not be suitable projects, depending upon the material used for crack sealing, since the heating process can affect the sealant to the point of making it flammable or cause excessive smoke during the heating process. The type of surface mix in place can also retard the heating effect; therefore, HIR should also not be used on rubber modified mixes or open-graded surface mixes. Figure 45 shows the pavement distress suitable for HIR.

**Figure 45. Photo. Pavement distress suitable for HIR (NCAT, 2011)**

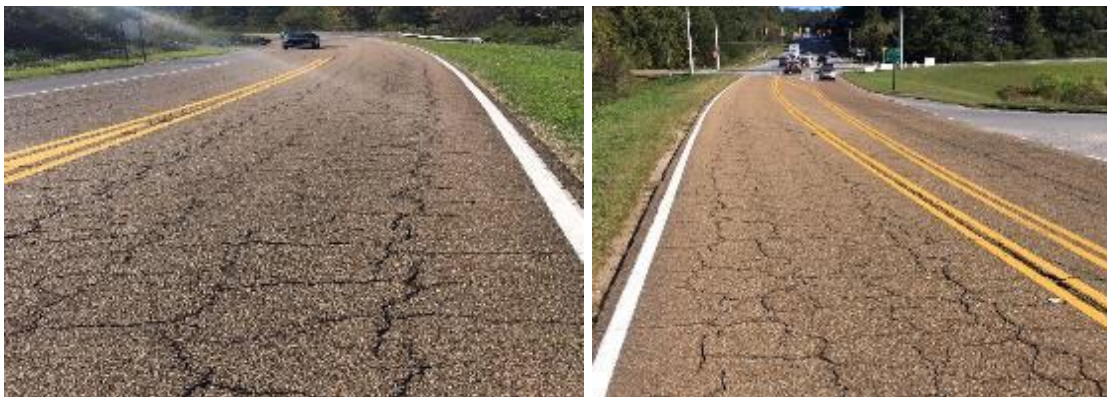
Since the HIR process involves heating the pavement, roadways with very shallow utilities or roadways with bushes or other flammable materials, or landscaping hanging over or close to the roadway could pose a hazard. Figure 46 shows good candidates for HIR.

**Figure 46. Photo. Good candidates for HIR**

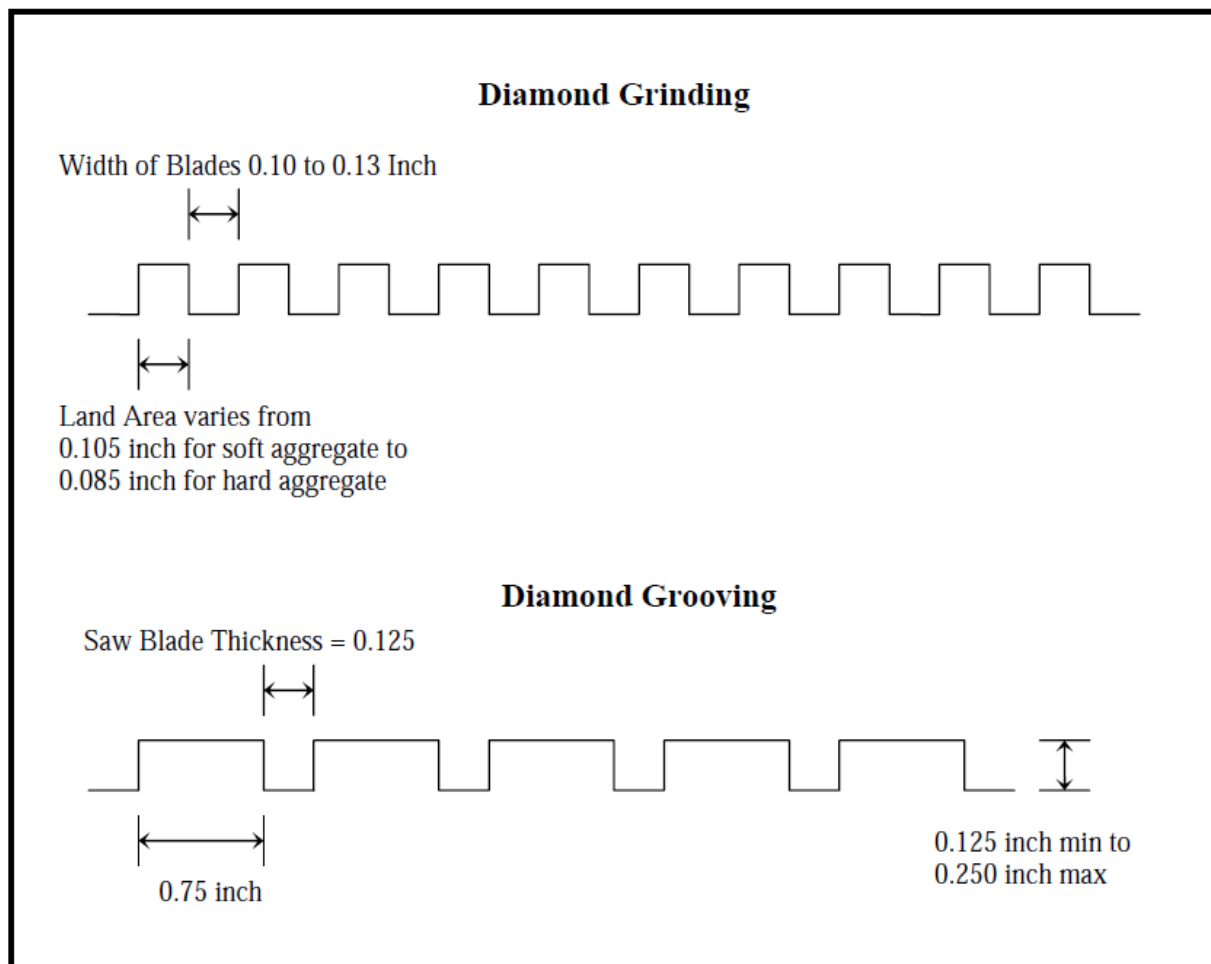
grooving is mainly used to produce channels to collect water and drain it from the pavement surface, thus reducing wet weather crashes caused by hydroplaning. Second is the difference of pavement surface texture after grinding and grooving. Figure 54 shows that the land areas of these two techniques are quite different, and the land area of diamond grooving is much longer than diamond grinding.

**Figure 54. Diagram. Diamond Grinding and Diamond Grooving (NMDOT, 2007)**

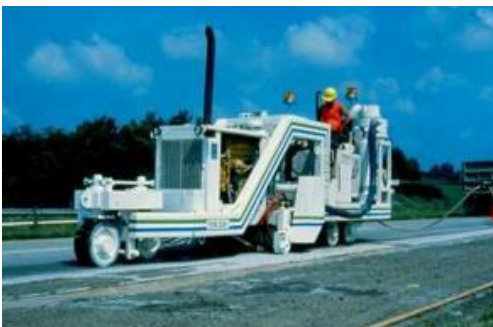
Diamond grinding equipment uses diamond saw blades that are gang mounted on a cutting head (Figure 57 and Figure 58). The three most important factors that are to be considered for a grinding machine are 1) weight of the machine; 2) the horsepower available to the grinding head, and 3) the grinding head (Correa & Wong 2001).

**Figure 57. Photo/Diagram. Grinding Equipment**

The front wheels pass over a bump or fault, and the centrally mounted cutting head will shave off the bump or fault. The rear wheels follow in the smooth path left by the grinding head. The cutting head usually has a width ranging from 910 to 970 mm (36 to 38 inch), but newer machines may go up to 1,200 mm (47 inch). Generally, appropriate texture is produced by a machine with spacing of 164 to 194 diamond blades per meter (50 to 60 per foot) of shaft (Correa et al., 2001).

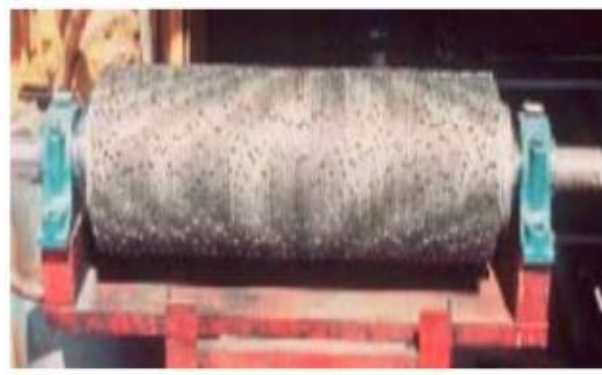
**Figure 58. Photo. Diamond Saw Blade and Cutting Head (Caltrans DOT, 2008)**

From FHWA's report in 2001, the 3 most important factors that a contractor should consider when choosing suitable saw blades are: diamond concentration, diamond size, and bond hardness. Typical diamond saw blade and cutting heads are shown in Figure 58.

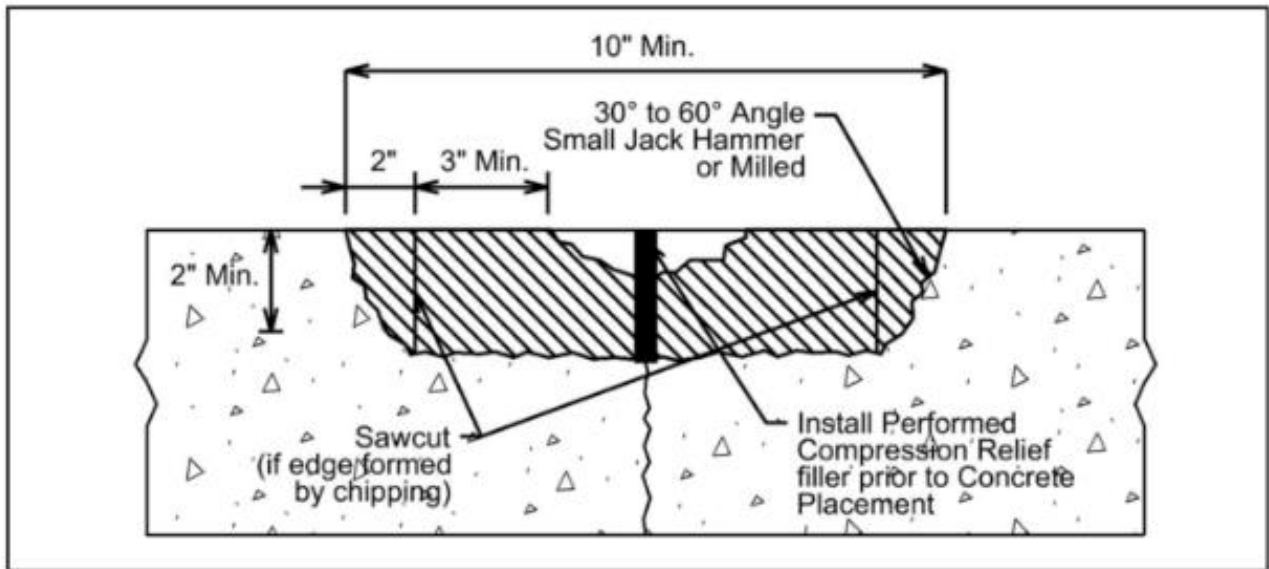
Partial-depth repairs usually includes 3 types: spot repair, long joint/crack repair, and bottom half repair. Spot repair and long joint/crack repair are standard partial-depth repairs; examples are shown in Figure 64 and Figure 65. Bottom half repairs are used for special repairs, including the bottom half of the slab. Spot repairs are usually between 10 inch and 6 ft long and typically used for pavements in which the existing load transfer devices (if any) are still functional (Daniel, 2011). Long joint/crack repairs are usually between 6 ft and one-third to one-half the depth of the concrete pavement in transverse and longitudinal joints. Figure 66 shows a deteriorated pavement corner for which bottom half repairs can be used. It should be noted that this repair is for work performed on the bottom half of the pavement; it should only be applied to edges or cross-joint locations and not exceed 18 inch (Daniel, 2011). For this study, we mainly focused on Type 1 and Type 2 PDR.

**Figure 64. Graph. Partial Depth repair (Spot and Long Joint/Crack Repair) (Daniel, 2011)**

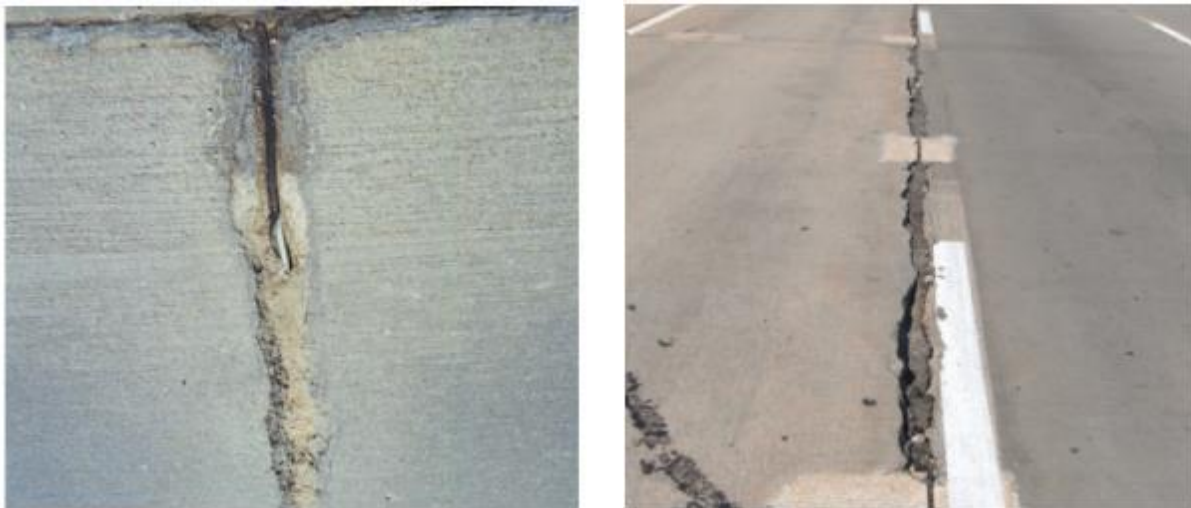
**Figure 65. Photo. Spot repair (Left) and Long Joint/Crack Repair (right) (Daniel, 2011)**

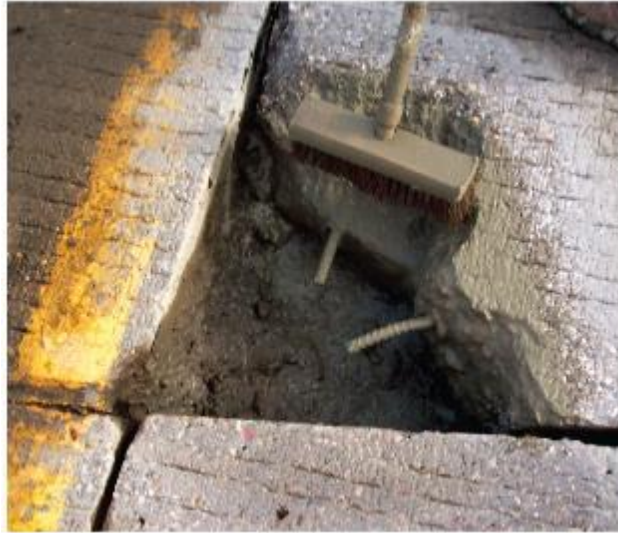
**Figure 66. Photo. Deteriorated Pavement Corner (Daniel, 2011)**

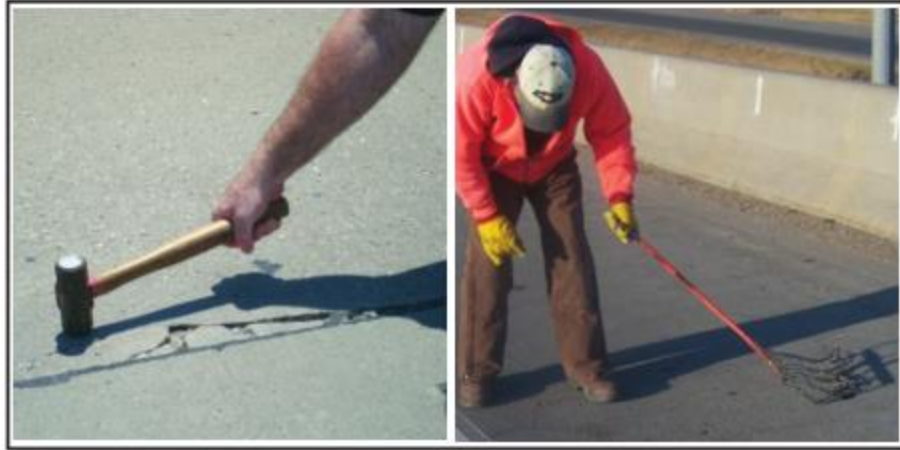
The repair area is first defined by listening to the sound given by a chain, ball peen hammer, or steel pipe striking the deteriorated pavement. Then, the boundaries for sawing and milling will be marked based on the area determination. The boundaries should extend 2 – 4 inch beyond the visible distressed area, and the suggest values for the PDR are as follows: length: 15 inch; width: 10 inch; depth: 2 inch (Daniel, 2011).

**Figure 67. Photo. Sounding deteriorated concrete using a hammer (left) and steel chain (right) (Frentress et al., 2012)**
