**GEORGIA DOT RESEARCH PROJECT 14-06**

**AN ENHANCED GDOT PAVEMENT  
PRESERVATION GUIDE WITH OPTIMAL  
TIMING OF PAVEMENT PRESERVATION**

1. Report No.: FHWA-GA-20-1406		2. Government Accession No.: N/A		3. Recipient's Catalog No.: N/A	
4. Title and Subtitle: An Enhanced GDOT Pavement Preservation Guide with Optimal Timing of Pavement Preservation			5. Report Date: January 2021

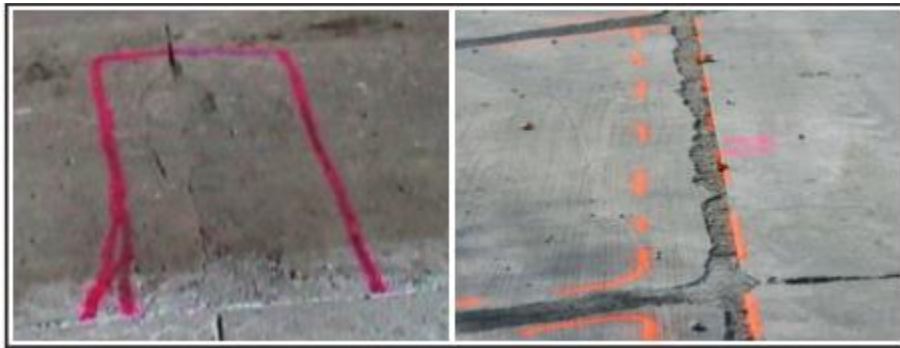
The repair area is first defined by listening to the sound given by a chain, ball peen hammer, or steel pipe striking the deteriorated pavement. Then, the boundaries for sawing and milling will be marked based on the area determination. The boundaries should extend 2 – 4 inch beyond the visible distressed area, and the suggest values for the PDR are as follows: length: 15 inch; width: 10 inch; depth: 2 inch (Daniel, 2011).

**Figure 68. Photo. Deteriorated Pavement Marked for Sawing (Frentress et al., 2012)**

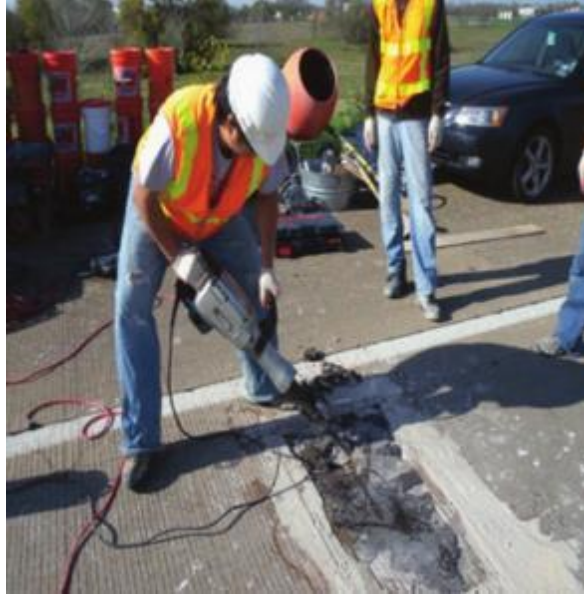
Concrete removal is often achieved by two methods: saw cutting and milling. Saw cutting is the most common method. However, it is recommended that patches be prepared using milling rather than saw cutting, since saw cutting requires more time and more patching material to fill repair areas (FHWA, 1999; Mulvaney, 2014). Different kinds of removal methods are referred to by the report by Frentress and Harrington in 2012.

**Figure 69. Photo. Removal Concrete with a Jackhammer (Jungheum, 2012)**

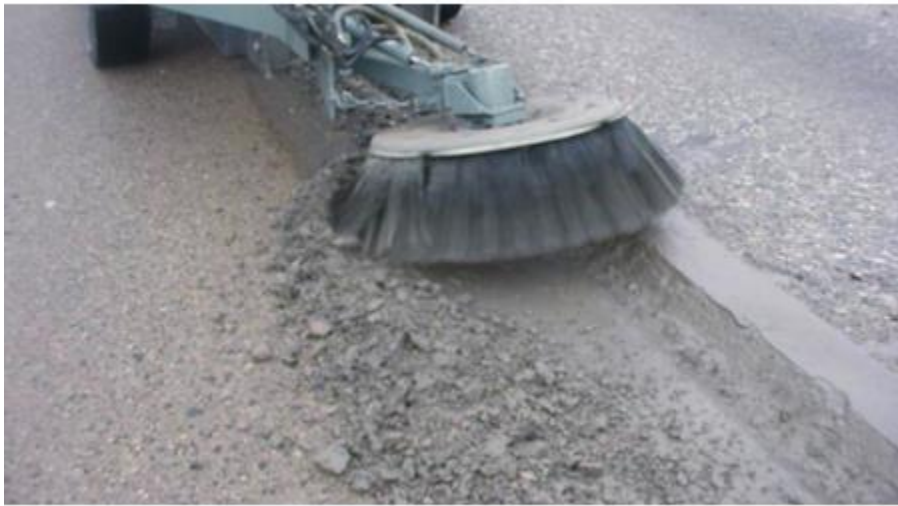
**Figure 71. Photo. Sweeping Loose Material (Frentress et al., 2012)**

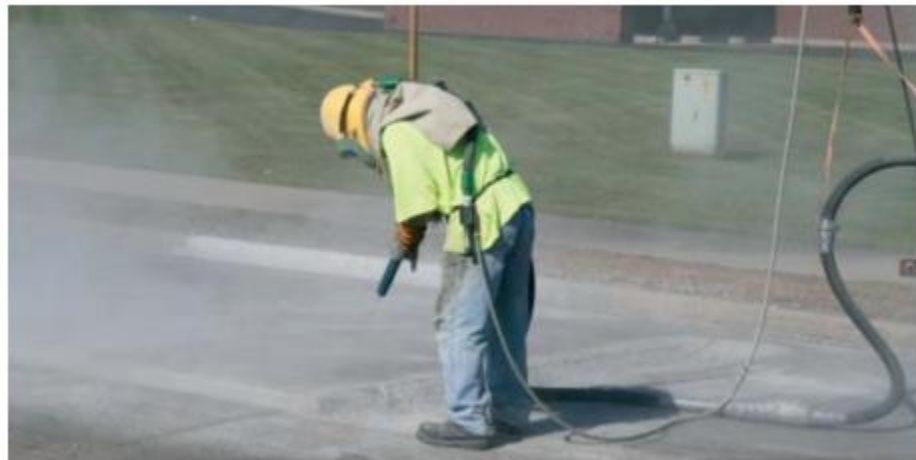
**Figure 72. Photo. Sandblasting to Remove Loose Debris (Frentress et al., 2012)**

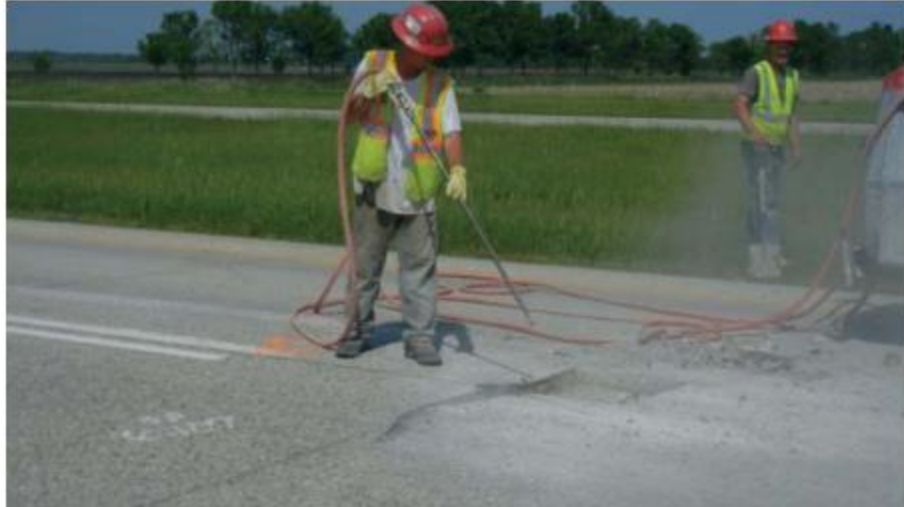
**Figure 73. Photo. Air Blasting to Remove Loose Debris (Frentress et al., 2012)**

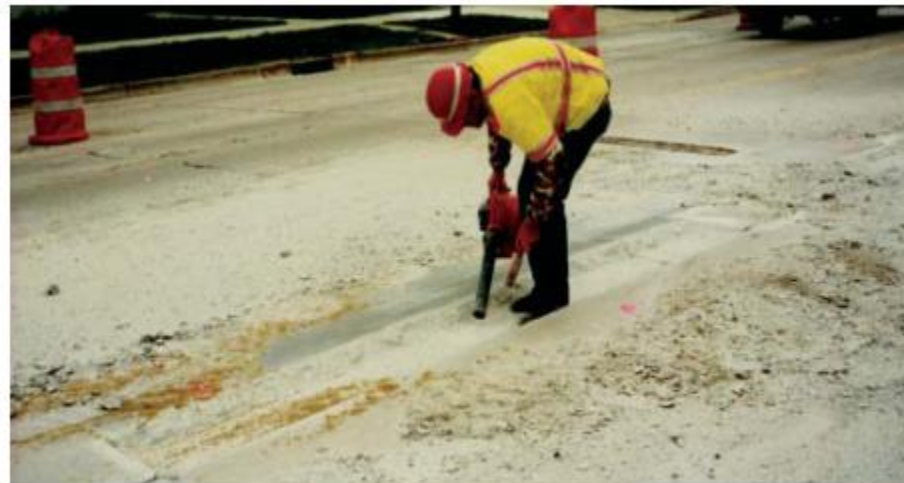
**Figure 74. Photo. Using a Leaf Blower for Final Removal of Any Contaminants**

**(Frentress et al., 2012)**

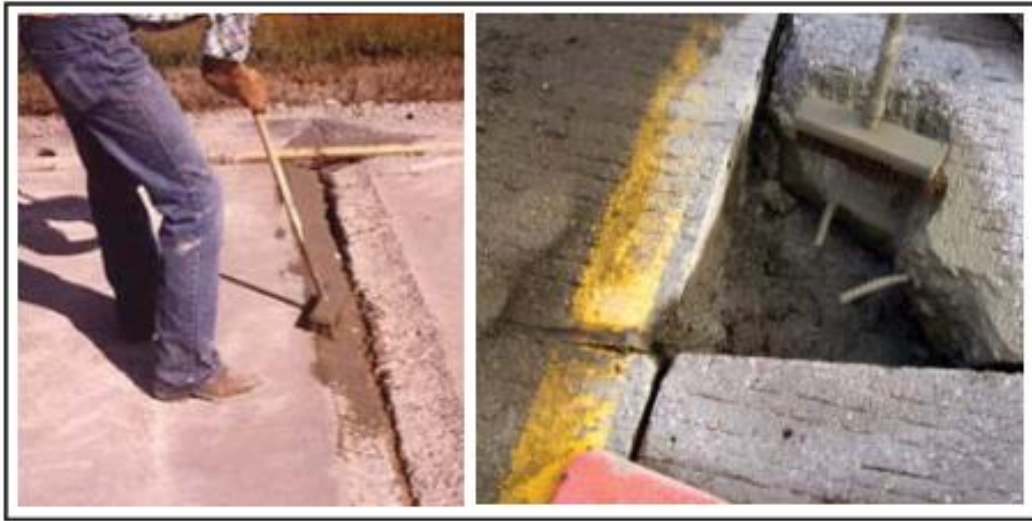
5) Apply bonding agent (do not allow to dry).

**Figure 75. Photo. Placement of Cement Grout as Bonding Agent (Frentress et al., 2012)**

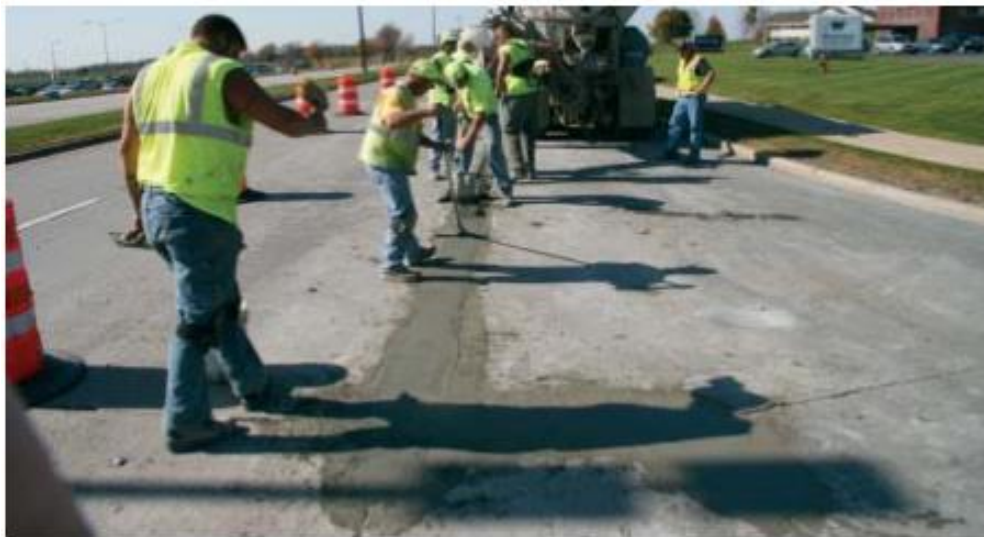
6) Place patch material

**Figure 76. Photo. Placement of Repair Material (Frentress et al., 2012)**

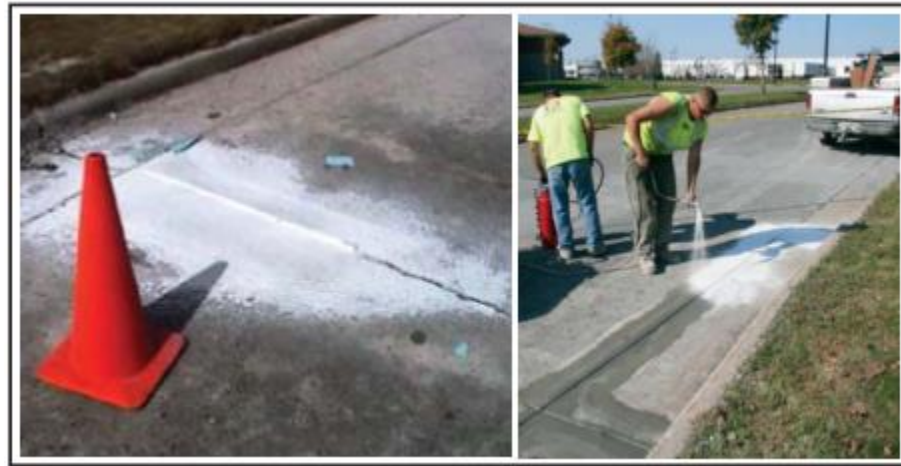
7) Apply curing compound.

**Figure 77. Photo. Curing of Repair Material (Frentress et al., 2012)**

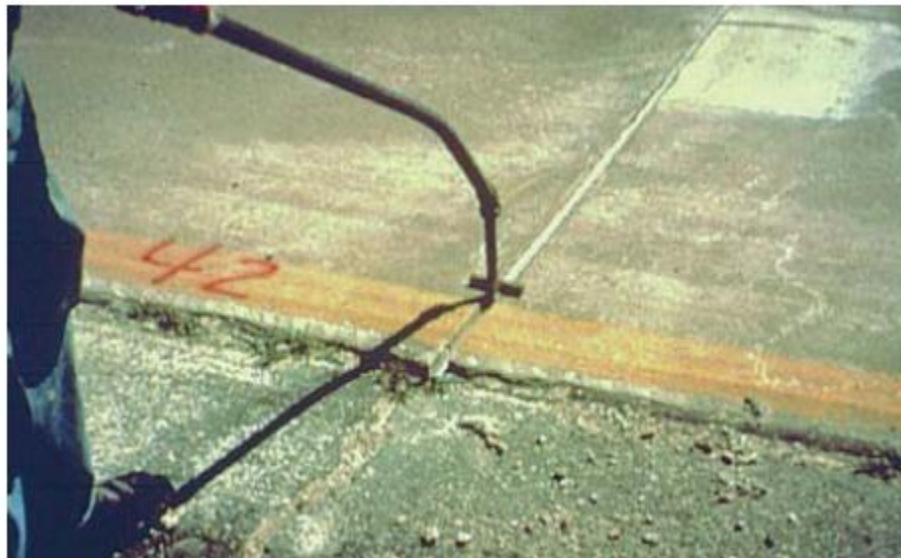
9) Seal joints.

**Figure 78. Photo. Joint sealing (Frentress et al., 2012)**

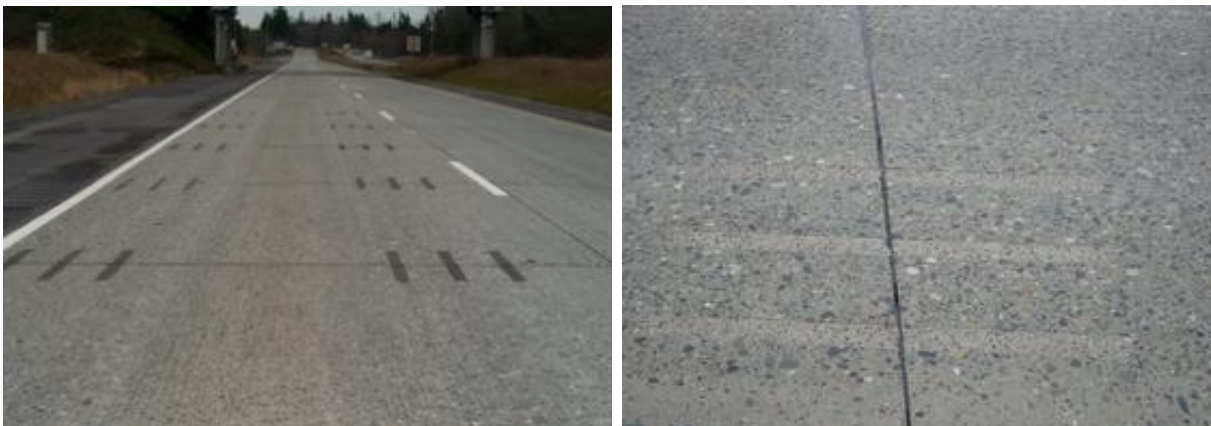
used to correct the faulting and bumping problem of concrete pavement. Figure 80 and Figure 81 show the bumping and faulting mechanism in a concrete pavement. Figure 82 shows a comparison of pavement before and after the dowel bar retrofit treatment. Since the 1970s, when Georgia started its DBR projects, this treatment method has been used in many states.

**Figure 82. Photo. Completion of Dowel Bar Retrofit (Pavement Interactive, 2014)**

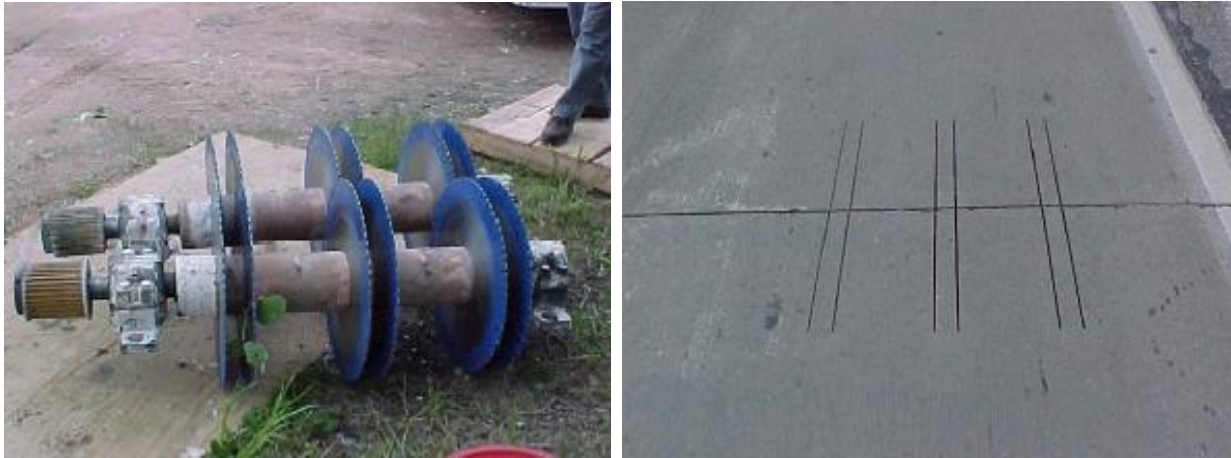
Slots: 1/2 inch wide and spaced 12 inch apart on the center (Pierce et al. 2003). Slots should be aligned to miss existing longitudinal cracks.

**Figure 84. Photo. Cutting Slots (Bischoff et al., 2002)**

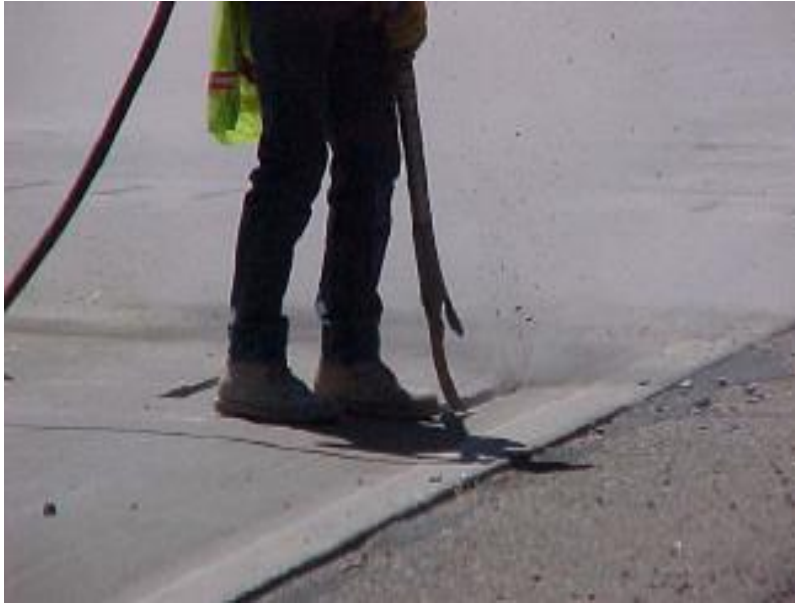
Next, the slots were sandblasted and blown using compressed air. Concrete chunks, dirt, debris, water, and slurry should be all cleaned off after these steps. During the cleaning process, the public should be protected from sand and blasting debris, as shown in Figure 85.

**Figure 85. Photo. Compressed Air Used to Blow Any Debris Out of the Slots**

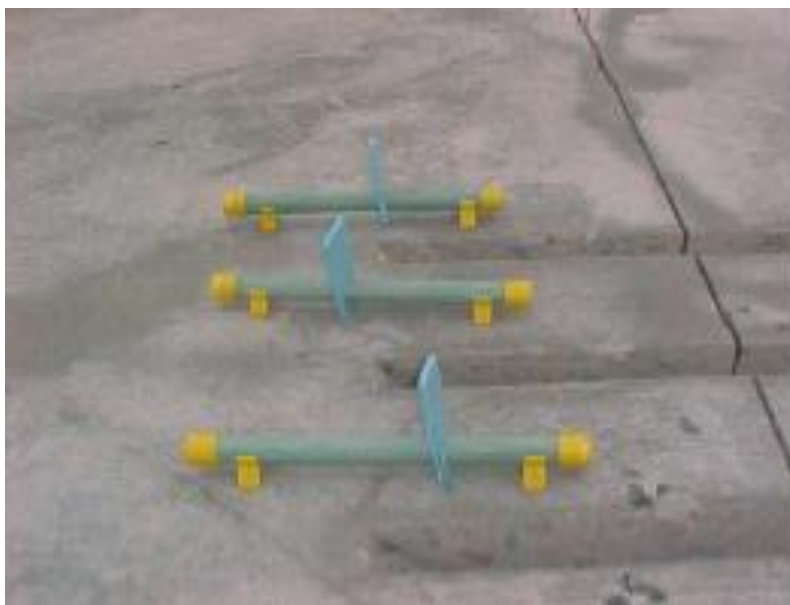
**Figure 86. Photo. Each dowel bar after preparation fitted with two end caps, two chairs, and a foam board (Bischoff et al.,2002)**

For example, the Wisconsin DOT uses the following 2 types of dowel bars for one of their studies: 1) The standard epoxy-coated steel dowel bars, which are 18 inch long and 1 1/4 inch diameter; 2) the Nuovinox dowel bars, manufactured by Stelax Industries, Ltd., which are 15 inch long and 1 1/4 inch diameter. After preparation, each dowel bar is fitted with two end caps, two chairs, and a foam board (Bischoff et al., 2002). A more detailed categorization of types of dowel bars is introduced in Figure 86. Table 22 shows the state highway practices for dowel bar diameter (inch) by pavement thickness, which is summarized from 2009 National Concrete Consortium questionnaire responses (NCPTC, 2011).

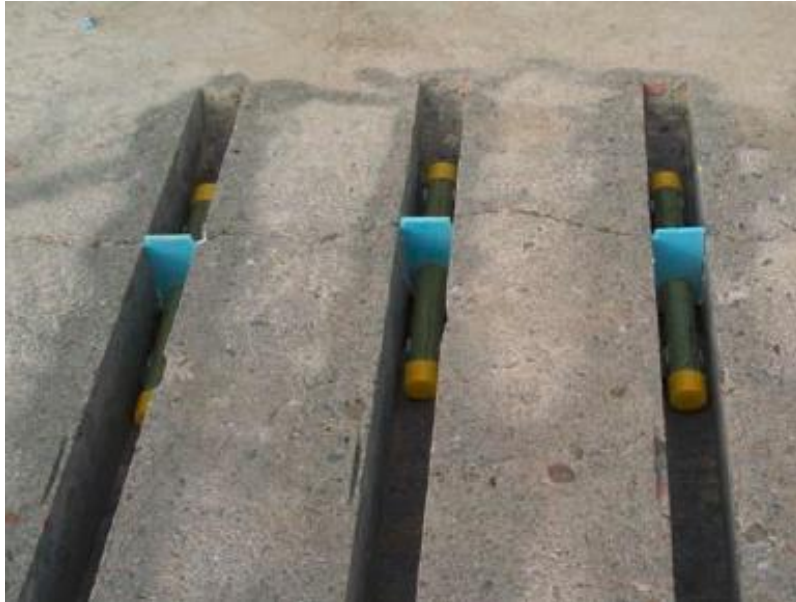
Once the slots have been cleaned and the dowel bars prepared, the dowel bars are ready to be put into the slots. Contractors should make sure that the dowel bar placement has the correct position. Figure 87 and Figure 88 show the dowel bars that have been placed and aligned in slots over a transverse crack. Generally, 3 dowel bars are placed per wheel path because of the study done by Florida, which showed that three dowel bars performed as well as 5 dowel bars for faulting. Tayabji (1986) identified the following categories of dowel misalignment: horizontal translation, longitudinal translation (side shift), vertical translation (depth error), horizontal skew (horizontal misalignment), vertical tilt (vertical misalignment)

**Figure 87. Photo. Dowel bars after placement**

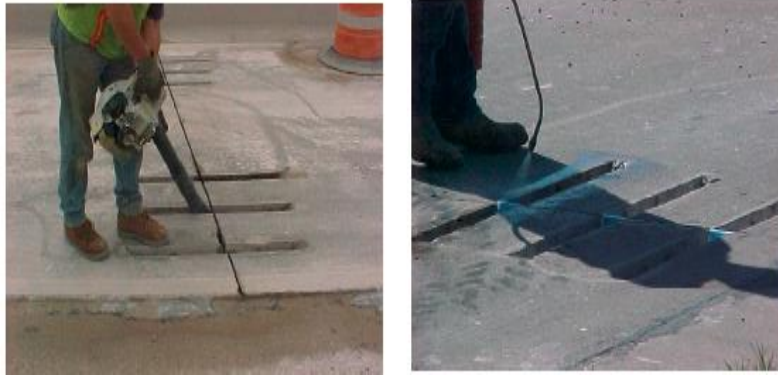
consistency. Then, the material is backfilled into the slots and consolidated by a spud vibrator around the dowel bar. Figure 89, Figure 90, and Figure 91 show that a spud vibrator is inserted in the slot on each side of the foam board to consolidate the patch material around the dowel bar.

**Figure 89. Photo. Slot preparation before patching (Bischoff et al., 2002)**

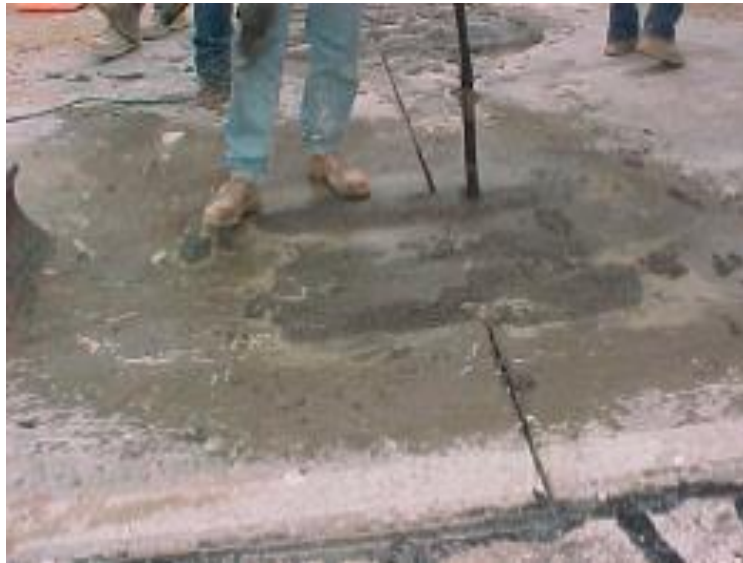
**Figure 90. Photo. Patching material consolidation (Bischoff et al., 2002)**

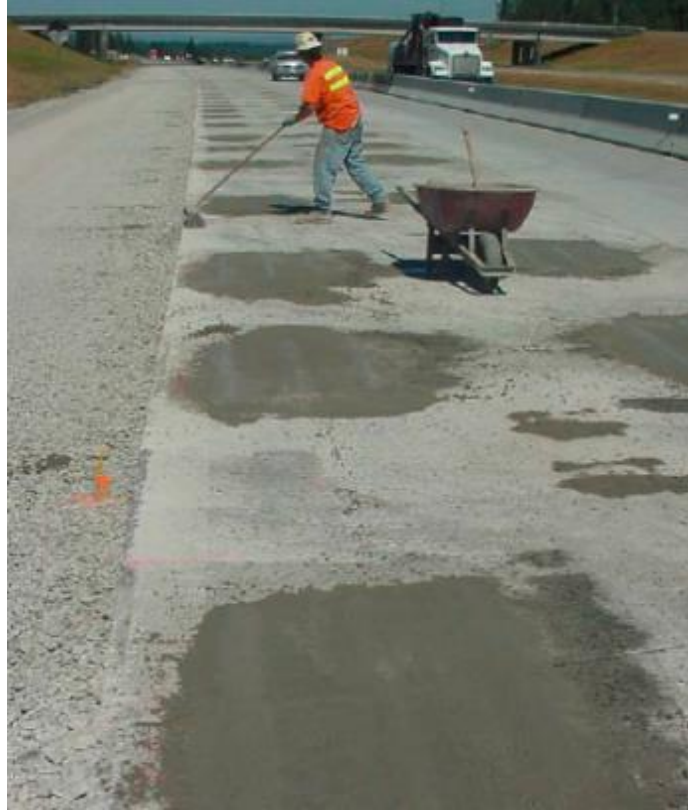
**Figure 91. Photo. Completed placement of patching material (Bischoff et al., 2002)**

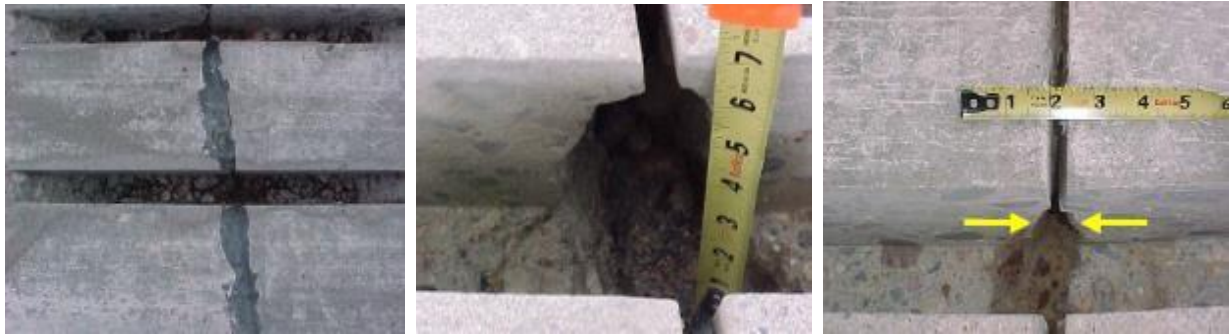
Patching material issues include poor bonding and poor consolidation, which can be seen in Figure 92 and Figure 93, which show examples from MnDOT.

**Figure 92. Photo. Potential pavement issues for dowel bar retrofit (Bischoff et al., 2002)**

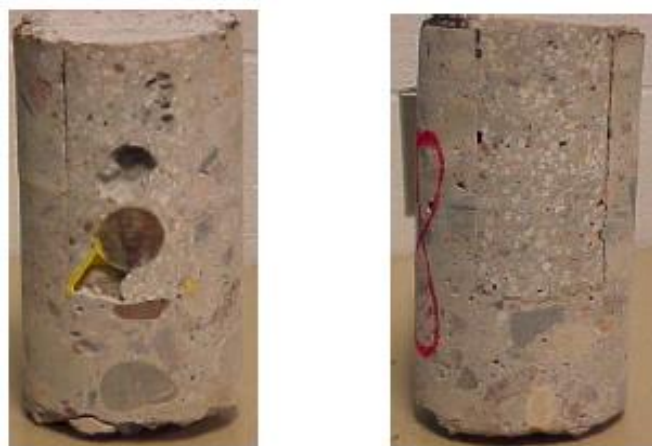
**Figure 93. Photo. Poor bonding and poor consolidation of patching material of MnDOT**

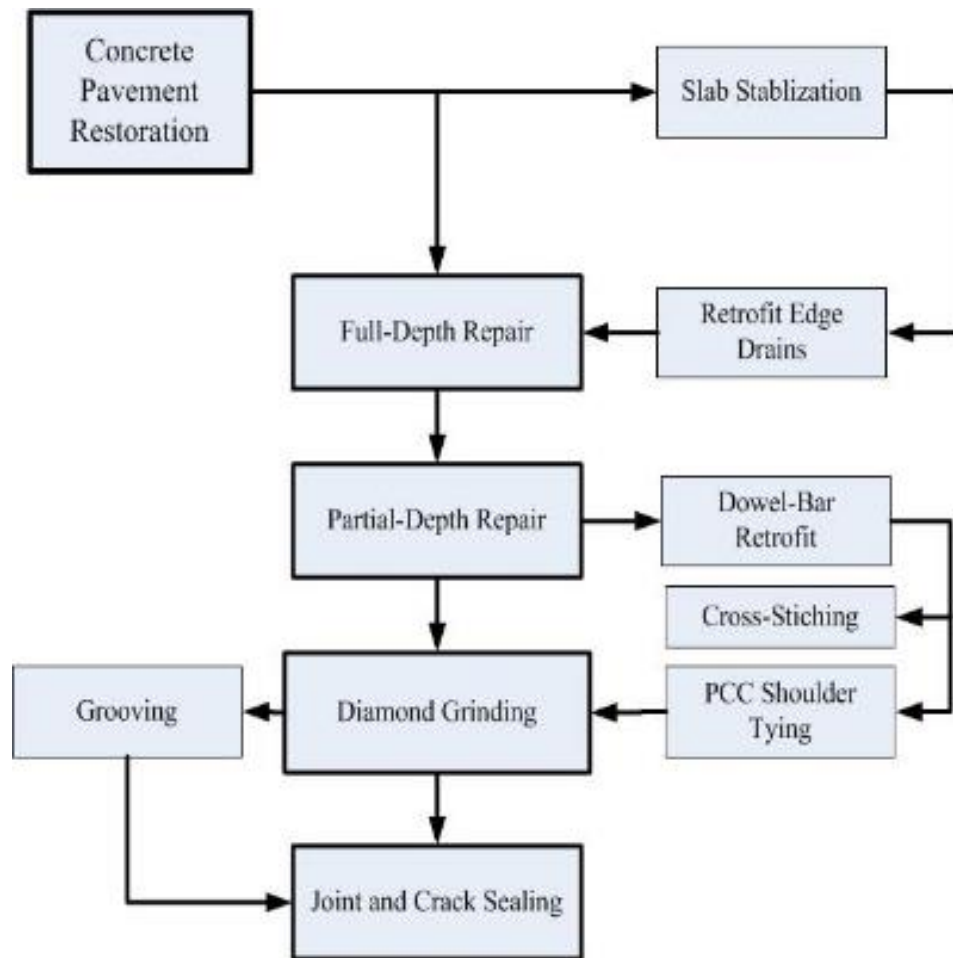
According to California DOT, full depth repair is suitable for transverse cracking with medium and high severity levels; longitudinal cracking with medium and high severity levels; corner breaks with low, medium, and high severity levels; spalling with medium, and high severity levels; blowup with low, medium, and high severity levels; D-Cracking with medium and high severity levels; and deterioration of existing repairs. According to ACPA, the suitable candidates are listed in Figure 97, Table 25, and Table 26.

Figure 97. Graph. CPR techniques (ACPA, 1997)

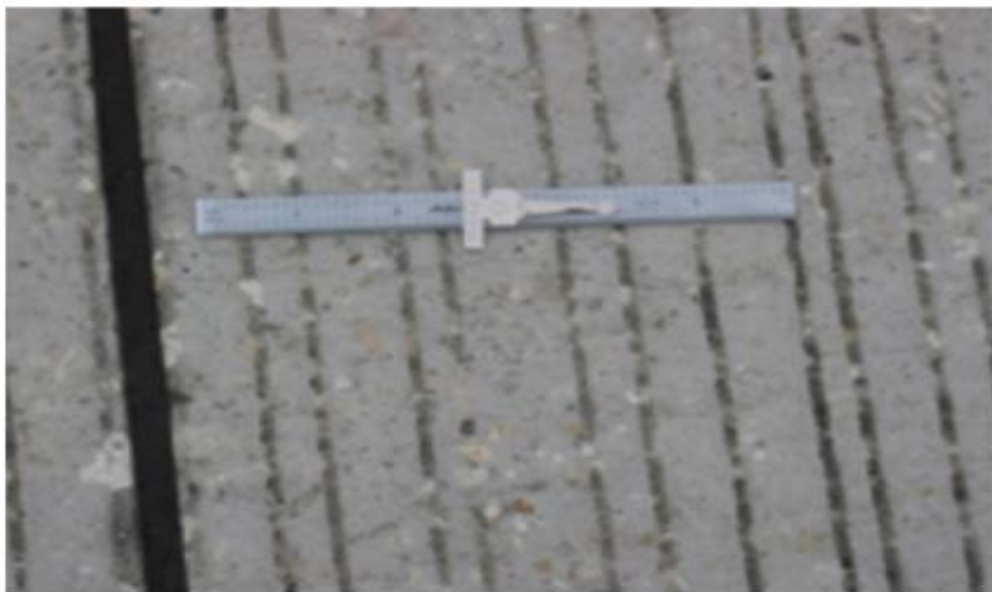
Polymer-modified/ground tire rubber-modified asphalt is the sealing industry standard. Different types and amounts of polymers and melted rubber are mixed into asphalt cement. The resulting sealants possess a large working range with respect to low-temperature extensibility and resistance to high-temperature softening and tracking. In recent years, softer grades of asphalt cement have been used in polymerized/rubberized asphalts to further improve low temperature extensibility. Figure 99 shows a transverse joint sealed with a hot-applied thermoplastic material.

**Figure 99. Photo. Joint Sealed with Hot-applied Thermoplastic Material (CP Tech Center)**

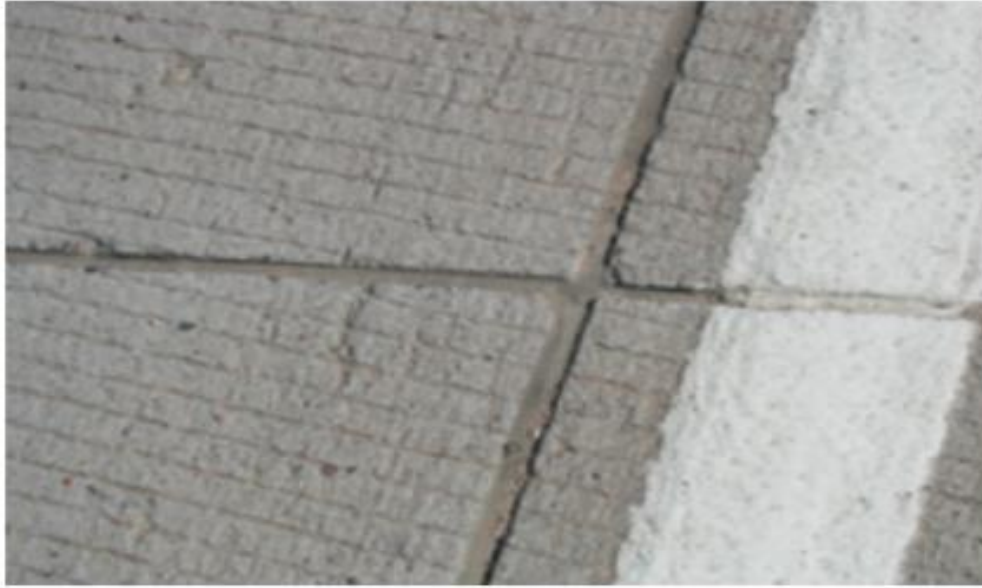
Silicone sealants are one-part cold-applied materials that exhibit good extensibility and strong resistance to weathering. These sealants have good bonding strength in combination with a low modulus, so they are able to be applied more thinly than the thermoplastic sealants. Figure 100 shows a project with both the transverse and longitudinal joints sealed with a silicone material.

**Figure 100. Photo. Joint Sealed with Silicone Material (CP Tech Center)**

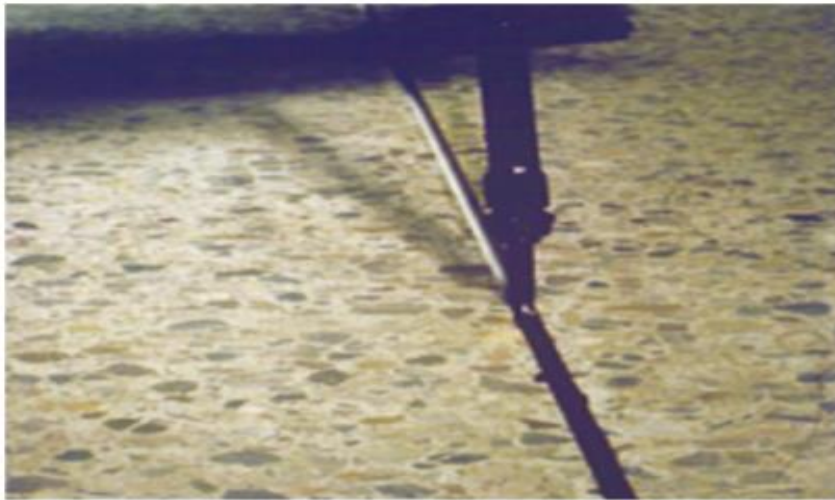
(1/8 – 1/4 inch) below the surface of the pavement to allow room for sealant expansion during the summer when the joint closes, thus preventing the sealant from being pulled out by traffic. For flush-fill and overband configurations, the joint reservoir should be overfilled and the sealant struck-off as needed to form the specified configuration. Figure 101 shows the installation of a hot-applied sealant material in a joint resealing project.

**Figure 101. Photo. Installation of hot-applied joint sealant**

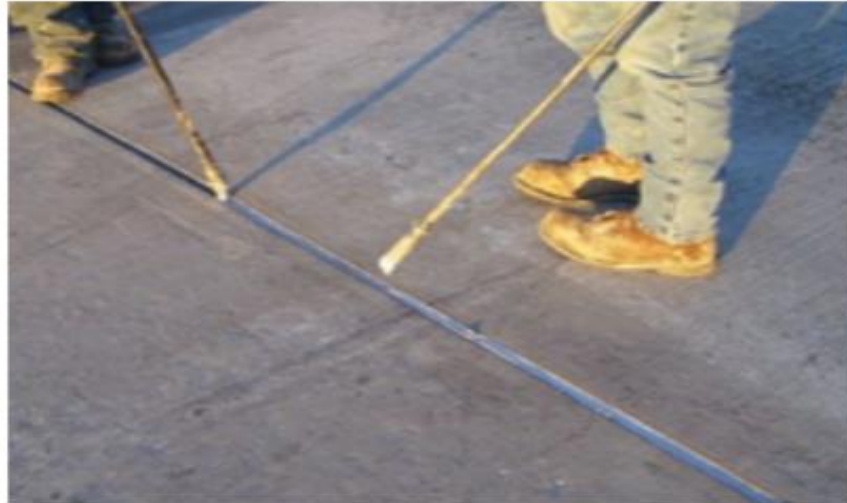
Figure 102 shows the tooling operation.

**Figure 102. Photo. Sealant Placement at left followed by tooling operation at right  
(CP Tech Center)**

Self-leveling silicone sealants do not require this tooling operation. However, workers should be cautious in the placement of the backer rod for self-leveling silicone sealants because the sealant can easily flow around a loose backer rod prior to curing and may flow out at the joint ends if not properly blocked.

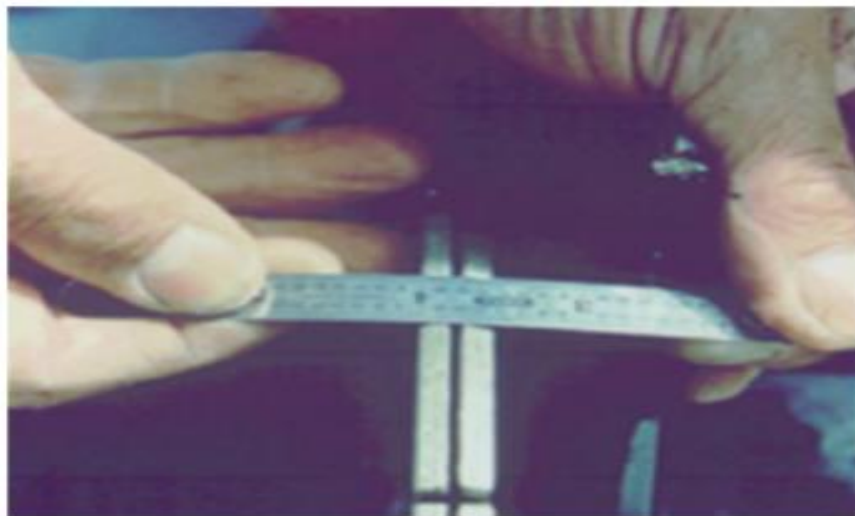
Refacing is generally done using a water-cooled saw with diamond blades. These saws may use a single sawblade or may use multiple blades ganged together to provide the desired cutting width. Figure 103 shows ganged sawblades.

**Figure 103. Photo. Ganged sawblades to provide desired cutting width (CP Tech Center)**

Generally, a joint should be widened by no more than 2 mm (0.08 inch) during the refacing operation. This will limit the amount of concrete that is removed, increase production, and limit the width of the joint through successive joint resealing operations.

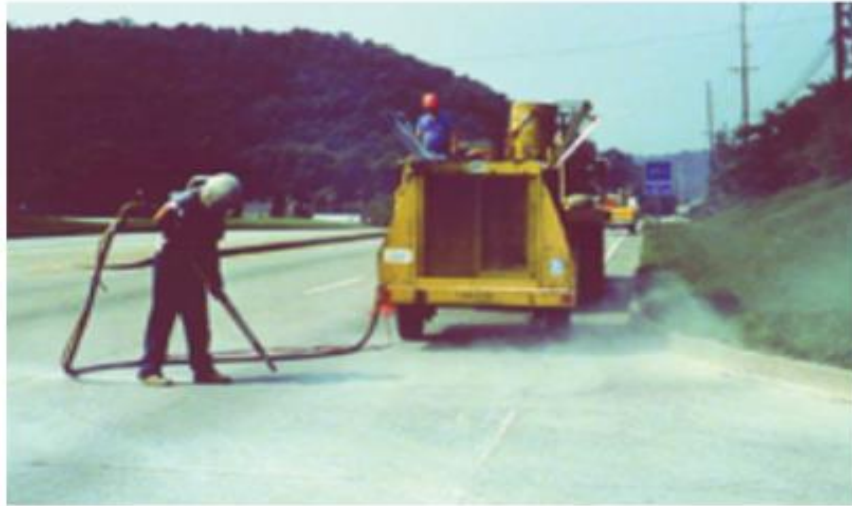
After the joint refacing, the joint should be cleaned with high-pressure air that is followed by light sandblasting. It helps to remove the laitance and any other residue on the joint faces. Air compressors used with the sandblasters must be equipped with working water and oil traps to prevent contamination of the joint bonding faces.

**Figure 104. Photo. Sandblasting along a transverse joint (CP Tech Center)**

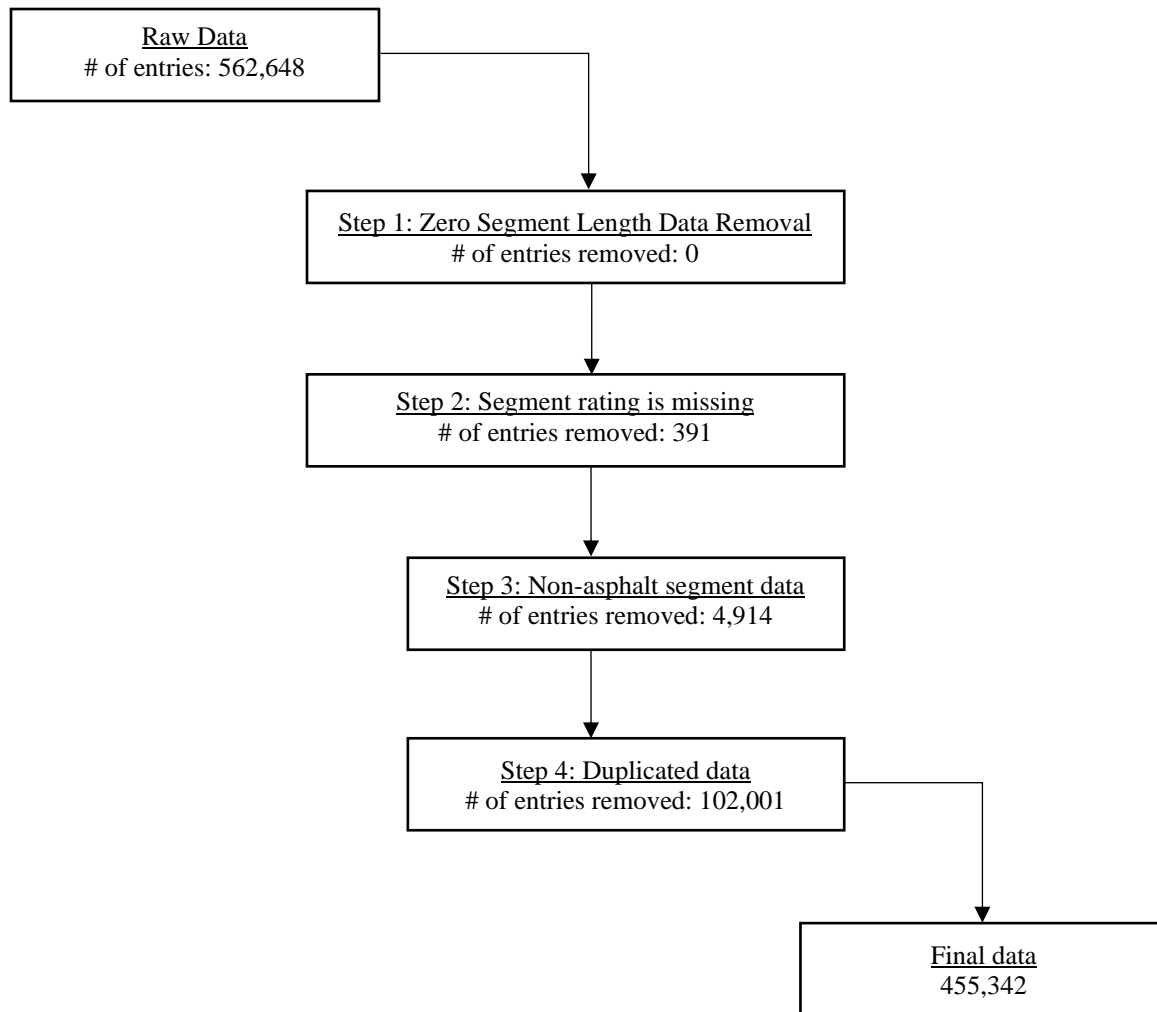
1) zero segment length data removal, 2) segment rating missing data removal, 3) non-asphalt segment data removal, and 4) duplicate data removal. The raw data has 562,648 entries. After data cleaning was conducted, 455,342 entries remained to be used in the later data analysis section in this study. The number of segment entries removed at each step was 0, 391, 4914, and 102,001. Figure 105 provides a schematic of the data cleaning procedure.

**Figure 105. Graph. Data cleaning procedures**

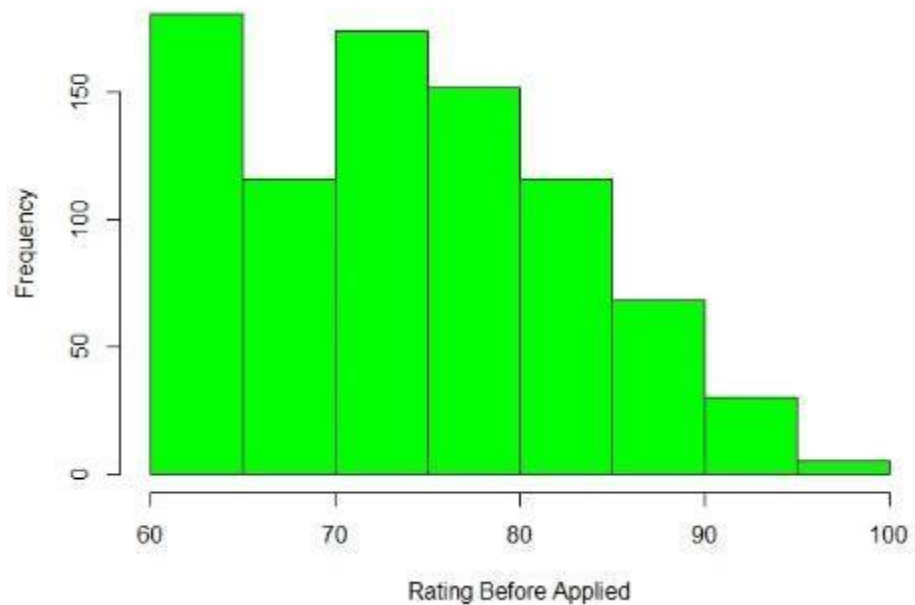
is found that the mean segment rating at one year before crack sealing is 70, which might indicate the current GDOT practices on crack sealing timing is at a mean pre-crack sealing COPACES rating of 70. However, this is not conclusive because there is a lot of missing information at the segment level in the COPACES data.

**Figure 106. Graph. Distribution of segment ratings at one year before crack sealing**

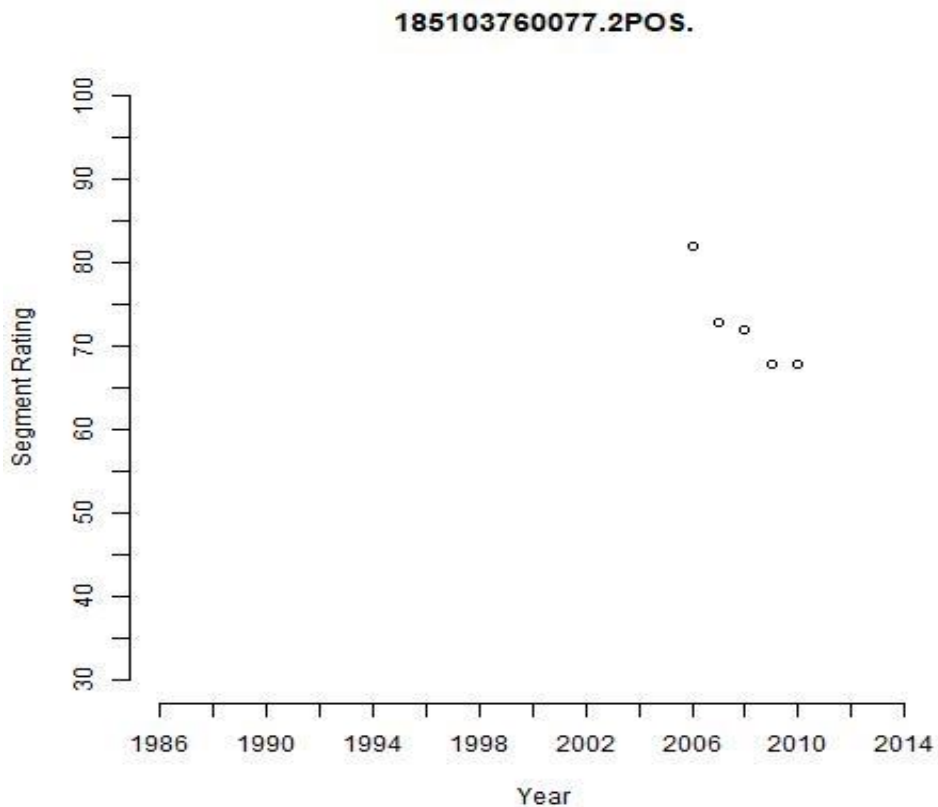
The crack sealed pavement life extension is determined by comparing the difference of Life 70 between crack sealed segments and non-sealed segments. Life 70 means the number of years until a pavement reaches a COPACES rating of 70, calculated from the start year of crack seal application. The following figure plots the consecutive COPACES rating of one segment from the start year of crack sealing application until it reaches 70. The survey conducted year was plotted on the x-axis while the segment rating was plotted on the y-axis.

**Figure 108. Graph. Plotting of one segment ratings over time**

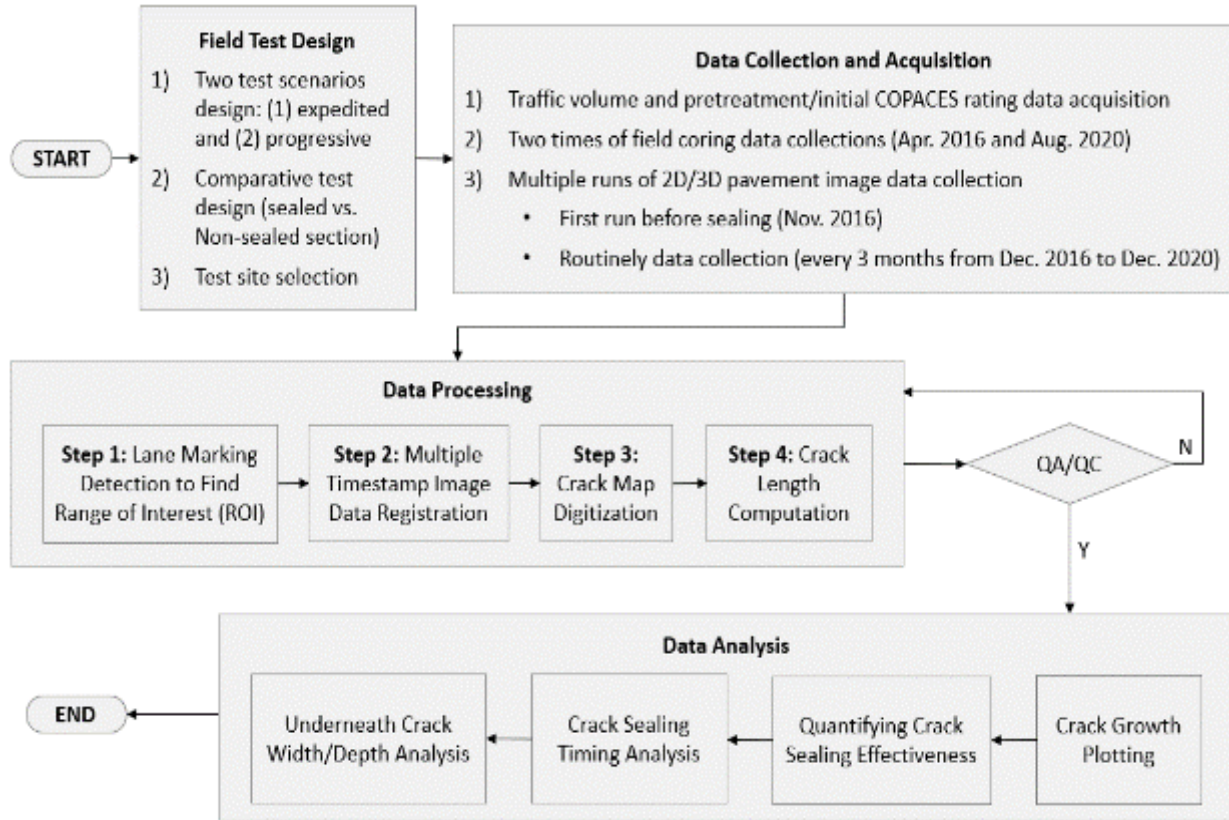
The data analysis component includes the following: 1) plotting crack growth, 2) quantifying crack sealing effectiveness, 3) analyzing crack sealing timing, and 4) analyzing crack sealing impact on pavement internal crack width/depth growth.

**Figure 110. Graph. Flowchart: Components of the Proposed Methodology**

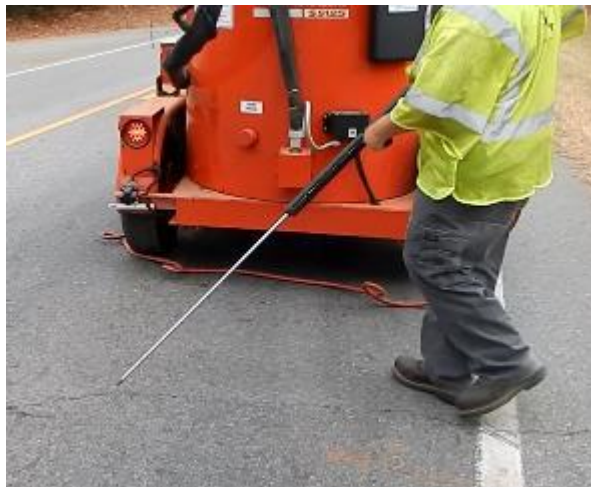
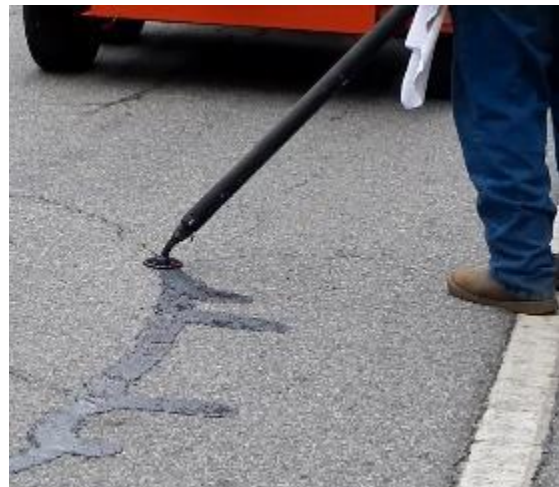
(a) Crack Clean (clean first)

(b) Crack

\*Crack sealing application operation at February 11<sup>th</sup>, 2020, at site 8 (Hwy 212, Covington, GA)

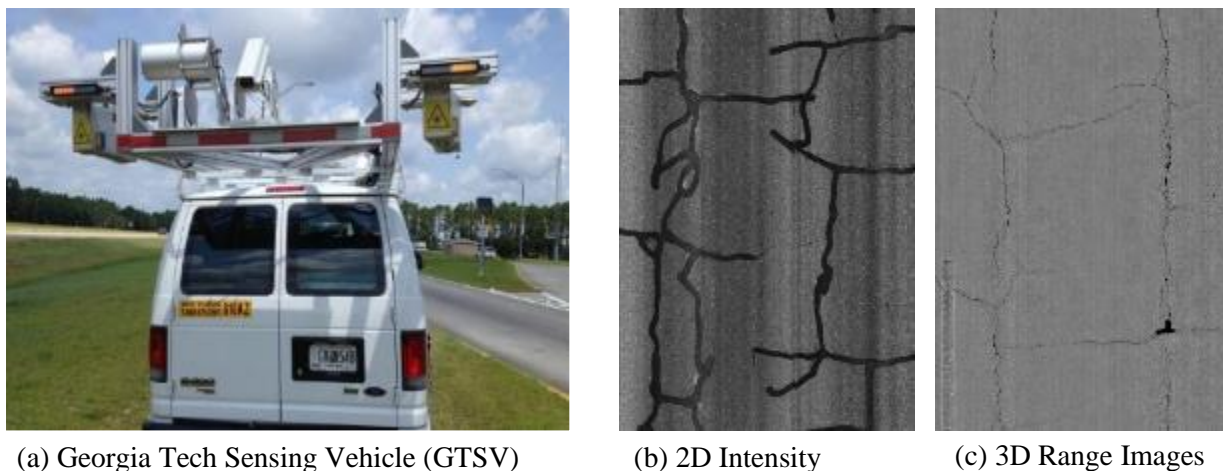
With the advancement of sensor technology, 3D laser technology has become a mainstream technology for collecting high-resolution, 3D pavement surface data. A survey shows eighteen states use a 3D automated data collection system, and seventeen states said they plan to use it within two years (Zimmerman, 2017); the states expect to use 3D technology and 3D pavement surface data to automatically and semi-automatically extract different pavement distresses, including cracking, rutting, faulting, raveling, etc. The 3D pavement surface data has been used for detecting and measuring cracking (Tsai & Li, 2012; Jiang et al., 2015) and its deterioration (Jiang et al., 2016), rutting (Tsai & Li et al., 2013; Tsai & Wang et al., 2015), concrete joint faulting (Tsai & Wu et al., 2012), project-level micro-milling pavement surface texture construction quality control (Tsai & Wang, 2014), automated raveling detection and classification (Tsai & Wang, 2015), automatic pothole detection (Tsai & Chatterjee, 2017), and a new area-based faulting measurement with an enhanced accuracy (Geary & Tsai et al., 2018).

**Figure 119. Photo. GTSV and Example of 2D, 3D Pavement Surface Images**

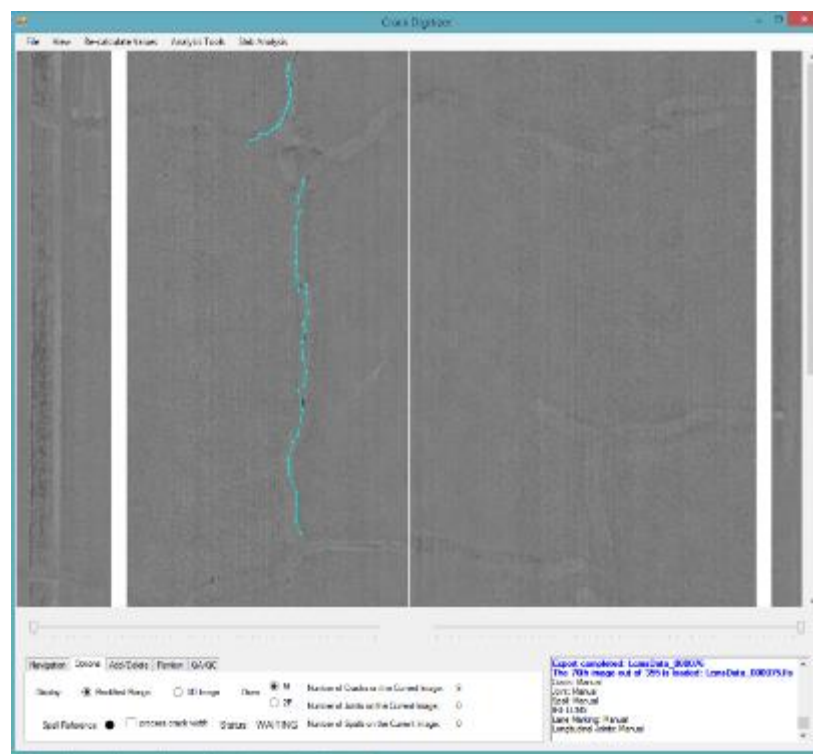
automatic crack digitization tool based on the Minimal Paths algorithm that was developed by the GaTech research team's previous study to reduce the effort and potential errors introduced by human digitization. This will also reduce the variability of 2D/3D image quality in images collected at different timestamps. Compared to the fully automatic crack detection algorithms, the semi-automatic method has higher digitization accuracy and lower sensitivity to the slight change of 3D pavement image quality. Figure 122 is the user interface of the developed semi-automatic crack digitization tool. The blue line with nodes is used to represent the digitized crack. This tool can separately record x, y nodes of the sealed crack and non-sealed crack into an XML file, which can be further read and processed to calculate the total crack length.

**Figure 122. Graph. User Interface of Semi-Automatic Crack Digitization Tool**

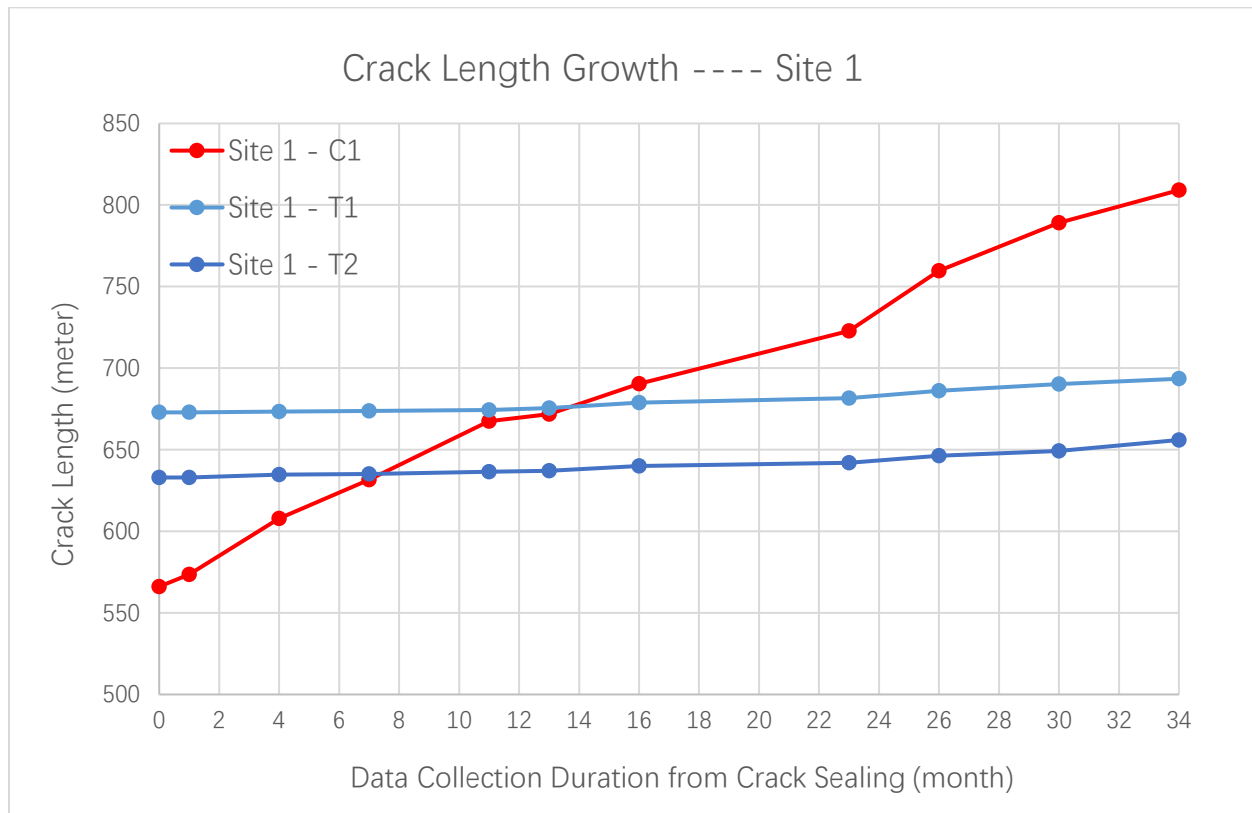
(Note: \*Crack sealing has been performed at the end of November 2016 for both T1 and T2)

**Figure 124. Graph. Crack Length Growth (Site 1)**
