**GEORGIA DOT RESEARCH PROJECT 14-06**

**AN ENHANCED GDOT PAVEMENT  
PRESERVATION GUIDE WITH OPTIMAL  
TIMING OF PAVEMENT PRESERVATION**

1. Report No.: FHWA-GA-20-1406		2. Government Accession No.: N/A		3. Recipient's Catalog No.: N/A	
4. Title and Subtitle: An Enhanced GDOT Pavement Preservation Guide with Optimal Timing of Pavement Preservation			5. Report Date: January 2021

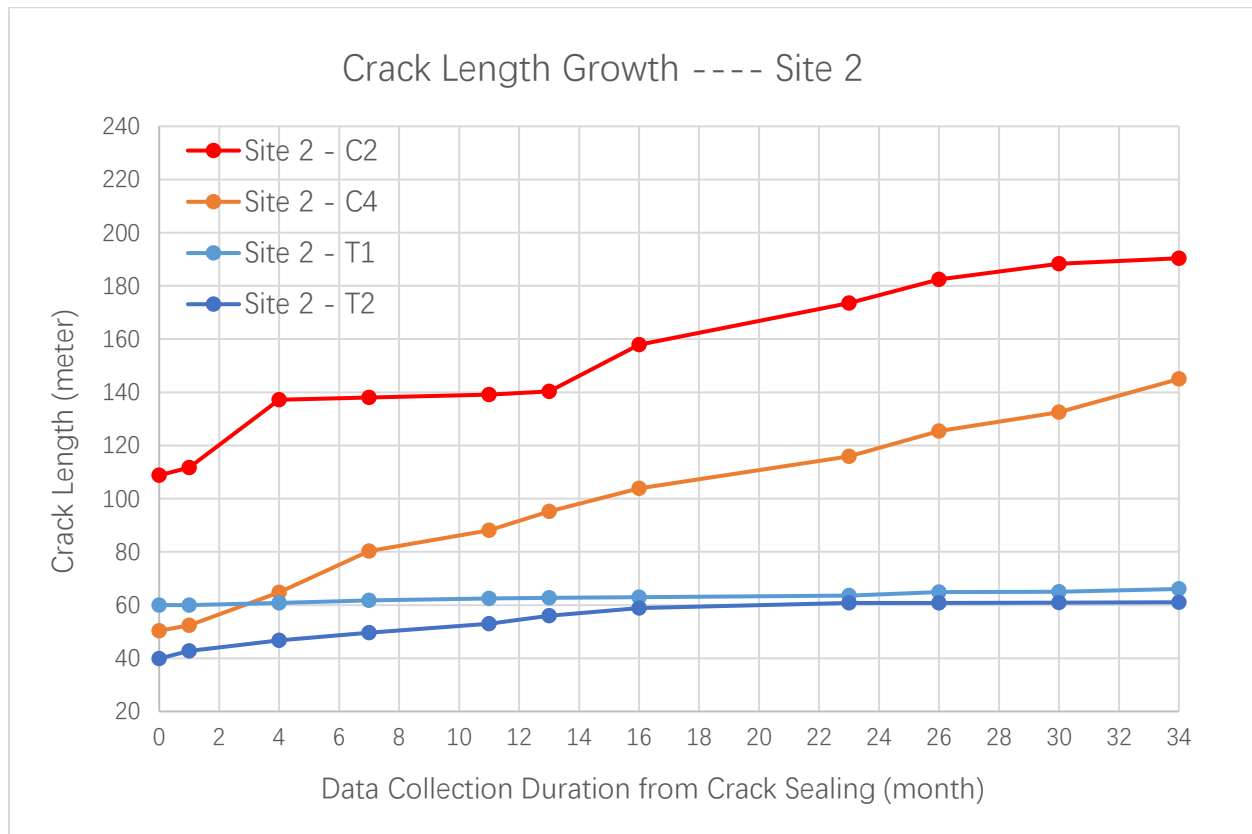
(Note: \*Crack sealing has been performed at the end of November 2016 for T1; \*\* at February 11<sup>th</sup> 2018 for T2)

**Figure 126. Graph. Crack Length Growth (Site 2)**

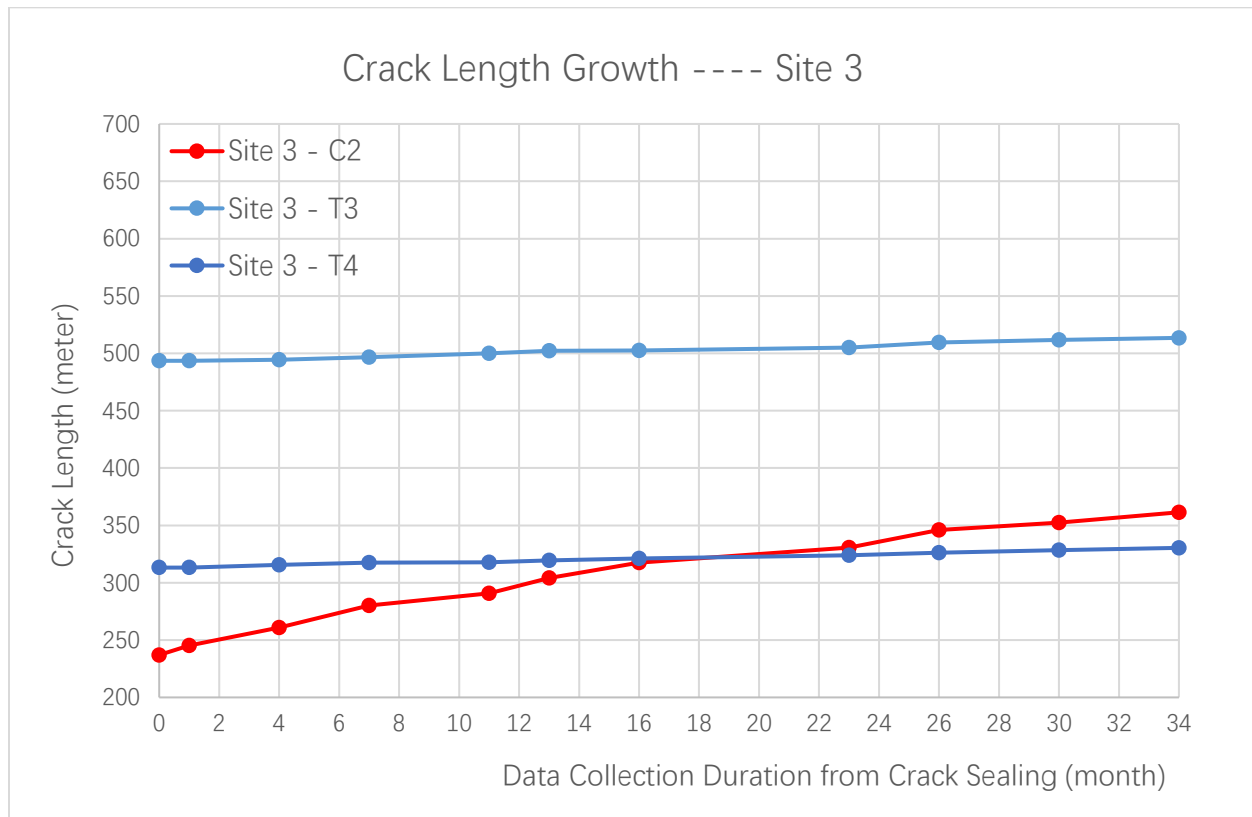
(Note: \*Crack sealing has been performed at the end of November 2016 for both T3 and T4)

**Figure 128. Graph. Crack Length Growth (Site 3)**

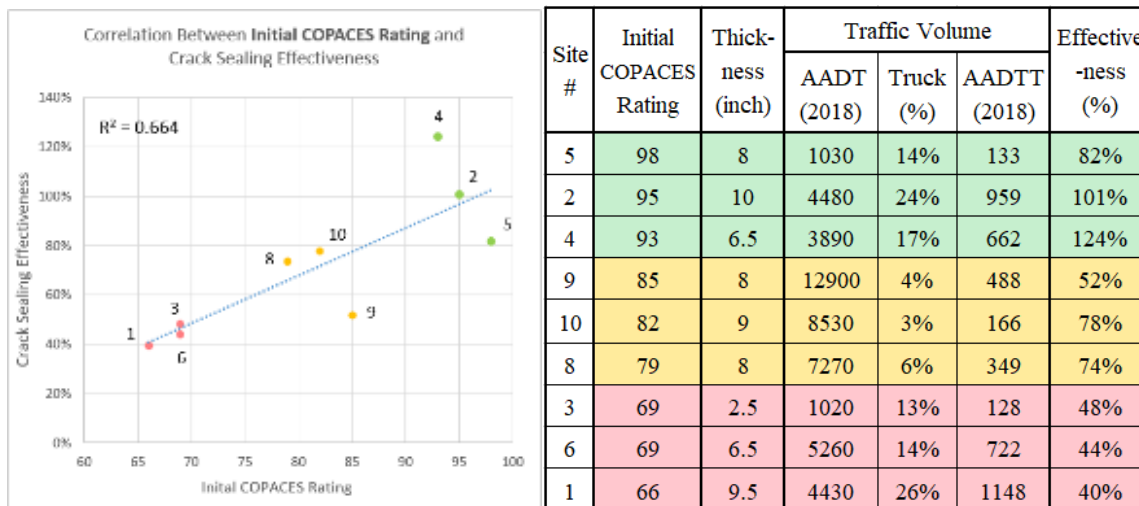
**Figure 142. Graph. Correlation Between Initial COPACES Rating and Crack Sealing Effectiveness**

- A higher pretreatment COPACES rating pavement provides better crack sealing effectiveness based on a breakdown study with 3 clusters of pretreatment COPACES ratings (66-69, 79-85, 93-98) having a 40%-48%, 52%-72%, 82%-124% crack sealing effectiveness, respectively. This finding supports GDOT's new policy of increasing its crack sealing criteria from a maximum COPACES rating of 85-90.

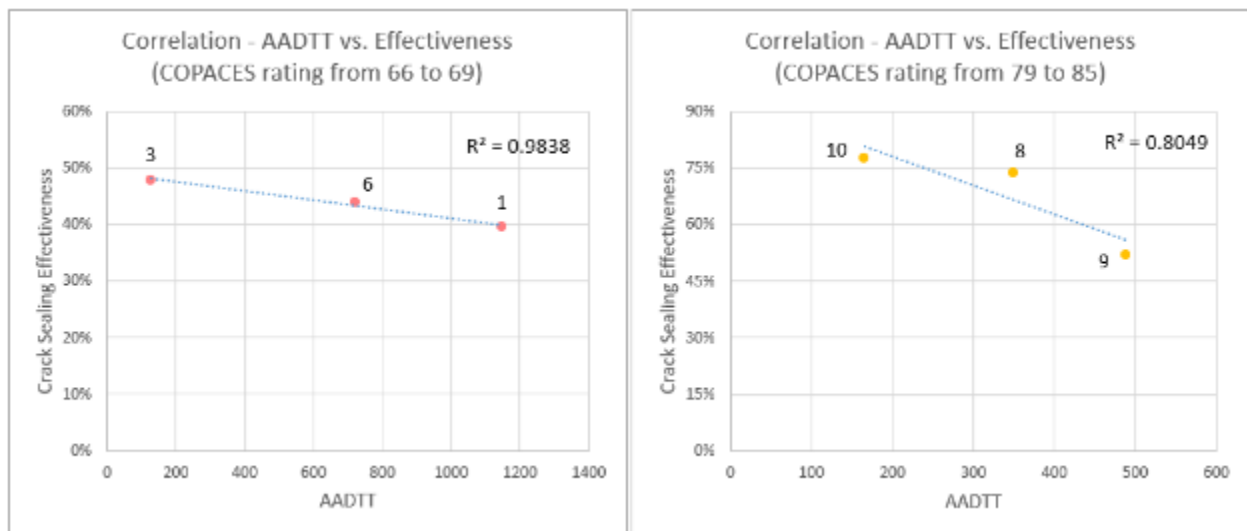
**Figure 143. Graph. Correlation Between Traffic Volume (AADTT) and Crack Sealing Effectiveness**

- Crack sealing effectiveness increases when truck traffic (AADTT) decreases; however, the finding is not conclusive. In addition, there is no clear trend for the impact of pavement thickness on crack sealing effectiveness.

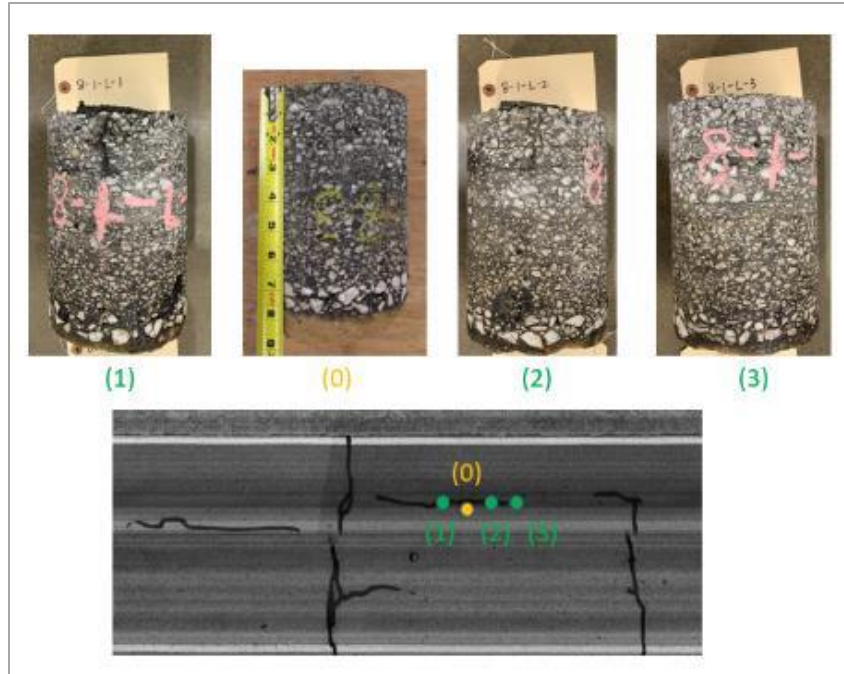
**Figure 145. Photo. Cores on Sealed Longitudinal Crack (Site 8)**

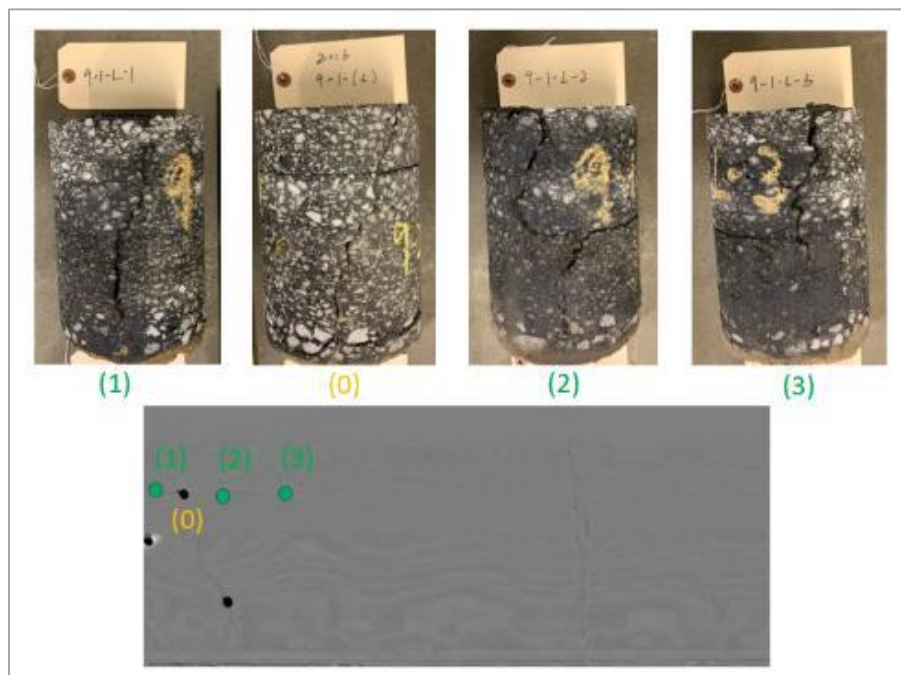
**Figure 146. Photo. Cores on Non-Sealed Longitudinal Crack (Site 9)**

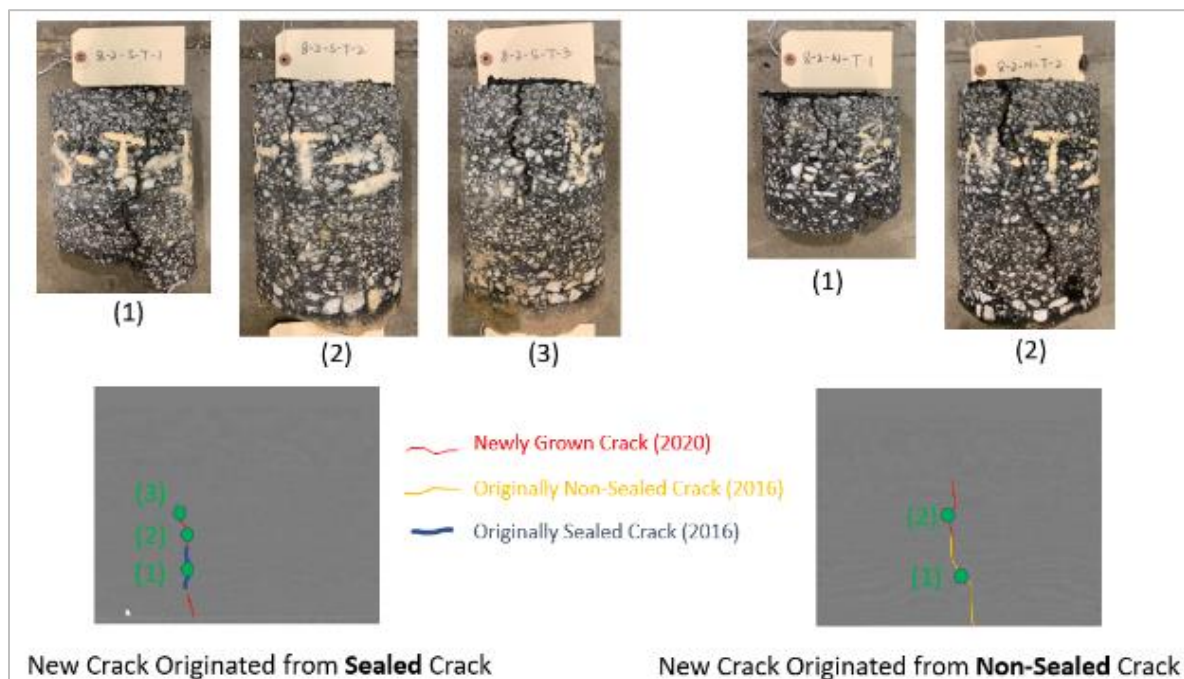
**Figure 149. Photo. New Crack Originated from Sealed and Non-sealed Crack  
(Transverse, Site 8)**

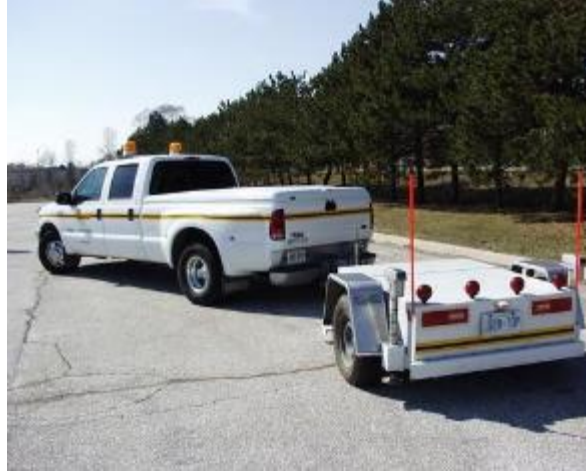
To address the above questions, locked-wheel tests were conducted by GDOT over time. The locked-wheel tester used in this research is shown in Figure 155:

**Figure 155. Photo. Locked-wheel Tester**

To take a measurement, the locked-wheel tester is brought to the desired testing speed (typically 64 km/hr (40 mph)) and water is sprayed ahead of the test tire to wet the pavement surface. The test tire braking system is then actuated to lock the test tire. Instrumentation measures the friction force acting between the test tire and the pavement and reports the result as a skid number (SN).

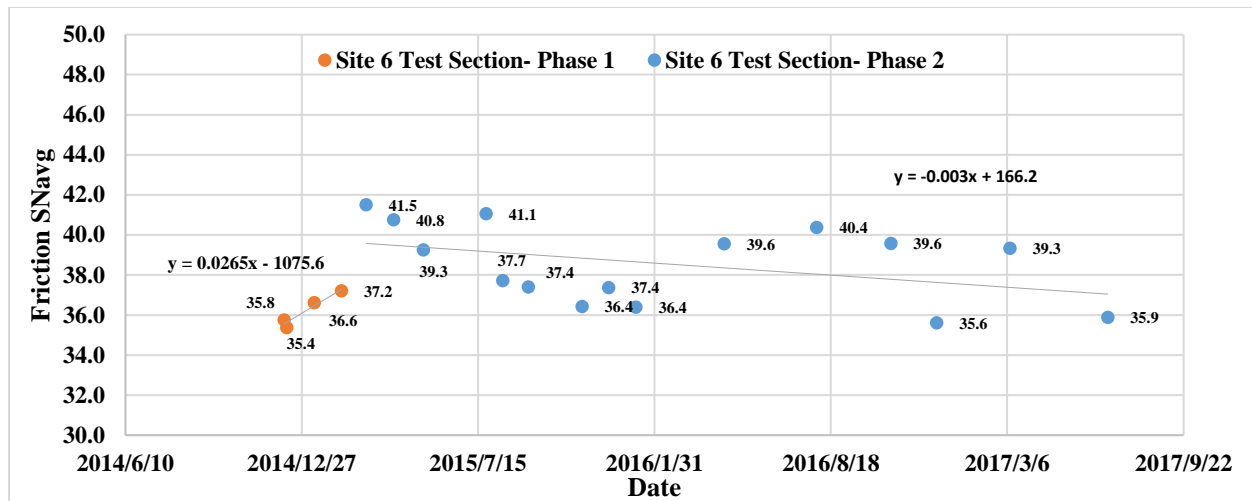
**Figure 164. Graph. Long-term Friction Behavior on Site 6.**

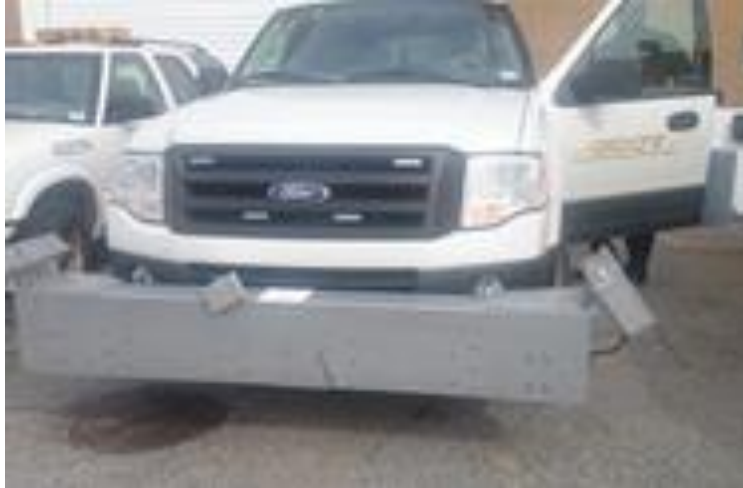
GDOT collected IRI data using the laser profiler shown in Figure 179. The data collection has been performed monthly over the entire 6 lanes of I-475 since September 2014. The obtained IRI measurements can be rated and placed into a series of categories (from very good to poor) according to the FHWA standard, as shown Figure 180. Note that the IRI value here is in inch/mile).

**Figure 179. Photo. Laser Profiler for IRI Collection**

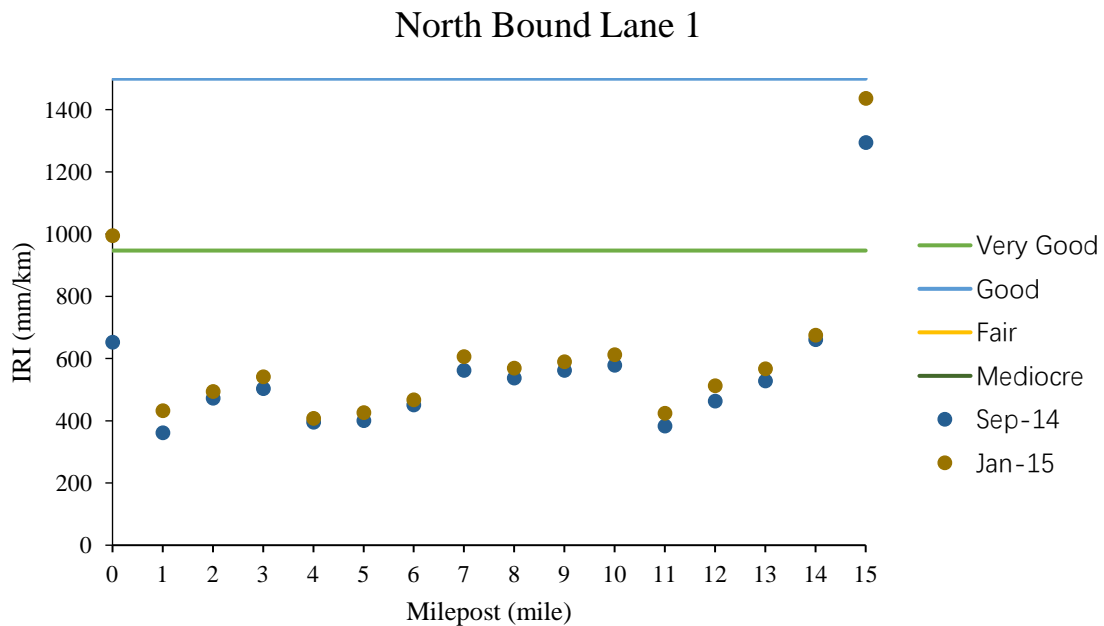
**Figure 181. Graph. IRI readings of NB Lane 1 before and after Fog Seal**

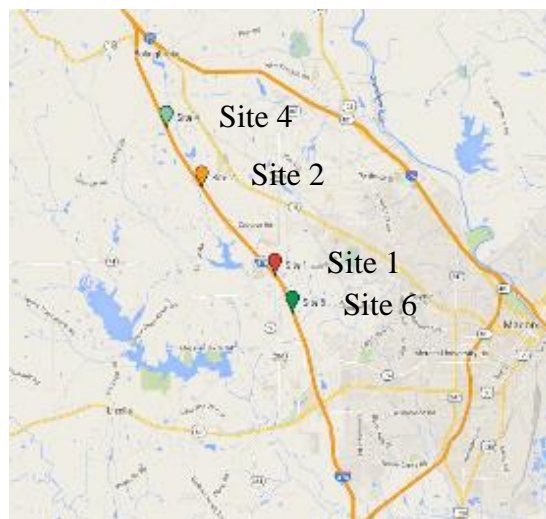
**Figure 194. Graph. 4 Sites Selected for Visual Inspection of Aggregate Loss**

As shown in Figure 194, the raveling condition varies in the southbound outside lane of I-475. Site 1 is just over one mile from Site 6; however, the sites' raveling conditions are different, as shown in Table 60. The wide variance in the raveling condition seen in this lane is consistent with what is reported in the windshield surveys taken by pavement engineers.

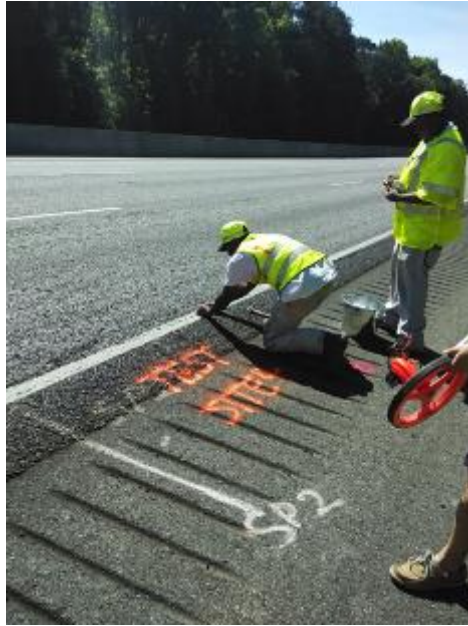
first 15-m of each control and fog seal section. We thank Mr. Clayton L. Moore and his colleagues at GDOT for their assistance in setting up the RPMs along each section, as shown in Figure 196.

**Figure 196. Photo. RPM Set-up**

However, due to the heavy traffic, the RPMs deteriorated very quickly and are no longer used to identify the four sections. To ensure the sites are always identified, the fluorescent orange paint used to initially mark the sites is periodically repainted. This allows for consistent visual inspection of the same location over time and also helps identify the sites for friction testing.

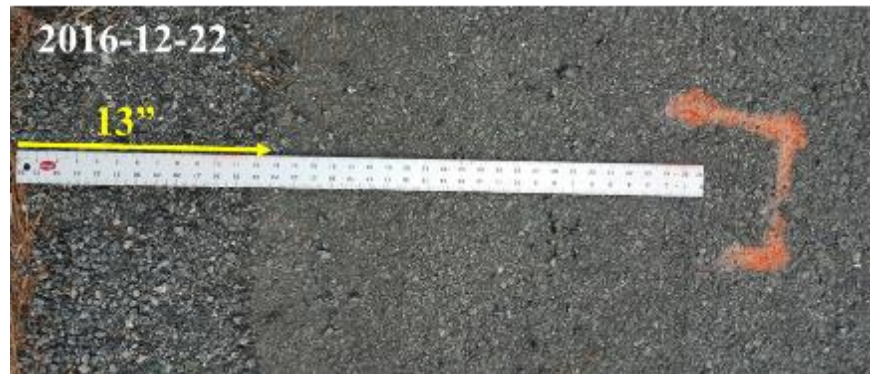
**Figure 197. Photo. Width of Aggregate Loss Area along the Shoulder of Site 1**

shoulder buildup at a consistent location began in March 2016. Measurements were originally taken quarterly; however, since July 2016, measurements have been taken monthly to better understand the trend of aggregate loss. To facilitate consistent measurements, a yardstick is consistently used to measure aggregate buildup, as shown in Figure 197.

As shown in the figure, the aggregate buildup is measured from the vegetation towards the edge of the travel lane. To ensure measurements were taken at the same location every time, the recording location was marked using fluorescent orange paint to identify the yard stick measuring location. For severe and medium severity raveling, in some cases, the width of the buildup exceeded the length of the yard stick, so the buildup could not be adequately measured. The following sections outline the buildup measurements for the four sites.

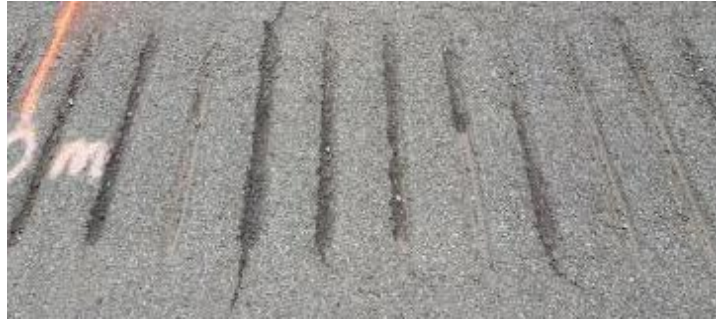
**Figure 198. Photo. Site 1 Wet Aggregate in Rumble Strip**

The two other measurements, highlighted in red in Table 65, show the decreased performance after the application of fog seal came from Site 1. For these March and December measurements, there was significantly more aggregate in the rumble strips of the fog seal section than in the control section. For the March measurement, the aggregate in the two sections had been building up for over four months (since November 2015). During this time, external factors, such as wind, rain, and shoulder cleanings, may have reduced the amount of aggregate in the control section. For the December measurement, it is believed that the accumulation of aggregate in the fog seal was affected by the presence of water in the rumbles strip, as shown in Figure 198.

As can be seen from the figure, on the day of collection, the rumble strips were not as dry as normal. The presence of water in the rumble strip creates a wet mixture of sand and loose aggregate. Previous measurements primarily included loose aggregate with a limited amount of sand collected. Because of this mixture, it was difficult to separate the sand and aggregate, resulting in the collection of more sand and water than normal. Excluding these two measurements, the application of fog seal appears to be 30-90% effective at reducing the amount of aggregate lost by raveling, depending on both temperature and raveling condition. This indicates that fog seal can be applied to severely raveling pavements to reduce the amount of aggregate loss in the short term in order to better maintain condition until resurfacing can be done.

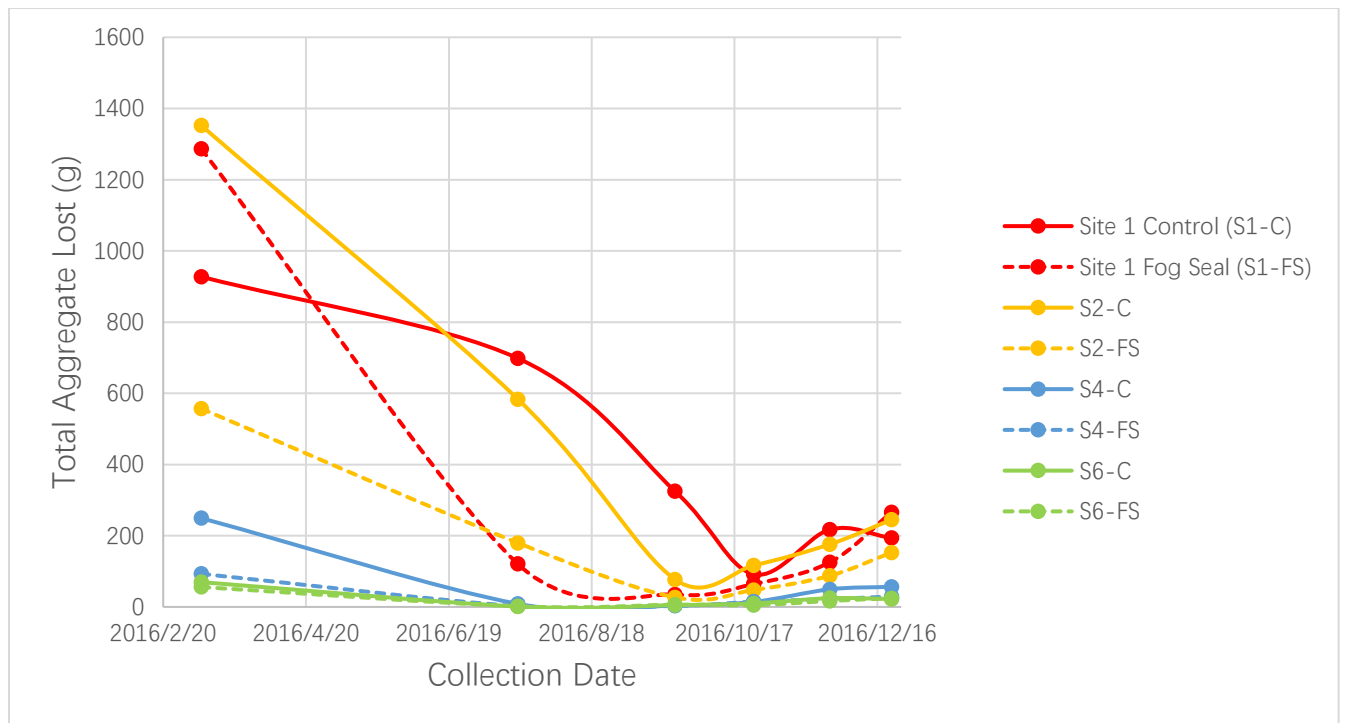
**Figure 199. Graph. Effectiveness of Fog Seal Treatment Against Control Sections**

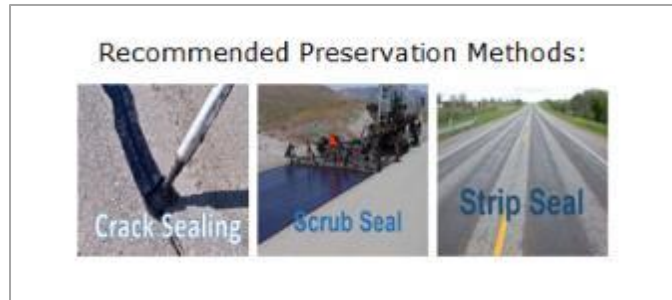
**Figure 205. Photo. Treatment Selection Outcome**

- Then, Single Click “Select Treatment” to select the adequate treatment. Figure 205 shows the recommended preservation methods corresponding to the “Severity Level 2 Load Crack” as the pavement condition inputs.

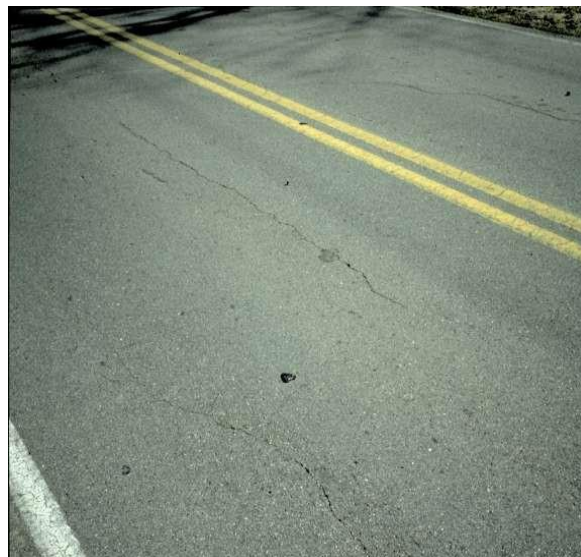
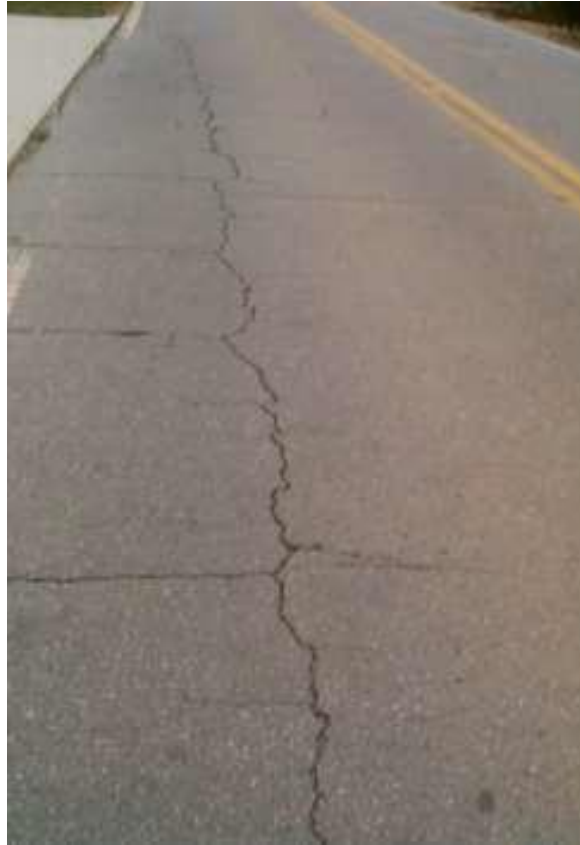
#### Examples of Level 1 Load Cracking

The illustration above is an example of the range in load cracking patterns to be recorded as level 1 load cracking. There is approximately 120 feet of cracking in the two wheelpaths, or 60% of the sample in lane one in the two wheelpaths, or 60% of the sample in lane one, and 130 feet (65%) of level 1 load cracking in lane two.

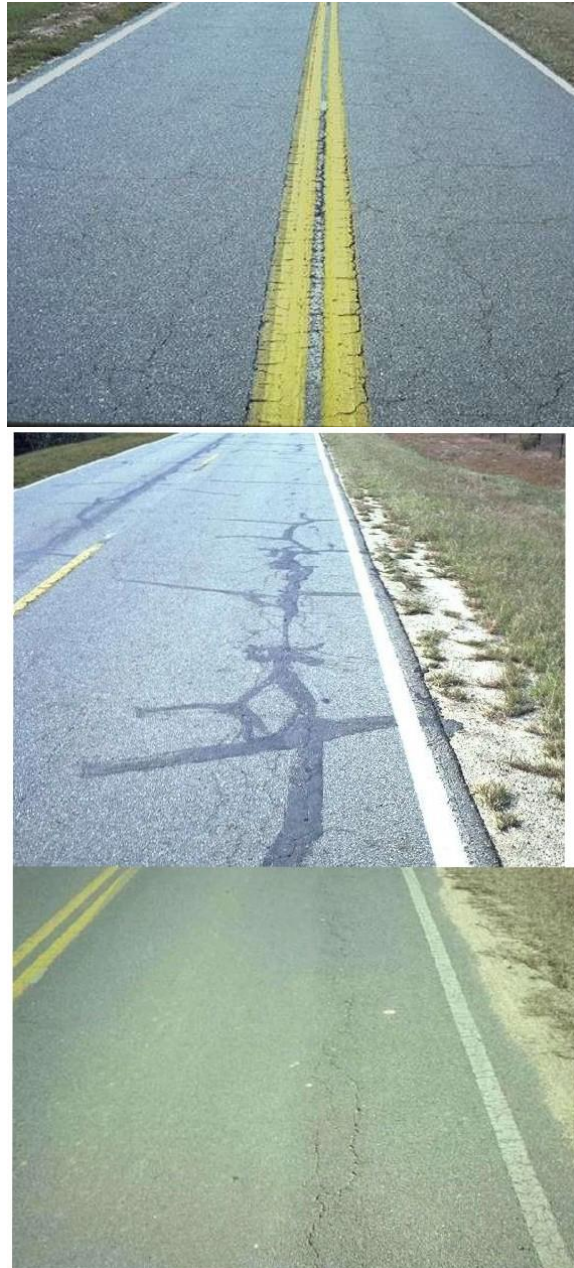
### Examples of Level 2 Load Cracking

The following illustration shows the general range in appearance of level 2 load cracking patterns. These cracks are wider than level 1 cracks and occur only in the wheelpaths. This level cracking has a single or double longitudinal crack with a much larger number of 0-2 ft. transverse cracks intersecting than in level 1 load cracking. Occasionally, polygons will form but are not prominent.

In this example, there is approximately 150 ft. of cracking in the 100 ft. sample area, or 75% of the sample area.

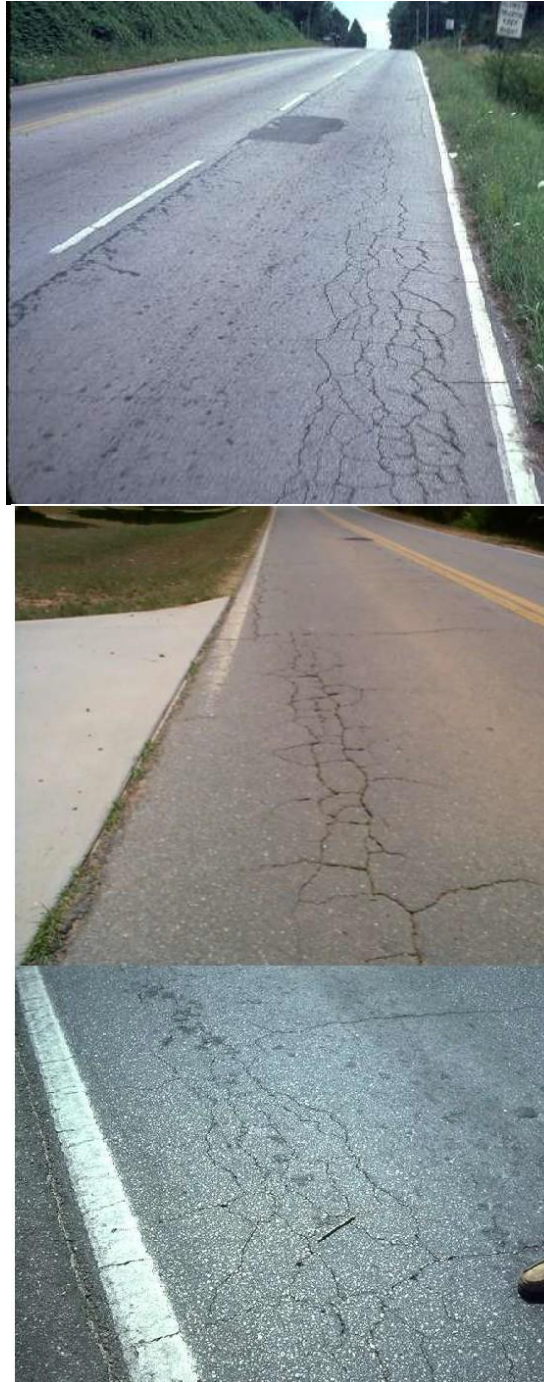
### Examples of Level 3 Load Cracking

The illustration shows the general appearance of level 3 load cracking patterns. This type pattern generally has three or more longitudinal cracks in the wheelpaths with many interconnecting transverse cracks. Many small polygons are formed causing the appearance of “alligator hide.” This type cracking is marked by a definite, extensive pattern of small polygons and is sometimes accompanied by severe rutting.

In this example, 60% of the sample has level 3 load cracking.

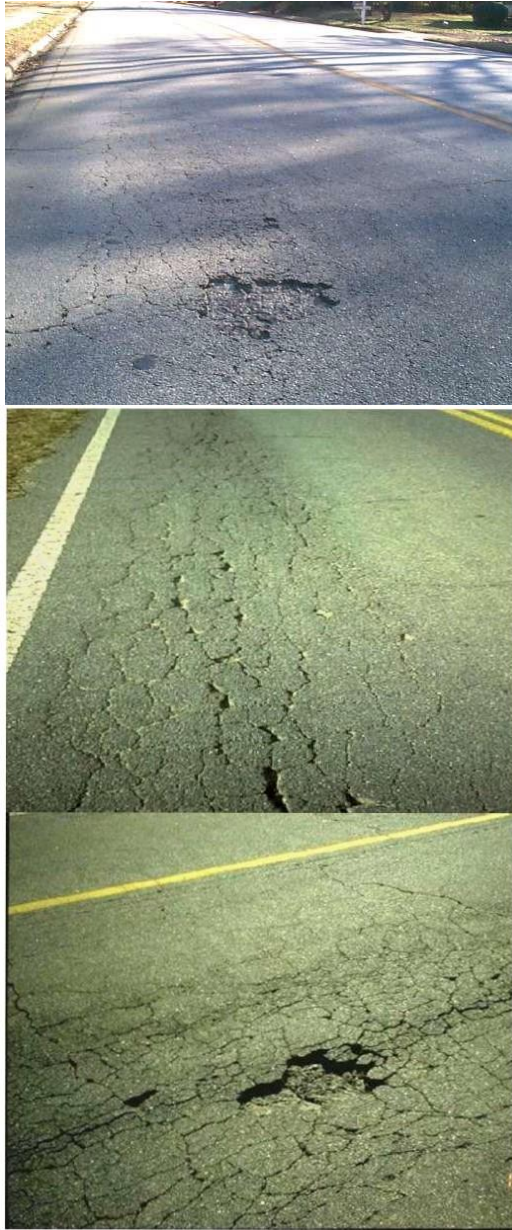
## Examples of Level 4 Load Cracking

The following illustration shows level 4 load cracking patterns. This type pattern has the definite “Alligator hide” pattern but has deteriorated to the point that the small polygons are beginning to pop out. Rutting is usually severe and pumping of base material is sometimes evident.

In this example, 60% of the sample area has level 4 load cracking.

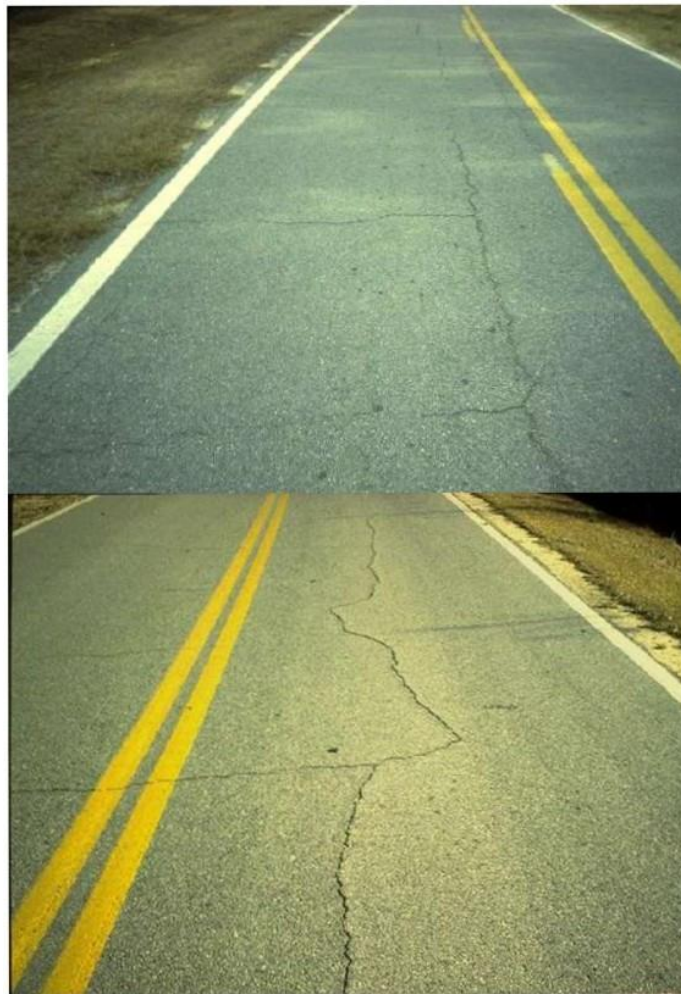
Examples of Level 1 Block/Transverse Cracking

This type cracking is caused by weathering of the pavement or shrinkage of cement treated base materials. Block/transverse cracking is not load related. The block pattern is distributed uniformly throughout the roadway and not concentrated in the wheelpaths. Block cracking is interconnecting cracks forming a series of large blocks usually with sharp corners.

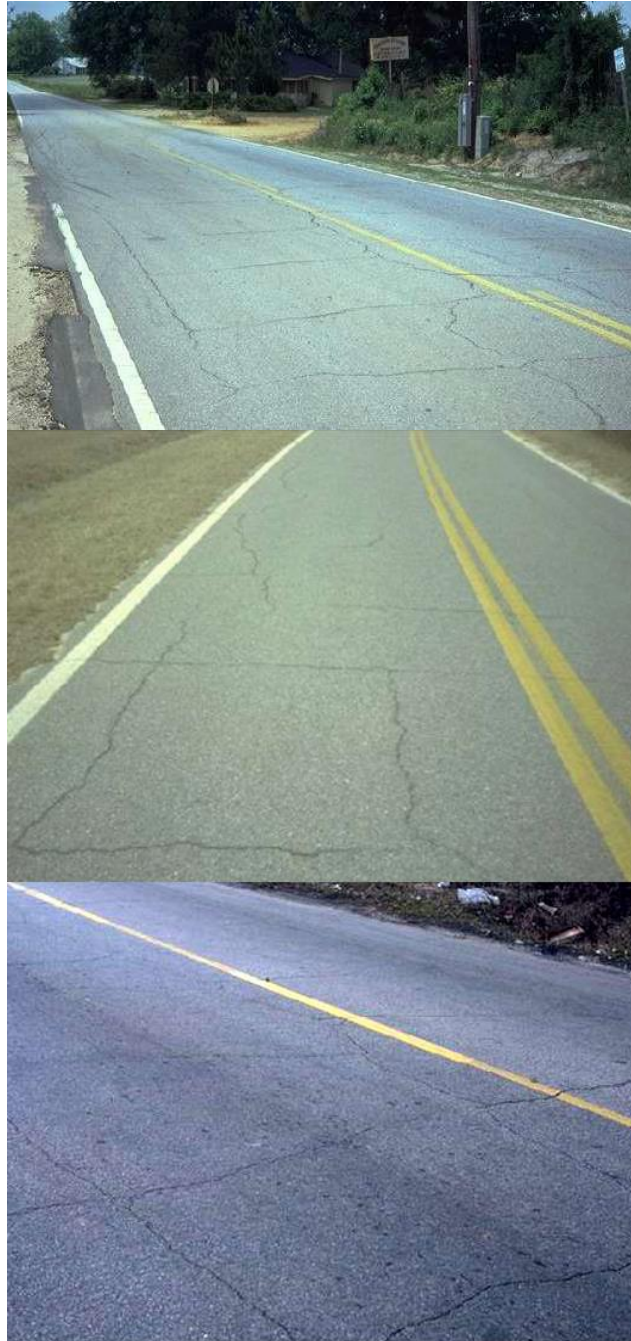
### Examples of Level 2 Block/Transverse Cracking

At this severity level, the cracking has developed definite block patterns. Some of the longitudinal cracks can occur in the wheelpaths for short distances without being considered load cracking when associated with a block pattern. The transverse and longitudinal cracks are wider than in level 1 but do not necessarily require sealing. The block pattern will usually be uniform across the entire roadway.

Following are sample images of level 2 block/transverse cracking.

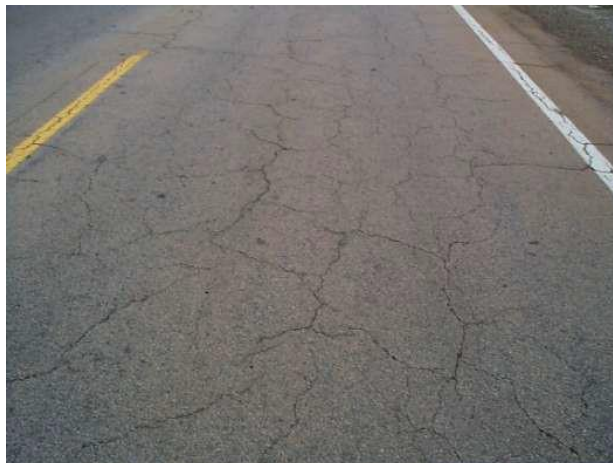
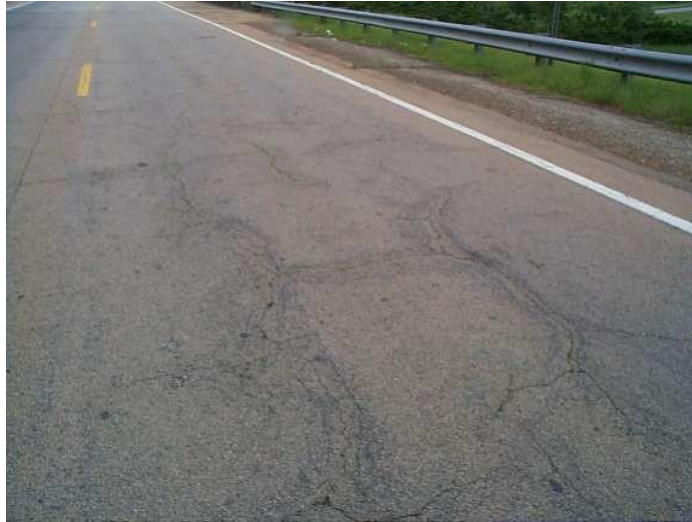
At this severity level, the cracking has a definite block pattern as in level 2, but the blocks are smaller and the cracks are wider than in level 2. Level 3 block/transverse cracking is marked by cracks that are wide enough to require sealing. Block cracking that has a very large number of small blocks is also considered to be level 3 block/transverse cracking. Some of the longitudinal cracks in this pattern may meander into the wheelpaths for a short distance but are still considered block cracking because large distances of wheelpaths are not affected, and this type cracking is not caused by loading. Some spalling of the cracking may be evident.

Level 3 block/transverse cracking – Notice width, subsidence and spalling of the cracks.

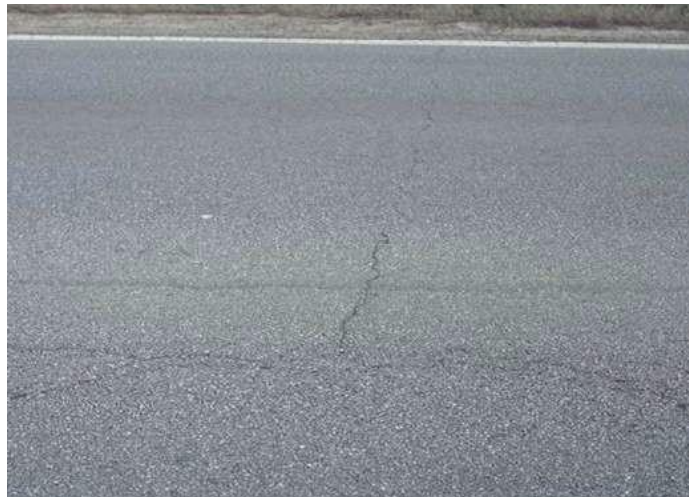
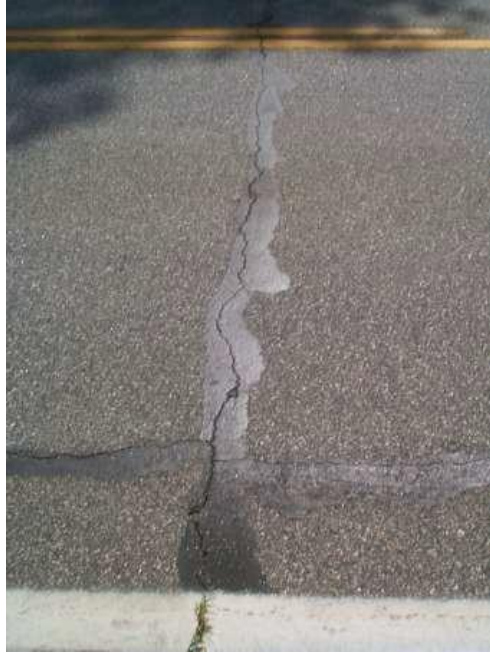
Here are some sample images of level 1 reflection cracking:

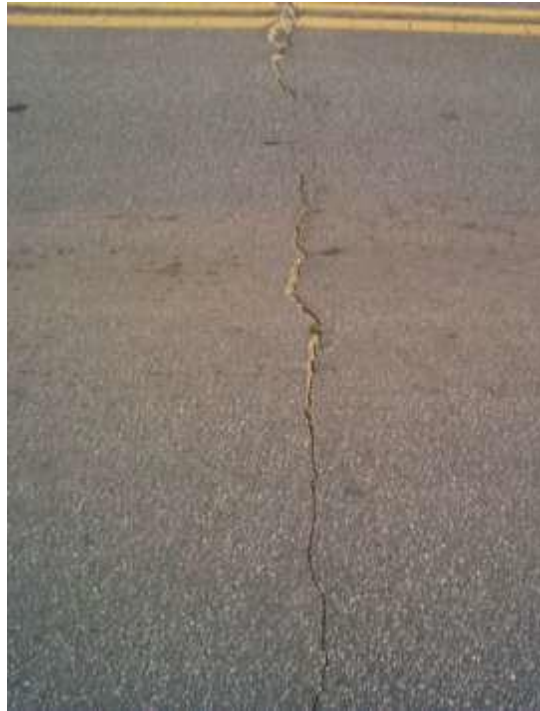
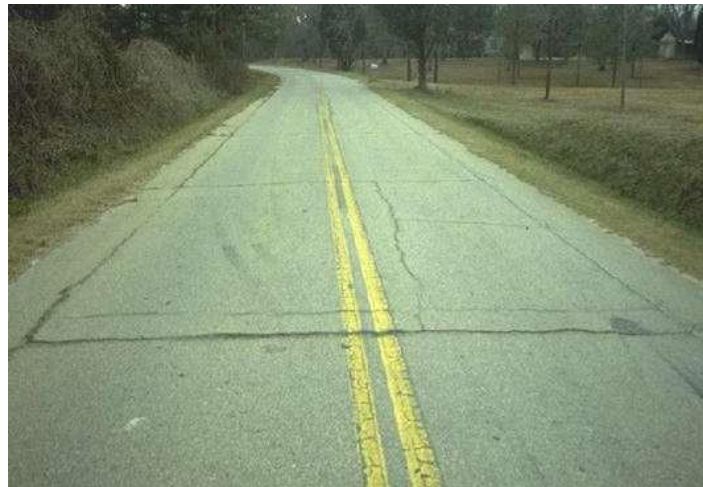
Level 2 Reflection.

This level of reflection cracking has progressed so that all underlying joints and cracks have reflected through the surface layer. The cracks are substantially wider than the level

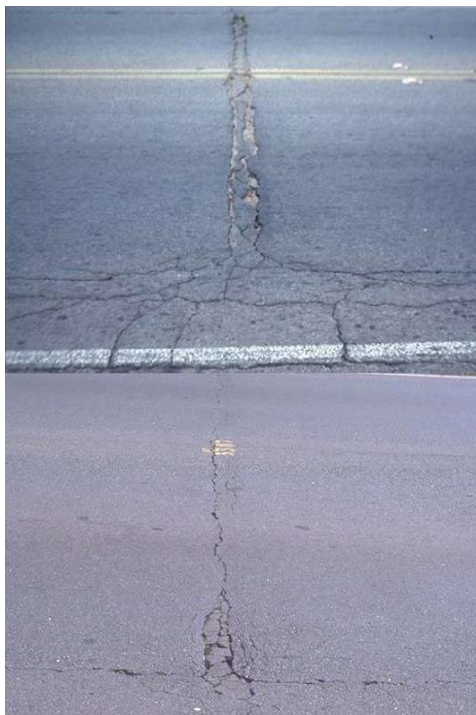
Here are some sample images of level 3 reflection cracking:

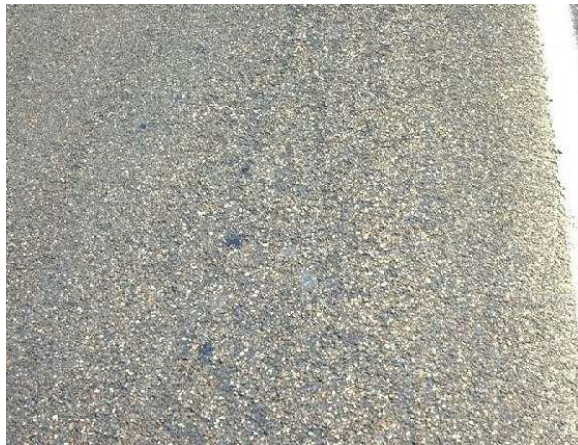
Level 1 – loss of substantial number of stones

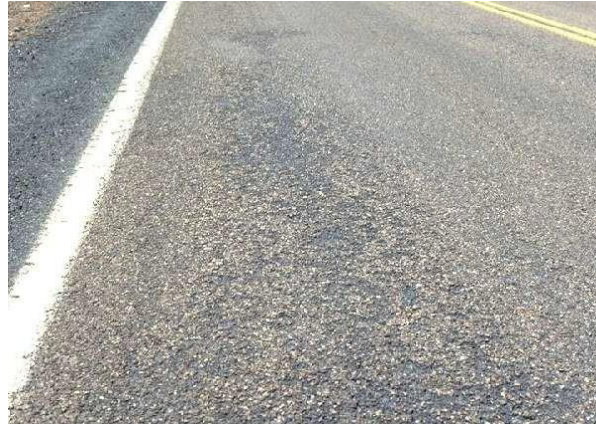
Level 2 – loss of most surface

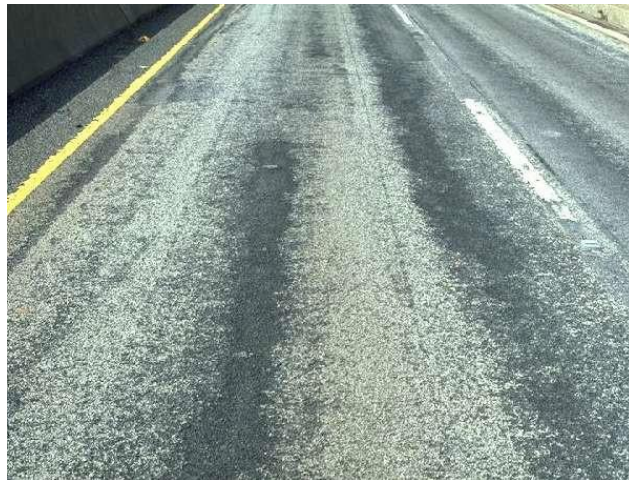
Level 3 – loss of substantial portion of surface layer ( >1/2 depth)

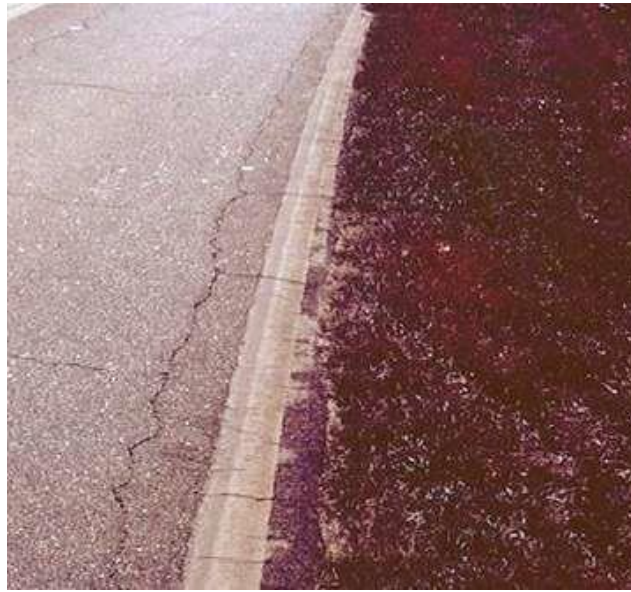
Level 1 – tight, hairline cracks

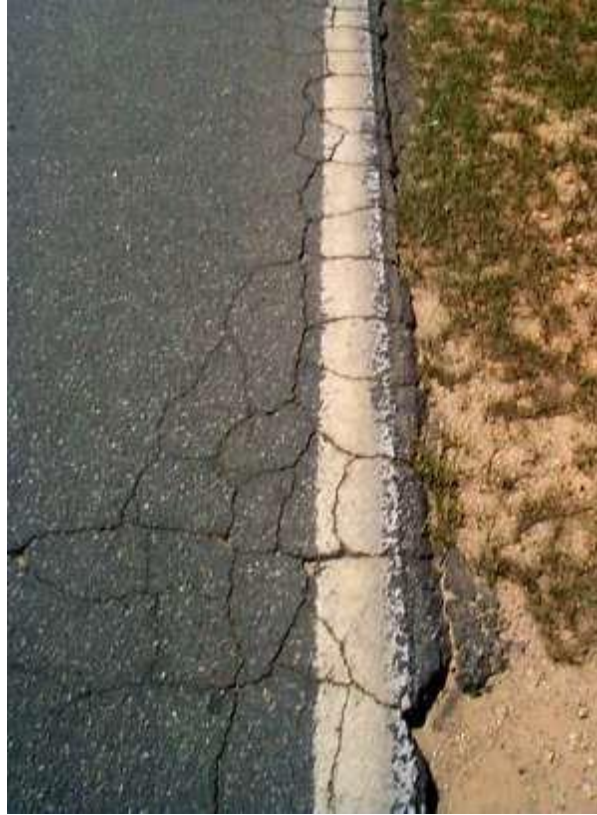
Level 2 – crack widths greater than 1/4 inch, double cracking, tight “alligator” cracking

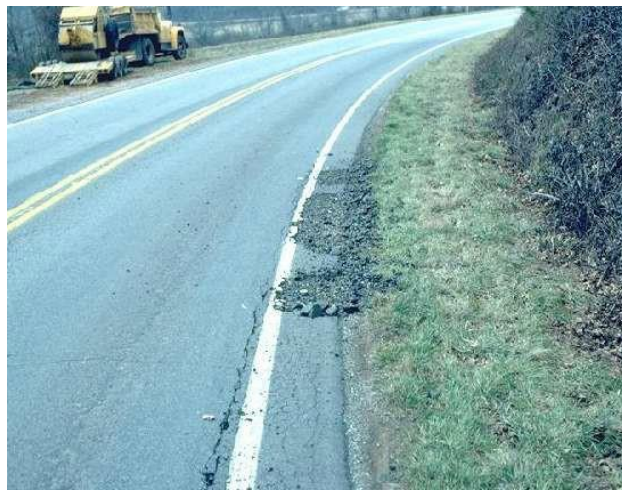
Level 3 – severe “alligator” cracking at edge, popouts, edge break off

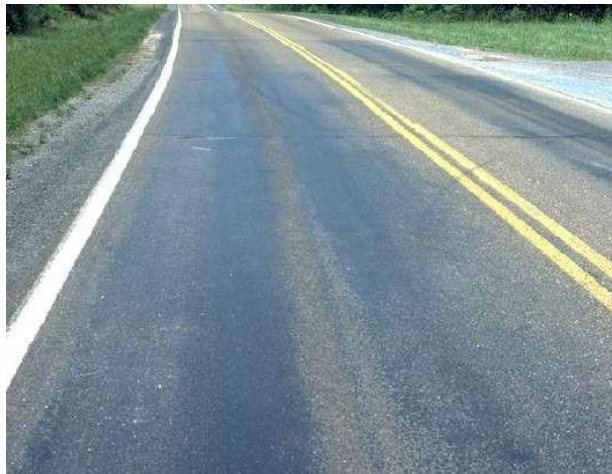
Level 1 – free bitumen is noticeable on the surface along with the aggregate in the mix

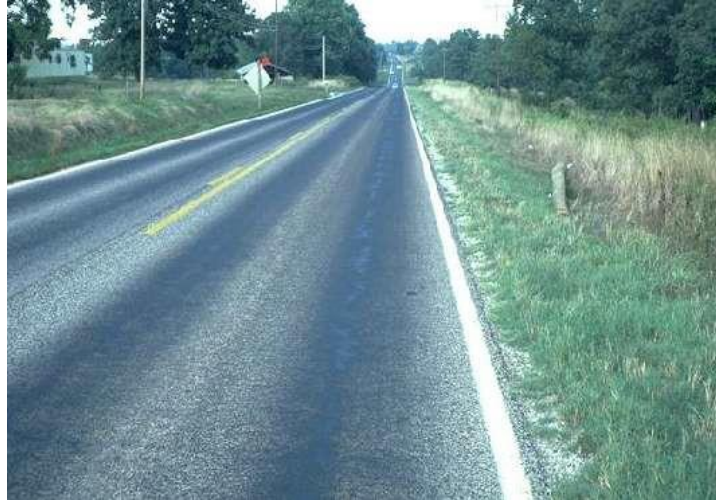
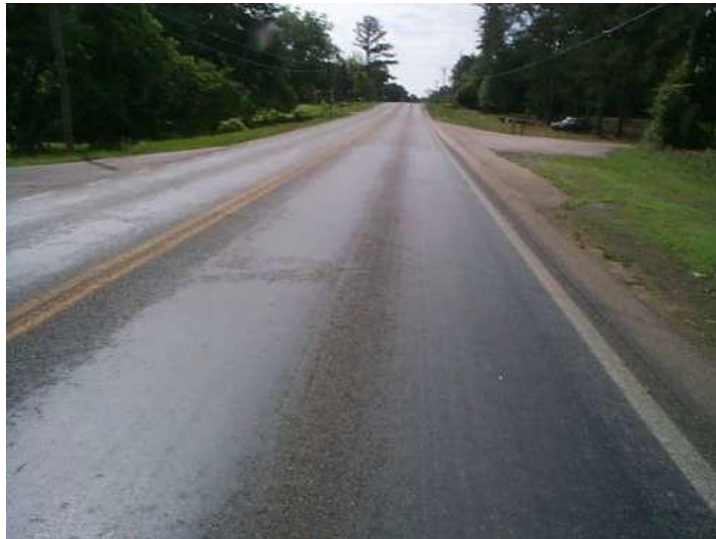
Level 2 – surface is black with very little aggregate noticeable

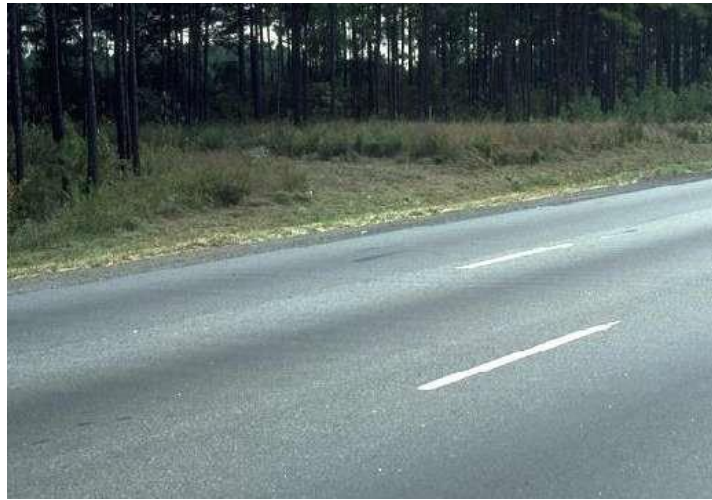
Level 1 – corrugations are visible and can definitely be felt in the steering wheel while driving
