**GEORGIA DOT RESEARCH PROJECT 14-06**

**AN ENHANCED GDOT PAVEMENT  
PRESERVATION GUIDE WITH OPTIMAL  
TIMING OF PAVEMENT PRESERVATION**

1. Report No.: FHWA-GA-20-1406		2. Government Accession No.: N/A		3. Recipient's Catalog No.: N/A	
4. Title and Subtitle: An Enhanced GDOT Pavement Preservation Guide with Optimal Timing of Pavement Preservation			5. Report Date: January 2021

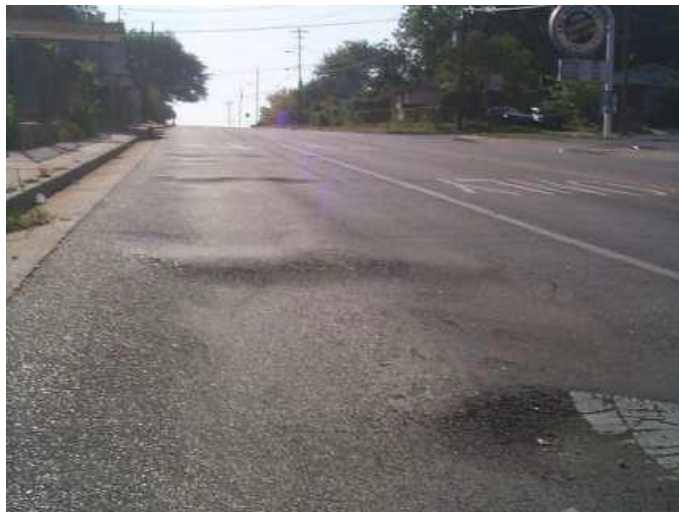
Level 2 – corrugations/pushing have significant effect on riding comfort, some reduction of speed may be necessary

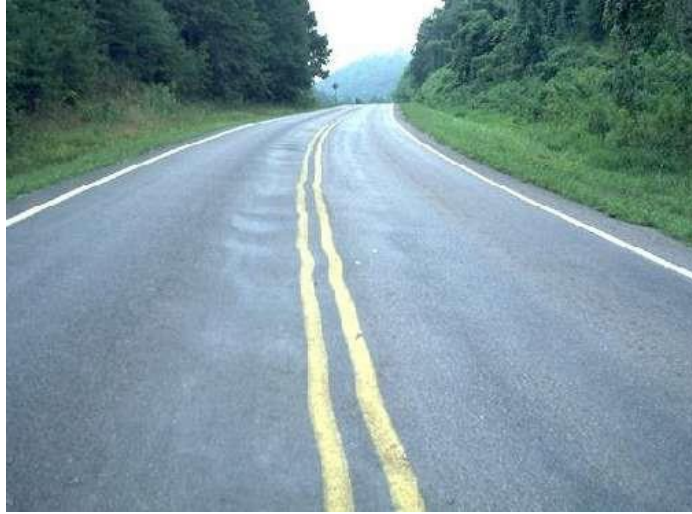
Level 3 – noticeable discomfort, excessive vibration, reduction of speed necessary

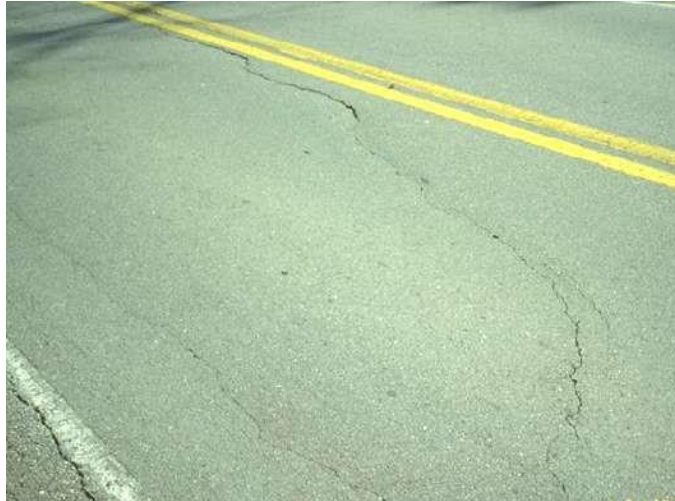
Level 1 (slight) – Noticeable swaying of vehicle, but no effect on vehicle control.

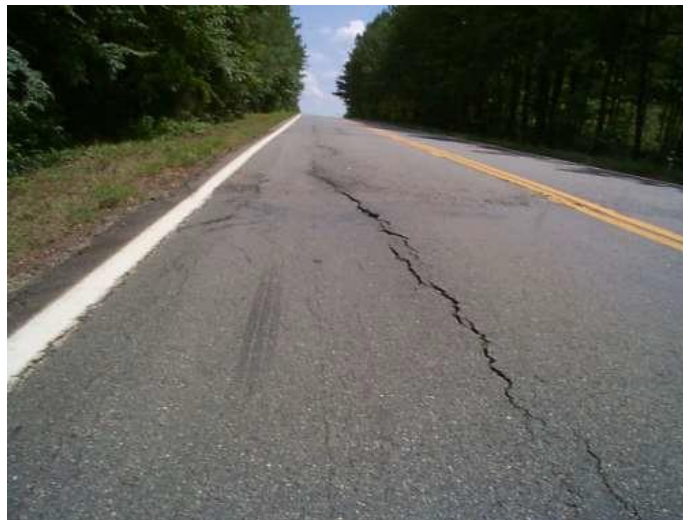
Level 2 (Moderate) – Heavy swaying of vehicle. Fair control of vehicle, driver has to anticipate dips ahead.

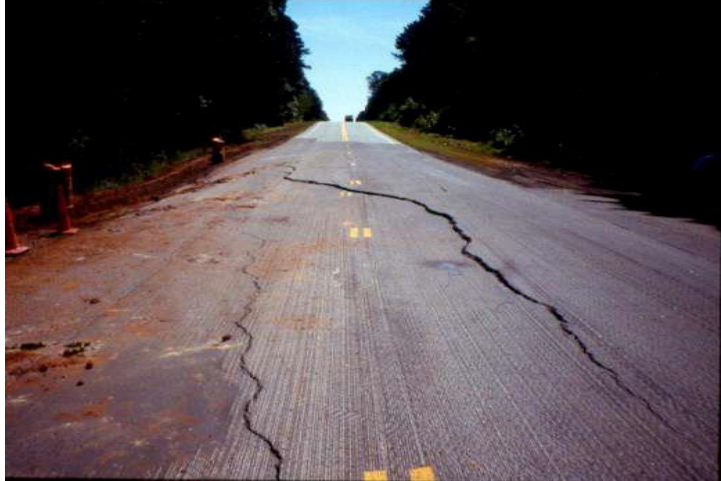
Level 3 (Severe) – Speed of vehicle must be greatly reduced for driver to maintain control.
