Effects of Tree Canopy on Pavement Condition, Safety and Maintenance - Phase 2

The Ohio Department of Transportation
Office of Statewide Planning and Research

September 2020

Final Report

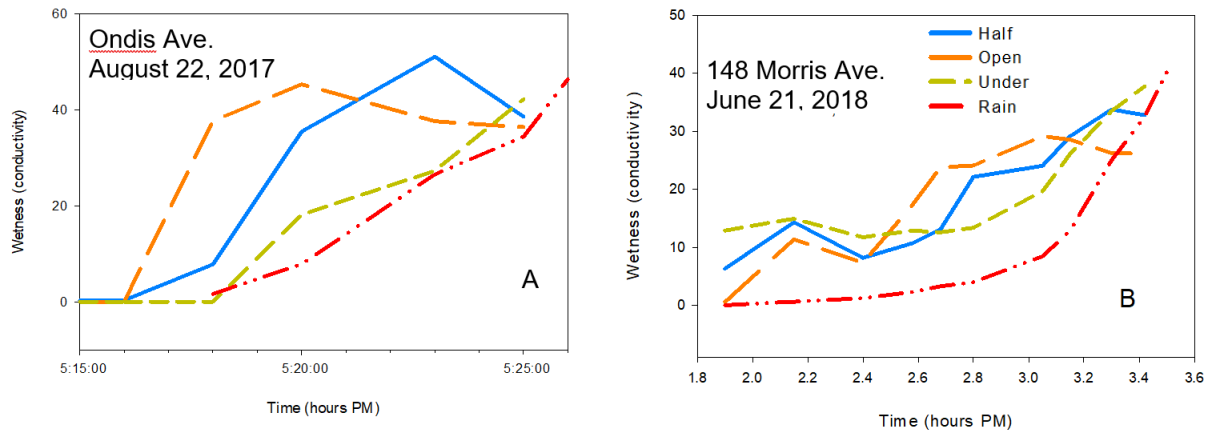
Figure 3. Accumulation of Moisture Through the Course of Rain Showers on Test Plots at trees in Athens, Ohio. Two trees are shown as examples.

Wetting was measured during natural rainfall under six trees. Rain typically began with gentle sprinkling and intensity increased over a span of 30 to 40 minutes, as in the examples in Figure 3. Wetness for “under” plots was lower than for “open” plots for approximately 30 minutes (median) although there was substantial variation between trials related to the intensity and speed of development of individual rainstorms (range: 3 to 77 minutes). In “partial” plots, wetness was detected as soon as in “open” plots (median delay = 0 minutes) though, the degree of wetness in “partial” plots reached that of “open” plots after a median delay of 22 minutes (range: 0 to 74 minutes).

Very little rain was necessary to cause a wetness response in “partial” and “under” plots (unmeasurable – 0.45 mm). “Partial” plots reached levels of wetness equivalent to “open” plots after 0.029 in (0.74 mm) of rain. “Under” plots reached wetness levels equal to “open” plots after 0.050 in (1.27 mm) median.

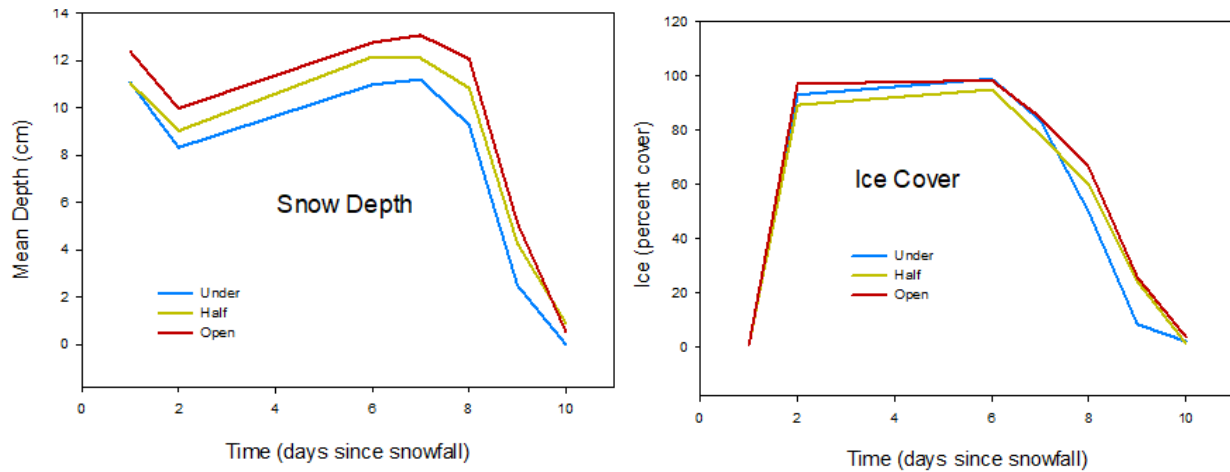
Figure 6. Snow Depth and Ice Cover on Pavement Under and Adjacent to Tree Canopies. Left: Snow depth; Right: Ice cover. (1 cm = 0.39 in).

No tree-canopy difference was detectable in ice cover ($p > 0.40$). After mean daily temperatures rose above freezing, snow and ice rapidly melted (Figure 6). Snow melted significantly faster under a tree canopy than under open sky ($\chi^2 = 6.122$, $p = 0.047$; Wilcoxon $p = 0.066$).

Although the research team did not systematically measure drainage or traffic volume, it became obvious that ice formation depended on two processes: packing of snow by passing vehicles and re-freezing of melt water when drainage was impeded by piles of plowed snow.

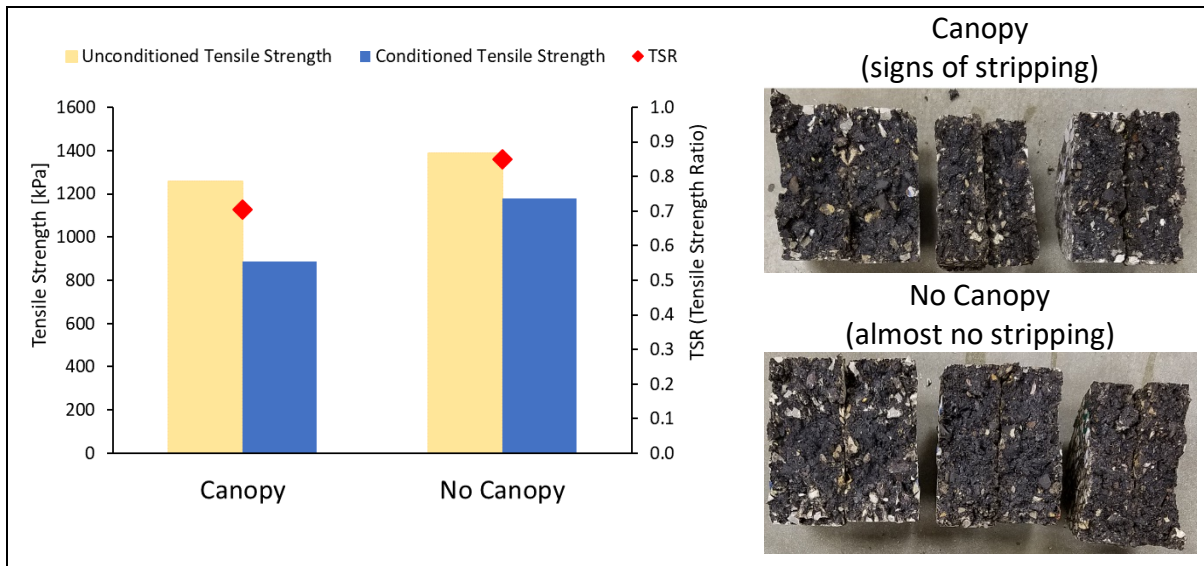
Figure 8. Tensile Strength and TSR Values for Canopy and No-canopy Conditions.

The tensile strength, average conditioned (dry) and unconditioned (wet) tensile strength and TSR values for the canopy and no-canopy sections are summarized in Table 6. Cores from pavement under canopy exhibited higher susceptibility to moisture damage (TSR = 0.71) than the cores from pavement under no-canopy conditions (TSR = 0.85). Figure 8 depicts the

unconditioned indirect tensile strength, which was found, as expected, to be on average higher where exposure to moisture was minimized (i.e. no-canopy sections). Additionally, visual inspection of the specimens revealed the presence of stripping (physical separation of the asphalt cement and aggregate surface) where tree canopy is present.

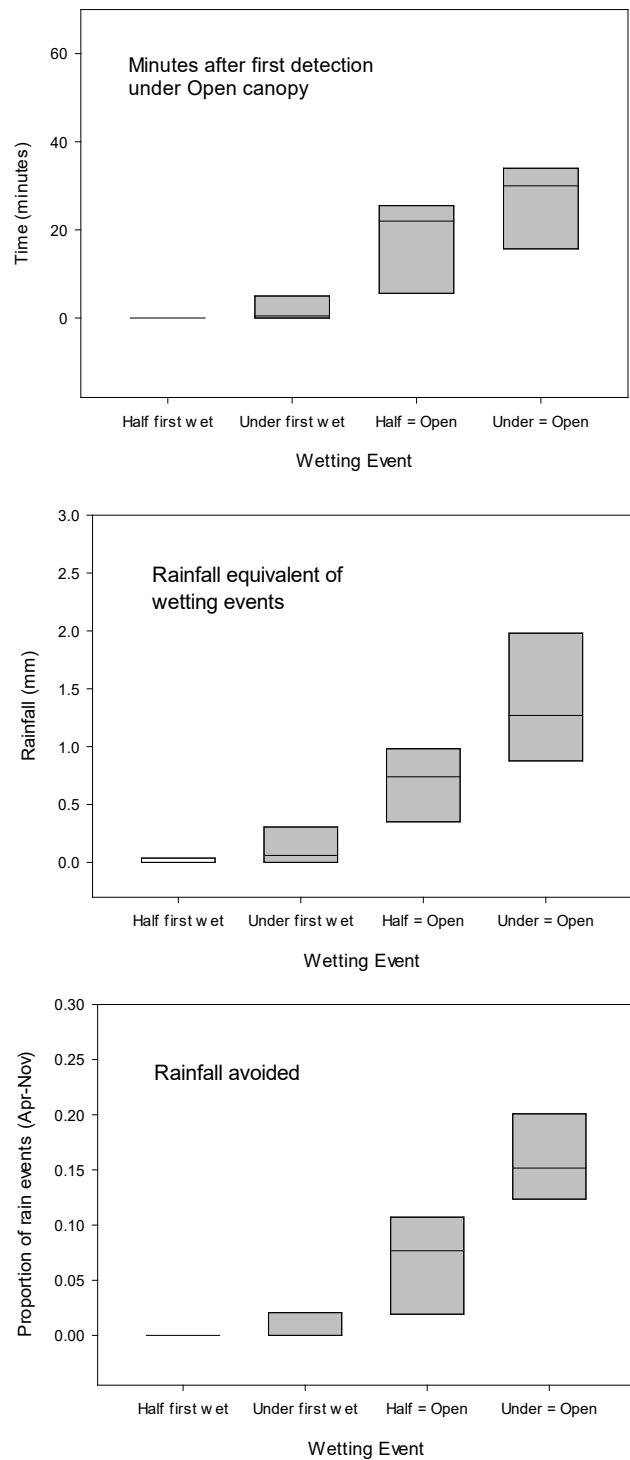
Figure A4. Rainfall in Pavement Plots Under and Adjacent to Trees in Athens, Ohio. Top: Time elapsed after moisture first detected in open-sky plots; Center: Rainfall equivalents judged from on-site rain gauges (1 mm = 0.04 in); Bottom: Rain events entirely or partially avoided under a tree canopy.

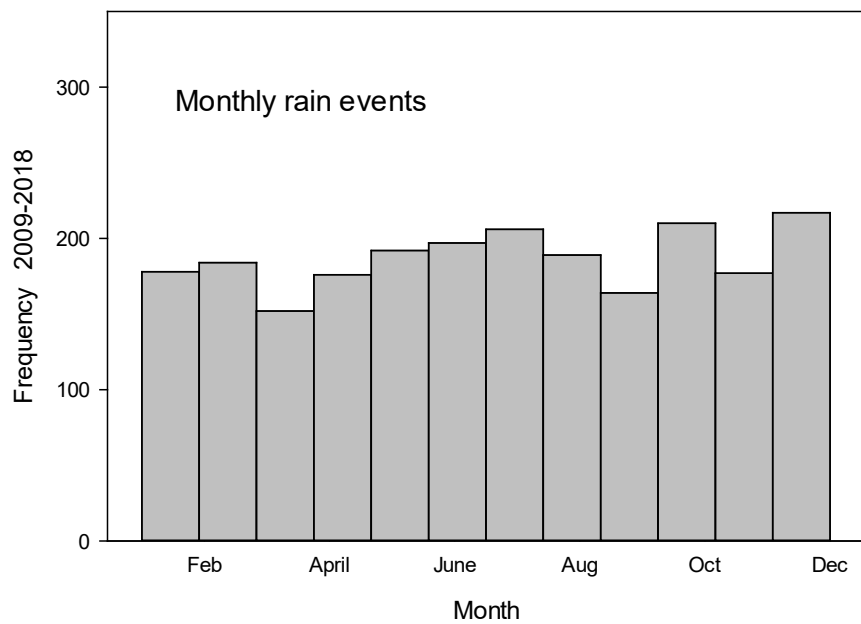
Figure A8. Frequency of Rainfall Events at the Ohio University Airport, Albany, Ohio, 2009-2018. Top: Ranked by event size; Bottom: Frequency by month. (25 mm = 1 in).

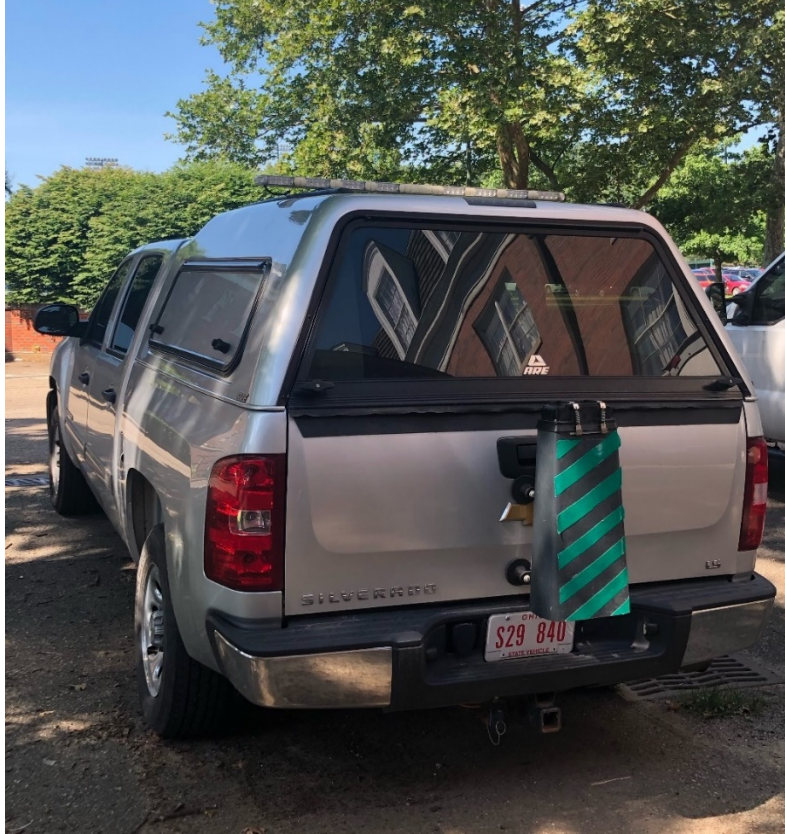
Figure C7. Lufft MARWIS Sensor.

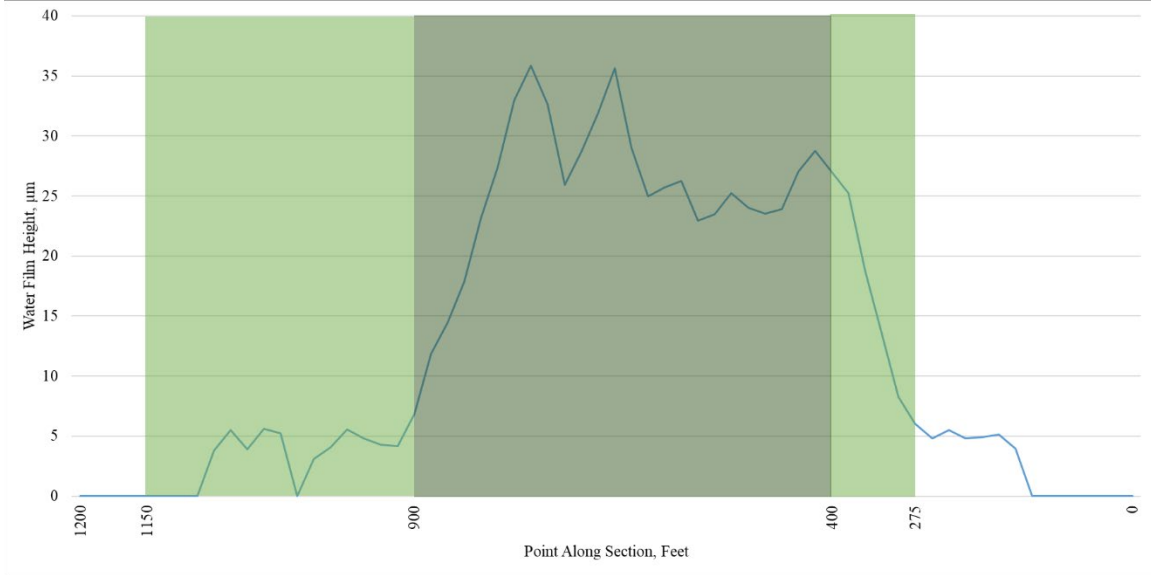
Figure C9. Measured Moisture Levels – SR 124 (2) (WB) in Jackson County, OH.

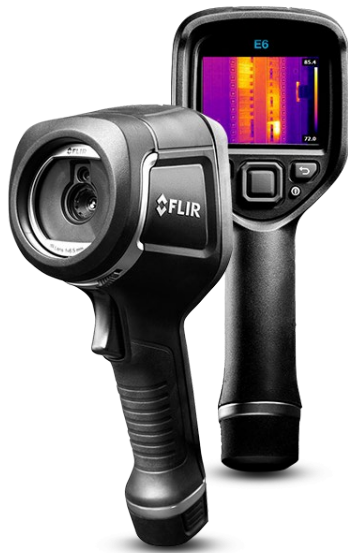
Figure C10. FLIR E6 Infrared Camera [FLIR Systems, Inc., 2019].

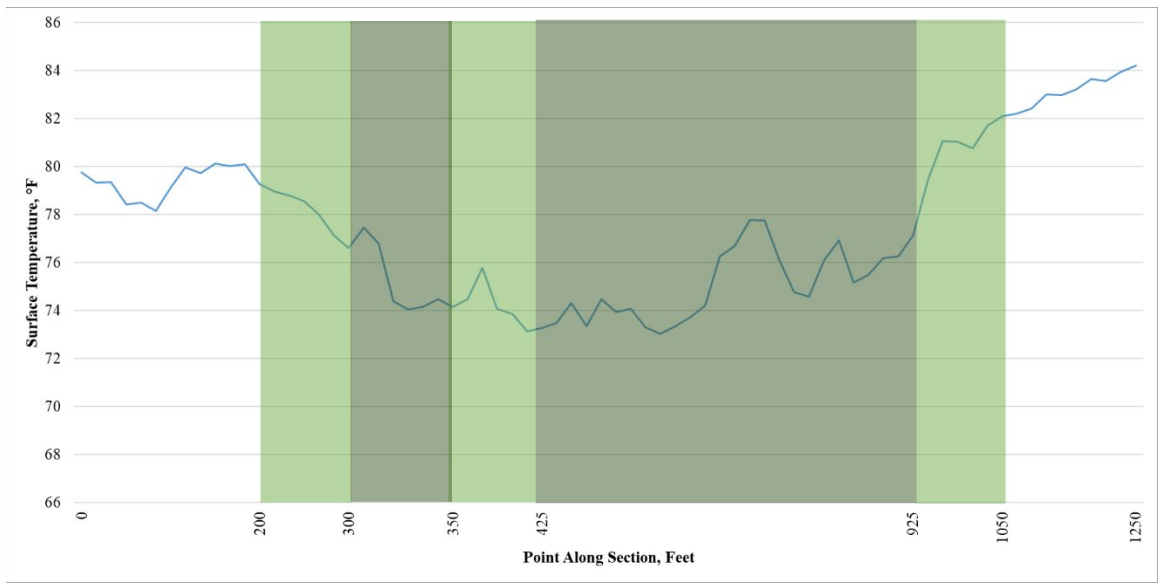
Surface temperature levels measured by MARWIS – SR 56 (WB) in Hocking County, Ohio
