Final Report 650

Load Rating of Existing Continuous Stringers on Louisiana's Bridges

5. Report No.
FHWA/LA.19/650
6. Report Date
October 2021
7. Performing Organization Code
LTRC Project Number: 18-4ST
SIO Number: DOTLT1000222
8. Type of Report and Period Covered
Final Report
06/2018 – 4/2021

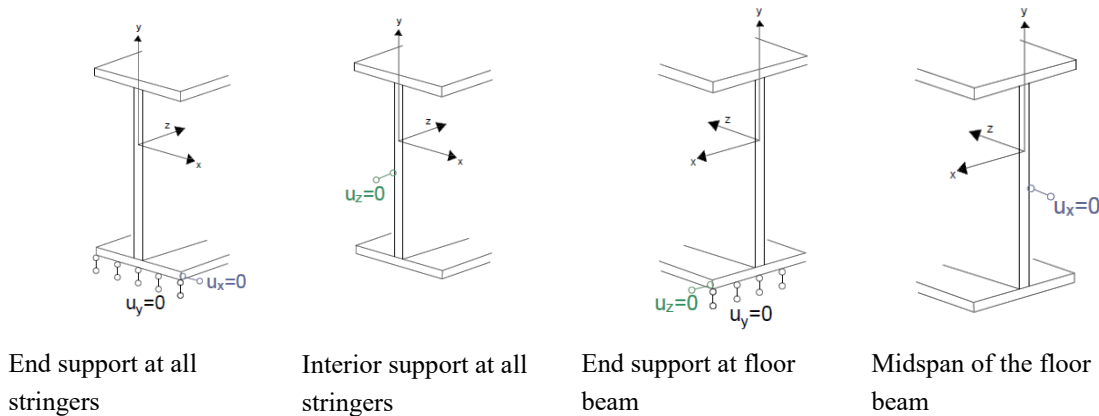
Figure 77. Boundary conditions

Finite element analysis (FEA) simulated stringer behavior while accounting for various parameters, including geometric imperfections, various bracing configurations, rigid and flexible interior supports, other loading conditions, etc. FEA was completed using ANSYS R19. A combination of static, linear Eigenvalue buckling, and non-linear buckling analyses were performed. Stringer geometry measurements were collected using laser scans prior to the tests. An initial imperfection for the interior stringer, approximately $L/1,500$ ($L = \text{span}$), was accounted for in the non-linear analysis following the critical buckling mode. The FEA model includes three lines of stringers, end diaphragms, and the floor beam (Figure 76). Also shown in Figure 76 is a non-composite concrete deck. Model boundary conditions at various supports are illustrated in Figure 77.

End support at all stringers

Interior support at all stringers

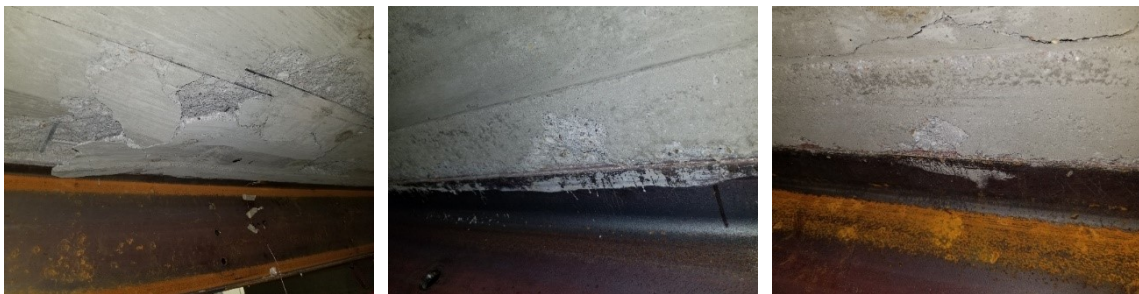
Figure 167. Deck soffit at various locations after testing

(a) Interior stringer near Loc. 3 (b) Exterior stringers near Locs. 13 & 17 (c) Interior stringer near Loc. 10
