Enhancing Evaluation of Wildlife Detection Systems

Project No. 19SAUNM03

Lead University: University of New Mexico

**Final Report
August 2020**

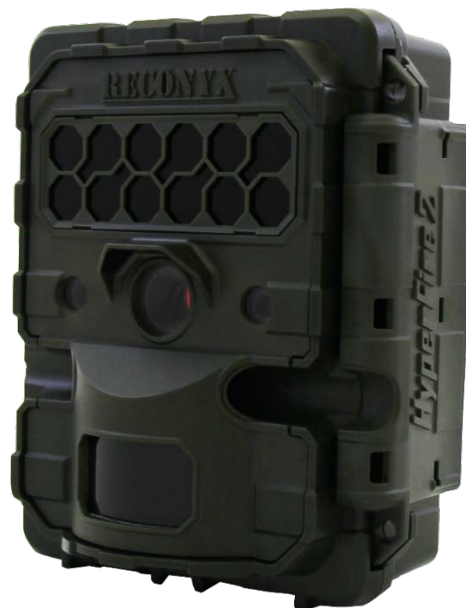
Figure 7. Reconyx HP2X HyperFire 2 professional covert infrared camera.

While there are several brands of wildlife camera traps, Reconyx is a leader in the field and their products are frequently used successfully in research (10, 39-44). The latest version of Reconyx wildlife camera traps is the HP2X HyperFire 2 Professional Covert Infrared Camera (Figure 7). This camera uses motion-detection bands instead of a cone of detection and detects both movement and changes in temperature of bodies in the field of vision. Range is approximately 40 feet and the cameras are set to trigger when both motion and a difference in temperature are detected. For nighttime tracking, the flash can be visible light or infrared. A trigger can result in a single photograph, a set of three photographs, or a video, depending on the preferred output. The cameras use SD memory cards and lithium AA batteries that can withstand extreme conditions in the field.

We used the latest version of Reconyx wildlife camera traps available at the time of purchase, the HP2X HyperFire 2 Professional Covert Infrared Camera (Figure 7). The cameras use motion-detection bands instead of a cone of detection and detect both movement and changes in temperature of bodies in the field of vision. Range is approximately 40 feet and the cameras are set to trigger when both motion and a difference in temperature are detected. Wildlife can be tracked at night with either a visible light or infrared flash. The cameras can record either pictures or videos and also record the temperature of the surrounding environment. Advertised operating temperature is -20 degrees to +120 degrees Fahrenheit (the lowest temperature we recorded in the field was -9 degrees Fahrenheit). Trigger speed is 0.2 seconds.

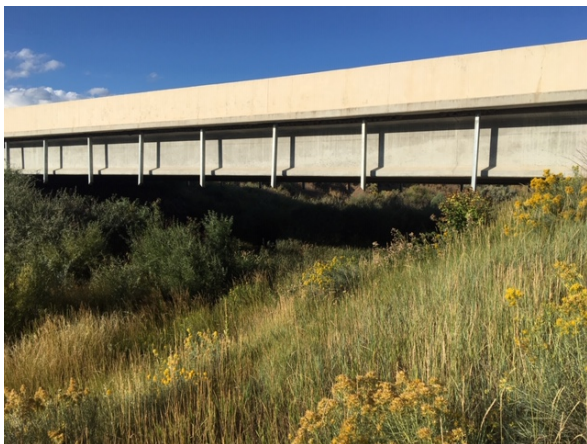
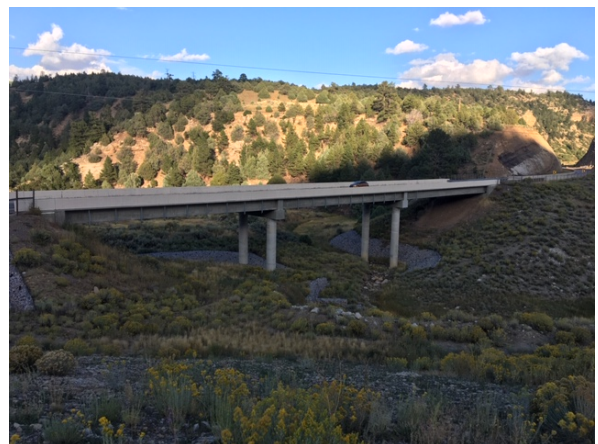
Figure 10. Bridge #9387 (left) and bridge #9415 (right).

Bridge #9387 is smaller at 109.9 feet long and 41.0 feet wide curb-to-curb with approximately 20 feet of clearance underneath (Figure 10). Bridge #9415 is 309.7 feet long and 42.0 feet wide curb-to-curb with approximately 40 feet of clearance underneath. Bridge #9387 was constructed in 2008 and #9415 in 2013. Both bridges are two lanes wide and carry less than 3,000 annual average daily traffic (AADT).

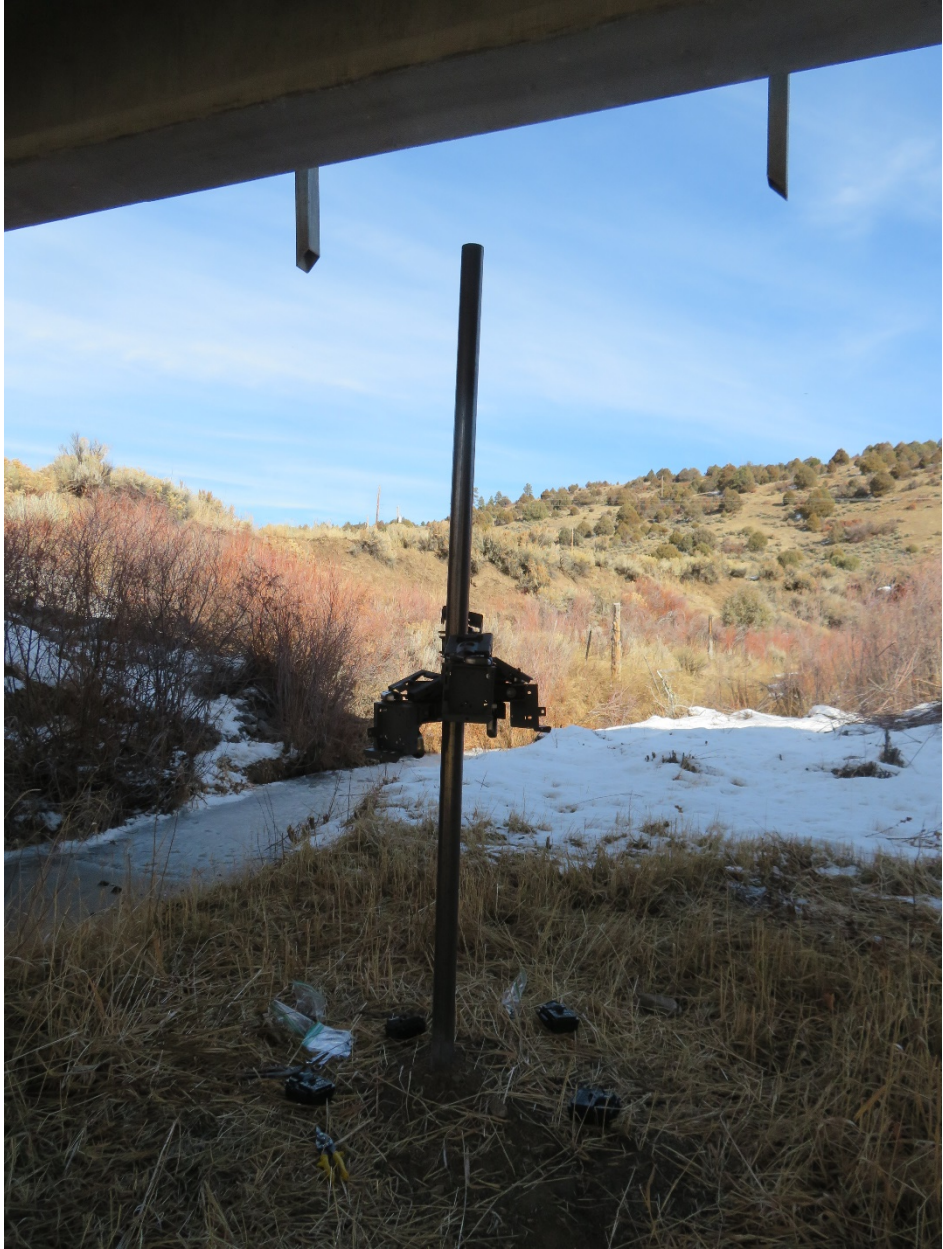
Figure 13. Pole installation at bridge #9387 looking north with Amargo Creek visible to the left of the pole.

While bridge #9387's structure is 109.9 feet long, there are steep slopes with riprap on either end of the bridge. The actual area that wildlife can use is approximately 45 feet wide. Amargo Creek flows on the northwest end of bridge #9387. The pole was installed approximately 15 feet southeast of the creek (Figure 13). Amargo Creek is typically frozen for several months each year and is occasionally dry. Wildlife use the creek itself for passage when these conditions exist. The cameras were installed with enough height and were angled down to monitor the creek bed itself. There is also a heavily used wildlife trail on the south end of the bridge. The positioning of the four cameras allowed us to capture both of these movements. Vegetation was thinned within 40' of the pole to prevent camera false captures.

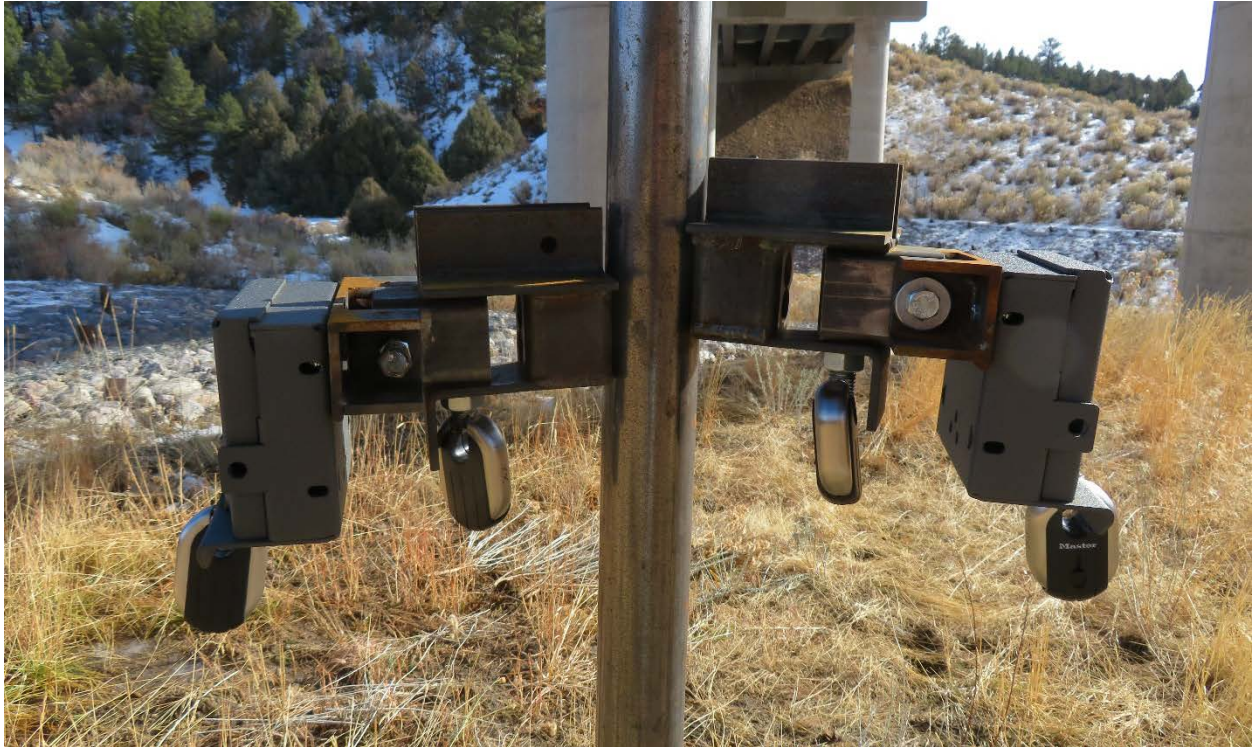
Figure 17. Pole A installation, looking east.

The two cameras on pole A (Figure 17) and the one camera on pole B (Figure 18) were installed at approximately 5 feet in height, allowing them to capture small and large wildlife. The camera on the pier (Figure 19) is installed approximately 7 feet above the creek bed. The camera is angled slightly downward so that it can monitor activity in the creek in addition to approaches. The bracket for the pier camera was bolted directly to the pier.

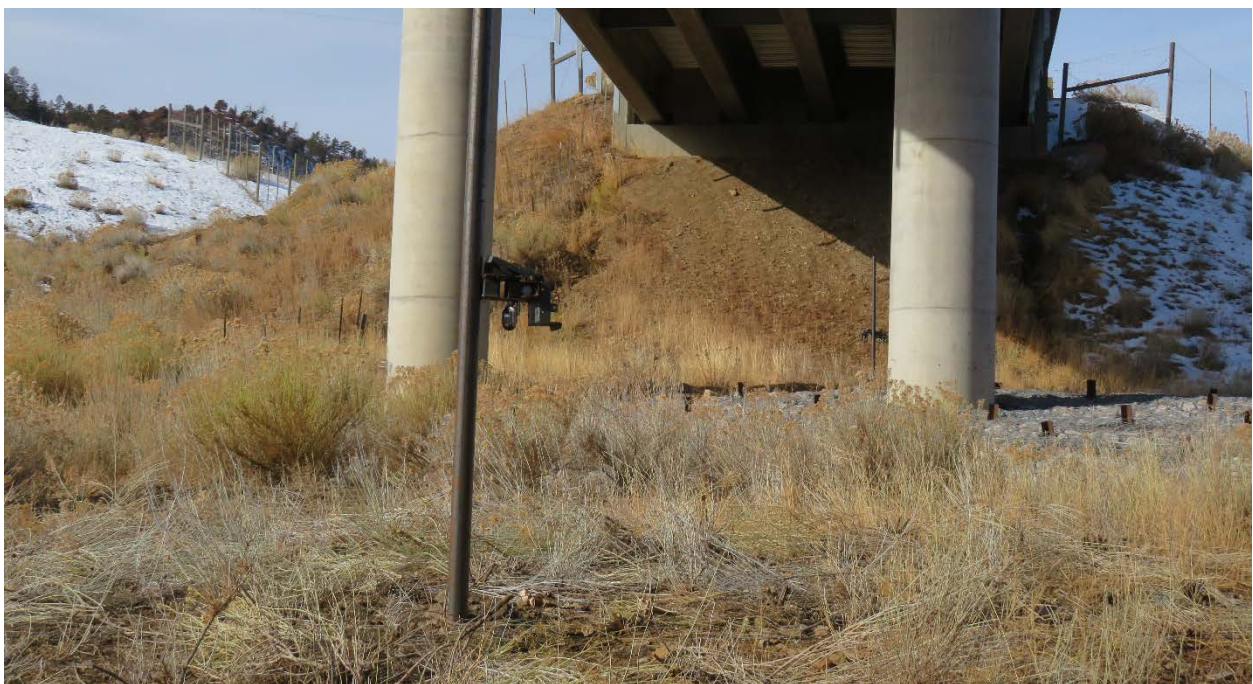
Figure 18. Pole B installation, looking west (pole A in the background to the left of the right-most pier).

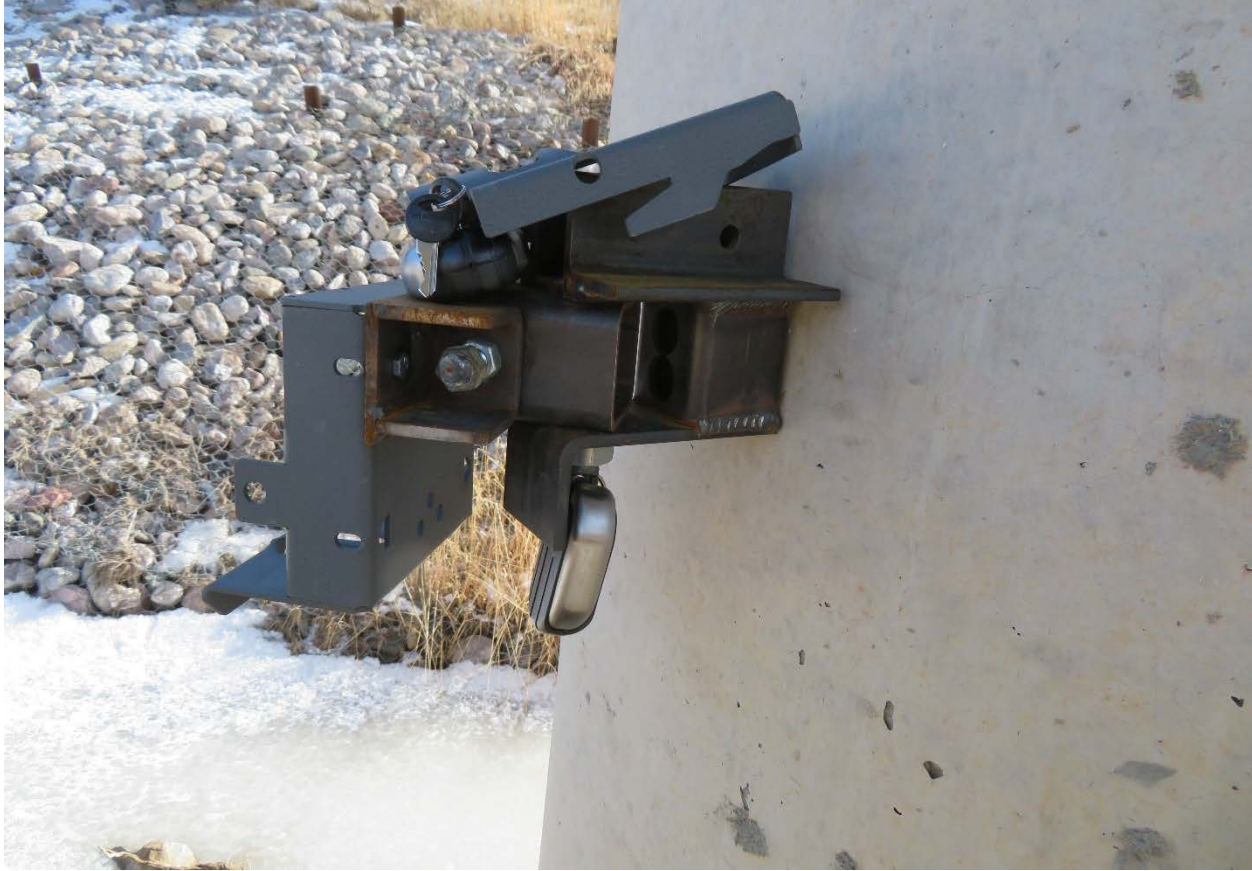
Figure 19. Pier installation.

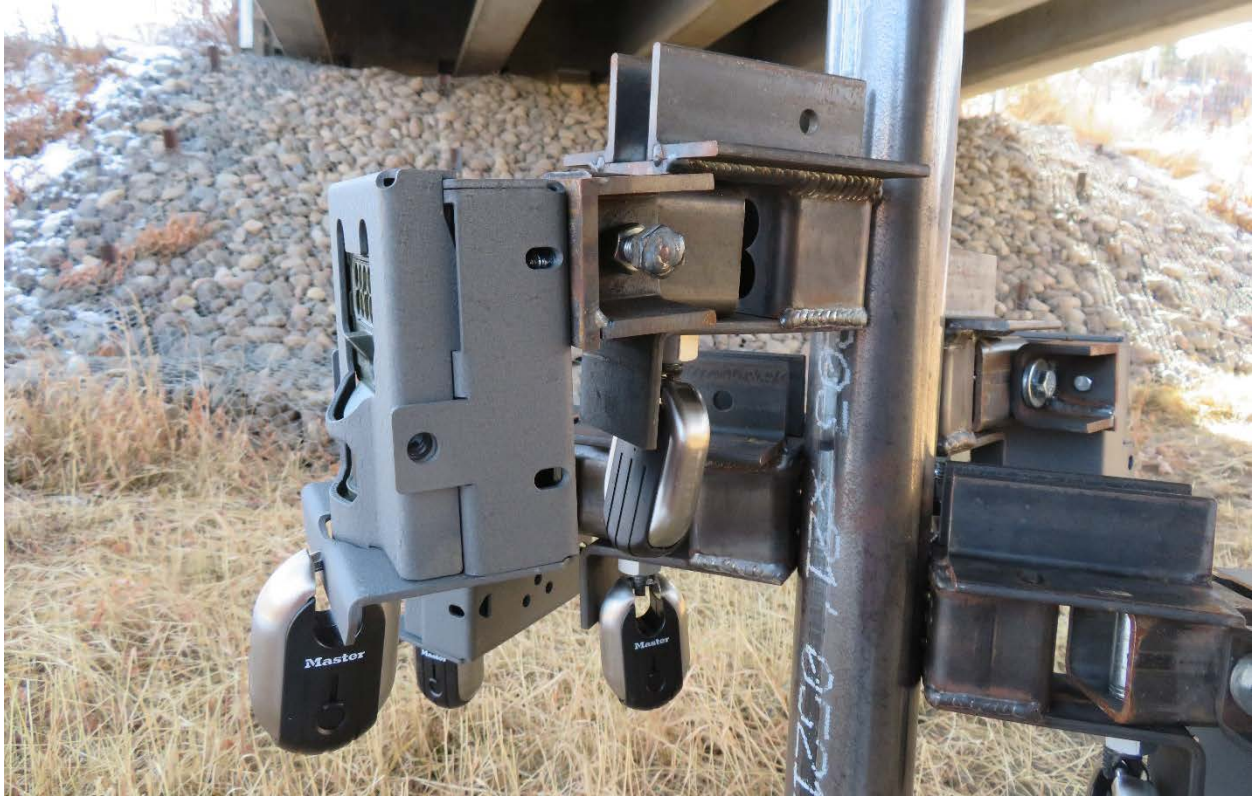
Figure 20. Camera installation.

To avoid vandalism and theft, the cameras were locked into steel enclosures, the enclosures were fixed onto mounts, and the mounts were secured to the poles (Figure 20). The steel enclosures were purchased from the camera manufacturer and were designed to securely hold the camera without obstructing the sensors or the recording device itself. The enclosure had a faceplate that can be removed to access the camera and can be locked when in use. We used keyed locks with protected shanks.

The enclosure is secured to the mount with bolts and nuts. The nuts are inside the enclosure so that they can only be removed if someone has access to the inside of the enclosure. The mounts allow for vertical and horizontal adjustments of the cameras (Figure 21). The vertical pivot is made around a bolt that has two nuts. The inside nut can be loosened to allow for adjustment of the mount and then tightened to secure the mount. The outside nut is welded to the end of the bolt so the inside nut cannot be removed, precluding disassembly of the mount. The horizontal pivot is made around a bolt that has one nut and a hole drilled in the end of the bolt. The nut can be loosened to allow for adjustment of the mount and then tightened to secure the mount. The hole at the end of the bolt allows for a padlock to be locked to it, precluding the removal of the nut or disassembly of the mount. The mounts were custom designed with help from AZGFD. The mounts were built by a steel fabrication shop in Albuquerque. To attach the camera mount to the pole, we used 7/16-14 bolts (2 per mount) after we drilled and tapped holes in the poles. The bolts are inside the mount and can only be accessed if the padlock on the horizontal-pivot adjustment bolt is removed and the front end of the entire mount is detached.
