MPC 21-426 | J. Seo, B. Kidd, and N. Wehbe

Field and Analytical Study  
for Deteriorating Precast  
Double-Tee Girder Bridges

This project discusses the performance of deteriorating double-tee (DT) girder bridges that have been in service for many years. This included field testing of two single-span DT girder bridges in South Dakota for live load distribution factors (LLDFs) and dynamic load allowance (IM). The LLDFs and IM were determined using strain data measured during the tests. When calculating LLDFs, nearly all the measured LLDFs were below the American Association of State Highway Transportation Officials (AASHTO) values. While analyzing the data, it was found that the stems on the same girder did not always have similar strain quantities. Hence, newly proposed stem and joint approaches to calculate the LLDFs were investigated and compared with the conventional girder approach. These results were also compared with those determined according to AASHTO Standard and Load and Resistance Factor Design (LRFD) specifications. It was found that both the AASHTO LRFD and Standard specifications were conservative when estimating IM, compared with the test results for both bridges.

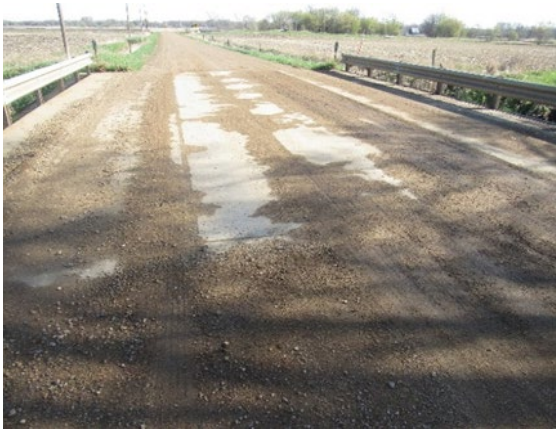
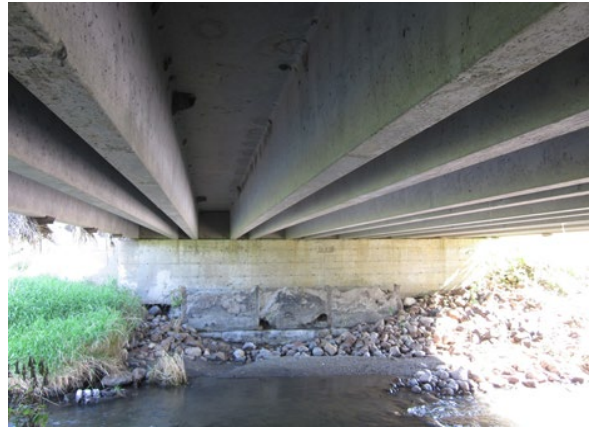
The first field testing was carried out on a single-span DT bridge, consisting of seven 762-mm-deep prestressed DT girders, on a gravel road. This DT girder is one of the standard sections used for DT bridges in South Dakota. The bridge span length was 11.6 meters. The bridge, which was located in Lincoln County, South Dakota, was 34 years old at the time of testing. Each of the girders, supported by concrete abutments, was 1.2-m wide and had a zero-degree skew angle. The girders were longitudinally connected using a steel plate connection and grouted shear key. Figures 3.1a and 3.1b show the road surface and bridge underneath, respectively.

**Figure 3.1** Description of Bridge A (Kidd et al. 2021): (a) view of the bridge from the road surface and (b) view from underneath the bridge

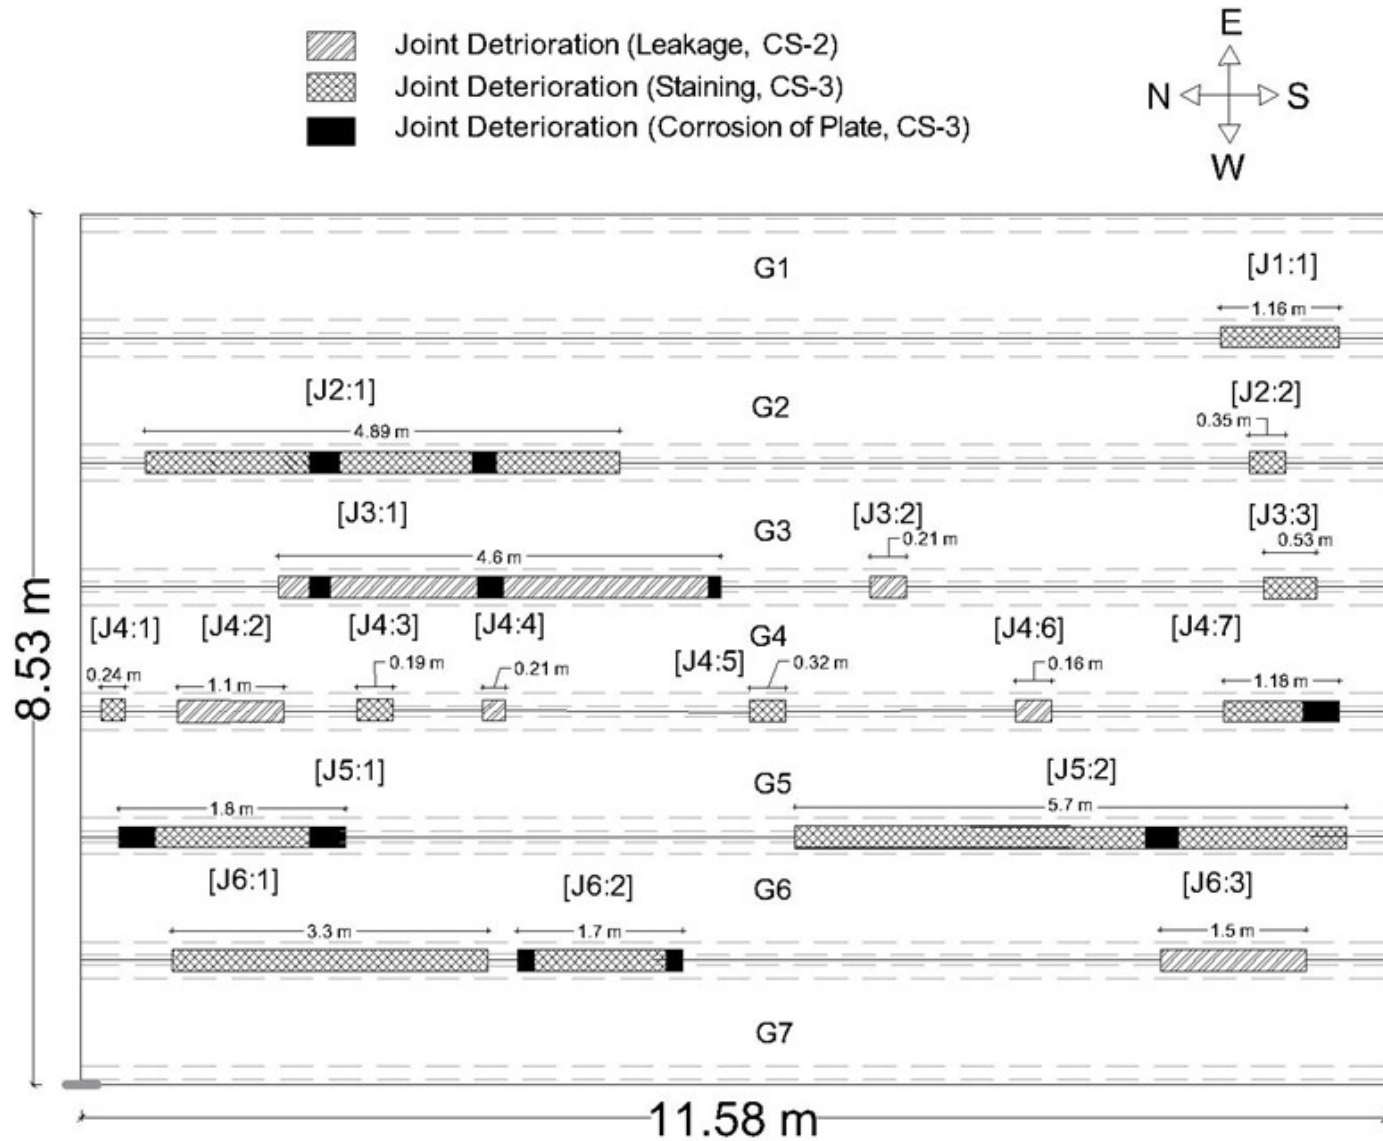
Figure 3.2 shows the damage map of the 762-mm-deep DT bridge observed before the field testing. The main bridge damage was the deterioration of the girder-to-girder joints, including leakage between joints, efflorescence, and corrosion of steel plates. Figure 3.3 shows an example of efflorescence on the 762-mm-deep girder bridge. Small spalling was also observed for some of the girder stems.

Figure 3.2 Damage of Bridge A from visual inspection

Detailed damage type, portion, and ratio from Bridge A and B are summarized in Tables 4.2 and 4.3, respectively, which can be seen on the damage maps shown in Figures 3.2 and 3.5. The first and second columns of Table 4.2 and 4.3 describe the damage location and type. Damage along the longitudinal joints included leakage, staining, and corrosion of the steel plates. When the grout in the joint deteriorates, water can get in the joint and leak through it. As it deteriorates more, efflorescence or staining occurs on the concrete below the joint. The joint includes a steel plate every 1.5 meters along the girder for both bridges. As the water penetrates the joint, it can accelerate the corrosion of the steel plates. For example, damage [J3:1] of Bridge A has both staining (S) and corrosion (C) present. The third columns of Table 4.2 and 4.3 show the amount of damage in terms of area. The portion was measured by hand using a tape measure. As mentioned previously, Bridge B only used the length of the damage because the large clearance and water level underneath the bridge did not allow the research team to get close enough to measure the width of the damage. Instance [J3:1] of Bridge A had 2932.3 cm<sup>2</sup> of staining and 153.2 cm<sup>2</sup> of corrosion at the joint. The AASHTO Manual (AASHTO 2013) for each damage instance is shown in

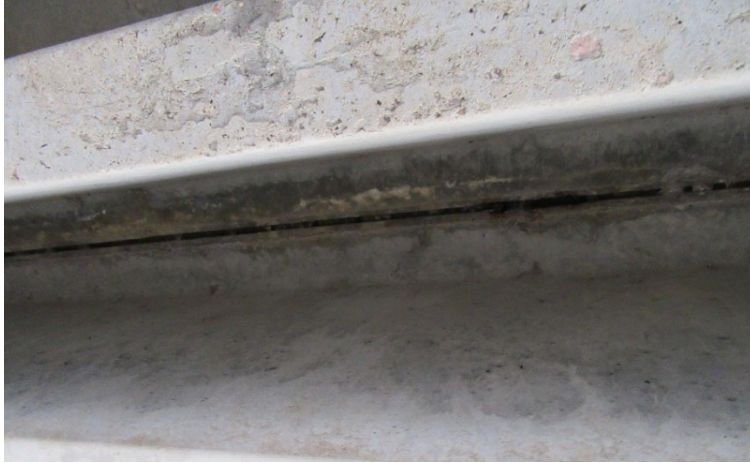
**Figure 3.3** Efflorescence and erosion between G7 and G6 on Bridge A (Credit: Brian Kidd)

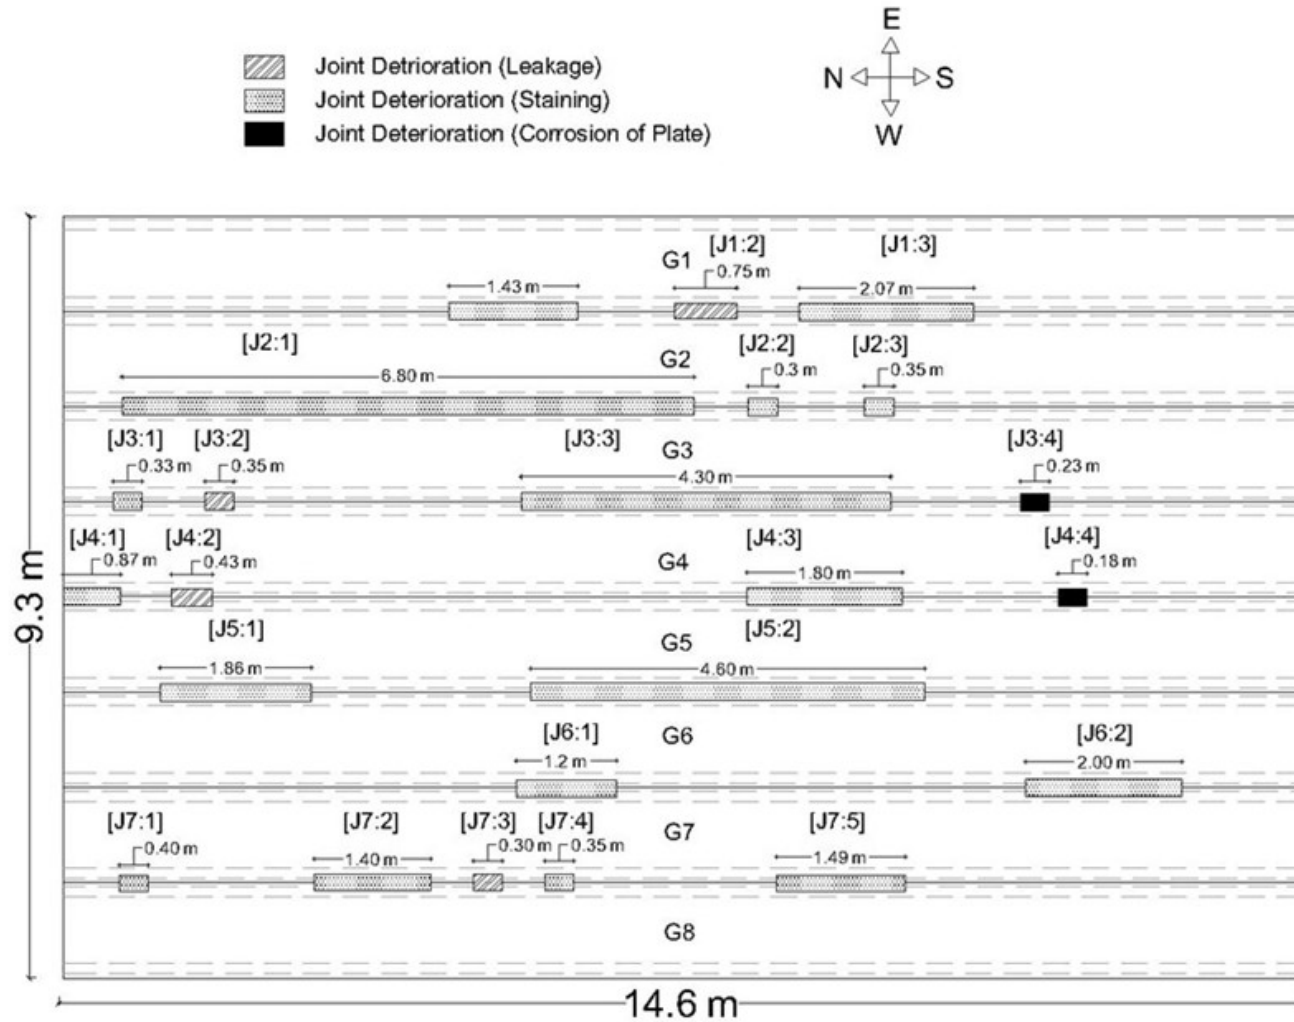
A visual inspection was conducted before the field tests, and Figure 3.5 shows the observed damage including the efflorescence and water leakage in the girder-to-girder joints. An example of the leakage is shown in Figure 3.6.

Figure 3.5 Damage on Bridge B from visual inspection

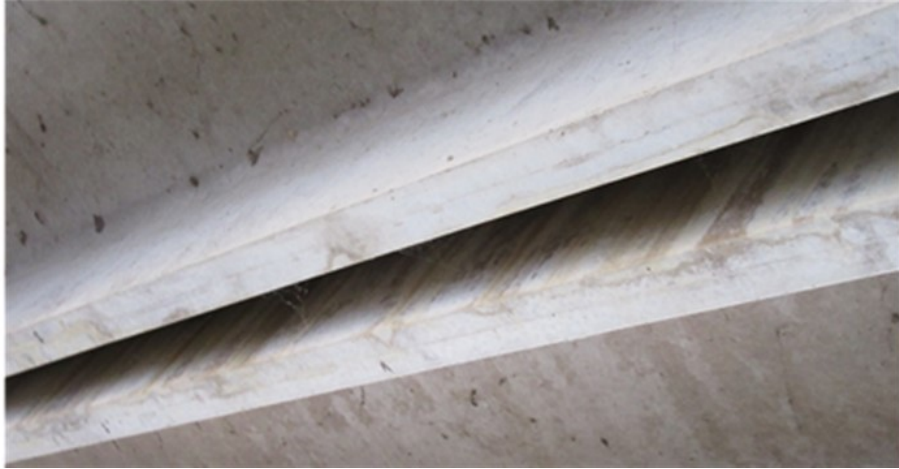
**Figure 3.6** Example of efflorescence on Bridge B (Credit: Brian Kidd)

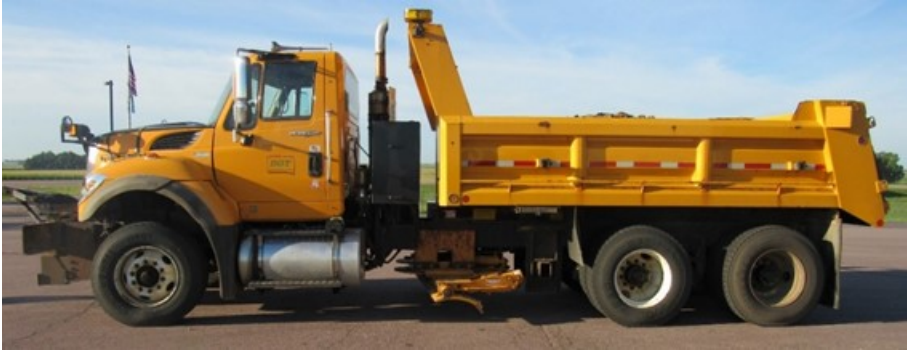
The truck used for the field testing weighed 222 kN, with a front axle weight of 74.6 kN and a combined weight of 147.7 kN for the back two axles. The distance between the first and second axle is approximately 4.97 meters. The distance between the back two axles is about 1.5 meters. The truck used for all field tests can be seen in Figure 5.4.

Figure 5.12 Truck used for field testing (Kidd et al. 2021): (a) side view and (b) axle configuration

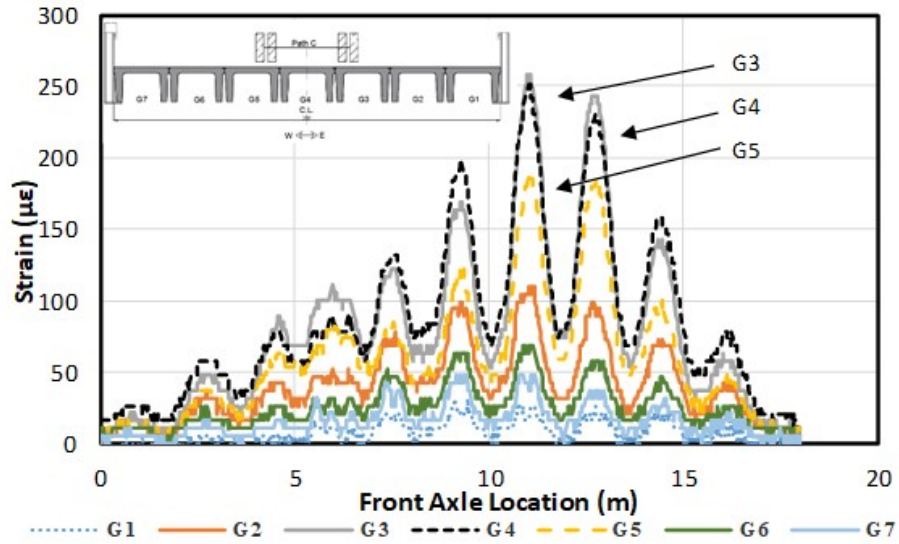
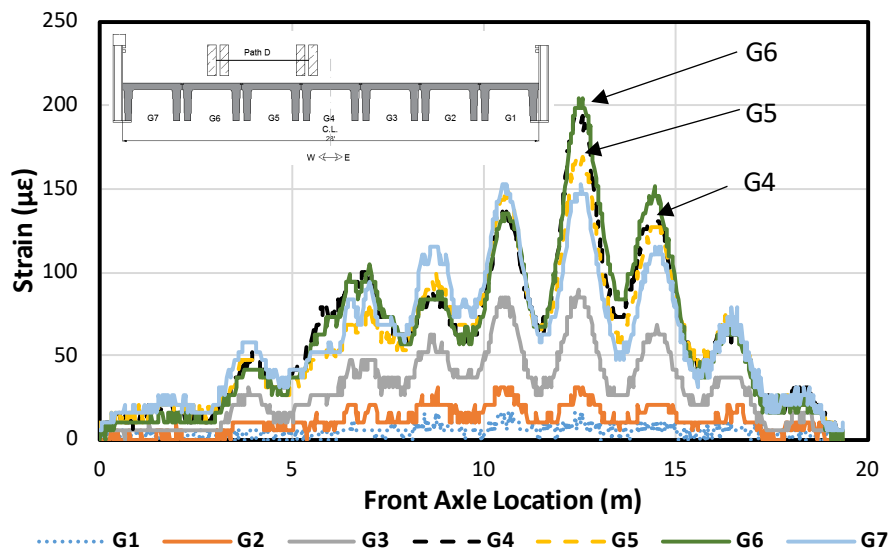
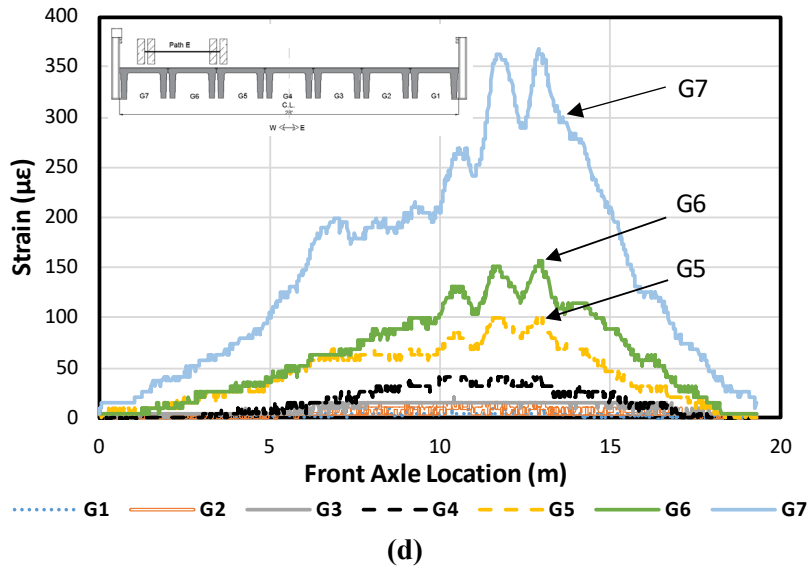
Figure 6.1 shows the measured strains over the length of Bridge A under the static loadings. Note that the data for Path A on Bridge A were lost when transferring from the data logger. Under the Path B loading, Girder G3 exhibited the highest strain, and Girders G4 and G2, which were directly underneath the wheel paths, had the next highest strains as shown in Figure 6.1a. The strains for other girders were significantly lower since the loads were farther away from these girders. The same trend was observed for other interior load paths (see Figure 6.1b and 6.1c). Figure 6.1d shows the measured strains for Path E loading, which was on an exterior girder. It can be seen that the exterior girder had significantly larger strains than the other girders. Furthermore, Figure 6.1d shows that the three girders (G5, G6, and G7) underneath the loads had significantly higher strain values than the remaining girders. The maximum strains measured in Bridge A were in a range of 200 to 350 microstrain. Note, the highest strain was measured in Girder G7 under the Path E loading (Figure 6.1d), while the lowest strains were seen in the girders under Path D loading (Figure 6.1c).

**Figure 6.13** Strain versus location of the front axle of truck for Bridge A (Kidd et al. 2021): (a) Path B, (b) Path C, (c) Path D, and (d) Path E

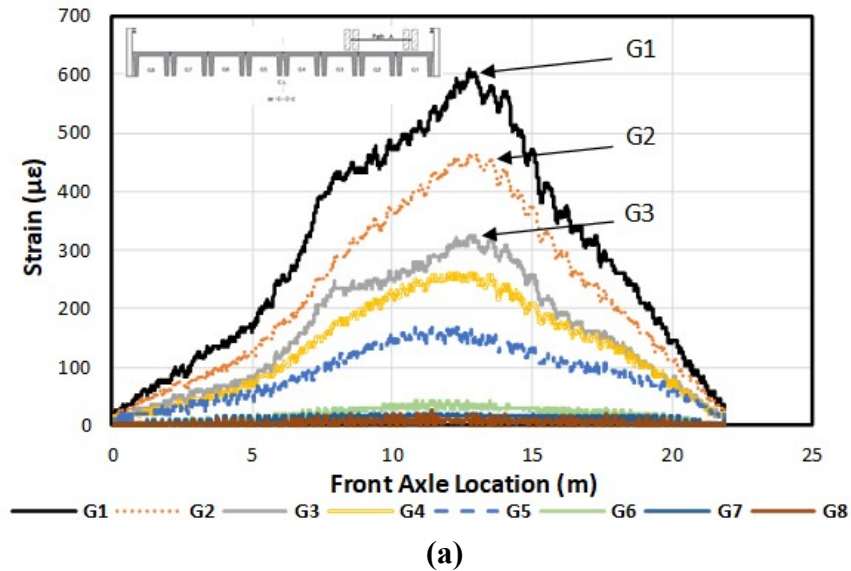
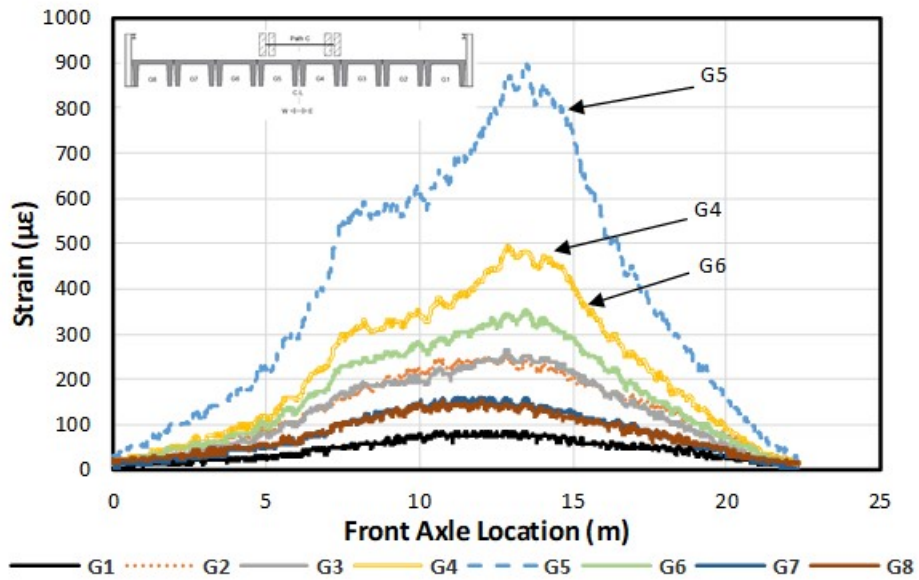
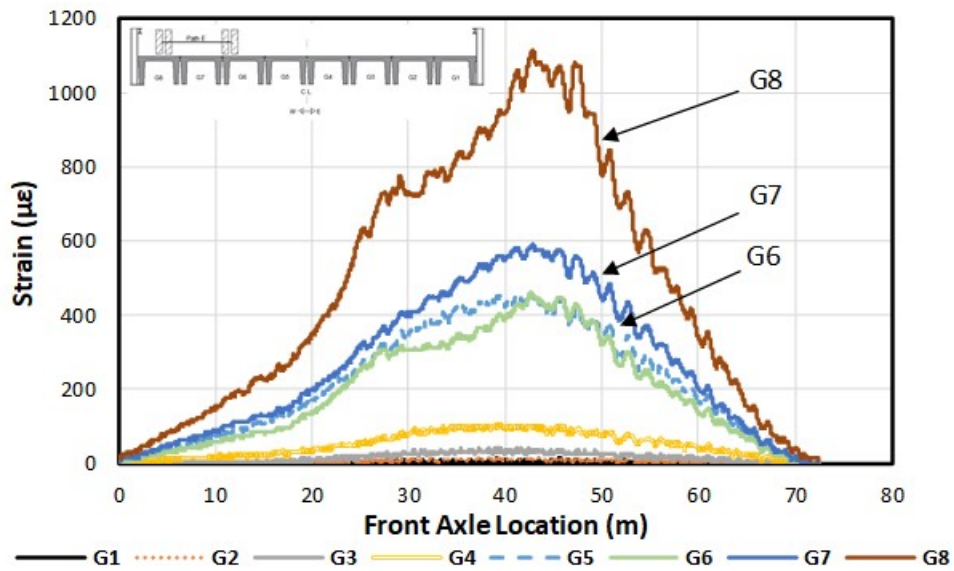
Figures 6.2a through 6.2e show the measured strains over the length of Bridge B under the static loadings. Bridge B had strain values ranging from 600 to 1100 microstrains from the field tests. Figures 6.2a and 6.2e show the strain responses resulting in the largest strain values for the exterior girders, G1 and G8, respectively. Figure 6.2c shows the larger strain values of the girders, which were directly underneath the loads, compared with the remaining girders. A similar trend is shown in all the strain response figures for Bridge B. Meanwhile, Figure 6.2b shows that G5 has similar strain values to G3. This demonstrates that the loads were more transversely distributed across the girders directly underneath the loads than the other girders.

**Figure 6.14** Strain versus location of the front axle of truck for Bridge B (Kidd et al. 2021): (a) Path A, (b) Path B, (c) Path C, (d) Path D, and (e) Path E

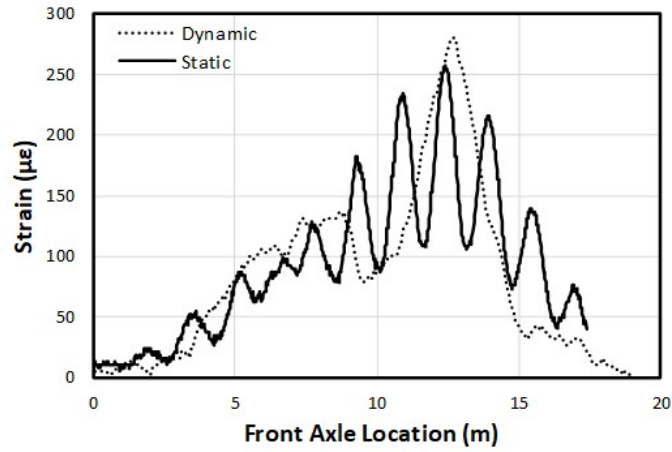
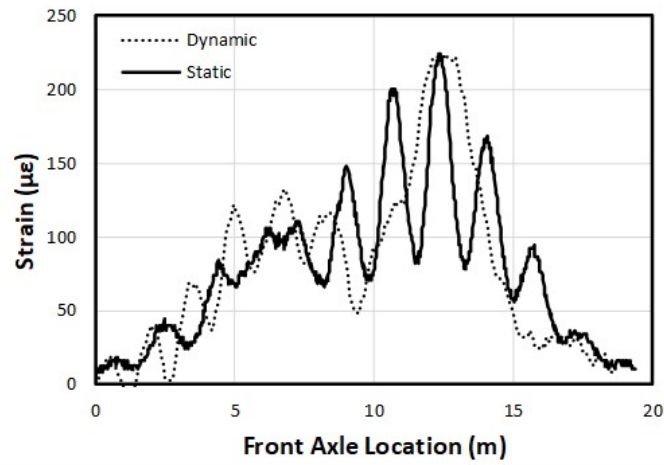
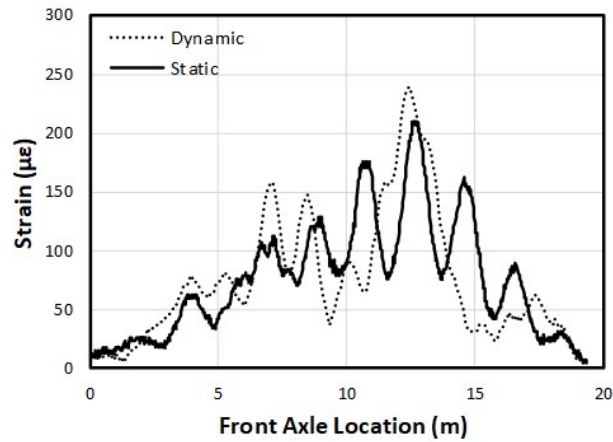
The goal of the dynamic tests was to determine IMs for the tested bridges. Using the strain data from both the static and dynamic tests, a strain versus truck location graph was created, comparing the strain caused by the dynamic load with the static load. Since two trials were conducted for each path, both static and dynamic, the average strain of the static field tests was compared with the average strain of the dynamic field tests. This relationship can be seen in Figures 6.3a through 6.3c for Bridge A and Figures 6.4a through 6.4c for Bridge B. The strain values from the girder with the largest maximum strain were used for these figures. As seen in these figures, the response caused by the dynamic load increased the strains when compared with the static load. However, it is noteworthy that Figures 6.3b and 6.4a show dynamic responses that are similar to the static response.

**Figure 6.15** Static versus dynamic response of Bridge A: (a) Path B, (b) Path C, and (c) Path D

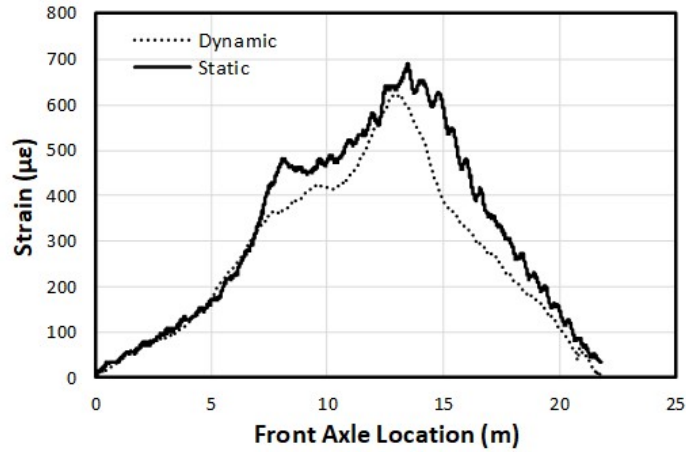
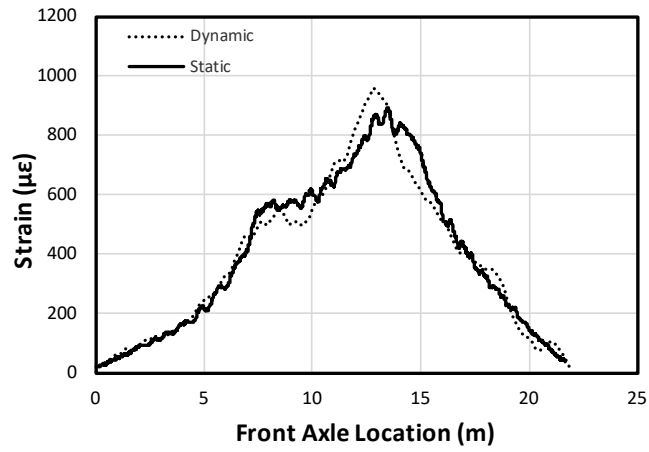
**Figure 6.16** Static versus dynamic response of Bridge B: (a) Path B, (b) Path C, and (c) Path D

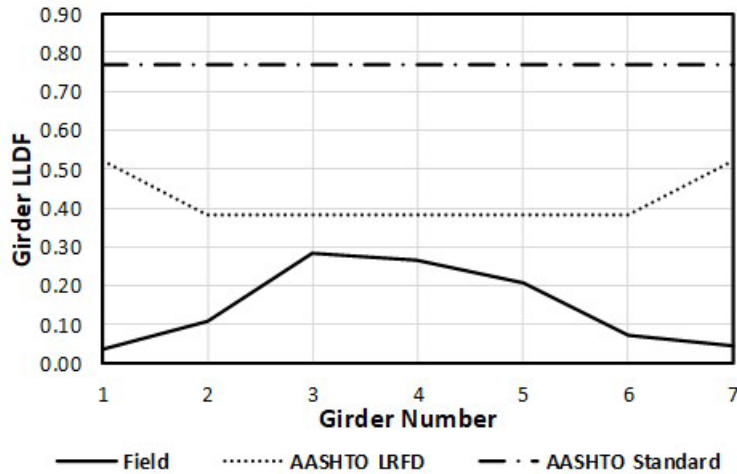
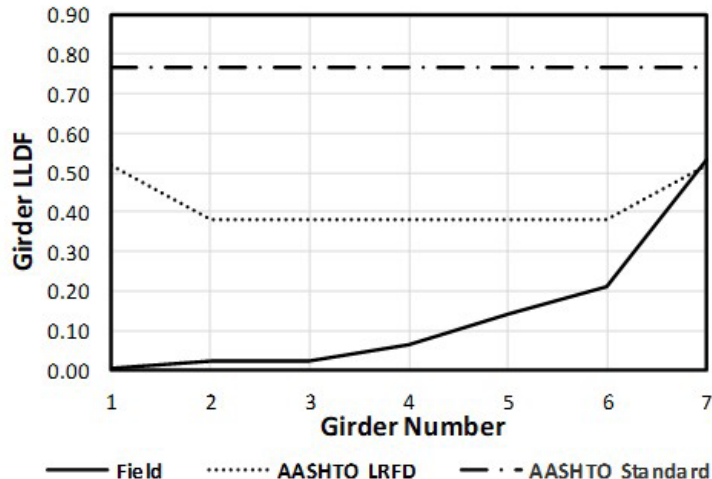
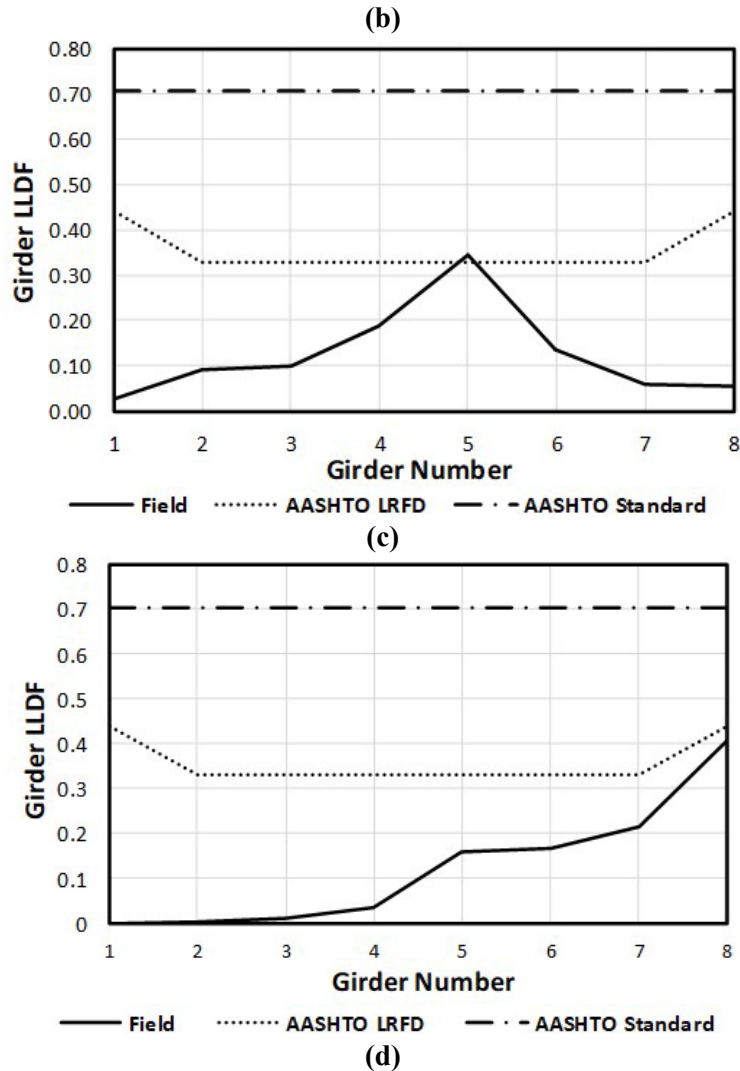
The comparison shows that the AASHTO LRFD LLDFs are higher than the field LLDFs in every case except the exterior girder G7. Specifically, the AASHTO LRFD LLDFs were, on average, 34.7% larger than the field LLDFs, while the field LLDF for G7 was only higher than the AASHTO LRFD value by 2.6%. This phenomenon can be explained by the visual inspection showing that damage to the longitudinal joint is present and causes a high LLDF for G7. Meanwhile, the AASHTO Standard Specifications were significantly higher than any field LLDFs. The AASHTO Standard values were, at a minimum, 36% higher than the field LLDFs and, on average, 90% larger.

**Figure 7.17** LLDFs using the girder approach (Kidd et al. 2021): (a) Bridge A – Path C, (b) Bridge A – Path E, (c) Bridge B – Path C, and (d) Bridge B – Path E

For Bridge B, the comparison can be seen in Figures 7.1c and d for paths C and E. Girder G5 has the only field LLDF that is greater than the AASHTO LRFD value. However, the field LLDF is only 2.9% larger than the AASHTO LRFD. Again, the comparison of field LLDFs and AASHTO LLDFs can be seen in Table 7.1. Leakage through the joint between G4 and G5 is believed to be the cause of this high LLDF (Kidd et al. 2021). The average percent difference between the field LLDFs and the AASHTO LRFD LLDFs is 33.3%, while the AASHTO Standard specifications significantly overestimate the field LLDFs by 91.5% on average. Again, the AASHTO Standard specifications were included in this investigation since the DT bridges are over 30 years old and were designed using the AASHTO Standard specifications.

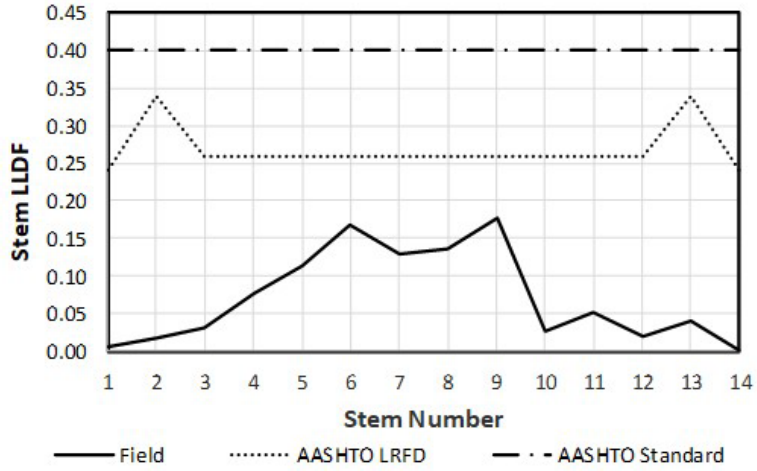
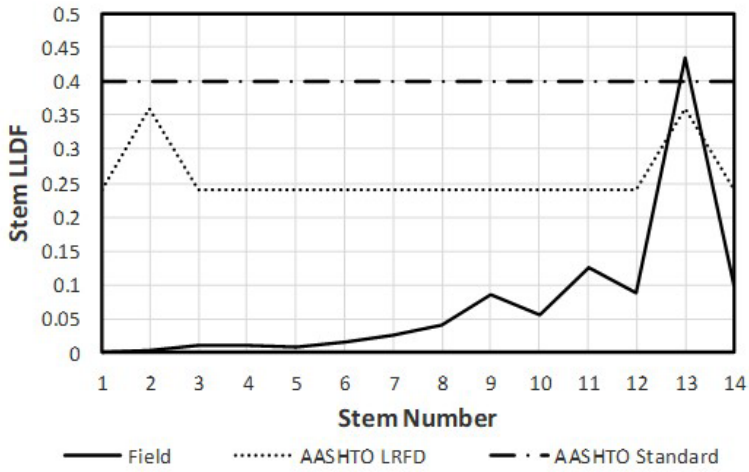
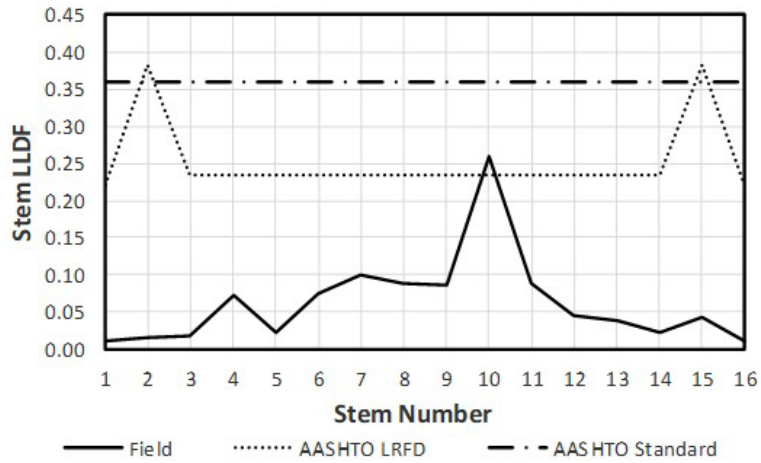
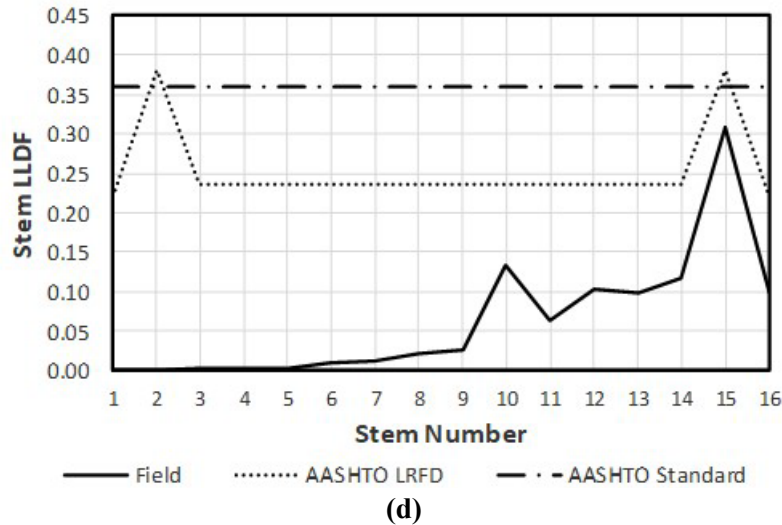
Figures 7.2a and 7.2b for paths C and E compare the LLDFs by stem to the AASHTO LLDF values for Bridge A. Stem 13, which is the inside stem of the exterior girder, has a substantially higher LLDF than the AASHTO LRFD LLDF value. Besides, Stem 13, the rest of the field LLDFs were lower than the AASHTO LRFD values. The percent differences for the stem approach can be seen in Table 7.2. Specifically, Stem 13 has a value 7.5% higher than the AASHTO Standard LLDF. It should be noted that Stem 13 on Bridge A is the only time the field LLDF exceeded the codified LLDFs from the AASHTO Standard specifications. Stem 12 has a noticeably smaller value than Stem 13; the two stems are separated by only a joint. This is another indicator of joint damage at that location. Path A data were lost when transferring the data between the data logger and computer; therefore, the field LLDFs of Stem 1 and 2 did not show a similar trend to the other exterior stems. As shown in Table 7.2, the average of all the percent differences of the stem approach was also calculated. The AASHTO LRFD and AASHTO Standard have average percent differences from the field LLDFs of 55.5% and 81.6%, individually.

**Figure 7.18** LLDFs using the stem approach: (a) Bridge A – Path C, (b) Bridge A – Path E, (c) Bridge B – Path C, and (d) Bridge B – Path E

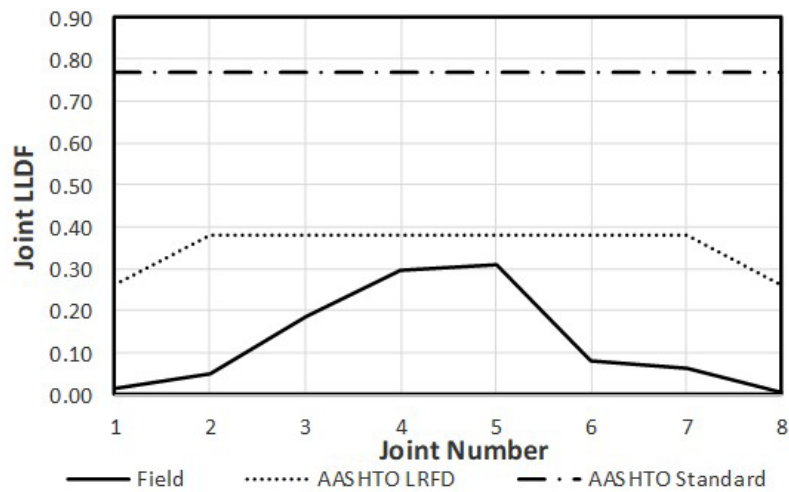
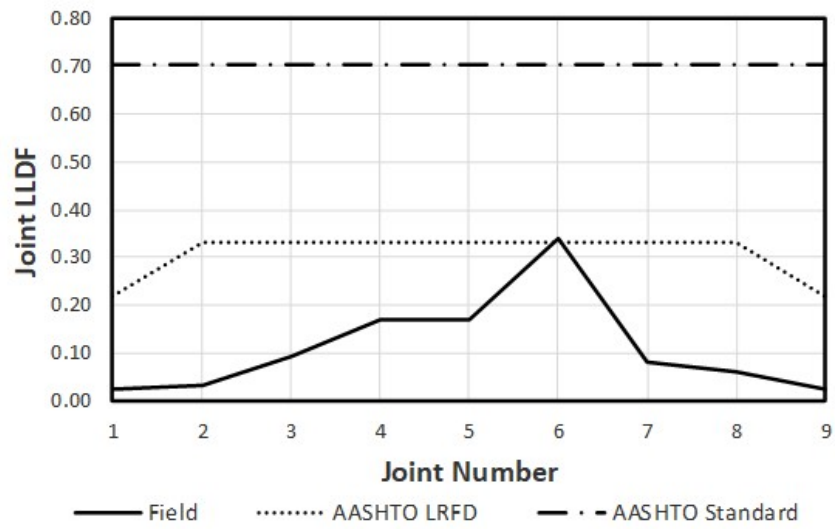
The comparison between the field LLDFs and the two AASHTO-compliant values for Bridge A can be seen in Figures 7.3a and 7.3b for paths C and E. Table 7.3 shows the percent difference of the field LLDFs compared with the two AASHTO values for Bridges A and B using the joint approach. Joint 7 on Bridge A, including stems 12 and 13, has the only LLDF higher than the AASHTO LRFD value by 22%. This is comparable to the result from the stem approach, but the LLDF is higher in the joint approach. It should be noted that the girder LLDF still yielded the highest value. The AASHTO Standard value is higher than all the field LLDFs by an average of 107.2%.

**Figure 7.19** LLDFs using the joint approach: (a) Bridge A – Path C, (b) Bridge A – Path E, (c) Bridge B – Path C, and (d) Bridge B – Path E

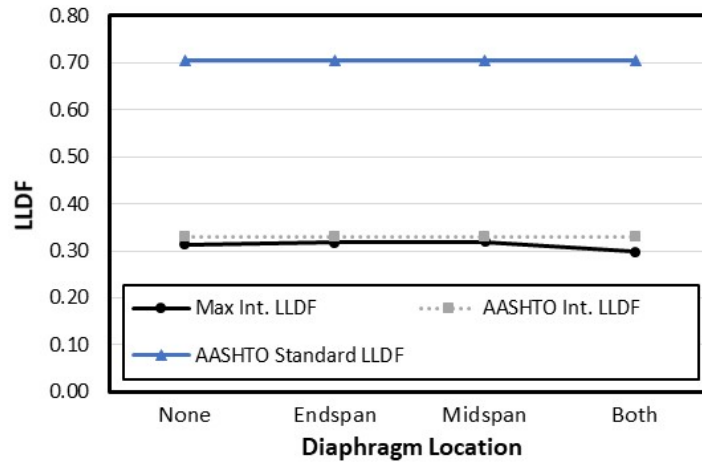
The same analysis was done on Bridge B, as seen in Figures 8.5a and 8.5b for interior and exterior girders and Table 8.6. When diaphragms are present at the midspan and endspan, both the LLDFs decrease. Otherwise, there is very little change (6% max) in LLDFs. The presence of diaphragms at the midspan and endspan changed the LLDFs by a maximum of 15% and 5% on average. Since this was not as obvious in Bridge A, it suggests that a 584-mm-deep DT girder cannot fully transfer the load like a 762-mm-deep girder when it is damaged. Similar to the trend in LLDFs due to the increase in the span length, the AASHTO Standard LLDFs appear to be much higher than those from the parametric study.

**Figure 8.24** Change in LLDFs due to diaphragm location in Bridge B: (a) interior LLDFs and (b) exterior LLDFs

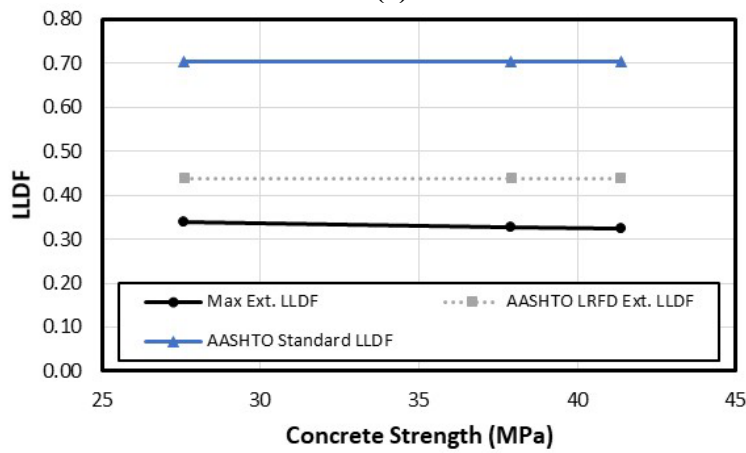
For Bridge B, the interior and exterior LLDFs of the analytical model and two AASHTO specifications are shown in Figure 8.9a and 8.9b and Table 8.10a and 8.10b. There are very minimal changes between  $f_c = 41.37$  MPa and  $f_c = 37.92$  MPa (<2%). However, when  $f_c = 27.58$ , both the interior and exterior LLDFs increased by 2.8% and 3.6%, respectively. Overall, the concrete strength has no significant effect on the LLDFs of DT girder bridges. It appears that the analytical LLDFs due to the increase in the concrete strength are much lower than those gained from the AASHTO Standard specifications.

**Figure 8.28** Change in LLDFs due to concrete strength in Bridge B: (a) interior LLDFs and (b) exterior LLDFs

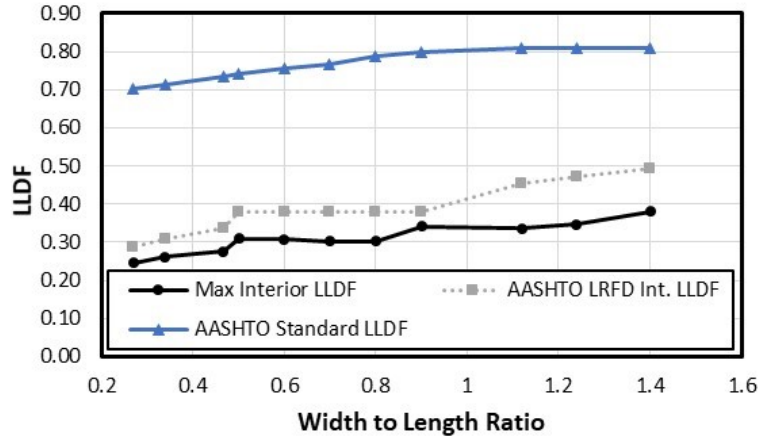
The effect of the width to length ratio on the LLDFs was investigated in this study. For Bridge A, change in the interior and exterior LLDFs can be seen in Figure 8.10a and 8.10b. Table 8.11a and 8.11b summarize all detailed LLDFs for the interior and exterior girders. As the width to length ratio increases, so do the LLDFs. The AASHTO LRFD interior LLDFs show a similar pattern to the analytical interior LLDFs but are slightly conservative compared with the AASHTO values. The maximum percent difference is 25.7%. The AASHTO exterior LLDFs are significantly higher than the analytical exterior LLDFs. The maximum percent difference between exterior LLDFs and the AASHTO LRFD exterior LLDF is 72%, which is too conservative.

**Figure 8.29** Change in LLDFs due to width-length ratio in Bridge A: (a) interior LLDFs and (b) exterior LLDFs

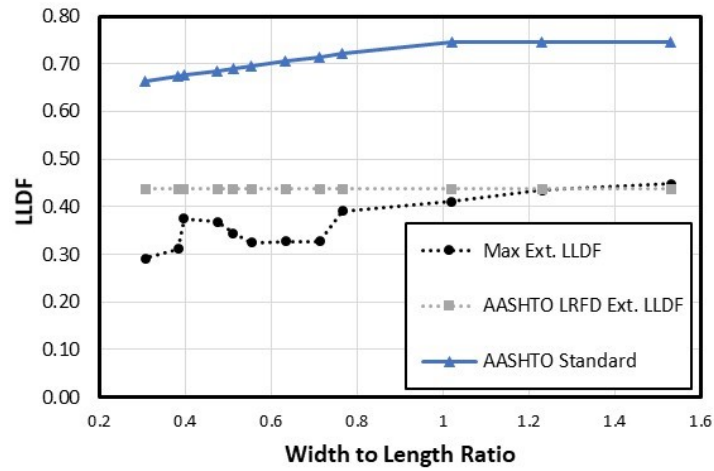
The effect of width to length ratio on the interior and exterior LLDFs for Bridge B can be found in Figure 8.11a and 8.11b and Table 8.12a and 8.12b. Again, both interior and exterior LLDFs increase as the width-length ratio increases. However, the AASHTO LRFD LLDFs are more consistent with Bridge B until the width-length ratio is larger than 0.766. The interior LLDFs then exceed the AASHTO LRFD LLDFs because of the shear crack at girder G4, and G5 is the only girder to exceed the AASHTO LRFD LLDF values. The exterior AASHTO LRFD LLDFs are more conservative than the interior LLDFs. For the width-length ratio of 1.53, the analytical LLDFs slightly exceed the AASHTO LRFD exterior LLDFs. The AASHTO Standard LLDFs are significantly larger than the analytical LLDFs for both interior and exterior girders for Bridges A and B.

**Figure 8.30** Change in LLDFs due to width-length ratio in Bridge B: (a) interior LLDFs and (b) exterior LLDFs
