Durability of Anchorage Pour-backs and Improvements

Prepared by:
Garrett Tatum and Natassia Brenkus

Prepared for:
The Ohio Department of Transportation,
Office of Statewide Planning & Research

Final Report

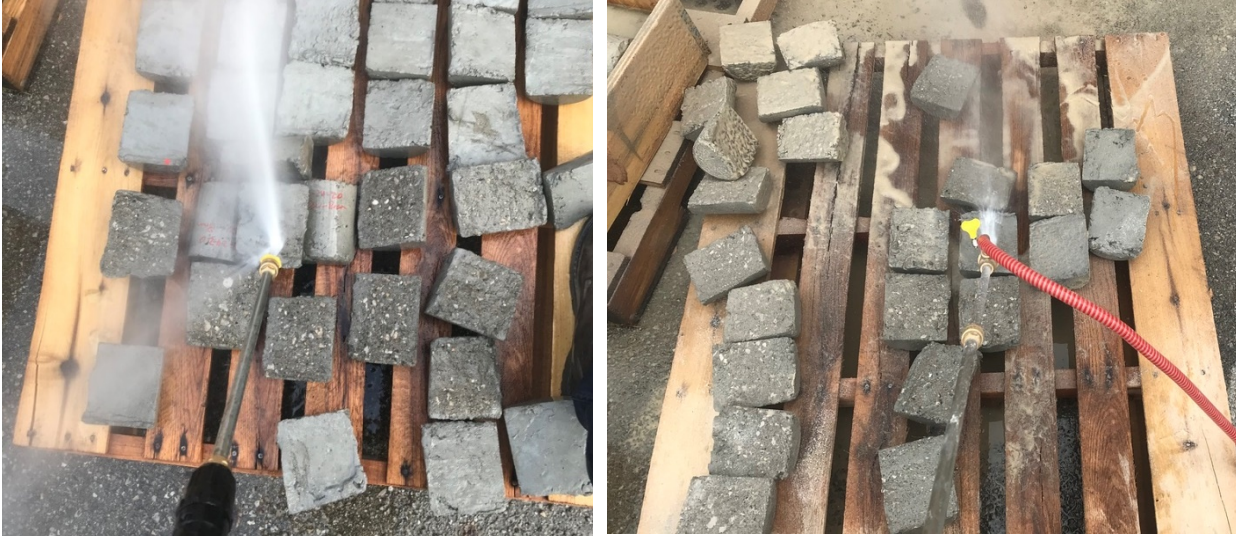
Water blasting was performed at a distance of 3-4 inches from the concrete such that the water jet striking the concrete was approximately ¾” wide (Figure 4a). An overlapping s-pattern was followed to roughen the whole surface area. Three passes were conducted to uniformly expose the coarse aggregate.

Wet sand blasting was performed at a distance of 3-4 inches from the concrete such that the water jet striking the concrete was approximately 1” wide (Figure 4b). An overlapping s-pattern was performed on each specimen. One pass was required to uniformly expose the coarse aggregate.

Specimens for diffusion testing were 4-inch diameter by 4.5-inches tall cylinders composed of half concrete and half grout. This sample type is a deviation from the procedures listed in ASTM 1556 (typical samples are 4-inch by 8-inch cylinders of neat concrete or drilled cores), but it allows sampling along the interface region between concrete and grout. The concrete was first cast in one half of a plastic concrete cylinder mold. The following day, the half cylinder was demolded and moved to moist curing conditions (Figure 7a). Surface preparation was conducted on the half-face of the cylinder and the sample replaced in moist curing; surface preparation was either water blasting or wet sand-blasting (Figure 4).

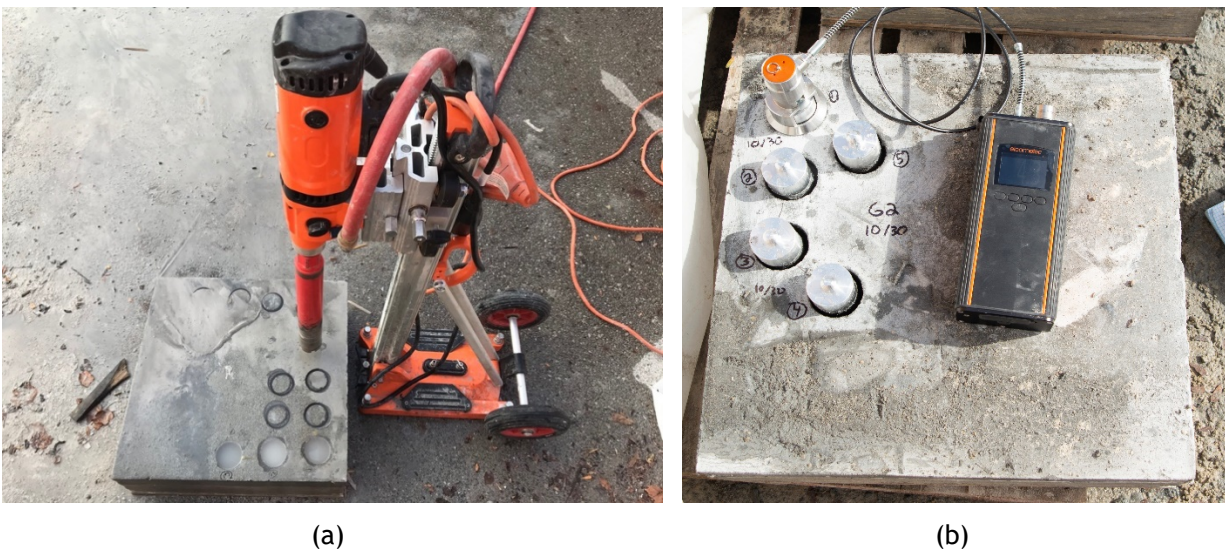
Figure 6. Pull-off testing procedures: (a) coring and (b) testing

Pull-off testing was conducted on slabs at 7, 14, and 28-days after casting the grout. Testing was conducted by drilling a 2-inch diameter ring around the test site with a coring rig to a depth of 0.5-inches into the concrete substrate (Figure 6a). The test site surface was then ground with an angle grinder and scrubbed with a damp cloth to ensure a smooth surface. The metal test dolly was mechanically roughened using an angle grinder, attached to the test site using a 2-part epoxy adhesive, and allowed to cure per the manufacturer’s recommendations before testing (Figure 6b). At least three pull-off tests were conducted on each slab for each test period.

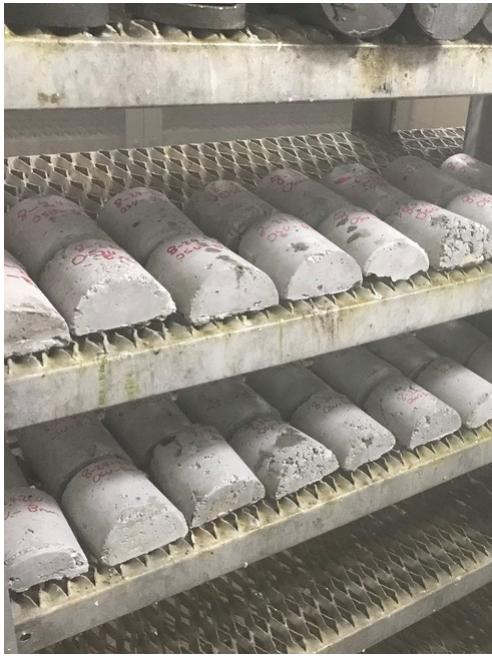
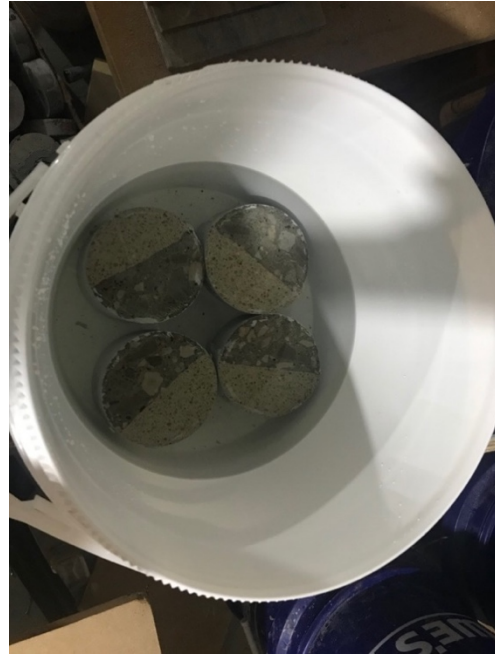
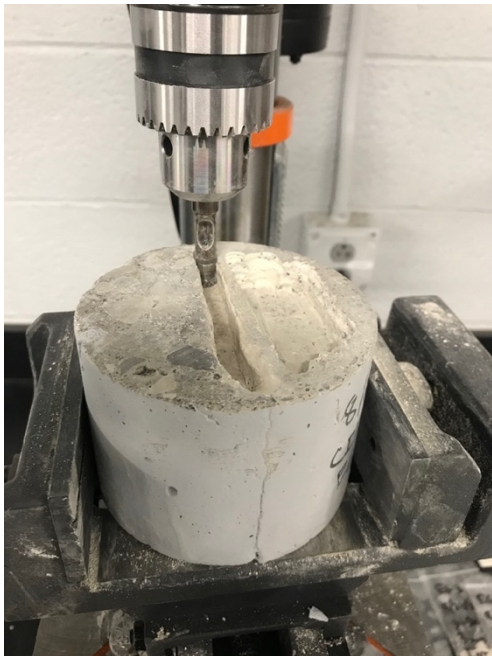
Figure 7. Ion Permeability Testing: (a) concrete cylinders before grout casting, (b) cylinders in salt solution, (c) milling samples, and (d) determining acid soluble chloride content

Profile grinding was then conducted using a milling machine with a concrete coring bit (Figure 7c). Eight layers were ground in 1-millimeter increments in each constitutive material and along the concrete-grout interface of each specimen. At least 3 specimens were used to constitute a single sample in the depth profile to obtain at least 10 grams of powder. Samples were also milled from the disks set aside to determine the initial chloride concentration. The acid-soluble chloride content was then determined for each sample by digesting the powder in nitric acid and chemically titrating the solution with silver nitrate to determine the equivalence point - the volume of silver nitrate required to fully react with the chlorides in the sample (Figure 7d). The equivalence point was used to calculate the acid-soluble chloride content per ASTM C1152. The chloride diffusion parameters were then calculated using non-linear regression analysis for the profile of each material and the error function procedures listed in ASTM C1556.

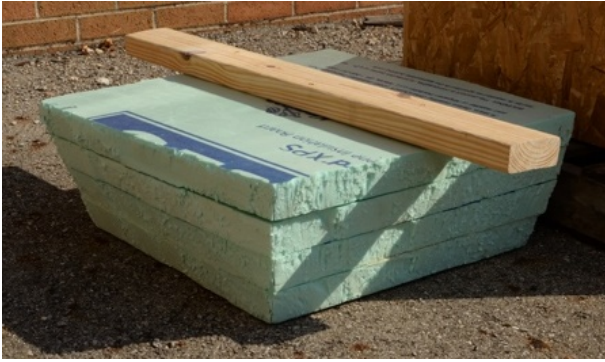
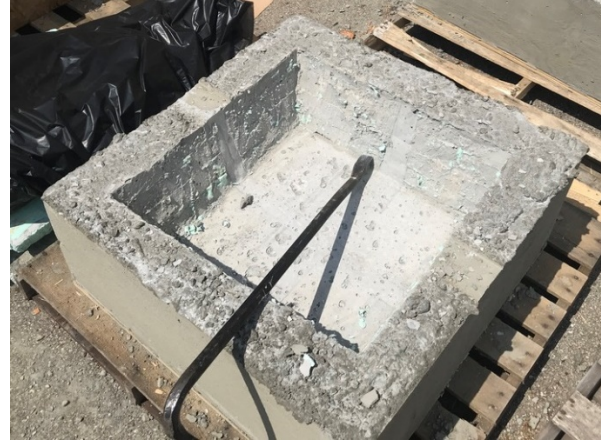
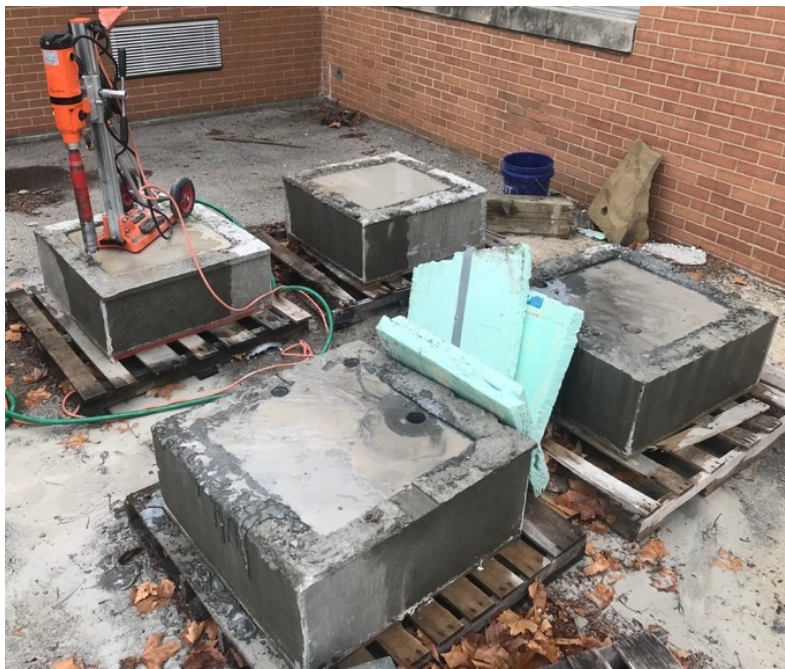
Figure 9. PT Anchorage Mock-ups: (a) Foam anchorage block-out, (b) demolded concrete substrate, and (c) mock-ups during coring

The pour-back region was formed by placing a foam block-out into the concrete forms during concrete casting (Figure 9a-b). Concrete was consolidated using a vibratory compactor. Surface preparation was conducted on the inside surface of the pour-back, and grout was cast seven days after the concrete placement. The grout was mixed using a mortar mixer according to the grout manufacturers' recommendations. After the grout was cast, the blocks were covered with a plastic tarp for initial curing. Blocks were monitored for cracking, and the widths of any cracks were photographed and measured with a feeler gauge. At the conclusion of the curing period, each block was cored along the concrete-grout interface to visually inspect the interface (Figure 9c). Cracks along the top of the interface were sealed with an epoxy adhesive before coring.

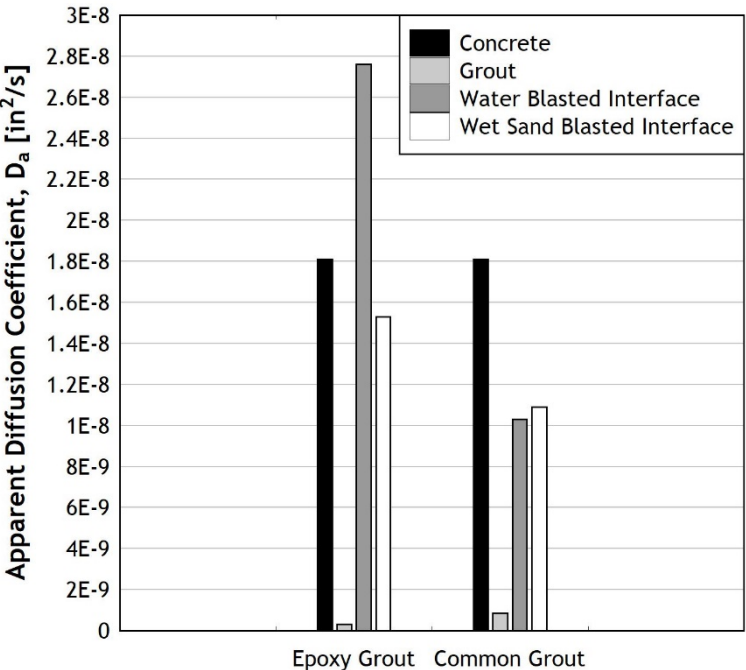
Figure 10. Apparent Diffusion Coefficients

Chloride profiles were measured for three constitutive materials and four interface types after 35 days of saltwater exposure. The apparent diffusion coefficient, D_a , is shown for each sample type in Figure 10. The other results are summarized in Table 4. An example of the measured chloride profile and non-linear regression is shown for concrete in Figure 11; full results are given in Appendix 1. The sampling methodology for determining the depth profile for each material and calculating the chloride diffusion parameters was based on ASTM C1556 (30). The chloride content of each sample was measured according to ASTM C1152 (29). Each data point represents the average of a minimum of three samples at an average depth from the exposed surface. The initial chloride content of each material before salt water exposure, C_i , is shown for each material. A non-linear regression analysis was performed on each material's chloride profile per ASTM C1556 to calculate two diffusion parameters - the projected surface chloride content, C_s , and the apparent diffusion coefficient, D_a . C_s is the estimate of the chloride content of the material at its exposed face. D_a provides an indication of the ease of chloride penetration into cementitious mixtures; the lower the D_a value, the greater resistance the material has to the diffusion of ions

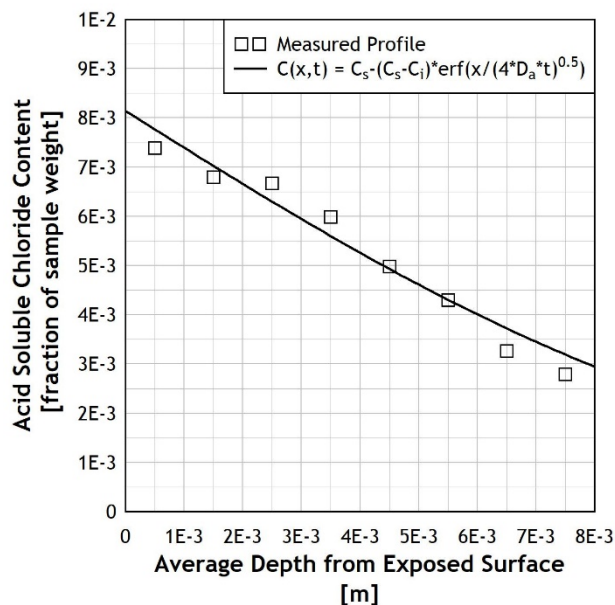
Figure 11. Concrete Chloride Diffusion Profile

The apparent diffusion coefficient, D_a , for the concrete was $1.807e-8$ square inches per second; this value is consistent with apparent diffusion coefficients for ordinary Portland cement (OPC) concrete with similar cementitious materials replacement exposed to saltwater for 35 days (12). Both the epoxy and common grout materials exhibited very low diffusion coefficients compared to those of OPC concrete (about 1.5 orders of magnitude lower than the other experimental groups), indicating that chlorides encounter relatively substantial resistance to diffusion in both grout materials. The D_a for each common grout interface was slightly more than half the D_a of concrete alone. The D_a for the common grout interfaces, regardless of surface preparation, are lesser than that for the epoxy grout interfaces, suggesting that the common grout provides greater resistance to ion diffusion. The D_a for water-blasted epoxy grout interface was 30% greater than the D_a for concrete alone, and the D_a for sand-blasted epoxy grout interface was 27% less than the D_a for concrete alone.

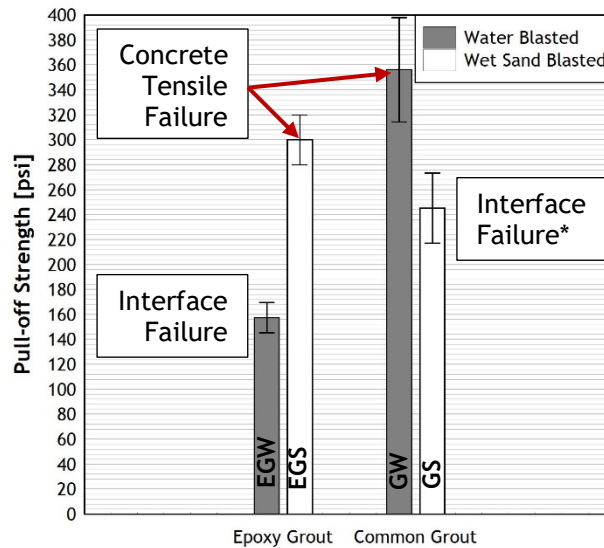
Figure 16. 28-Day Pull-off Test Results

Figure 16 presents 28-day pull-off testing; all data is from the first set specimens (August), except for sand-blasted common grout. The greatest pull off strengths were associated with tensile stress failures in the concrete, and the lower pull-off strengths occurred with interface bond failures. Of the two slabs exhibiting interface bond failures, EGW (epoxy grout, water blasted) had the lower pull-off strength at 158 psi, which is lower than the currently specified minimum value of 175 psi. GS (common grout, sand blasted) exhibited a higher strength at 245 psi. The other two experimental groups exhibited concrete tensile failures at 300 psi for EGS and 356 psi for GW, indicating that the developed bond strength was higher than the tensile strength of the constitutive materials.

Particularly noteworthy is the common grout specimens with water-blasted surface preparations had high pull-off strengths (Figure 16) exceeding the specified minimums. These specimens also exhibited the greatest resistance to ion diffusion. While not causally related, greater pull-off strength does correlate to greater resistance to chloride ion intrusion.

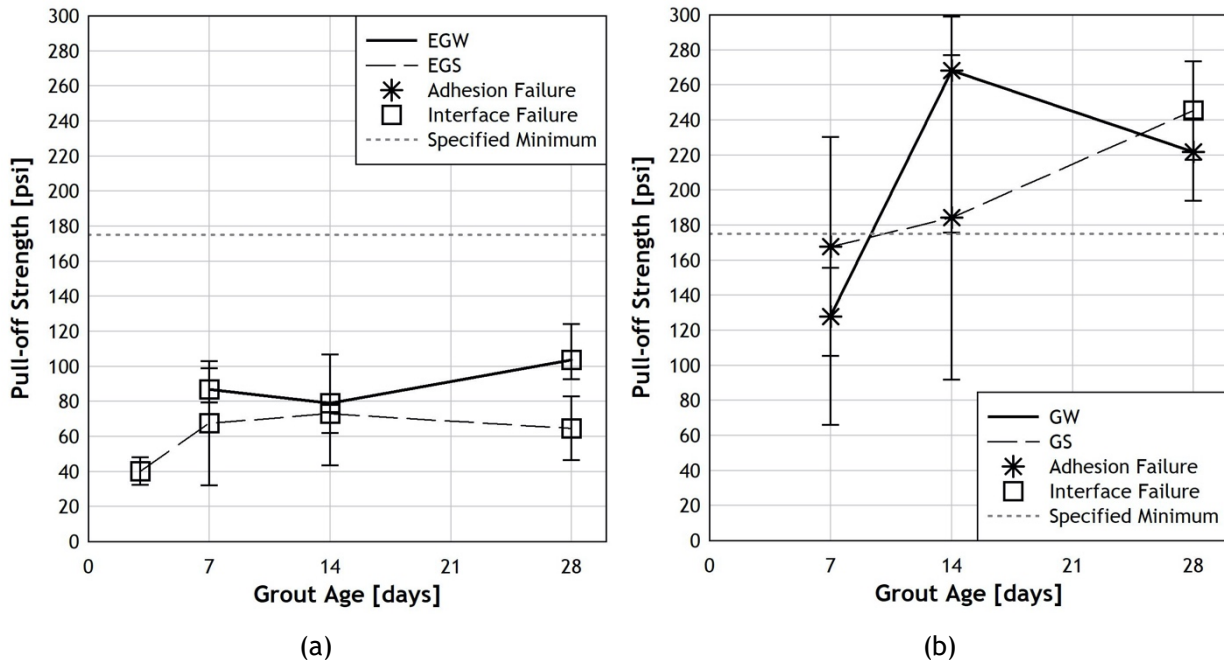
Figure 17. Pull-off Strength Over Time - October Specimens

Figure 17 presents the pull-off test results over time for the second set of slabs (October casting). Pull-off strengths for the epoxy grout slabs had little variation at each sampling age and exhibited similar pull-off strengths after 7 days, though all pull-off values were below the ODOT specified minimum of 175 psi (Figure 17a). It is noteworthy that the epoxy grout pull-off strengths from the October slabs (Figure 17) are substantially - 50-75 percent - less than the pull-off strengths noted for the August specimens (Figure 16), and the observed failure mode was consistently interface failure. It is believed ambient conditions played a role in the strength development of the bond. For the October specimens grout materials were mixed at temperatures within the manufacturers' recommendations and were largely cured outside in ambient conditions, though slabs were brought inside if freezing temperatures were predicted.

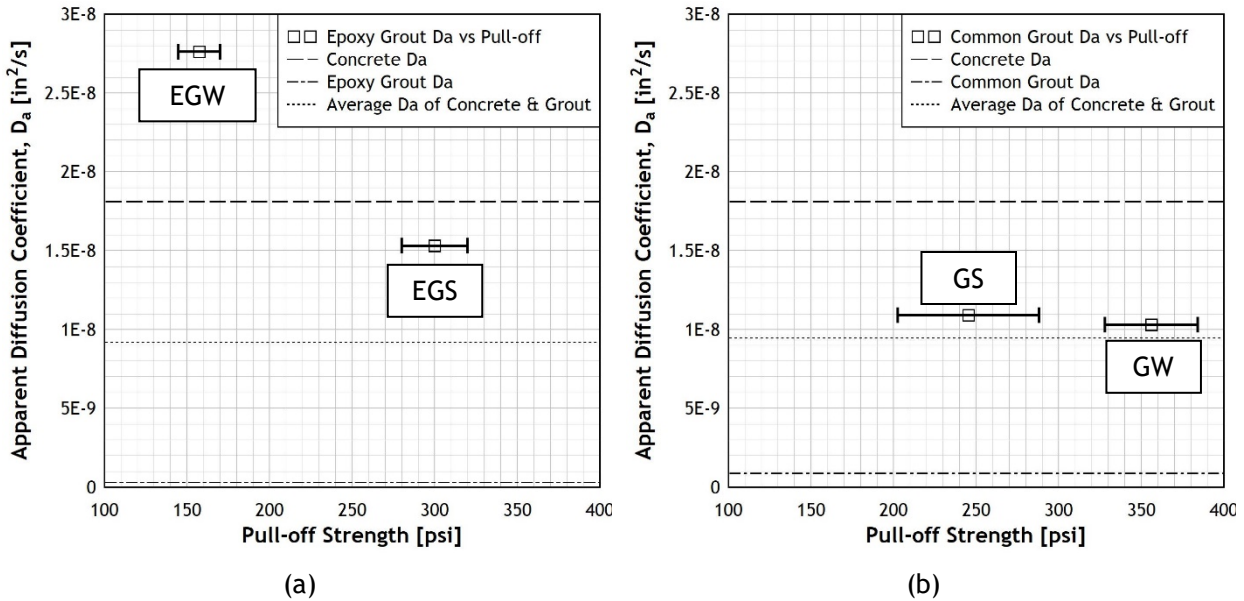
Figure 22. Apparent Diffusion Coefficient vs Pull-off Strength, 28-day: (a) Epoxy Grout Interface and (b) Common Grout Interface

The water-blasted epoxy grout had a much lower bond strength and much higher diffusion coefficient, while the sand-blasted epoxy grout group had a higher bond strength and lower diffusion coefficient. The water-blasted epoxy grout had a much higher diffusion coefficient than even the constitutive concrete material, and both points were far from the average apparent diffusion coefficient of epoxy grout and concrete. The results indicate that a more abrasive surface preparation technique provides a stronger bond with decreased opportunity for chloride permeation in epoxy grout pour-backs.
