# Methods for Evaluation of the Remaining Shear Capacity in Steel Bridge Beams With Section Losses Attributable to Corrosion Damage

Final Report VTRC 22-R4

**METHODS FOR EVALUATION OF THE REMAINING SHEAR CAPACITY  
IN STEEL BRIDGE BEAMS WITH SECTION LOSSES  
ATTRIBUTABLE TO CORROSION DAMAGE**

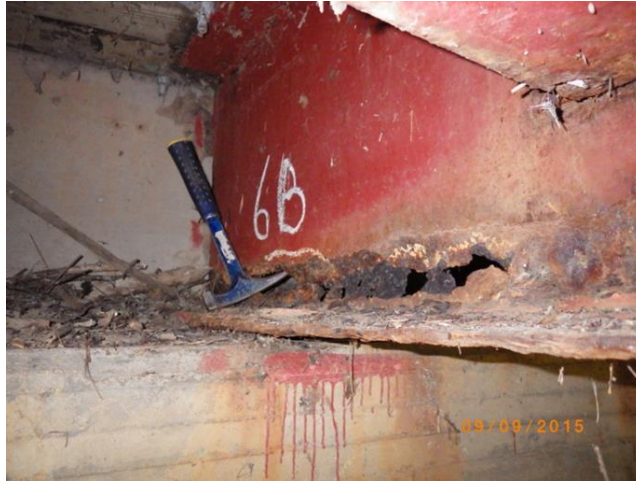
**Figure 1. Example of Extensive Beam End Corrosion Damage**

This issue is further illustrated when the shear capacity formulas are considered; they rely on a uniform web thickness. Corroded steel beam webs often display highly localized and irregular section profiles, with varying thicknesses along their length and height. This variation in web thickness creates some confusion in determining what thickness is appropriate to use in residual capacity analyses.

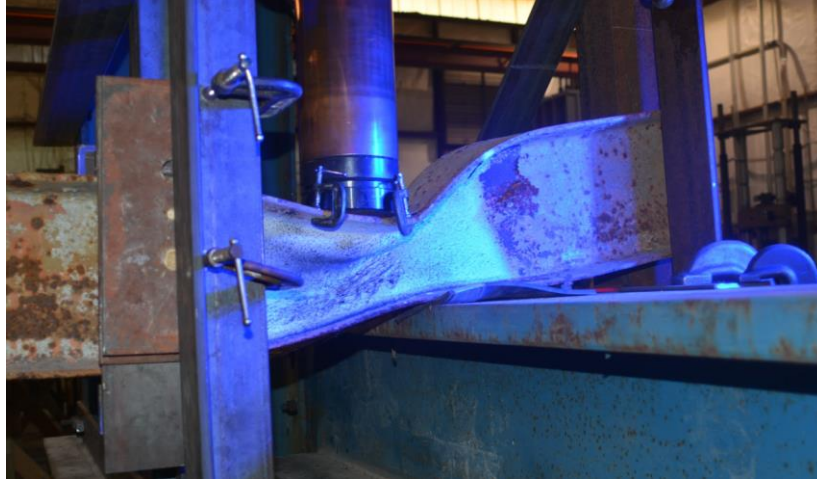
**Figure 8. Example of Beam Lifting at End Because of Applied Loads**

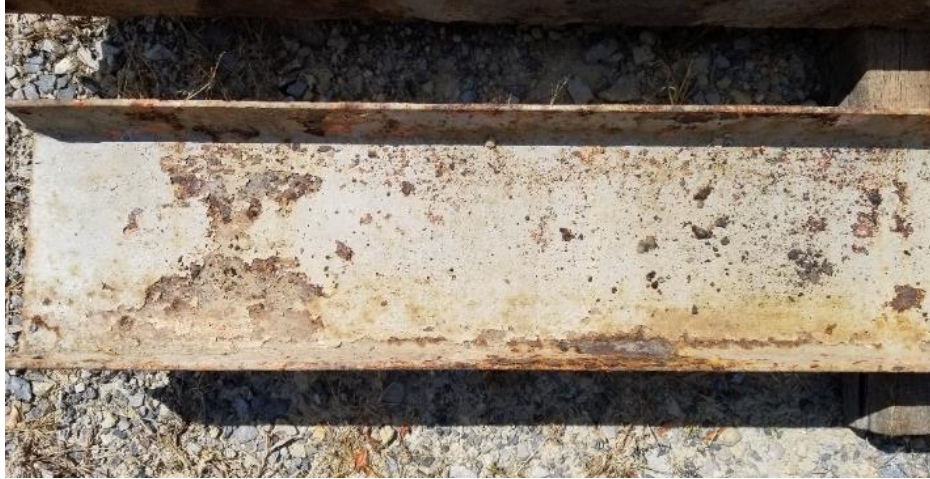
**Figure 13. Image of Specimen 1-S8-L After Arrival at Laboratory**

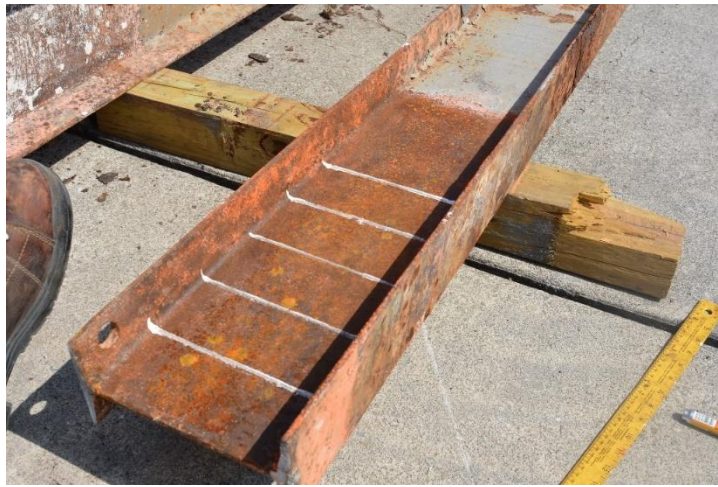
**Figure 14. Specimen 1-S8-L Stripped of Paint**

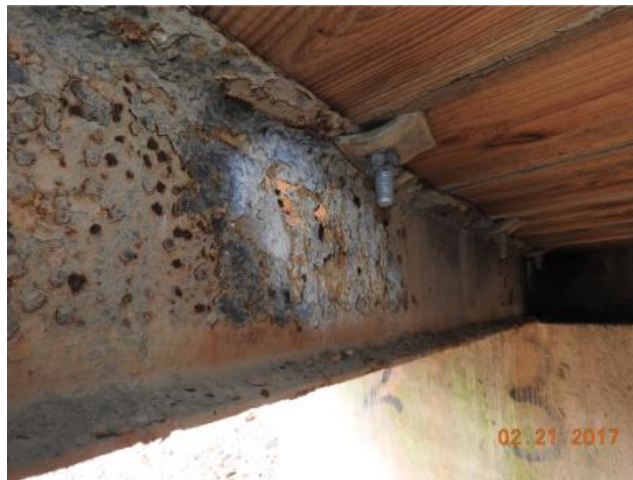
**Figure 15. Example of Steel Beam Timber Deck Web Corrosion**

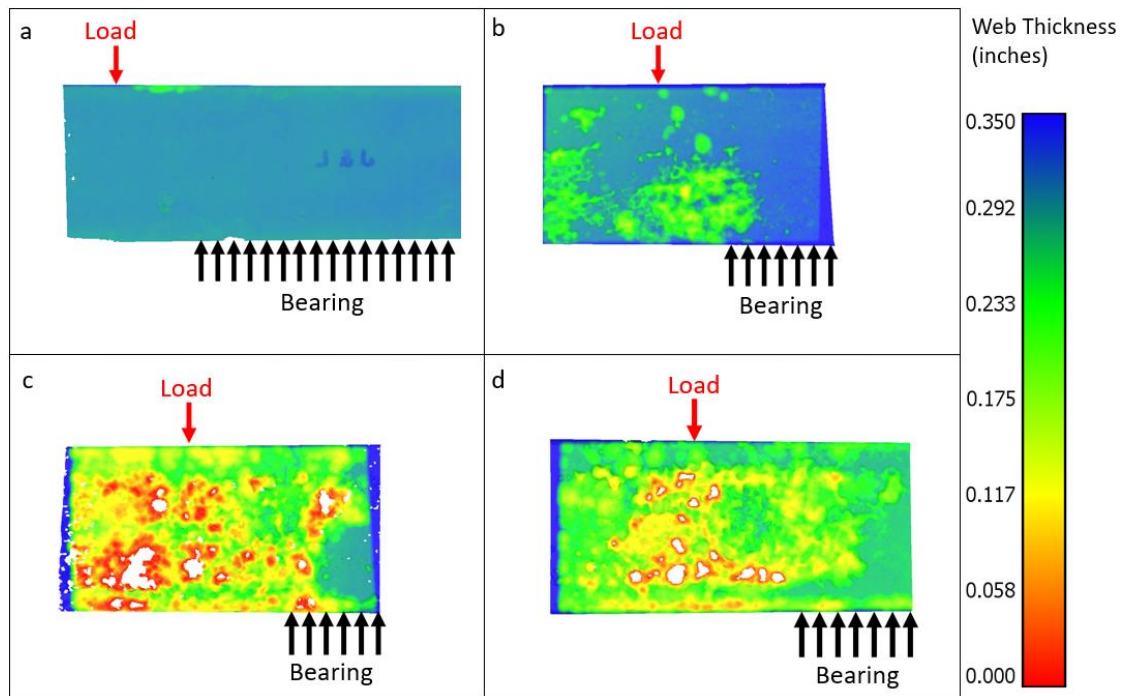
Because of Specimen 1-S8-L being the low-damage beam, there is nothing of note about the surface profile outside of the fact that few noticeable section losses were present. In Figure 24a, small amounts of section loss can be seen toward the top of the web in green. However, the depth of these deformities is approximately 0.06 in or slightly less than 1/16 in. For the purpose of this study, Specimen 1-S8-L can be compared to a new beam as these losses equate to a highly localized 2% thickness loss. This type of damage is insignificant by the measure of any of the studies mentioned in the literature review. The multiple holes present on the figure's left and right are due to the DIC camera failing to recognize points on the painted stochastic pattern.

**Figure 24. Heat Maps Showing Web Thickness of S8x18.4 Beam End Specimens: (a) 1-S8-L; (b) 2-S8-ML; (c) 3-S8-MH; (d) 4-S8-H.**

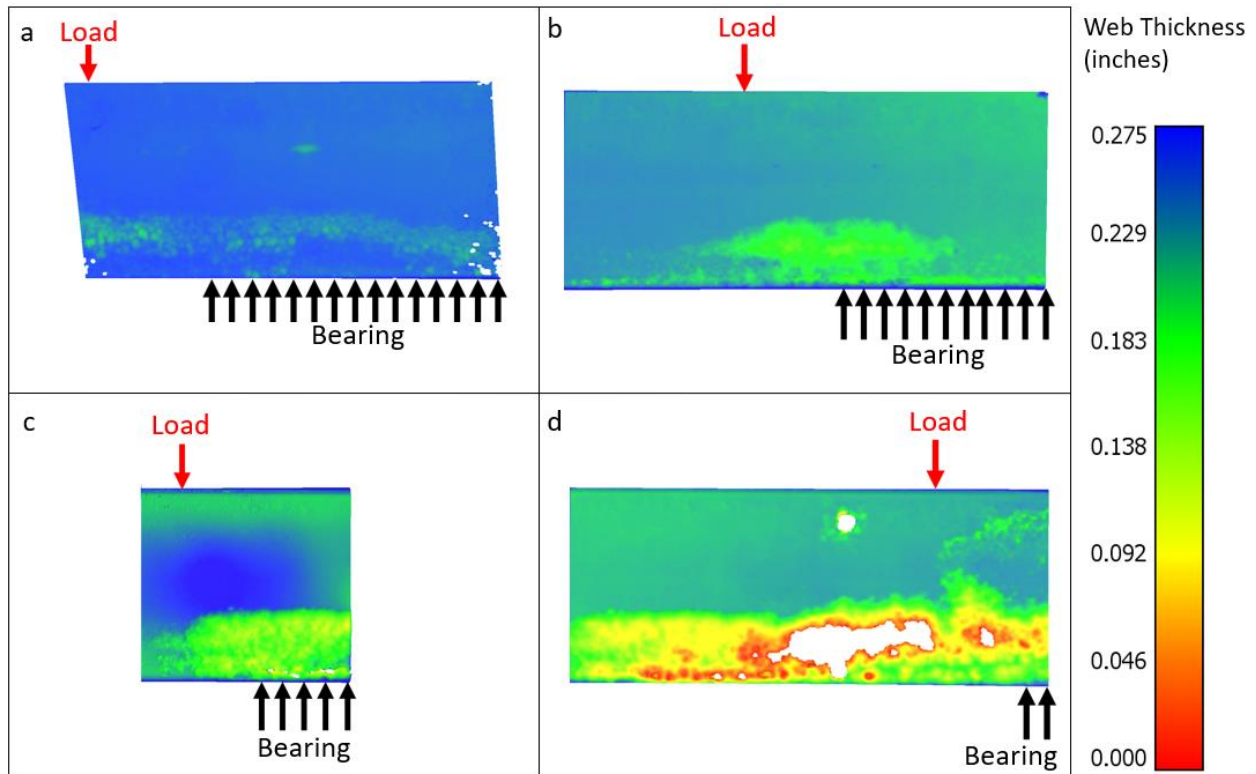
The uniform corrosion in Specimen 5-W10-L amounted to approximately 0.03 in of thickness loss, which was the least of any of the W10x45 shapes tested. The deepest section losses appear as green on the heat map in Figure 25a; however, they still represent only about 0.05 in of loss.

**Figure 25. Heat Maps Showing Web Thickness of W10x26 Beam End Specimens: (a) 5-W10-L; (b) 6-W10-ML; (c) 7-W10-MH; (d) 8-W10-H.**

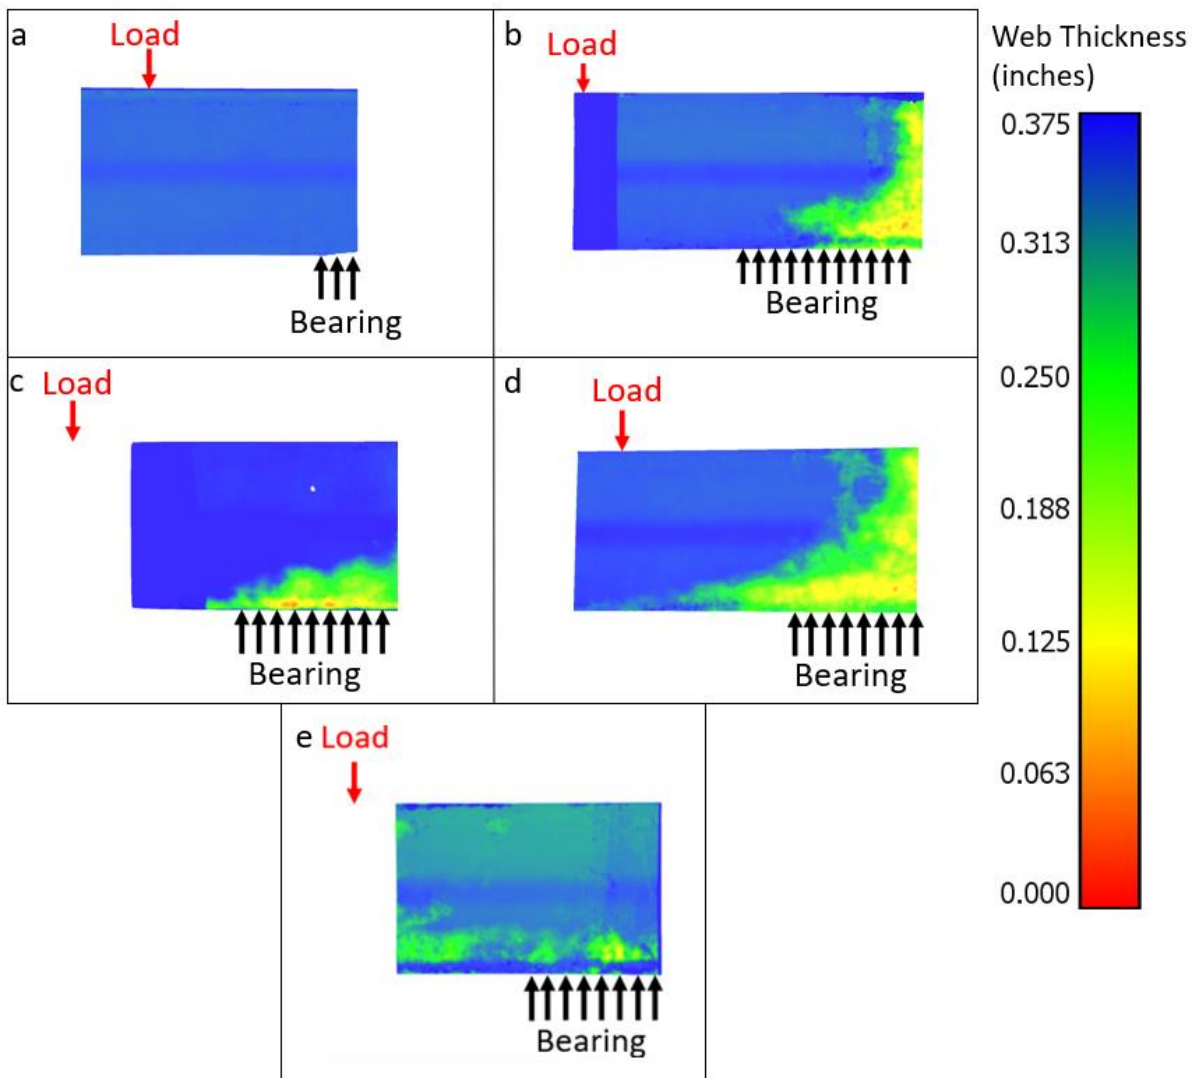
Specimen 10-W16-ML was selected as the medium-low-damage beam because of web section losses near the bottom flange across its length, which is characteristic of corrosion patterns caused by water pooling. Damage to the W16x45 beams was relatively consistent with this lower web loss pattern, and the order of severity was selected based on the presence of localized damage. Upon visual inspection, Specimen 10-W16-ML showed relatively low amounts of section losses on both sides of the web, ranging from 0.04 to 0.2 in of total web thickness loss, as shown in Figure 26c. It should be noted that the web scans for Specimen 10-W16-ML do not continue to the applied load location because of the range of the DIC camera. The red arrow representing the load is placed approximately where the point load was applied during testing to the left of the scan.

Figure 26. Heat Maps Showing Web Thickness of W16x45 Beam End Specimens: (a) 13-W16-L(A); (b) 9-W16-L; (c) 10-W16-ML; (d) M1-W16-MH; (e) 12-W16-H.

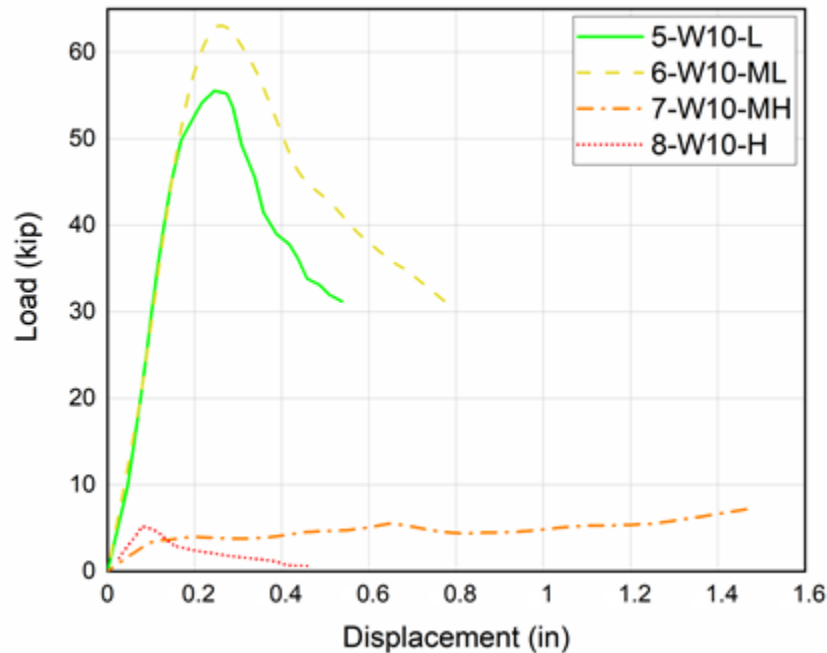
The separation between the low- and medium-low-damage specimens and the two higher-damage beams was much greater than for the first beam set. Although the two high-damage W10x26 beams had holes like the S8x18.4 beams, the main distinguishing factor was the reduced web surface to resist cracking. After a crack propagated across the full length of the engaged shear area, the webs failed. Discussion of the strain fields later in the report discusses this behavior regarding Specimens 7-W10-MH and 8-W10-H.

Figure 29. Load vs. Displacement Data for W10x26 Beams

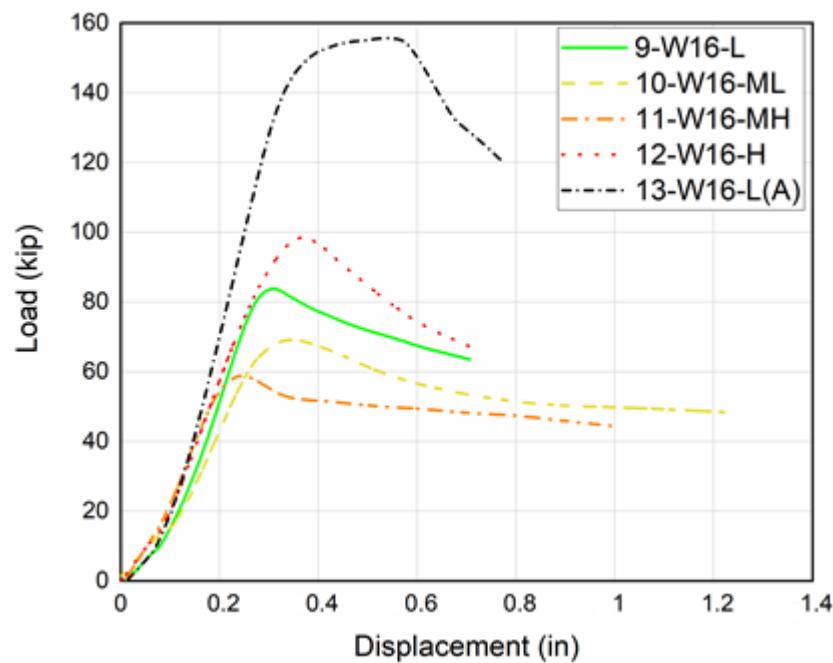
Figure 30. Load vs. Displacement Data for W16x45 Beams

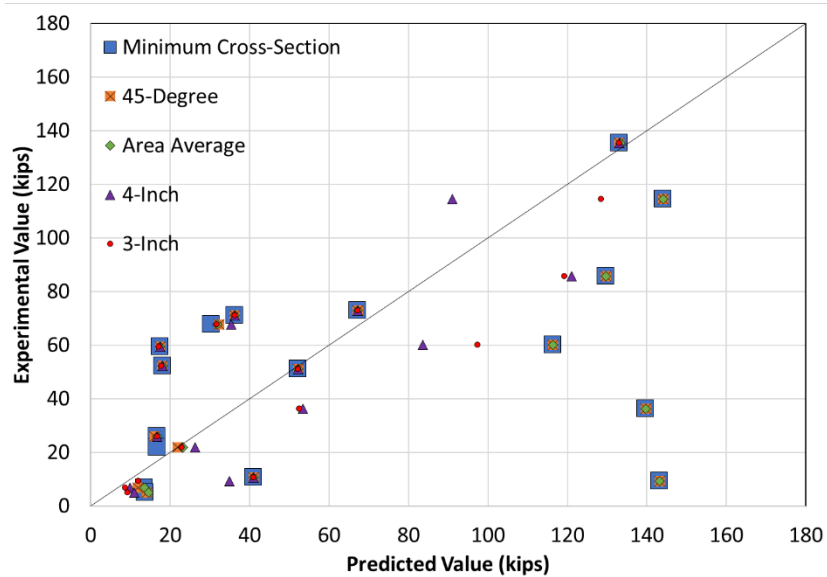
Figure 41. Prediction Error Plot of Maximum Experimental Shear Load vs. AASHTO Shear Capacity Using Five Thickness Measurement Methods

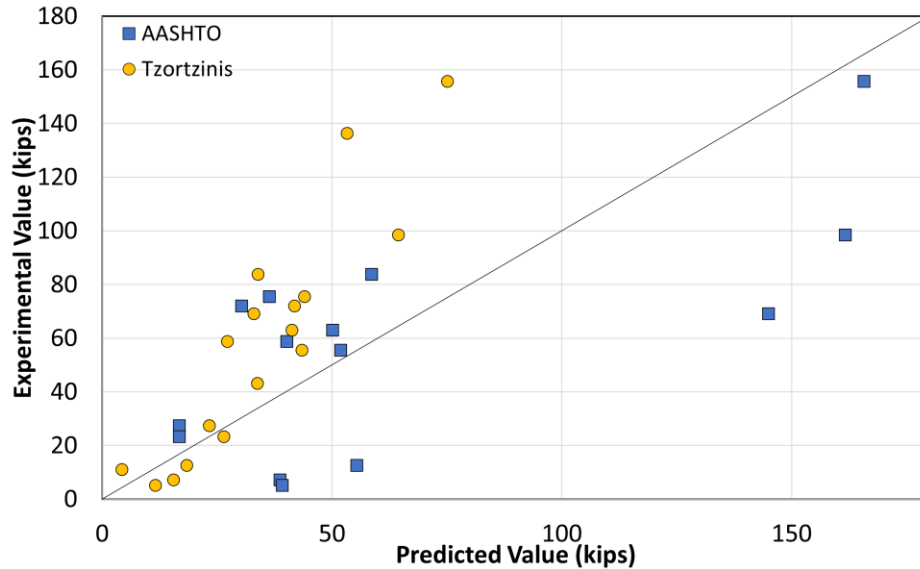
**Figure 43. Prediction Error Plot for AASHTO and Tzortzinis et al. Capacity Calculations Using Remaining Average Thickness Over Corroded Web Portion**

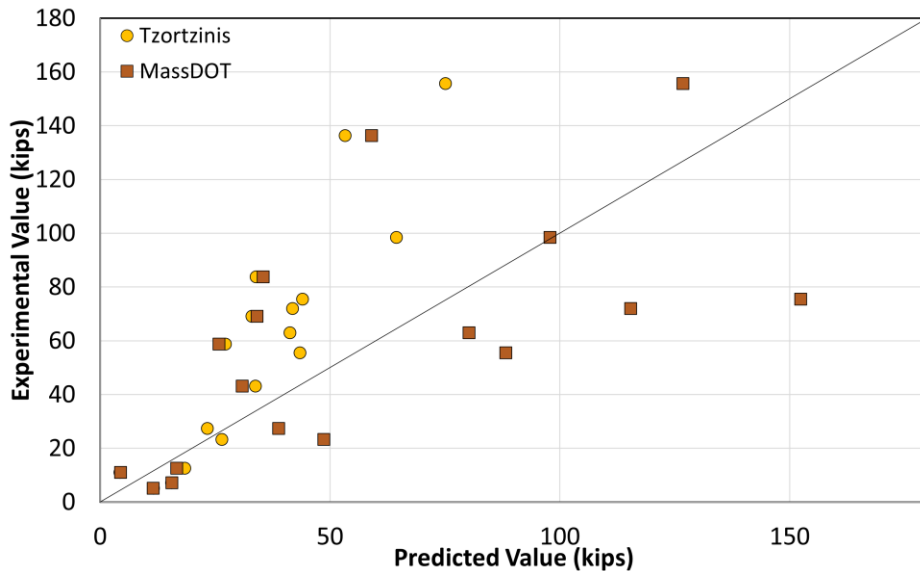
Figure 44. Prediction Error Plot for MassDOT and Tzortzinis et al. Capacity Calculation Methods

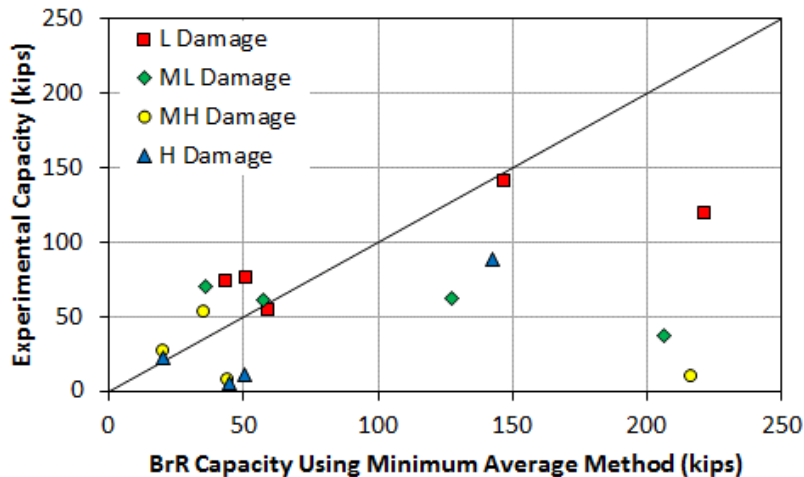
Figure 47. Comparison of Experimental and BrR Capacity Using the Minimum Average Method. L = low; ML = medium-low; MH = medium-high; H = high.

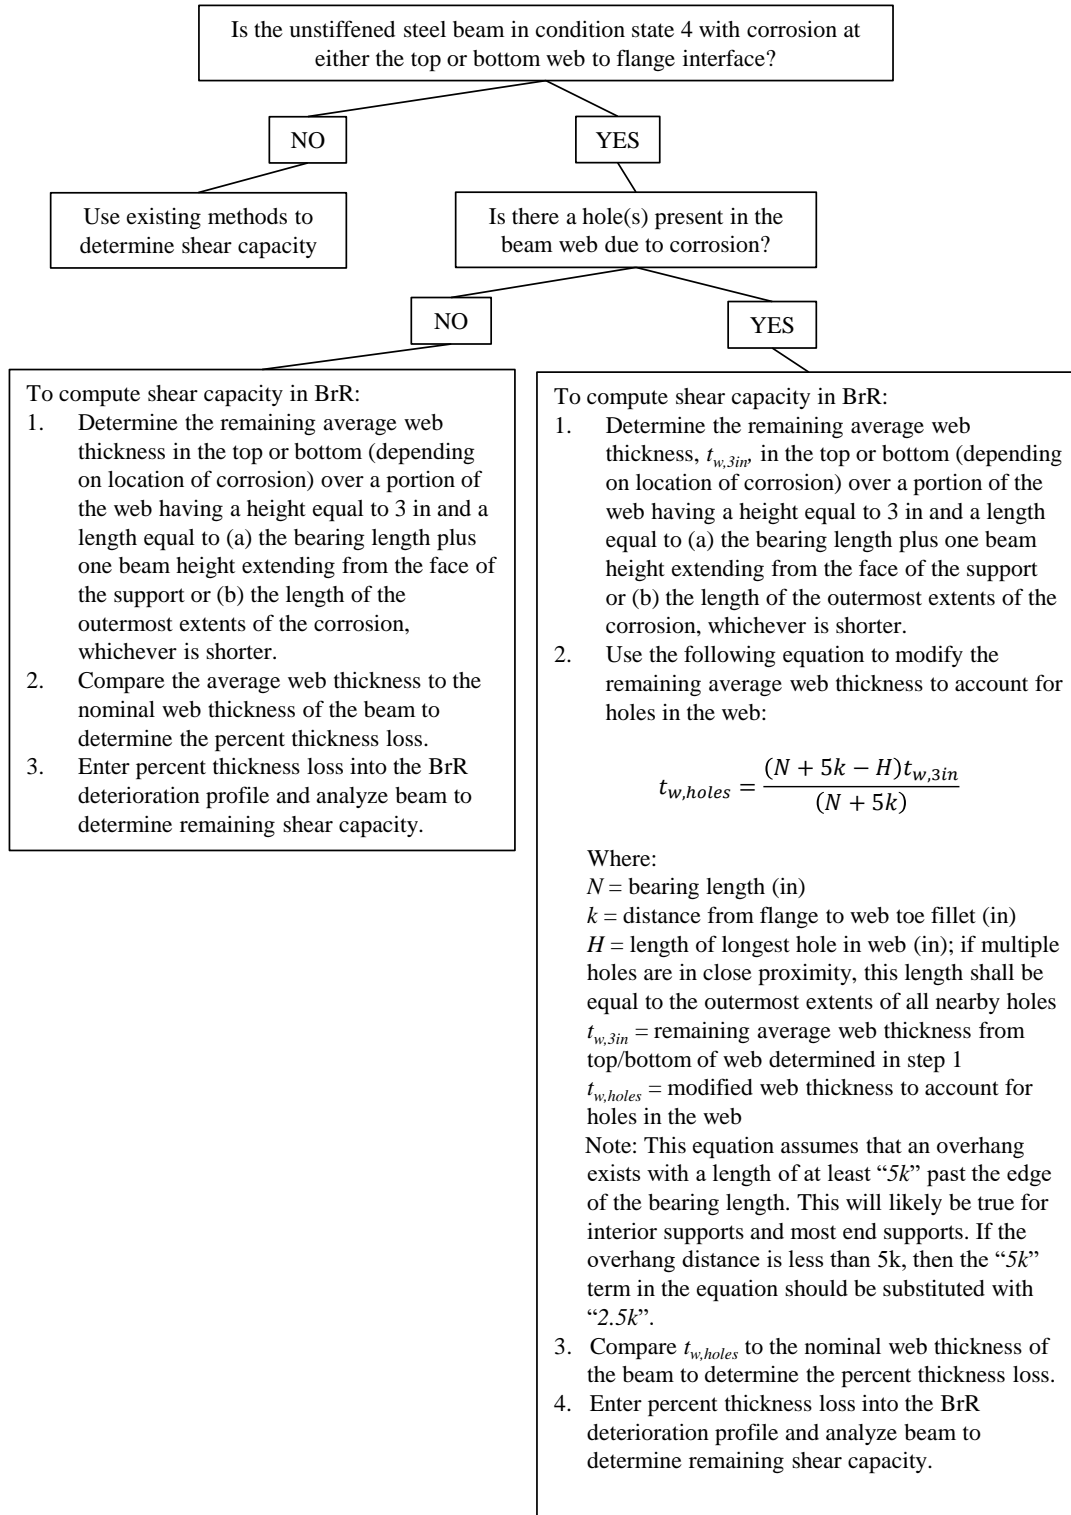
Figure 52. Flowchart for Determining Shear Capacity of Deteriorated Steel Beam End in BrR
