FINAL REPORT (Project BDV25-977-56)

**QUANTIFYING THE DURATION OF THE CORROSION PROPAGATION STAGE IN
STAINLESS STEEL REINFORCEMENT**

Final Report to Florida Department of Transportation

December 2020

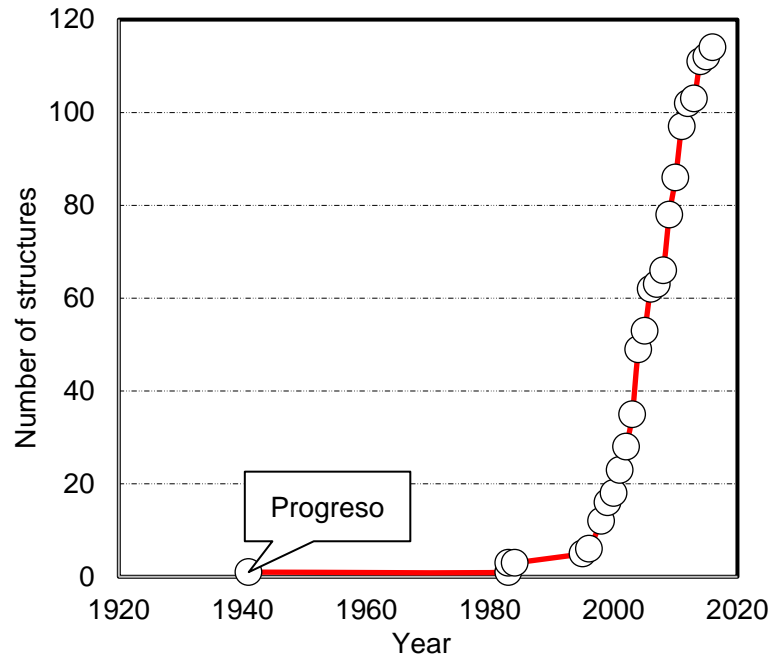
Figure 2.1: Cumulative worldwide tally of bridges with SS rebar.

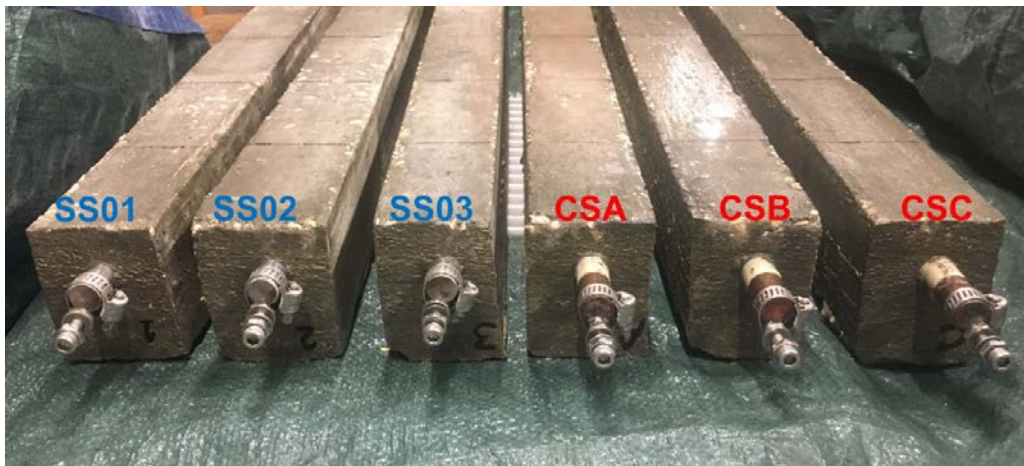
Figure 3.8: Electrical connections at the right end of all specimens. The left end of AISI 1018 CS specimens was epoxy-coated and UNS S41000 SS specimens were not.

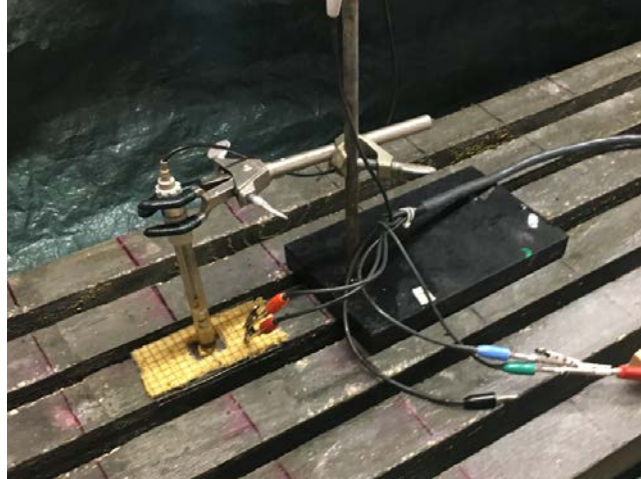
Figure 3.10: EIS measurement on specimen CS01. Counter-electrode (titanium mesh), reference electrode (SCE), and electrical junction device (yellow sponge).

The EIS measurements were obtained using a Gamry Reference 600+ potentiostat/galvanostat with a potential perturbation of 10 mV. A three-electrode array, shown in Figure 3.9, in which the steel reinforcement served as the working electrode, a ~10 cm long hollow rectangular titanium mesh on top of a moist sponge was used as the counter-electrode, and a SCE electrode with a small moist sponge on its tip placed in the middle served as the reference electrode. An initial range of frequencies between 10 mHz to 100 kHz with 10 points per decade was selected. The lower bound was later adjusted to 1 mHz at the end locations of the SS specimens to determine behavior in the low frequency portion of the impedance response. EIS measurements were conducted regularly to estimate the values of corrosion rates as a function of position.

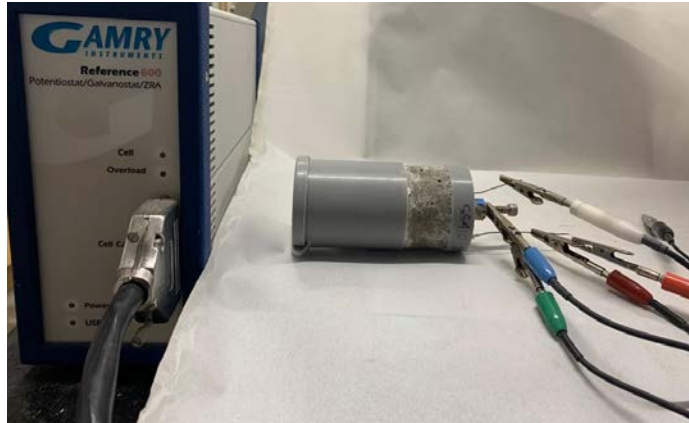
Figure 3.17: EIS measurement on UNS S41000 specimen labeled as B-I. Counter-electrode (embedded titanium mesh), reference electrode (embedded titanium wire), and working electrode (steel reinforcement bar).

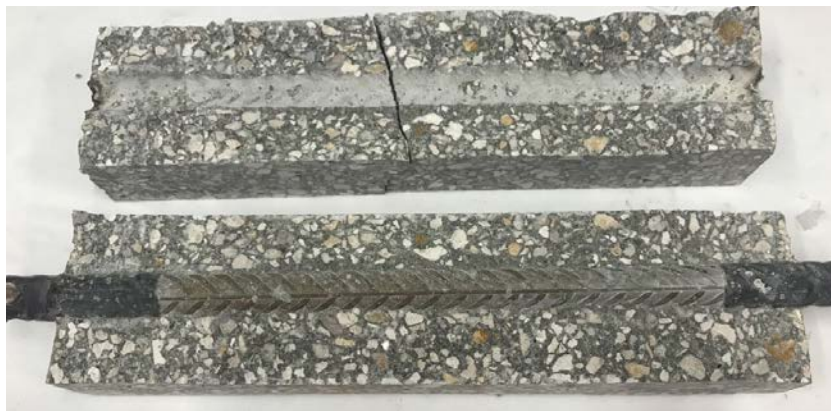
Figure 3.21: Resultant legacy specimen sections.

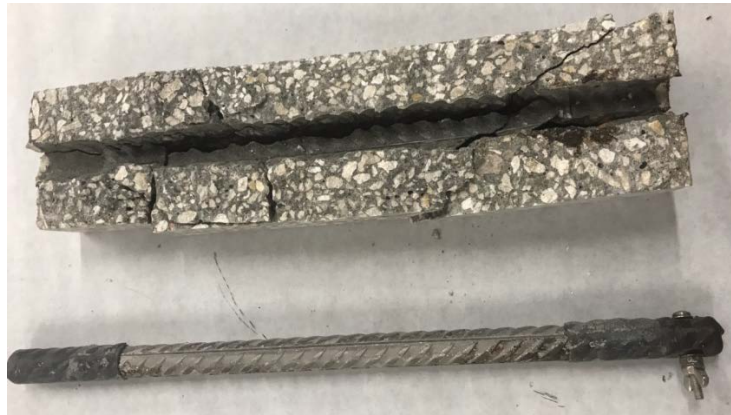
Figure 3.22: Steel reinforcement and concrete section after extraction.

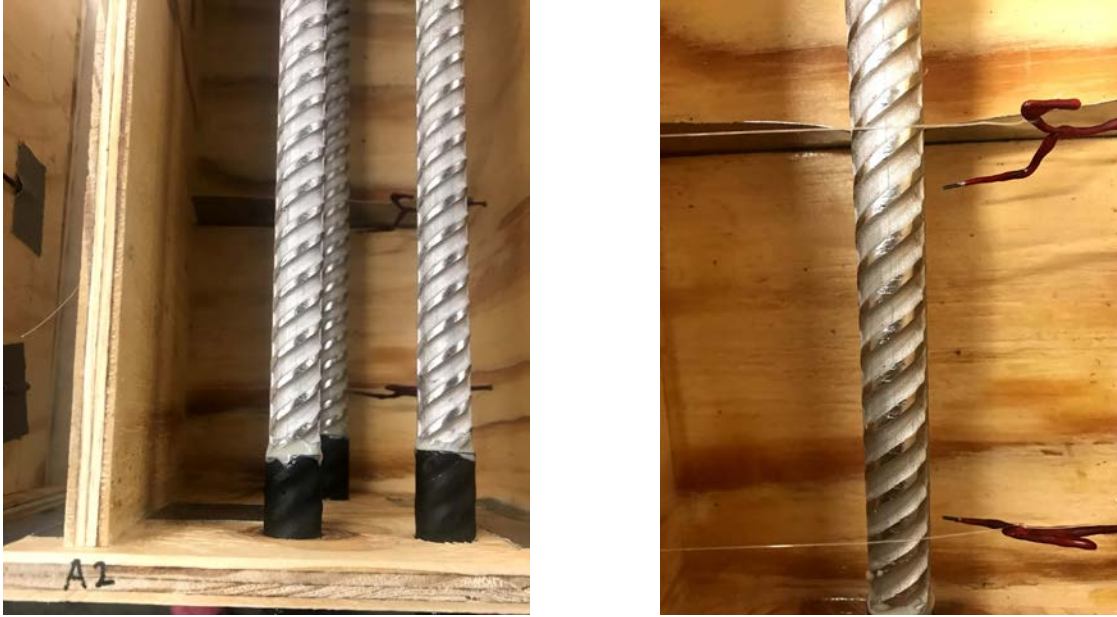
Figure 3.26: Experimental setup of reference electrodes.

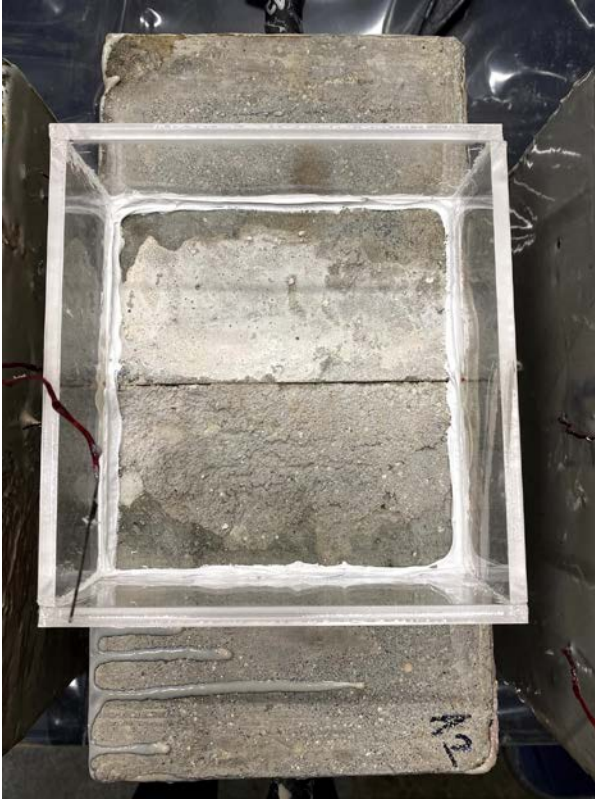
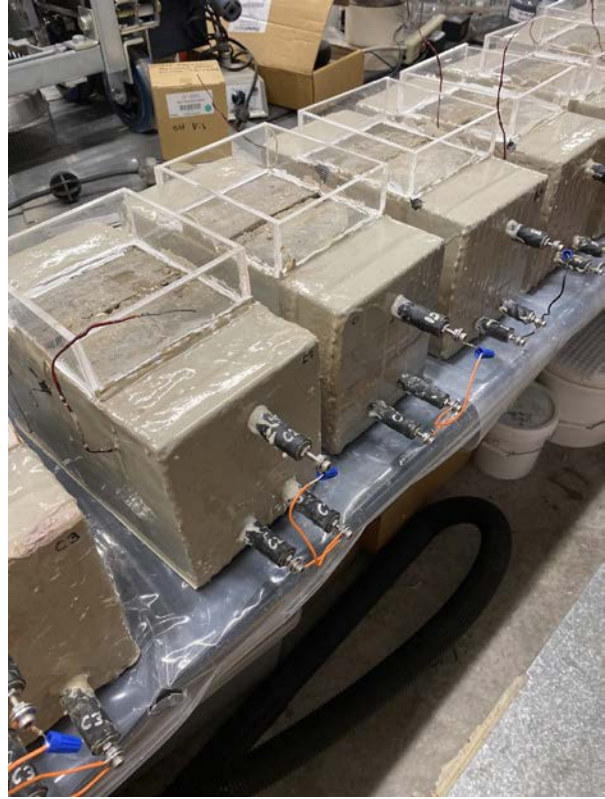
Figure 3.29: Specimens with concrete deficiencies. (a) Top view after acrylic reservoirs were installed; (b) preparation procedure prior to testing finished, two layers of epoxy were used to coat specimens and electrical connections. Circuit with 10-ohm resistor between anode and cathodes.

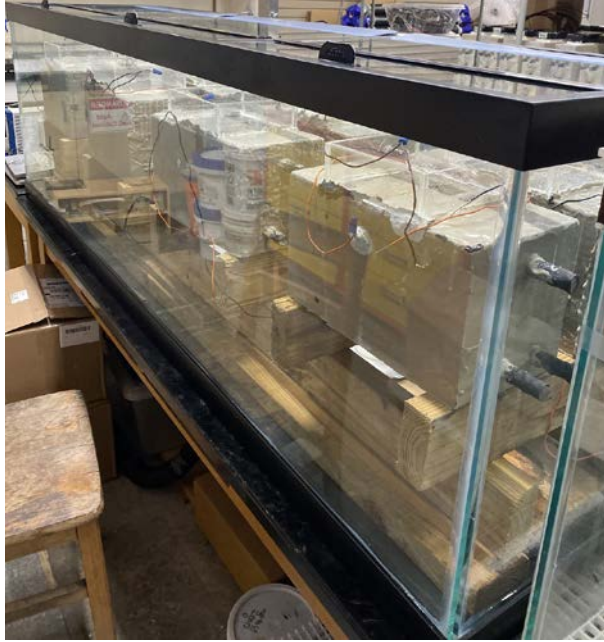
Figure 3.30: Specimens with concrete deficiencies in enclosed glass container.

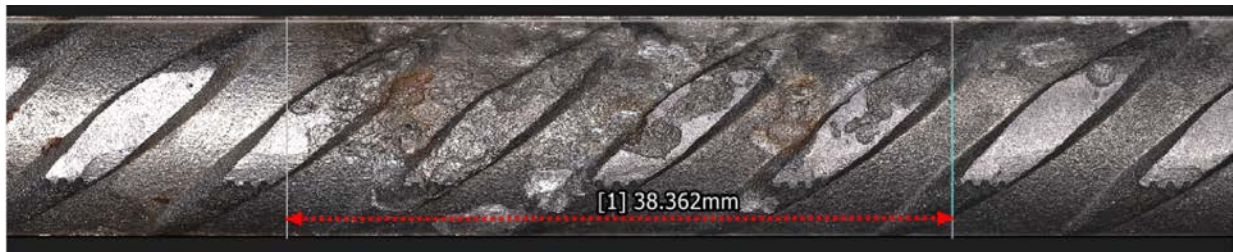
Figure 4.2: Optical image of plane measurement of the length of the anode in steel reinforcement.

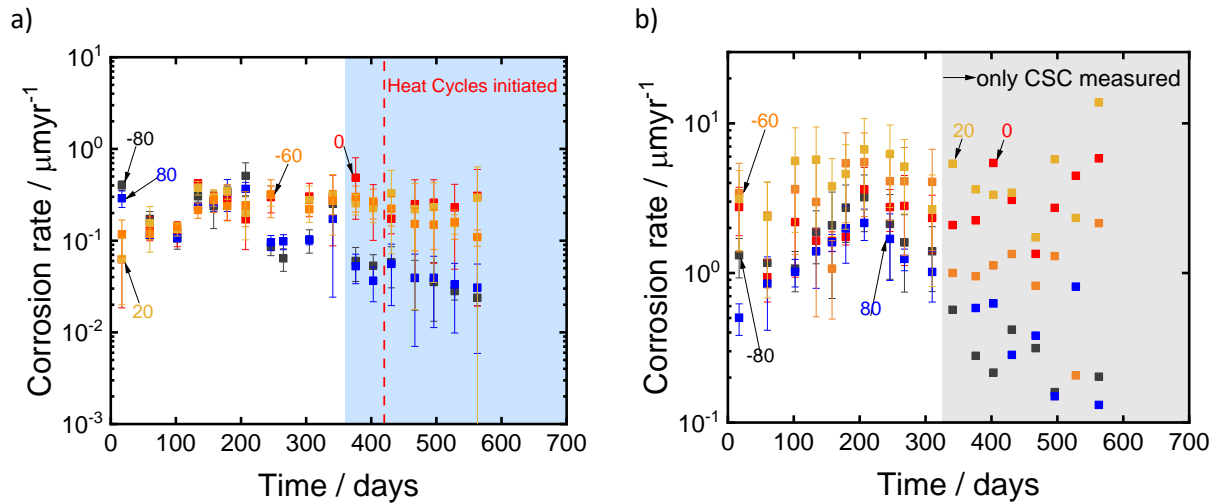
Figure 4.3: Behavior of the corrosion rate over time in (a) stainless steel (SS01, SS02, and SS03), and (b) carbon steel (CSA, CSB and CSC) specimens. Each data point represents the average value for the three specimens and the error bars the standard deviation. Black, orange, red, yellow and blue represented data points at locations -80 cm, -60 cm, 0 cm, 20 cm and 80 cm, respectively. Dashed line indicates initiation of elevated temperature exposure. Blue-shaded region designates the point at which low frequency limit of the impedance was extended to 1 mHz for points -80 cm and 80 cm. The number pointing to each series represents the position along the beam as described by number line shown in Figure 3.3.

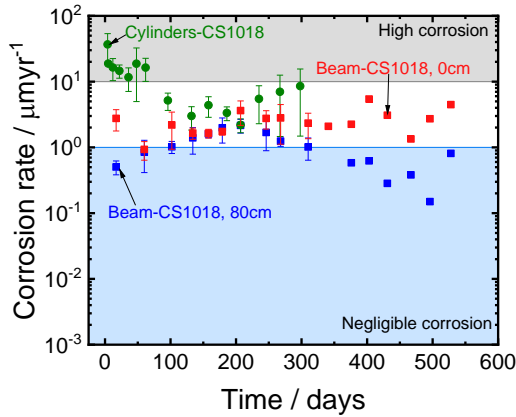
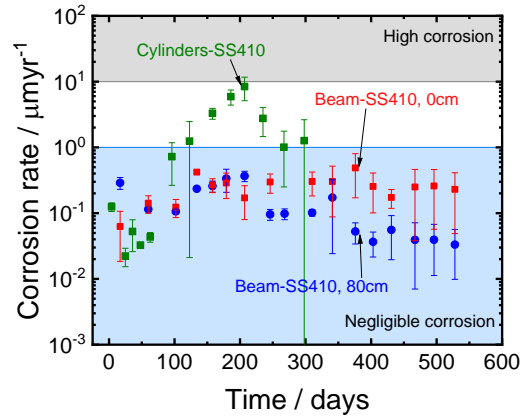
Figure 4.4: Corrosion rate as a function of time at different locations (i.e. end and center) of beams compared to cylindrical specimens reinforced with (a) SS and (b) CS.

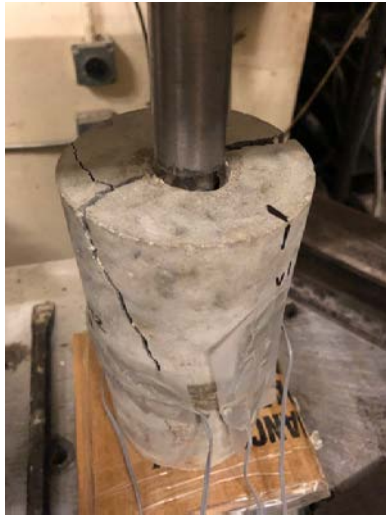
Figure 4.6: Extreme localized corrosion experimental results showing (a) concrete cracks, and (b) failure locations at the concrete cover. The red lines around the lead plug represent the concrete cover thickness at different locations ranging between 1.358 in and 1.595 in.

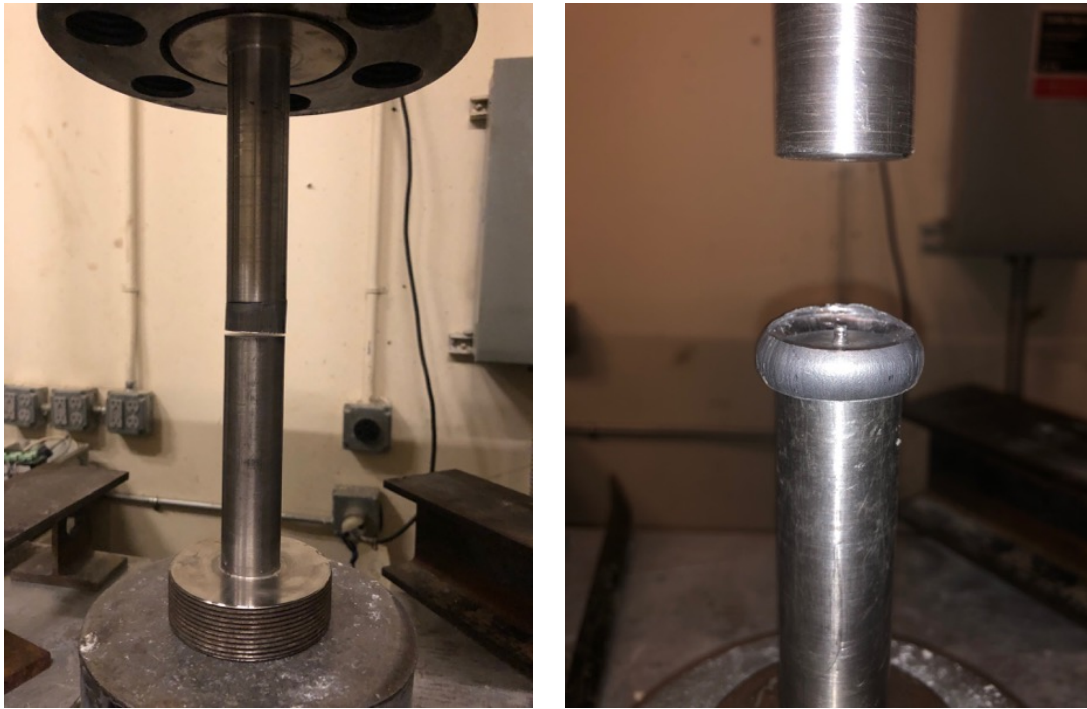
Figure 4.9: (a) Initial lead sample and (b) deflected shape of lead calibration.
