MASH TEST 3-11 ON F-SHAPE PORTABLE CONCRETE BARRIER WITH X-BOLT CONNECTION

Test Report 0-7086-R1

**TEXAS A&M TRANSPORTATION INSTITUTE
COLLEGE STATION, TEXAS**

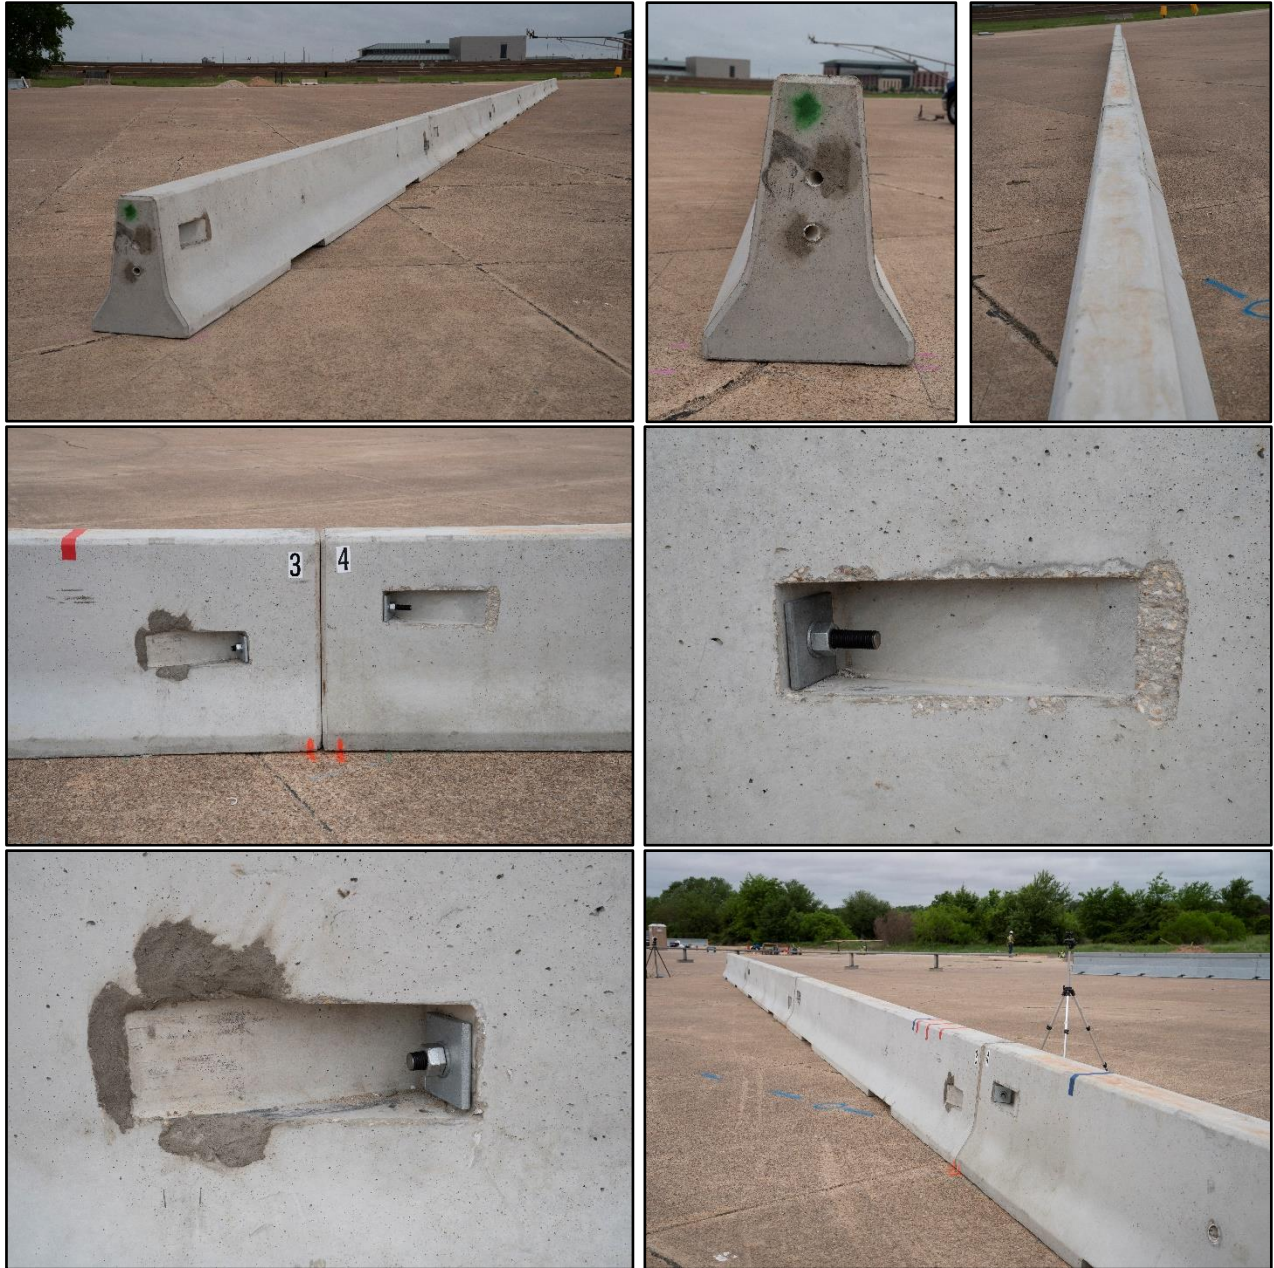
Figure 2.2. F-Shape PCB with X-Bolt Connection prior to Testing.

The test installation consisted of seven 30-ft-long precast steel reinforced portable concrete barrier (PCB) segments placed end to end, for a total length of 210 ft. The barriers were connected to each other using two 29-inch-long sections of a $\frac{7}{8}$ -inch-diameter B7 threaded rod and associated hardware at each joint. The threaded rod passes through PVC pipe cast into the ends of the barrier segments at two different elevations that form an “X” in plan view. Recesses were cast in the exterior faces of the barriers so that the ends of the threaded rod and associated hardware did not protrude past the exterior faces. All barriers were freestanding (not secured to the concrete apron).

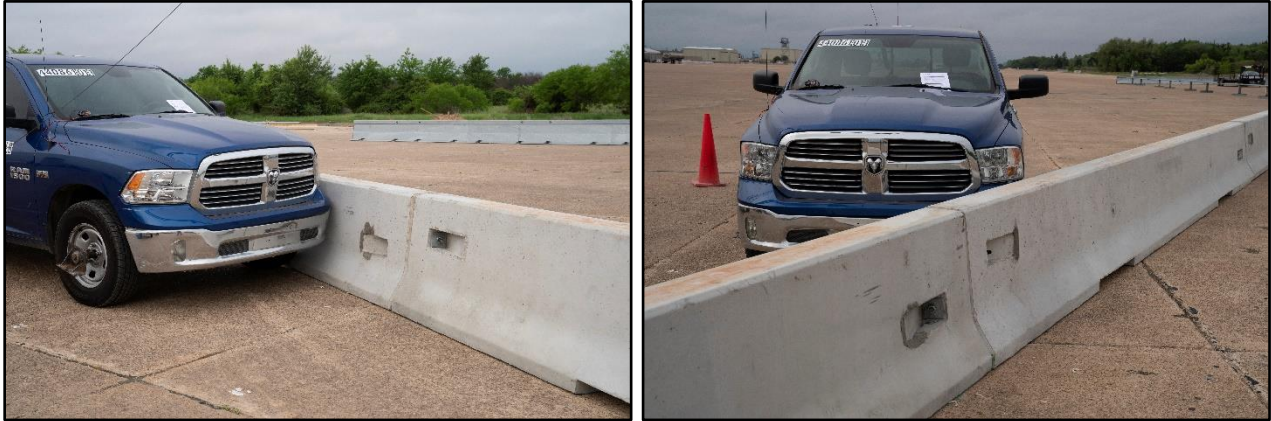
Figure 5.1. F-Shape PCB with X-Bolt Connection/Test Vehicle Geometrics for Test No. 440861-01-1.

The 2270P vehicle weighed 5031 lb, and the actual impact speed and angle were 62.4 mi/h and 24.8 degrees. The actual impact point was 4.0 ft upstream of the centerline of the joint between barrier segments 3 and 4. Minimum target impact severity (IS) was 106 kip-ft, and actual IS was 115 kip-ft.

MASH Test 3-11 involves a 2270P vehicle weighing $5000 \text{ lb} \pm 110 \text{ lb}$ impacting the CIP of the longitudinal barrier at an impact speed of $62 \text{ mi/h} \pm 2.5 \text{ mi/h}$ and an angle of $25 \text{ degrees} \pm 1.5 \text{ degrees}$. The CIP for *MASH* Test 3-11 on the F-shape PCB with X-bolt connection was $4.3 \text{ ft} \pm 1 \text{ ft}$ upstream of the centerline of the joint between barrier segments 3 and 4. Figure 3.1 and Figure 5.1 depict the target impact setup.

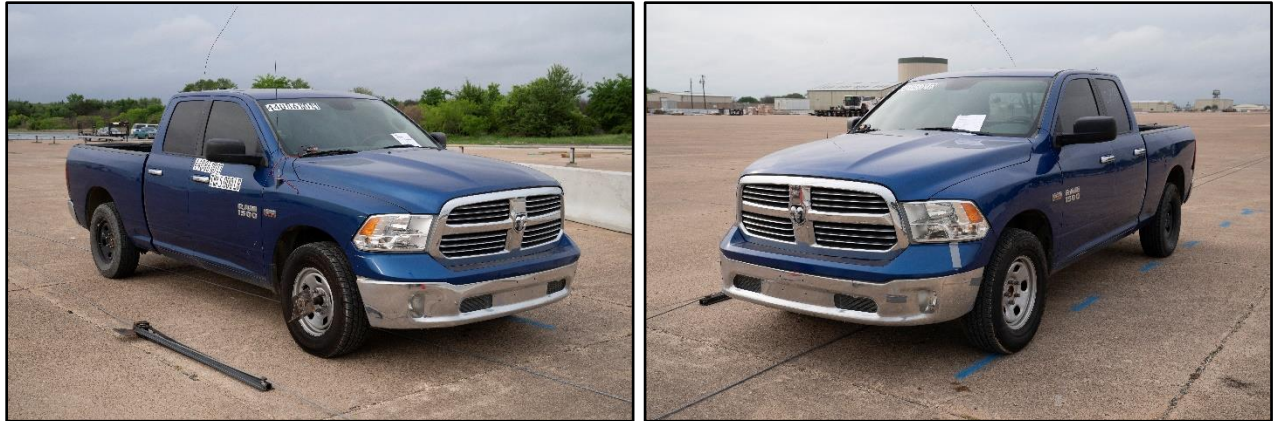
Figure 5.2. Test Vehicle before Test No. 440861-01-1.

Figure 5.2 shows the 2016 RAM 1500 pickup truck used for the crash test. The vehicle's test inertia weight was 5031 lb, and its gross static weight was 5031 lb. The height to the lower edge of the vehicle bumper was 11.75 inches, and the height to the upper edge of the bumper was 27.0 inches. The height to the vehicle's center of gravity was 28.25 inches. Tables C.1 and C.2 in Appendix C.1 give additional dimensions and information on the vehicle. The vehicle was directed into the installation using a cable reverse tow and guidance system and was released to be freewheeling and unrestrained just prior to impact.

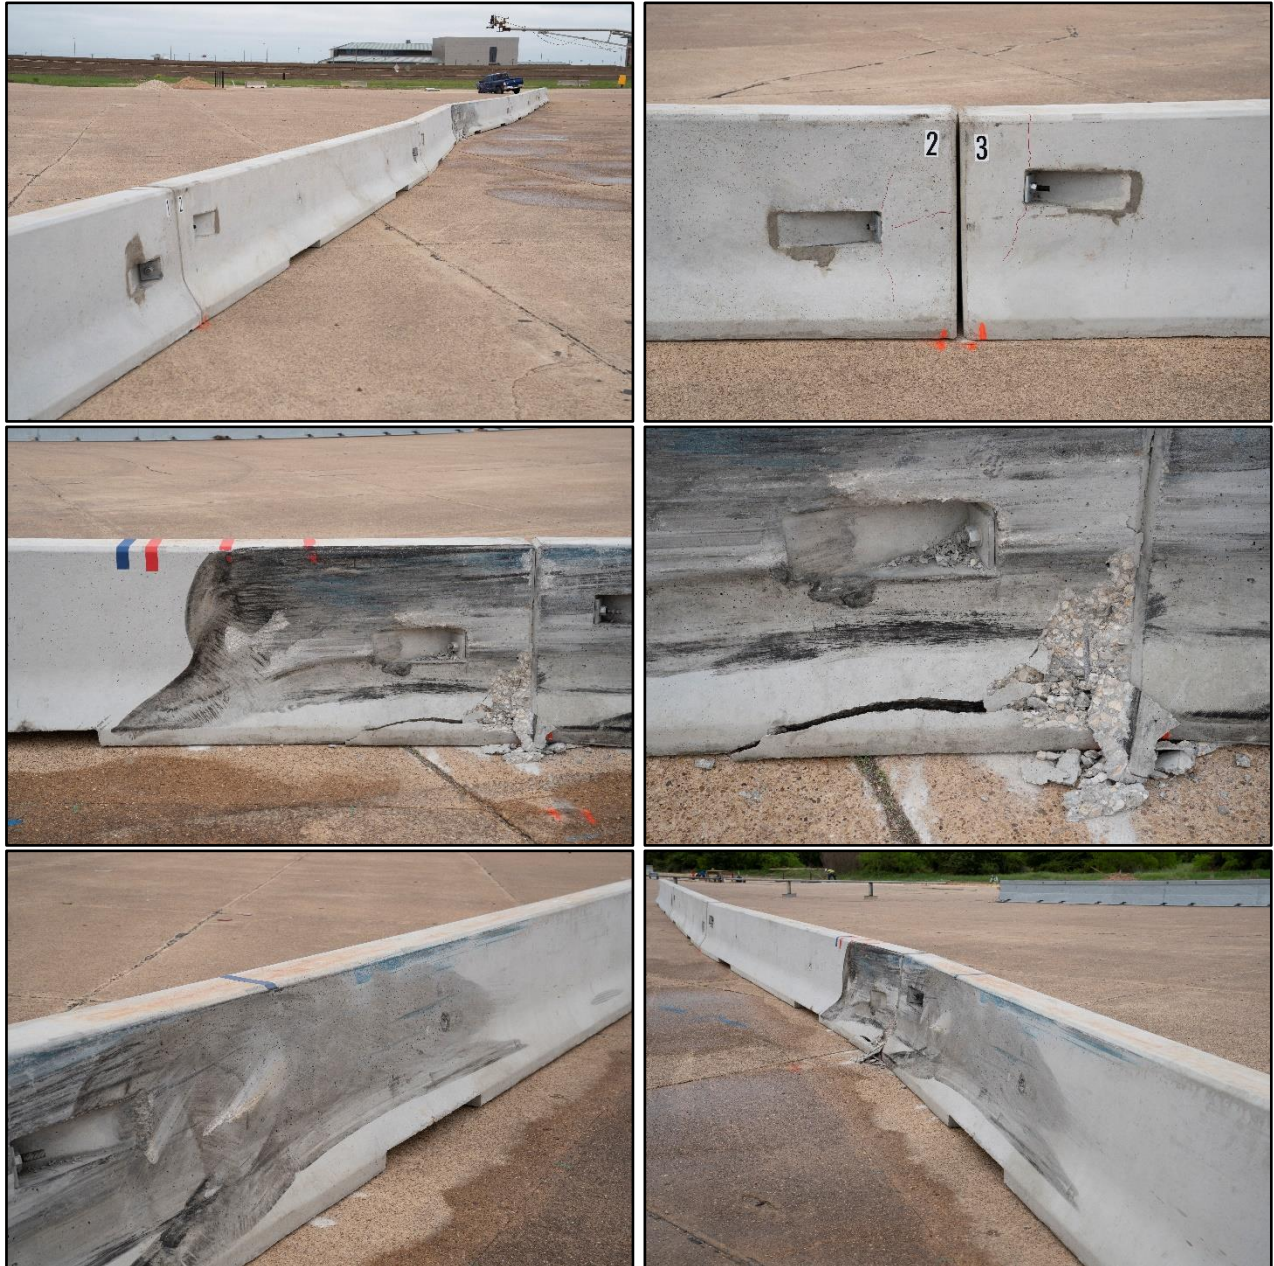
Figure 5.3. F-Shape PCB with X-Bolt Connection after Test No. 440861-01-1.

Figure 5.3 and Figure 5.4 show the damage to the F-shape PCB with X-bolt connection. There was scuffing from multiple impacts downstream from the initial loss of contact. One of the bolts connecting barrier 3 to barrier 2 was deformed, and both bolts at the joint of barriers 3 and 4 were deformed. The red lines shown in the photos indicate cracks observed post-impact.

Table 5.2 and Table 5.3 provide barrier movement and barrier damage, respectively. Working width* was 48.3 inches, and height of working width was 3.0 inches. Maximum dynamic deflection during the test was 26.6 inches, and maximum permanent deformation was 25.5 inches.

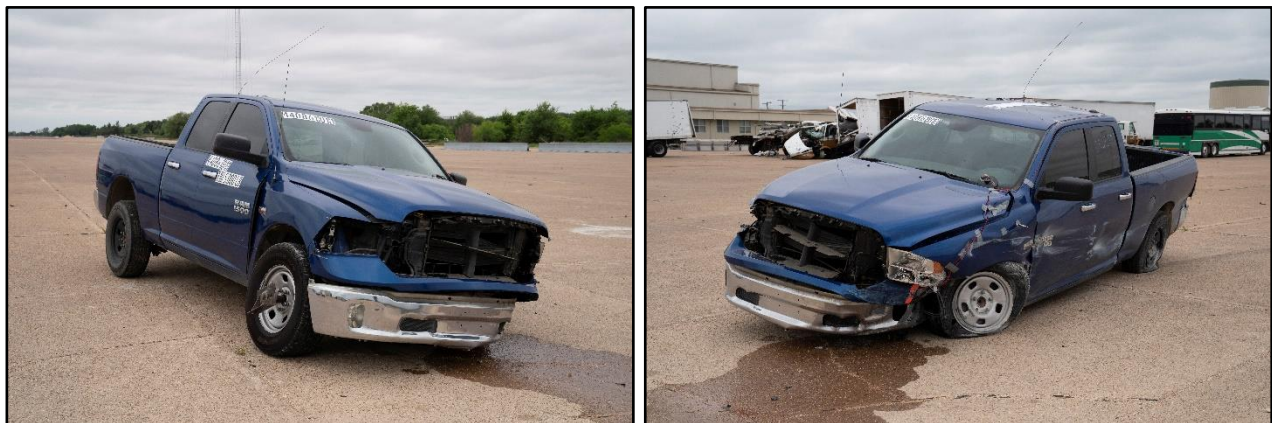
Figure 5.5. Test Vehicle after Test No. 440861-01-1.

Figure 5.5 shows the damage sustained by the vehicle. The front bumper, hood, grill, left front fender, left front tire and rim, left front and rear doors, left front corner of the floor pan, left rear cab corner, left rear exterior bed, left rear tire and rim, and rear bumper were damaged. No fuel tank damage was observed. No windshield damage was observed. Maximum exterior crush to the vehicle was 11.0 inches in the side plane at the left front corner at bumper height. Maximum occupant compartment deformation was 1.0 inch in the left front firewall/toe pan area. Figure 5.6 shows the interior of the vehicle. Tables C.3 and C.4 in Appendix C.1 provide exterior crush and occupant compartment measurements.

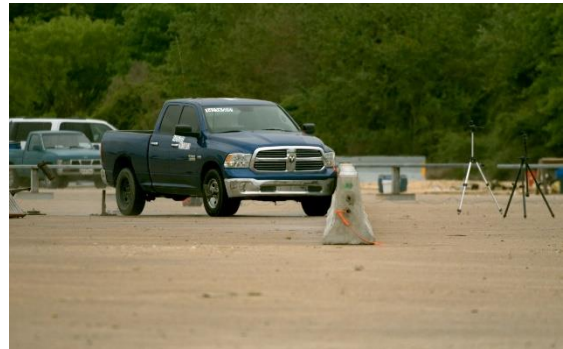
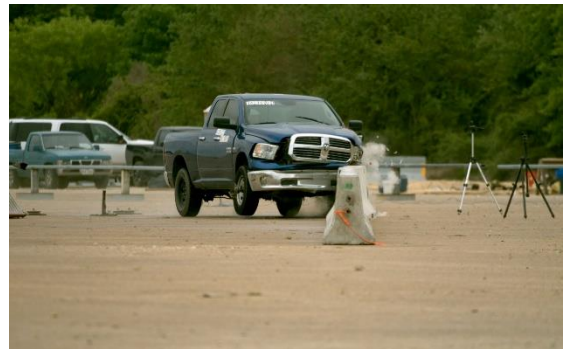
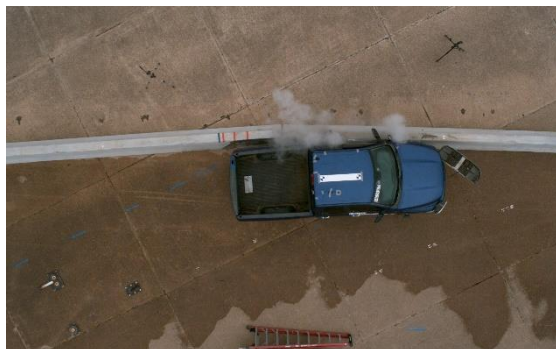
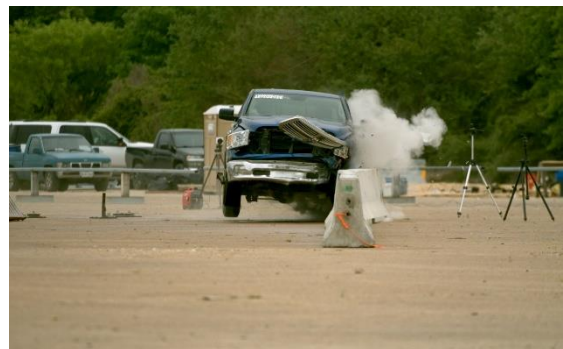
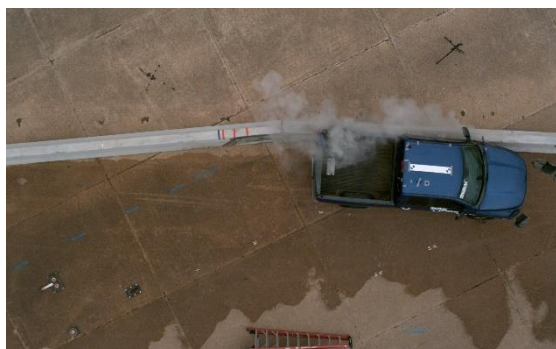
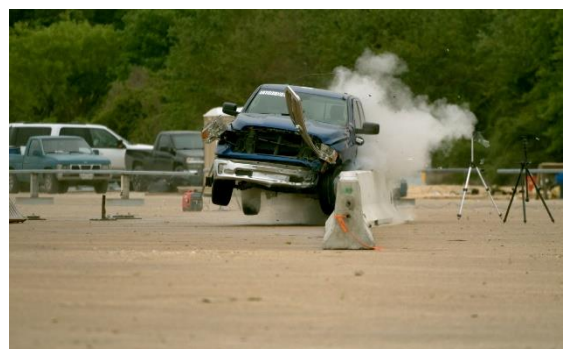
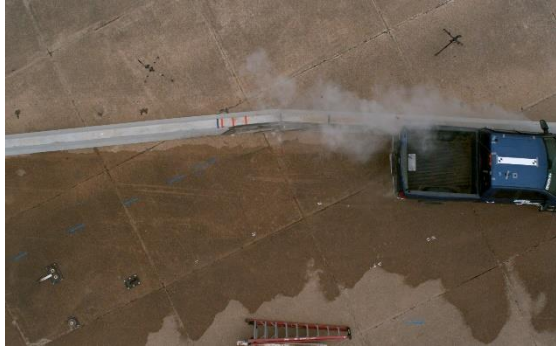
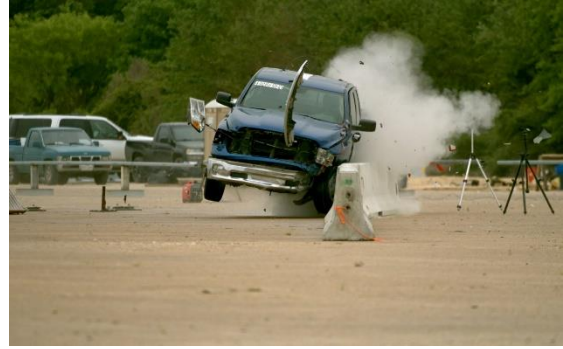
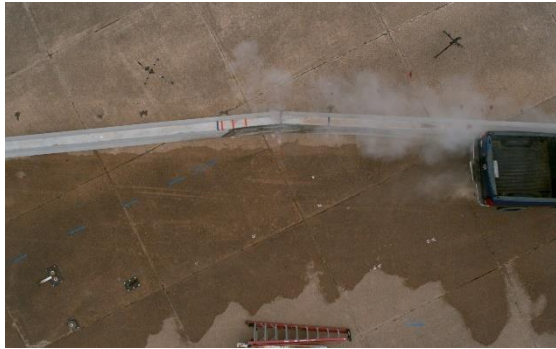
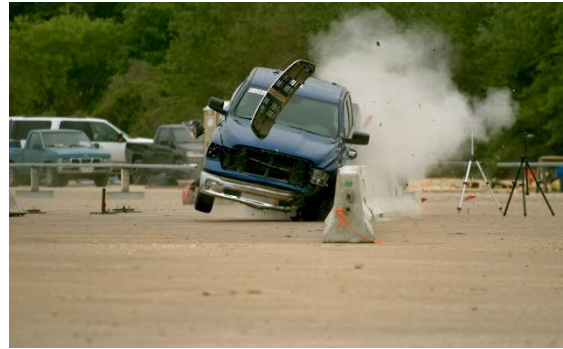
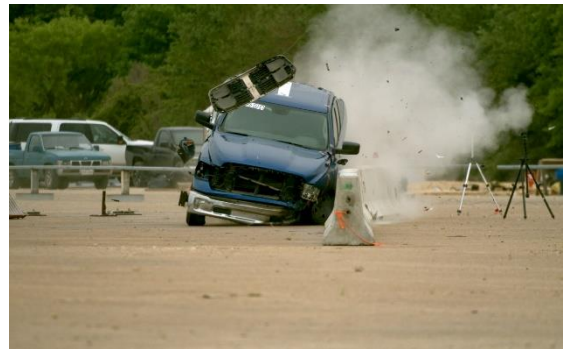
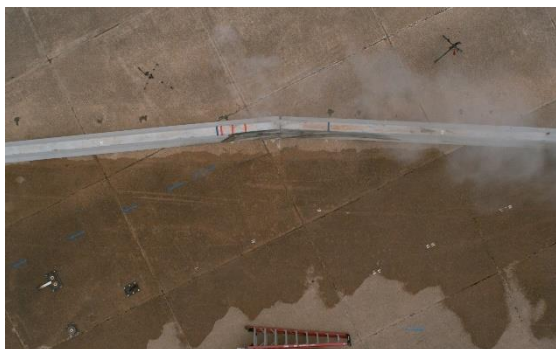
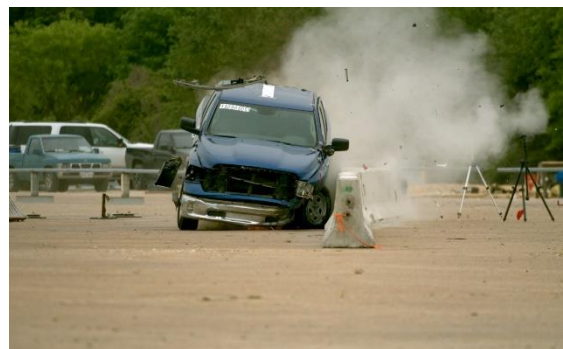
Figure C.1. Sequential Photographs for Test No. 440861-01-1 (Overhead and Frontal Views).

Figure C.1. Sequential Photographs for Test No. 440861-01-1 (Overhead and Frontal Views) (Continued).
