# **MASH TEST 5-12 EVALUATION OF TxDOT T80SS BARRIER WITH SOUNDWALL**

## **Test Report 0-7086-R4**

1. Report No. FHWA/TX-22/0-7086-R4		2. Government Accession No.		3. Recipient's Catalog No.	
4. Title and Subtitle <b>MASH TEST 5-12 EVALUATION OF TXDOT T80SS BARRIER WITH SOUNDWALL</b>				5. Report Date <b>Published: September 2021</b>

16. Abstract <p>The purpose of the test reported herein was to assess the performance of the Texas Department of Transportation (TxDOT) T80SS barrier with soundwall according to the safety-performance evaluation guidelines included in the American Association of State Highway and Transportation Officials (AASHTO) <i>Manual for Assessing Safety Hardware (MASH)</i>. The crash test was performed in accordance with <i>MASH</i> Test 5-12, which involves a 36000V vehicle weighing 79,300 lb impacting the longitudinal barrier while traveling at 50 mi/h and 15 degrees.</p> <p>This report provides details on the TxDOT T80SS barrier with soundwall, a description and results of the crash test, and a performance assessment of the TxDOT T80SS barrier with soundwall for <i>MASH</i> Test 5-12 longitudinal barrier evaluation criteria.</p> <p>The TxDOT T80SS barrier

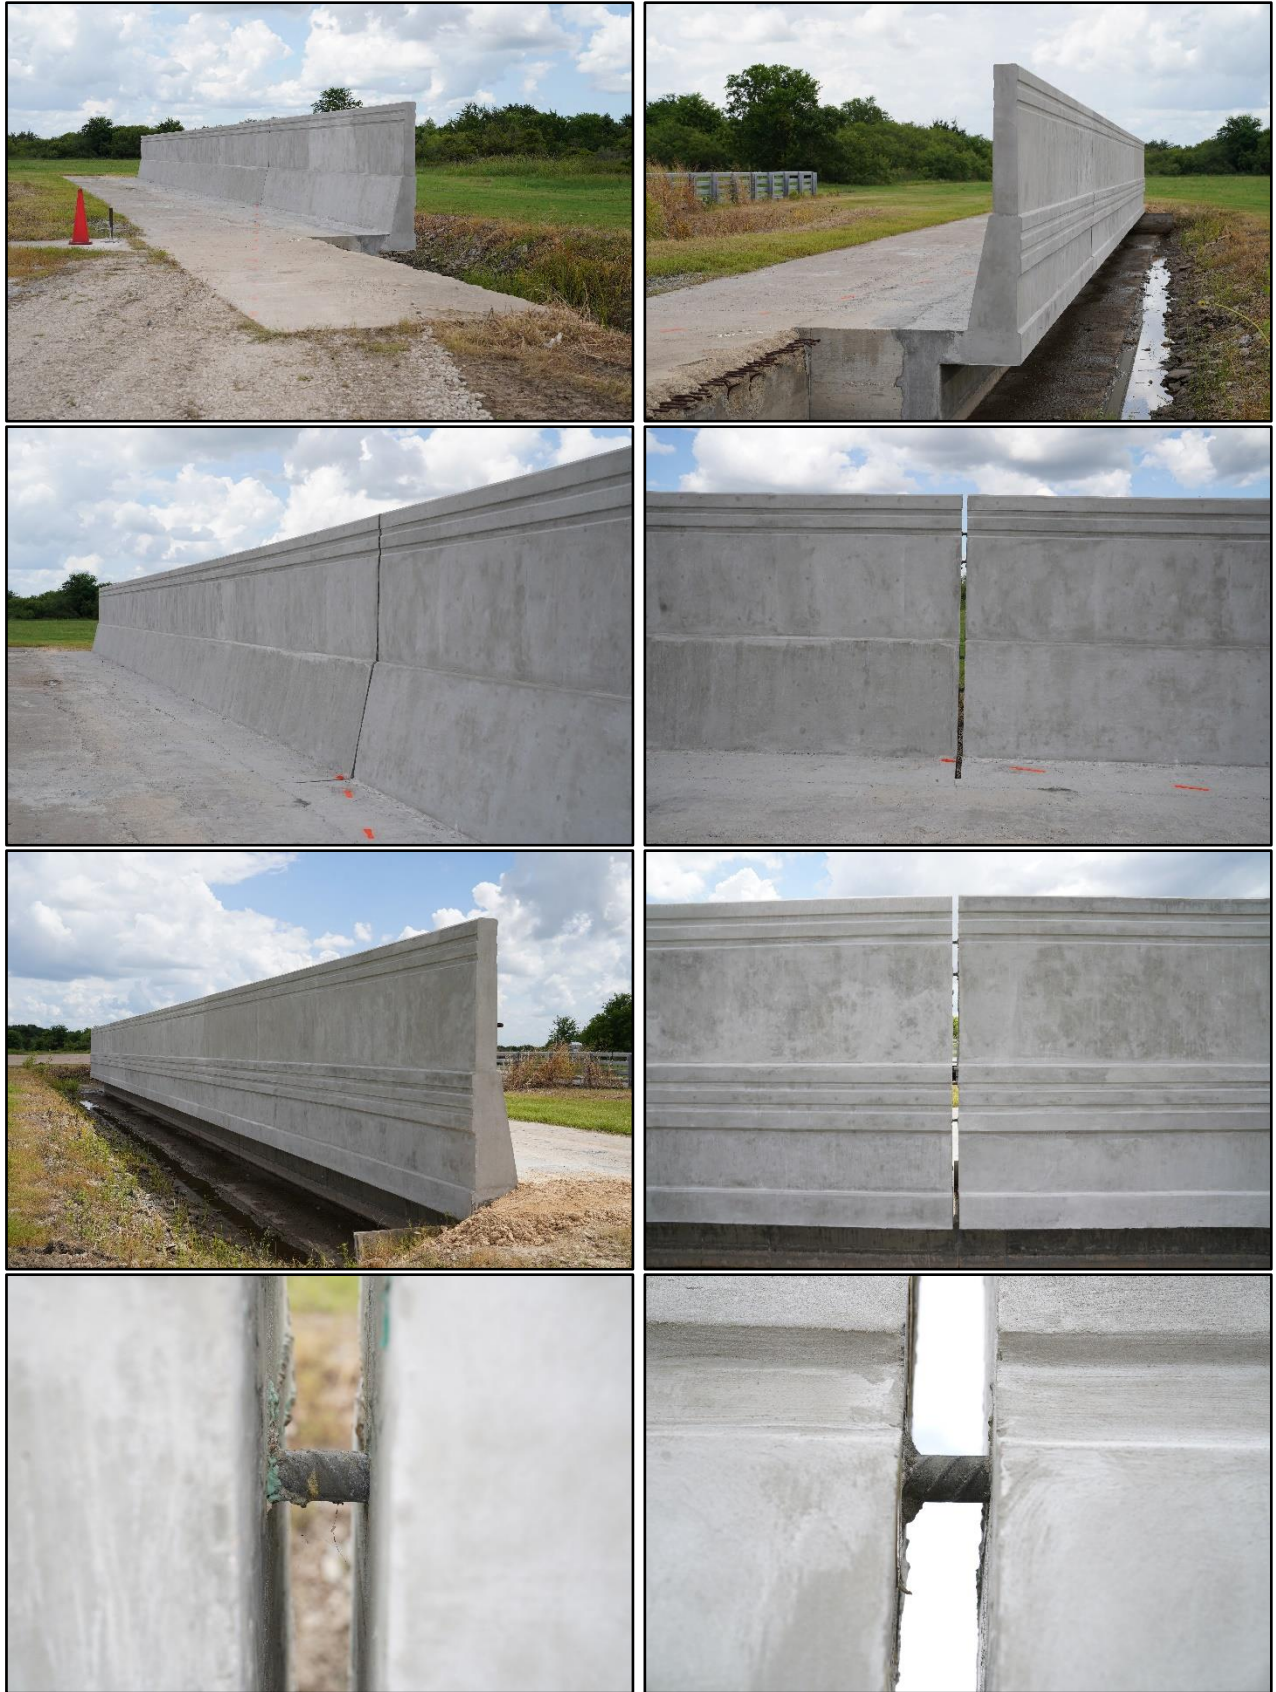
**Figure 2.2. TxDOT T80SS Barrier with Soundwall prior to Testing.**

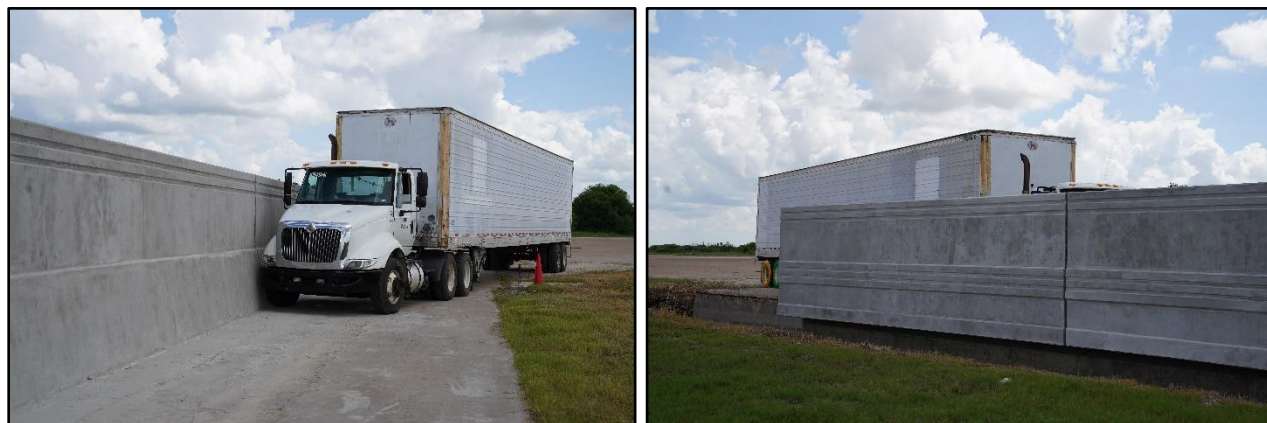
**Figure 5.1. TxDOT T80SS Barrier with Soundwall/Test Vehicle Geometrics for Test No. 440861-4.**

MASH Test 5-12 involves a 36000V vehicle weighing 79,300 lb  $\pm$  1100 lb impacting the CIP of the longitudinal barrier at an impact speed of 50 mi/h  $\pm$  2.5 mi/h and an angle of 15 degrees  $\pm$  1.5 degrees. The CIP for MASH Test 5-12 on the TxDOT T80SS barrier with soundwall was 12 inches  $\pm$  12 inches downstream of the centerline of the expansion joint. Figure 3.1 and Figure 5.1 depict the target impact setup.

The 36000V vehicle weighed 80,030 lb, and the actual impact speed and angle were 50.4 mi/h and 14.3 degrees. The actual impact point was 20.9 inches downstream of the centerline of the expansion joint. Minimum target impact severity (IS) was 404 kip-ft, and actual IS was 415 kip-ft.

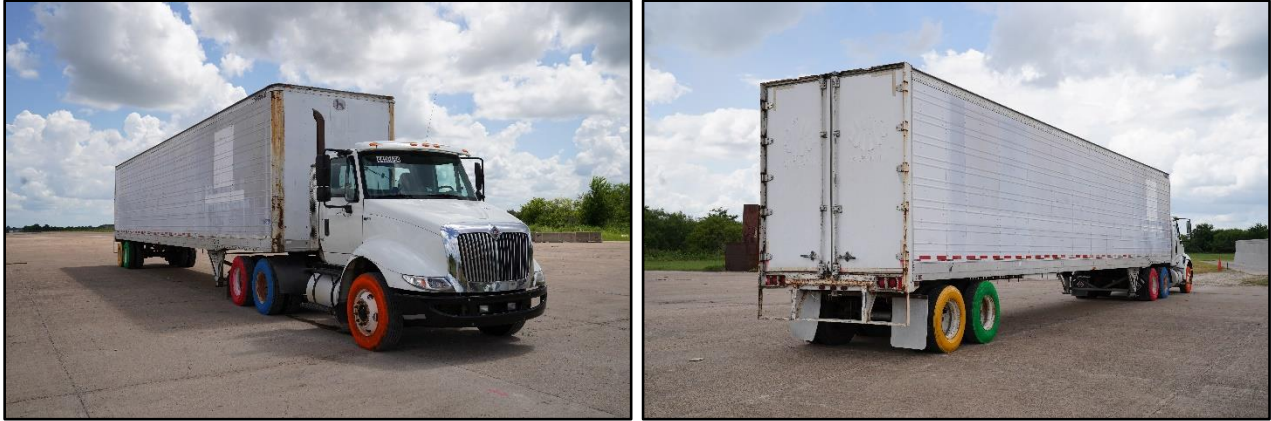
**Figure 5.2. Test Vehicle before Test No. 440861-4.**

Figure 5.2 shows the 2013 International 8600 tractor with 1988 Great Dane 7311TCHL53 trailer used for the crash test. The vehicle's test inertia weight was 80,030 lb, and its gross static weight was 80,030 lb. The height to the lower edge of the vehicle bumper was 14.0 inches, and height to the upper edge of the bumper was 29.5 inches. The height to the center of gravity of the vehicle's ballast was 73.0 inches. Table C.1 in Appendix C.1 gives additional dimensions and information on the vehicle. The vehicle was directed into the installation using a cable guidance system, and was released to be freewheeling and unrestrained just prior to impact.

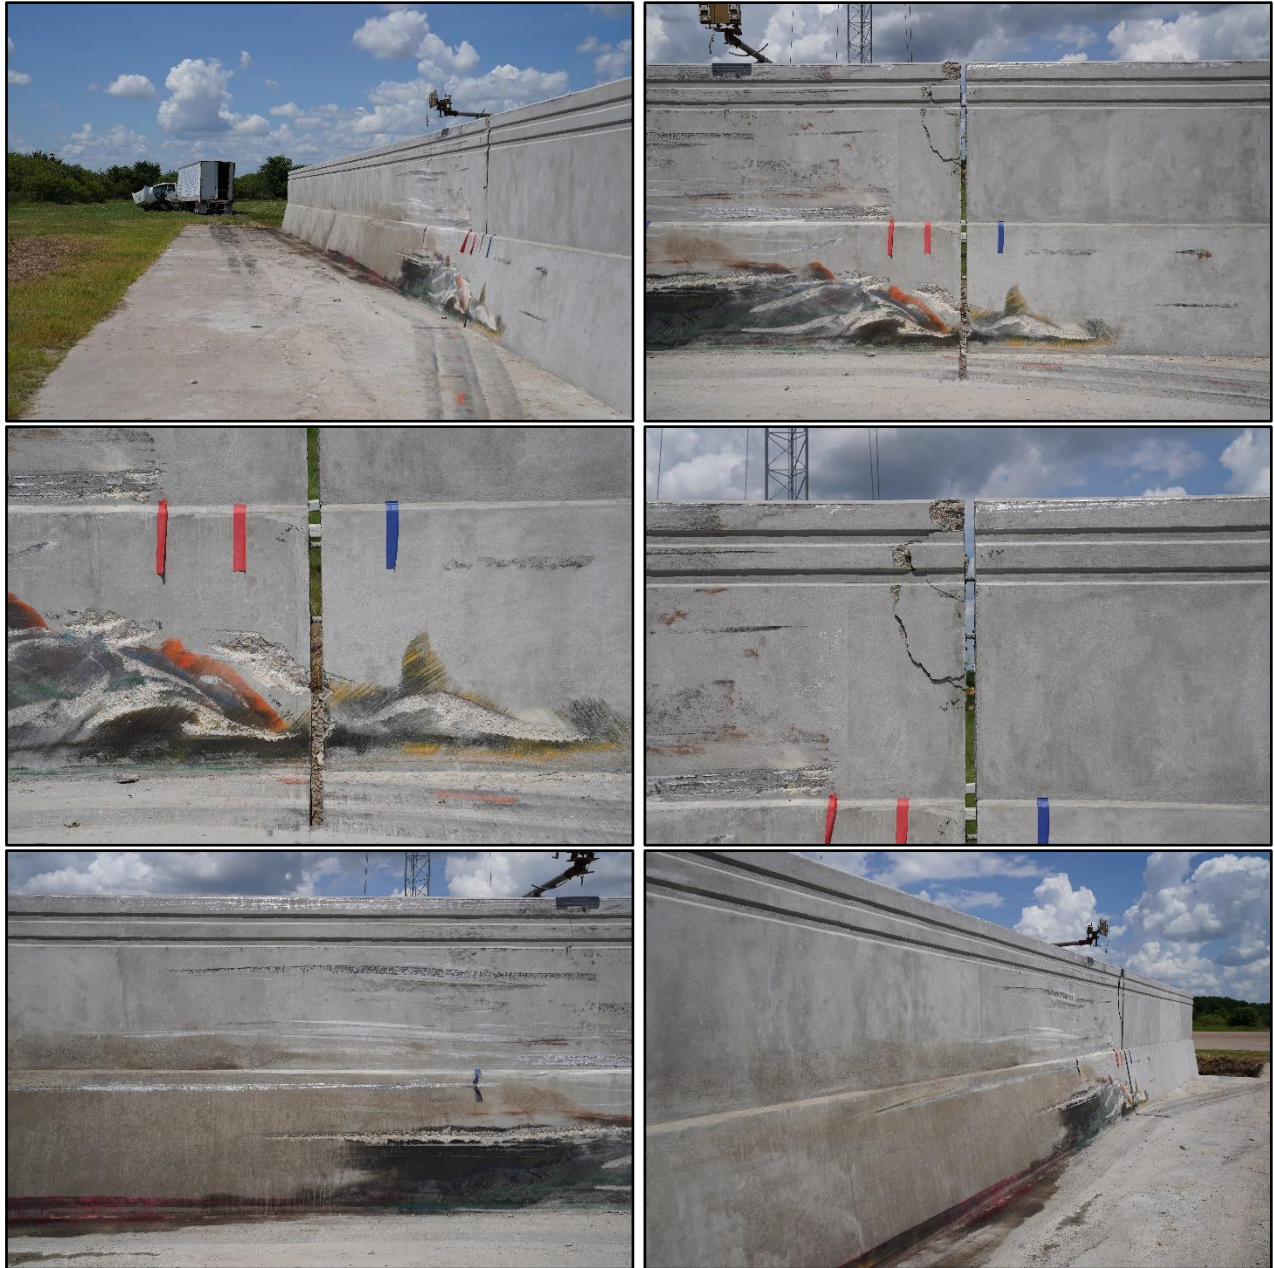
**Figure 5.3. TxDOT T80SS Barrier with Soundwall after Test No. 440861-4.**

Figure 5.3 and Figure 5.4 show the damage to the TxDOT T80SS barrier with soundwall. The downstream section of the soundwall had spalled concrete at the joint. There was gouging and scuffing of the concrete at impact and upstream and downstream of impact. There were minor cracks in the deck at the joint. There were also minor cracks on the field side of the soundwall downstream from the joint. Two of the vertical cracks ran from the top to the bottom of the barrier and were measured at 32 inches and 44 inches downstream from the center of the joint. A third vertical crack ran from the middle of the barrier to near the bottom and was measured at 108 inches downstream from the center of the joint. There was one 93-inch-long horizontal crack, which began at the downstream edge of the joint and was measured at

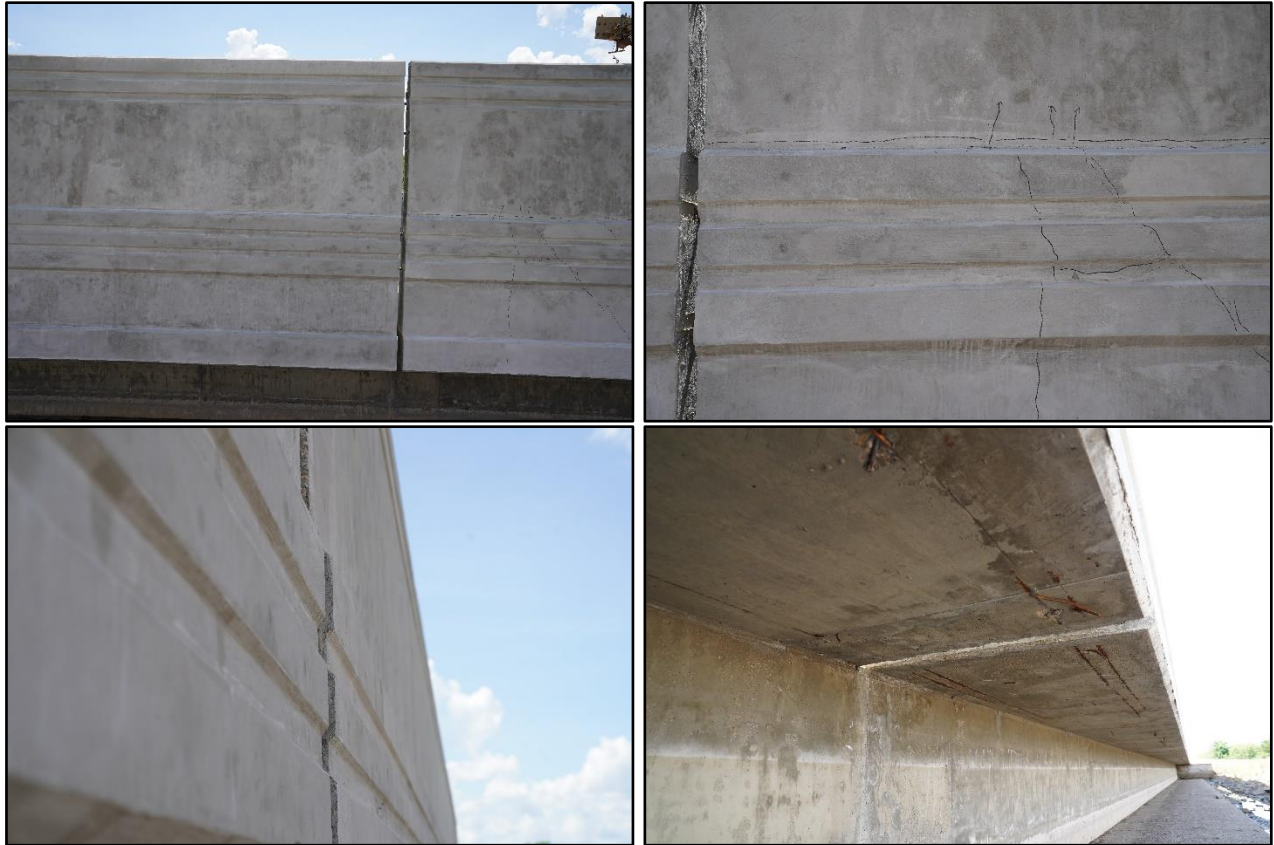
*Note: Cracks outlined with black marker for visualization.*

**Figure 5.4. Field Side of TxDOT T80SS Barrier with Soundwall after Test No. 440861-4.**

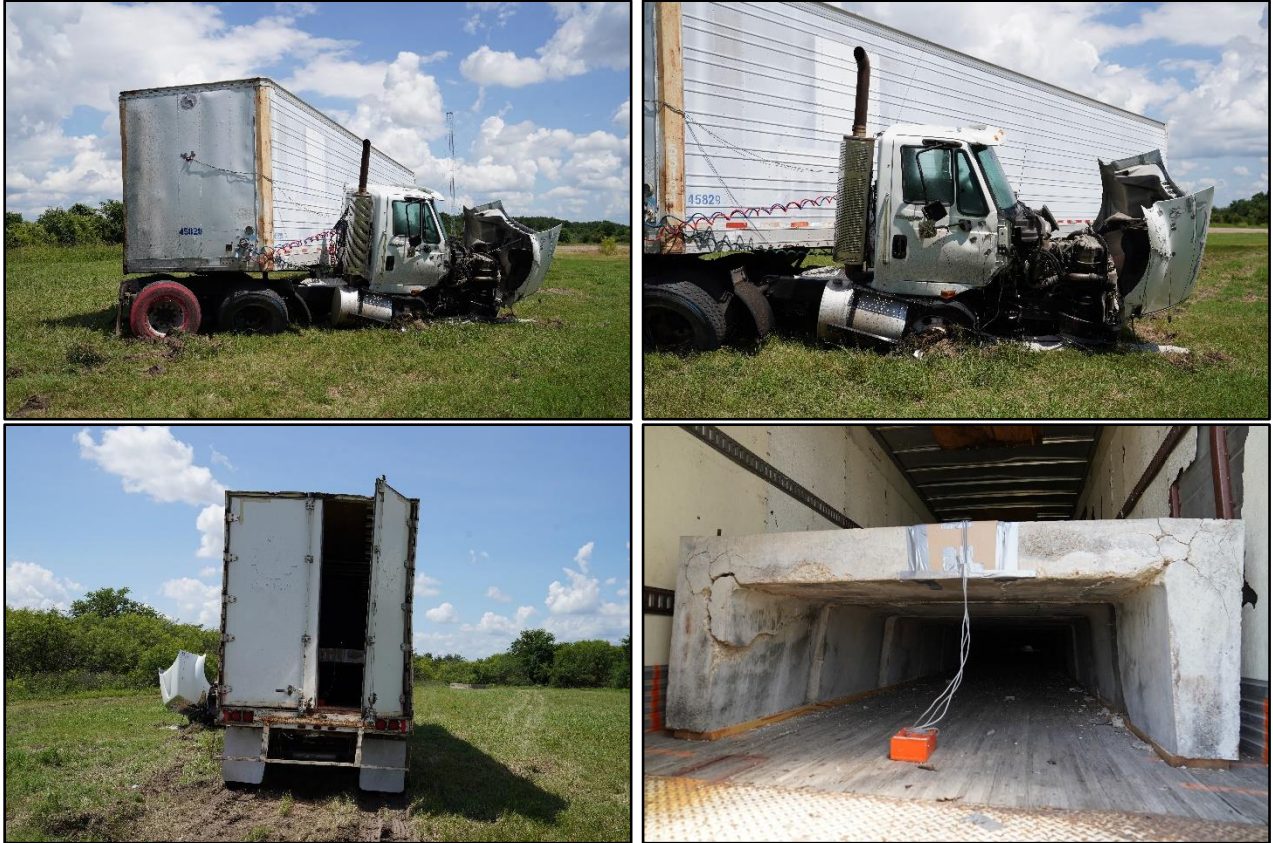
**Figure 5.5. Test Vehicle after Test No. 440861-4.**

Figure 5.5 shows the damage sustained by the vehicle. The front bumper, left front axle spring assembly, hood, right door, right front tire and rim, right front outer tandem tire and rim, right fuel tank (deformed only; no visible cuts or holes; no leaks), right side steps, right front corner of the trailer, and right rear upper corner of the trailer were damaged. The windshield had cracks radiating upward and inward from the lower right corner. Maximum exterior crush to the vehicle was 18.0 inches in the front plane at the right front corner at bumper height. No occupant compartment deformation or intrusion was observed. Figure 5.6 shows the interior of the vehicle.

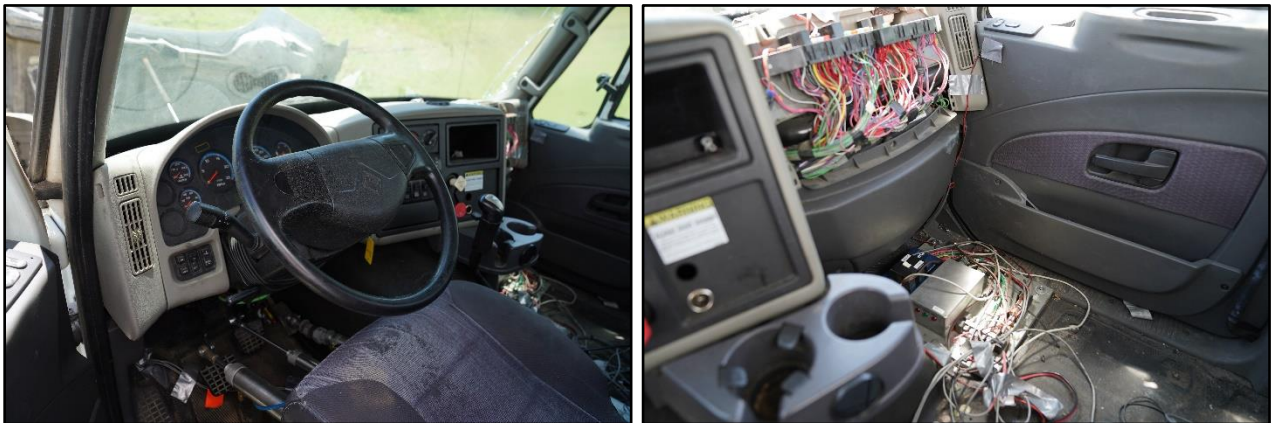
**Figure 5.6. Interior of Test Vehicle after Test No. 440861-4.**

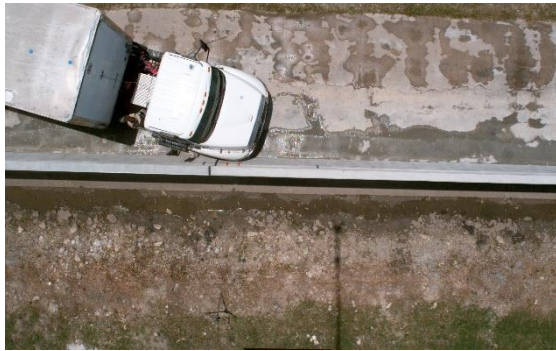
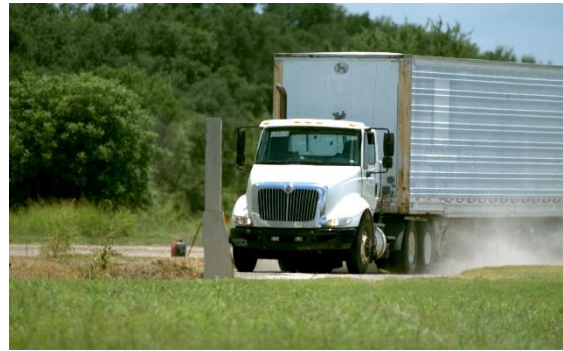
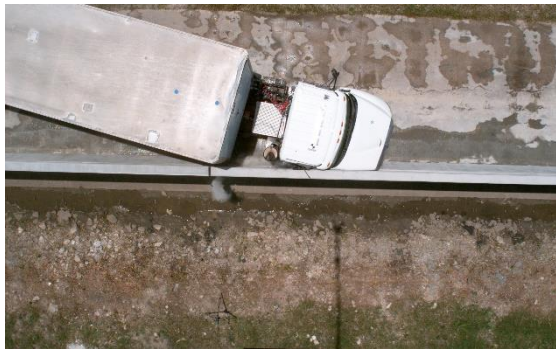
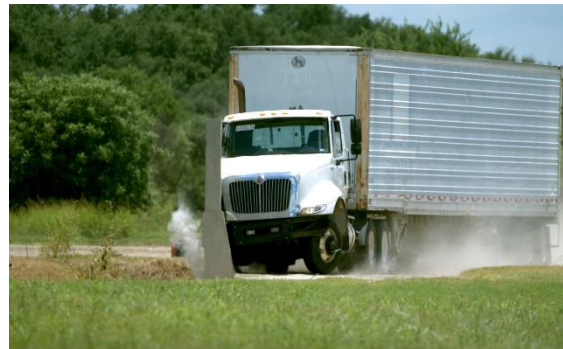
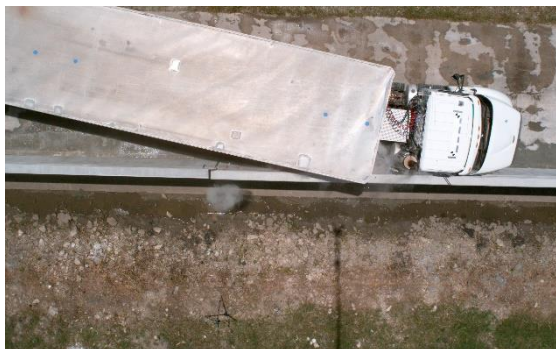
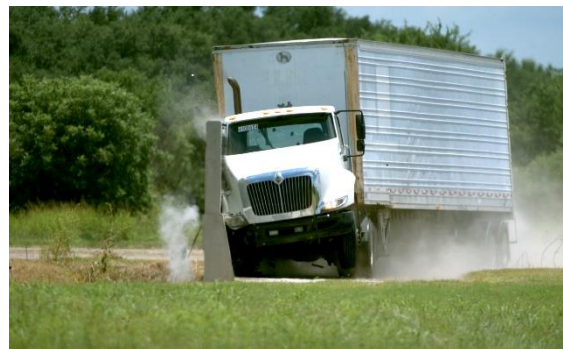
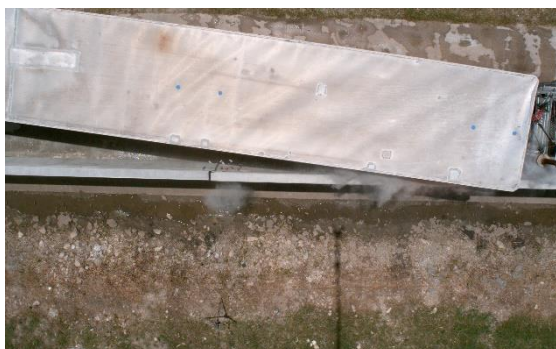
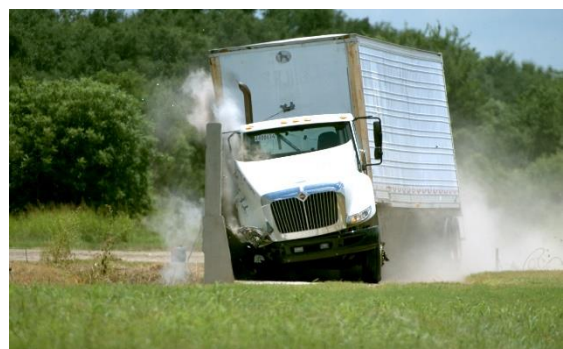
**Figure C.1. Sequential Photographs for Test No. 440861-4 (Overhead and Frontal Views).**

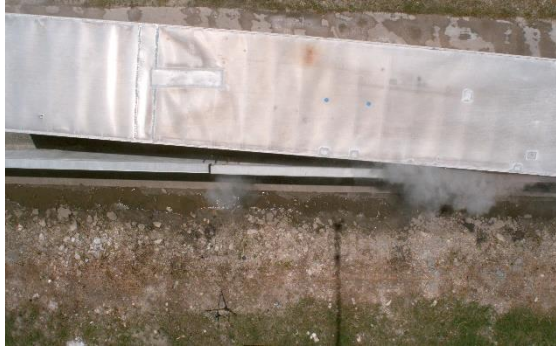
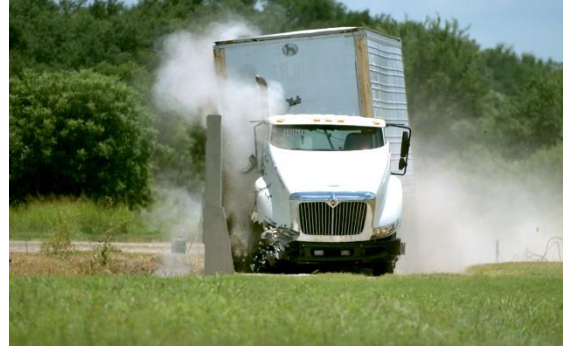
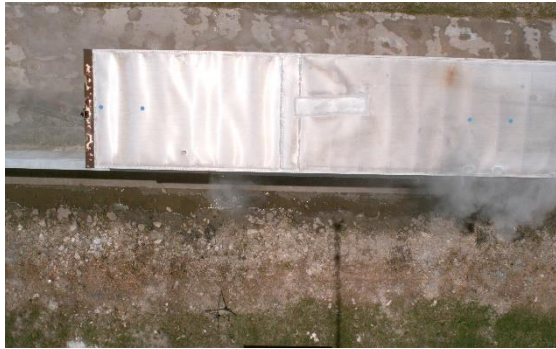
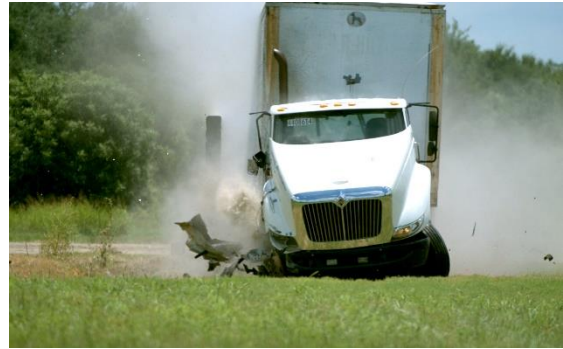
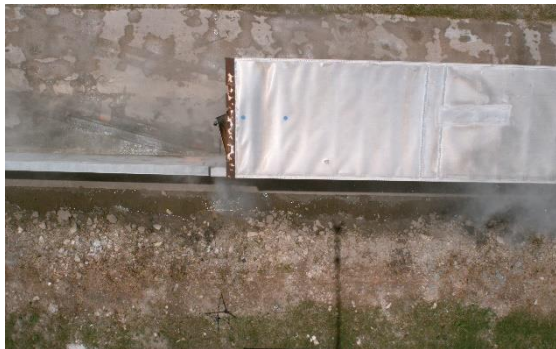
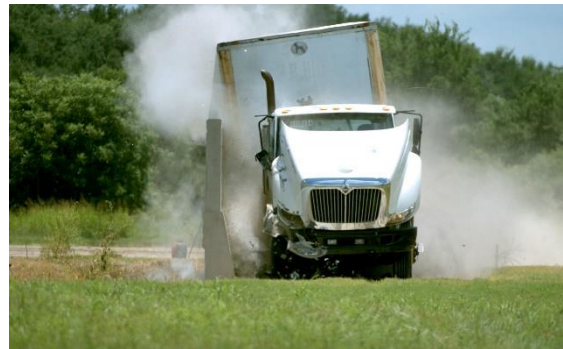
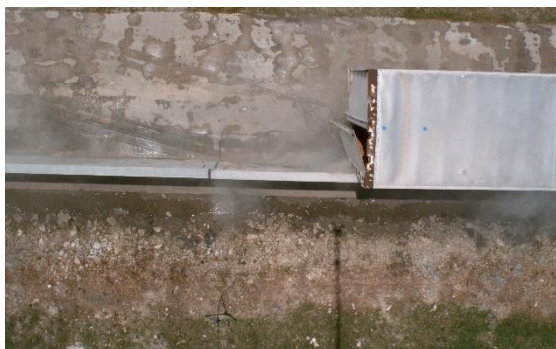
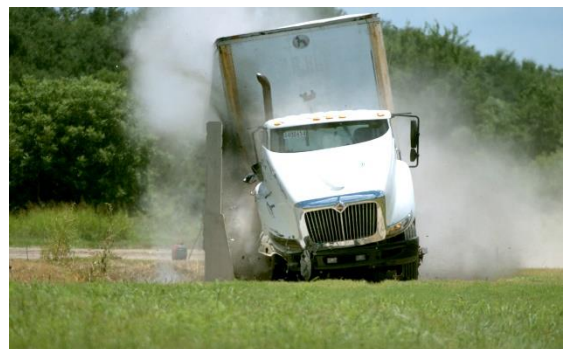
**Figure C.1. Sequential Photographs for Test No. 440861-4 (Overhead and Frontal Views) (Continued).**

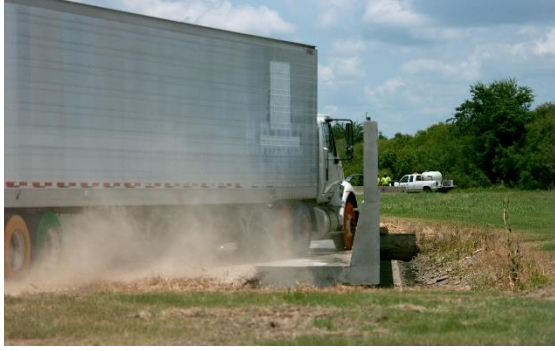
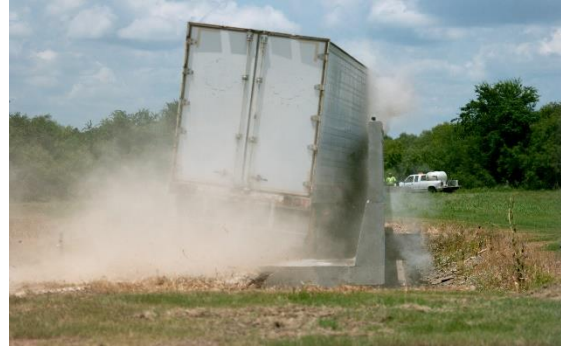
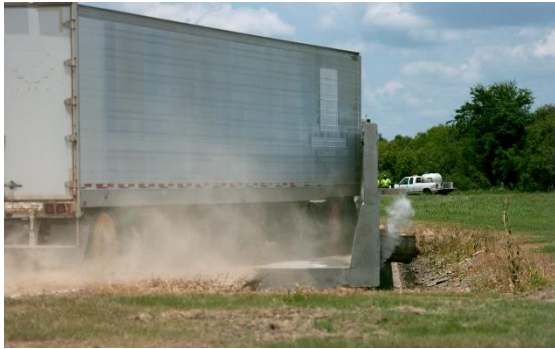
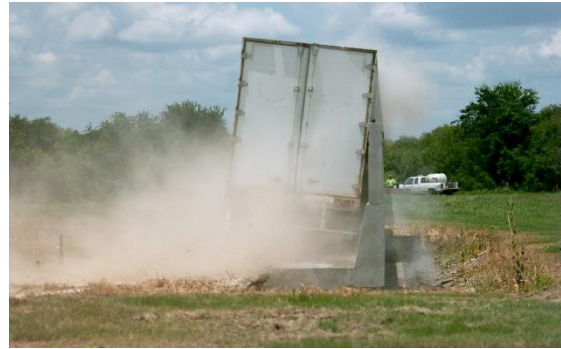
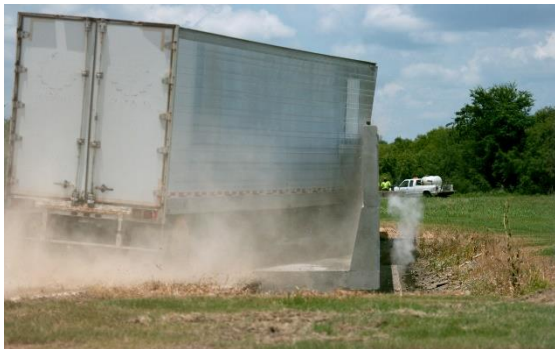
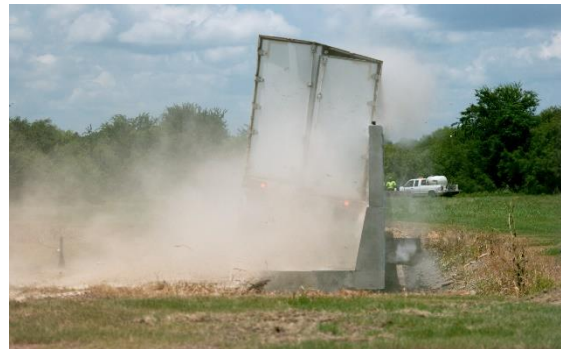
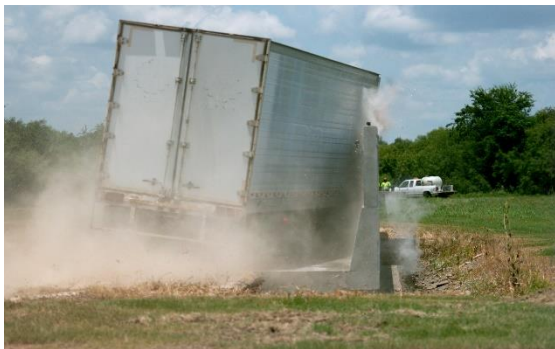
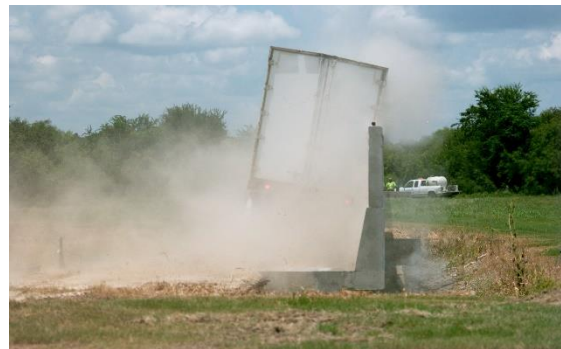
**Figure C.2. Sequential Photographs for Test No. 440861-4 (Rear View).**
