Public Roads

VOL. 4, NO. 7

NOVEMBER, 1921

| | Page |
|---|---|
| Tests of Impact on Pavements by the Bureau of Public Roads | 1 |

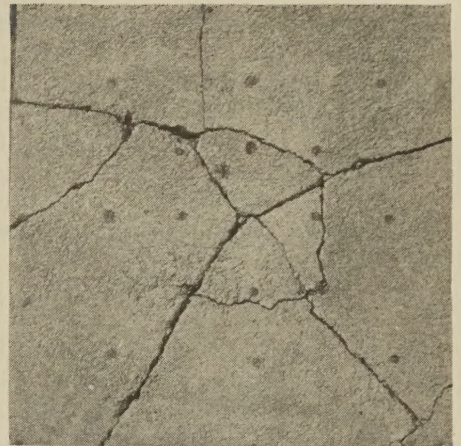
FIG. 2.—CONCRETE PAVEMENT SECTIONS.

In this group of sections are slabs 2, 4, 6, 8, and 10 inches thick. Their center settlement curves are shown in figure 7 and the figures representing their resistance to impact are given in table 1A. Photographs of representative failures are shown in figure 2.

Section No. 115. Concrete, 1:1½:3 mix, 2 inches thick, on dry subgrade. This slab offered little or no resistance to the ½-inch drop, developed the first crack after the tenth blow, followed by rapid punching out at the center. The condition which resulted after 51 blows is shown in the photograph, figure 2. It can be said that the slab resisted 7,800 pounds static load, the weight of the plunger. The settlement of 1 inch occurred after 30 blows. It can readily be seen that a surface of this thickness can be of little value for road purposes.

Section No. 17. Concrete, 1:1½:3 mix, 4 inches thick, on wet subgrade. This slab received a total of 634 blows, 500 beginning with ½-inch drop and 134 beginning with ¼-inch. Although cracks were not observed until after the five hundredth blow it is evident from the curve, figure 7, that failure commenced somewhere between 250 and 500 blows. This failure is assumed to have occurred on a 0.204-inch drop, which was the height of fall at the four hundredth blow, the corresponding force for which is 14,900 pounds. The result after 634 blows was a badly broken slab with the center punched out. Settlement of 1 inch occurred after 600 blows.

Section No. 113. Concrete, 1:1½:3 mix, 4 inches thick, on dry subgrade. This slab withstood 500 blows beginning with ½-inch drop, and failed during 441 blows beginning with ¼-inch; the first crack was observed after the five hundred and fortieth blow. The actual resistance was somewhere between 12,800 and 20,400 pounds, the values corresponding to the total drop at the end of the first 500 blows and the ¼-inch drop, respectively. Settlement of 1 inch occurred after 770 blows. From both curves and photographs it can be seen plainly that No. 113 offered considerably more resistance than No. 17. Since the two slabs are of the same mix and thickness, the difference in their behavior must be due to the difference in support offered by the subgrades. Table 1-A shows that the penetration of the bearing value determinator was 2.15 inches around No. 17 and only 1.15 around No. 113. The rates of settlement as shown by the curves also indicate that there was better support under No. 113 than under No. 17. Consequently it was to be expected that the former would show the greater resistance.

Section No. 16. Concrete, 1:1½:3 mix, 6 inches thick, on wet subgrade. This slab resisted 500 blows beginning with ½-inch drop and 500 blows beginning at ¼-inch. It failed under the ¾-inch blows, the first crack developing soon after the one hundredth blow, at that height with the center settling rapidly under the following 239 blows. The resistance is indicated as being between 23,700 and 26,700 pounds. Settlement of 1 inch occurred after 1,160 blows.

Section No. 112. Concrete, 1:1½:3 mix, 6 inches, thick, on dry subgrade. This slab resisted 500 blows beginning at ½-inch drop, 500 blows beginning at ¼-inch, and failed under the ¾-inch blows with the first crack developing at the eleven hundred and seventy-fifth blow, followed by a second crack and resulting in the

condition shown in the photograph, figure 2, after the fourteen hundred and fourteenth blow. The indicated resistance lies between 21,600 and 26,700 pounds. Settlement of 1 inch occurred after 1,300 blows. The curves show that during the first 1,000 blows settlement was greater for No. 16, but that after cracks developed the settlement was greater for No. 112. It is of interest to note that after the principal cracks developed the resulting blocks resisted the blows without additional breaking. No. 16 can be considered as having shown slightly greater resistance than No. 112; first, because it received blows of greater force during the second 500 drops than No. 112 and also because it broke into but three instead of four pieces. It will be noted in Table 1-A, that the moisture content was greater in the subgrade of No. 16, while, contrary to what might be supposed, the supporting power is also indicated as being somewhat better than that of the subgrade under No. 112. It is again indicated that other things being equal the resistance of a road surface is dependent upon the support offered by the subgrade.

Section No. 15. Concrete, 1:1½:3 mix, 6 inches thick, on a wet subgrade. This slab, which was 14 instead of 7 feet square, was used for the first calibration of the impact machine. It resisted drops of from 0 to 3½ inches at a time when the subgrade was apparently frozen. The first crack, however, was noticed after a 3-inch drop, when the frost was coming out of the ground. The force corresponding to this 3-inch drop is 41,400 pounds. When the first cross crack occurred a second developed at right angles to it, followed by two diagonal cracks and then by punching out of the center. The final condition is shown in the photograph.

Section No. 19. Concrete, 1:3:6 mix, 6 inches thick, on wet subgrade. This slab resisted 500 blows at ⅛-inch, 500 blows at ½-inch, and failed under ⅞-inch blows. One of the photographs shows the result after the one thousand and seventy-third blow. The indicated resistance lies between 21,900 and 26,700 pounds. Settlement of 1 inch occurred after 1,080 blows. It will be noted that radial cracks have developed in this section, which as a rule are preliminary to punching out of the center. This condition would indicate less resistance to impact than one in which only three or four blocks were formed; but in other respects this slab seems to be the equal of No. 112, the 6-inch slab of 1:1½:3 concrete.

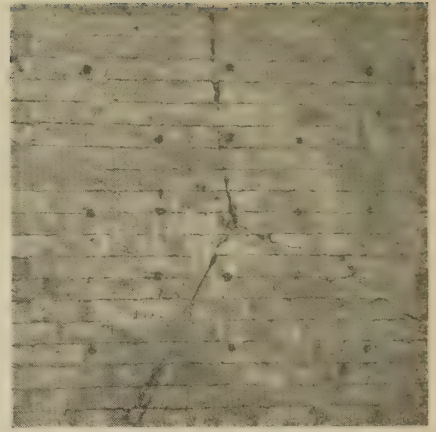
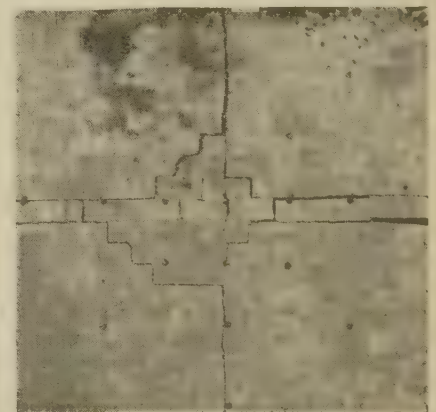
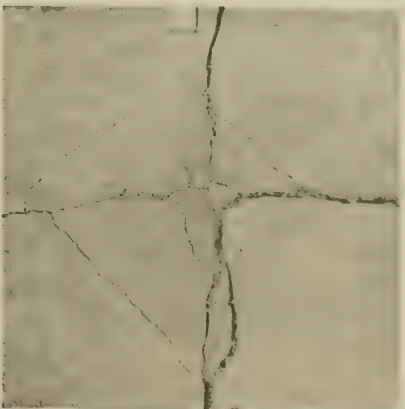
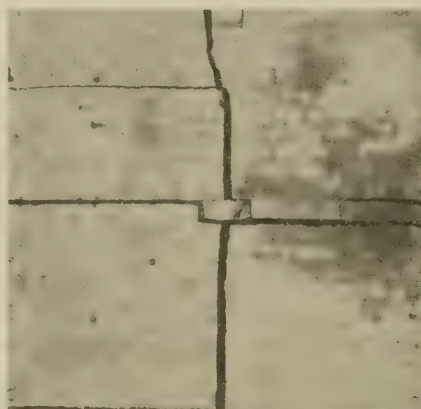
FIG. 3.—BRICK TOPS ON CONCRETE BASES WITH 3/16-INCH SAND-CEMENT CUSHIONS (MONOLITHIC CONSTRUCTION).

The sections in this group have grouted-brick surfaces with ¼-inch sand-cement cushions laid on green concrete bases. The combined concrete and brick slabs range in thickness from 5 to 10 inches. The center settlement curves are shown in figure 7, while representative failures appear in figure 3. Table 1-B gives the indicated resistances.

Section No. 22. Four-inch wire cut lug brick, laid on a 1:3:6 base, 2 inches thick, wet subgrade. This slab withstood 500 blows, beginning with ⅛-inch drop, 500 blows, beginning with ¼-inch, and broke up rapidly under 144 blows, beginning at ⅞-inch. The indicated resistance was between 22,300 and 26,700 pounds. The views of the top and base (fig. 3) show the inability of a surface of this thickness to withstand the forces to which it was subjected. This point is clearly brought out by the badly shattered condition of the base.

Section No. 129. Four-inch wire cut lug brick, laid on a 1:3:6 base, 2 inches thick, dry subgrade. This slab resisted 500 blows at ⅛-inch drop and 163 blows at ½-inch, after which a badly broken condition resulted with the succeeding 59 blows. The indicated resistance was 20,400 pounds. Like No. 22, the base of this slab was also badly shattered. A comparison of the two slabs shows, however, that No. 129 offered less resistance than No. 22. As the possible explanation we find, by reference to Table 1-B, that the bearing power of the subgrade under No. 22 seems to be considerably greater than that of No. 129. In No. 129

Section No. 127. Four-inch wire cut lug brick, laid on a 1:3:6 base, 1 inch thick, dry subgrade. This slab was subjected to 1,200 blows. It resisted 1,000 blows, beginning with the ⅛-inch drop. The first crack was observed after 500 blows. Settlement, however, remained uniform through the next 500 blows with rapid breaking up during the last 200. The indicated resistance was 18,300 pounds. Table 1-B shows that there is little difference between the moisture content and bearing power of the two subgrades to account for the difference in the behavior of these two slabs of the same construction. It is possible that the difference may have been caused by separation of the base and top in one section before the other. It is also to be remarked that the first crack in No. 127 occurred under a number of repeated blows at approximately the same height of fall rather than after a change in the height of fall. This type of failure, which seems to be common with monolithic construction, can be explained by the fact that up to a certain point the slab acts as a monolith, but after a number of repeated blows the brick is separated from the concrete base, resulting in two slabs, the combined resistance of which is not greater than the sum of resistance of the two parts.

Section No. 20. Three-inch wire cut lug brick laid on a 1:3:6 base, 3 inches thick, wet subgrade. This slab resisted 500 blows at ⅛-inch drop and was badly broken under 520 blows, beginning with ½-inch. The indicated resistance lies between 12,000 and 20,400 pounds.

Section No. 119. Three-inch wire cut lug brick laid on a 1:3:6 base, 3 inches thick, dry subgrade. This slab resisted 500 blows at ⅛-inch drop and was badly broken under 500 blows, beginning with ½-inch. The indicated resistance lies between 12,200 and 20,400 pounds. Although the subgrade under No. 119 was better than that under No. 20, there seems to be little difference in the resistance offered by the two slabs. Again, it is evident that instead of acting as a monolith this section simply acted as two independent 3-inch slabs.

Section No. 21. Three-inch wire cut lug brick, laid on a 1:3:6 base, 4 inches thick, wet subgrade. This slab resisted 500 blows at ⅛-inch drop, 500 blows at ½-inch, and 250 at ⅞-inch, breaking up under 395 addi-

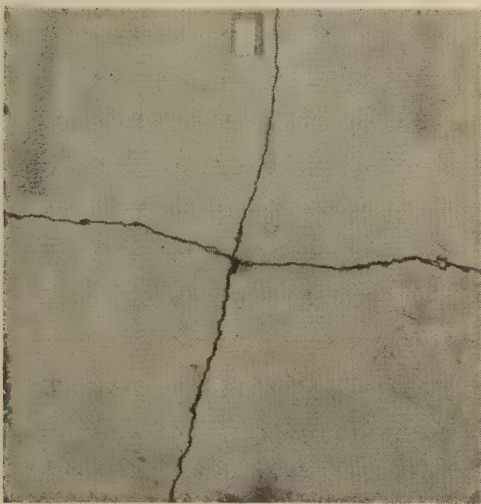
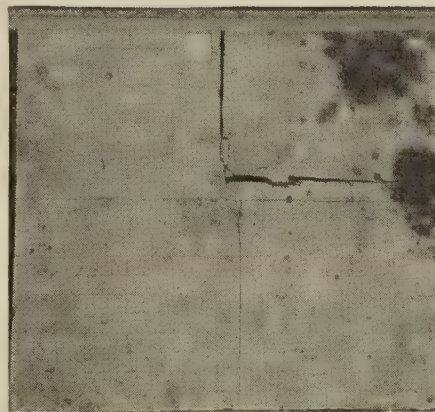
FIG. 4.—BRICK TOPS ON CONCRETE BASES WITH 1-INCH SAND-CEMENT AND ½-INCH TAR-MASTIC CUSHIONS (SEMI-MONOLITHIC CONSTRUCTION).

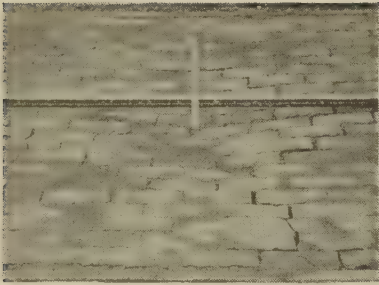
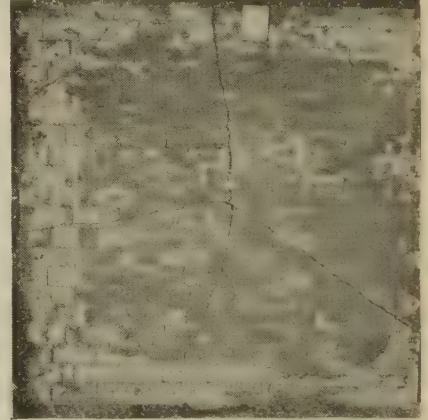
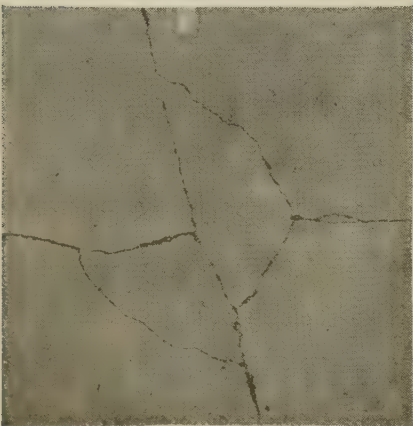
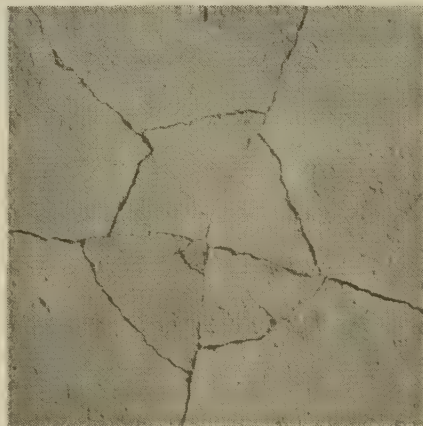
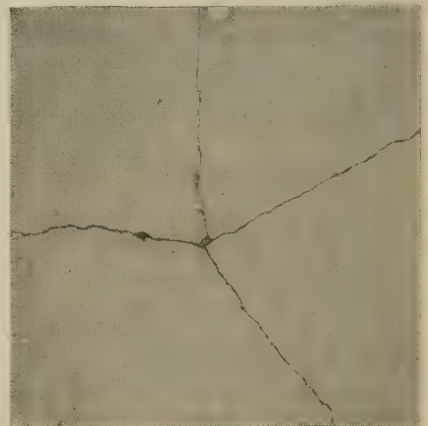
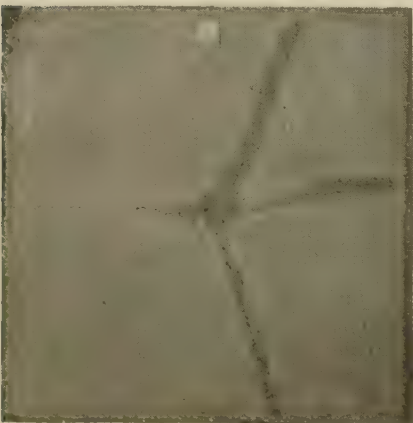
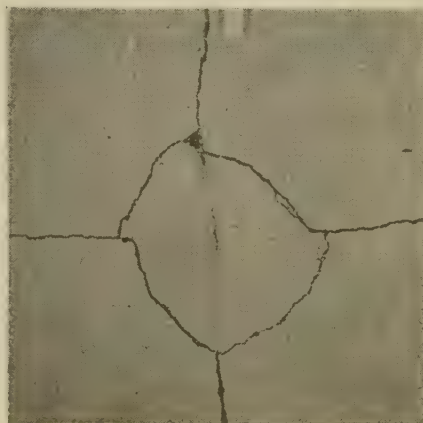
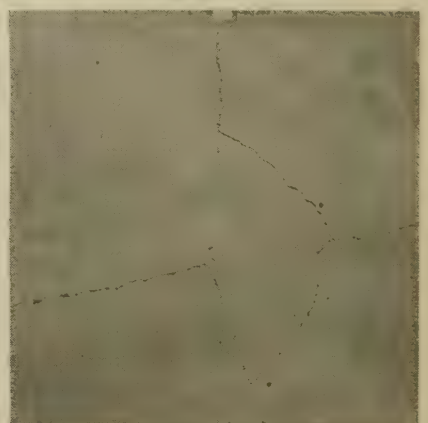
FIG. 5.—BITUMINOUS-FILLED BRICK TOPS ON CONCRETE BASES.

The most difficult cases to interpret were those of the bituminous-filled brick sections which failed by cracking of the base under the one-eighth inch drop. The difficulty in these cases was due to the fact that there was no discernable crack and the height of fall which caused failure could only be assumed from a study of the rate of settlement.

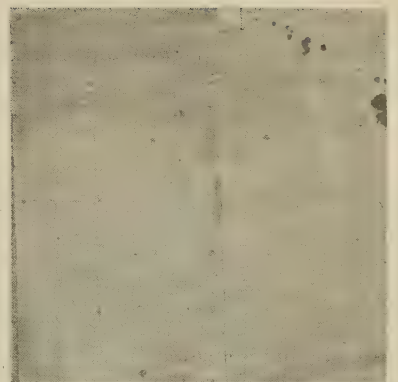
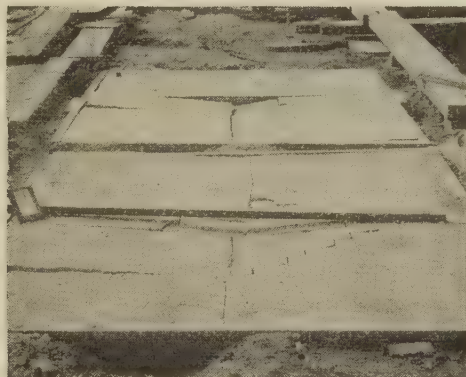
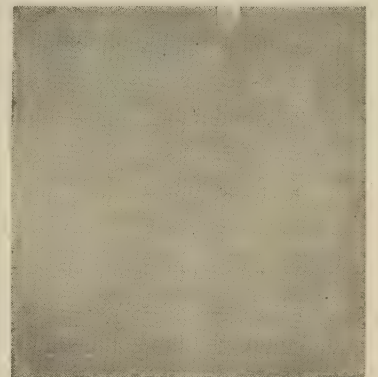
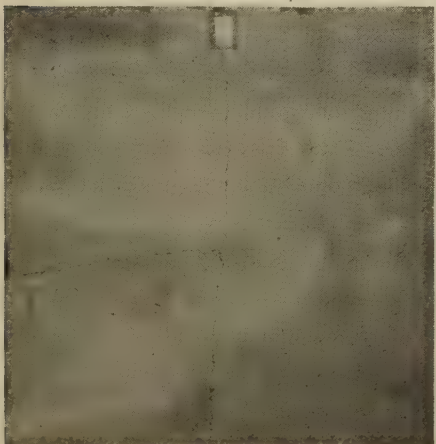
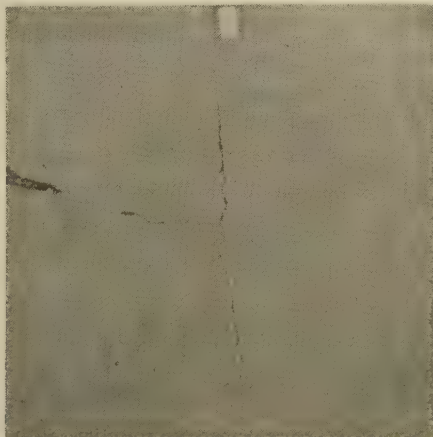
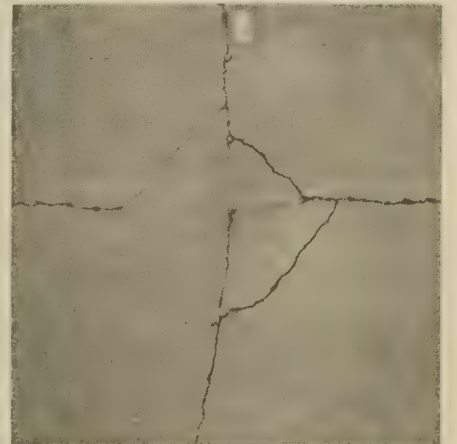
FIG. 6.—GROUTED BRICK TOPS ON CONCRETE AND MACADAM BASES.

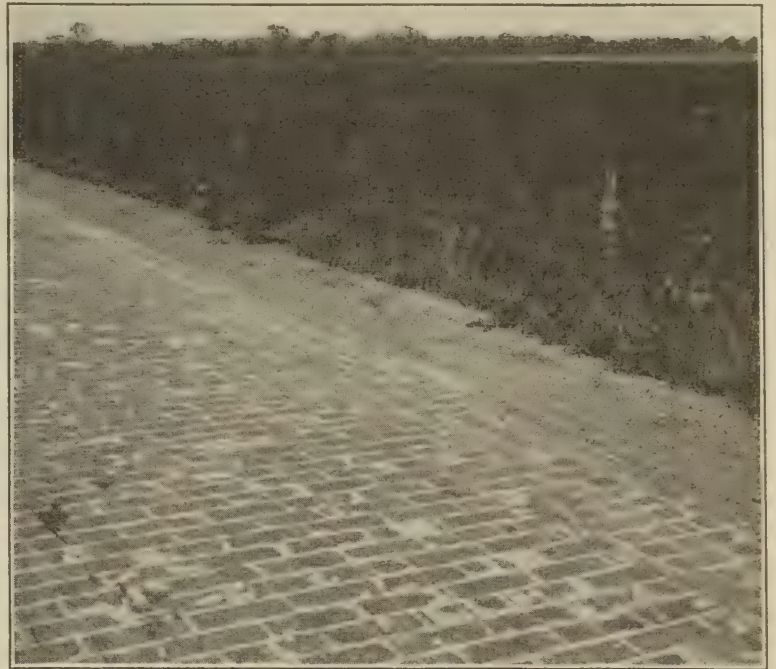
FIG. 1.—GROUT FILLED BRICK PAVEMENT ON GRAVEL BASE, COLUMBUS-CHILlicothe ROAD.

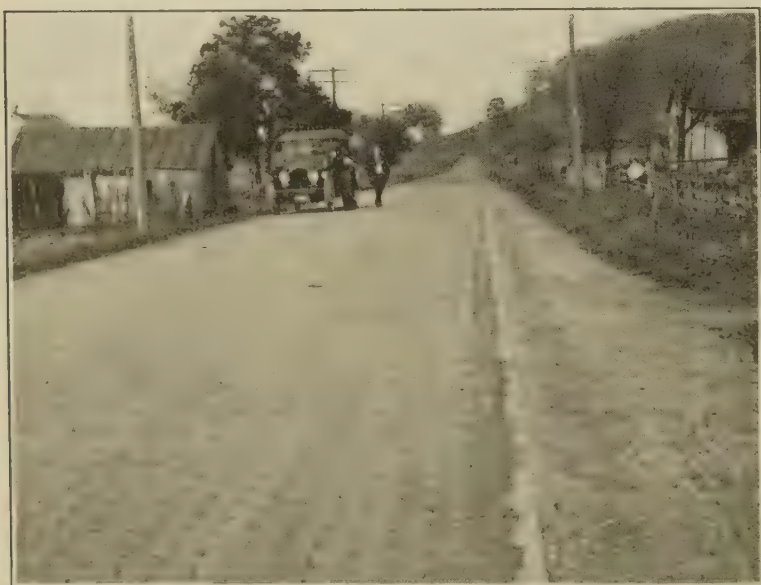
FIG. 2.—BRICK ROAD ON GRAVEL BASE, TAR-MASTIC FILLER.

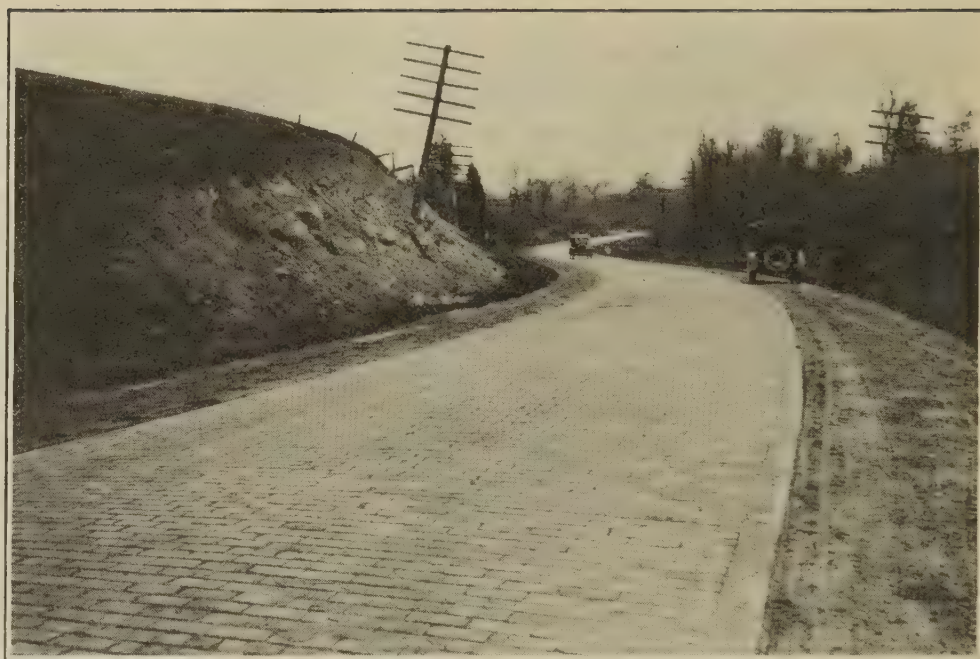
FIG. 3.—REPRESENTATIVE SECTION OF THE NATIONAL ROAD, A TAR-MASTIC FILLED BRICK ROAD ON A CRUSHED SANDSTONE BASE.

The portion of the road lying in Muskingum County and east of Zanesville (fig. 3) was constructed in 1918 and due to war conditions every effort was made to complete it in the shortest possible time. The road is in two sections, about 13 miles long and is constructed for the most part on a base consisting of the soft local sandstone, showing a percentage of wear in the neighborhood of 20 by the standard Deval abrasion test. The nominal thickness of base is 8 inches, $3\frac{1}{2}$ -inch brick were used, and the filler was a tar mastic. A detailed inspection at several points along the road failed to show any serious foundation failures. In one place just east of Zanesville the highway was constructed over an 18-foot fill. Some movement in this fill has caused the road to settle very slightly resulting in a somewhat un-

even surface on the side of the road where the fill is deepest. The condition of the road at this place illustrates very forcibly the value of using a flexible slab for wearing surface under conditions similar to those just described. Had the brick surface over this fill been grouted as was the former practice on roads of this type the slab would undoubtedly have cracked under the impact of traffic due to the yielding support and the section would probably have failed entirely by this time. As it is, the slight settlement is the only evidence that anything unusual has taken place.

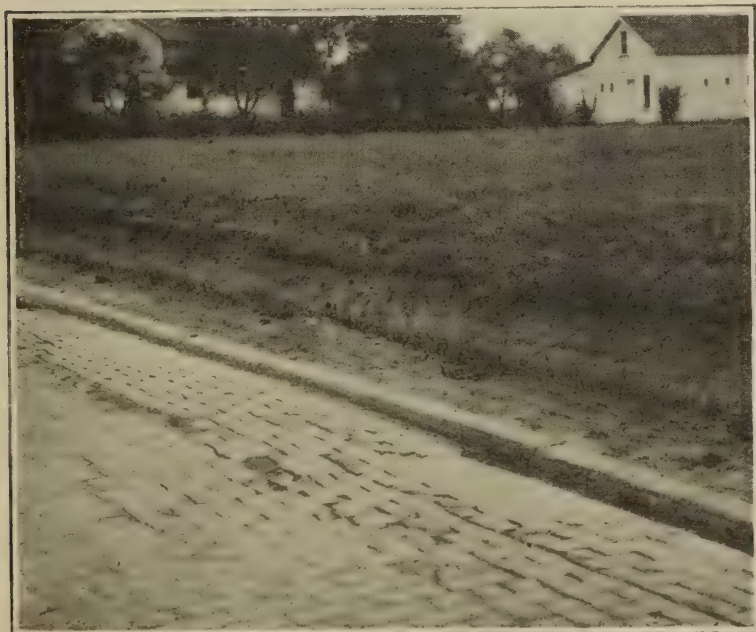
FIG. 4.—GROUTED BRICK ON 6-INCH SLAG BASE
STARK COUNTY, OHIO.

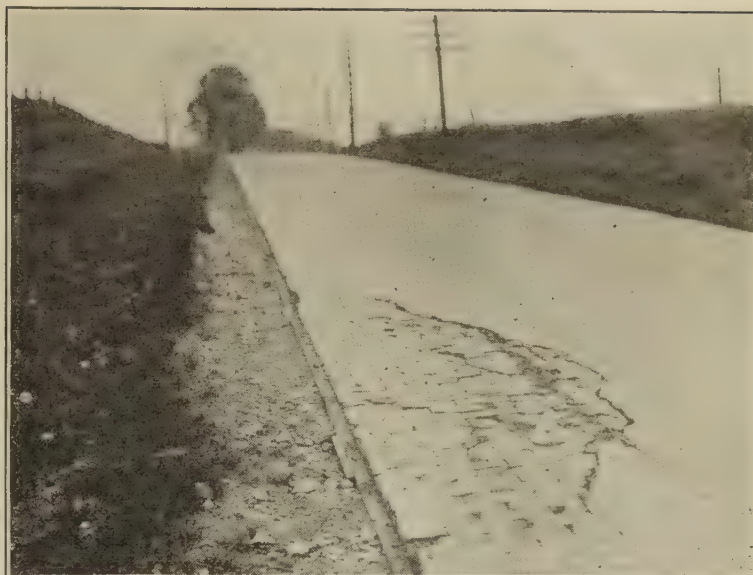
FIG. 5.—GROUTED BRICK ROAD ON SLAG BASE,
MAHONING COUNTY, OHIO.

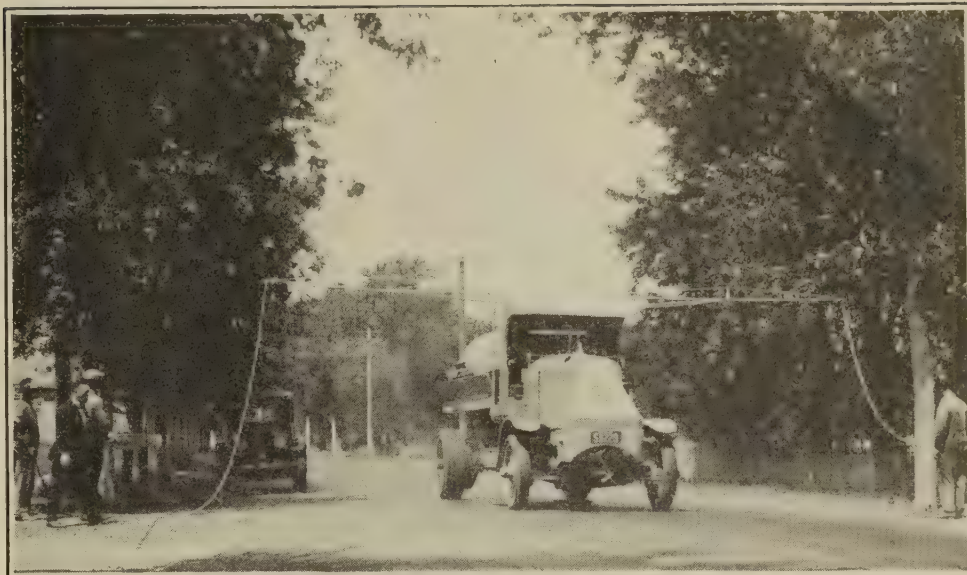
AN ARMY TRUCK CONVERTED TO SPRAY WHITWASH ON POLES IN NEW JERSEY.

Odd but ingenious use has been made by New Jersey of a Mack truck originally intended as a water sprinkler and equipped with a centrifugal pump which was mounted beneath the tank and driven by the propeller shaft. This was changed to a machine for spraying whitewash on poles along the State highways. The sprinkler heads at the rear were disconnected and two other connections were made from the outlet of the pump—one extending forward, the other to the rear. The forward connection was carried to pipes at each side which rise to the top of the cab and are there connected to garage car-washing swivels. The other connection enters the tank through the filling cap in the bottom. Inside the tank on this connection was placed an ell with a short nipple pointing forward. This connection was made for the purpose of agitating the whitewash mixture by pumping a part of the mixture back into the tank, and in order to increase the agitation the nipple at the end of the connection was flattened. The spraying mixture is pumped through the forward connection, and the garage swivels lengthened to 10 feet with 25 feet of hose attached permit traffic to pass while the truck is at work.
