PUBLIC ROADS

A JOURNAL OF HIGHWAY RESEARCH

VOL. 7, NO. 3

MAY, 1926

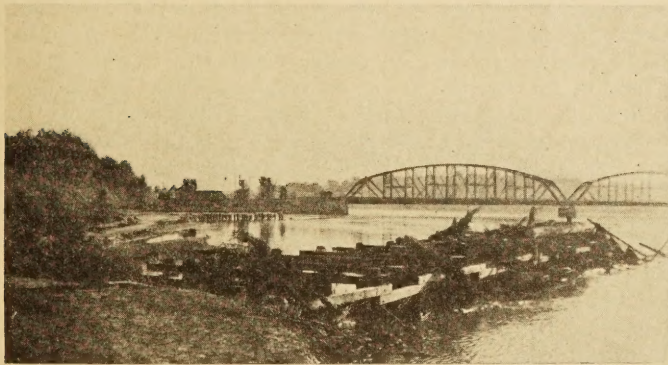
FIG. 3.—Middle dike of a series of three pile dikes protecting bridge at Leavenworth Kans. Note accumulation of drift

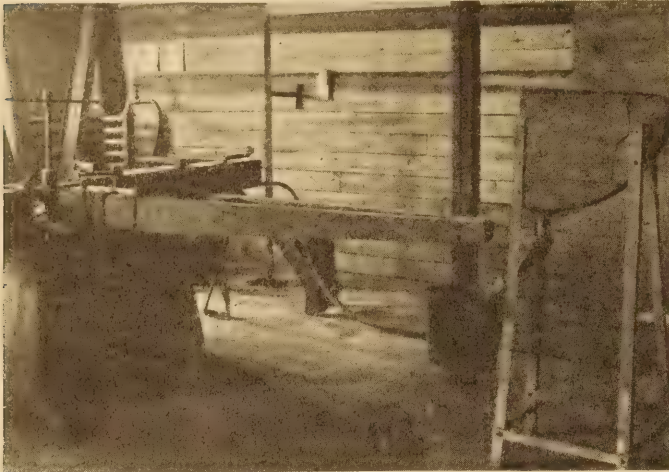
FIG. 2.—Apparatus used in determining transverse breaking strength of concrete beams
